The Queen's Head Chambers.  
16 St John's Road,  
Clacton on Sea.

Heritage Statement/Report.  
2021

Prepared by J Parker MSc (Conservation of Buildings)

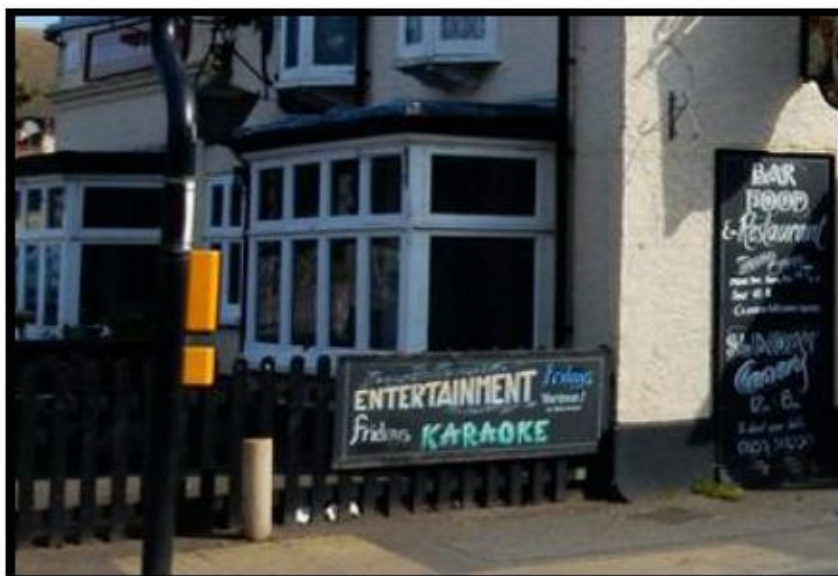
The bay windows. This window was undergoing repairs to the outer frame at the time of the initial survey. There were signs that the lower-level casements had previously been removed and then the frame been directly glazed. A picture from 31/3/2016 supported this claim.

The fanlight design of the bay and profile of the windows is of a style common in the 1930's and 1940's.

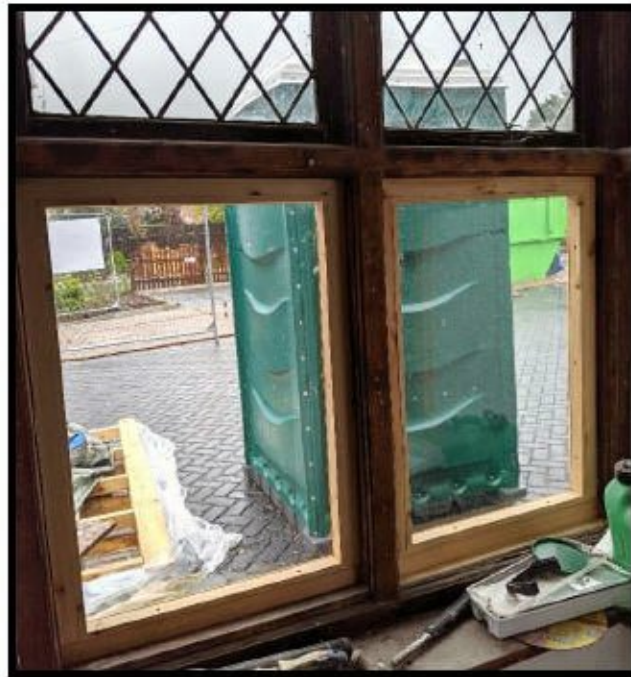
Front bay sash window.

On inspection there is evidence of filled cut outs for hinges for the lower-level casements. Casements were made on site, unfortunately they did not reference the existing profiles of the upper-level casements resulting in a poor replica. The leaded lights are stuck on over a single sheet of float glass. See below.

The sashes are in overall acceptable condition, with the exception of some poor replacement glazing and a few missing glazing bars. The bottom rails are in workable

condition which is usually the site of decay. There is no evidence of sash weights or any of the expected iron monger associated with a traditional sash window. They will need sympathetic repairs to the joinery and glazing materials including putty that has failed, prior to decoration. The exterior cills show signs of previous repairs that are in need of attention.

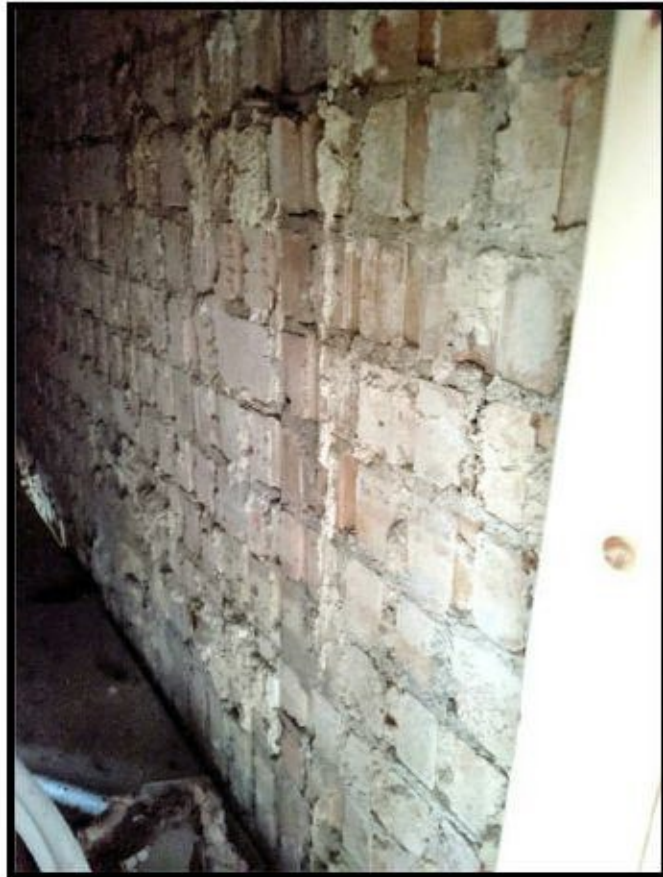
Pic 3

The majority of the rear walls have been boarded over yet there are sections that are still bare, revealing a furrowed Fletton type brick.

This type of brick was used to provide an adhesion key for cement render before the introduction of Aerated concrete blocks in the 1960's. This corresponds with the ground floor and once again there are no traces of a previous timber framed rear wall.

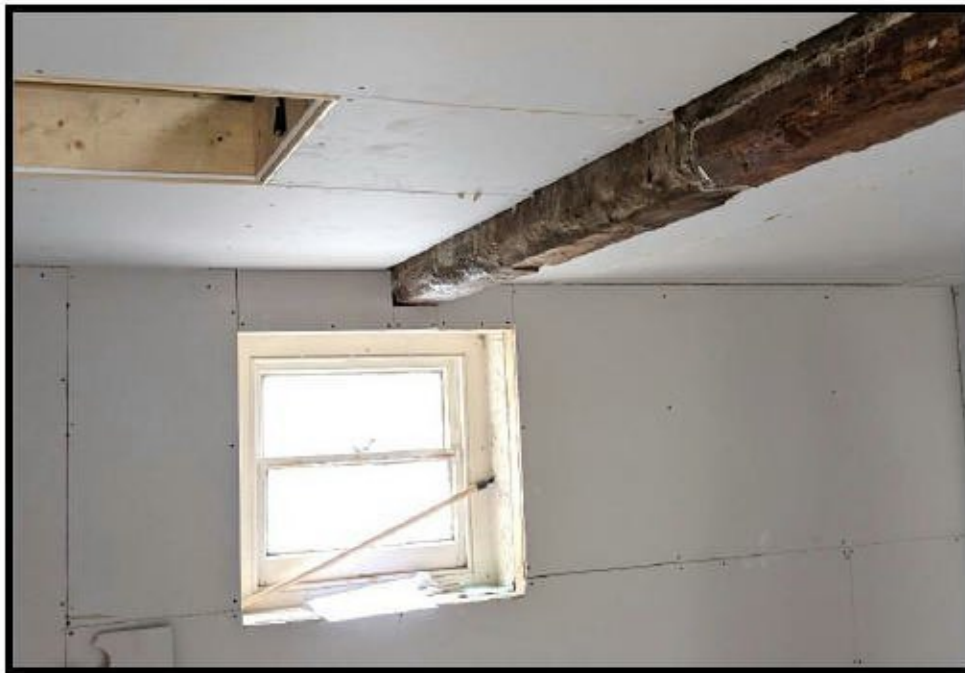
Pic 4

Further along in the Lounge (Pic 4) the rear window reveal is solid and has a depth akin to a 9" or 225mm solid brickwork wall.

There are no sash cords attached and the sash cord wheels have been painted over. These will need to be replaced and repaired to gain full function of the window.

The glazing is float glass.

The picture also shows the loft hatch that has replaced the poorly made stairs that were used to access the loft room.

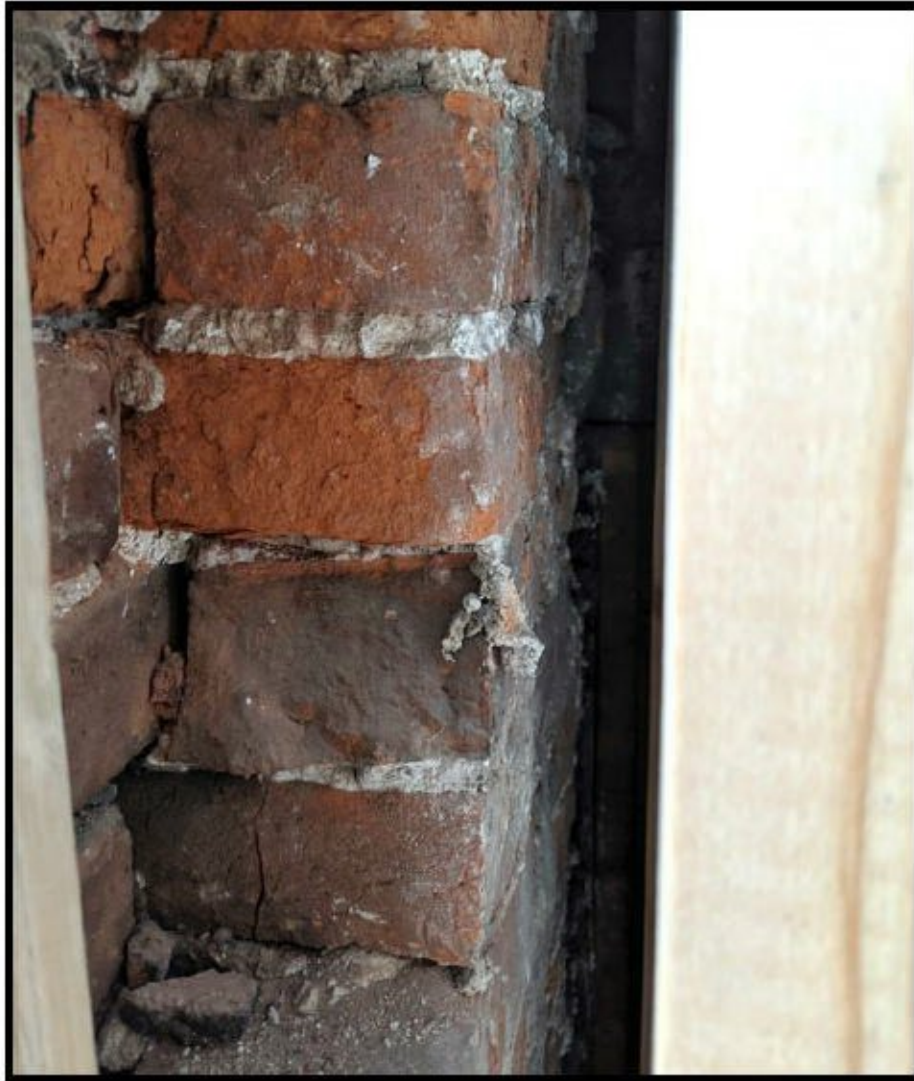
Pic 6

The brick dimensions are consistent with a brick size manufactured from the mid C19 to 1936.

Therefore, it is safe to assume the timber frame, front and side walls were replaced with the brickwork in the Victorian era or early C20.

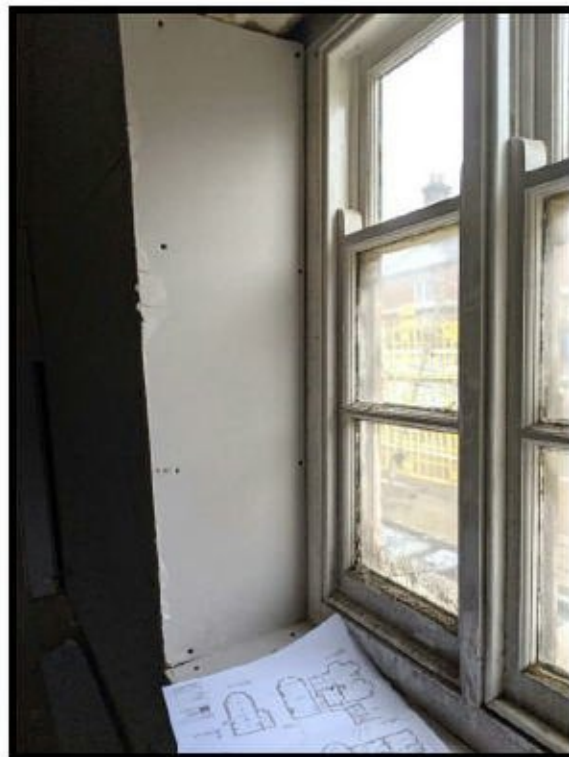
Pics 7 & 8

Small casement windows to the west elevation.

These windows replaced the C20 oriel windows and reference the casements from the 1903 picture.

The horizontal glazing bar is missing. The overall aesthetic would be improved if the glazing bar were to be reintroduced. Beyond that the profile of the casement and frame appear to be almost identical in size.

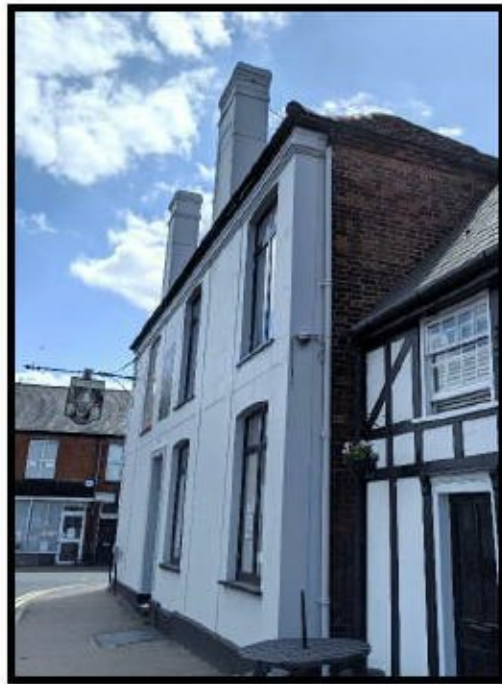
To the far end of the buildings the original brickwork is still visible.

From the brick sizes we can make a conservative estimate of the age of this part of the building.

The 9-inch Imperial face brick built in a Flemish bond with lime mortar suggests C19 construction. The wall is in good condition partly due to the protection of its shielded position protected by the neighbouring building.

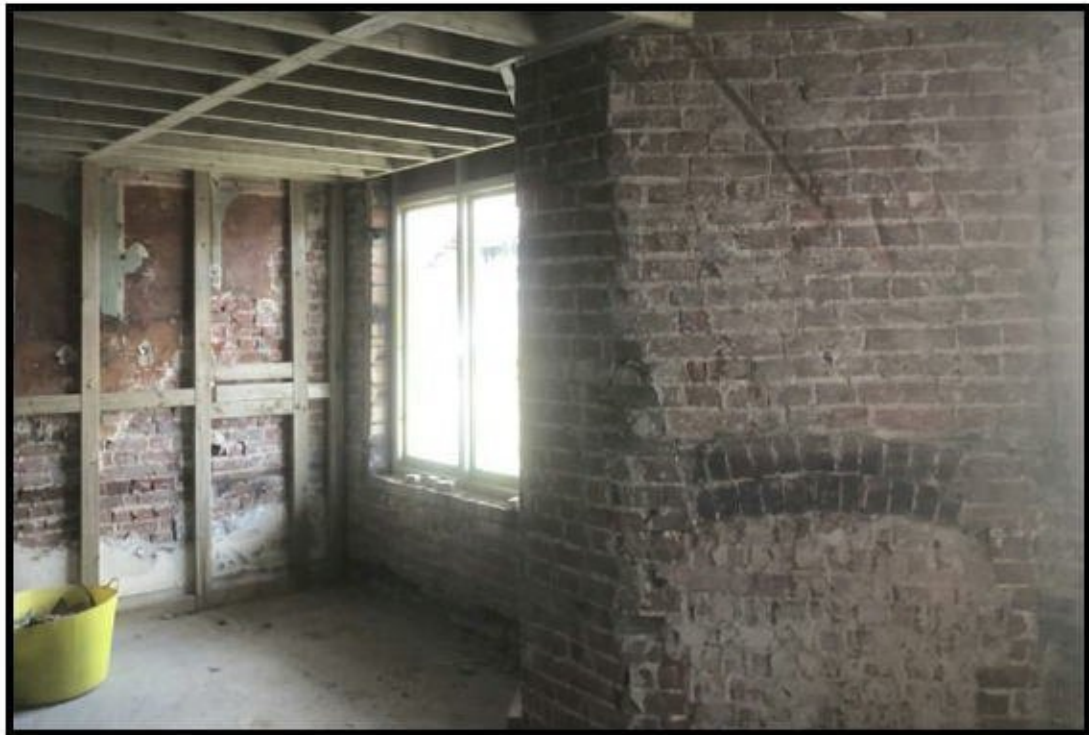
The picture shows the brickwork with what was reported as cement render removed.

The fireplace to the left was previously bricked up in C20 bricks and cement mortar.

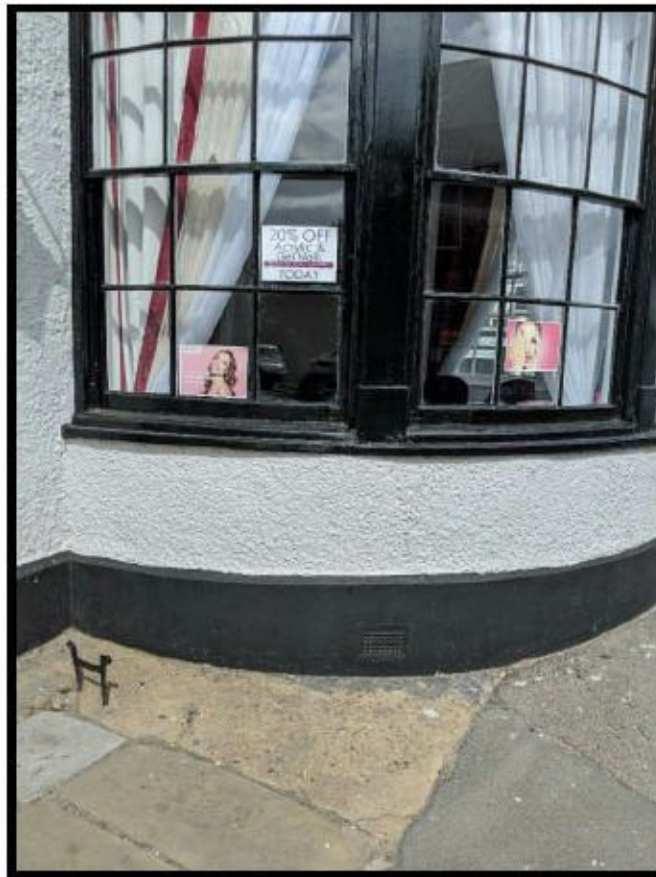
This picture shows the original plinth with an air brick, there is a second air brick on the other side to vent the floor.

The boot scraper serving the doorway to the corridor between the Section 1 and 2 remains. These were most popular in the late C19 due to the pre-tarmac roads and the widespread use of horses, as is evident in the picture on page 2.

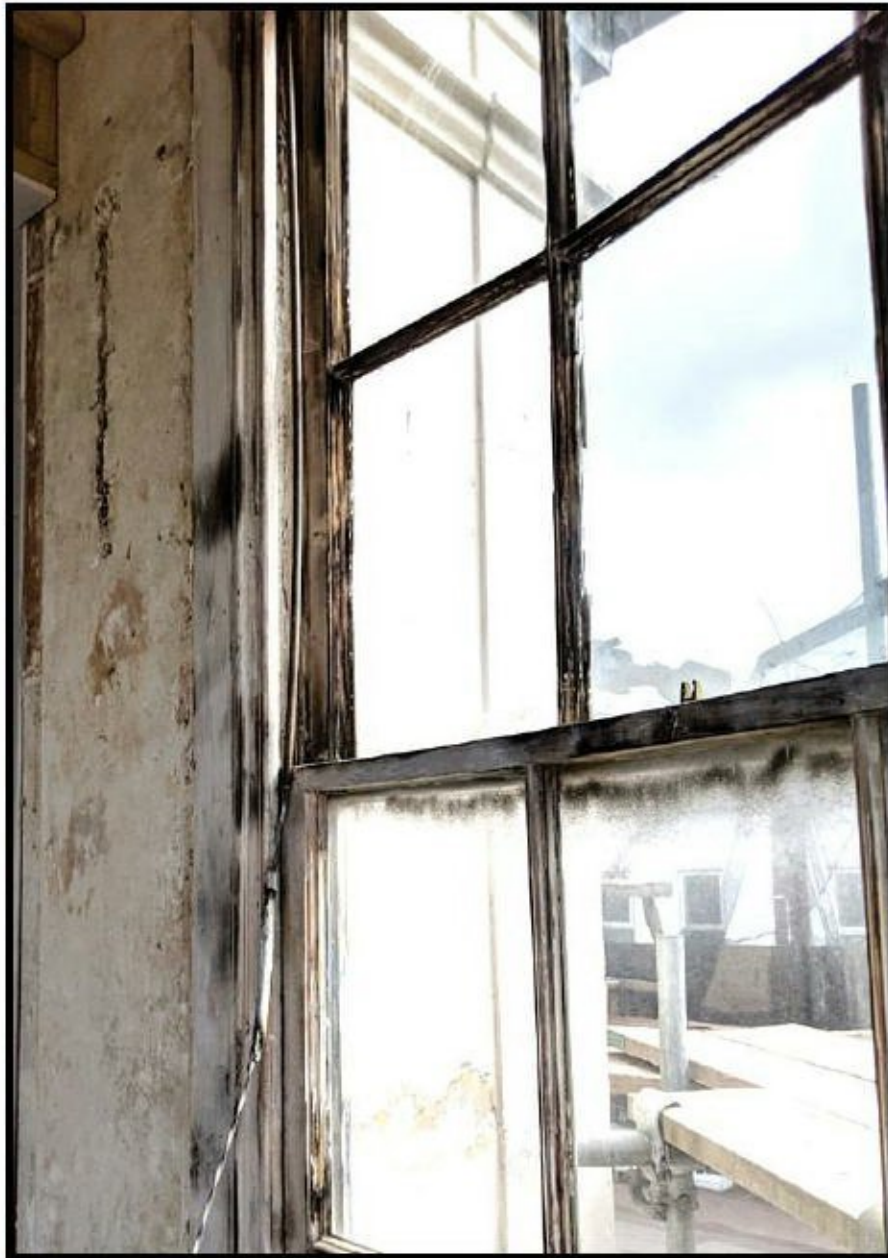
The picture shows the sash opening mechanism, a Spiral balance.

Invented in America these balances were introduced in the 1930's, but their popularity really took off after WWII.

A check at the top of the window frame confirms there are no signs that these are a later conversion as there is no evidence of a repair from a pulley removal or sash weight boxes. This, the float glass, and the lack of space for weights presents the windows as C20 replacement items.

Due to the intrusive works required to repair the failed spiral balances on many of the sashes it is proposed to respectfully fix shut the sashes with the failed balances leaving one double sash on each floor operational. This will ensure no further damage to the existing sashes while still providing adequate ventilation and means of escape from the rooms they service.

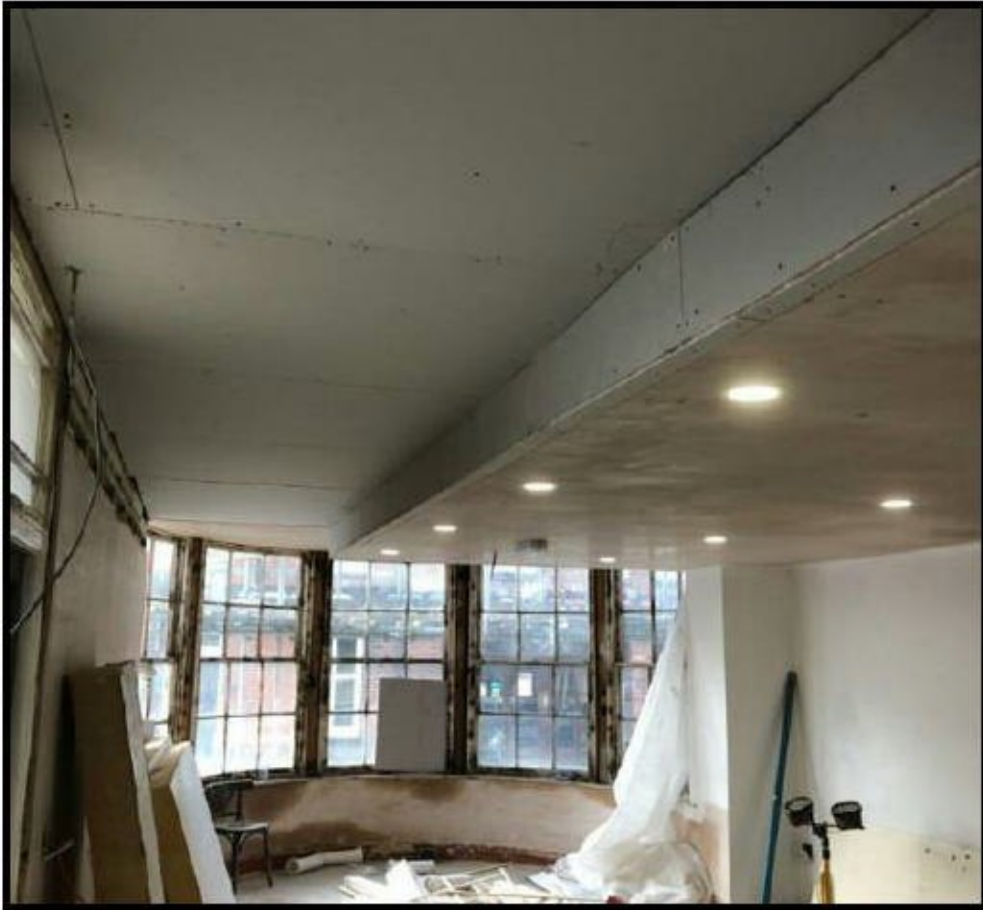
Above the new ceiling is the original lath and plaster item with sign of previous damage caused by the installation of the earlier suspended ceiling. Agreement with the TDC's conservation consultant to reduce the ceiling to its current layout has resulted in the configuration in the picture on the next page.

The raised ceiling height matches the full height of the bow window. See drawing number  
P&P/20/160/01

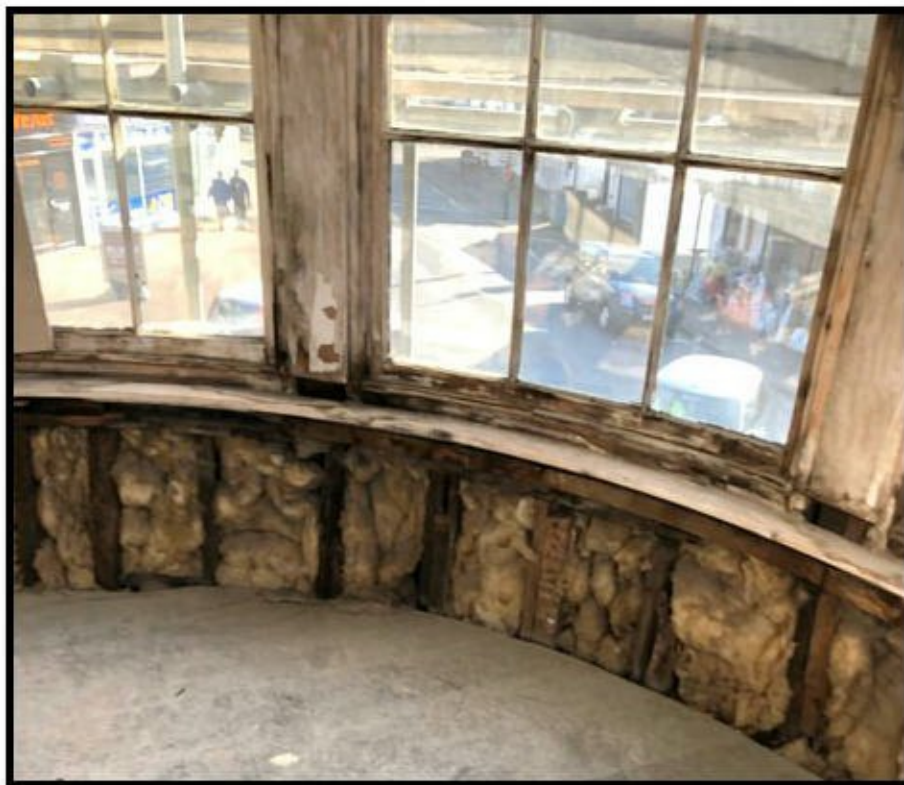
In a change from the ground floor under the bow wall is softwood timber studwork. This has since been lathed and lime plastered.

The picture shows the bark timber studwork.

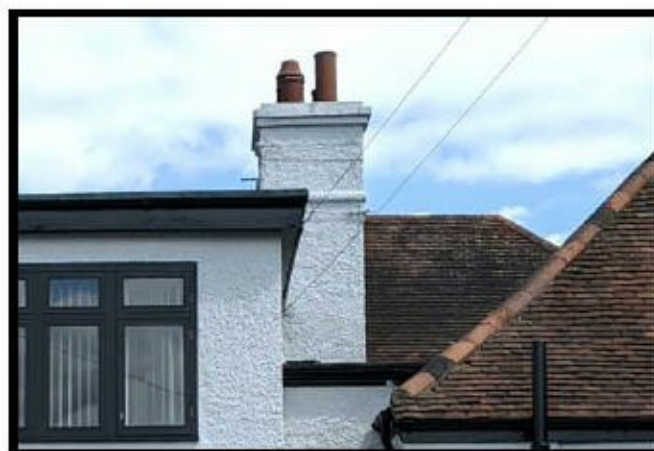
The chimney has had a similar pargetted design to those in Section 2 that has subsequently

been covered in pebbledash prior to painting. The chimney has been reduced in height from the 1903 picture.

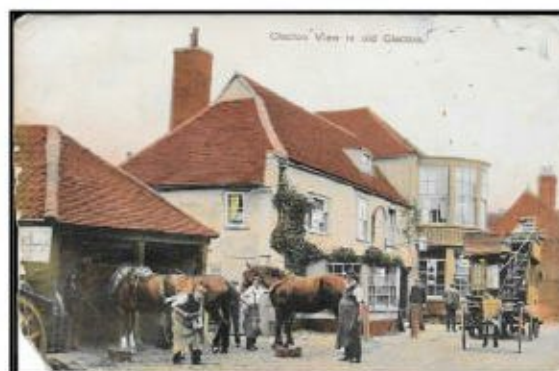
The current chimney has been reduced in height from the original in the 1903 image.

It has had 2 additional flues added to it. This would require it being rebuilt. This chimney would have originally been built to serve Section 1 on the rear wall of the original building.

This is evident by the 2 chimney pots for ground and first floor. It has later been replaced with the current lower chimney that has the 4 pots to serve both Section 1 & 3. It is now redundant due to central heating installed throughout the building.

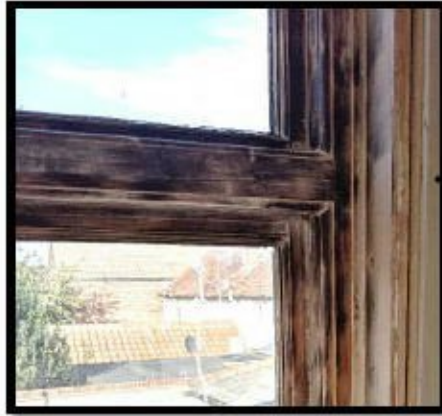
First floor. The single casement window has a drip bar beneath the top, top hung casement. The profile in the picture below suggests it was constructed to match the bay window below which is established as an early C20 construction.

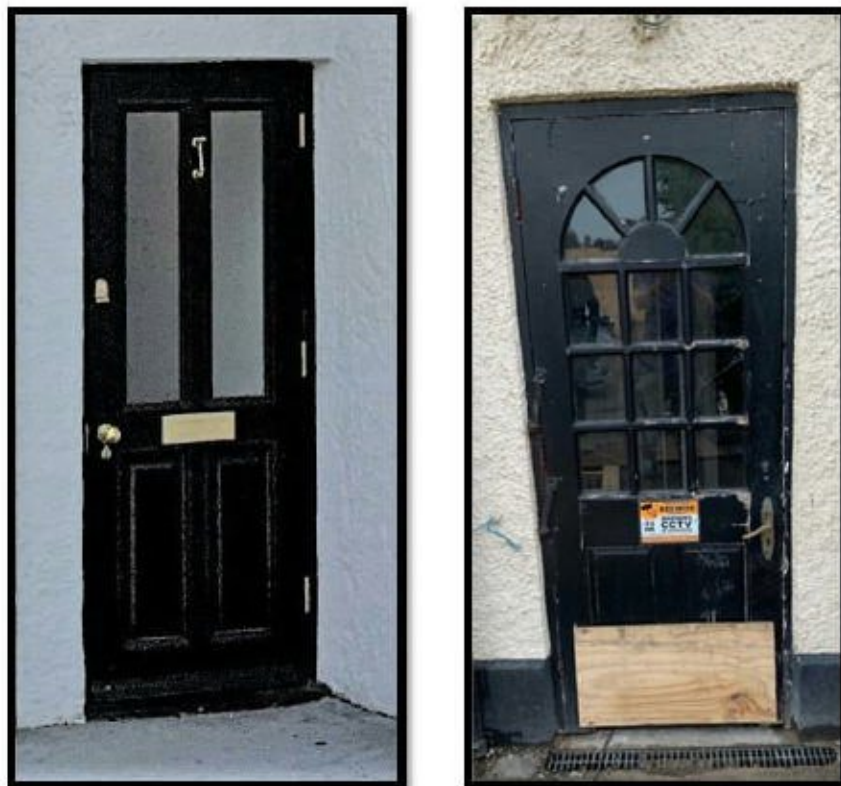
Side door.

It is proposed the new hardwood Victorian style door on the left replaces the failed C20 mock Georgian style door on the right.

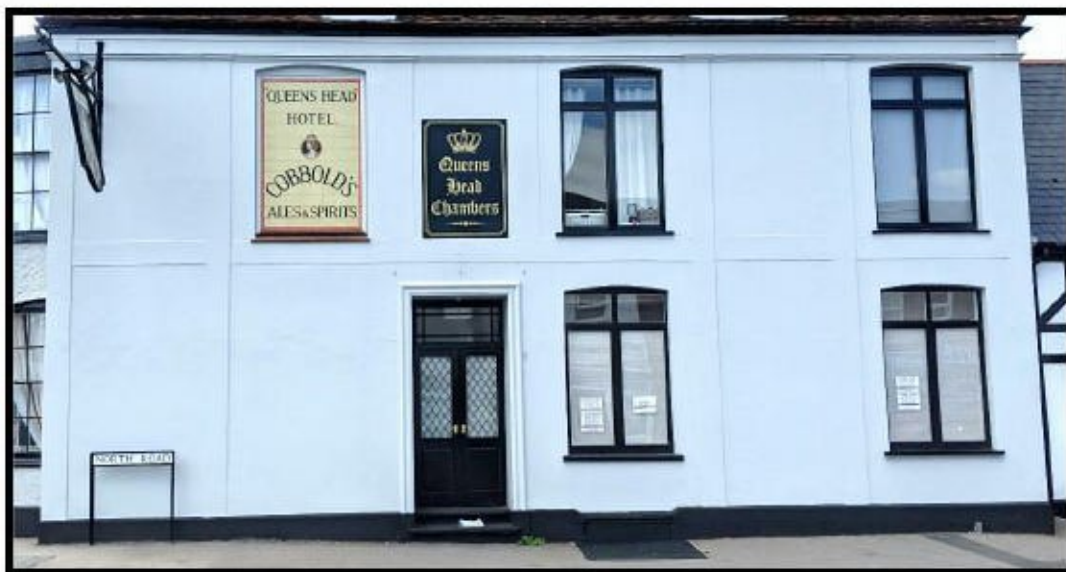
Current.

The previous windows appeared to be attempting to reference a mullion window yet due to their heavy profile gave the appearance of uPVC items and sat uncomfortably in the elevation. The lower sections of the casements and cills show signs of decay this had resulted in the bottom rail of one of the windows becoming detached (see page 39) exposing the single pane of glass with the stick on imitation leaded lights.

The current windows have referenced the profiles of existing casements and the double doors. The windows were designed with 2 large casements to allow safe exit in case of fire.

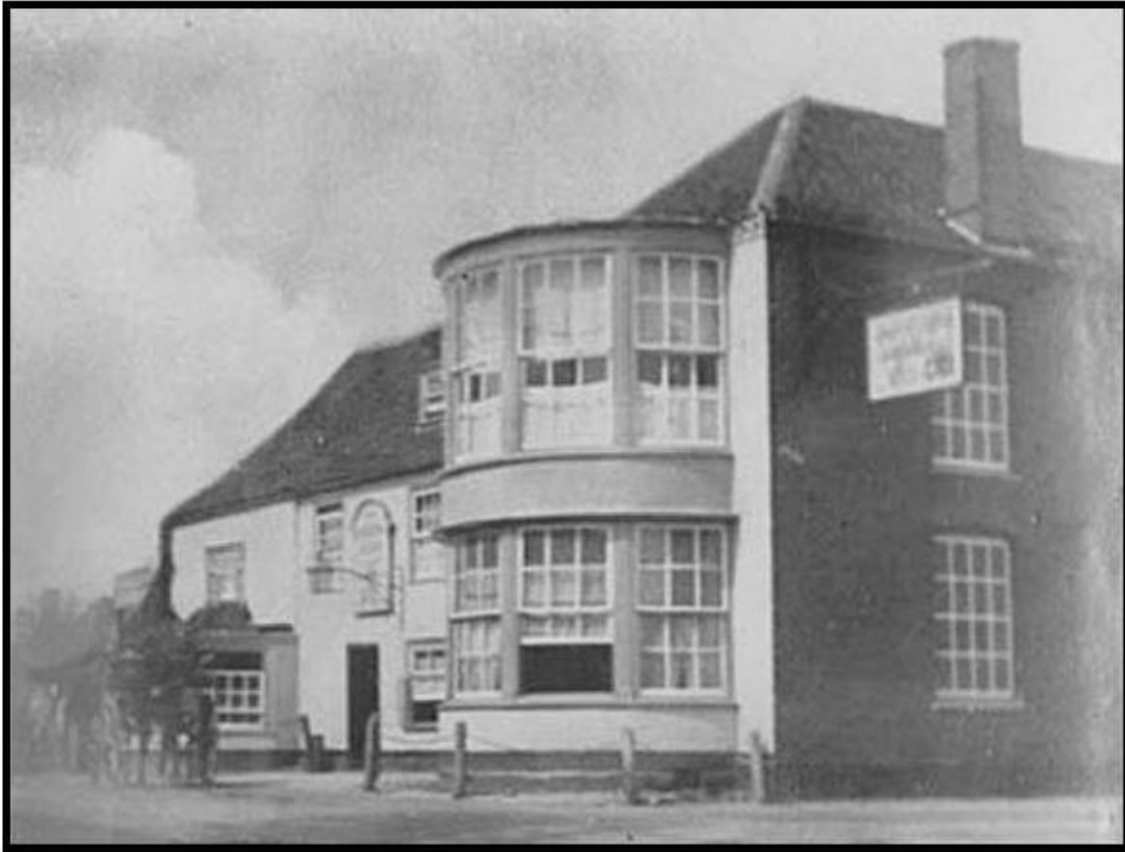
The above picture from 1895 shows painted on Georgian style windows that may have imitated sash windows further along the elevation. Since then, the openings have been reduced.

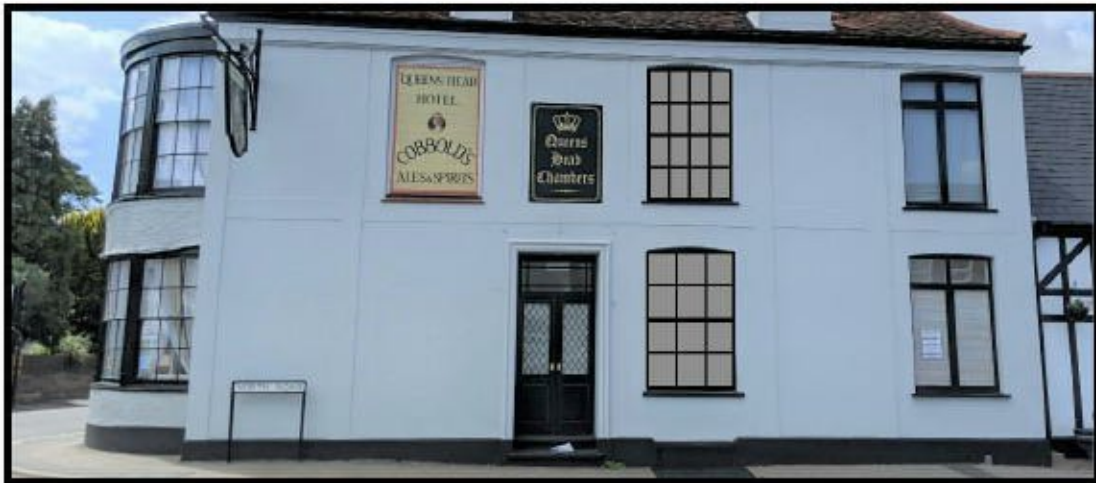
The very basic mock-up above shows how replacement Georgian sash windows would appear and confirms the current previously reduced apertures do not suit this style of window leaving the panes both too narrow on the first floor 4x2 sashes and too wide in the ground floor 3x2 sashes. Both designs also appear at odds with the feature bow window. Therefore, it is proposed for a maximum of five years to keep the current casement windows in contrast to the bow window, whilst being an improvement over the windows they replace.

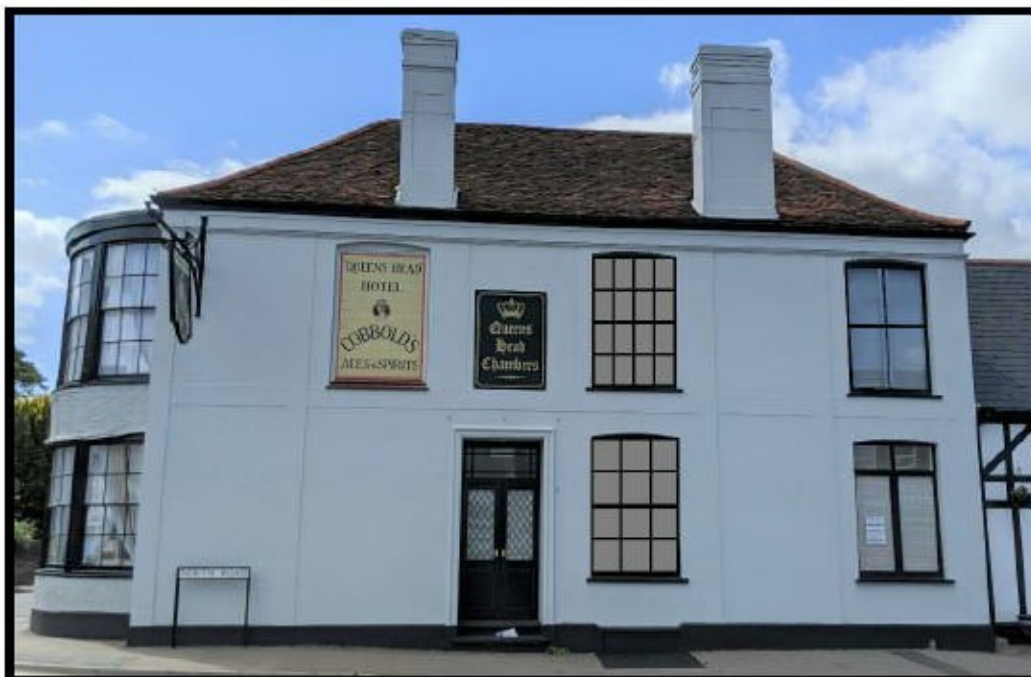
- The mock-up drawing shows the top right window as a Victorian style sash window which sits comfortably in the elevation.

It is proposed that upon redecoration of the exterior of the building the current windows are removed and replaced with the replacement timber Victorian style new box sash windows. The profile of the replacement windows is to be an exact copy of the first-floor tall sash windows in Section One. They are to be glazed in modern float glass with the lower sashes being glazed with toughened glass in accordance with current building regulations due to their height from finished floor level. The windows are to be designed and have sufficient sash weights to accommodate the heavier toughened glass. This will add continuity to the fenestration whilst continuing the commitment to the long-term conservation of the building.
