ASBESTOS MANAGEMENT SURVEY REPORT
Of
THE PADDOCKS
HONILEY ROAD
BEAUSALE
WARWICKSHIRE
CV35 7NX

REPORT REFERENCE: S2069

Site: The Paddocks
Honiley Road
Beausale
Warwickshire
CV35 7NX

Client	Mr Adam Hicken	Survey Ref	S2069
Survey Type	Management Survey	Survey Date	17/08/2020
Site Address	The Paddocks, Honiley Road, Beausale, Warwickshire, CV35 7NX	Surveyor	Sul Ibrahim
		Report Date	25/08/2020

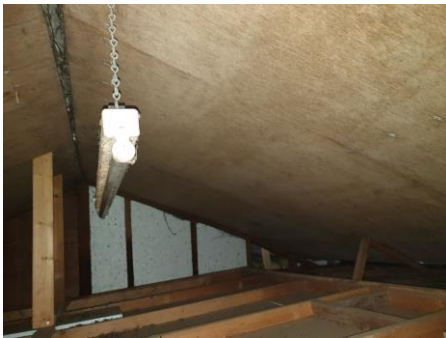
Ref No.	Floor/Room	
G1	Building 1/Loft	
Comments		
Timber ceiling. Timber joists, beams and hatch. Polystyrene partition to wall. Electrics to timber.

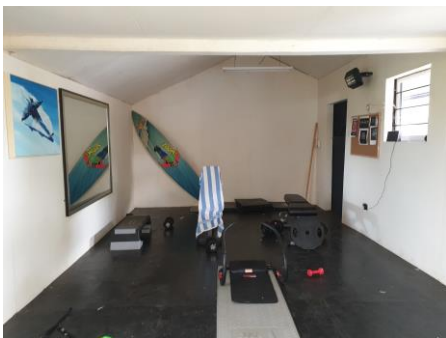
Ref No.	Floor/Room	
G2	Building 1/Gym	
Comments		
Timber ceiling panels. Timber wall panels. Vinyl to timber floors. Timber doors and door frames. uPVC window and timber sills. Modern wall mounted storage heater.

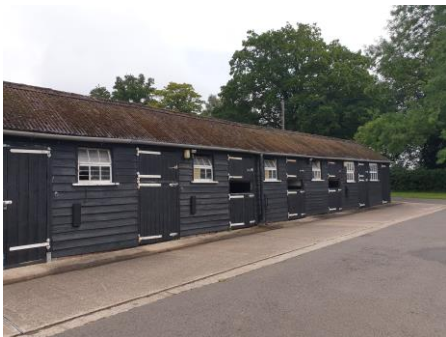
Ref No.	Floor/Room	
G3	Buildings 1 & 2/Externals	
Comments		
Timber and brick walls. Timber cladding to walls. Concrete and timber floors. Plastic rain-water goods. Timber window frames.

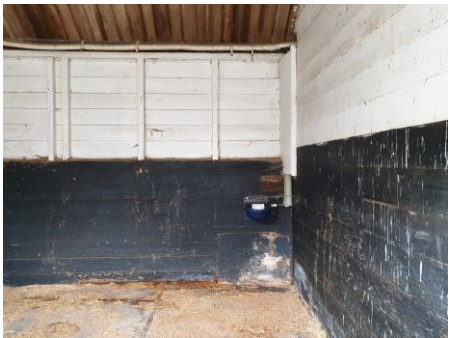
Ref No.	Floor/Room

G4	Building 2/Stables	
Comments		
<p>Timber ceilings. Timber walls. Timber floors. Timber doors and door frames. Timber window frames. Timber boxing. Metal and plastic pipework. Foam insulated metal pipes. Metal clad doors.</p>

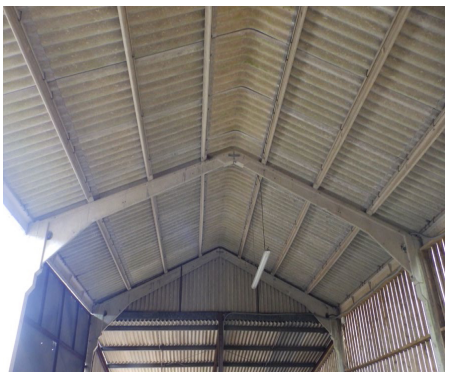
Ref No.	Floor/Room

G6	Building 3	
Comments		
<p>Concrete beams and pillars. Cement and block walls. Concrete floors. Cement roof. Cement downpipes and gutters.</p>

The cement walls, roofs, gutters and downpipes were in a good condition and can remain in situ. If these materials are likely to be significantly disturbed, they should be removed under controlled conditions and disposed of in accordance with Hazardous Waste Regulations (2005). This is not a licensed activity but the Control of Asbestos Regulations (2012) must still be adhered to. For further guidance on removal please see <http://www.hse.gov.uk/asbestos/essentials/>.

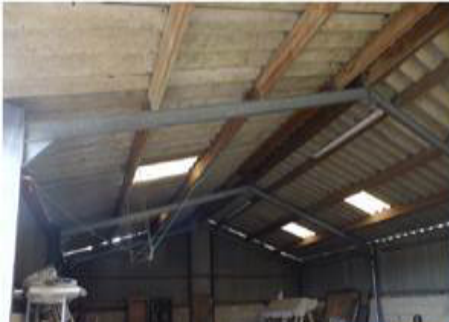
Ref No.	Floor/Room

G7	Building 4	
Comments		
Concrete beams and pillars. Cement and block walls. Concrete floors. Cement roof. Plastic and metal rain-water goods.

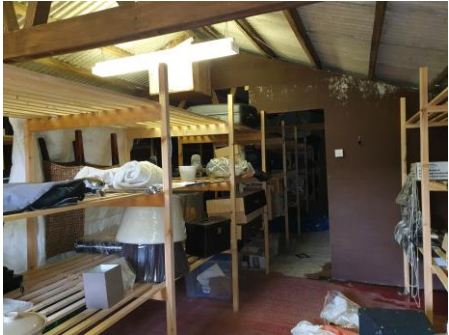
Ref No.	Floor/Room

G8	Building 5/Store	
Comments		
Timber beams and joists. Timber and cement wall panels. Concrete floors. Timber doors and frames.

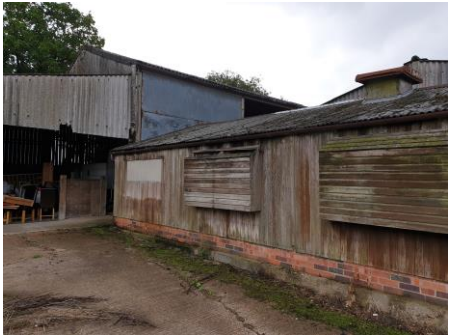
Ref No.	Floor/Room

G9	Building 5/Externals	
Comments		
Cement Roof. Timber and brick walls. Timber wall cladding to exterior.

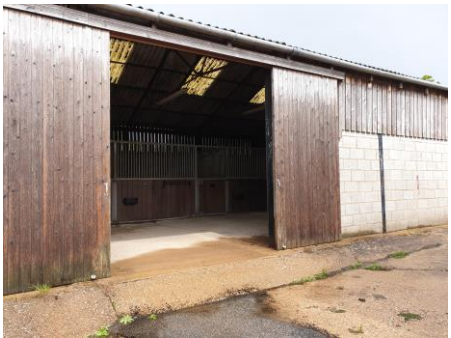
Ref No.	Floor/Room

G10	Building 7/Externals	
Comments		
Block and cement walls. Cement roof. Timber doors. Plastic rain-water goods.
