Date: 12 May 2021
Ref: P2291 0521 L1

Re: Inspection and Biodiversity Enhancements at Hargrave Lodge

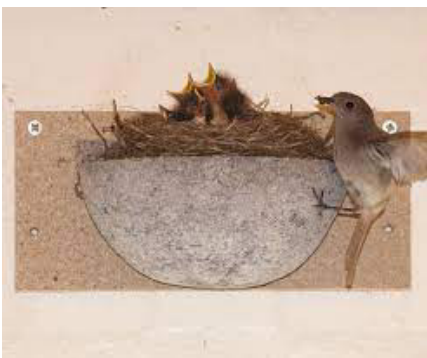
Schwegler swallow nest

To promote the use of the site area, five artificial swallow nest boxes will be erected in the locations shown in Figure 1. These will be positioned on the north gable end of Barn B2. These will be permanent artificial nest boxes which will be fitted on the north side of the building directly under the gutter line where these will be sheltered. It is recommended that Schwegler swallow nest bowls are used (as shown below) as these do not deteriorate over time and can be permanently affixed to the existing stonework / brickwork.

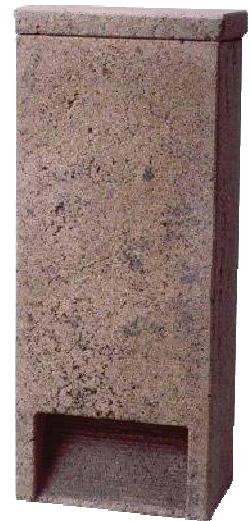
Schwegler bat roost tube.

To promote the use of the site area by bats it is recommended that a single artificial bat roost brick or tube should be erected in the location shown in Figure 1 below. This is a south facing position close to the existing boundary hedgerow that is easily accessible to bats. This purpose built, integral artificial roost box will be fitted close to the apex of the roof in a position that is not directly over any doors or windows. In this position the roost entrance should be not less than 5m above ground level.
