Job Title
Brunswick Place

Prepared for
Maryland Securities

Report Type
Structural Appraisal

Date
06/05/2021

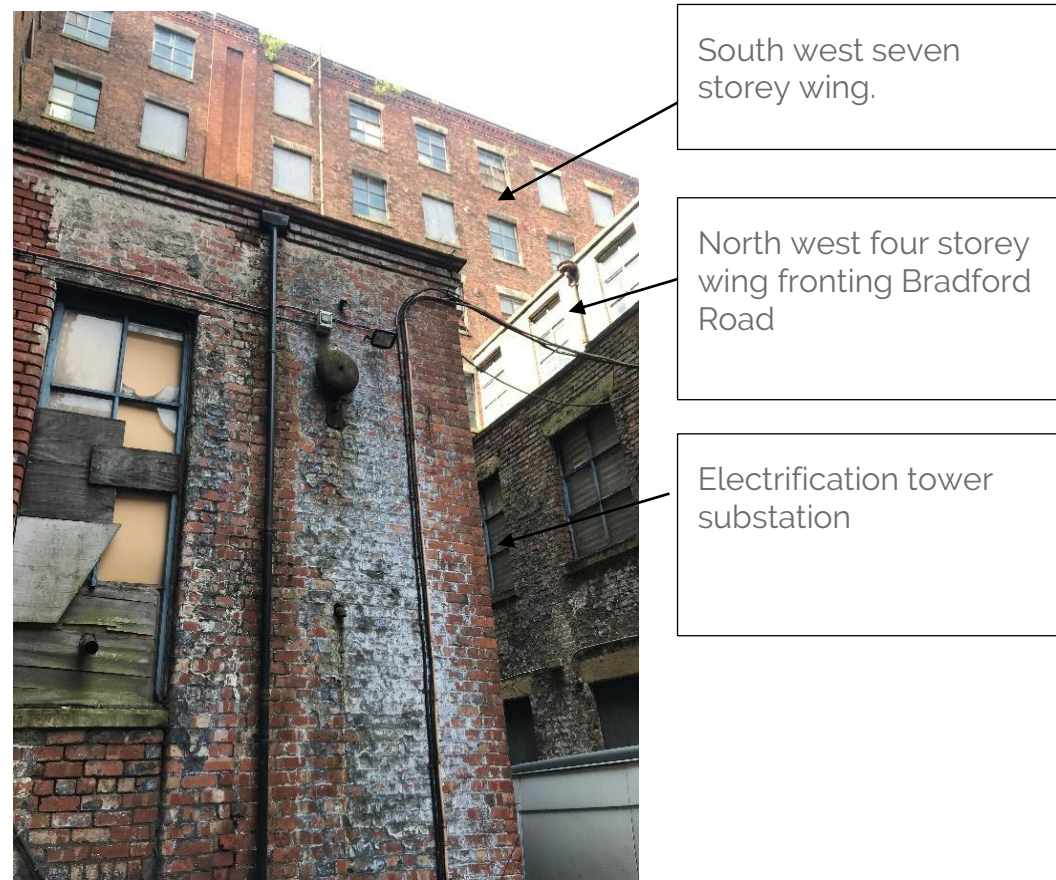
Figure 10: Southern Electrification Tower (looking south)

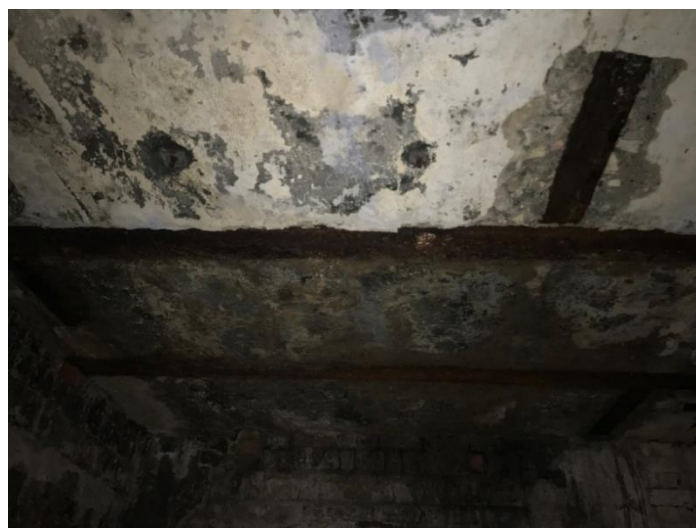
Again, although not accessible due to safety concerns, the ground floor structure, could be seen from above windows and semi basement soffit to be formed in steel filler joist floors with reinforced concrete slabs spanning between. Refer to figure 9.

Figure 9: Steel Filler Joist Floor

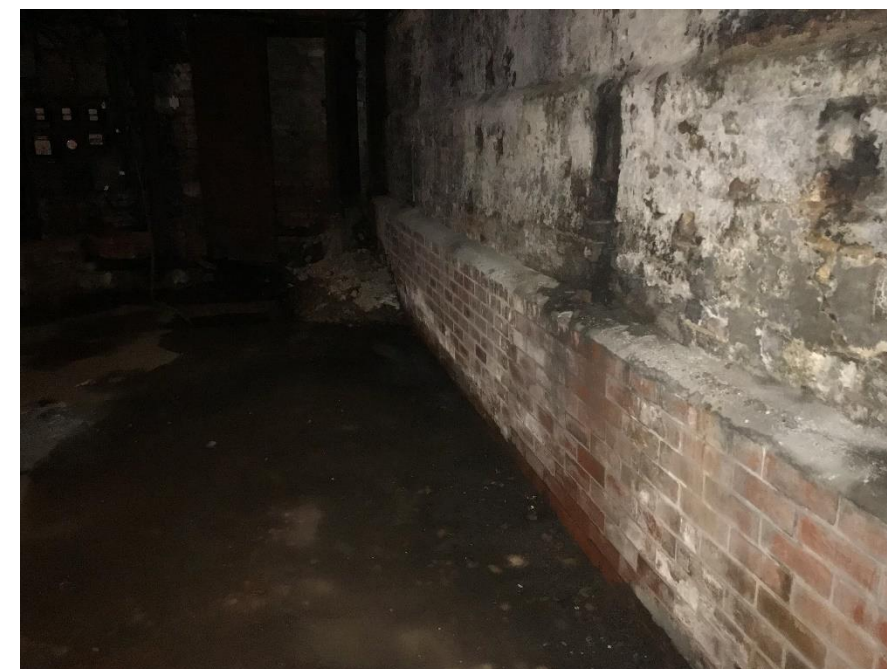
Foundations were not exposed as part of these investigations however, corbelling of the masonry walls could be seen within the semi basement therefore it is likely that foundations will be typical masonry corbel footings cast directly on to the subsoil. Refer to figure 10.

Figure 11: Corbelled Masonry Footing of Main Wing Viewed from within Electrification Tower

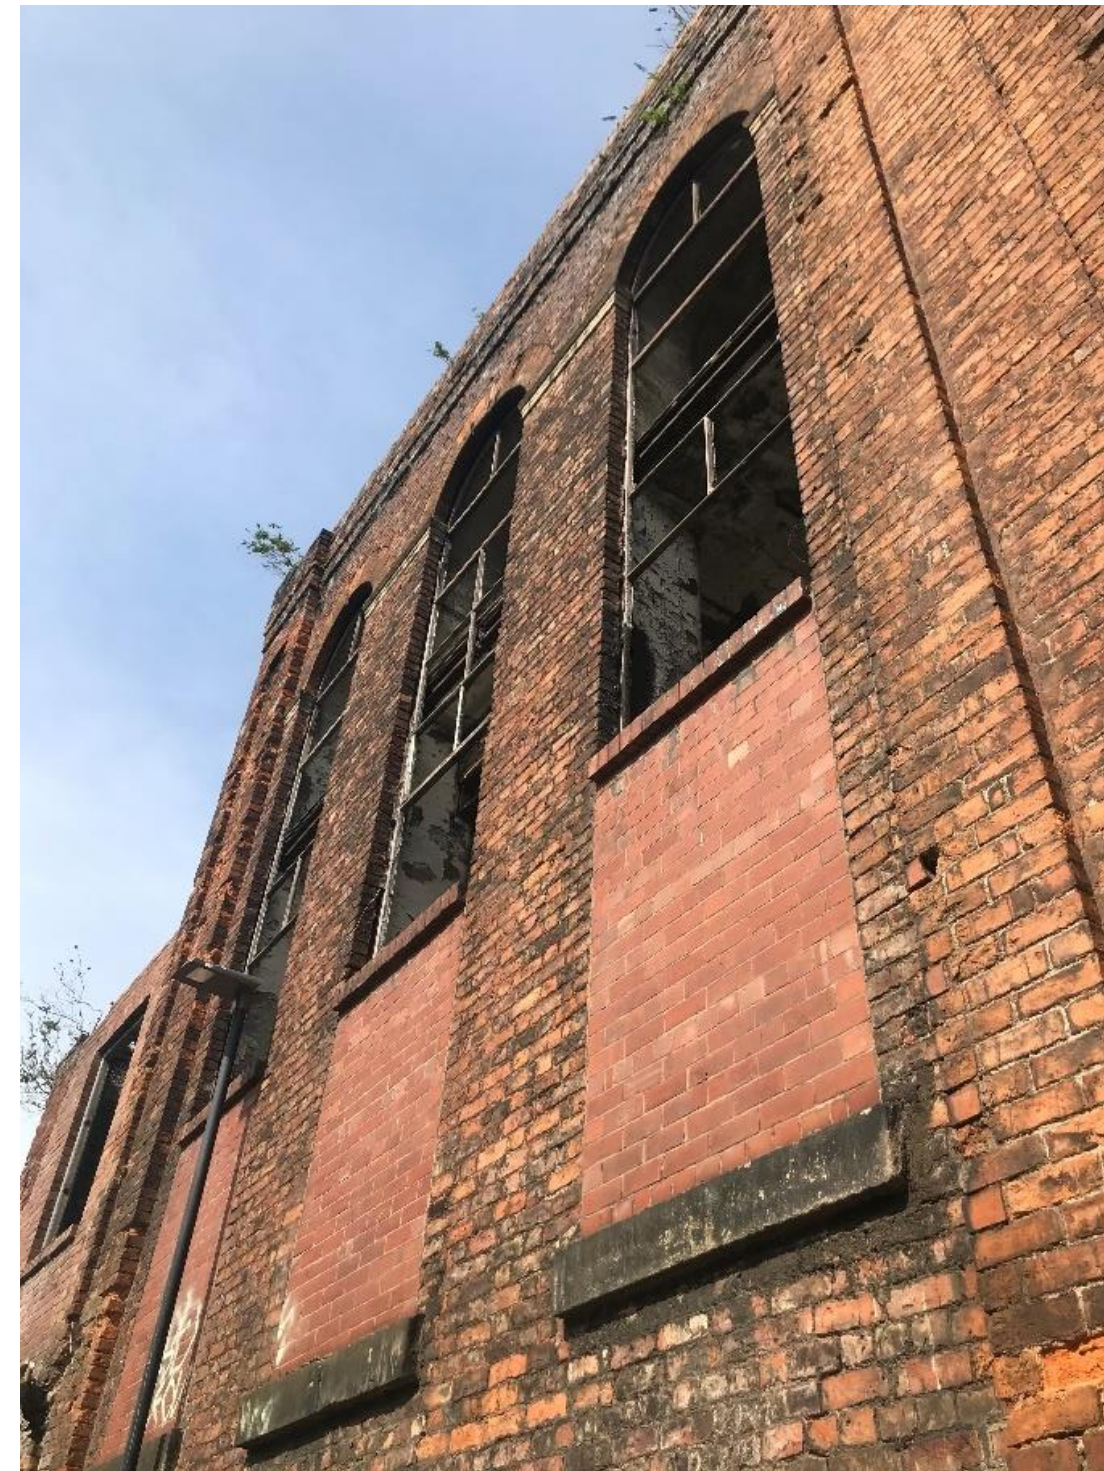
From further observations, looking down from roof of the mill and towpath behind it can be seen the boiler house has sustained significant fire damage at some point in the past and would therefore not be safe to access. Refer to figures 11 and 12.

Figure 13: Rear Elevation of Boiler House from Towpath

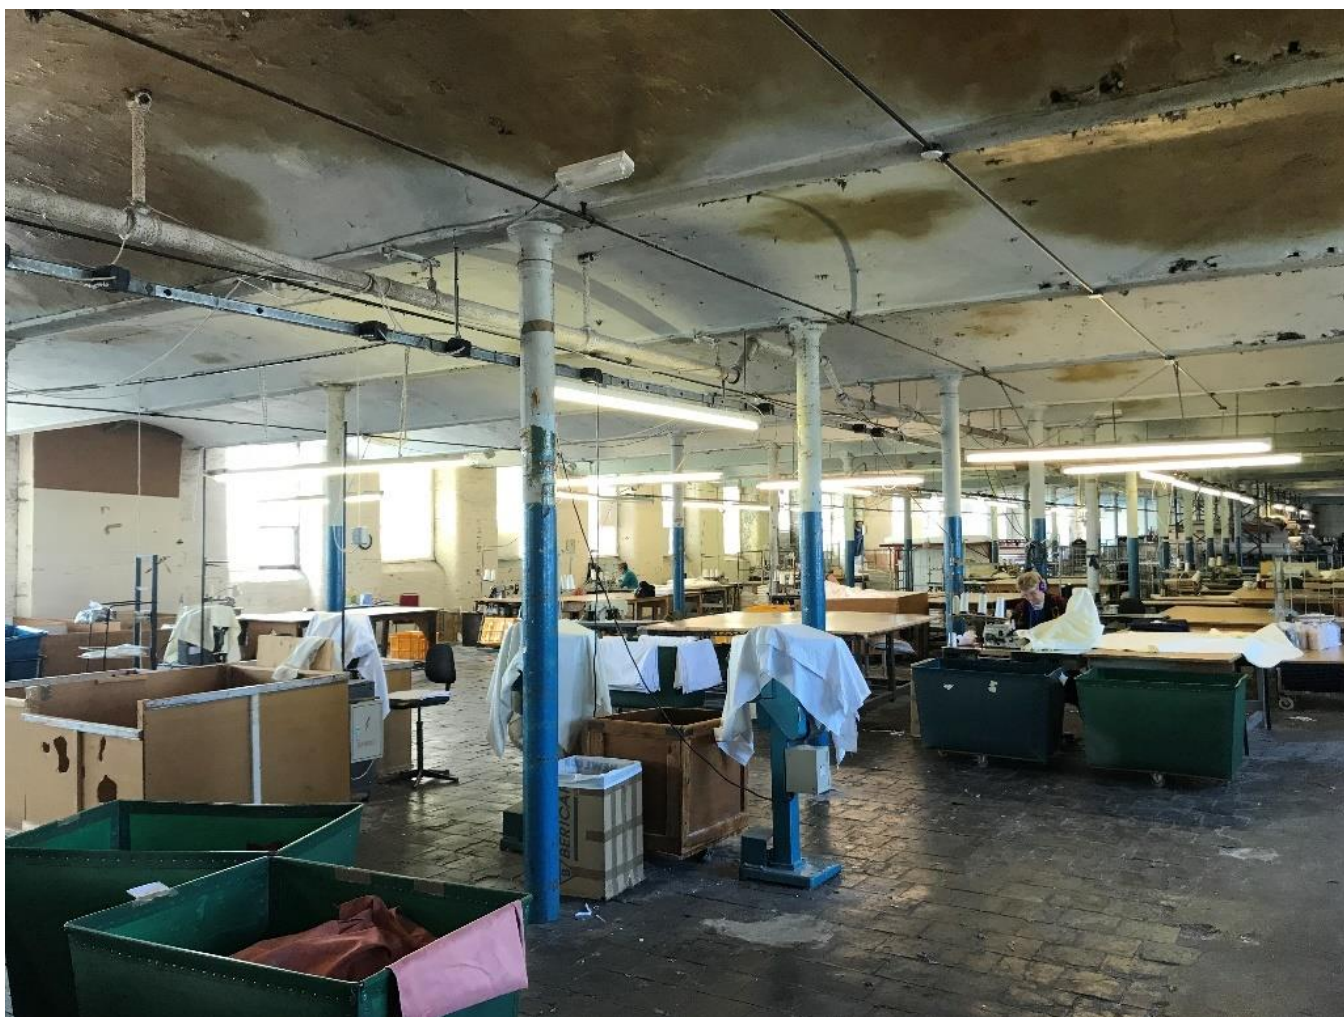
Figure 26: General View of Fourth Floor

There is evidence of significant water ingress and associated damage to masonry jack arches and lamination of cast iron structure. Refer to figure 26.

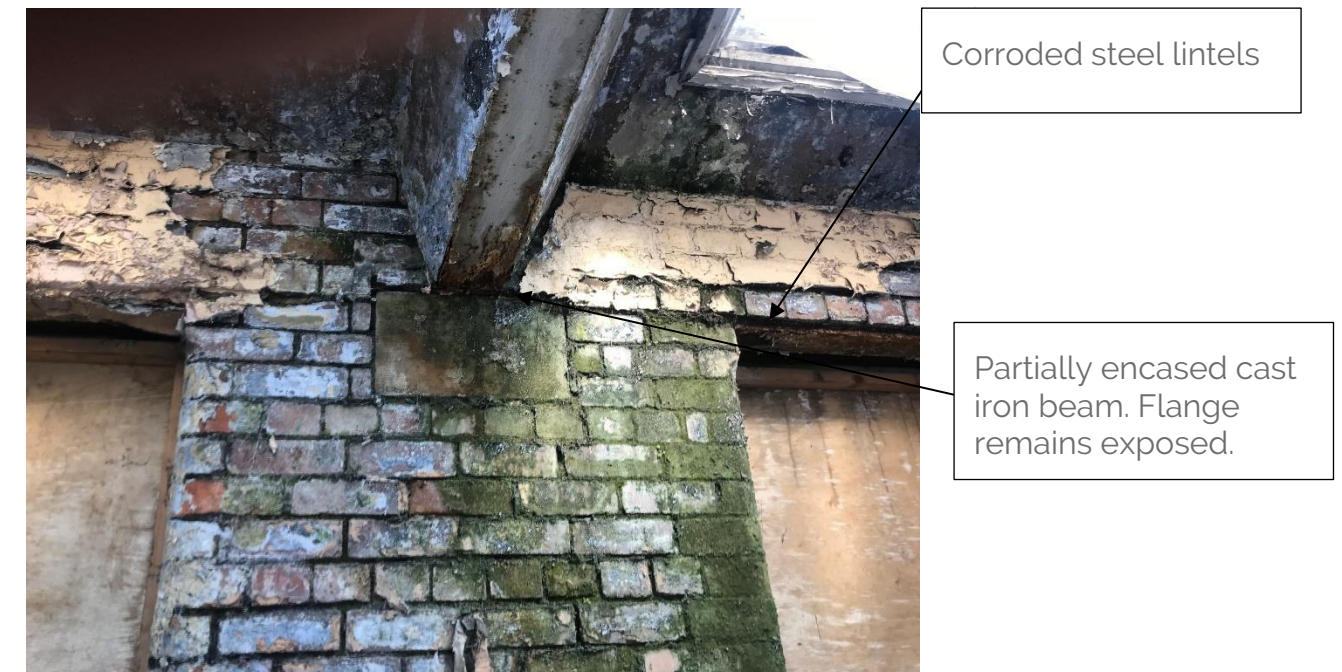
Cast iron beams are partially encased in concrete to create a chamfered detail between roof slab and beams. Refer to figure 31.

Figure 32: Partially Encased Cast Iron Beam

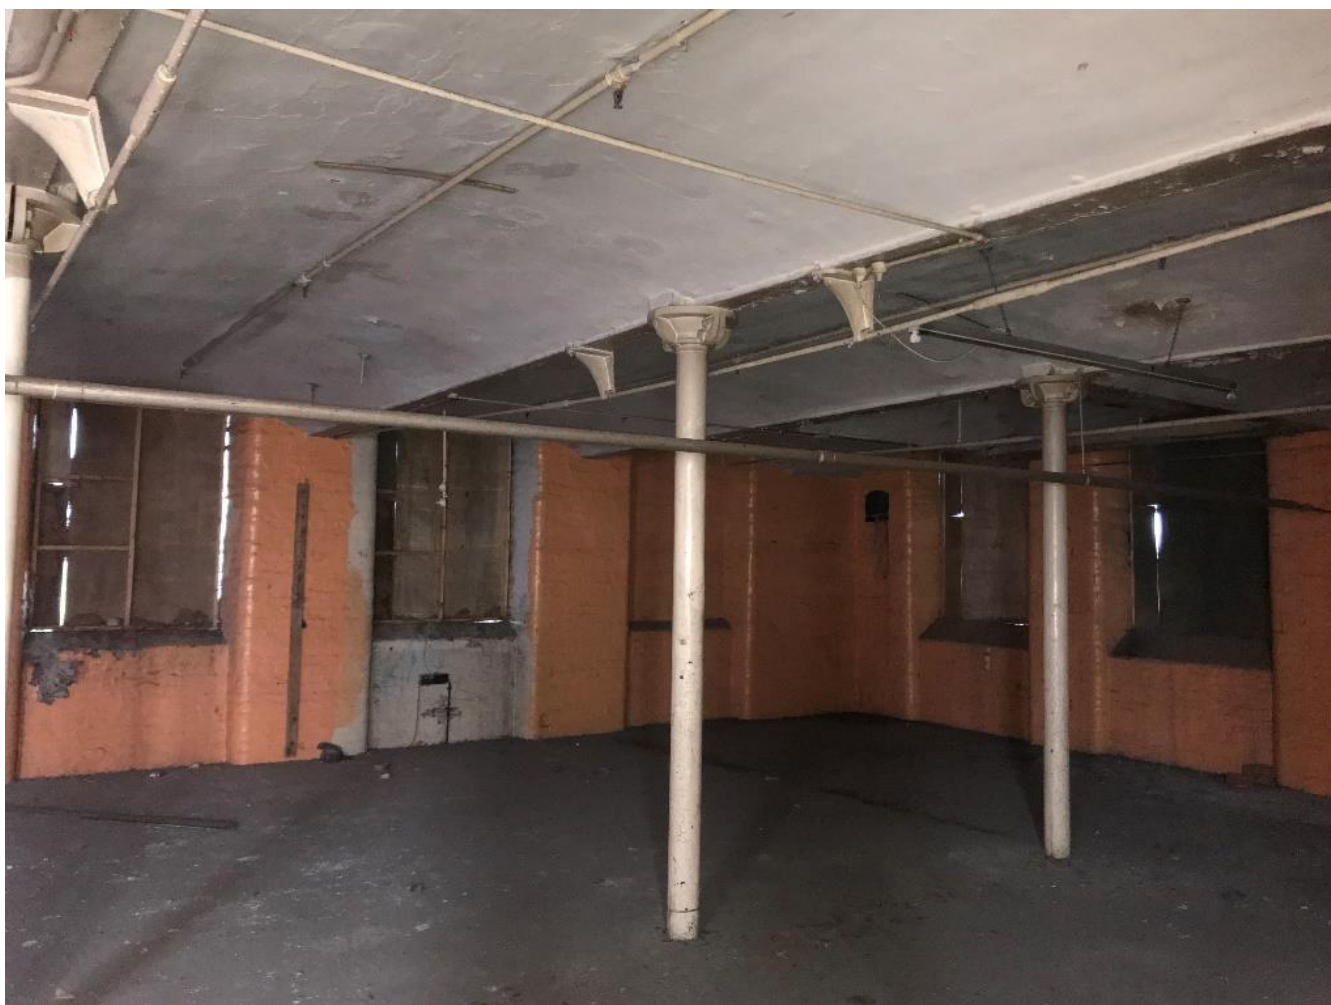
In the south west wing of the third floor lateral ties are present across each pier. Steel bars are threaded through both external piers to restrain walls laterally. Bars are suspended from cast iron super structure by moulded clamps. Refer to figure 36.

Figure 37: Lateral Tie Bars Between Piers

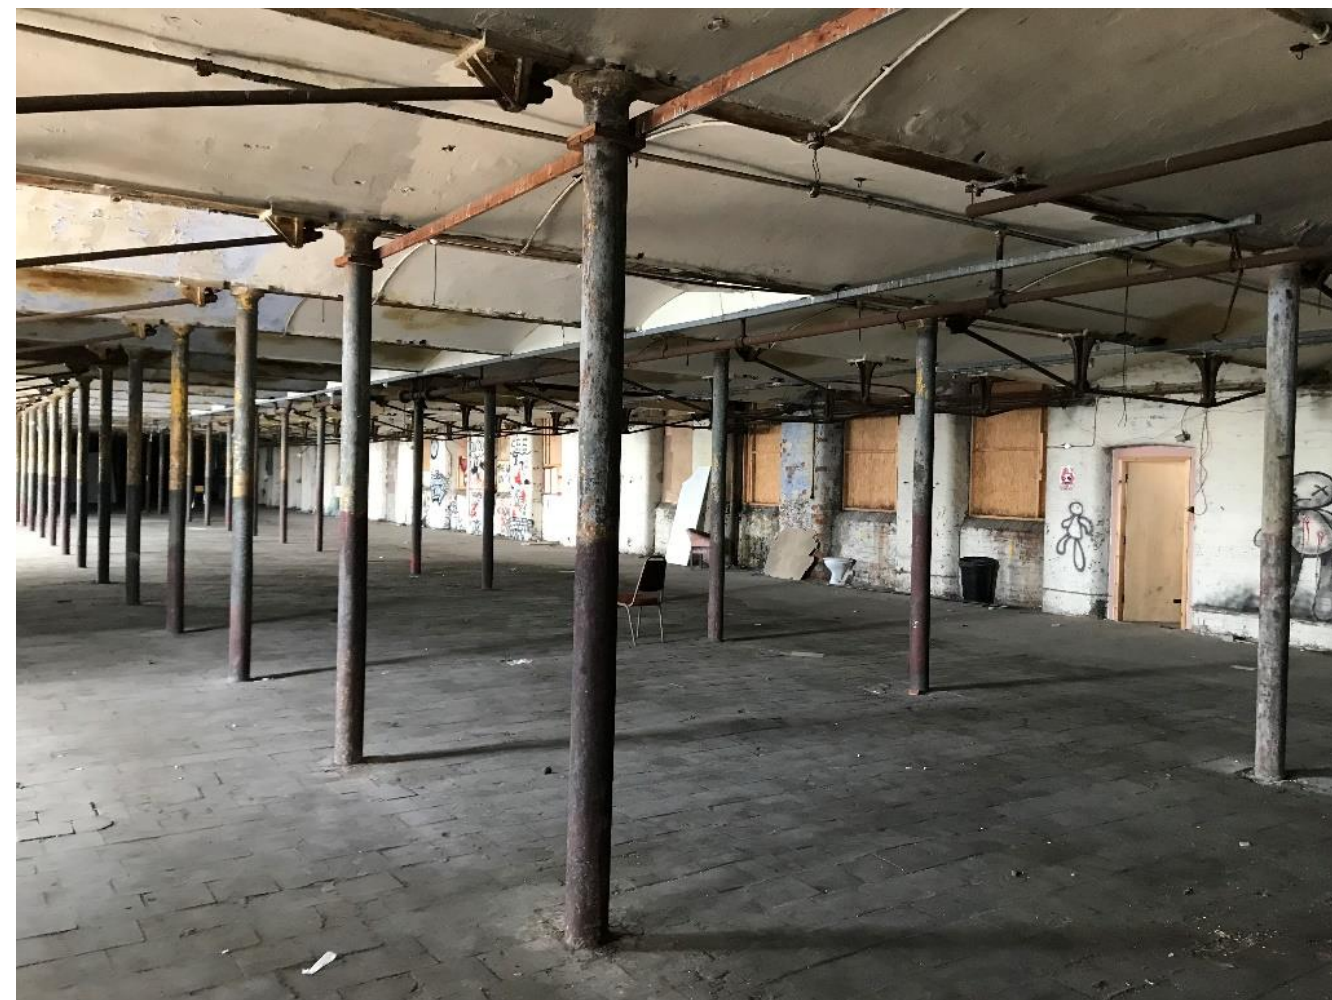
As per other levels, the outer bays of the rear wing have been strengthened with underslung steel tie bars. Refer to figure 37.

Figure 38: Strengthened Inner and Outer Bays

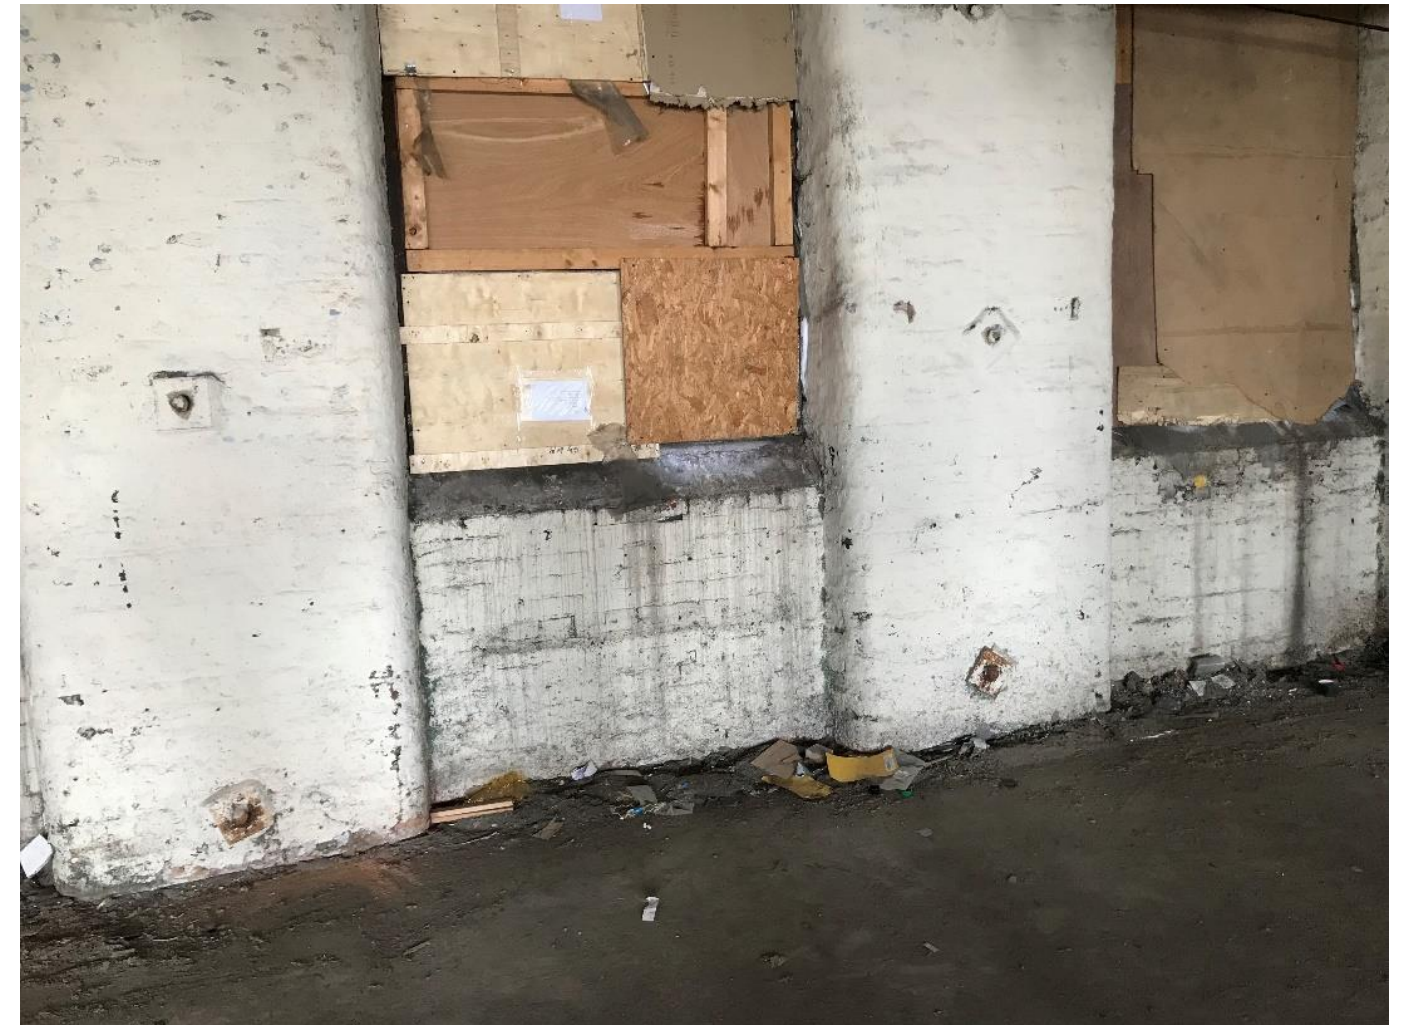
To the inner elevation (facing the courtyard) there appears to be historic tie plates embedded within the masonry piers. These are symmetrical about the elevation but do not appear to be currently serving a purpose. These could have formed part of a historic hoist, or fire escape staircase. Refer to figure 39.

Figure 40: Tie Bars and Plates to Fixed Through Piers

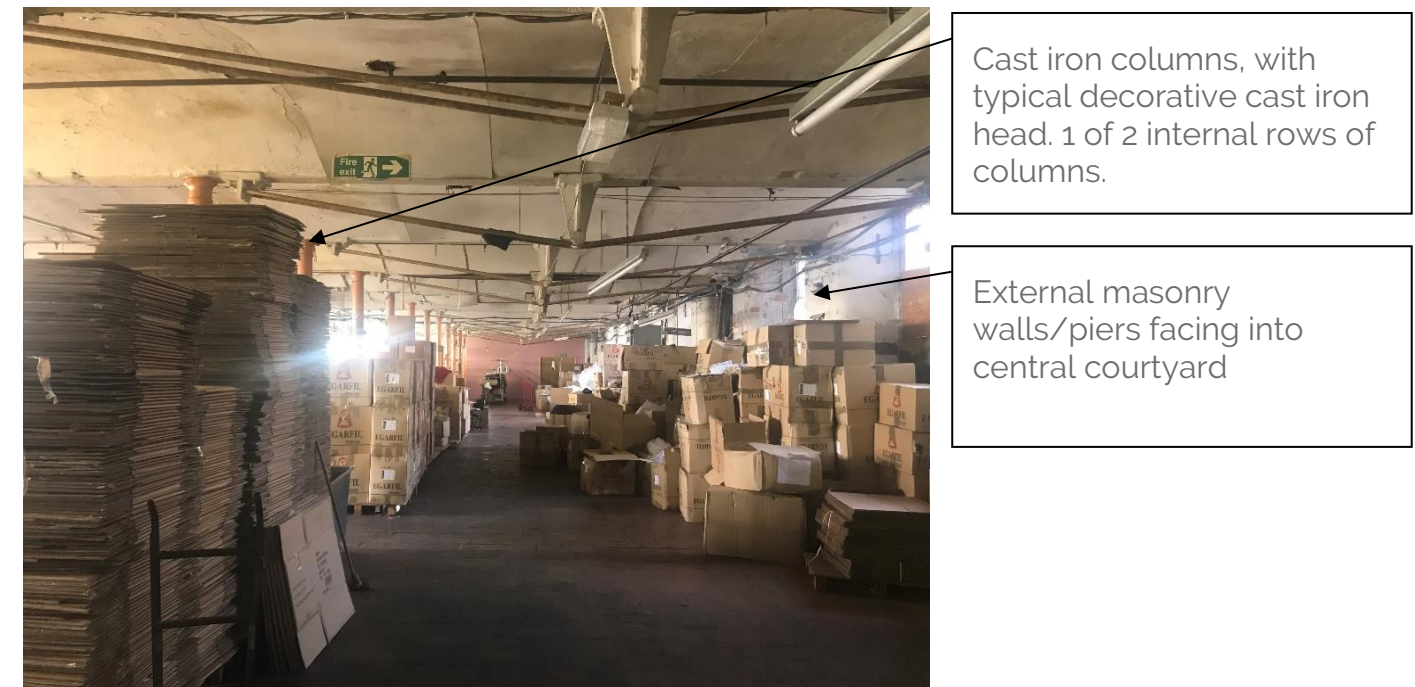
Figure 45: Looking South West into Main Wing

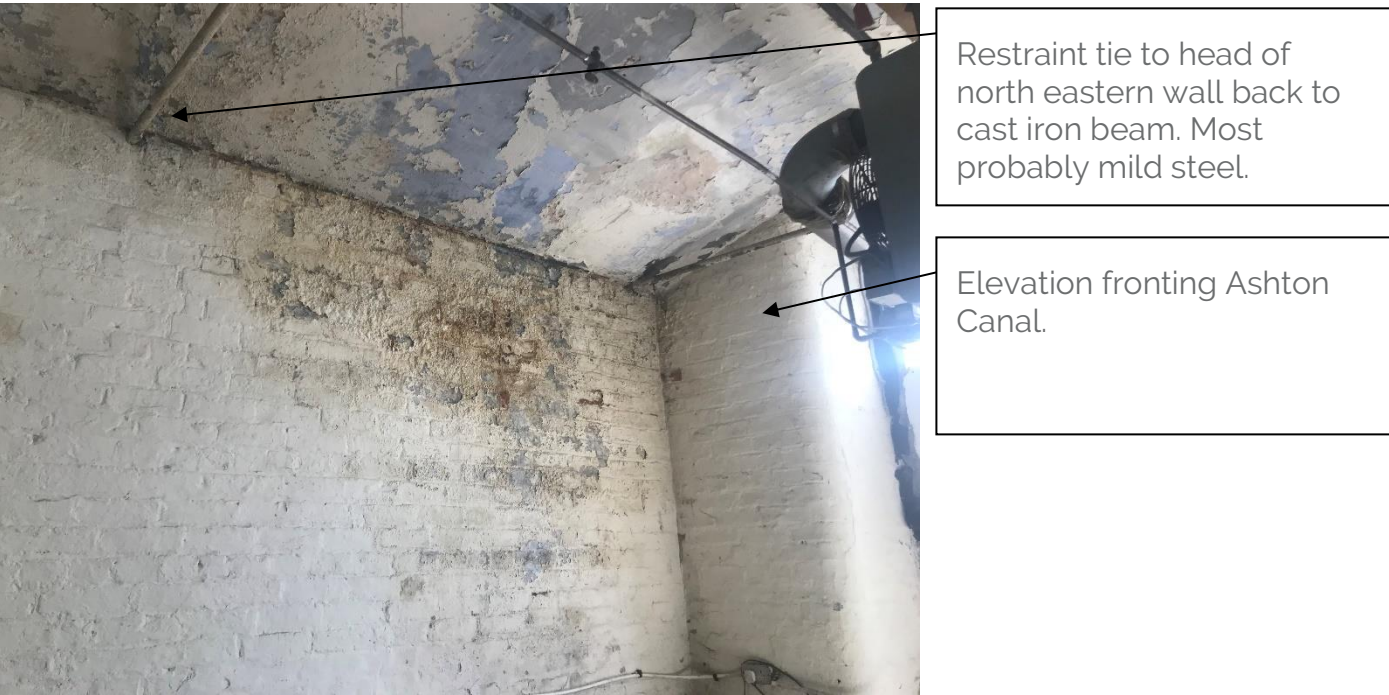
Within the former waste house of the second storey the north eastern outer masonry wall has been tied back (at the head of the wall) to the most adjacent cast iron floor beam. This has been carried out to restrain the outer walls, shown in figure 45. It is unknown when this was installed.

Figure 46: Restraint Bars to North Eastern Wall of Former Waste Room Second Floor

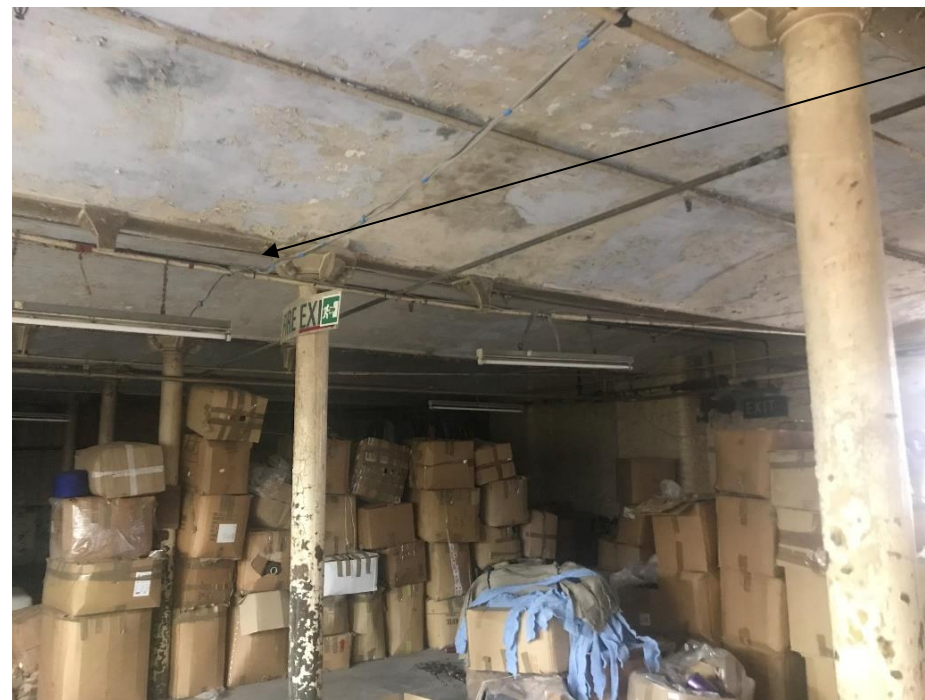
Within the south western wing the outer masonry walls (north eastern and south western) have been laterally tied (at the head of wall) to each other using steel bars. The bars span the full width of the wing and appear to have been installed to restrain the walls. It is unknown when this was installed. Refer to figure 49.

Steel tie bar spanning full width of winning tying outer masonry walls together.

Figure 50: Lateral Tie Bar South Eastern Wing

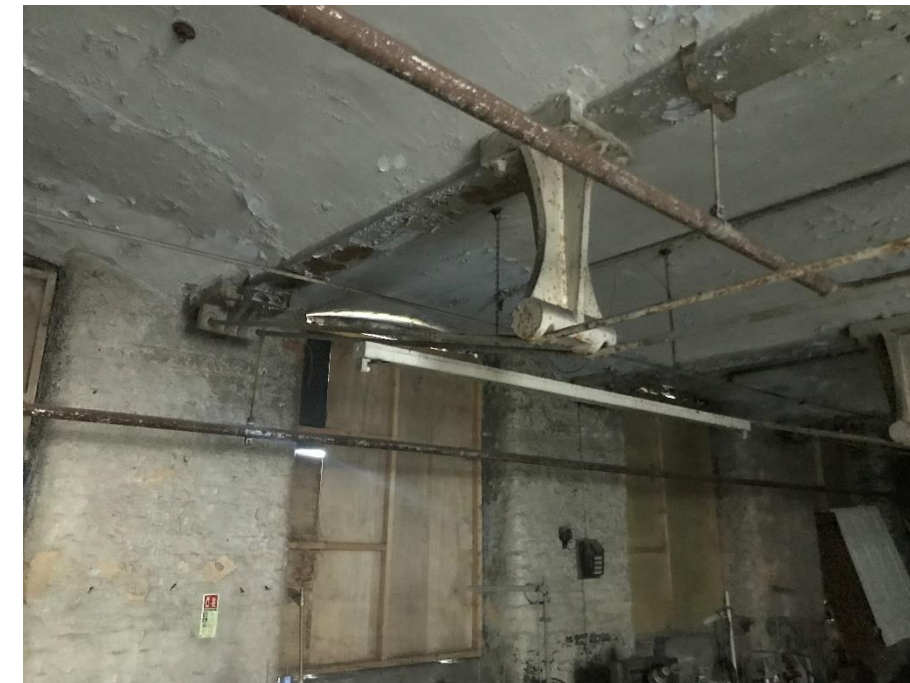
Towards to northern end of the wing beams at high level have been strengthened as per other levels with underslung steel tie bars. Refer to figure 50.

Figure 52: Beam Strengthening.

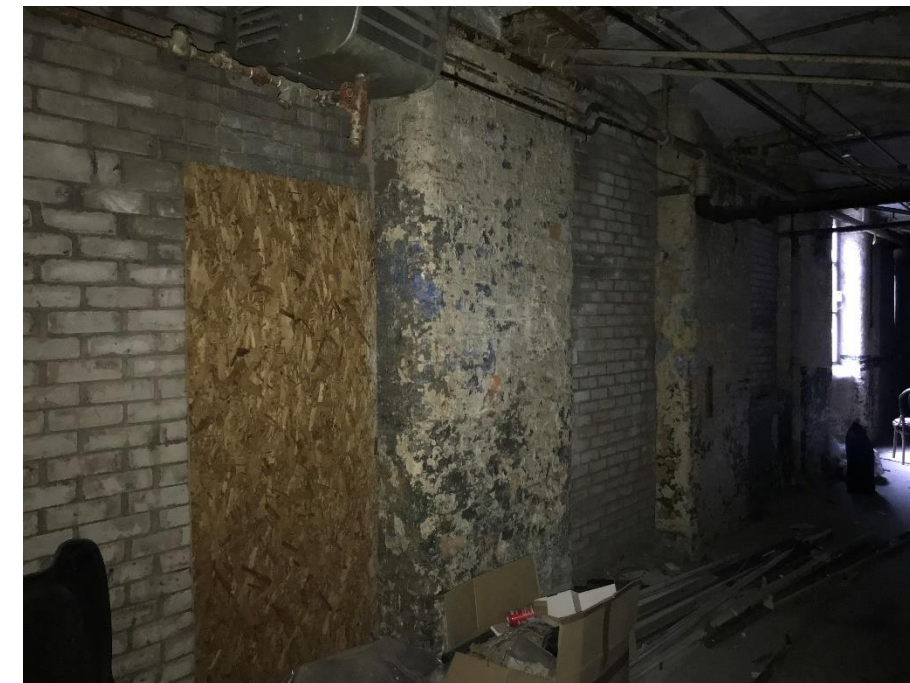
Various openings have been infilled to the north east wing but also due to the construction of the courtyard two storey building. Refer to figure 52.

Figure 53: Infilled Openings

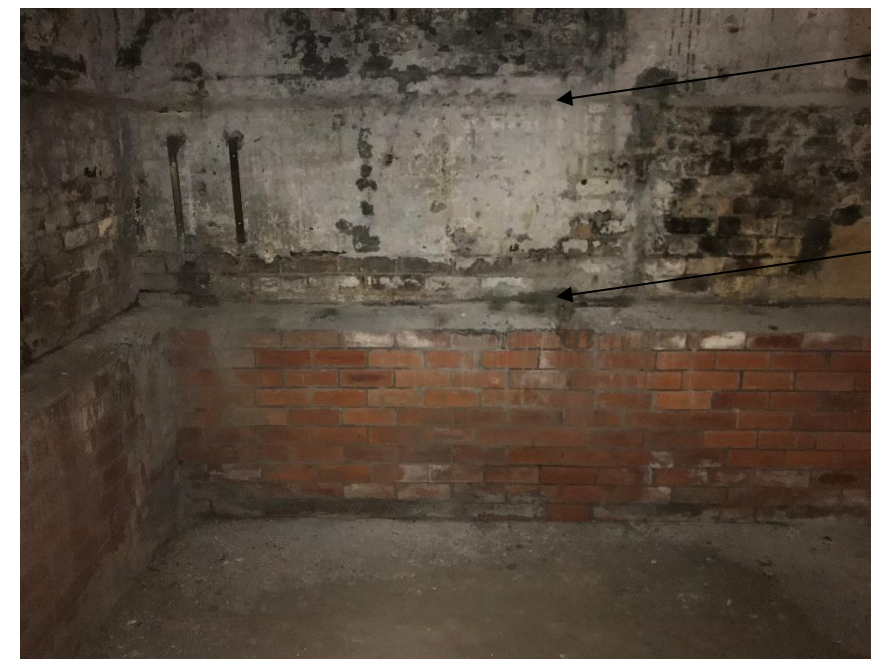
The walls within the semi basement appear to show corbelling of the original masonry elevations. However, the colour and condition of these bricks would indicate these to have been installed recently. The reason for this is unknown. Refer to figure 60.

Figure 60: Corbelled Walls

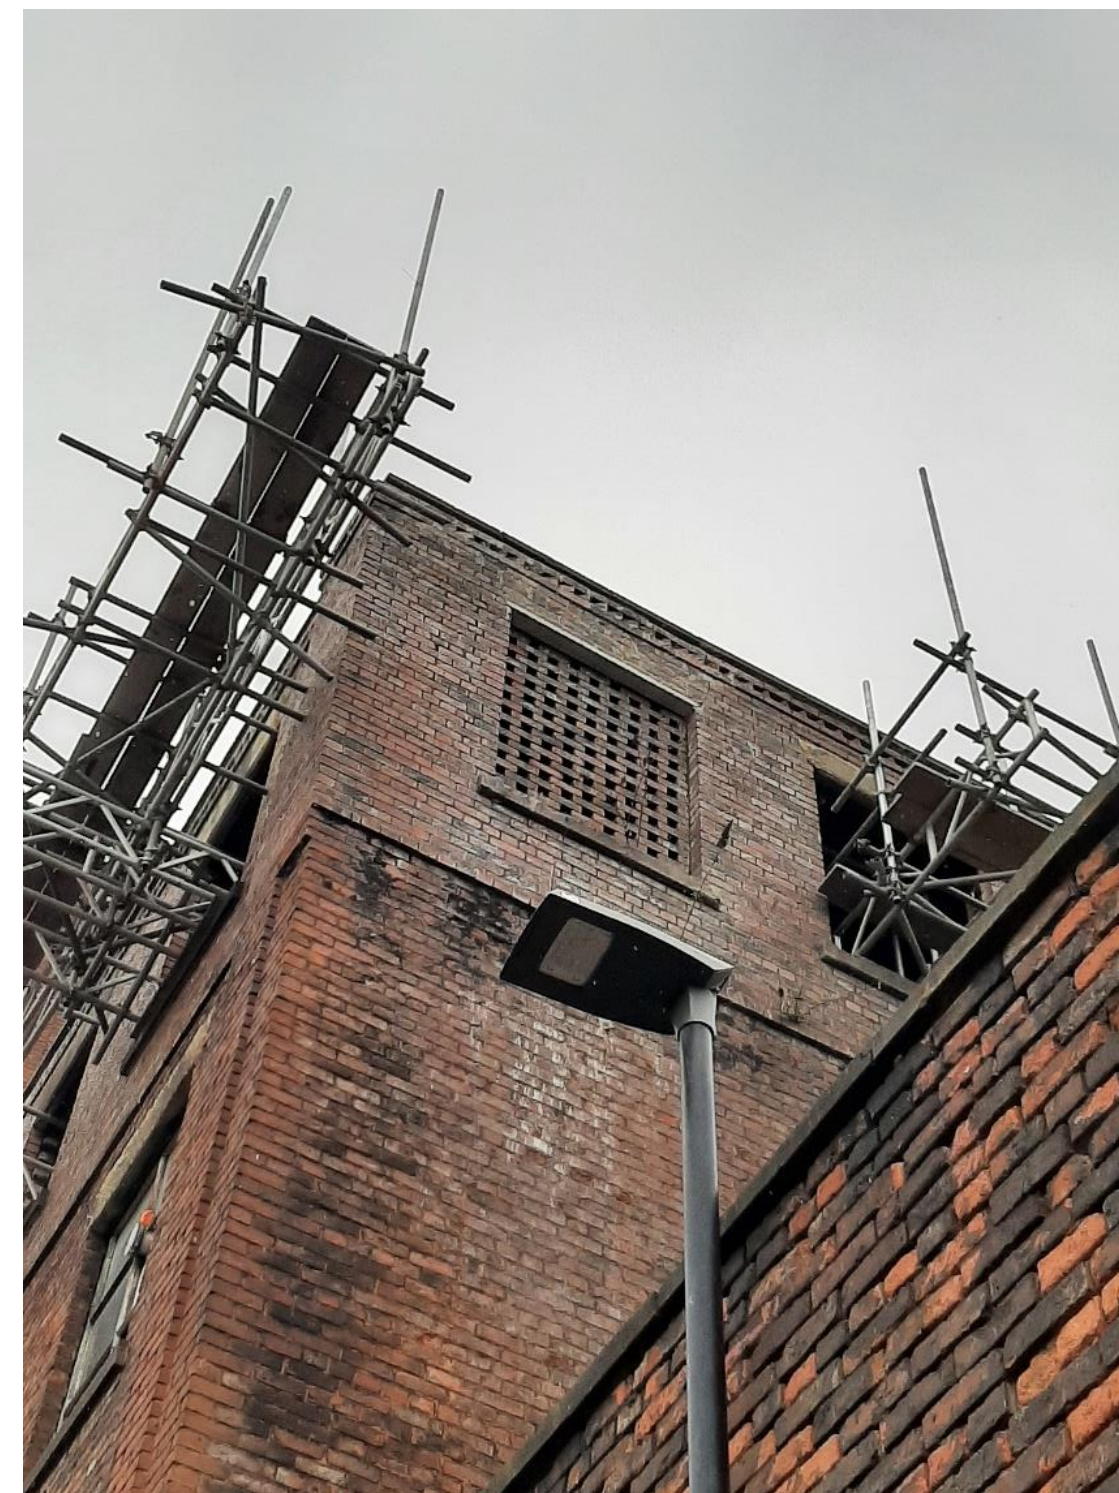
To the right of elevation 2 there appears to have been recent works to repoint an area of brickwork between levels three and four. This appears to coincide with the replacement of a rainwater pipe fixed to the elevation. Refer to figure 66.

Figure 66: Repaired Masonry Elevation

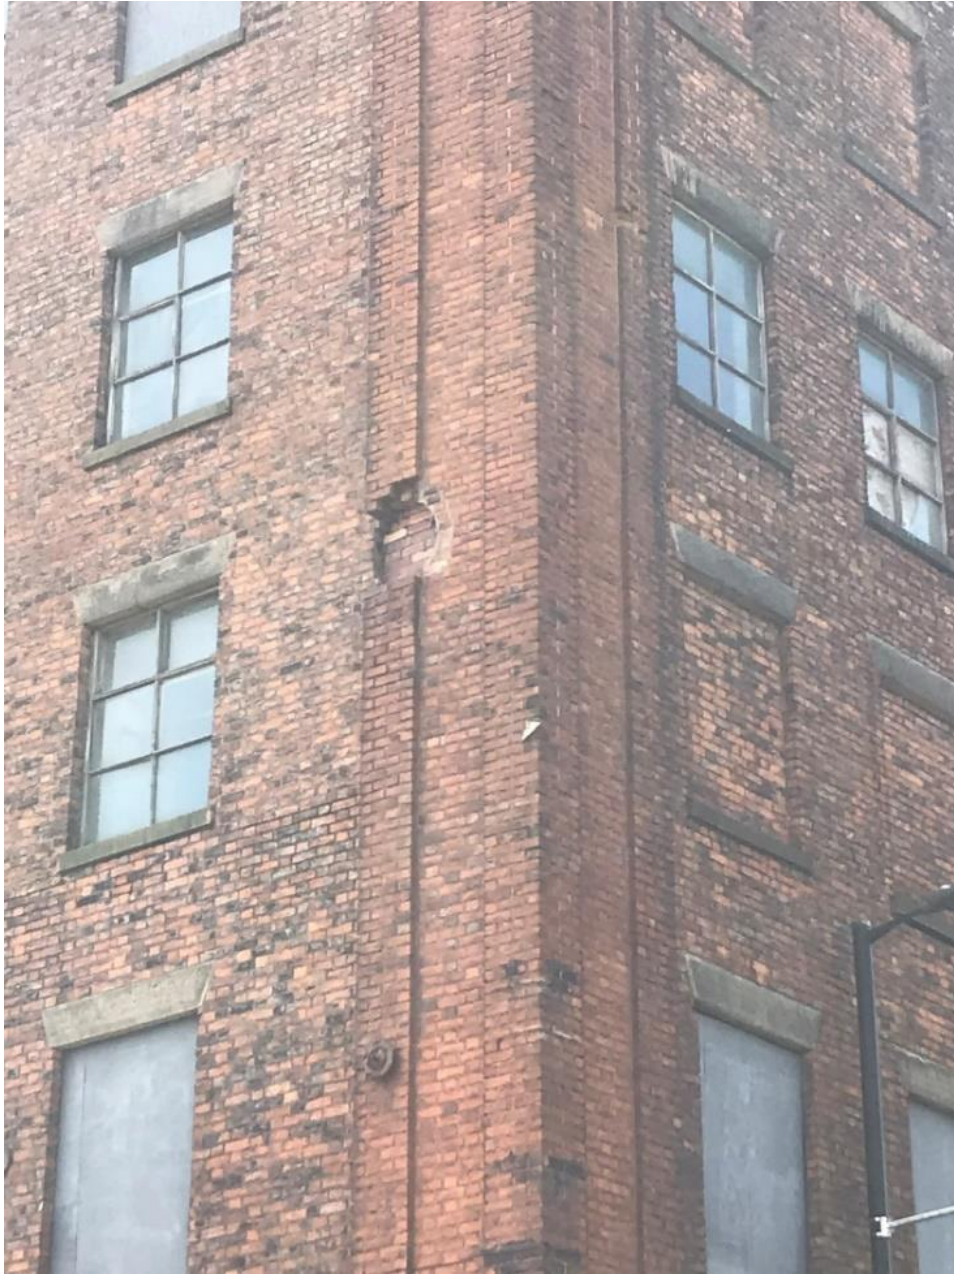
To the right of elevation 2, at the interface with elevation 1, the pier shows localised loss of masonry units. As intrusive investigations are yet to be carried out it is inconclusive whether the area of section loss extends through the full width of pier and has been retrospectively bricked up internally or there has only been a loss of one skin of brickwork. However, it is most likely that the former is the case. Refer to figure 67.

Figure 67: Localised Loss of Masonry to Pier

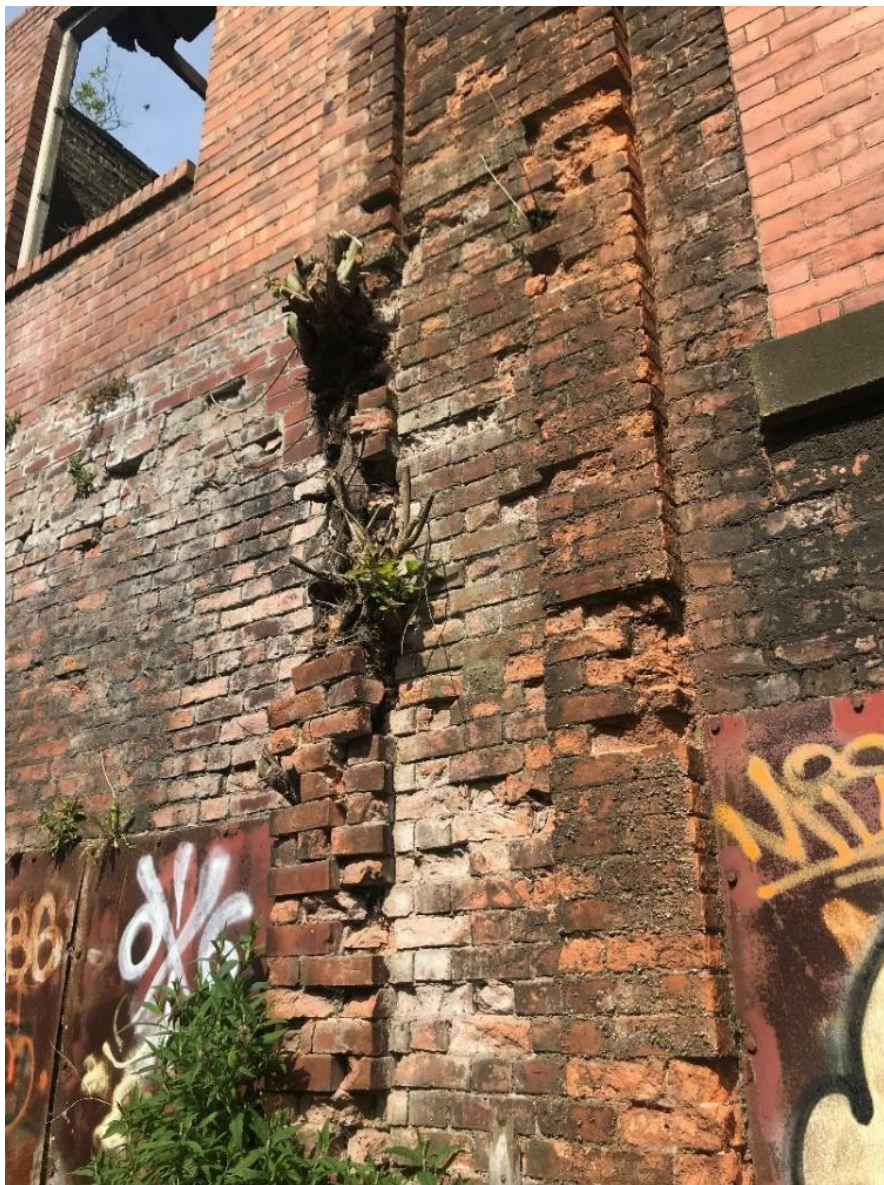
Figure 70: Vegetation Growth Through Pier

Overgrown vegetation can be seen along areas of the parapet and façade. At the interface with the former boiler house to the south of elevation 3 a large tree has been cut back though roots are still present which are continuing to grow and displace brickwork units further. Refer to figure 70.

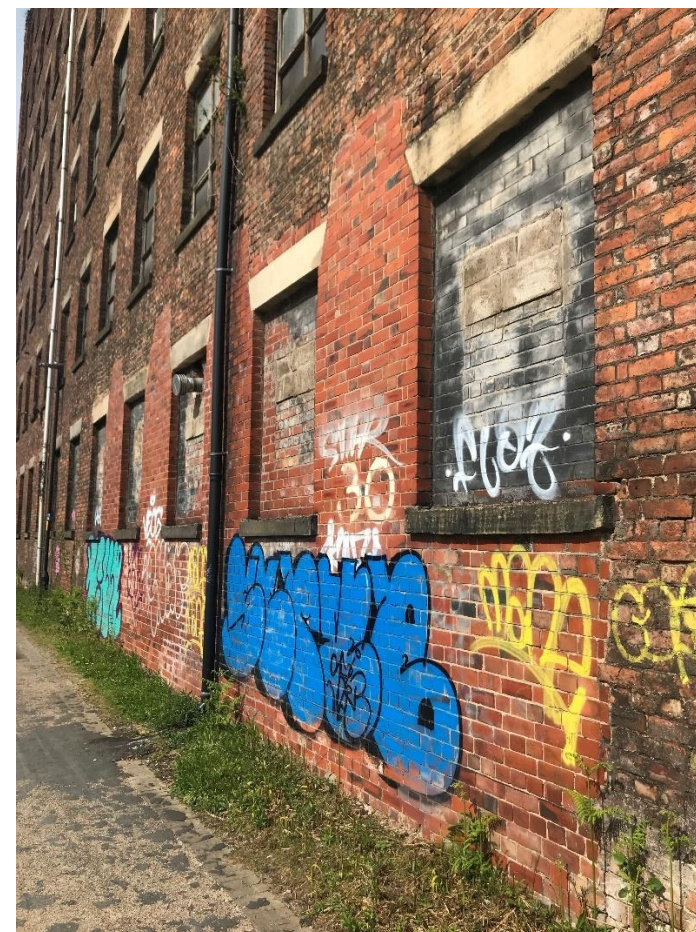
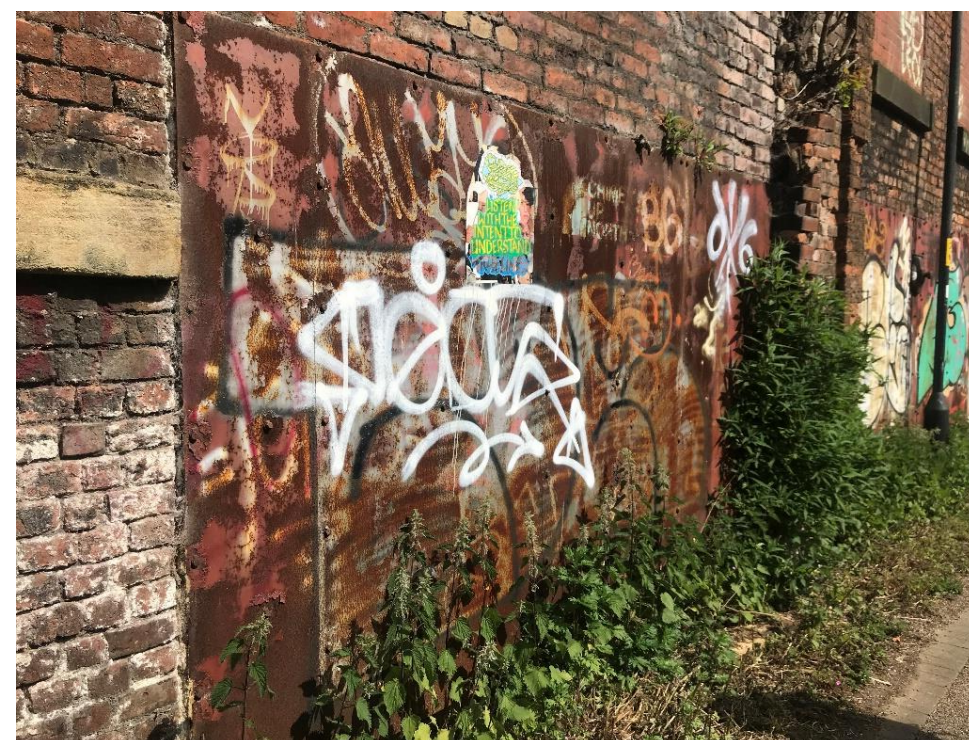
Figure 72: Infill to Historic Openings

At ground floor in approximately the second quarter of elevation (south to north) the wall appears spandrel panels and lintels. It is evident the masonry piers in this area have been repaired and/or strengthened using engineering bricks sometime in the past. Refer to figure 72.

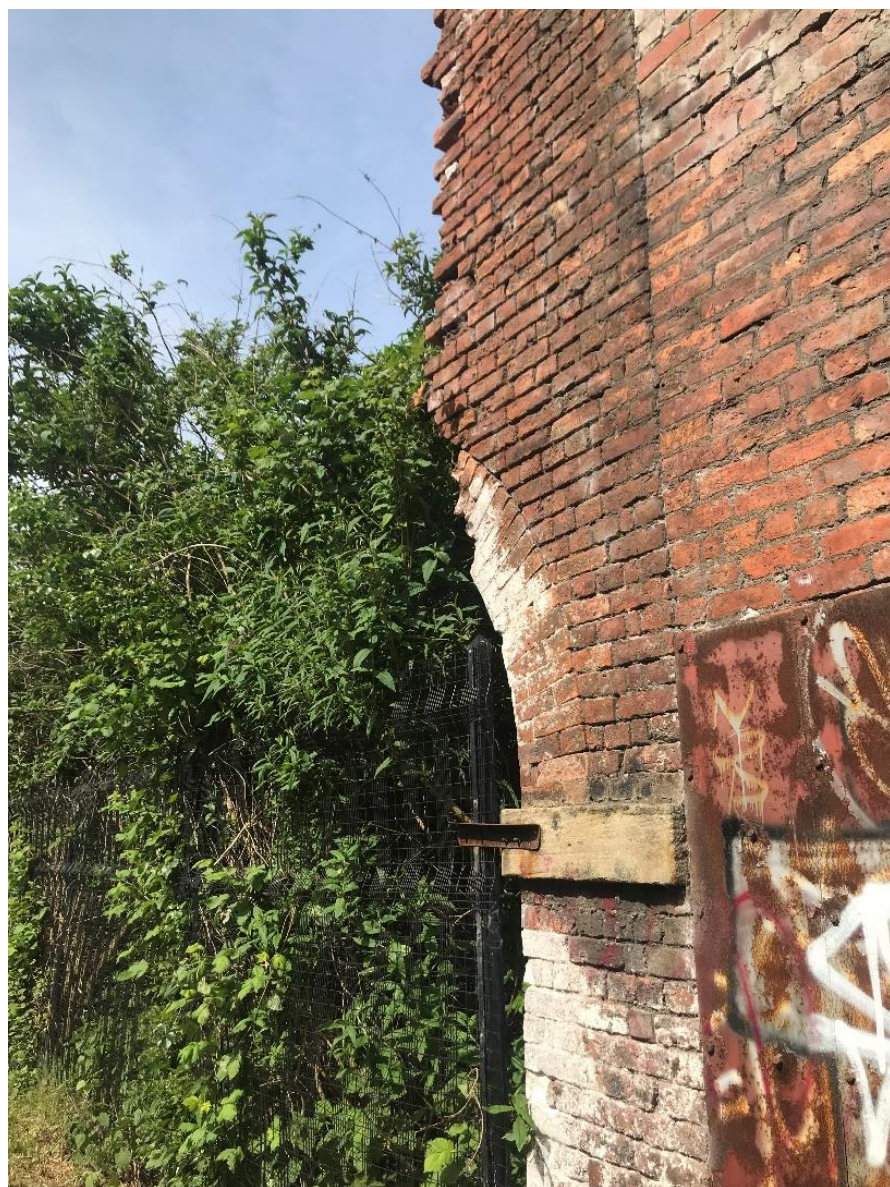
Figure 73: Archway Structure

There is evidence, to the southern end of elevation 3, of an additional archway structure which has been demolished previously. This is not indicated on the site boundary of the historic Brunswick Mill and is thought to have formed part of India Mill which was demolished along with Pooleys Mill in the site south west of Brunswick Mill. Refer to figure 73 and 74.
