Job Title
Brunswick Place

Prepared for
Maryland Securities

Report Type
Structural Appraisal

Date
06/05/2021

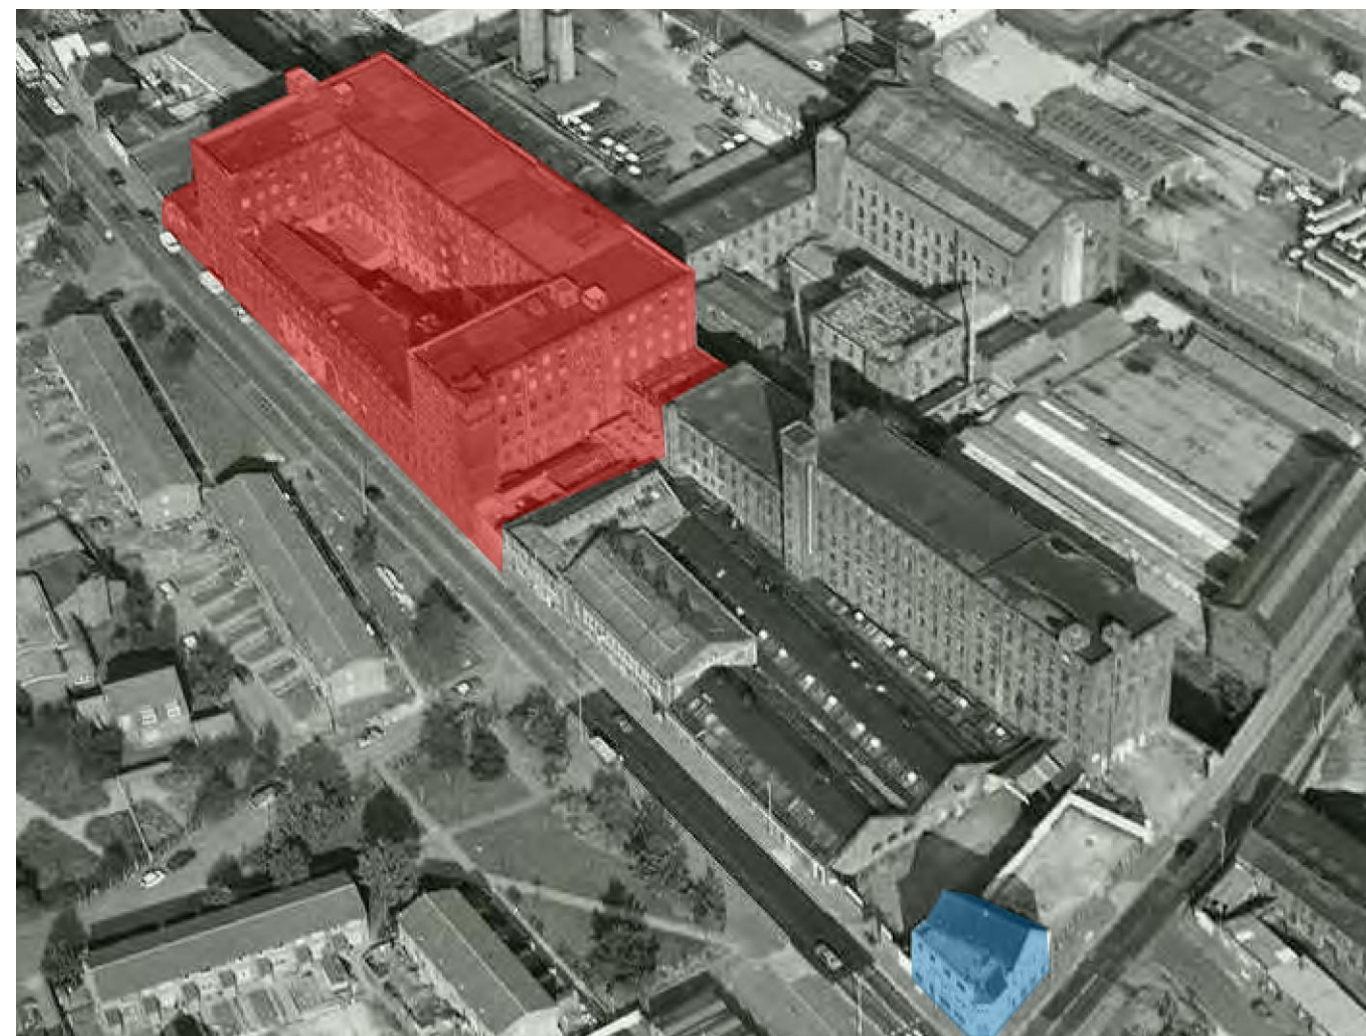
Figure 74: Former (Now Demolished) India Mill to the South East (as viewing image) of Brunswick Mill (in pink)

There is evidence, to the southern end of elevation 3, of an additional archway structure which has been demolished previously. This is not indicated on the site boundary of the historic Brunswick Mill and is thought to have formed part of India Mill which was demolished along with Pooleys Mill in the site south west of Brunswick Mill. Refer to figure 73 and 74.

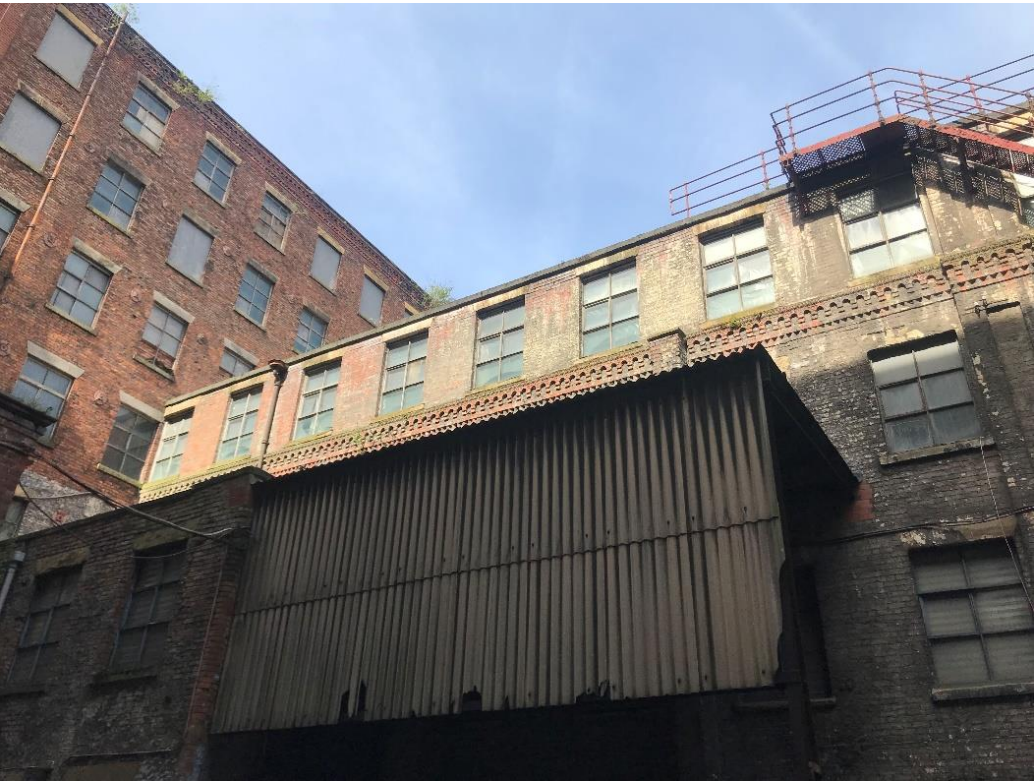
Figure 78: External Steel Lean to Canopy Installed

Within the courtyard a steel lean-to canopy has been constructed against the historic two storey structure. The canopy is not believed to be of historic construction, this is evident from its connection into the existing elevation which shows steel beam to bear directly onto newly installed engineering brickwork. Refer to figure 78 and 79.

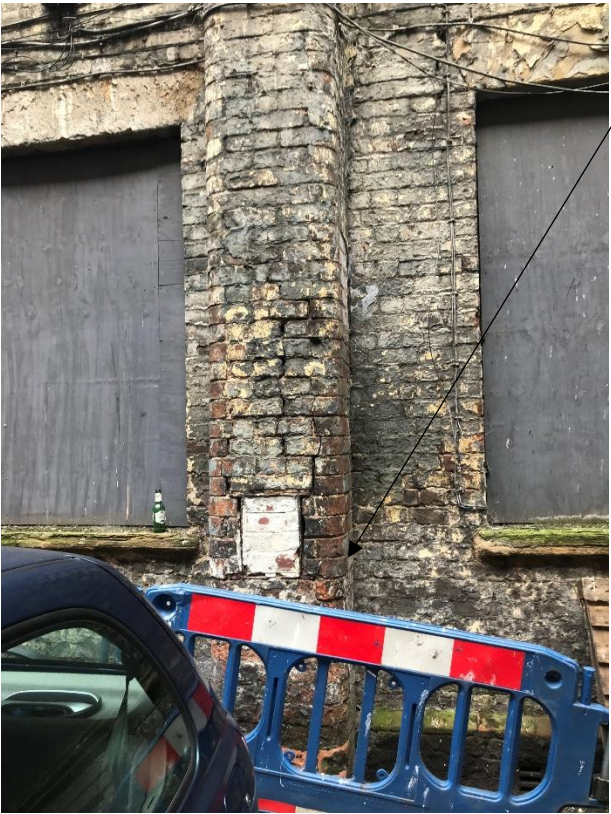
Figure 80: Steel Beam Ends Built into Masonry Pier

At ground floor, within the structural pier adjacent to the northern two storey structure, there is evidence of former steelwork built into the pier. Steel beam ends are still present within the pier and openings have been bricked around. This could suggest the presence of a historic platform which coincides with a high level beam and opening to form a hoist. Refer to figure 80 and 81.

Beam ends remaining,
openings surrounding
bricked up

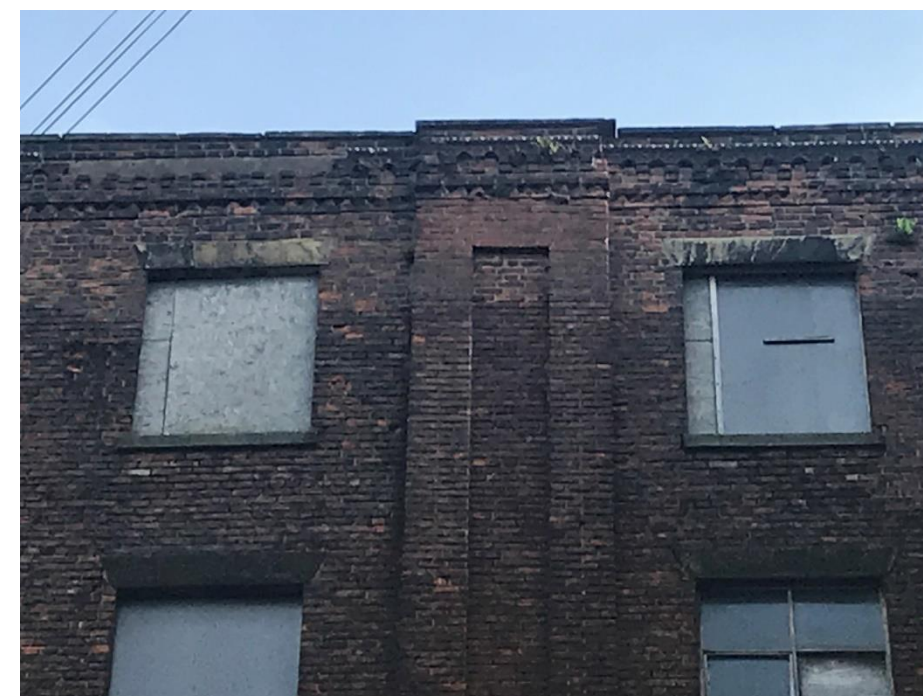
Figure 84: Differing Opening Levels

Observing the high level windows of elevation 6 it could be concluded that the wall may have settled as windows appear to have differing levels. However, on closer inspection it can be seen these opening have purposely been formed at different levels. As shown in figure 84 the left hand window is constructed three courses down from the decorative corncicing whereas the right hand window is constructed four courses down.

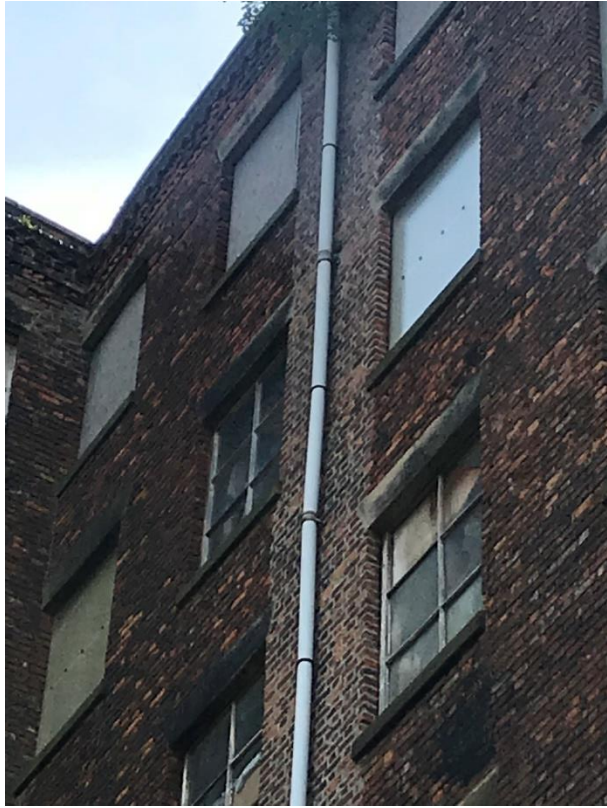
Figure 86 Repointed Brickwork

To the northern end of elevation 7 there appears to have been recent works to repoint an area of brickwork between level 2 and the roof. This appears to coincide with the replacement of a rain water pipe fixed to the elevation. Refer to figure 89. At lower levels, in this location, underneath later installed steel canopy there is significant staining of brickwork behind the rain water pipe. Refer to figure 86.

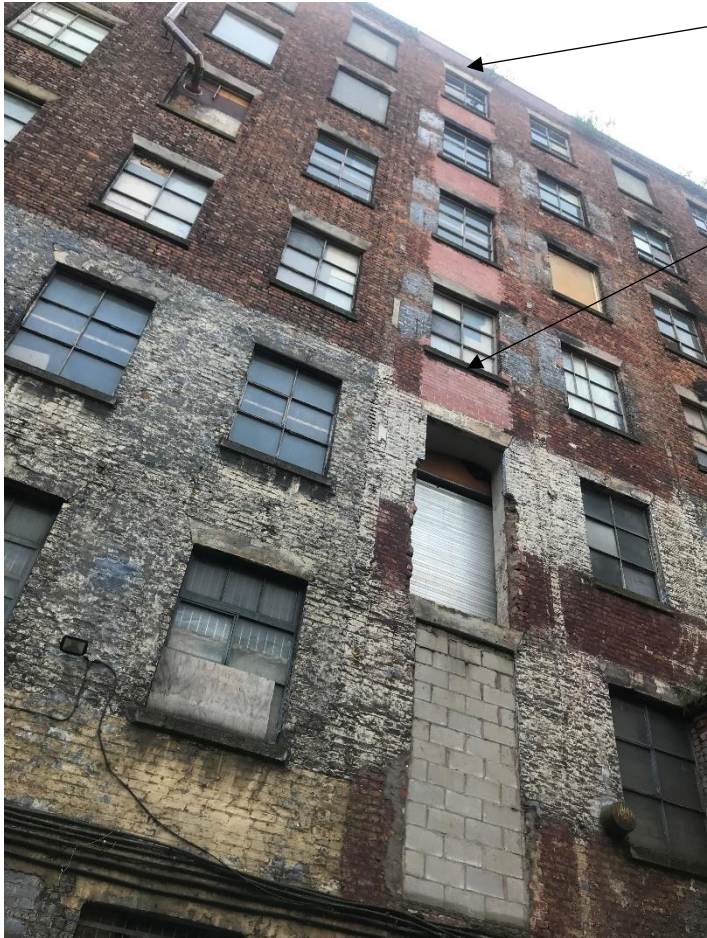
Figure 89: Infilled Openings to Northern End of Elevation 7

In 2No locations, north and south, symmetrically about elevation 7 a series of former opening across all levels have been infilled with engineering brickwork and blockwork units sometime in the past. This includes the parapet at high level. The reason for this is unknown though it may well have been a former location of a hoist to or provided egress as a fire escape a per the adjacent bays. Refer to figure 89.

Infilled section of parapet and vegetation growth

Infilled openings with engineering brickwork and blockwork below

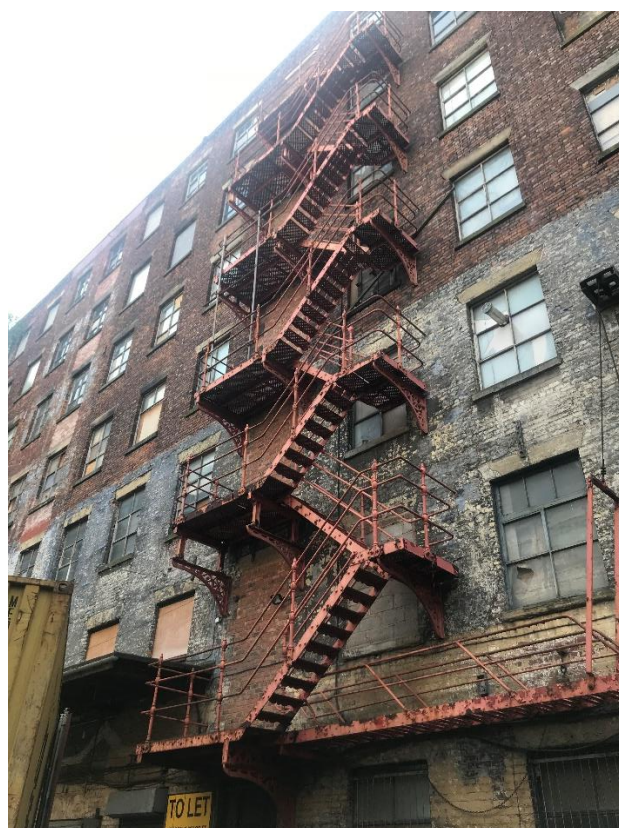
Figure 90: Historic Staircase and Associated Openings Infilled with Engineering Brick

To the centre of the elevation a historic external staircase is present though this is no longer is use. The openings in levels to which the stair historically served have been infilled with engineering brickwork at some time in the past. The topflight of staircase has been removed which may suggest that the adjacent infilled bays (described above) also served as access routes for external staircases. Refer to figure 90.

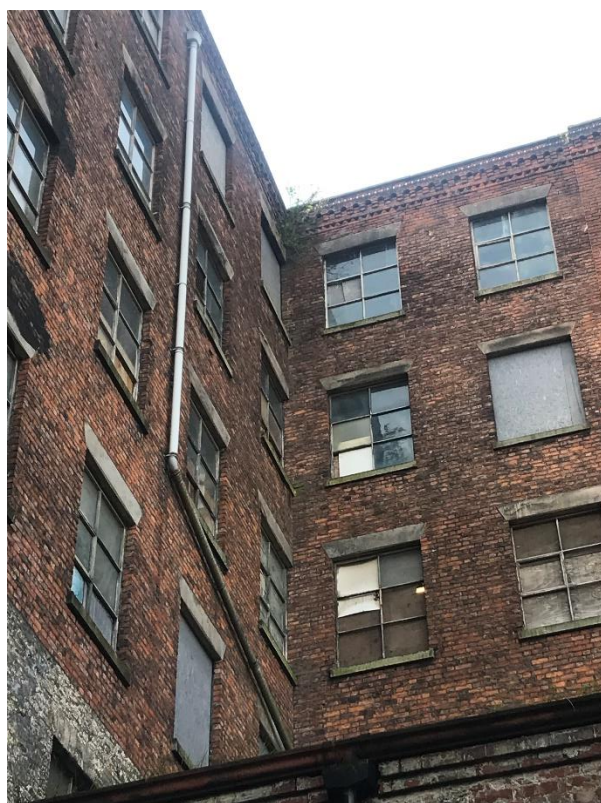
Figure 91: Opening Line Corresponding with Wing Interface Line

To the south of elevation 7 at the interface with elevation 8, window openings are formed on the interface line. This would suggest reduced restraint to the masonry panel at this location across the full height of the building. Refer to fig 94.
