Claire Collett
Archicollett
34 Plover Way,
London
SE16 7TT

Condition Report Veined Carrara Marble Chimney-piece
GFF 88 Seymour Street, London W2 2JJ

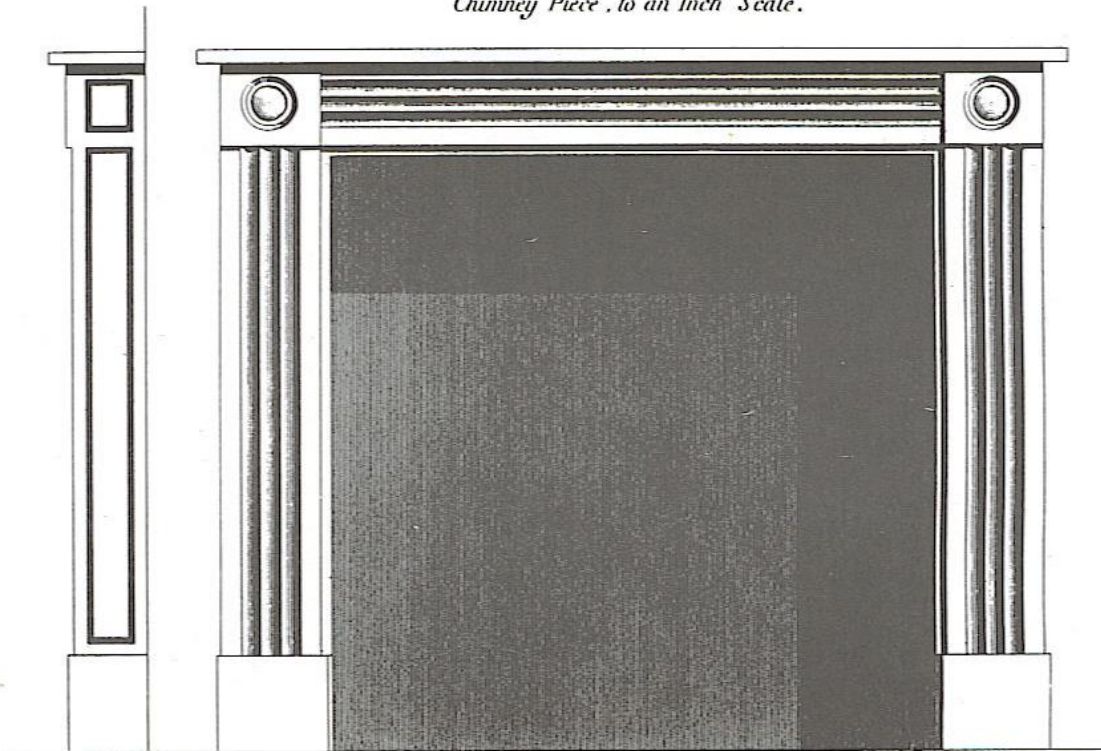
Chimney Piece, to an Inch Scale.

Design for a Dressing Room chimney-piece as published within W.F. Pocock's 1811 *Modern Finishings for Rooms*. The form of the chimney-piece is related to that seen in the GFF and 1FF of 88 Seymour Street. Note the un-moulded shelf or Cornice.
