# Principal Staircase Report

## S.1 Structural Condition Appraisal

Curtins Ref: B077572-CUR-ZZ-ZZ-RP-S-00003

Site Address: Cuerden Hall, Shady Ln, Bamber Bridge, Preston PR5 6AZ

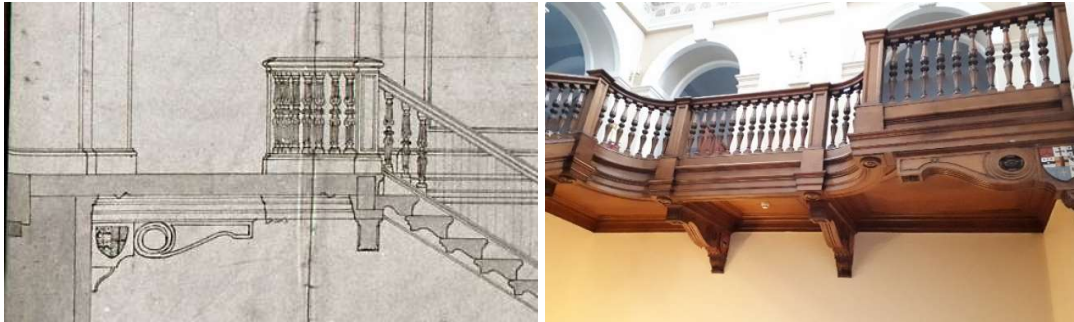
- 2.13 The beam drawn below the line of the stairs and post on the detail below does not appear to have been built. While these drawings are helpful in understanding the intent behind the design, we cannot know if it was built exactly like these illustrations show unless we open up and assess the current construction.

Figure 4: Detail of cantilevering balcony (left) and picture of balcony from stair below (right).
