Client: **SHENTON GROUP**

Project: **CUERDEN HALL**

Orig Title: **SURVEY RECORD DRAWINGS, BASEMENT AND ATTIC FLOOR PLANS**

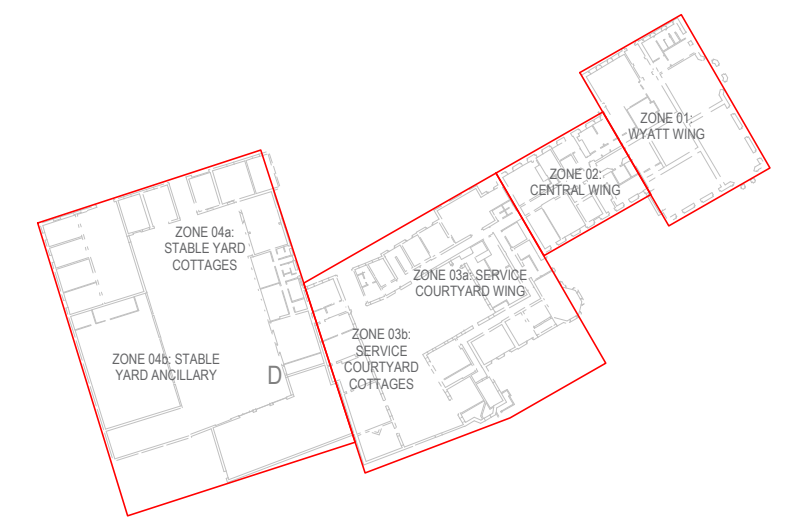
ZONES 01-03a: BASEMENT

1. BARREL VAULT CUT OFF AT CROWN TO MAKE WAY FOR STAIRCASE. HOLES IN VAULT FOR SERVICES VERTICALLY SUPPORTED BY BLOCKWORK WALL. REMNANTS OF VAULT HAS BEEN REMOVED. CONCRETE FLOOR ABOVE. ARCHED OPENING HAS BEEN WIDENED. MASONRY CORBELLING EITHER SIDE OVER JAMBS. CONSOLIDATE MASONRY.

2. STEEL BEAMS THROUGH BARREL VAULT SUPPORTING MASONRY AND SERVICES. CORRODING AT EMBEDDED END (CIRCA 20MM DELAMINATION + CIRCA 3MM SECTION LOSS).
3. GEOMETRY OF QUADRIPARTITE VAULTS SOUND. NO STRUCTURAL DEFECT OF NOTE.

4. NO STRUCTURAL DEFECT OF NOTE QUADRIPARTITE VAULTS. SHELVING MADE OF SOLID STONE SLABS ARRANGED VERTICALLY AND SOME ARE UNSTABLE.
5. NO STRUCTURAL DEFECT OF NOTE TO QUADRIPARTITE VAULT.

6. NO STRUCTURAL DEFECT OF NOTE TO QUADRIPARTITE VAULT.
7. NO STRUCTURAL DEFECT OF NOTE TO QUADRIPARTITE VAULT.
8. SHALLOW ARCHED OPENING APPEARS TO HAVE ARTICULATED AND FLATTENED. JAMBS LEAN OUT AT SPRINGER POINT.

9. NO STRUCTURAL DEFECT OF NOTE TO THIS ROOM ALTHOUGH CHECK BELOW FINISHES.
10. SERVICES RUNNING THROUGH VAULT. NO STRUCTURAL DEFECT OF NOTE.
11. HALF OF VAULT REMOVED IN THIS BAR. CROWN DETAIL UNKNOWN.

12. GEOMETRY OF BARREL VAULT FLATTENED SLIGHTLY. SOME BRICK UNITS HAVE SLIPPED. SERVICES HAVE BROKEN THROUGH BARREL VAULT AT THIS LOCATION.
13. NO STRUCTURAL DEFECT OF NOTE TO BARREL VAULT.

14. 2 NO. STEEL BEAMS SUPPORTING WALL ABOVE.
15. BLOCKWORK WALLS.
16. NO STRUCTURAL DEFECT OF NOTE ALTHOUGH SERVICES RUNNING THROUGH WALLS.
17. STEEL BEAMS AND AERATED CONCRETE FLOOR ABOVE. NO STRUCTURAL DEFECT OF NOTE TO MASONRY.
