# Principal Staircase Report

## S.1 Structural Condition Appraisal

Curtins Ref: B077572-CUR-ZZ-ZZ-RP-S-00003

Site Address: Cuerden Hall, Shady Ln, Bamber Bridge, Preston PR5 6AZ

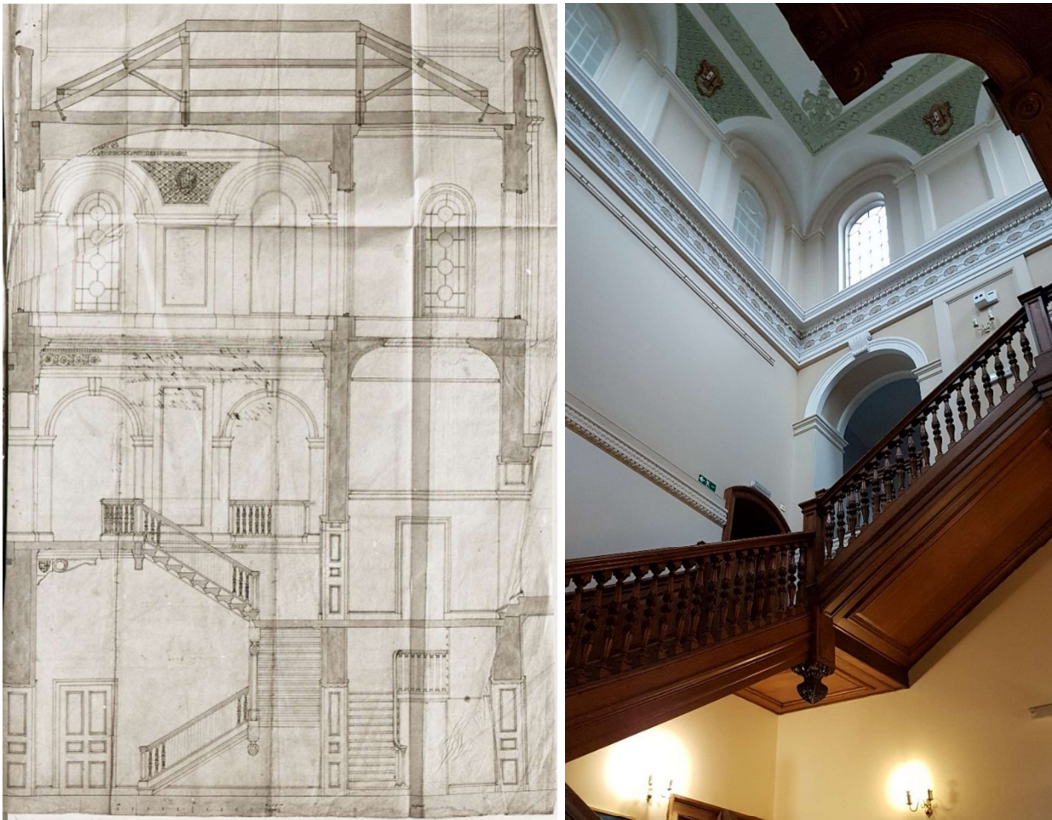
Figure 1: Grand timber staircase and cantilevering balcony within decorated lantern.

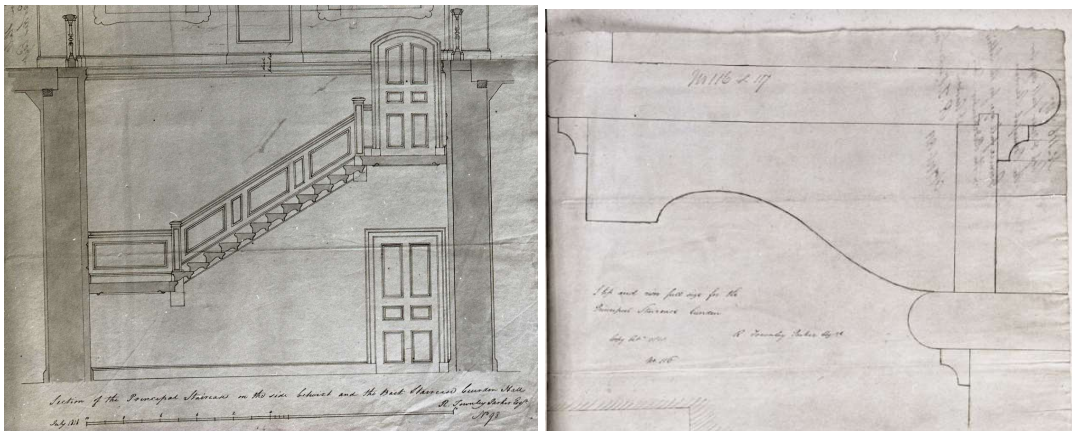
- 2.2 The grand staircase provides access between ground floor and first floor within a high lantern space with a decorated ceiling above. Decorated oak balusters separate the large handrail and outer stringer. There are no vertical posts which bear down to the ground at the landing corners.

Figure 3: Drawing of principal stair showing no vertical supports at each landing (left) and detail of stair composition (right).

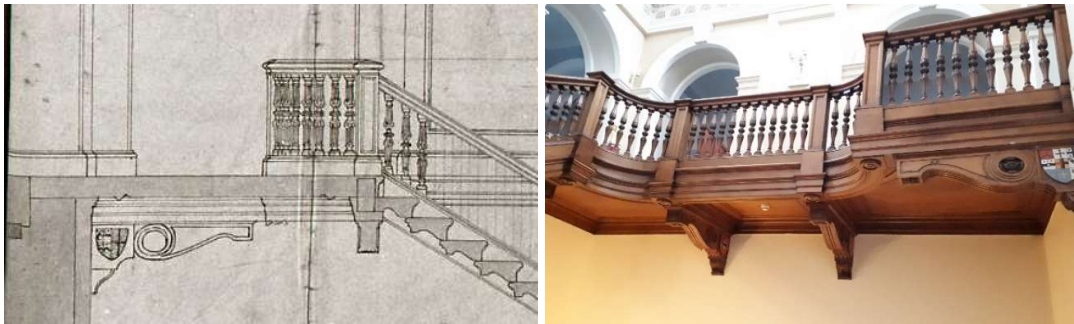
- 2.13 The beam drawn below the line of the stairs and post on the detail below does not appear to have been built. While these drawings are helpful in understanding the intent behind the design, we cannot know if it was built exactly like these illustrations show unless we open up and assess the current construction.

Figure 4: Detail of cantilevering balcony (left) and picture of balcony from stair below (right).
