SITE INVESTIGATION REPORT

PROJECT : PROPOSED GARDEN CENTRE

ADDRESS : IRVINE ROAD, FAIRLIE

PROJECT REF NO : 09602

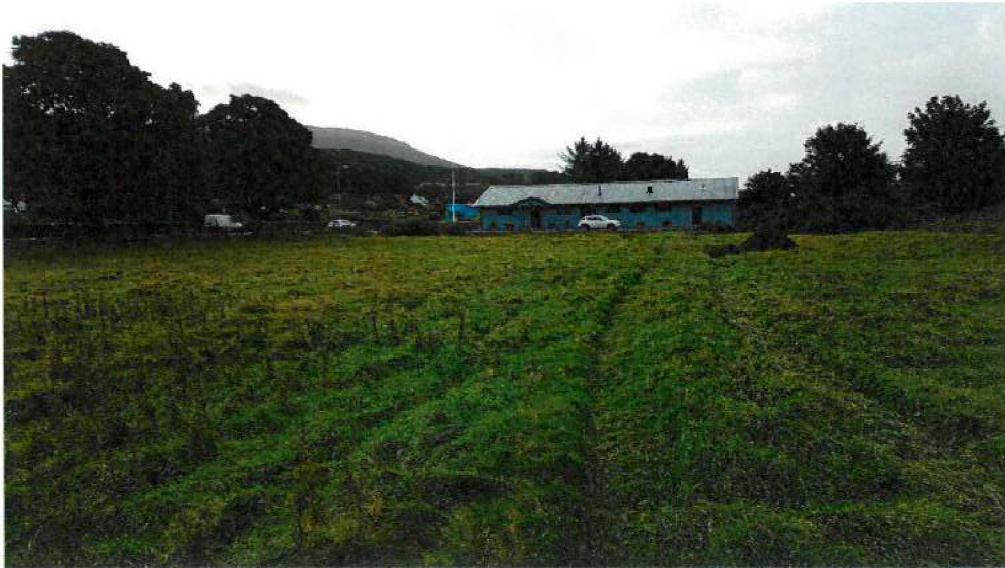
View South Towards Bowling Club

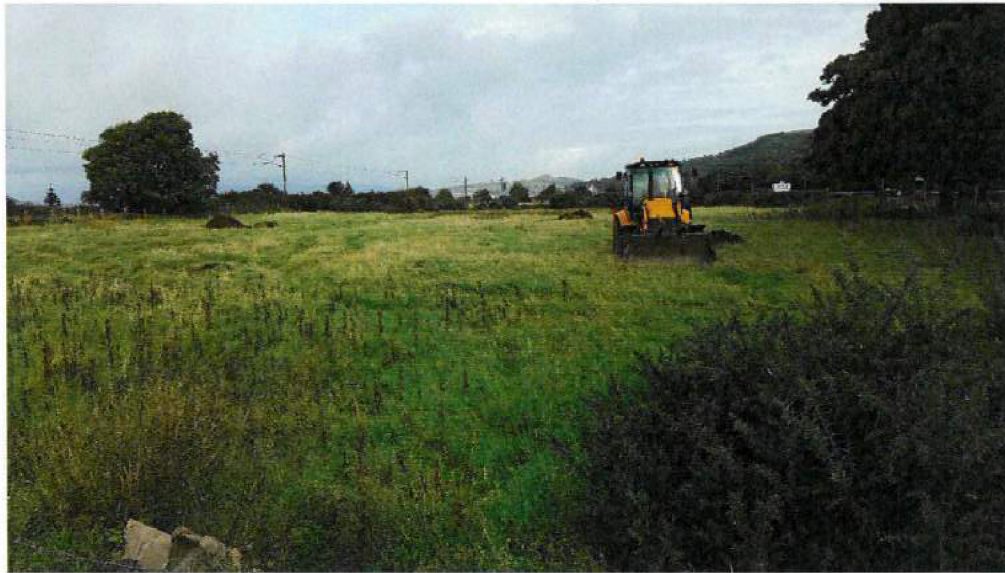
View North Across Site

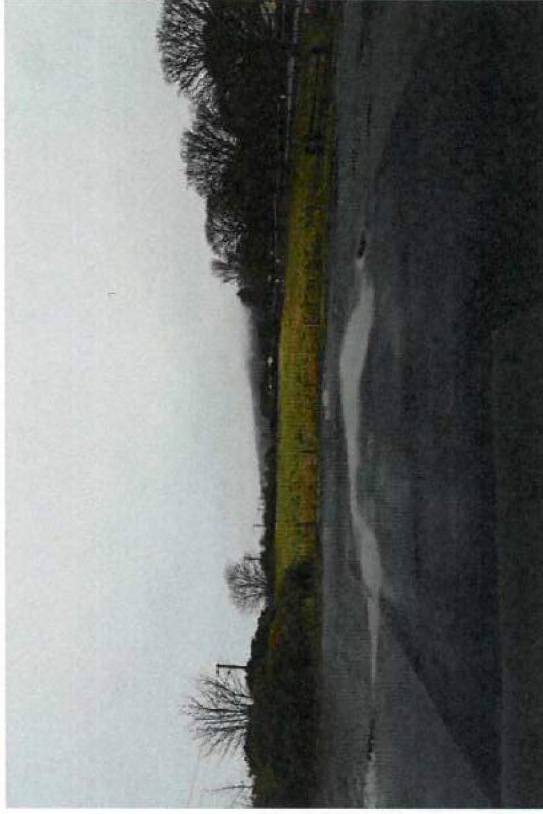
Plate 1: Looking north towards proposed development site. Bowling Club car park in foreground. Photograph taken from NS 20978 56192.

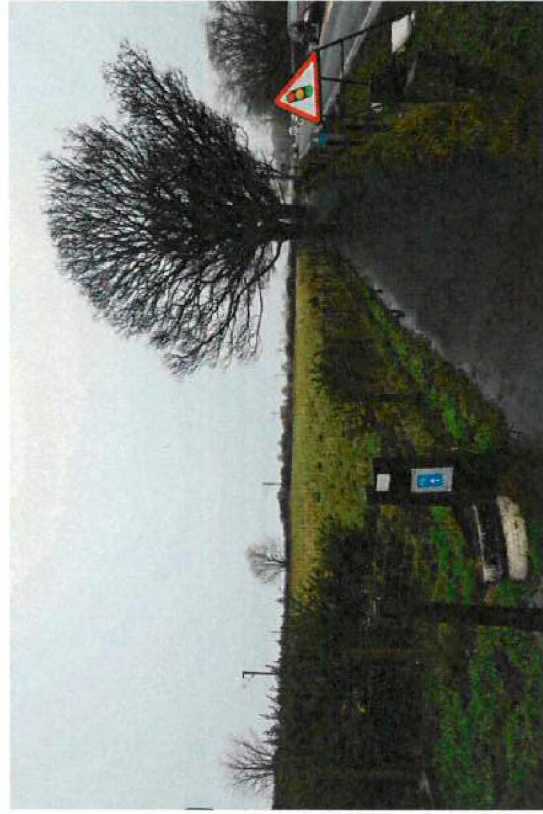
Plate 2: Looking north towards proposed development site from where cycle track meets Bowling Club car park. Photograph taken from NS 21006 56200.

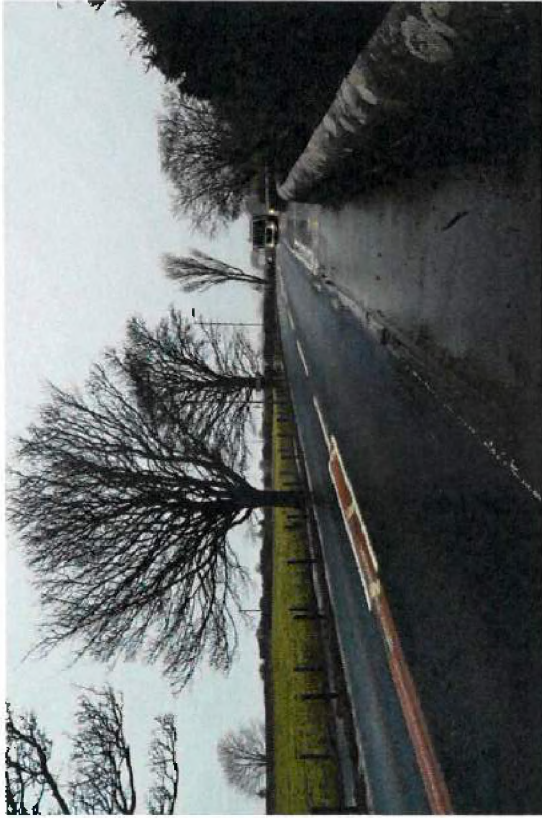
- 2.4 The map also indicates a medium likelihood of surface water flooding at the NW and SE extents of the land proposed for development. The flooding shown doesn't appear to mirror actual ground levels at the site. For example, ground levels at the NW extent of the site are similar to those at the SW extent (plates 2 and 3) and no significant depressions in the landform were observed during the site visit nor appear in the topographical survey data. The same applies to the flooding shown at the SE extent. This is located on the left-hand side of plate 3. This too indicates inaccuracy in the digital terrain data used for the flood map at this location.

Plate 3: Looking north with proposed development site on left of frame (the horse in the distance runs along the banks of the subject watercourse). Photograph taken from NS 21028 86217.

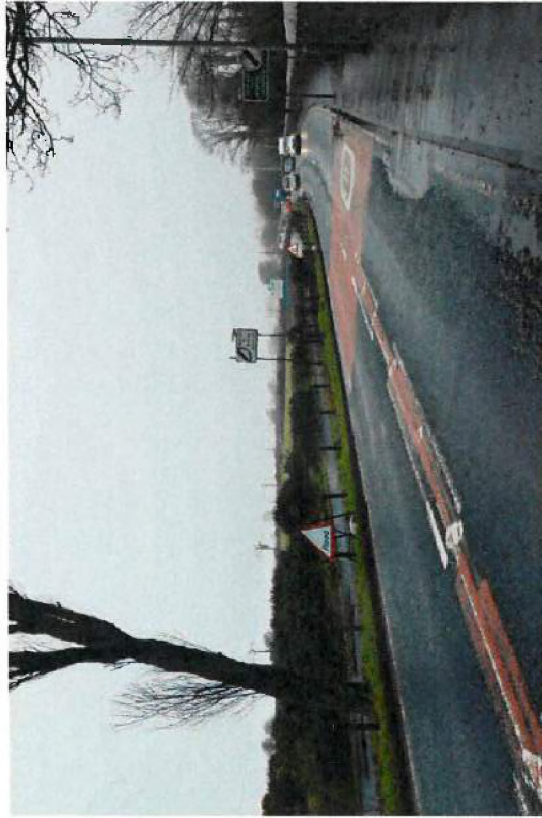
- 3.7 It is not known whether the wall has been repaired since our site visit but assuming it has/will be then for a 1:200 year flood event water will flow behind it in northerly direction towards the unnamed burn which lies north of the entrance to the Kelburn Castle Country Centre. This flood water will not reach the site due to the lower lying land in this location (best viewed in plates 4 and 6).

Plate 4: Looking north with subject watercourse on left of frame (the horse behind the tree lies either side of the watercourse channel). Photograph taken from NS 21034 56271. NB: Beyond the site boundary/watercourse the landform slopes north.

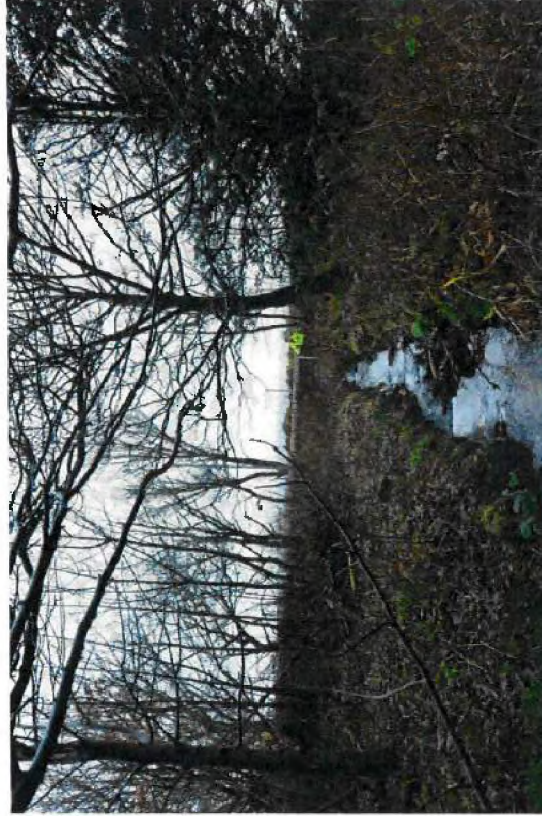
- Constraint to fluvial flow at or towards the site**
- 3.4 The constraint to fluvial flow at the site is the culvert intake (plates 8 and 9). This has an ID of 0.55 m which provides a cross-sectional area of 0.2 m². This is significantly smaller than the minimum cross-sectional area of the open channel which from the site visit and the topographical survey⁽⁴⁾ was estimated to be in excess of 5.0 m². Even when taking into consideration the higher roughness of the open channel and the slightly lower slope it provides significant capacity to convey the maximum discharge from the culvert.

Plate 8: Subject watercourse upstream of A78 culvert intake.
Photograph taken from NS 21065 56283.

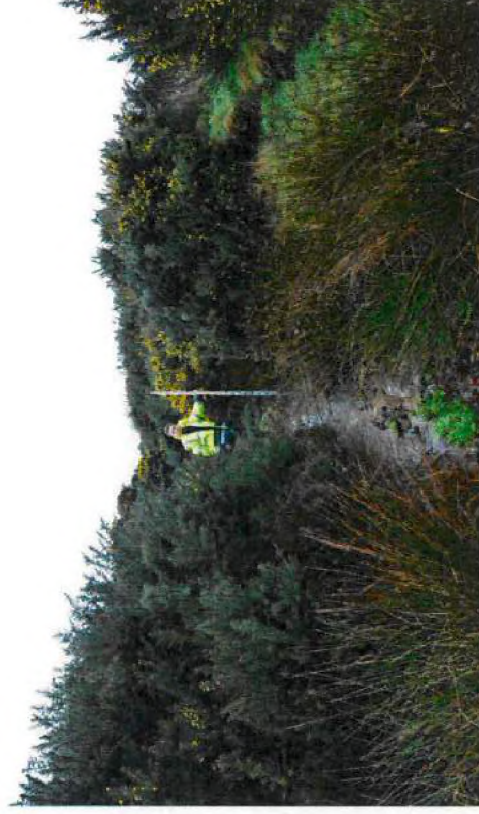
- 3.2 Flow from the catchment enters a 0.55 m ID circular pipe (plate 9) which travels beneath the A76/cycle track and discharges into the open channel (plate 13) towards the north end of the proposed development site (plates 14 to 17). Somewhere beneath the A76/cycle track the 0.55 m ID pipe connects into a 0.55 m H x 0.7 m W ID elliptical vitrified clay pipe which forms the outfall (plate 12).

Plate 14: Channel of subject watercourse downstream of culvert outfall.
Photograph taken from NS 21024 56293 looking downstream.

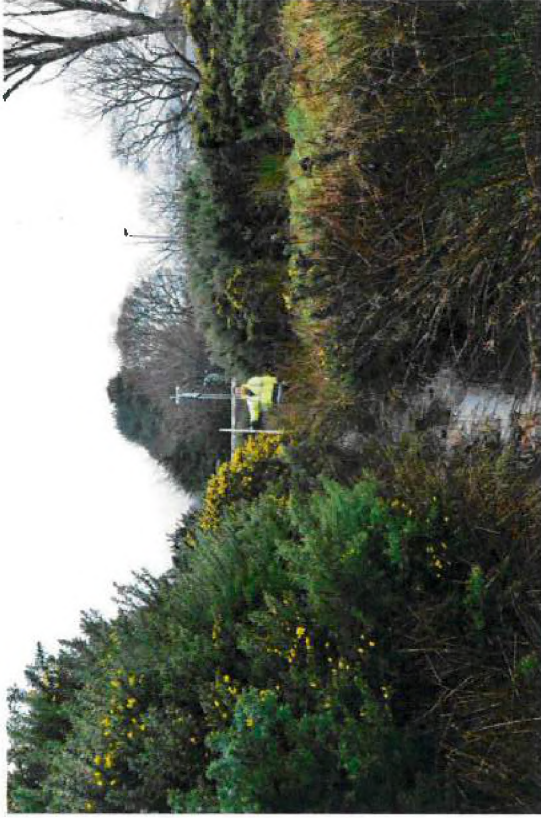
Plate 15: Channel of subject watercourse.
 Photograph taken from NS 21008 56295 looking upstream. Staff in same location as plate above.

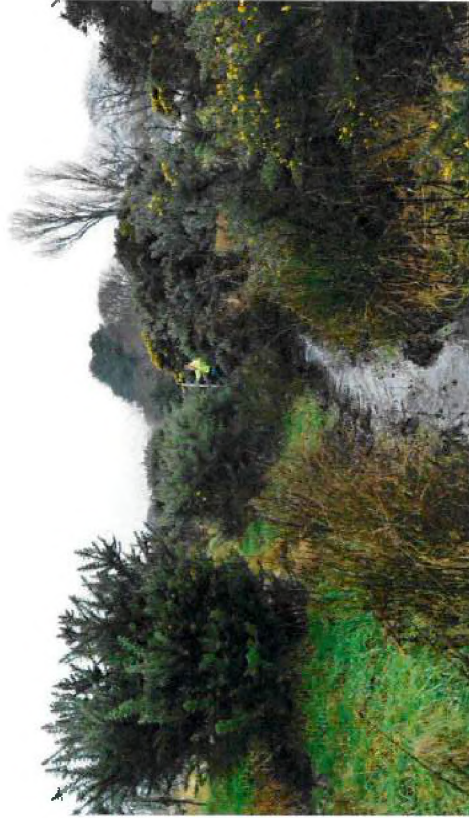
Plate 16: Channel of subject watercourse.
 Photograph taken from NS 20977 56296 looking upstream.

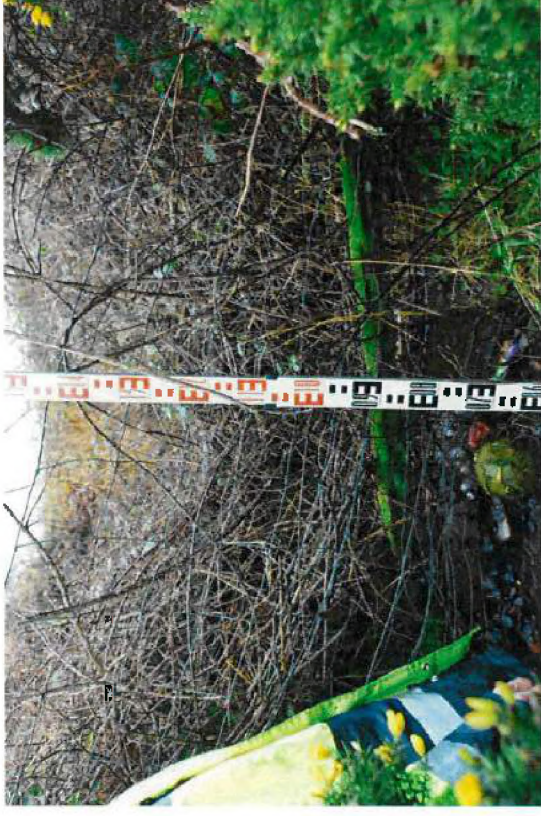
Plate 17: Channel of subject watercourse in front of railway line culvert.
 Photograph taken from NS 20985 56296 looking downstream.
