Re: Stoford Developments, ICON Harlow – Statement of Practical Completion

STATEMENT OF PRACTICAL COMPLETION

ICON HARLOW UNIT B ELECTRICAL PROGRESS INSPECTION REPORT

UNIT B SNAG LIST

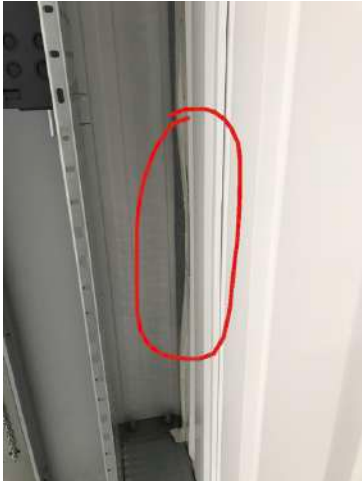
21
Daylight visible.
