THE OLD VICARAGE

HIGH STREET, ABBOTS LANGLEY,
HERTFORDSHIRE, WD5 0AS

HISTORIC BUILDING
RESEARCH

JANUARY 2021

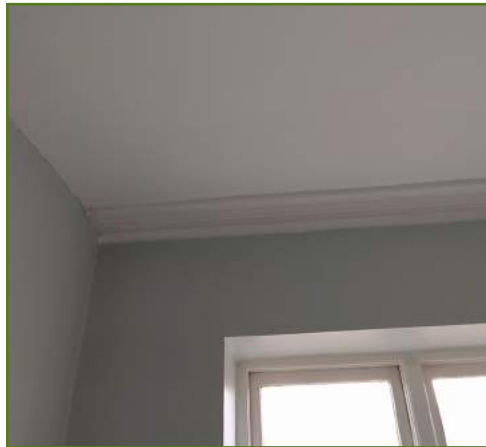
IMAGE 21

The internal distribution of the house was also reconfigured during the 1960s/70s in order to insert modern domestic facilities such as kitchens and bathrooms (image 19). This new distribution of the space is obvious in one of the first-floor rooms within the 18th century block, where the room has been divided into a toilet, a bathroom and a cupboard, accessed by an awkward corridor (image 20). The original plaster coving of the room can be seen running through these three spaces (images 21 and 22).

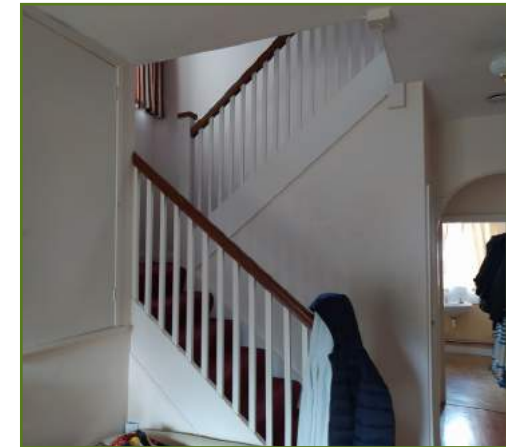
IMAGE 23

Many of the doors were inserted or replaced in the 1960s/70s and there are still remnants of former door frames encapsulating the modern frames (image 23).

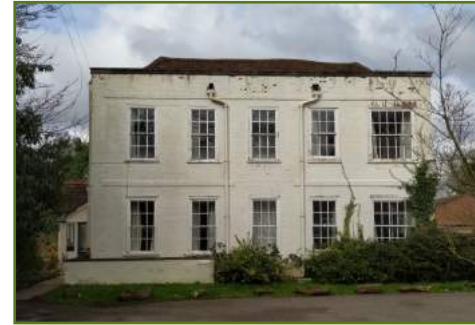
The south-east elevation seems to have been originally a symmetrical early Georgian façade. However, its symmetry was broken when the windows on the right side were

later enlarged. The façade terminates in a brick parapet which extends to the side elevations.

South-east elevation of The Old Vicarage.

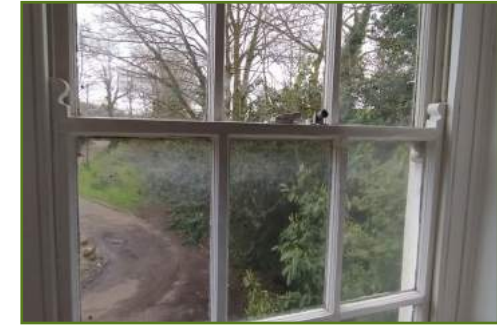
Detail of sash window frame.

All windows show, to a greater or lesser extent, signs of decay and this will lead to further water ingress and in turn further decay. The paintwork is failing on many of the windows. The same is true for the doors.

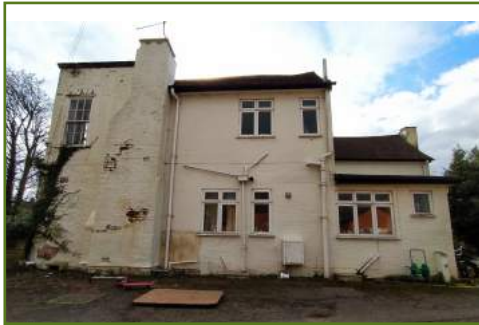
The north-east elevation shows the side of the 18th century building and the single-storeyed modern extension. This elevation has been significantly altered as indicated by the large amount of modern brickwork and the modern windows.

North-east elevation of The Old Vicarage.

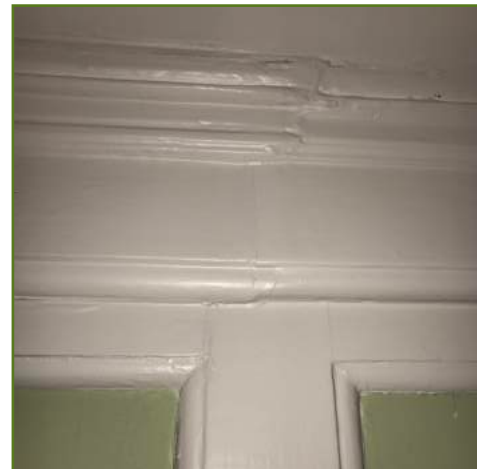
The panelling around the same area in the drawing room was removed to reveal modern brick infill from the quarter landing height of the original staircase upwards. This explains the differences found in the panelling (join lines, method, materials and quality).

Panel join lines.

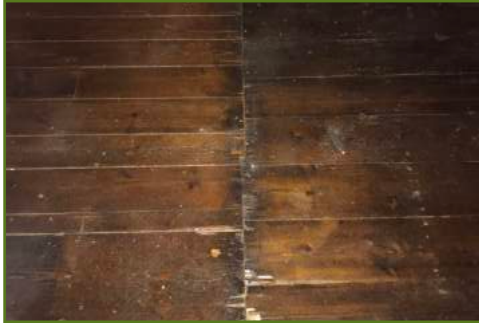
The removal of the carpet in the room over the drawing room revealed evidence of new construction by a line in the floor boards and the same modern tongue and groove flooring used as the one found in the existing landing to this bedroom. The removal of some of the boards showed evidence of trimmer and landing.

Join line of flooring in bedroom over the drawing room.

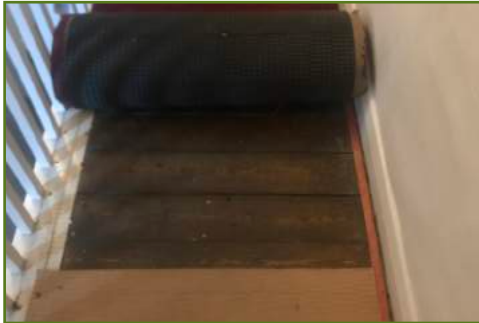
Modern joists and floorboards forming landing to bedroom over drawing room.

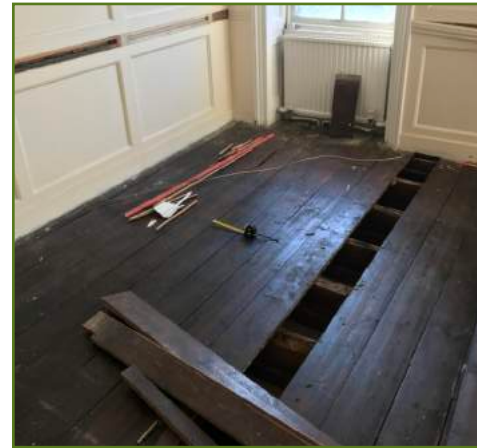
The examination of the floorboards in the bedroom over the drawing room suggested that the area adjacent to the stairwell and landing were of a different width to those of the rest of the room. This suggested that there was a separate room in line with the wall at the top of the landing before the original entrance to the bedroom was built. This also coincides with the position of an earlier window (now blocked) found on the south-west elevation.

Narrower floorboards in pale yellow from bedroom over drawing room

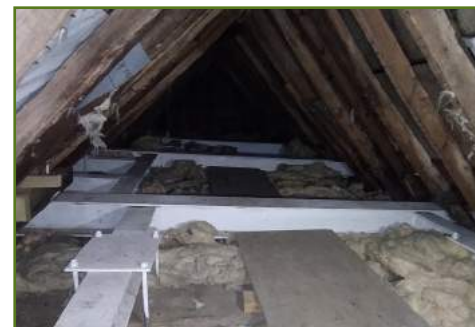
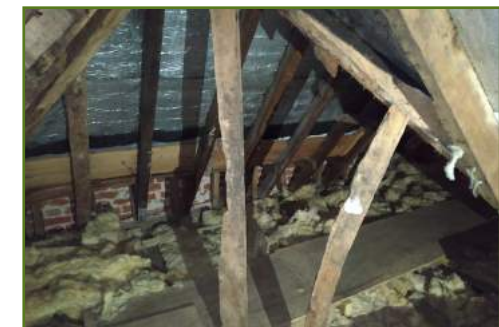
Part of the loft under the roof was inhabited, probably by servants. This theory is supported not only by the existing evidence in the loft, but also by the existence of a dormer window (now lost) in the roof's eastern slope. The current access is with a ladder through a hole; however, the presence of the former stairwell indicates the existence of a narrow staircase in the same area. The roof structure is a mixture of early and modern timbers with multiple modern additions nailed to the rafters. The rafters are covered with iron nails, and there are remnants of wood slats showing the rafters were covered. Few burnt rafters suggest a fire in the house. The roof was restored a few years ago as there was a risk of collapsing. The roof structure was secured by adding large iron beams.

Roof structure.

The roof structure has suffered from decay historically, but this has been addressed to some extent with the relatively recent insertion of a steel frame structure. There is, however, evidence of beetle in many of the timbers, potentially historic, which should be monitored and ideally treated by a specialist. The roof should be maintained dry and adequate ventilation provided. If the building is re roofed an opportunity to address this should be taken. Individual timbers may require replacement or localised repair and a full survey of all timbers should be carried out.
