**The Thatched Cottage,
Bradfield,
Essex**

Historic Building Record

The Thatched Cottage, Wix Road, Bradfield, Essex

Heritage Asset Assessment

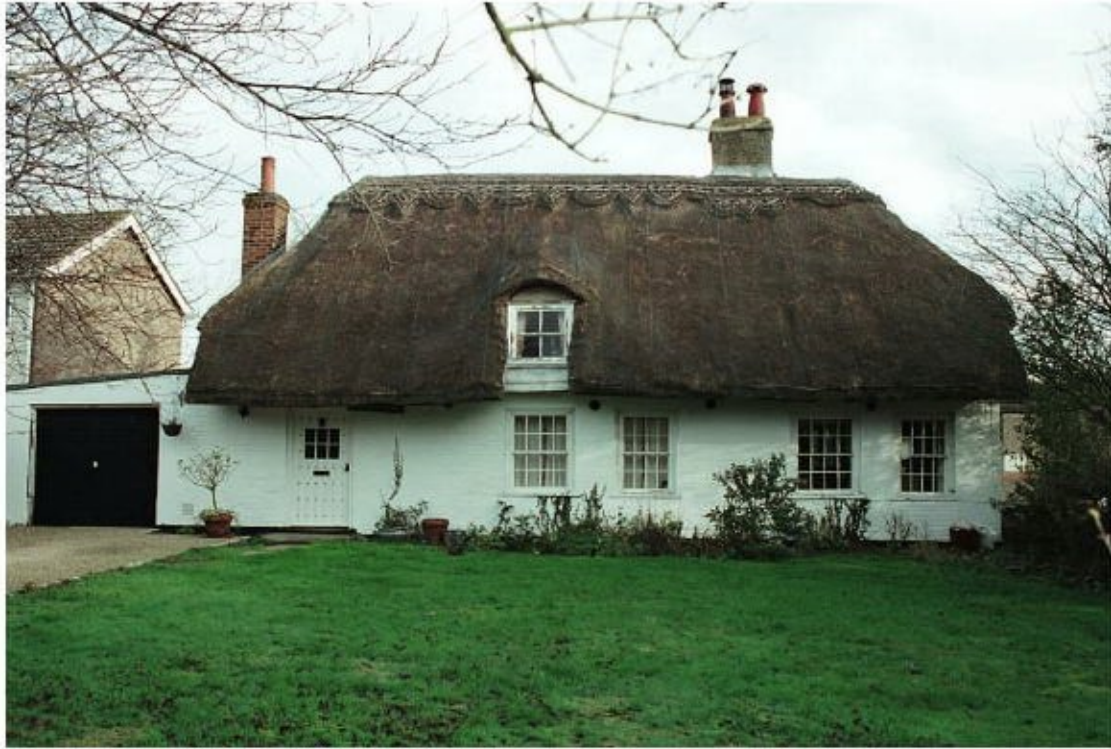
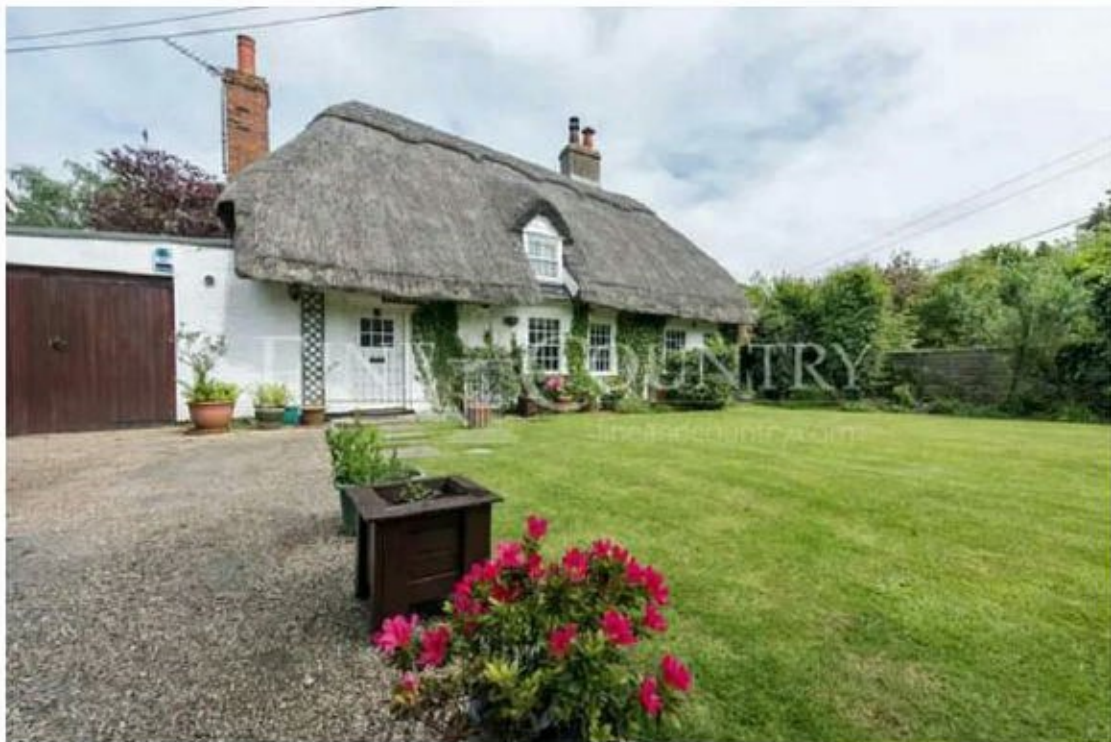
Figure 8
The south-western facade before the fire, taken in 2004 (top) and from Fine & Country's sales particulars of 2016.

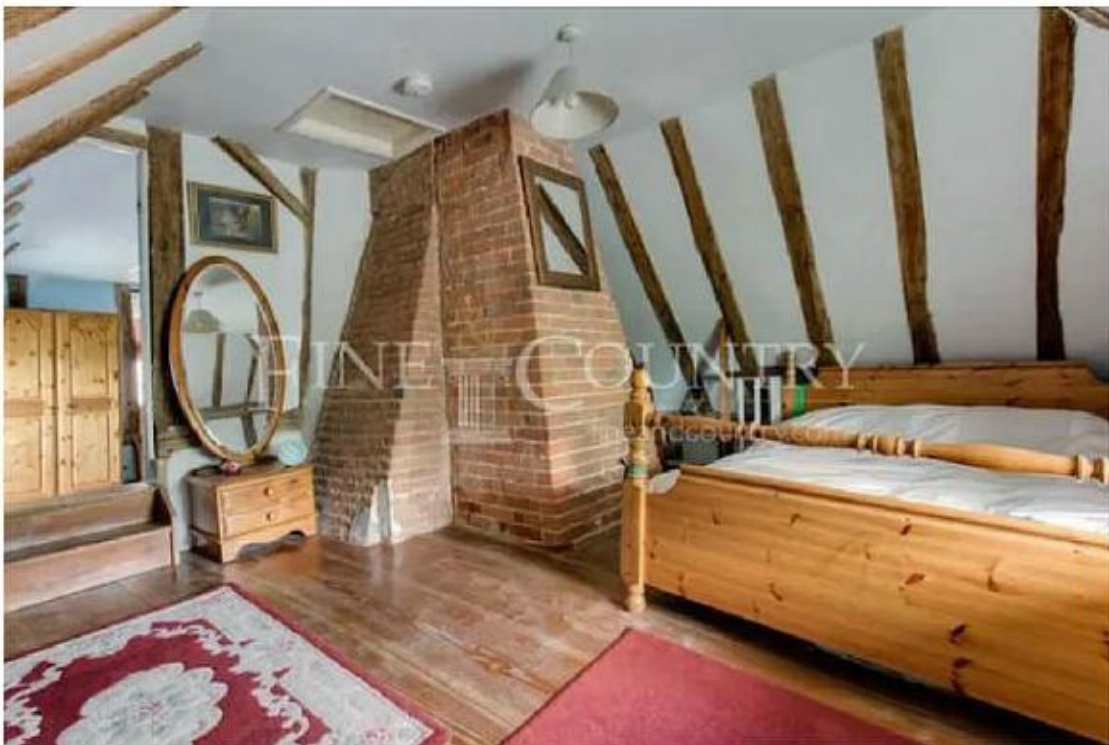
Figure 9b

The two adjoining chimney stacks exposed in the south-eastern bedroom (bedroom 3 in figure 12) from the sales particulars of 2016. Compare illustration 31.

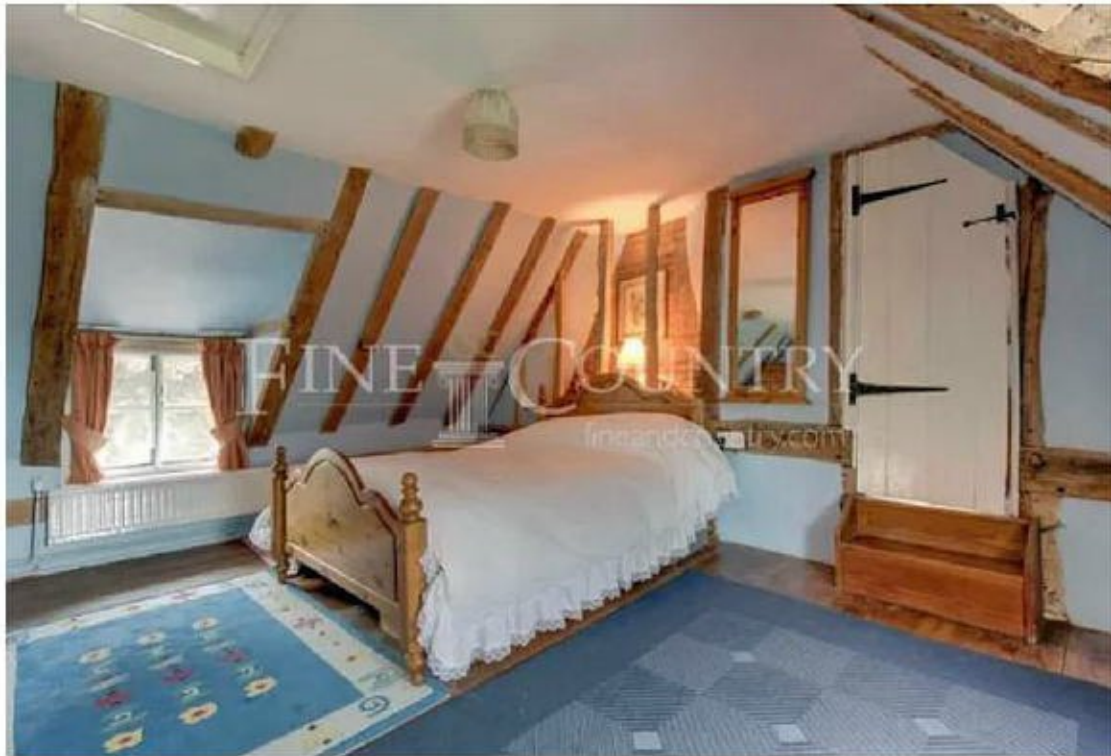
Figure 10a.

The central bedroom from the south-western facade (bedroom 2 in figure 12), showing the rear dormer window. From the particulars of 2016. The substantial flat-sectioned rafters appear to survive from the original structure but the purlins and collars are hidden above what appears to be a plasterboard ceiling. Compare illustration 29.

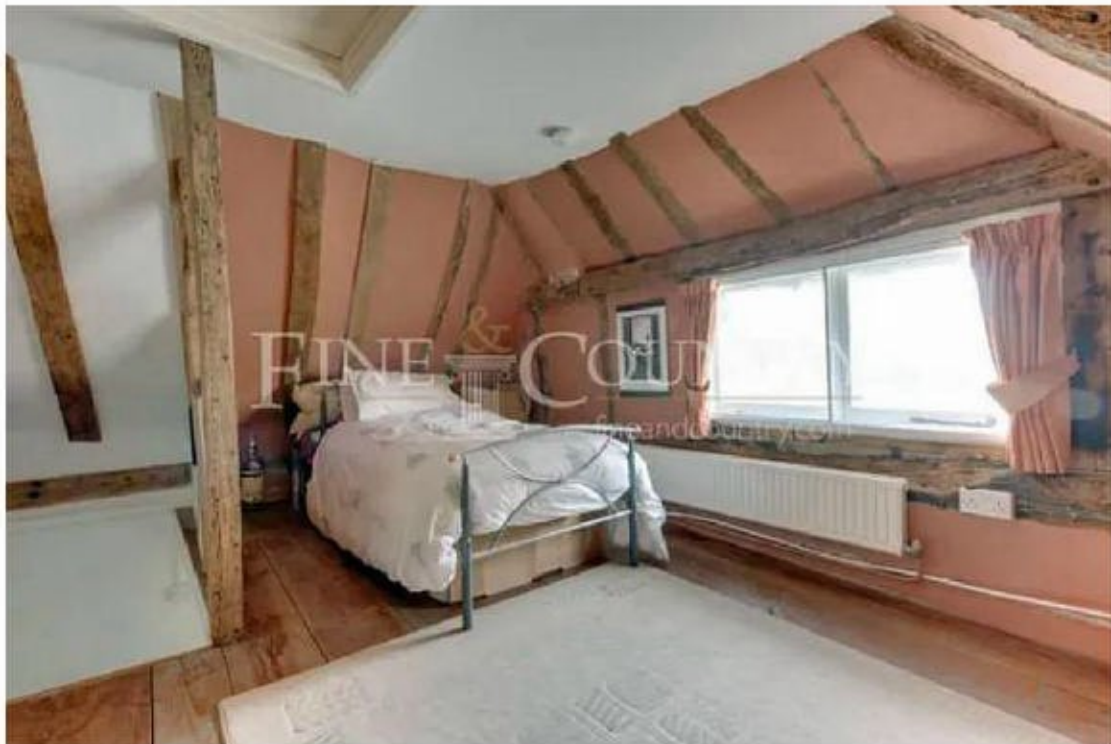
Figure 10b. The north-eastern bedroom with the original gable on the right and the 19th century stair to the left (bedroom 1 in figure 12). From the sales particulars of 2016. Compare illustration 22.

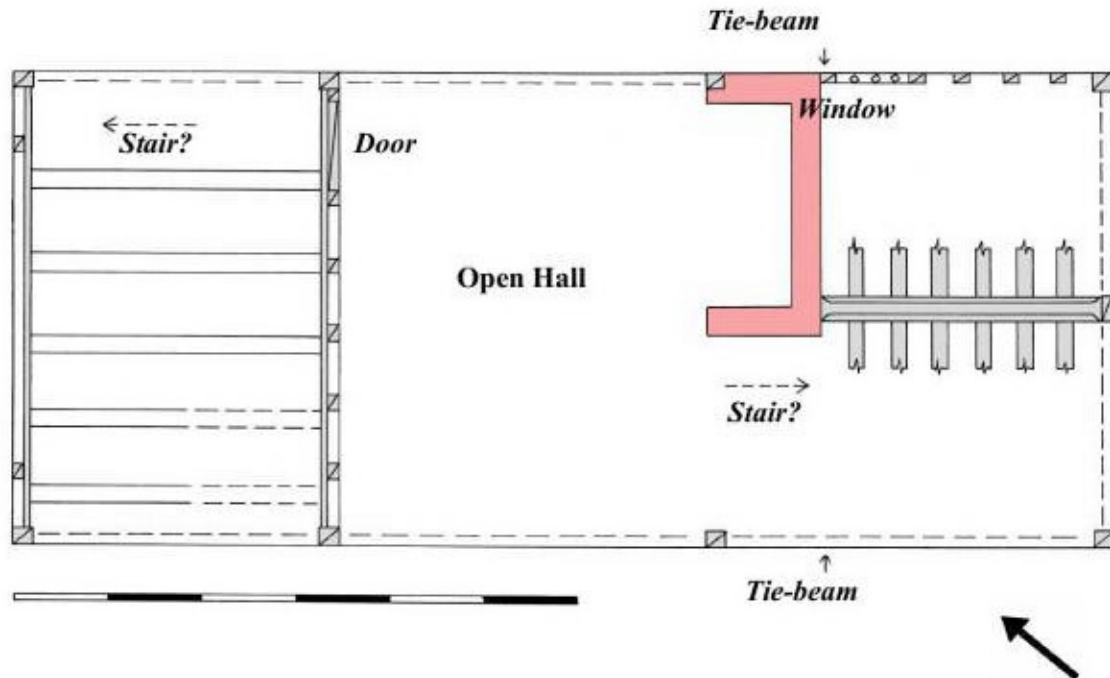
Figure 13

Original ground plan. The brick chimney is an original feature (or possibly an early replacement of a timber-framed predecessor in the same position), respected by the ceiling of the room to its right and defined by an additional tie-beam (arrowed), but the central hall was open to its roof in the medieval tradition. The framing of the front and rear walls is either concealed or rebuilt and the position of the original entrance is unclear. Scale in metres.

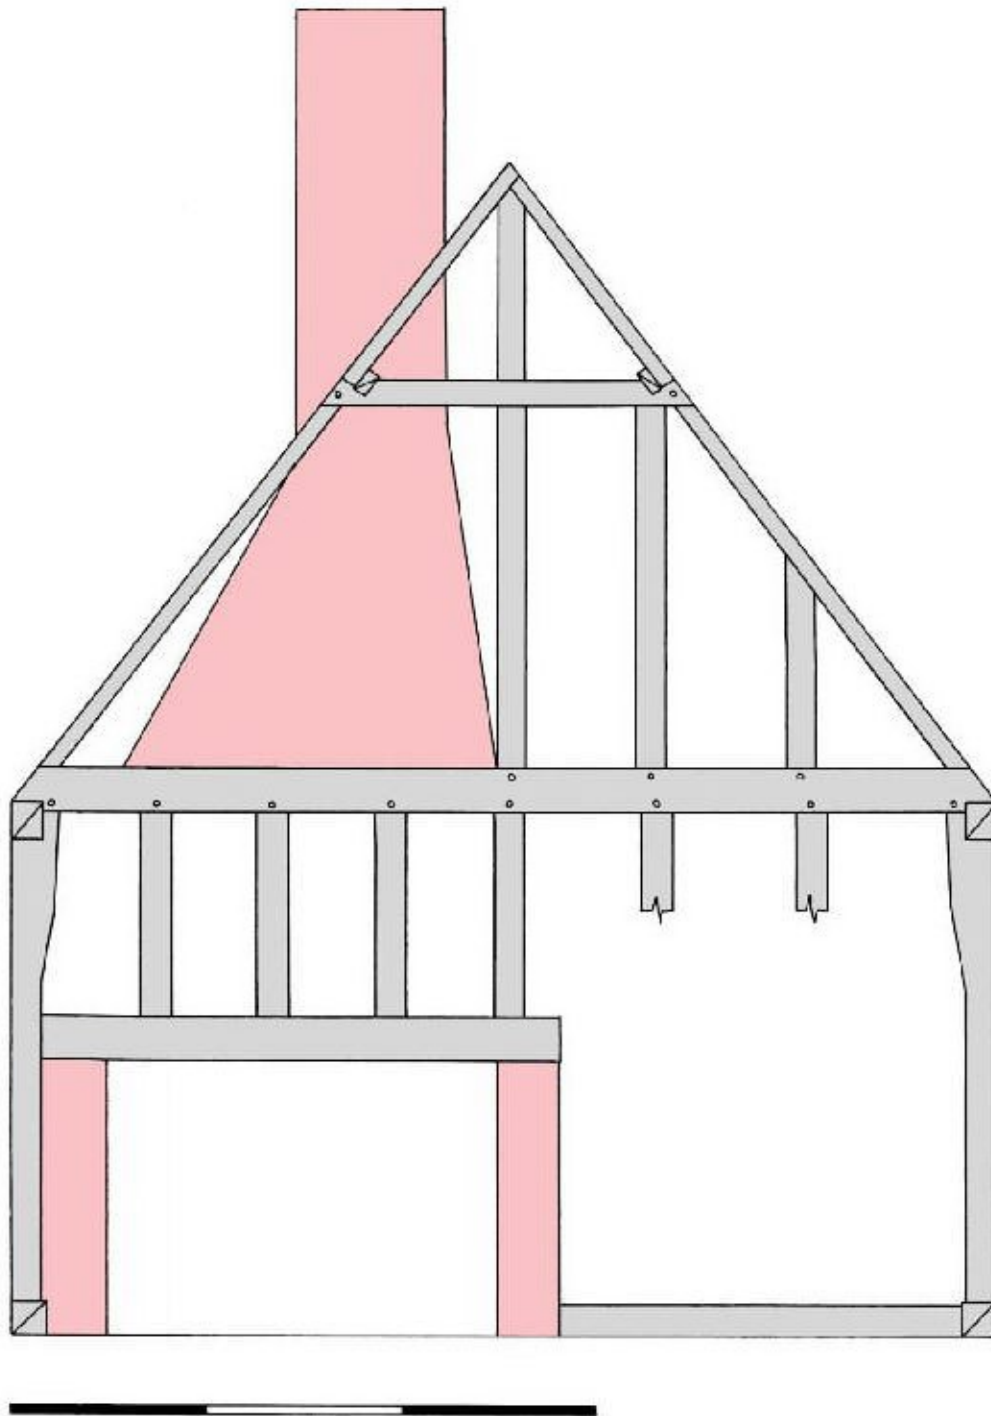
Figure 14

Reconstruction of the south-eastern wall of the central hall with framed studs concealing the chimney below the tie-beam. The wider spacing of the two studs to its right relate to the door of the room beyond and possibly another opening onto a stair but their precise configuration is speculative and therefore omitted from the reconstruction. The studwork below the tie-beam in front of the present chimney breast is either lacking or hidden and may have belonged to a timber-framed predecessor. Scale in metres.

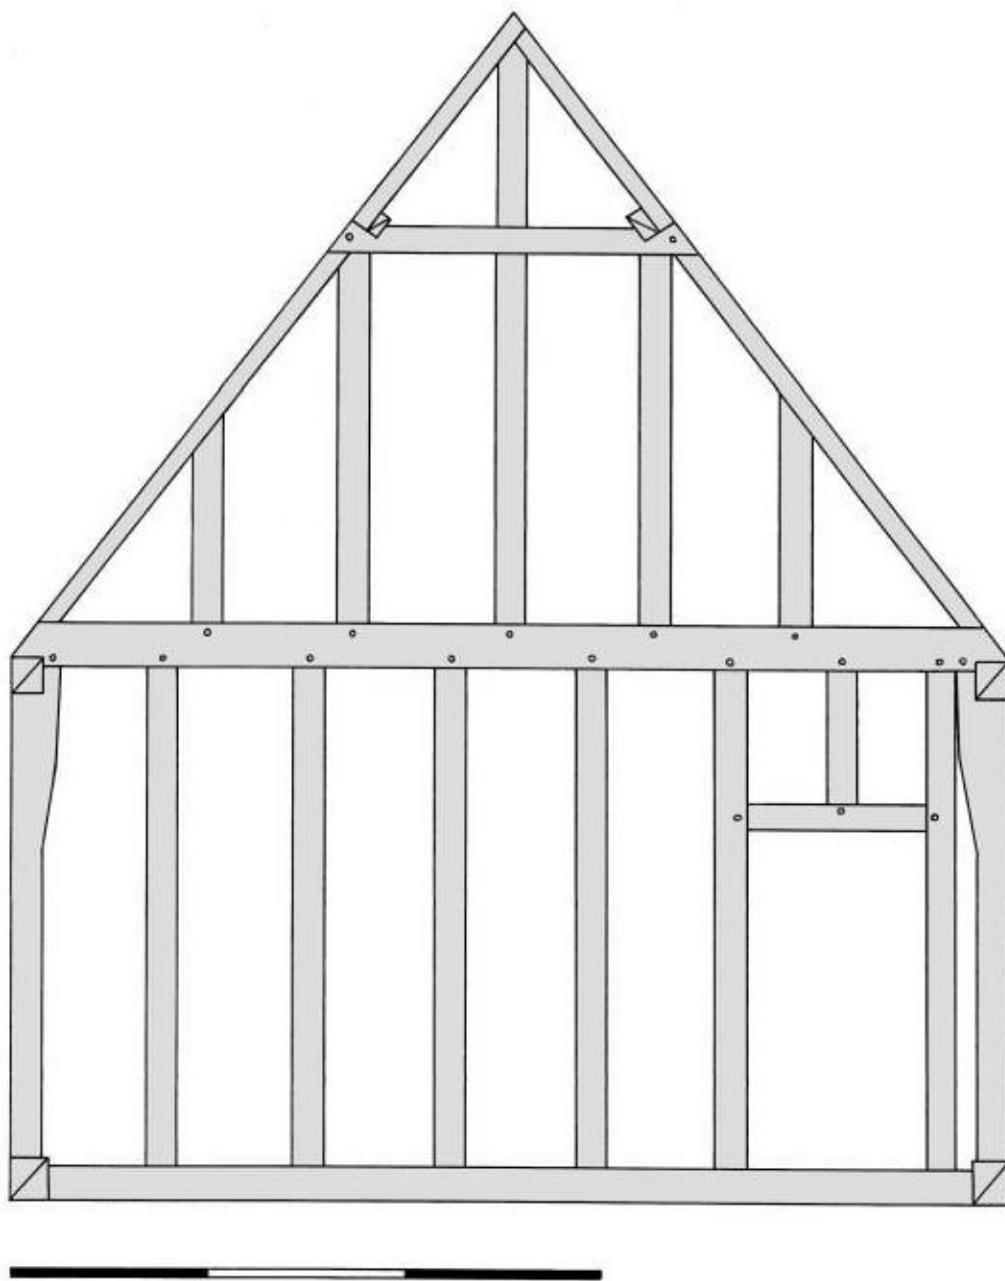
Figure 15

Reconstruction of the north-western wall of the central hall which contained a single door against the back wall in the manner of a 'high' end – yet the position of the chimney suggests this formed the 'low' end of the hall with the service bay beyond. Given its similarity to standard high end this is the most likely interpretation, and the north-western room was probably the parlour.

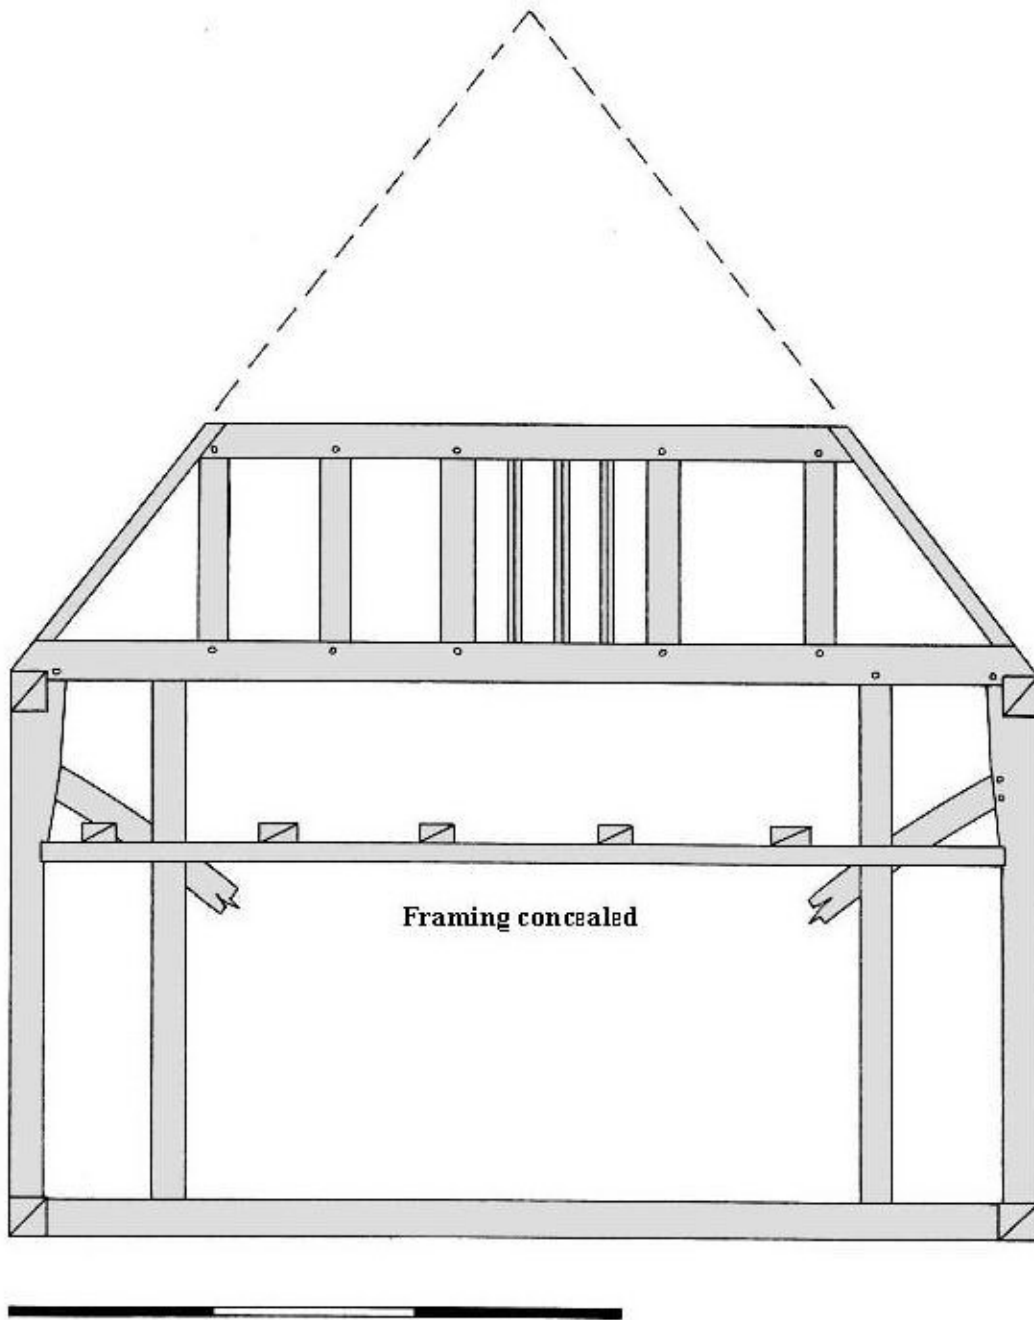
Figure 16
Reconstruction of the internal half-hipped north-western gable showing a diamond-mullion first-floor window to the right of its centre. This asymmetry was probably designed to light a stair in the right-hand corner. The upper tie-beam contains a groove for a sliding internal shutter.
Scale in metres.

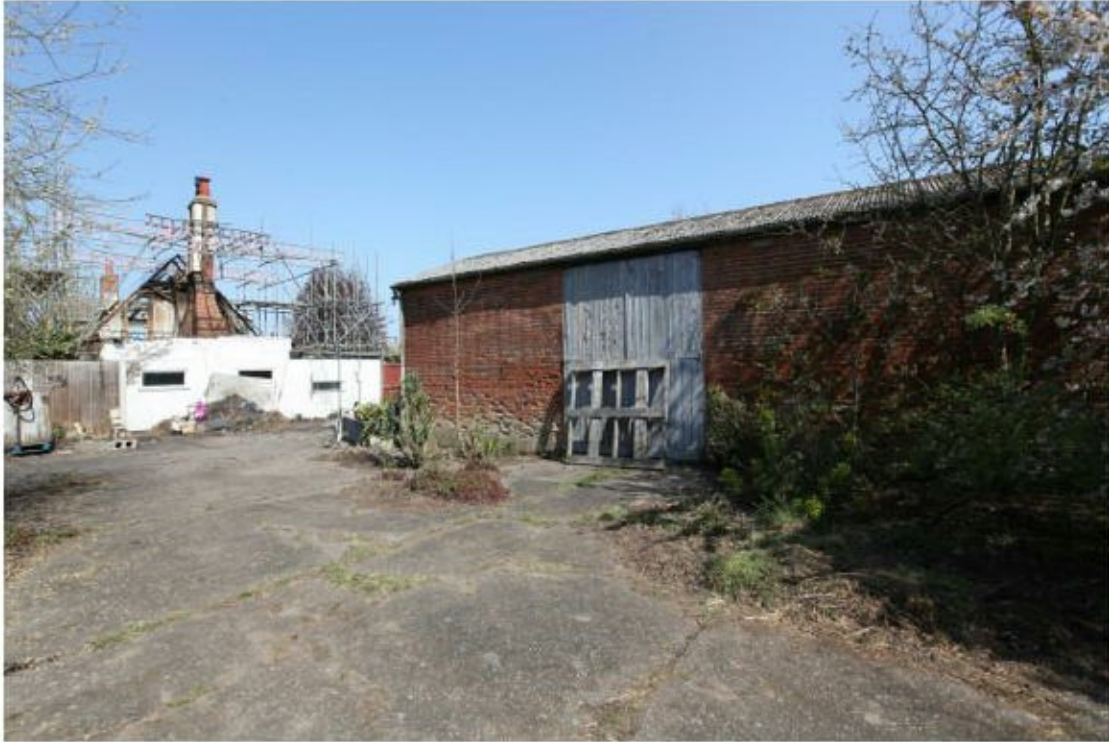
Illus. 3. The cottage from its former farm yard to the south-east showing the late-20th century horizontal windows of its 19th century gable of painted brick with the mid-19th century threshing barn on the right. The latter's doors are respected by the bonding.

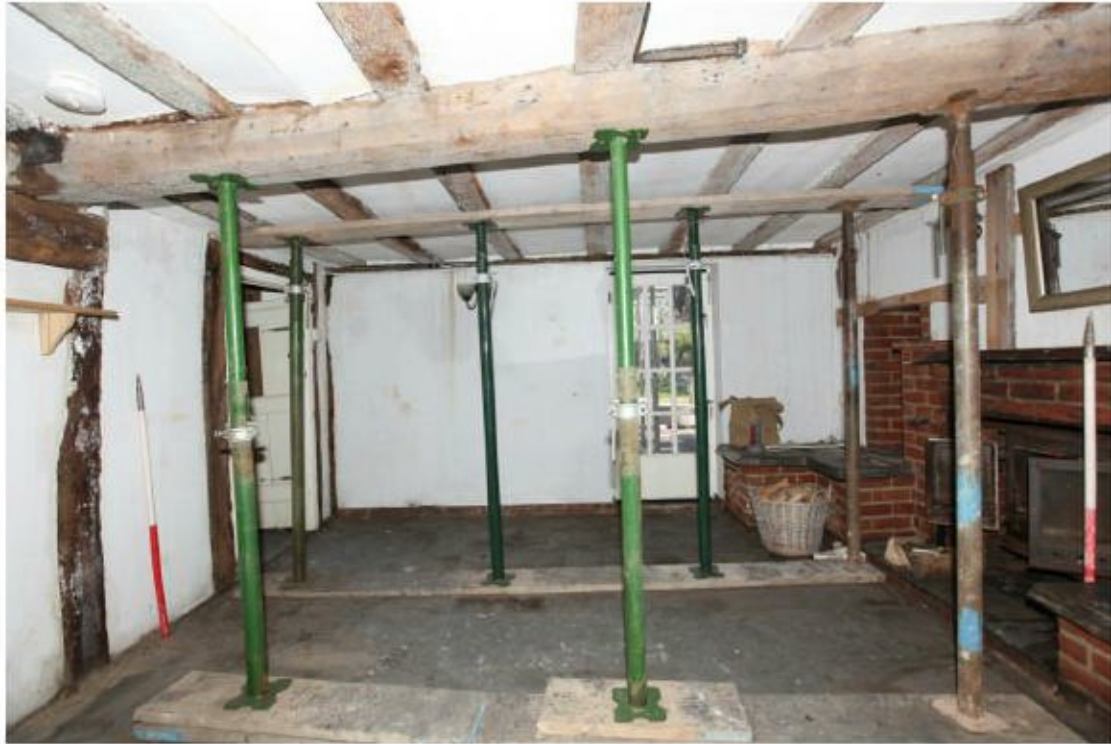
Illus. 5. The central hall from the south-west showing the rendered rear (north-eastern) wall with the modern fireplace in the original chimney on the right and the ostensible 'high end' wall to the left. The complete 16th or early-17th century ceiling has been inserted into a former open hall.

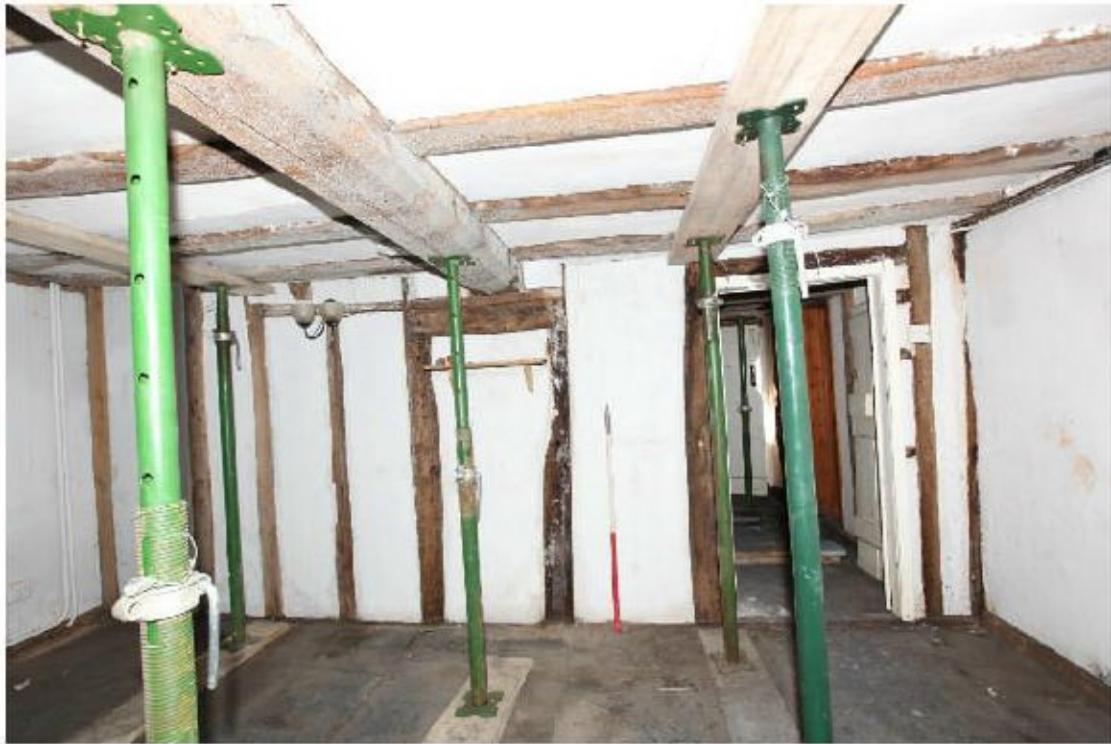
Illus. 9. The north-western wall of the central hall showing an original doorway with a pegged lintel to the right and a nailed rail supporting the axial joist of the inserted ceiling. The nailed lintel of a blocked inserted door is visible to the left of the rail but there is nothing to suggest this wall contained a second door initially.

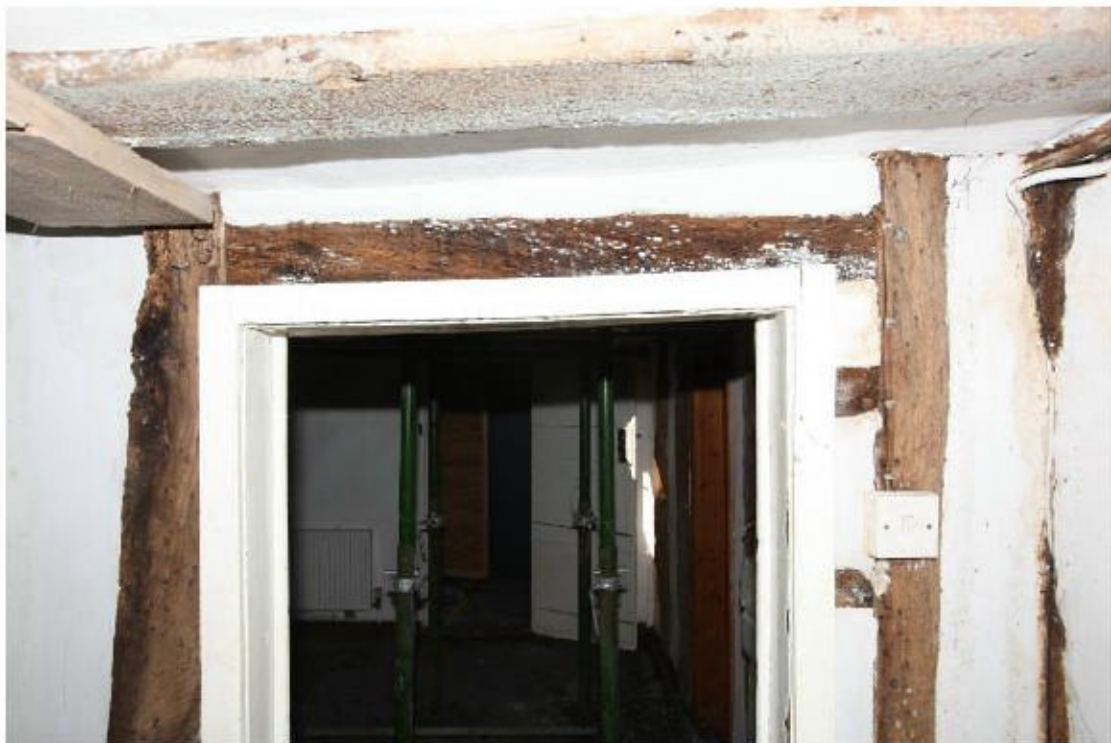
Illus. 10. A detail of the original door lintel in the north-western wall of the central hall showing the pegged joints in both jambs. The two jambs are also tenoned and pegged to the tie-beam above.

Illus. 27. The partition to the north-west of the hall chamber with an ostensibly inserted doorway to the chamber beyond between two intact studs tenoned and pegged to the tie-beam. The stud pegs in the same tie-beam are evenly spaced with no evidence of ground-floor doors apart from the example shown in illustration 10. See figure 15.

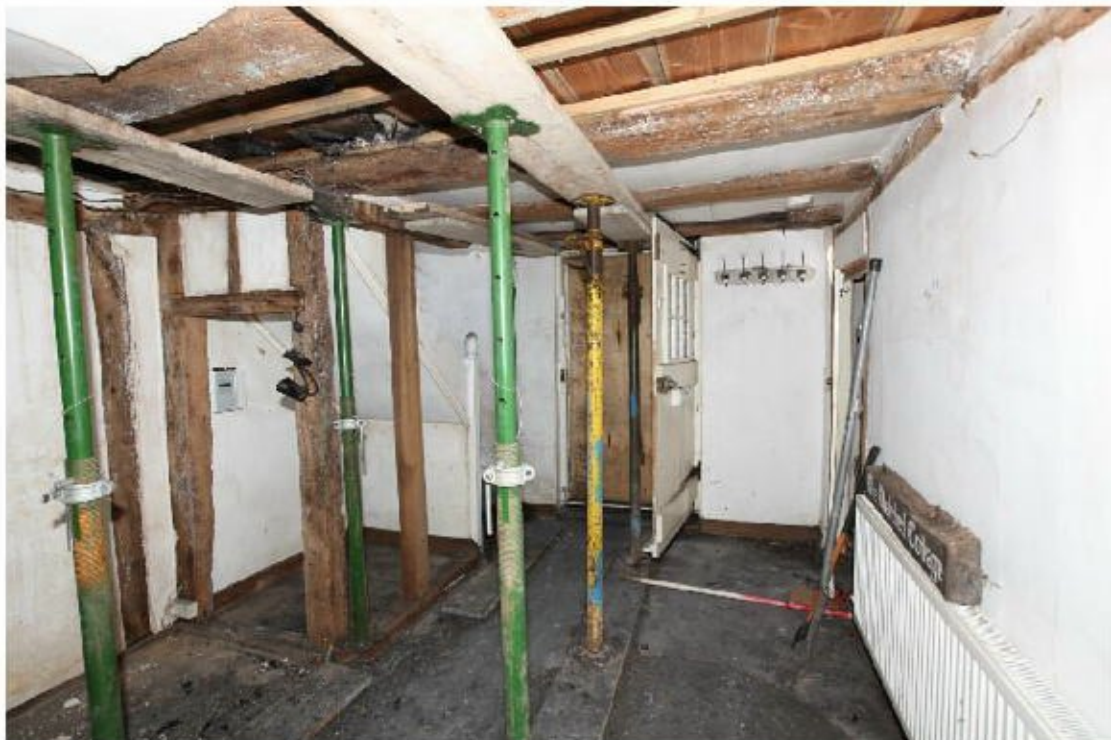
Illus. 12. The service room showing the modern entrance door in its south-western facade with the hidden fabric of the north-western gable to the right and the 19th century staircase of pine boards to the left. The substantial ceiling joists of 18 cm by 13 (7 inches by 5) are original features lodged on pegged clamps but the vertical timbers beneath the stair are re-used 20th century insertions.

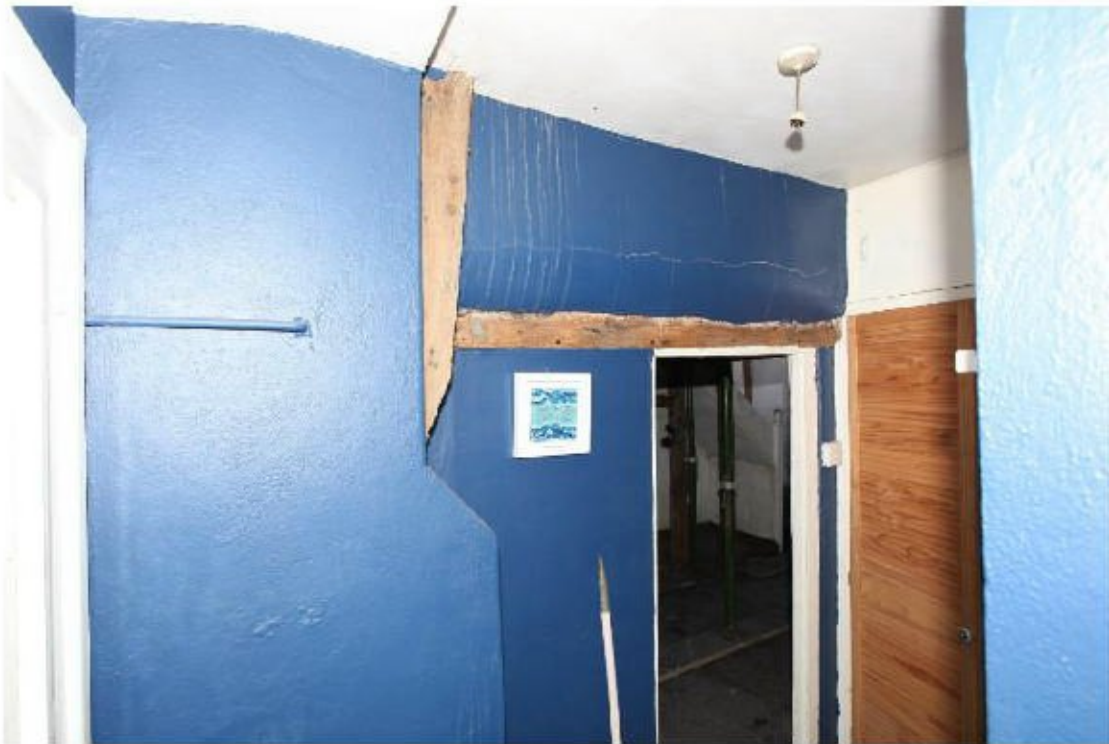
Illus. 14. The northern corner post of the original structure from its later extension showing the ceiling rail or clamp of the service gable from which the lower studs have been removed. The jowled post contained a double-pegged mortice for a descending externally trenched wall brace.

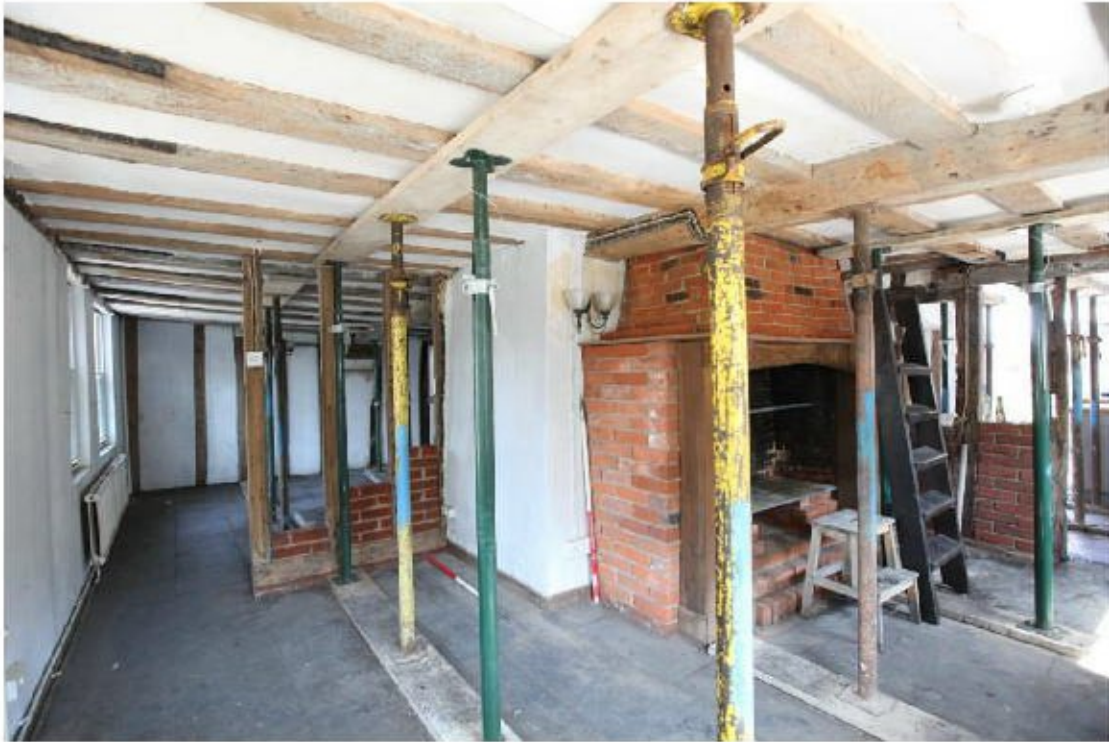
Illus. 15. The right-hand (south-eastern) bay seen from its gable with the 19th century fireplace against the back of the rendered 16th or 17th century chimney in the centre. The ceiling joists adjoining the front of the earlier chimney have been renewed, suggesting that a stair may have existed here. The open studs and brickwork dividing this space from the central hall in the rear are not original.

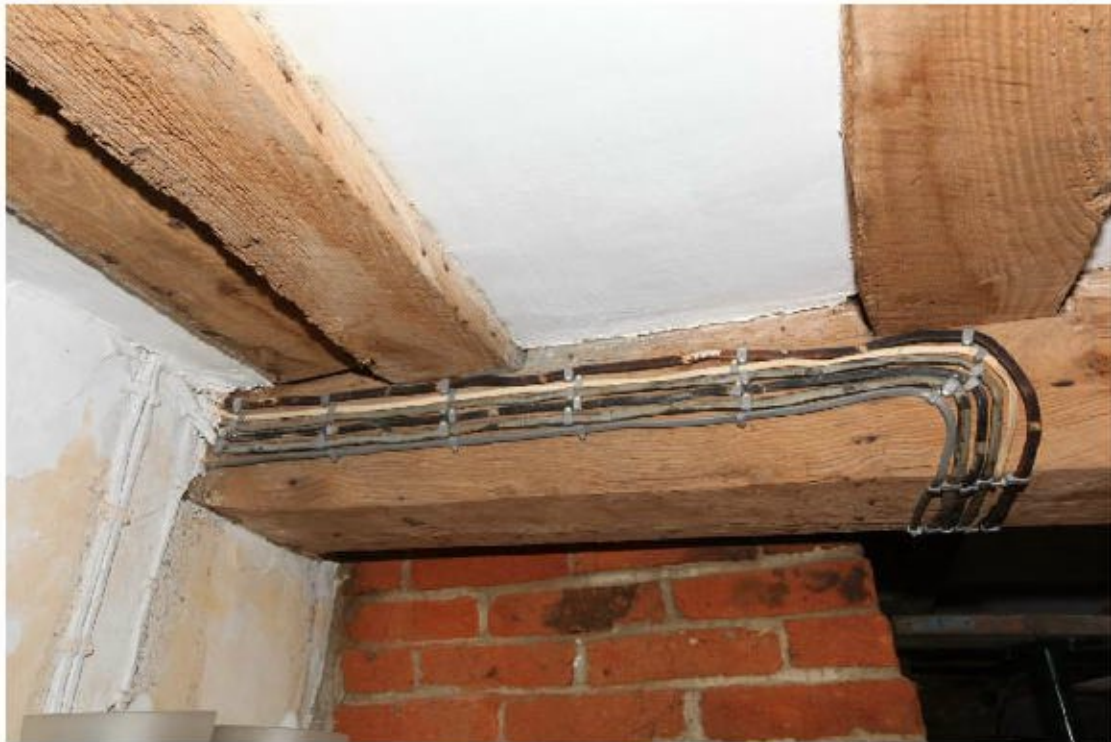
Illus. 17. A detail of the axial joist in the south-eastern bay showing the run-out chamfer stop which respects the ostensibly original chimney on the left (but not the 19th century chimney in the centre). The joists appear to consist of elm but have been cleaned.

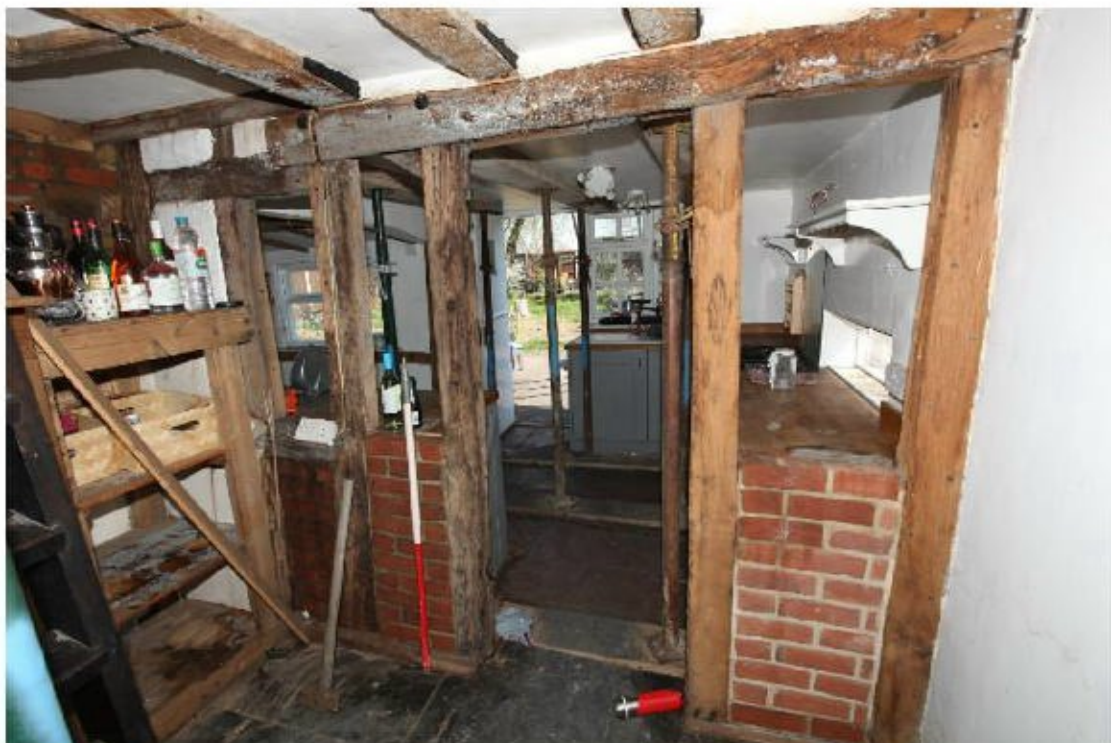
Illus. 18. The rear (north-eastern) internal wall of the parlour showing the lintel and sill of an original window on the left. This is the only section of original external wall framing exposed on the ground floor and adjoins the later lean-to containing the modern kitchen. The original ceiling joists are cut by the 19th century chimney on the left and a modern ladder stair adjoins its brickwork.

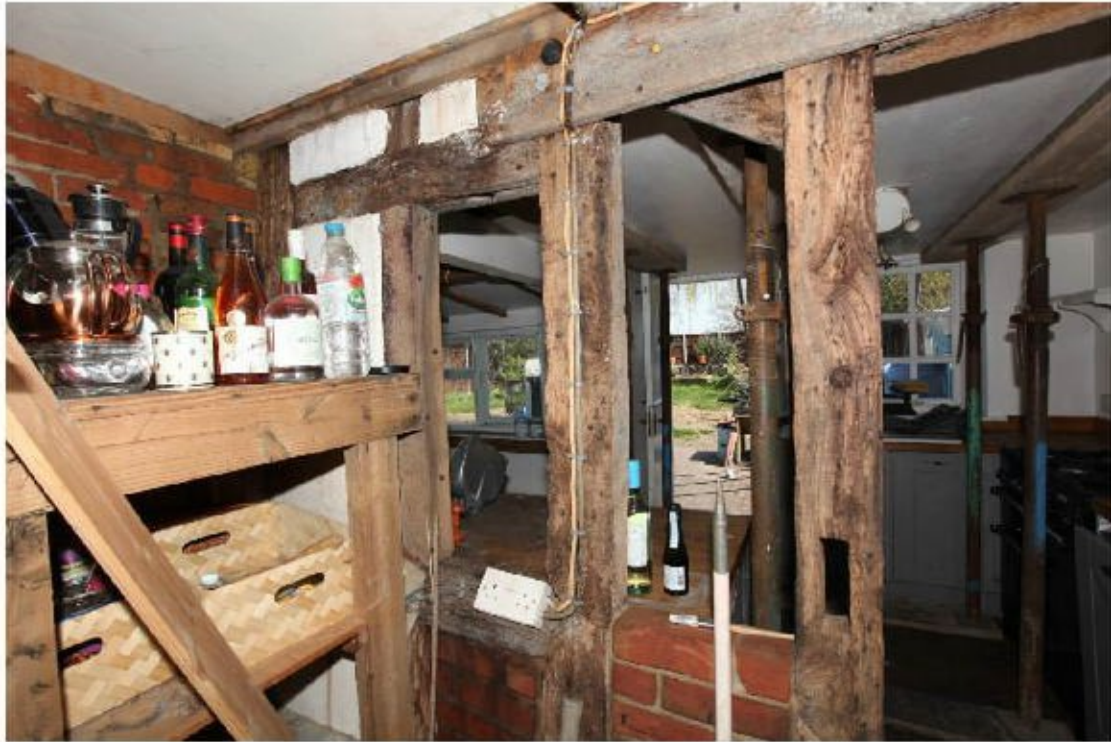
Illus. 19. The rear internal wall of the parlour with an original window lintel and sill tenoned between two studs on the left and an externally trenched brace rising from the stud on the right which is weathered internally and clearly re-used.

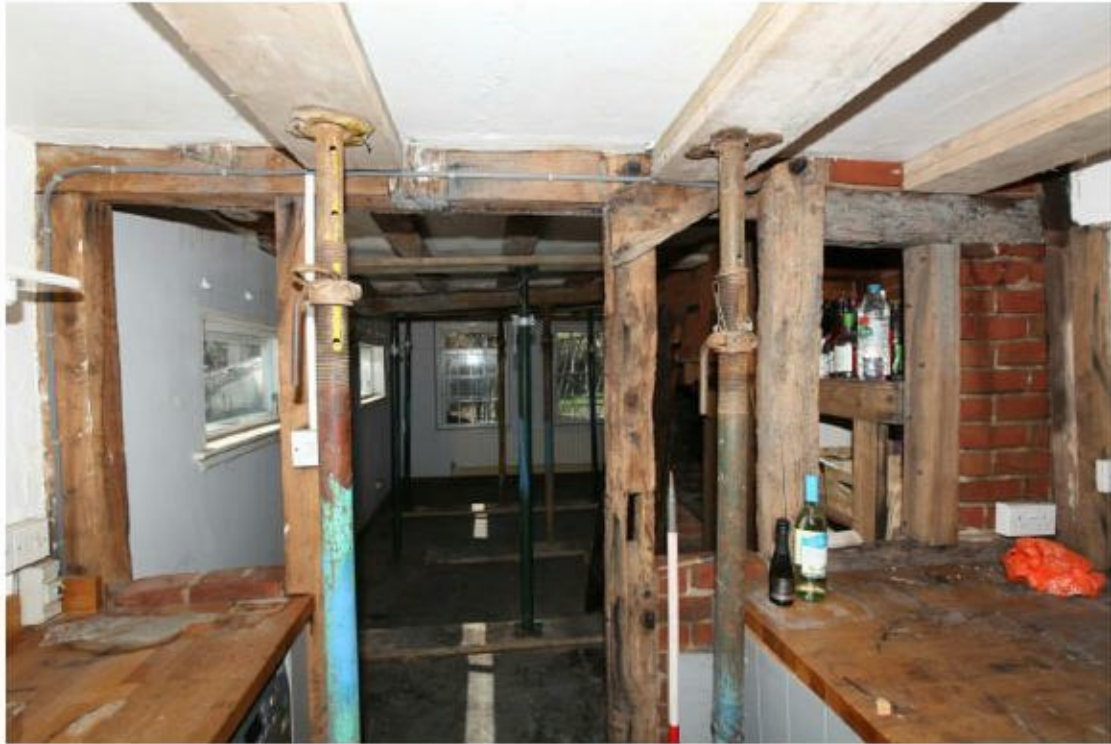
Illus. 21. The exterior of the parlour's rear wall from the lean-to kitchen extension showing two original truncated studs above the modern false studs on the left and a truncated original externally trenched wall brace against the central stud. The original window jamb and lintel are visible on the right.

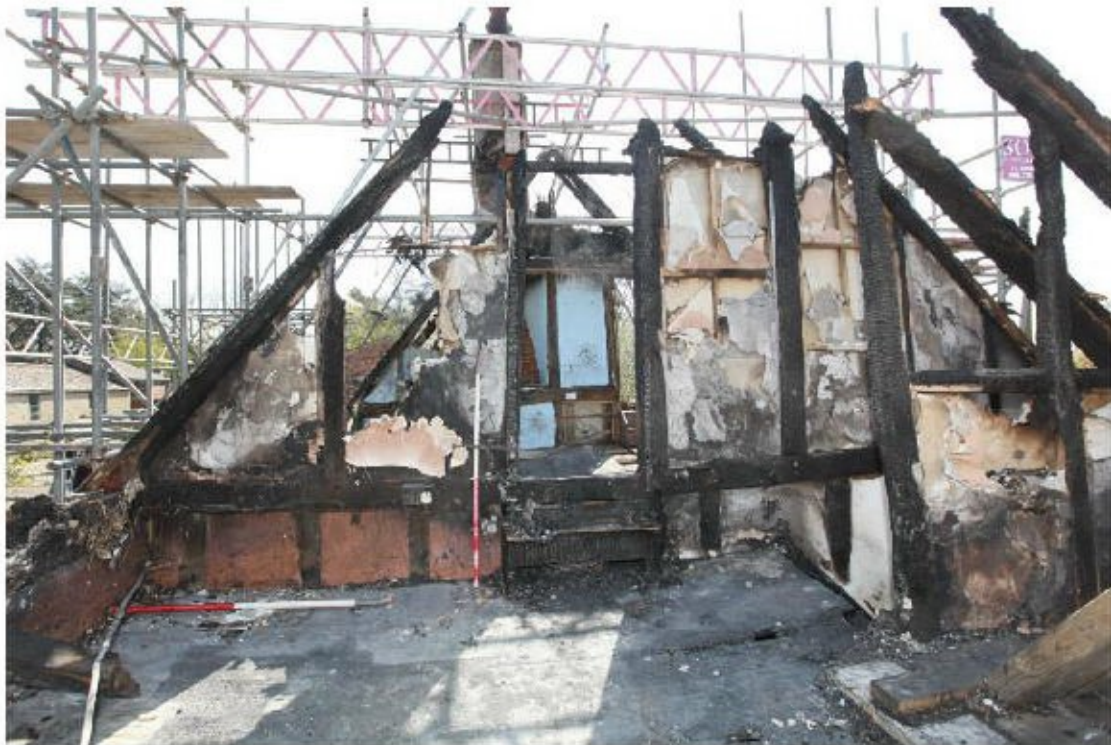
Illus. 25. The chamber above the probable parlour from its gable to the north-west showing the fully framed partition adjoining the central hall chamber. The jamb of the original ground-floor door lies close to the storey post on the left with a pegged short stud above the lintel and the first-floor door is an insertion between to original studs. The floorboards consist of recent softwood throughout the upper storey with no evidence of earlier boards beneath.

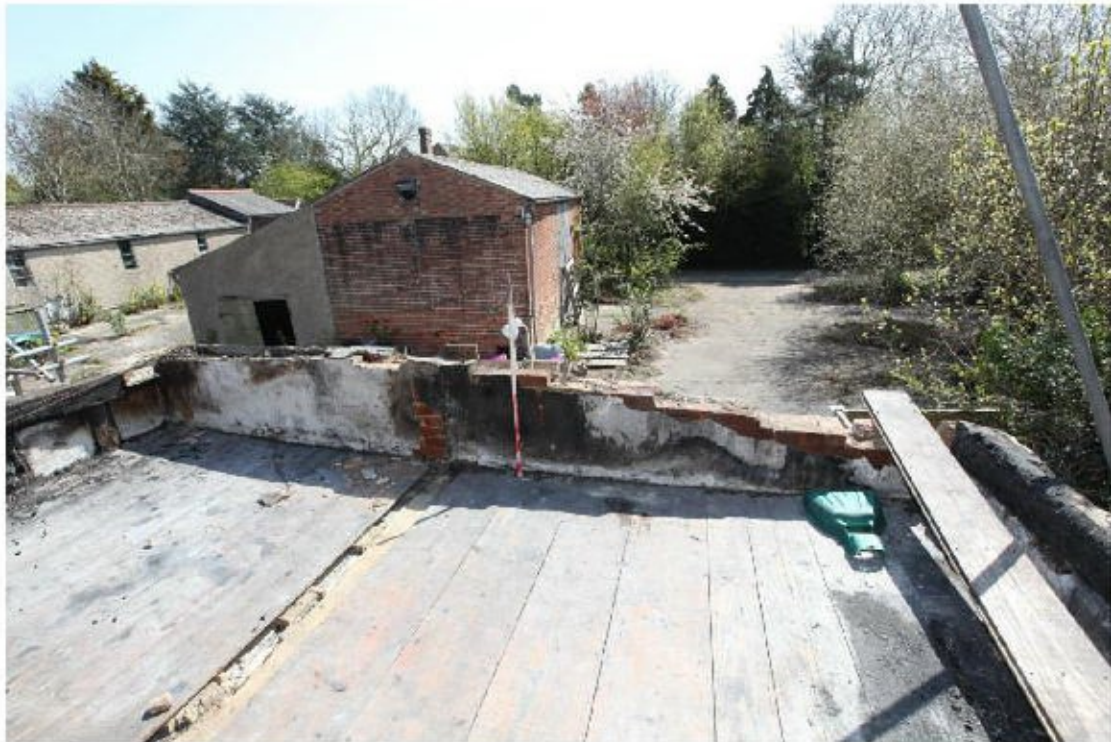
Illus. 34. The south-eastern gable of 19th century brickwork with the farm yard and mid-19th century brick threshing barn beyond. The gable and south-western wall may have been rebuilt in brick as part of the same site refurbishment that included the barn. Most farm yards in the region adjoined service rather than parlour gables.

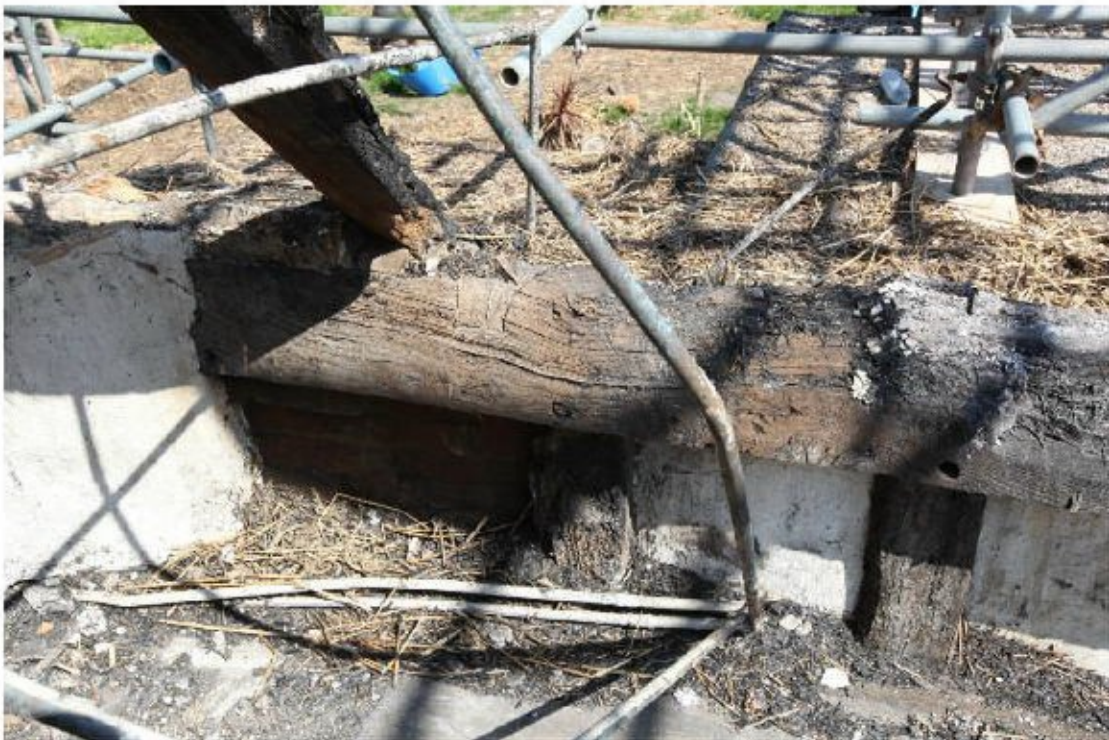
Illus. 36. A detail of the rear roof-plate in the south-eastern chamber showing a plaster-filled original dovetail joint for a missing tie-beam that formed a 1.1 m wide bay for the original chimney and corresponds with another in the front plate.
