MASONRY DAMP INVESTIGATION OF LOWER GROUND FLOOR AT 7 WIMPOLE STREET

JOB NO. 153.75

20 APRIL 2021

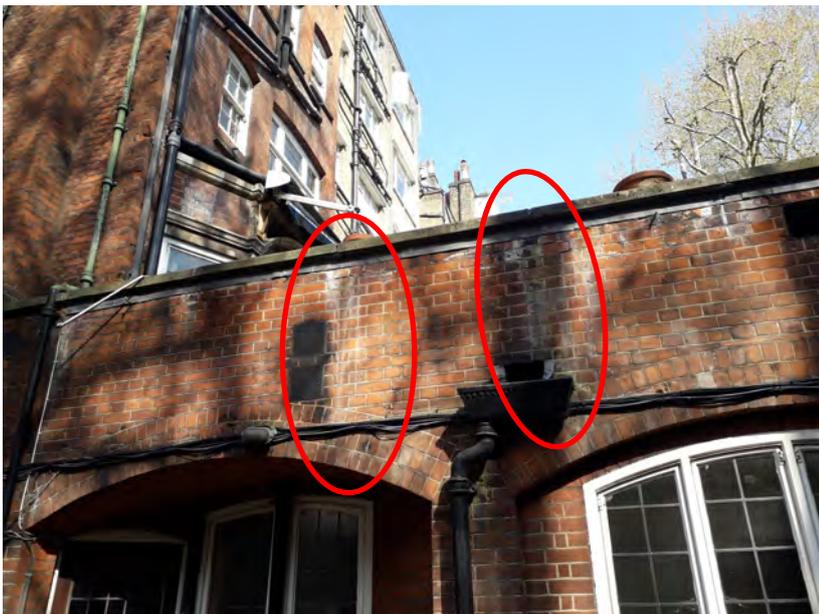
Fig 16:

East extension, south side; showing 'streaking' of soluble minerals below open joints in parapet wall copings

If the raised parapet walls towards the east of the east extension are to be retained on proposed refurbishment, consideration should be given to re-detailing them with projecting copings and damp-proof courses as present elsewhere. Retained copings should be refurbished, raking out loose material from joints and replacing in a suitable lime mortar mix

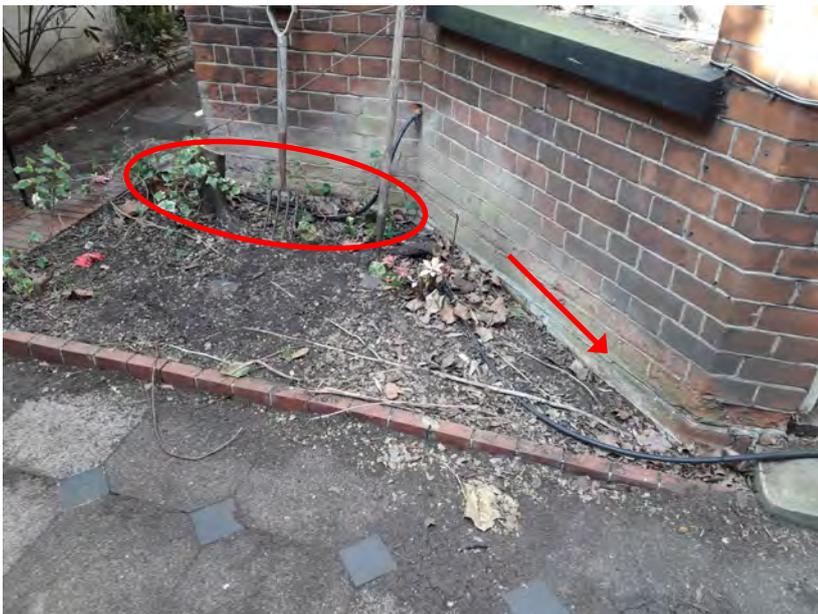
Fig 18:

East elevation of east extension to south of entrance doorway; showing external ground levels partially bridging the horizontal damp-proof course. Note staining and biological growth on brick surfaces consistent with water 'splashing back' onto the façade from the ground, having drained from projecting architectural features above

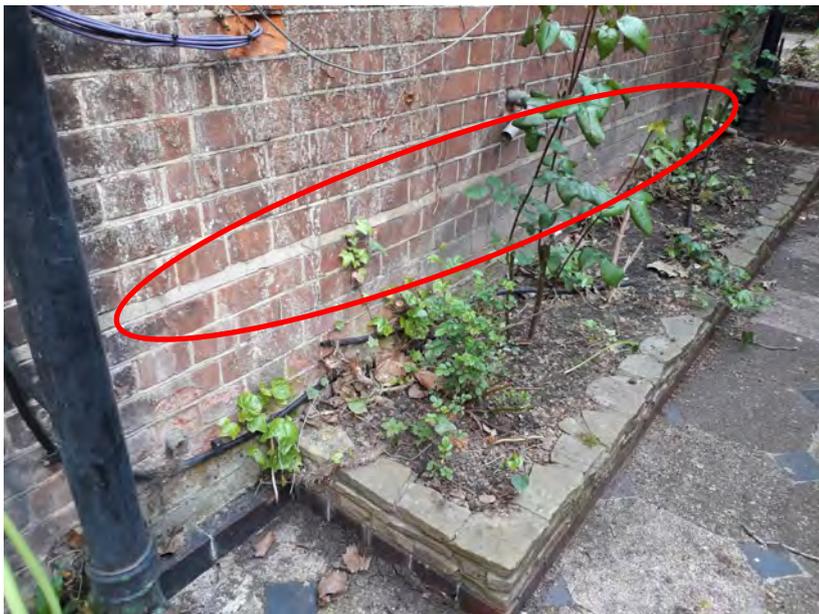
Fig 20:

East extension, south side; showing a wide mortar band concealing the multiple slate horizontal damp-proof course, typically 400-600mm above external ground levels

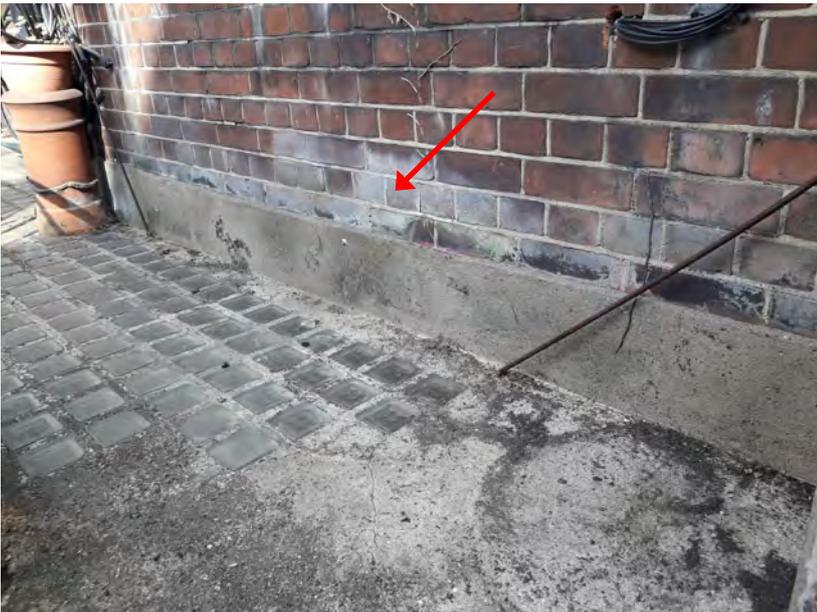
Fig 22:

East elevation, south side; showing walkway at ground level formed from concrete framed glazed pavement lights, with a concrete render skirting at the base of the façade. Note salt efflorescence on brickwork above the skirting, indicating intermittent saturation of brickwork locally where there was exposure to wind driven rain from the south

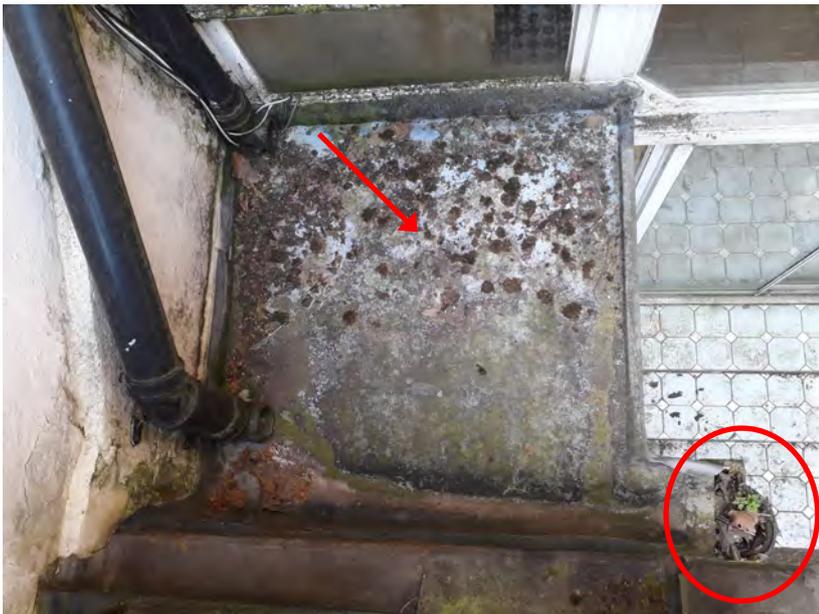
Fig 24:

East elevation, south side; showing small area of lead covered flat roof, collecting discharge from the high-level roof drainage system. Note hopper to lower ground floor level largely obstructed by vegetation and debris

H+R assume that the provision for roof drainage is to be extensively overhauled or replaced on proposed refurbishment. Consideration should be given to a general re-design of the roof drainage system to increase capacity and improve provision for access, cleaning and maintenance. Consideration should also be given to undertaking roof drainage calculations based on up-to-date meteorological data to ensure that adequate drainage capacity is provided to discharge surface water clear of the structure at all times

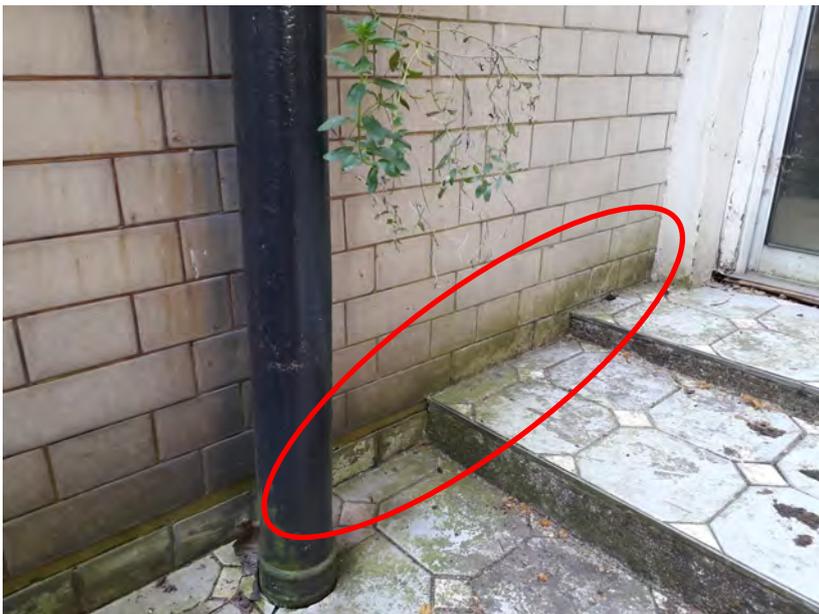
Fig 28:

Lower ground floor east courtyard, west end of south wall; showing step structures providing level access to the interior bridging the horizontal damp-proof course. Note plant growth exploiting open joints in masonry and staining to the wall surface, where water splashing onto the facade would have drained from the edge of the flat roof immediately above

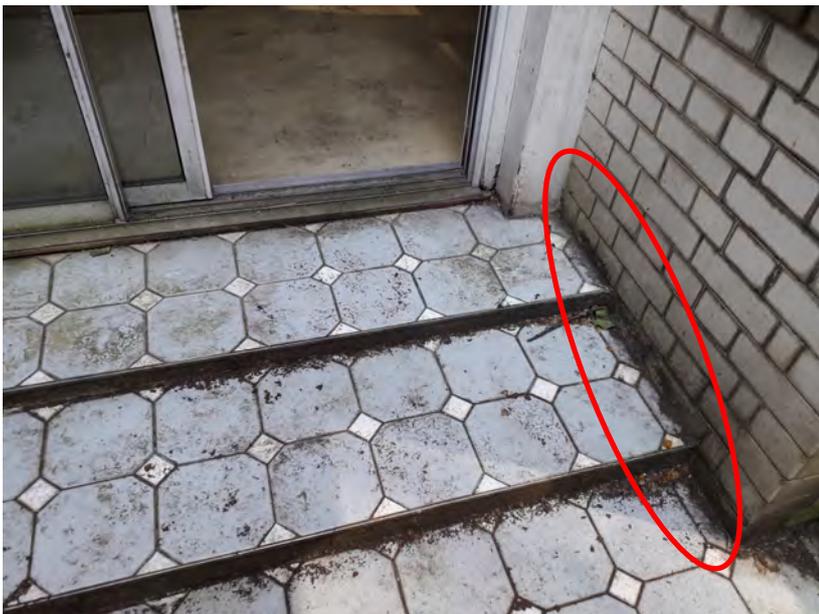
Fig 30:

Lower ground floor east courtyard, west side; showing steps installed to provide level access to the interior, bridging the horizontal damp-proof courses installed in surrounding structures

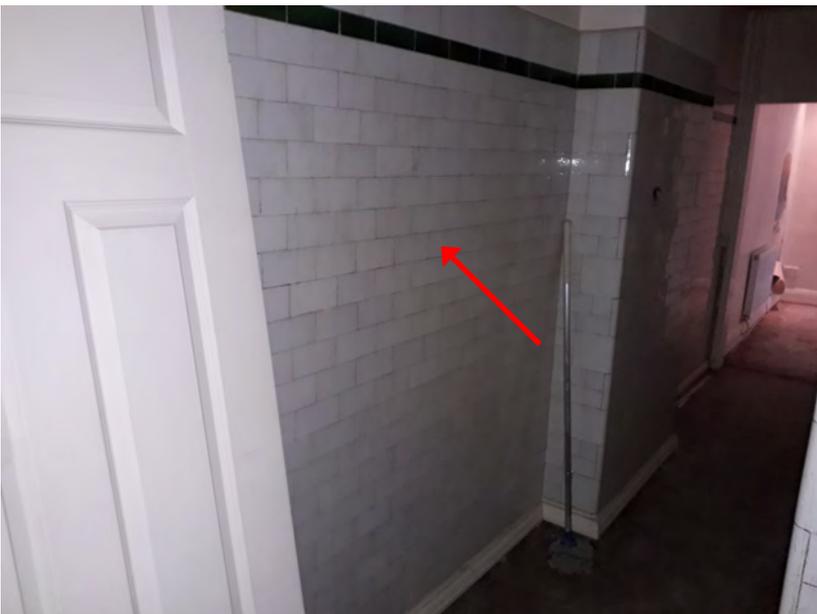
Fig 32:

Lower ground floor, corridor on north side; showing generally good condition of historic tiled wall finishes

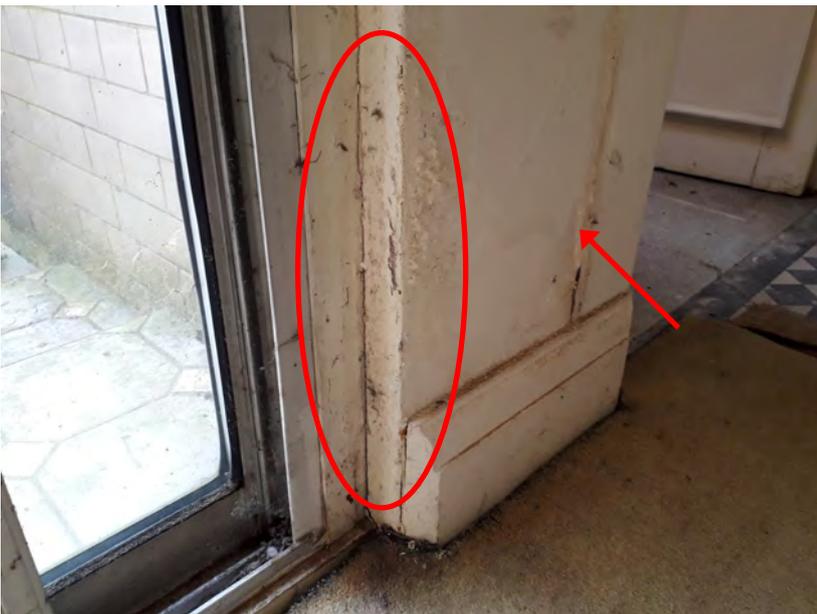
Fig 34:

- 2 South east room of main house: Staining and salt efflorescence were observed, affecting decorative finishes adjacent to the doorway leading to the east lower courtyard, where bridging of the horizontal dpc and defects in external drainage systems had created damp conditions in masonry locally. Some lining papers adjacent to the doorway had also blistered and lifted from the substrate on the west side, indicating damp conditions in the structures behind

Lower ground floor, south-east room in main house; showing salt efflorescence damage and staining to the south of the French doors to the exterior, consistent with defective external drainage and bridging of the horizontal dpc

Works described elsewhere in this report should be undertaken to restore the effectiveness of the existing horizontal wall dpc and to repair external drainage systems. Damp affected walls in the south-east room of the main building should be stripped of existing finishes to allow detailed inspection of the masonry behind, taking care to avoid impact and vibration damage to the historic tiling in the corridor on the south side. Allowance should be made for installing ventilated dry linings over exposed masonry, based on vertical studded plastic isolating membranes, to protect vulnerable materials and finishes during and after refurbishment. Details provided by the Architect, approved by H+R and similar to those included at Appendix D should be used throughout. H+R can provide further advice on remedial detailing if required

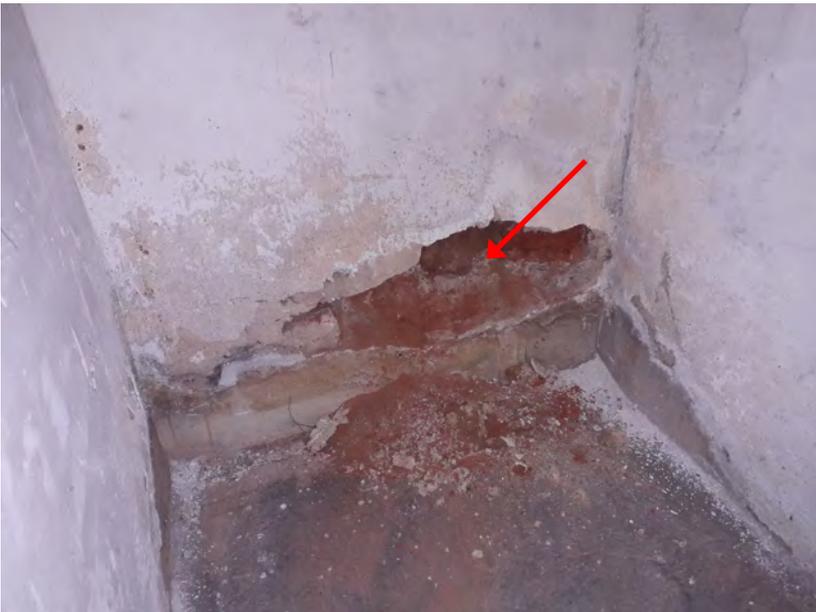
Fig 36:

- 4 Wine store on north side: Wall surfaces were extensively eroded at the base of the north wall, which was assumed to be shared with the neighbouring property. Damage was consistent with chronic moisture migration from below ground to the wall surface and the effects of intermittent interstitial condensation during and since previous occupancy. The wine store was unventilated and this would have increased the risk of intermittent condensation where warm moisture laden air from other parts of the property tended to migrate to under ventilated and less frequented areas, including the wine store and other ancillary spaces of the lower ground floor

Lower ground floor, wine cellar on north side; showing localised erosion of brickwork at low level in the south-east corner, consistent with ground water transit through the wall and intermittent interstitial condensation since construction

No urgent remedial works are required. No chemically injected horizontal damp-proof courses or cementitious render tanking systems are required or recommended. Allowance should be made for through and cross ventilation of all habitable rooms, service spaces and enclosed voids on future occupancy, as directed by the Architect, for the effective control of airborne moisture and condensation. The use of film forming paint systems should be avoided on masonry which is vulnerable to historic damp

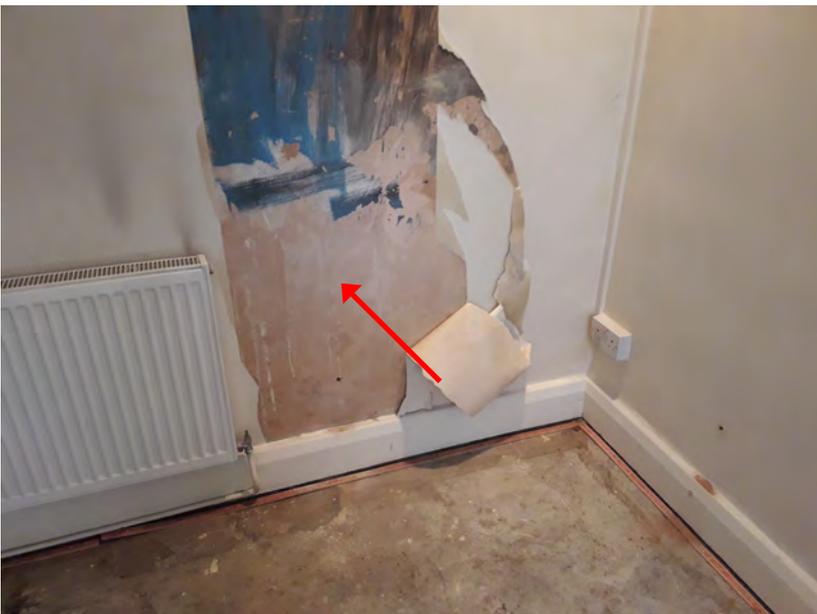
Fig 38:

- 3 East room below east wing: Wall lining papers had blistered and fallen away on the north side. Exposed plaster was wet to the touch and masonry behind was found to contain surplus residual moisture on analysis of samples, as described at Section 3.3. below

Lower ground floor, east room of east wing/extension; showing detachment of decorative papers from the gypsum plaster substrate, where excess residual moisture was present in the wall behind and there was a vulnerability to intermittent condensation

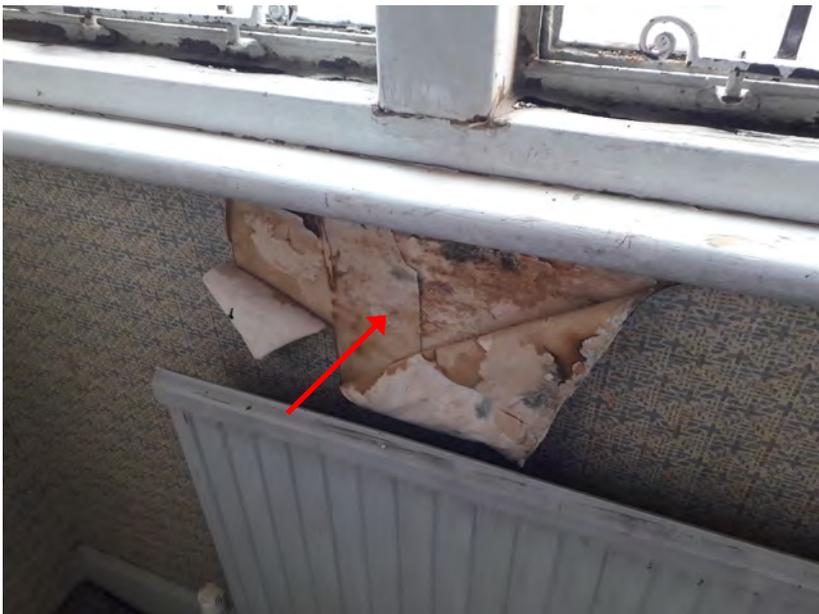
Fig 40:

Fourth floor, west side; showing damage to decorative finishes consistent with water penetration below and around a window opening where there was significant exposure to wind driven rain from the west

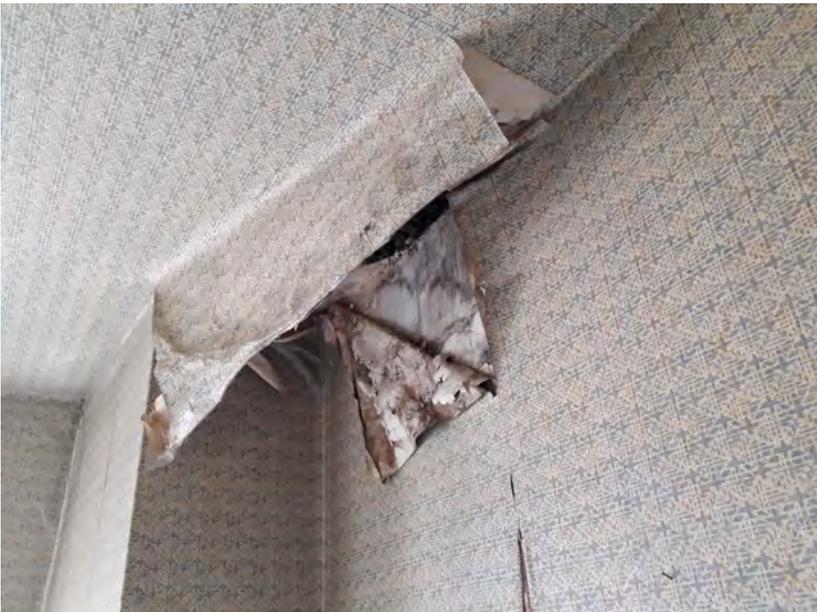
Fig 42:

Fourth floor, north-west room; showing failure of ceiling finishes and linings consistent with water penetration through roof finishes, possibly due to failure of flashings around a chimney stack

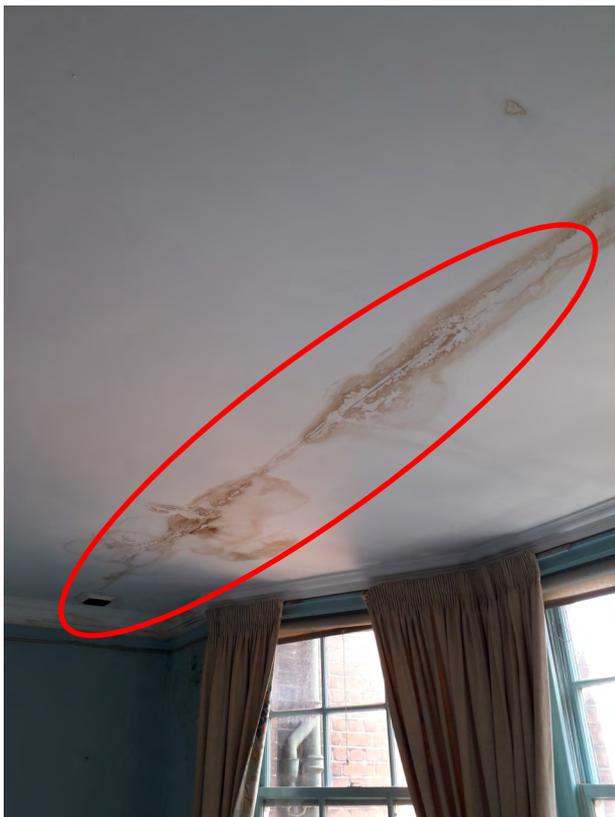
Fig 44:

Third floor, south-east room; showing discoloration of ceiling finishes, consistent with intermittent water penetration through roof coverings above, assumed to be a failure of the junction between the roof/terrace over the bay window and the principal east elevation

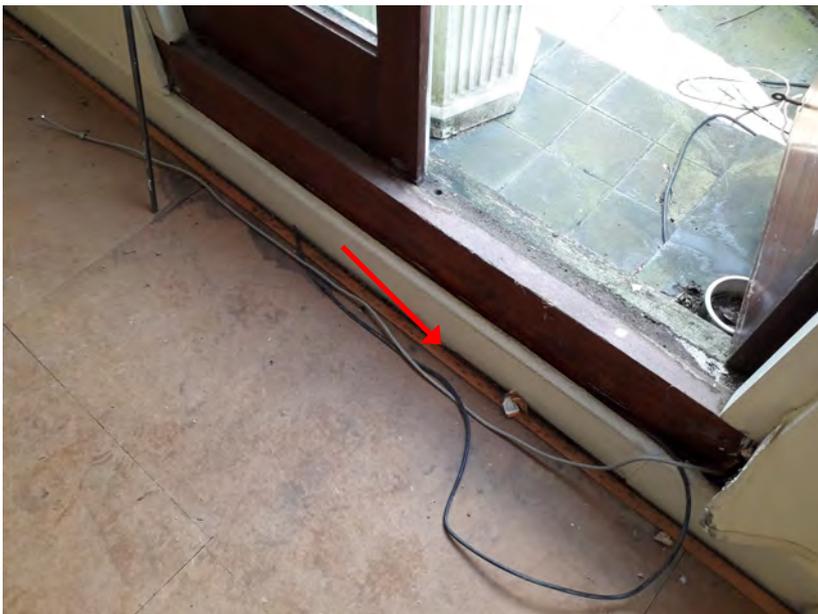
Fig 46:

Fourth floor, south-east room; showing structures likely to be allowing water penetration above the damaged ceilings illustrated in fig. 44 above

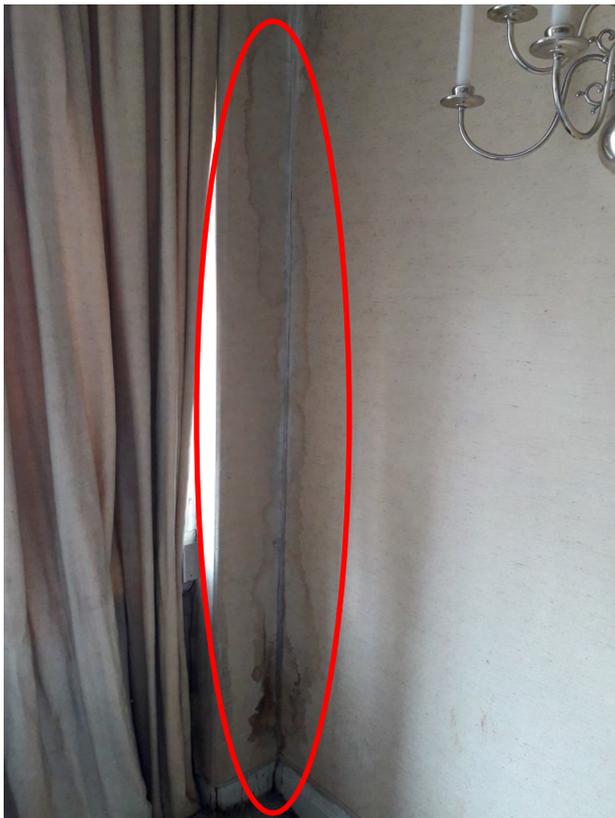
Fig 48:

Third floor, south-west room, north-west corner; showing damage to decorative finishes consistent with water penetration, following failure of the parapet gutter linings or escape of water from building services. A duct box was installed in the north-west corner of the room to full height

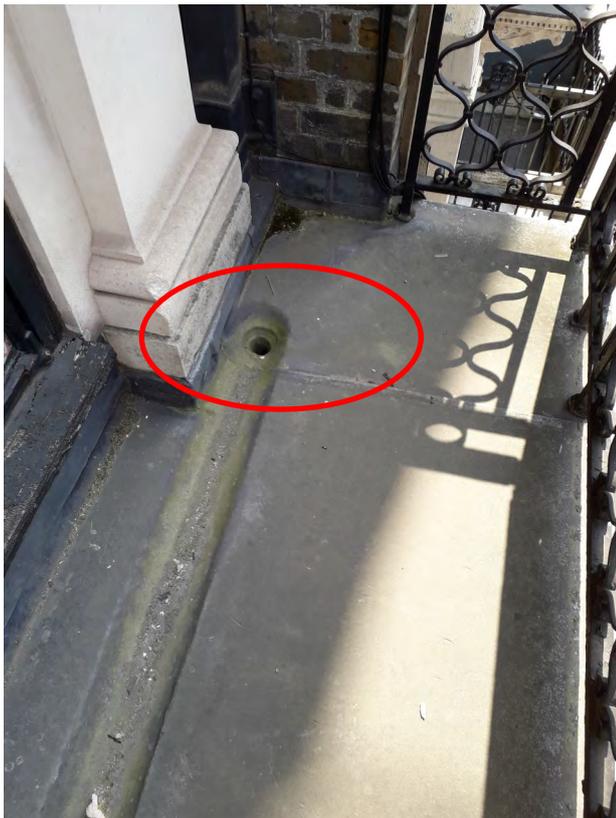
Fig 50:

West elevation, south end; showing sheet lead waterproofing to the first-floor balcony and outlet in generally good condition, with no defects identified that were allowing water to drain into the structures below

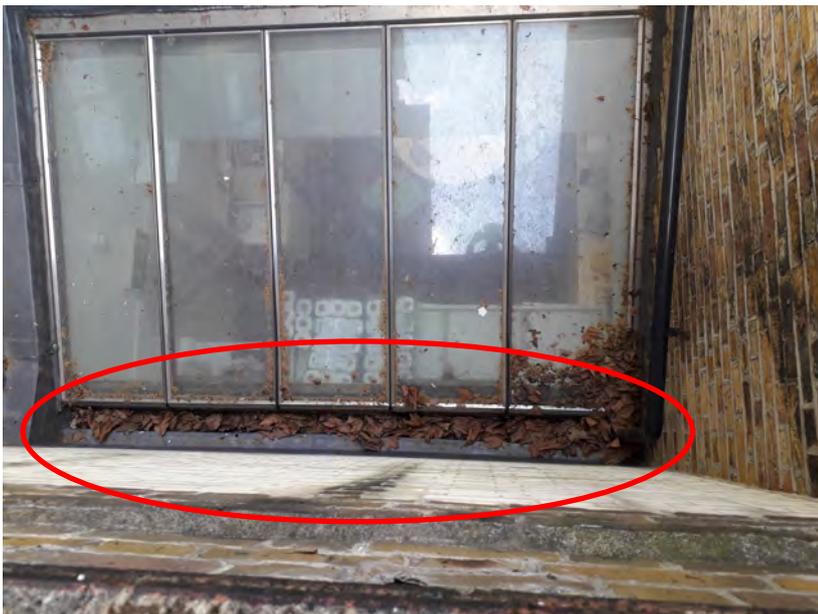
Fig 52:

Neighbouring property on north side at centre of north party wall; showing drainage systems to skylight glazing difficult to access and vulnerable to blockage and kitchen systems at ground floor level that may have been allowing escape of water from plumbing services, affecting the structure of the north party wall

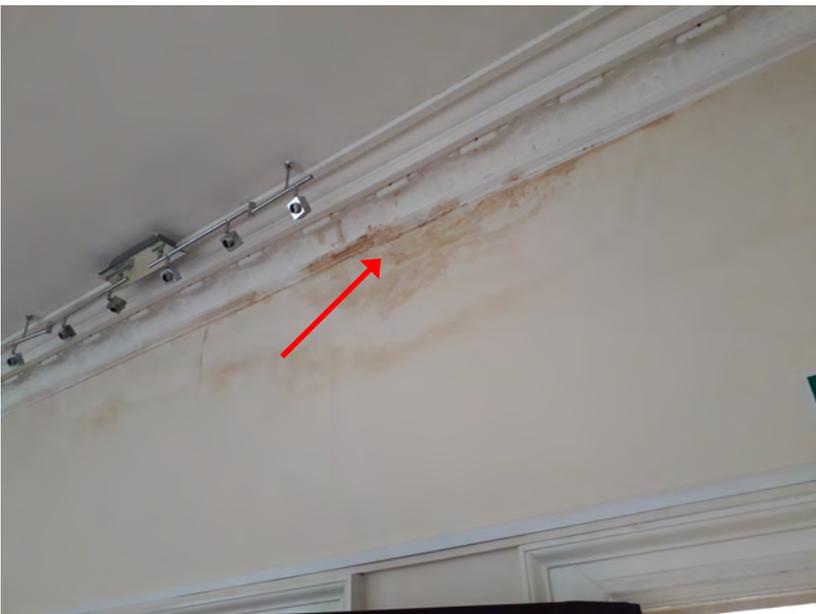
Fig 54:

Upper ground floor, east room of east extension; showing damage to ceiling finishes and covings at the wall/ceiling junction on the west side, consistent with water penetration through the step structures in the terrace above

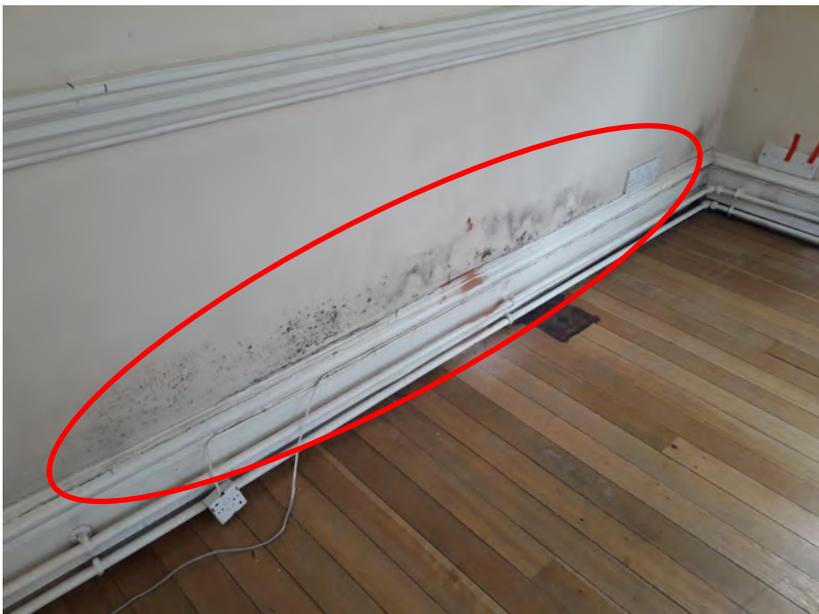
Fig 56:

Upper ground floor, north wall of east room; showing mould growth on wall surfaces, indicating intermittent condensation since vacancy
