Building Recording - First Floor

External and Internal Windows

showing existing photos, noted location, frame condition, glass condition and proposed refurbishment works.

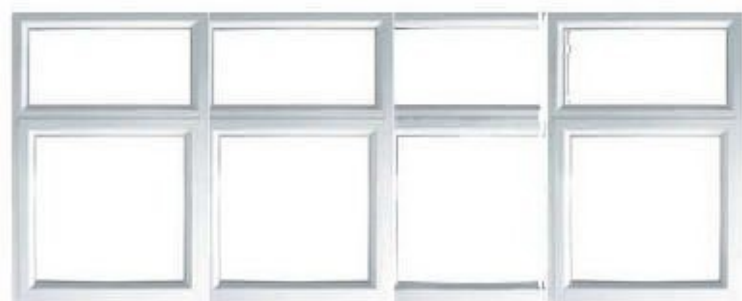
Precedent images for metal frame windows

Condition - Good

Frame - Presumed Original

Glass - Presumed Original

Proposed works:

- To be replaced new metal frame opening window in a colour to match the existing listed house windows

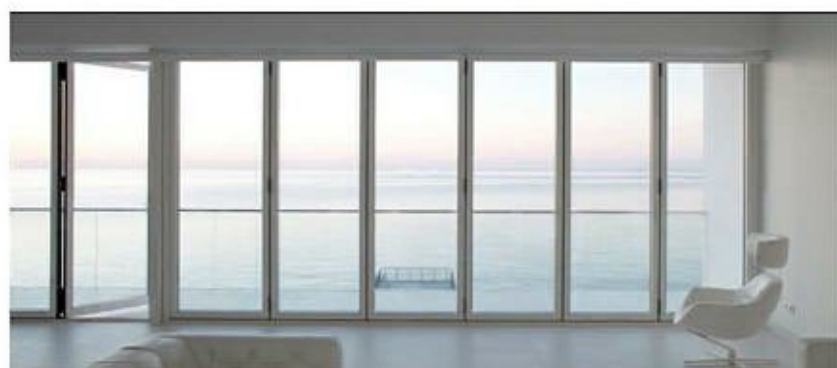
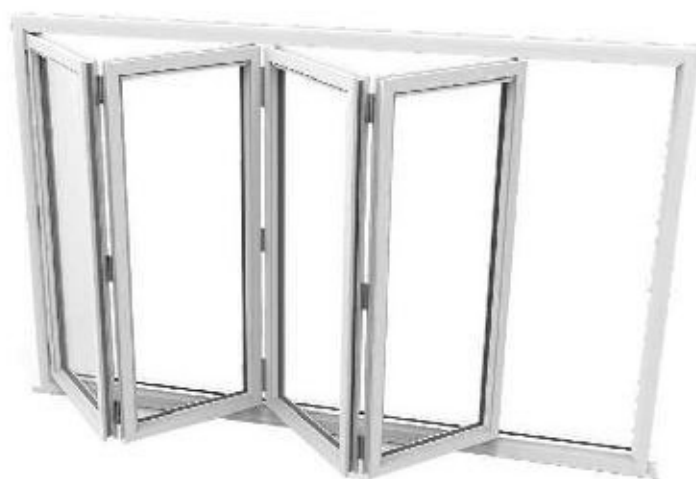
Precedent images for metal frame bi folding doors

Located with 1990's section of the building

Condition - Good

- To be replaced new metal frame bi folding doors in a colour to match the existing listed house
