# Geotechnical Survey Report

Issue Date:	October 2020
Risk Address:	15 Sladburys Lane Clacton-on-sea Essex CO15 6NU
Claim Ref:	107232

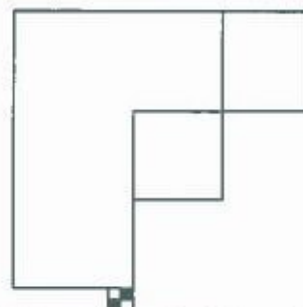
**Trial Pit Location:** ☒ TP1/ BH1

D1 @ F.L. (0.65m)

V = 72-74kPa

Founding strata:

Firm Mid brown silty CLAY containing minor grey mottle
