Addendum Subsidence Report

15 Sladburys Lane

Date: 1st May 2021

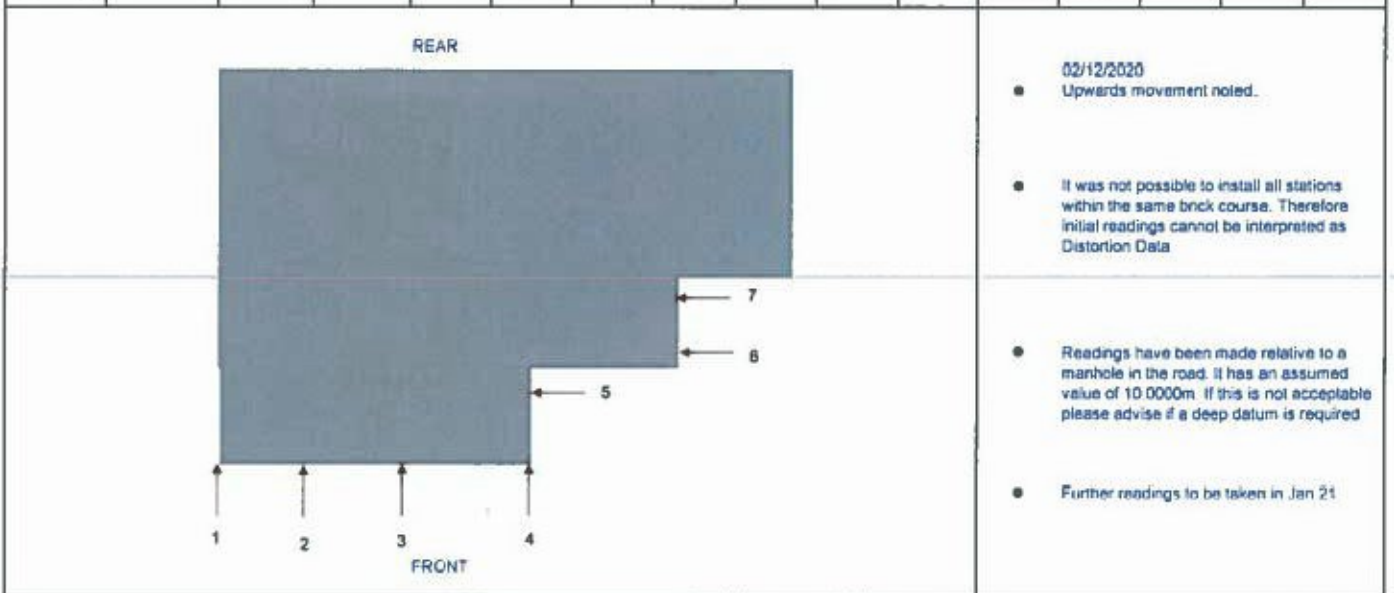
- 19/01/2021
 - Upwards movement noted
- It was not possible to install all stations within the same brick course. Therefore initial readings cannot be interpreted as Distortion Data
- Readings have been made relative to a manhole in the road. It has an assumed value of 10 0000m. If this is not acceptable please advise if a deep datum is required
- Further readings to be taken in March 21

Target Date:													
		Reading Date:													
		Issue Date:													
Row No.	Point Name	X Co-ordinate	Y Co-ordinate	1	2	3	4	5	6	7	8	9	10	11	12
1	1	0.00	0.00	11.2516	11.2621										
2	2	3.20	0.00	11.2121	11.2137										
3	3	5.30	0.00	11.1739	11.1757										
4	4	7.50	0.00	11.1509	11.1543										
5	5	7.50	2.10	11.4300	11.4834										
6		7.50	2.80												
7		9.00	2.80												
8	6	9.00	3.80	11.1341	11.1384										
9	7	9.00	6.80	11.2385	11.2424										
10		9.00	7.30												
11		11.90	7.30												
12		11.80	13.10												
13		0.00	13.10												
14															
15															
16															
17															
18															
19															
20															
21															
22															
23															
24															
25															
26															
27															
28															
29															
30															
31															
32
