Preliminary Bat & Bird Assessment

Buildings at Porthmissen Farm, 2 Cuckoo Mill, Padstow, Cornwall

29th April 2021

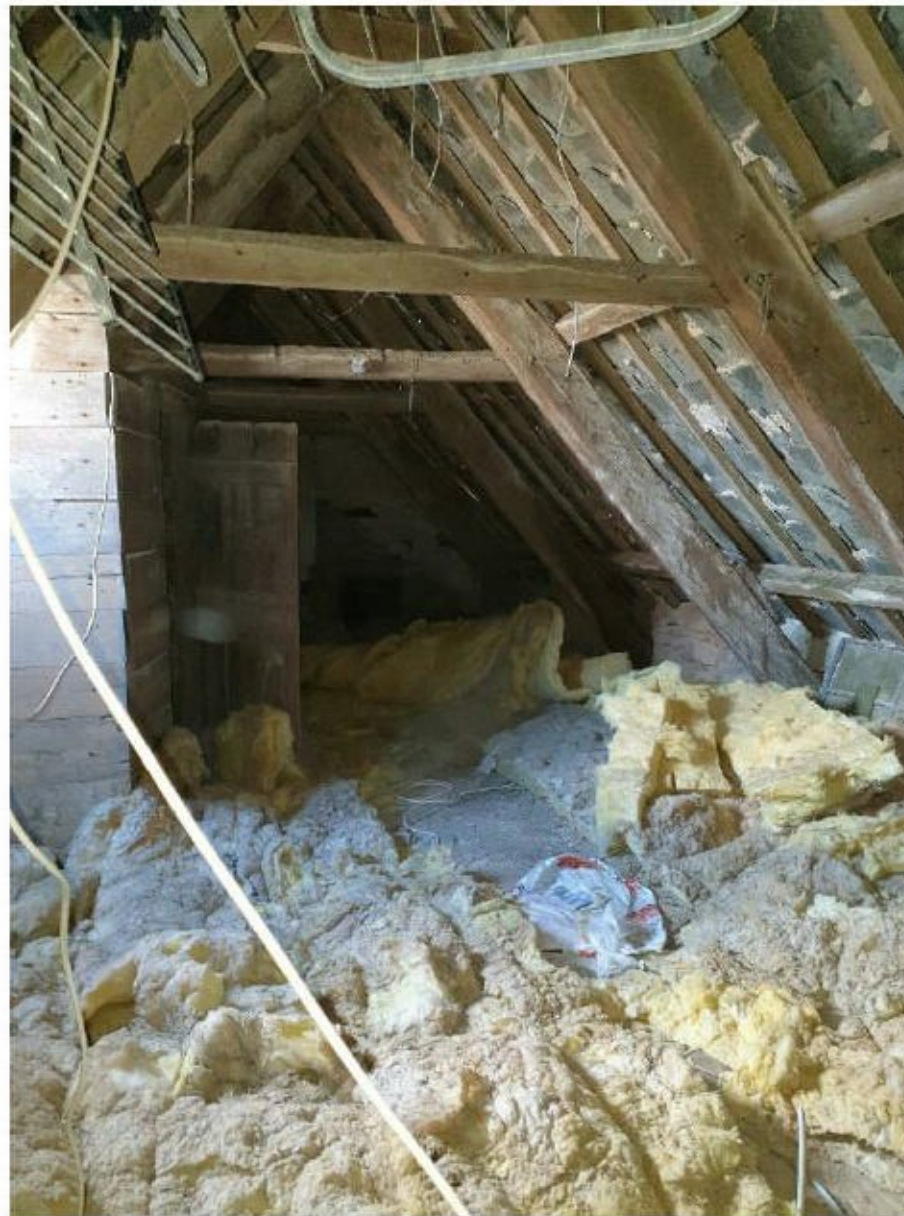
Access to the southern roof void is possible through a gap above the height of the ceiling between the first floor rooms below, connecting the interior of the property to the southern roof void above (Figs. 6 & 7). The interior of this roof void is light, due to the gap leading to the open first floor room and due to the presence of a window in the centre of the northern elevation of this roof. There is thick mineral fibre loft insulation on the floor and the underside of the roof is unlined. The gable end walls are part bare stone and part plastered. It was not possible to fully inspect the southern roof void due to the thick loft insulation covering the ceiling joists. There appears to be a small timber enclosed area at the eastern end of this void. It is not known if this void connects internally to the void over the north eastern section and there is no loft hatch present to access this roof void.

Figure 7: Interior of southern roof void (viewed towards the east)

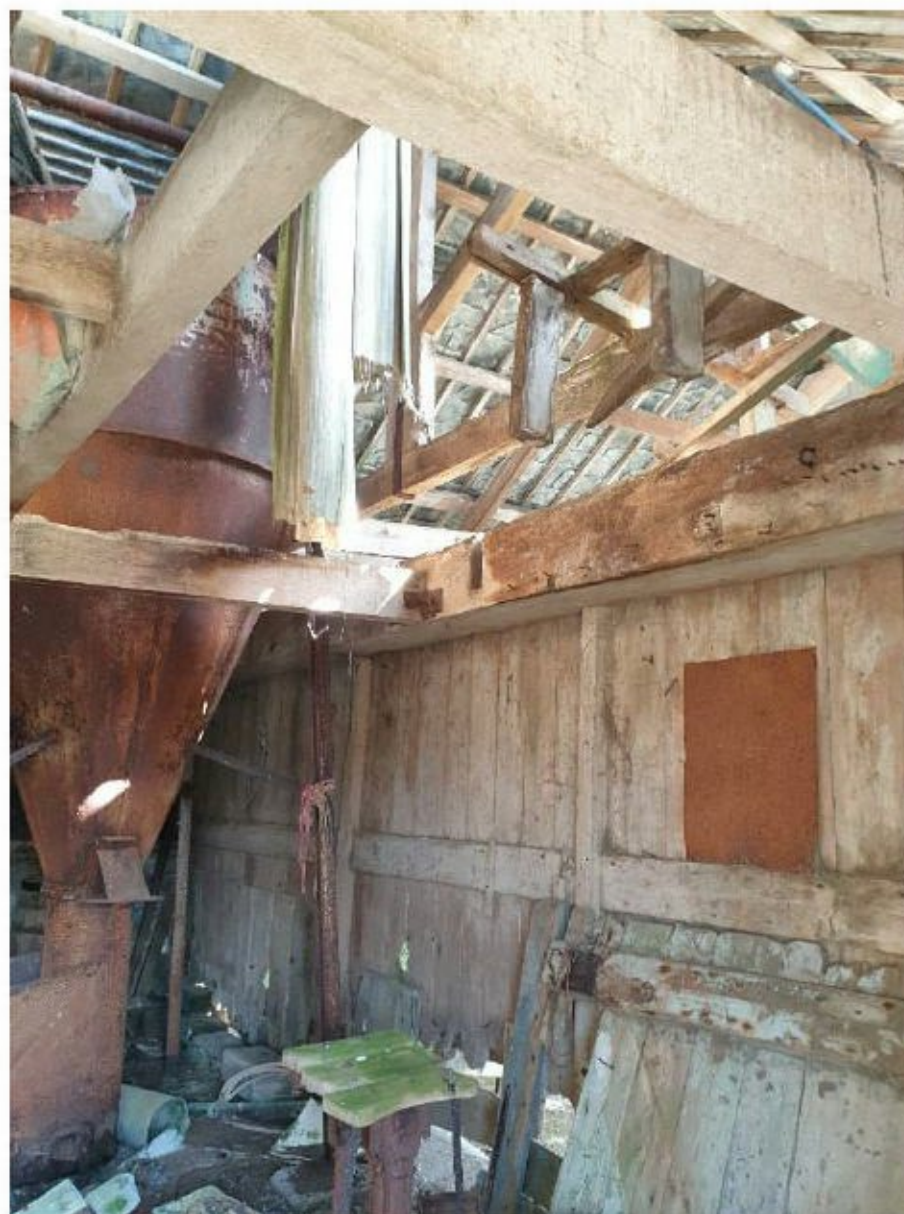
Figure 12: Interior of single-storey section of Barn 1 (viewed towards the north)

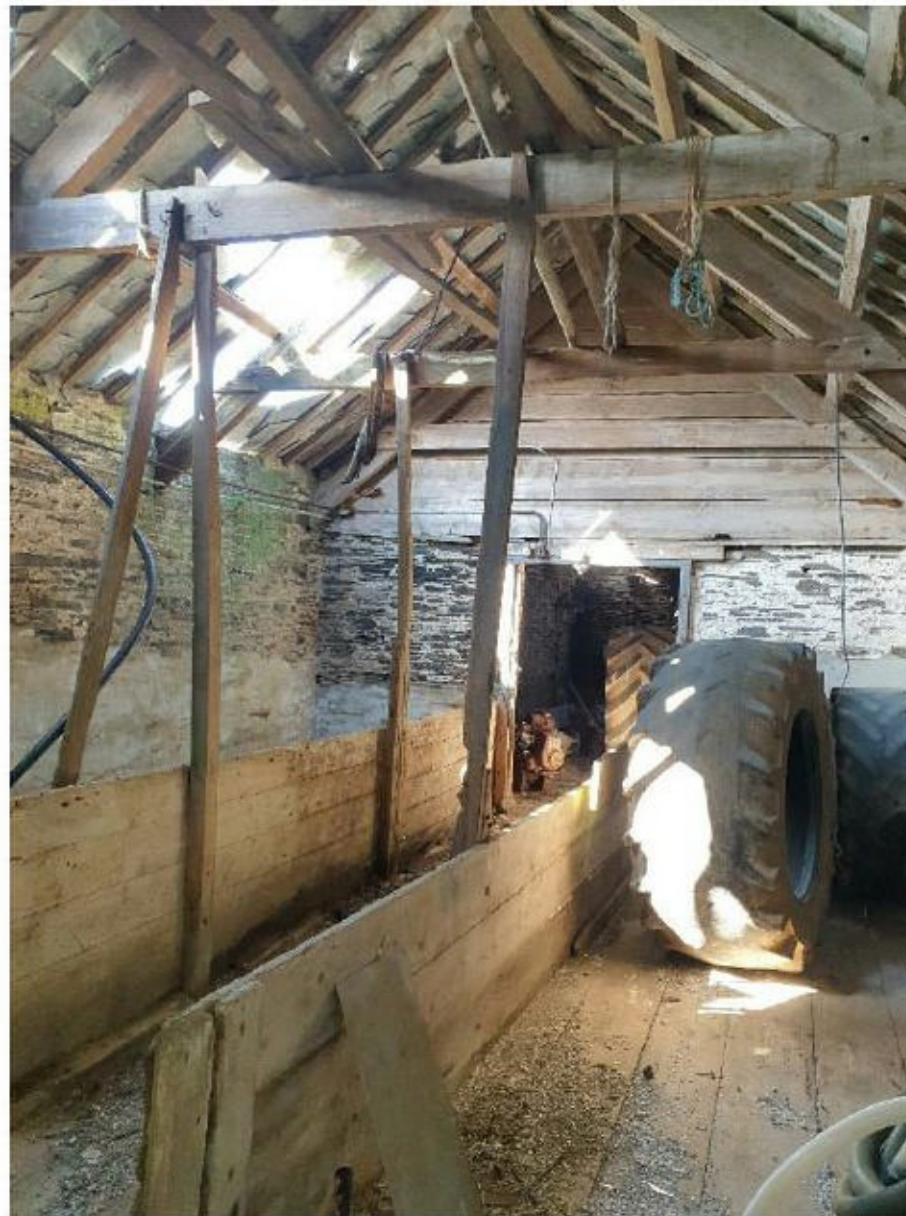
The first floor of the two-storey section consists of a large L-shaped room at the eastern end, which links internally to a smaller room at the western end (Fig. 14). The first floor is accessed via an external door on the northern elevation of the building where the level of the ground is raised up to first-floor level at the eastern end. The interior is very light and draughty due to the open windows, doors and holes in the roof. The walls are bare stone or plastered and the wall tops appear to be enclosed. The floor is timber and the underside of the roof is unlined. At the western end there are a number of large plastic seed sacks hanging up over the crossing timbers. It was not possible to fully inspect the first floor rooms due to the floor being dilapidated in places.

Figure 14: Interior of first-floor of Barn 1 at Porthmissen Farm (viewed towards the south west)

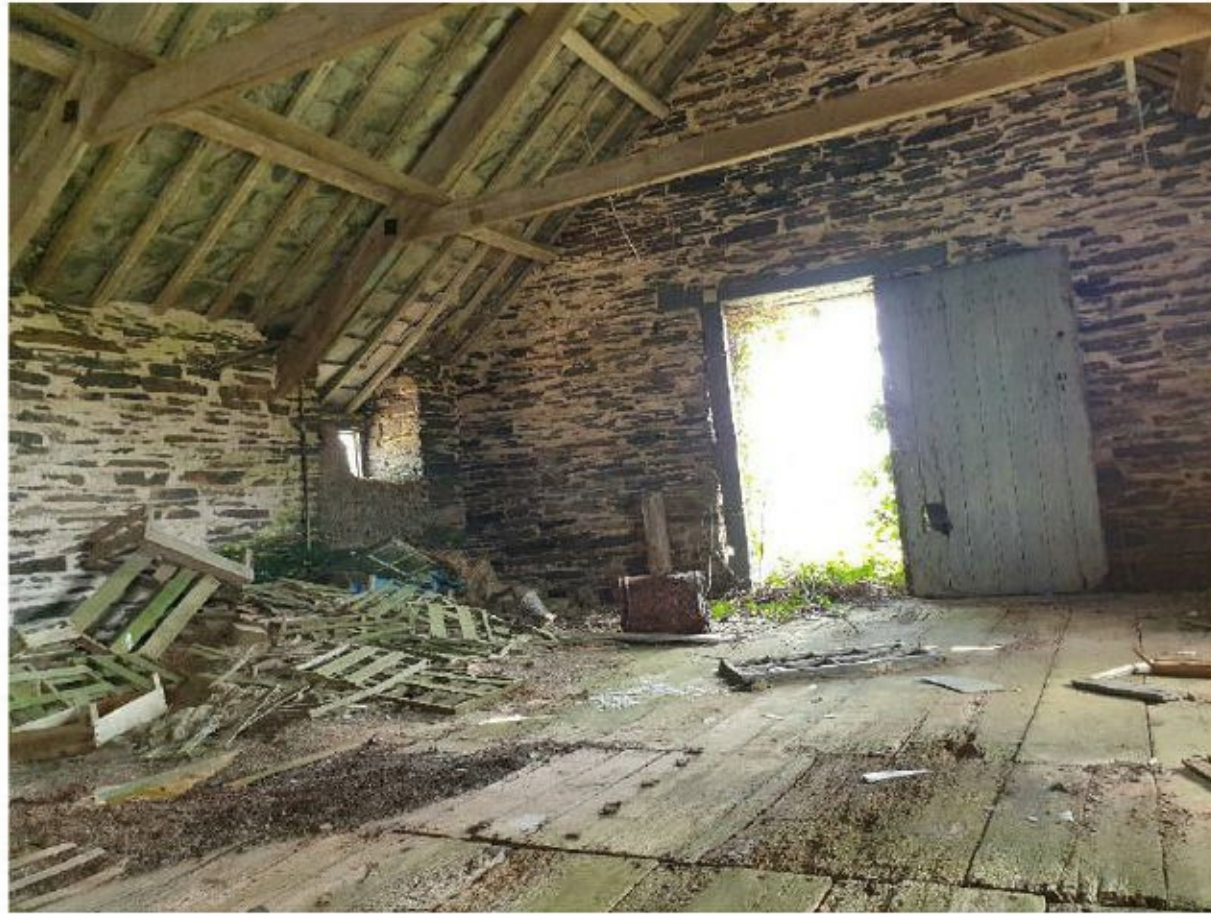
Internally the two-storey section consists of a single room on the ground floor, a former cattle shed, with a single room on the first floor (Figs. 17 & 18). Both rooms are light, open and draughty due to the open windows and doors and the walls are plastered. The ground floor has a concrete floor with concrete cattle stalls and the ceiling is timber. There is a large hole in the first-floor linking the ground and first-floors internally and an internal door linking the ground floor room to an adjacent enclosed room within the single-storey section. On the first-floor the underside of the roof is unlined, the walls are bare stone and the wall tops are enclosed. This part of the building was inspected from a ladder through the hole in the floor, although it could not be fully inspected on health and safety grounds due to the floor being dilapidated in places.

Figure 18: Interior of first floor of two-storey section of Barn 2 at Porthmissen Farm (viewed towards the east)

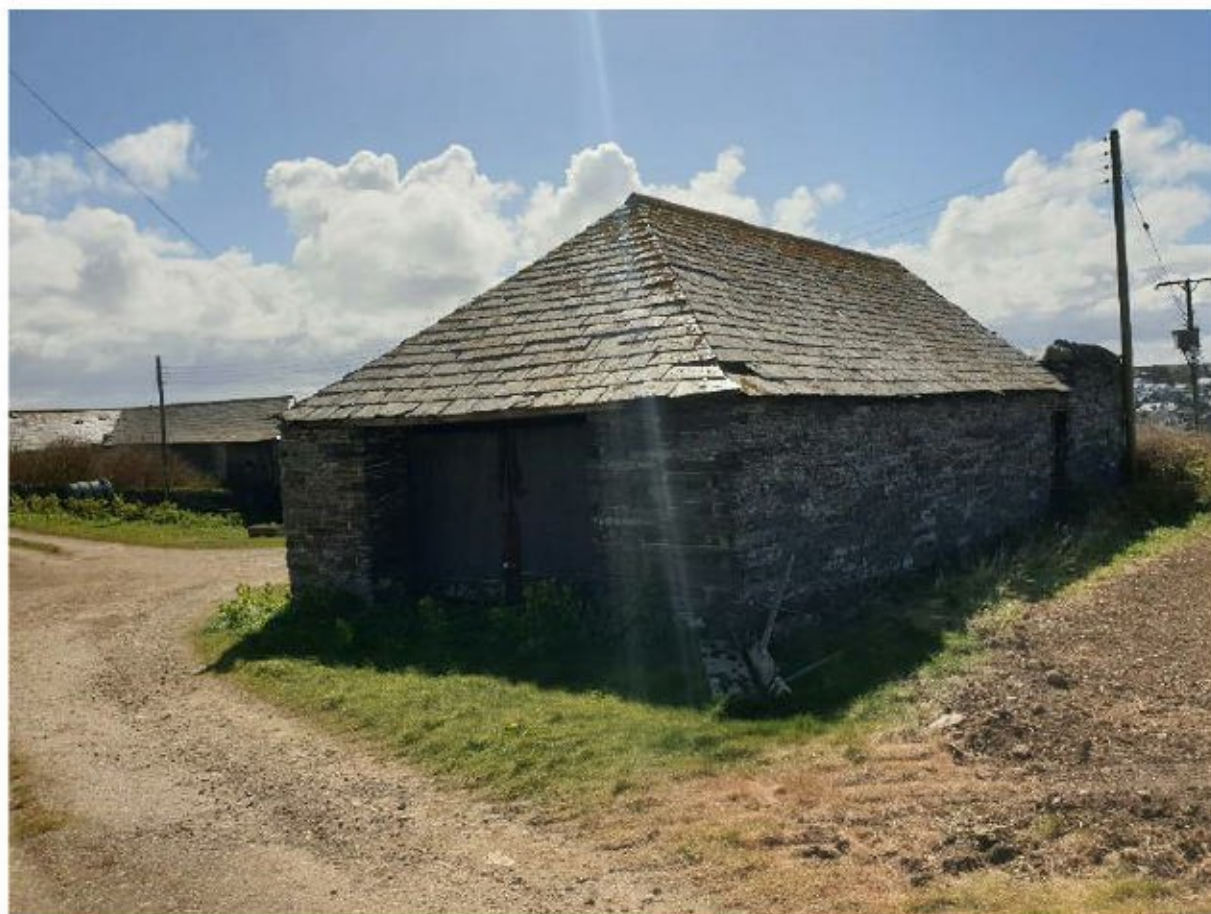
This building is to the north west of the farmhouse and consists of a single-storey stone barn with a pitched rag slate roof and clay ridge tiles (Figs. 21 & 22). The roof has a hip-end to the north and a gable end to the south. There are crevices in the external walls, gaps under hanging slates, where slates have lifted/ slipped and underneath ridge tiles, all of which provide potential roosting opportunities for crevice-dwelling bats and potential bat access into the interior. There are also gaps around the timber doors on the northern elevation, holes in the roof and open door and window apertures which provide further potential bat access.

Figure 22: Northern and western elevations of Barn 3 at Porthmissen Farm
