Preliminary Bat & Bird Assessment

Buildings at Porthmissen Farm, 2 Cuckoo Mill, Padstow, Cornwall

29th April 2021

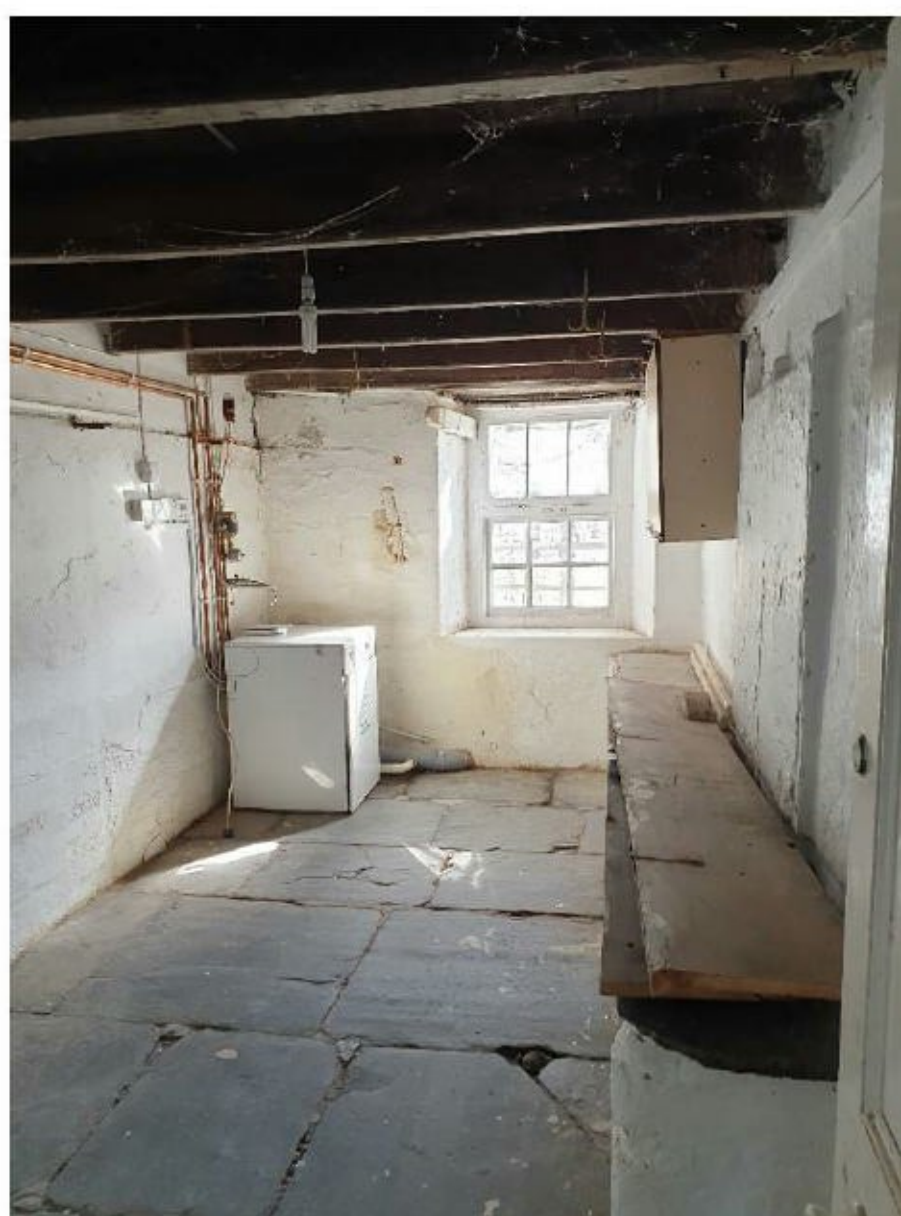
Internally this building consists of a number of dilapidated rooms on the ground floor and first-floor, with wall paper/ bare plaster/ whitewashed stone walls and concrete, stone or timber floors (Fig. 5). The interior of the lean-to is open to the inside of the farmhouse and the underside of the roof is lined with polystyrene insulation boards. There are two enclosed roof voids within the southern and north eastern roof sections. The ceiling below the roof void within the north western roof section has been removed opening it up to the rest of the property and the underside of the roof is partly unlined and partly lined with bitumen membrane (Fig. 6). There are holes in the roof in places which make the interior draughty and which enable potential bat access into the interior.

Figure 5: Interior of one of the ground floor rooms within the farmhouse at Porthmissen Farm

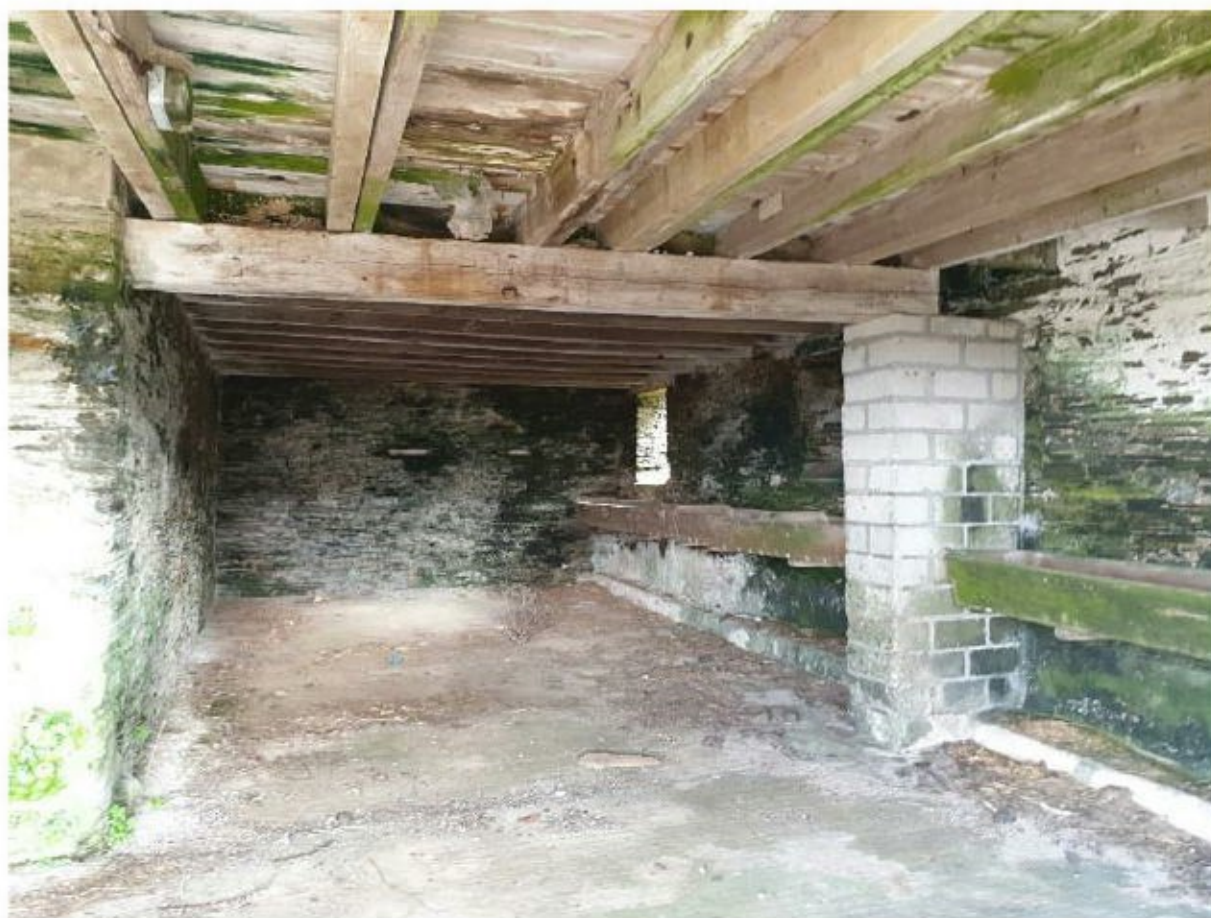
Internally this building consists of two rooms on the ground floor of the two-storey section; a small room to the west and a large L-shaped room to the east (Fig. 10). Within the single-storey section is a single room (Fig. 12 & 13). The internal walls are bare stone/ whitewashed, with concrete or earth floors. In the L-shaped room are timber and concrete stalls and timber troughs along the walls. The rooms are light, open and draughty due to the presence of open door and window apertures on the southern elevation. The rooms in the two-storey section are open from the floor to the underside of the timber first floor, which is dilapidated in places. A single bat dropping was found within a timber trough on the eastern wall of the L-shaped room (Fig. 11). The dropping was characteristic of a long-eared bat spp., likely to be brown long-eared bat (*Plecotus auritus*) as the site is outside the known range of grey long-eared bat (*Plecotus austriacus*). NB: species present must be confirmed with DNA analysis of the bat dropping. A number of butterfly wings (indicating bat feeding remains) were also found within this part of the building.

Figure 10: Interior of L-shaped room on ground floor of Barn 1 (viewed towards the north)

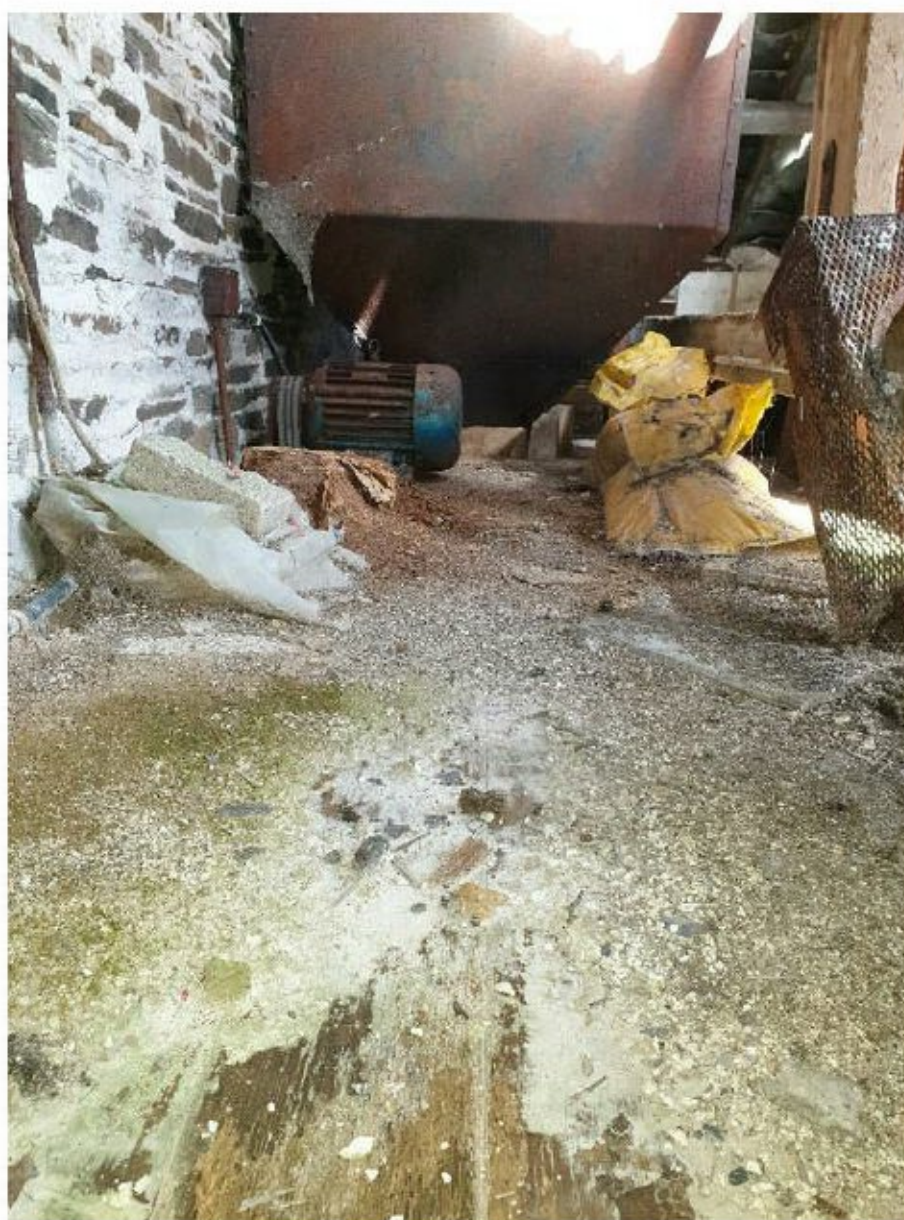
Within the single-storey section there is a timber partition in the centre of the room, with old farm machinery at the western end. Above the farm machinery is a small mezzanine timber floor at the western end (Fig. 13). This room is very light and draughty due to the holes in the roof and open door. It is open from the floor to the underside of the roof, which is unlined.

Figure 13: Mezzanine floor at western end of single-storey section of Barn 1 (viewed towards the north)

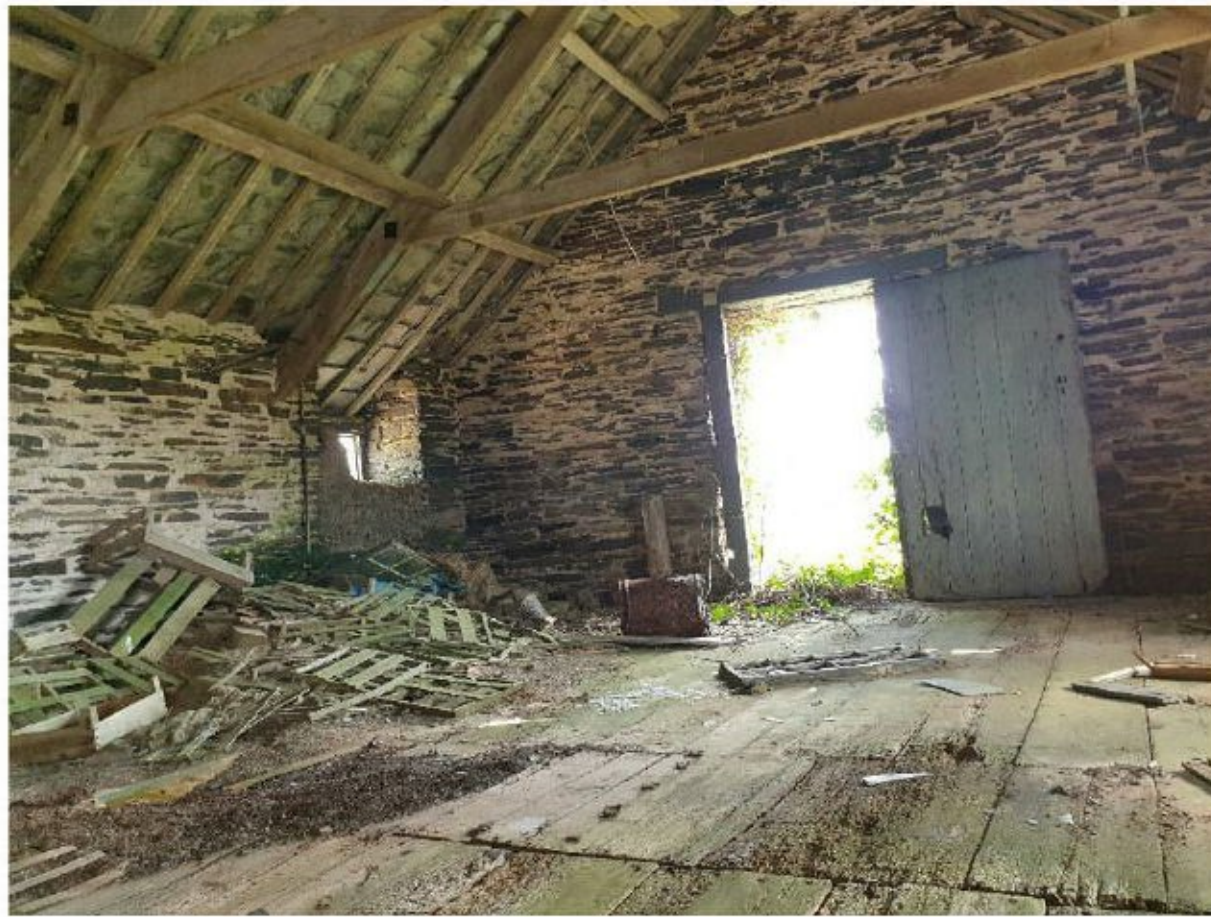
Internally the two-storey section consists of a single room on the ground floor, a former cattle shed, with a single room on the first floor (Figs. 17 & 18). Both rooms are light, open and draughty due to the open windows and doors and the walls are plastered. The ground floor has a concrete floor with concrete cattle stalls and the ceiling is timber. There is a large hole in the first-floor linking the ground and first-floors internally and an internal door linking the ground floor room to an adjacent enclosed room within the single-storey section. On the first-floor the underside of the roof is unlined, the walls are bare stone and the wall tops are enclosed. This part of the building was inspected from a ladder through the hole in the floor, although it could not be fully inspected on health and safety grounds due to the floor being dilapidated in places.

Figure 18: Interior of first floor of two-storey section of Barn 2 at Porthmissen Farm (viewed towards the east)

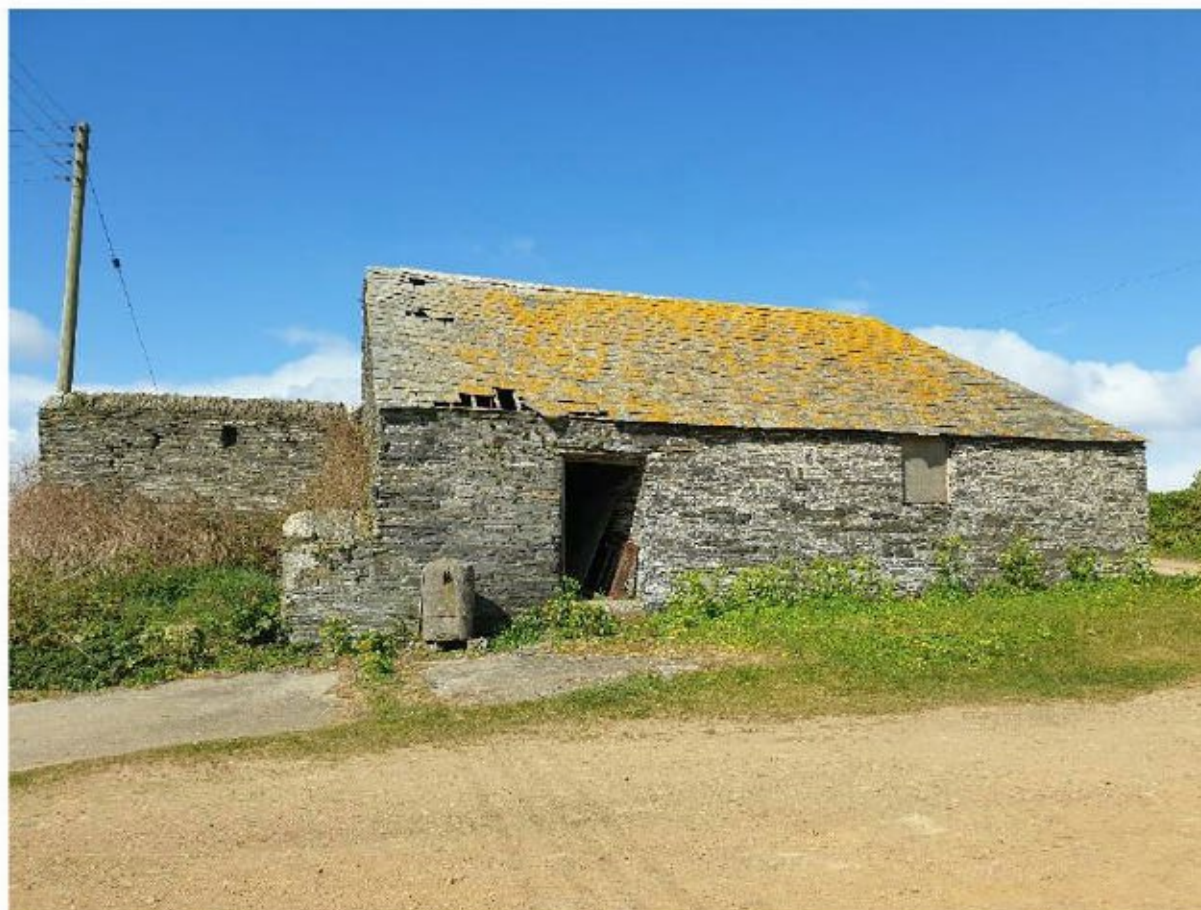
Barn 3 was, therefore, assessed as being of '**low suitability**' to support roosting bats.

Figure 21: Eastern elevation of Barn 3 at Porthmissen Farm
