## **Preliminary Bat & Bird Assessment**

Buildings at Porthmissen Farm, 2 Cuckoo Mill, Padstow, Cornwall

29<sup>th</sup> April 2021

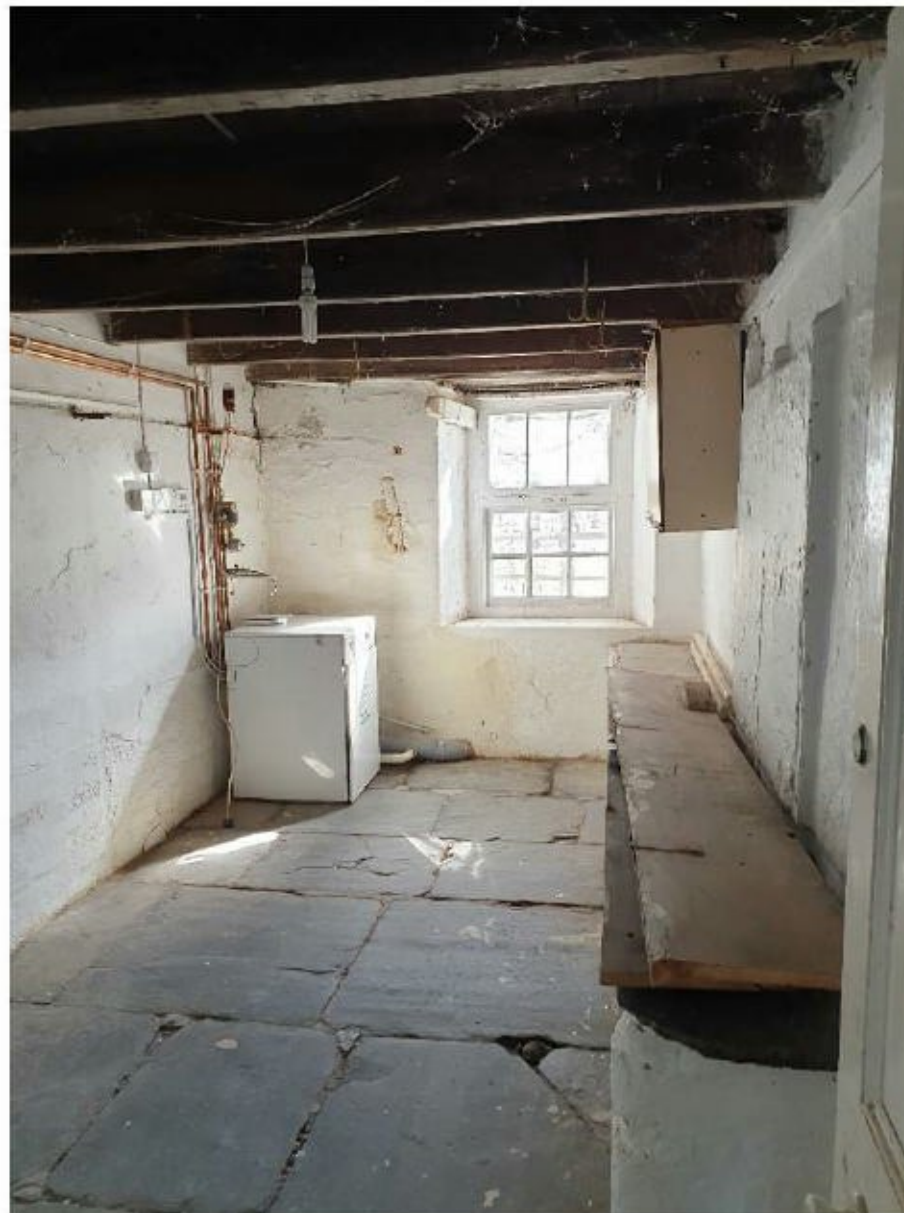
Internally this building consists of a number of dilapidated rooms on the ground floor and first-floor, with wall paper/ bare plaster/ whitewashed stone walls and concrete, stone or timber floors (Fig. 5). The interior of the lean-to is open to the inside of the farmhouse and the underside of the roof is lined with polystyrene insulation boards. There are two enclosed roof voids within the southern and north eastern roof sections. The ceiling below the roof void within the north western roof section has been removed opening it up to the rest of the property and the underside of the roof is partly unlined and partly lined with bitumen membrane (Fig. 6). There are holes in the roof in places which make the interior draughty and which enable potential bat access into the interior.

Figure 5: Interior of one of the ground floor rooms within the farmhouse at Porthmissen Farm

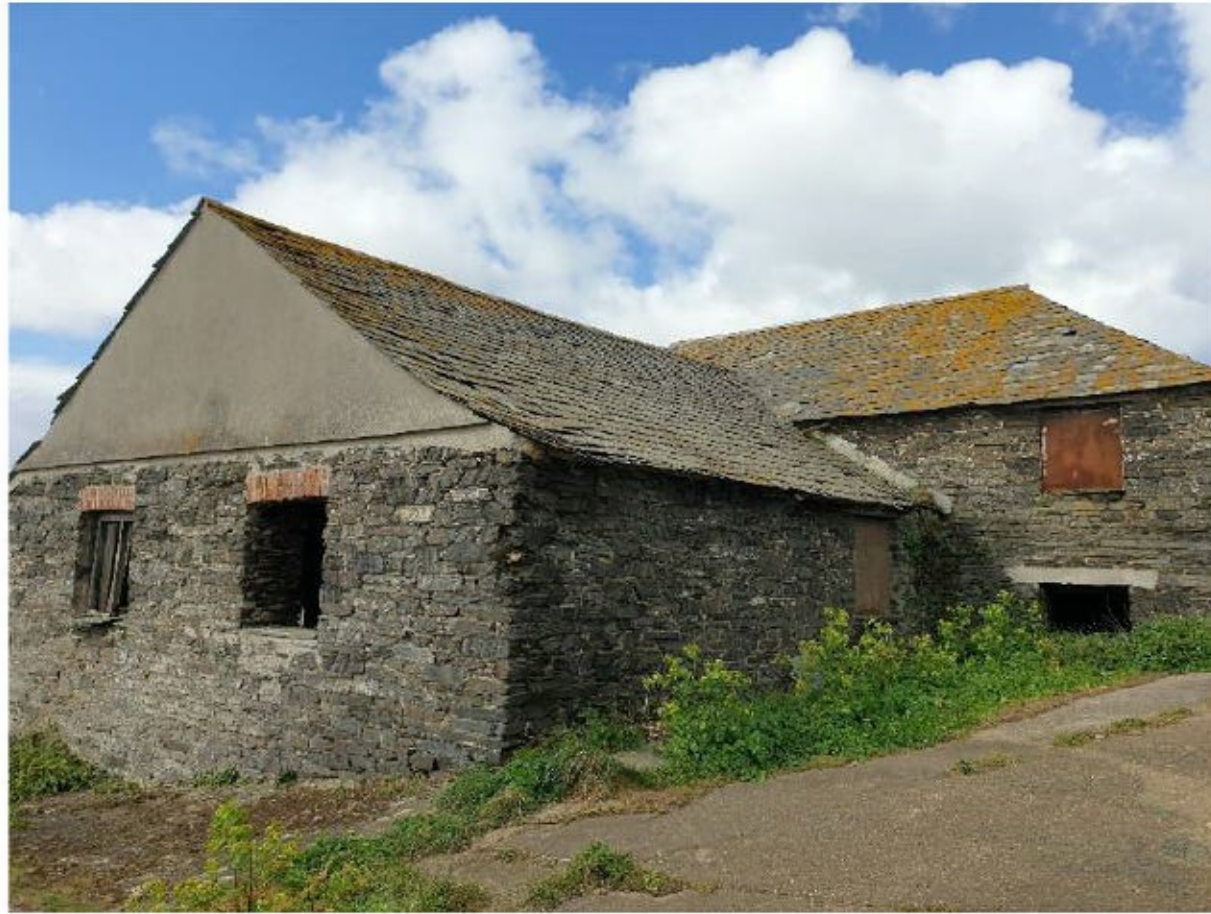
This building is to the north east of the farmhouse and consists of an L-shaped barn which is part two-storey to the west and part single-storey to the east (Figs. 8 & 9). It is constructed from stone, concrete block and brick with a pitched rag slate roof and clay ridge tiles. The roof is part hip and part gable. There are a number of holes in the roof where slates have slipped/ lifted and a number of open door and window apertures, all of which enable potential bat access into the interior. Some doors and windows have been boarded up with timber/ concrete block. The external walls are either bare stone/ brick or cement render and the barn features metal guttering and slate/ concrete windowsills. There are crevices in the stonework in places which provide potential roosting opportunities for crevice-dwelling bats.

Figure 9: Northern and eastern elevations of the single-storey section of Barn 1 at Porthmissen Farm

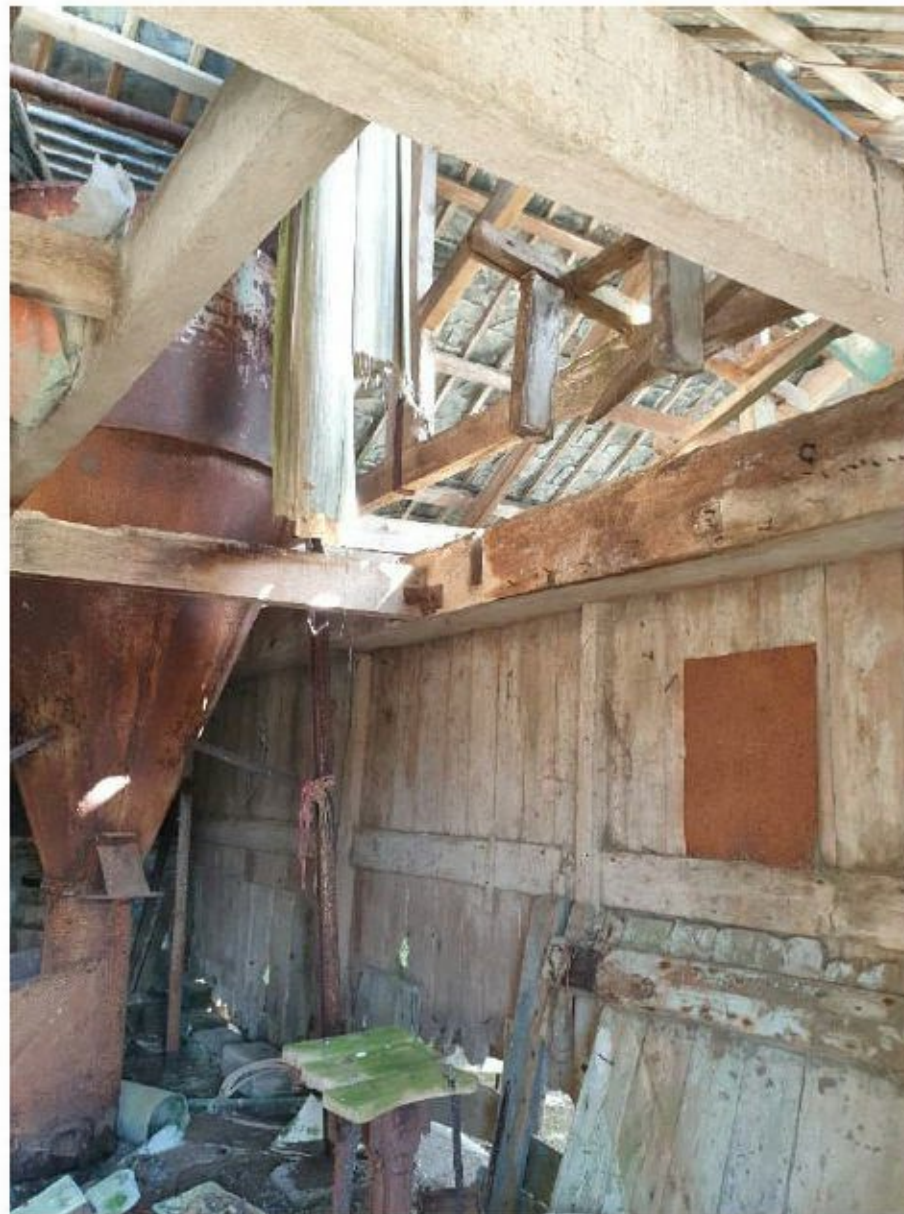
Figure 12: Interior of single-storey section of Barn 1 (viewed towards the north)

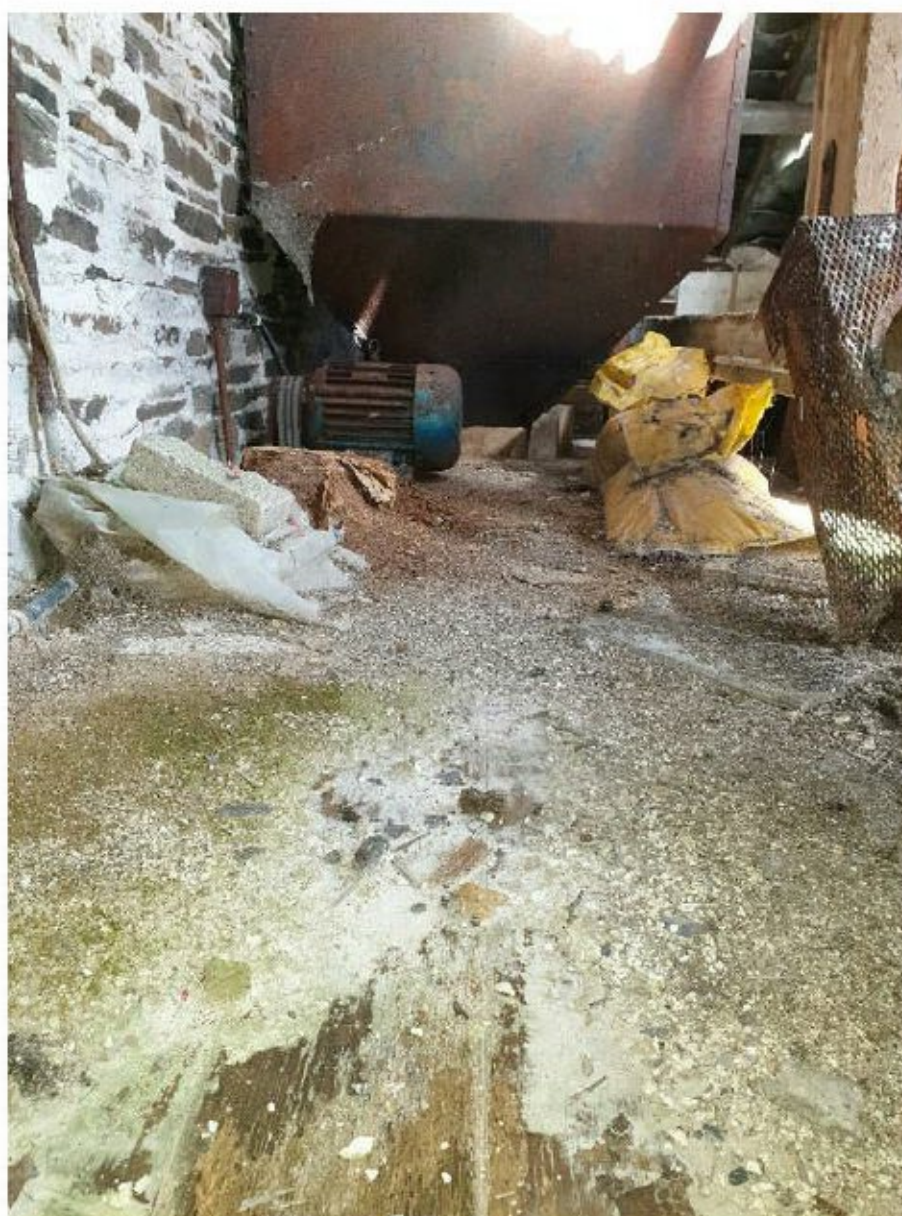
Within the single-storey section there is a timber partition in the centre of the room, with old farm machinery at the western end. Above the farm machinery is a small mezzanine timber floor at the western end (Fig. 13). This room is very light and draughty due to the holes in the roof and open door. It is open from the floor to the underside of the roof, which is unlined.

Figure 13: Mezzanine floor at western end of single-storey section of Barn 1 (viewed towards the north)

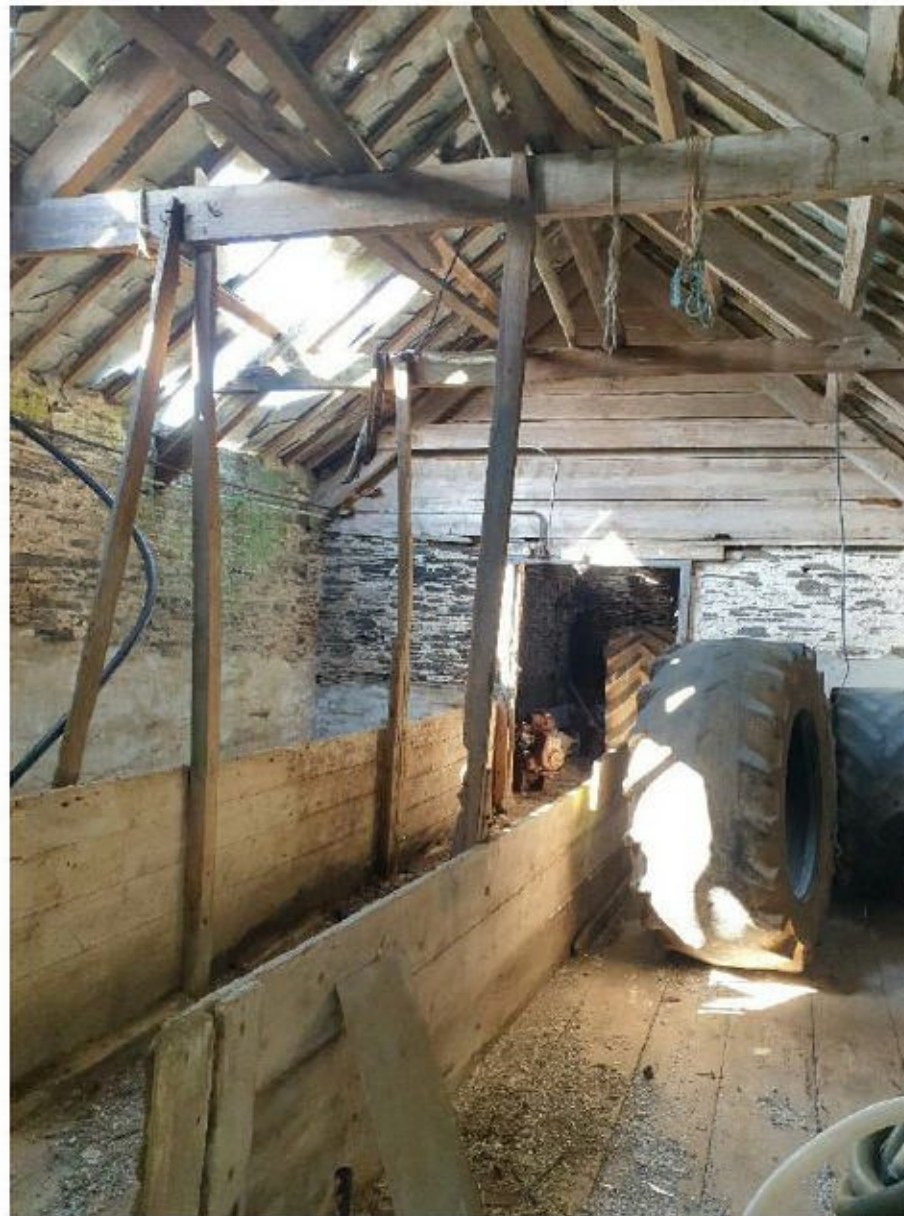
The first floor of the two-storey section consists of a large L-shaped room at the eastern end, which links internally to a smaller room at the western end (Fig. 14). The first floor is accessed via an external door on the northern elevation of the building where the level of the ground is raised up to first-floor level at the eastern end. The interior is very light and draughty due to the open windows, doors and holes in the roof. The walls are bare stone or plastered and the wall tops appear to be enclosed. The floor is timber and the underside of the roof is unlined. At the western end there are a number of large plastic seed sacks hanging up over the crossing timbers. It was not possible to fully inspect the first floor rooms due to the floor being dilapidated in places.

Figure 14: Interior of first-floor of Barn 1 at Porthmissen Farm (viewed towards the south west)

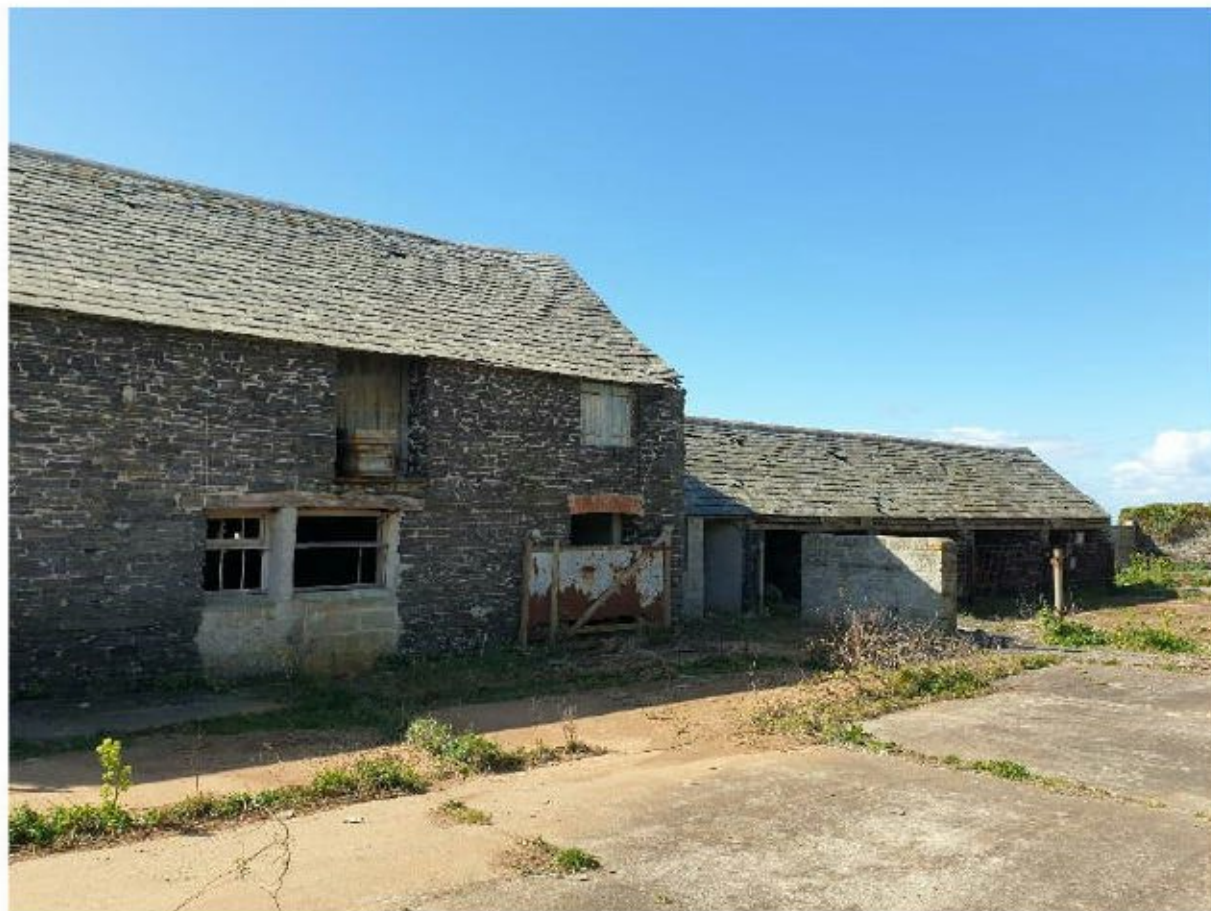
This building is to the south of Barn 1 across a concrete yard and is constructed from stone, brick and concrete block (Figs. 15 & 16). It consists of a part two-storey, part single-storey building with a pitched rag slate roof and clay ridge tiles over each section. There is an external stone staircase at the eastern end leading up to an open doorway, although this part of the building is overgrown with thick vegetation hindering access. There are holes in the roof where slates have lifted, the single-storey section is open-front along its northern elevation and the two-storey section has open window and door apertures, all of which enable potential bat access into the interiors. There are also gaps under lifted slates and ridge tiles which provide potential roost sites for crevice dwelling bats. There are metal gates across some of the northern elevation of the single-storey section. There is ivy growth on the south eastern corner of the barn which could obscure further potential bat roost features (Fig. 16).

Figure 15: Northern elevation of Barn 2 at Porthmissen Farm

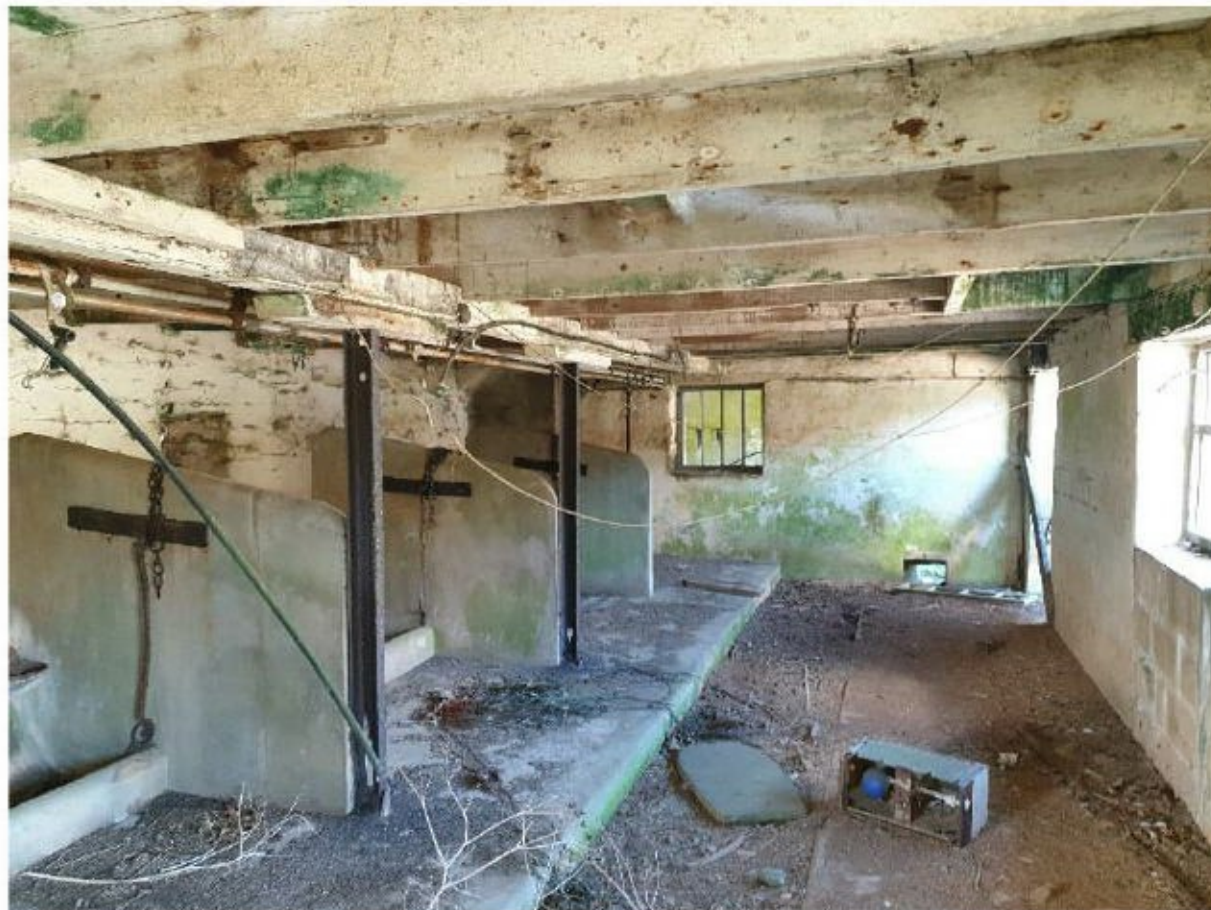
Internally the two-storey section consists of a single room on the ground floor, a former cattle shed, with a single room on the first floor (Figs. 17 & 18). Both rooms are light, open and draughty due to the open windows and doors and the walls are plastered. The ground floor has a concrete floor with concrete cattle stalls and the ceiling is timber. There is a large hole in the first-floor linking the ground and first-floors internally and an internal door linking the ground floor room to an adjacent enclosed room within the single-storey section. On the first-floor the underside of the roof is unlined, the walls are bare stone and the wall tops are enclosed. This part of the building was inspected from a ladder through the hole in the floor, although it could not be fully inspected on health and safety grounds due to the floor being dilapidated in places.

Figure 17: Interior of ground floor of two-storey section of Barn 2 at Porthmissen Farm (viewed towards the west)

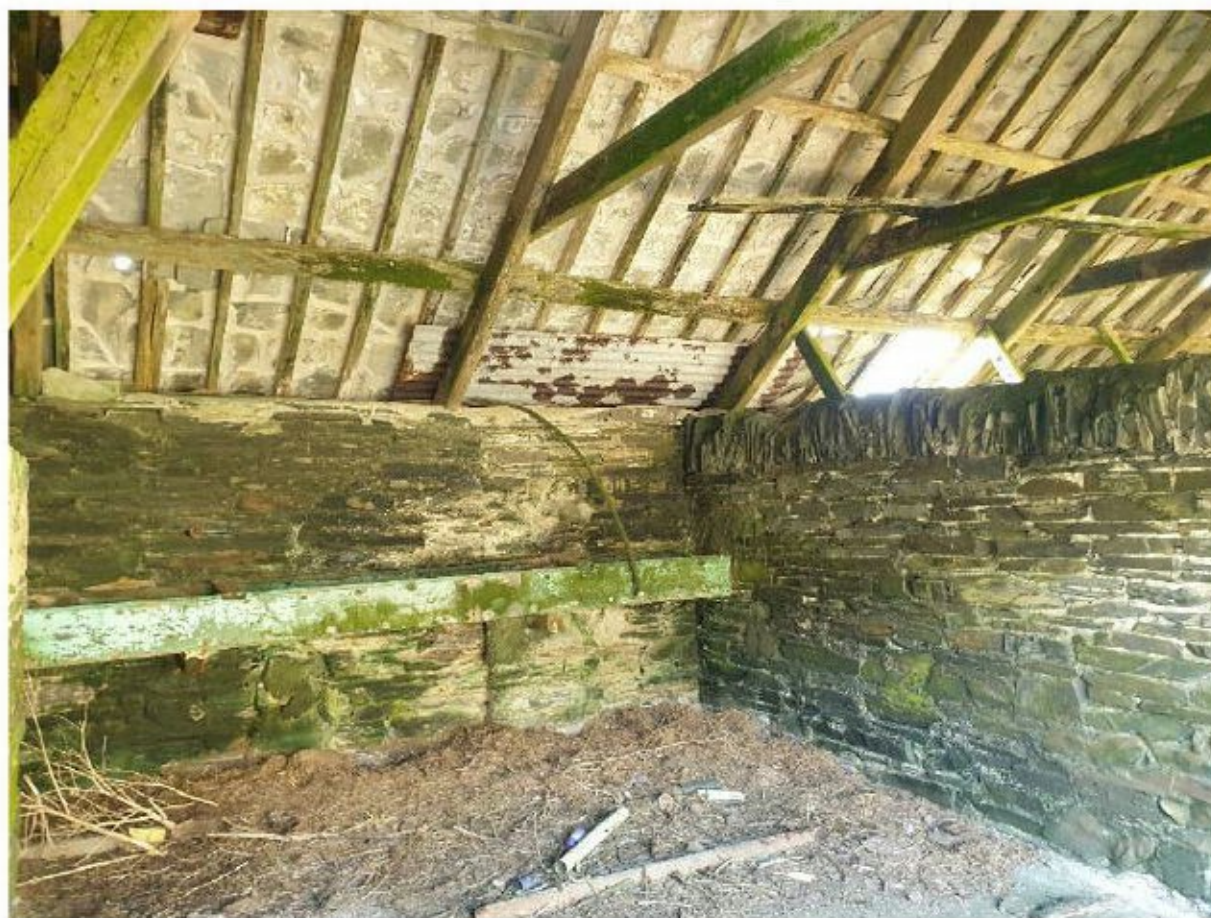
The interior of the single-storey section consists of five stalls, which are connected to each other internally separated by low stone walls and open-fronted to the north (Fig. 19). The underside of the roof is unlined and there are a number of holes, the walls are bare stone, the floors are earth and the interiors are very light and draughty. At the western end is an enclosed room, which links internally to the cattle shed within the two-storey section. This room has plastered walls, a concrete floor with a boarded ceiling under the roof (Fig. 20). There was no access to the roof void. A door on the southern elevation has been partially blocked up and on the northern elevation is an open door.

Figure 19: Interior of one of the stalls within the single-storey section of Barn 2 at Porthmissen Farm

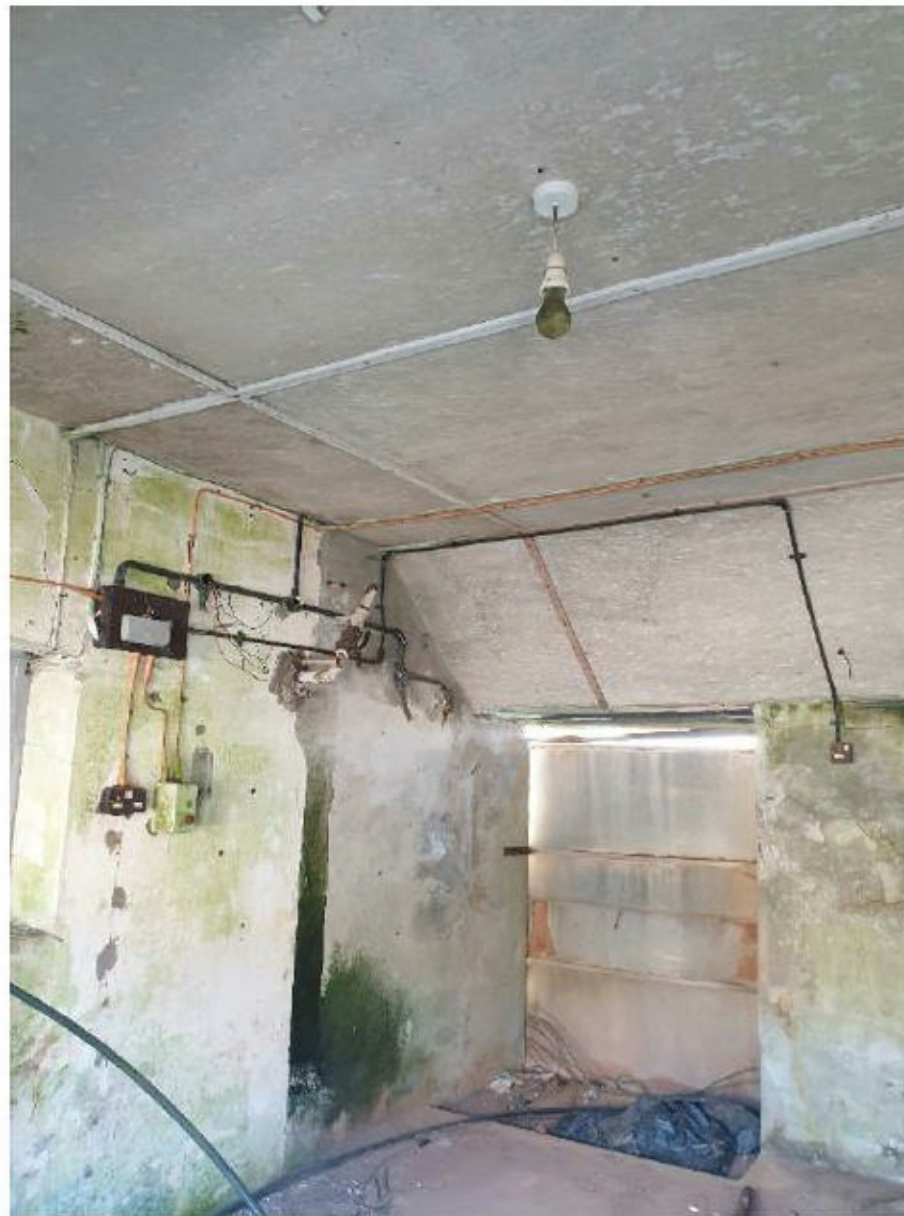
Figure 20: Interior of enclosed single-storey room within Barn 2 at Porthmissen Farm (viewed towards the south east)

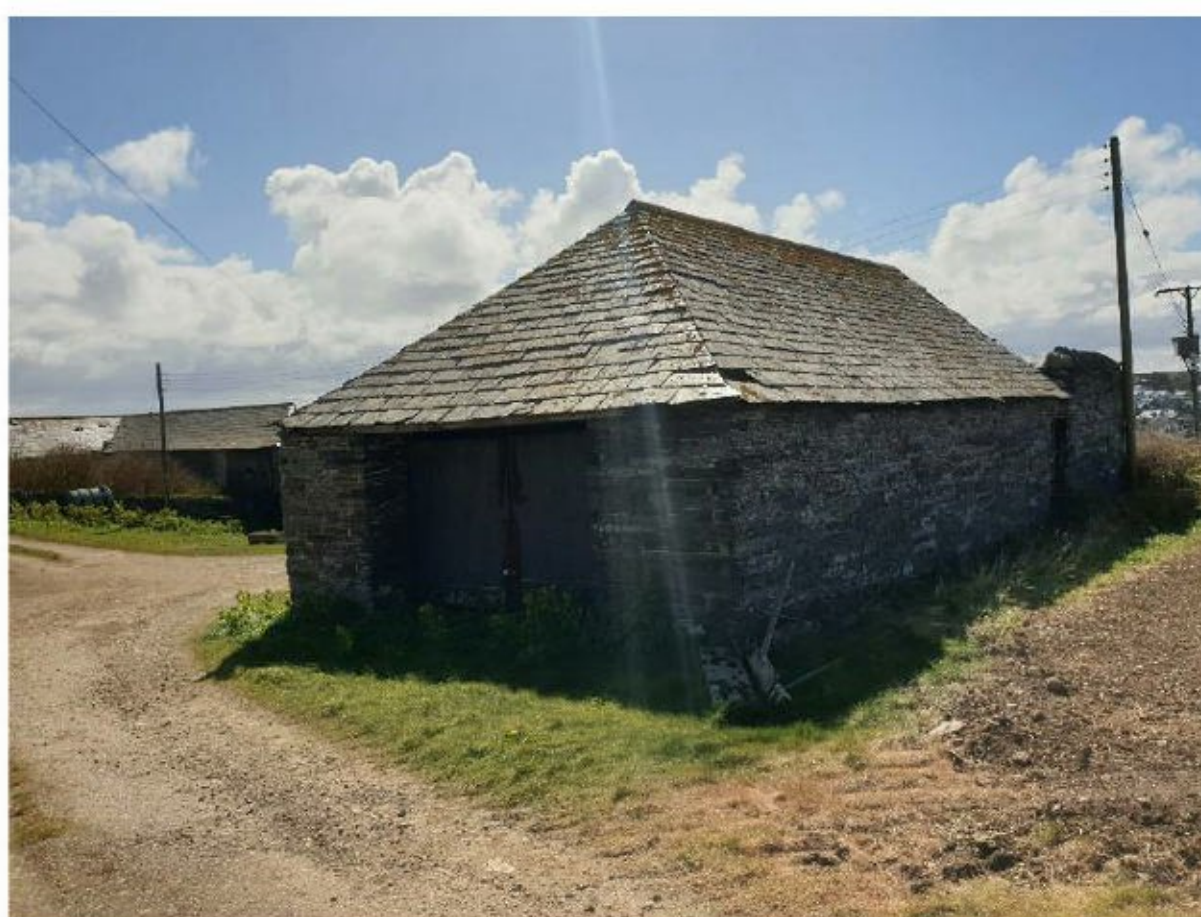
Figure 22: Northern and western elevations of Barn 3 at Porthmissen Farm

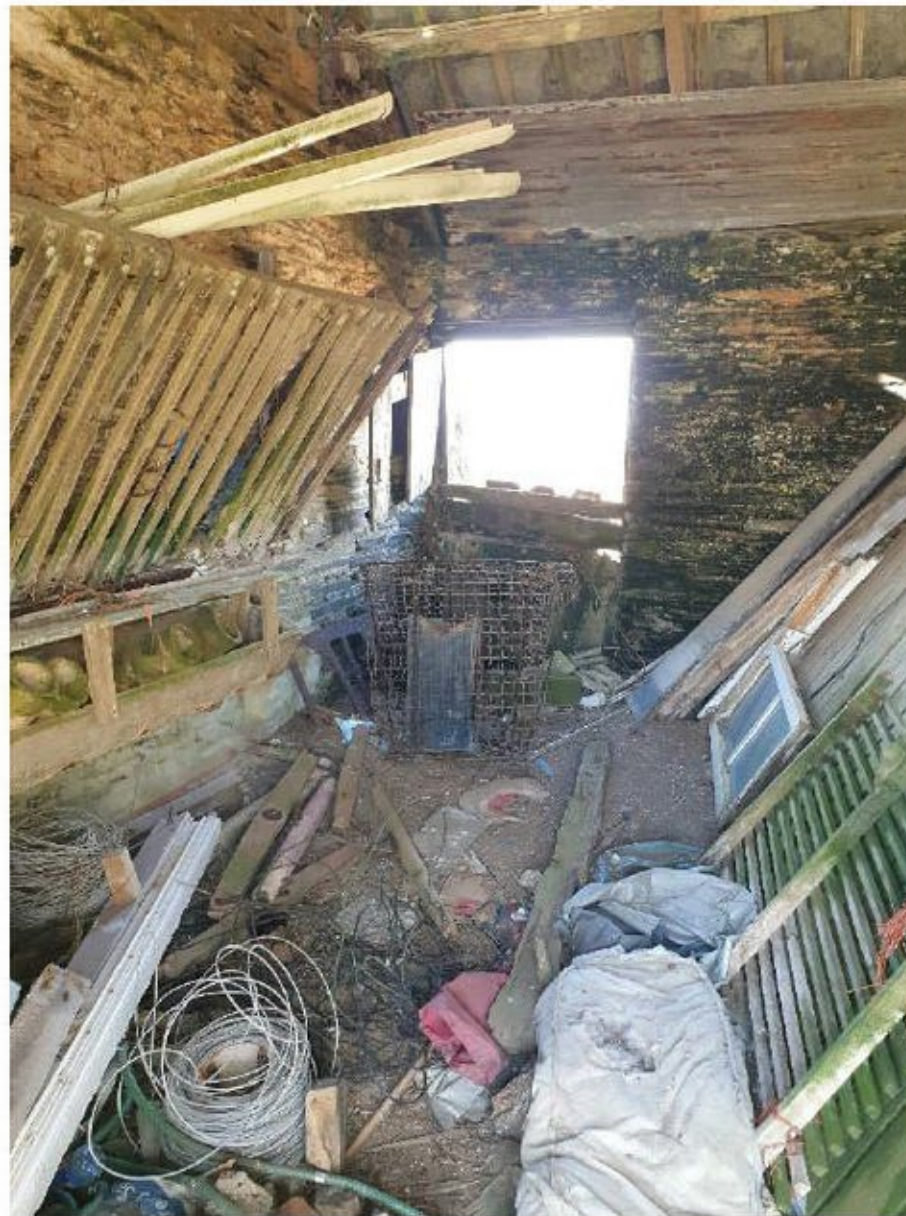
Internally this building consists of two rooms; a small room to the south accessed via an open door on the eastern elevation (Fig. 23) and a larger room to the north accessed via a set of timber double doors on the northern elevation, which could not be fully accessed but could be inspected through gaps in the doors. The rooms have concrete floors, bare stone walls, the roof is unlined and they are used for storage. The larger room is dark, whilst the smaller room is light and draughty internally.

Figure 23: Interior of smaller room within Barn 3 at Porthmissen Farm (viewed towards the west)
