ARBORICULTURAL IMPACT ASSESSMENT

Site:	700 St Johns Road, St Johns Nursery Site Earls Hall Drive, Clacton-On-Sea, Essex, CO16 8BJ
Client:	Kelsworth Ltd
Date	3rd June 2021
Our Ref:	EAS-004v4
Planning Ref:	18/01779/FUL

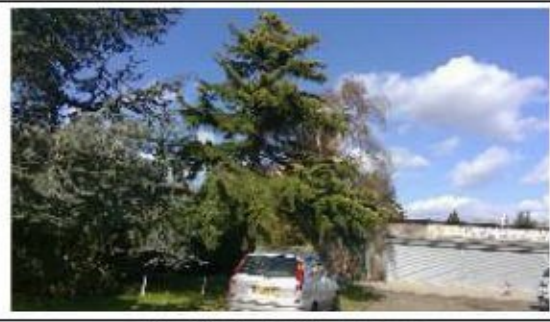
T1 - Cedar (Blue Atlas)

Tree No.	Species	Ht (m)	CS N	CS E	CS S	CS W	DBH (mm)	No of Stems	RPA (m2)	RPR (m)	BS Cat	Age Class	Life Expect.	Observations	Recommendations
T1	Cedar (Blue Atlas)	11	8	8	7	5	500	1	113.1	6.0	C2	Mature	20-39	Poor form (asymmetric canopy), shape and condition. Subject to historic crown management, reduced from power cables. Dense crown, minor dead wood throughout crown.	Crown reduce and reshape by 1.5m to reshape to no more than 30% by crown volume.
T2	Cedar of Lebanon	11	5	5	5	5	330	1	49.3	4.0	B2	Early Mature	40+	Average form, shape and condition. No significant recent crown management. Dense crown, moderate dead wood throughout crown. Hanging snapped branch in lower crown.	Remove dead wood >5cm diameter throughout the crown and snapped branches overhanging the site.
T3	Birch (Silver)	12	4	4	4	4	350	1	55.4	4.2	B2	Early Mature	20-39	Average form, shape and condition. No significant recent crown management. Dense crown, minor dead wood throughout crown. Lower limbs pruned to stubs over car park.	No works.

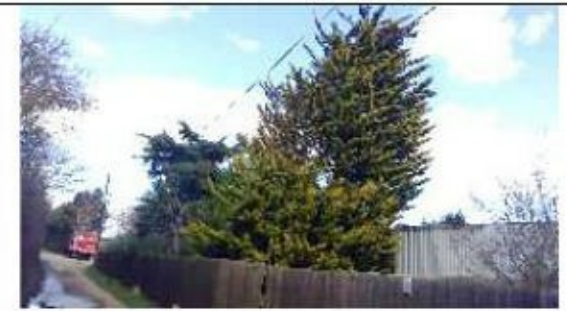
T4 - Cypress (Lawson)

Tree No.	Species	Ht (m)	CS N	CS E	CS S	CS W	DBH (mm)	No of Stems	RPA (m2)	RPR (m)	BS Cat	Age Class	Life Expect.	Observations	Recommendations
T4	Cypress (Lawson)	6	3	3	3	3	400	10	72.4	4.8	C2	Early Mature	10-19	Poor multiple stemmed form, shape and condition. No significant recent crown management. Dense crown, minor dead wood throughout crown.	No works.
T5	Hawthorn	4	3	3	3	3	100	1	4.5	1.2	C2	Semi-Mature	20-39	Average form, shape and condition. No significant recent crown management. Dense crown, minor dead wood.	No works.
T6	Cypress (Golden Monterey)	12	4	4	4	4	450	2	91.6	5.4	C2	Mature	10-19	Average form, shape and condition. No significant recent crown management - previously cut back from power cables. Dense crown, minor dead wood throughout lower crown.	No works.
T7	Cherry	5	2.5	2.5	2.5	2.5	100	1	4.5	1.2	C2	Semi-Mature	10-19	Poor suppressed form, shape and condition. No significant recent crown management. Open crown, minor dead wood throughout crown.	No works.

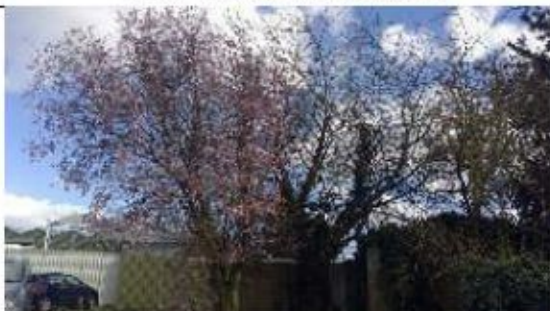
TG1 - Cypress (Lawson)

Tree No.	Species	Ht (m)	CS N	CS E	CS S	CS W	DBH (mm)	No of Stems	RPA (m2)	RPR (m)	BS Cat	Age Class	Life Expect.	Observations	Recommendations
TG1	Cypress (Lawson)	14	6	6	6	6	350	4	55.4	4.2	B2	Early Mature	20-39	Average form, shape and condition. No significant recent crown management. Dense crowns, minor dead wood throughout crowns. X 4 trees growing close together in group.	No works.
SG1	Mixed species shrubs: Elaeagnus, Cypress	6	3	3	3	3	100	10	4.5	1.2	C2	Early Mature	20-39	Average form, shape and condition. No significant recent crown management. Dense crowns, minor dead wood throughout crowns.	No works.
T12	Elder	6	3	3	3	3	200	4	18.1	2.4	C2	Mature	10-19	Poor form, shape and suppressed condition. No significant recent crown management. Open crown, moderate dead wood throughout.	No works.
T13	Cherry	11	6	6	6	6	500	1	113.1	6.0	B2	Mature	10-19	Average form, shape and condition. No significant recent crown management. Dense crown, moderate dead wood throughout crown. Ivy clad crown and stem, unable to fully inspect.	Remove dead wood >5cm diameter throughout the crown. Sever Ivy at 2m from ground level and remove section. Re-inspect.

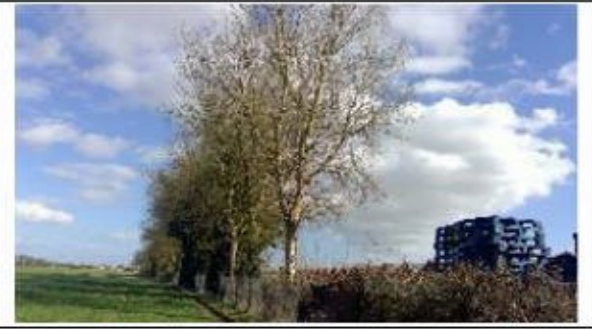
TG2 - Cypress (Lawson)

- 1.4.2 The removal and replacement of the tired and poor condition leyland hedge / screen along Earls Hall Drive, TG2 & TG3, which have been heavily cut back on the road side leaving that side of the screen brown and given the species unlikely to grow back. Several of the trees in this screen are suppressed and have died.

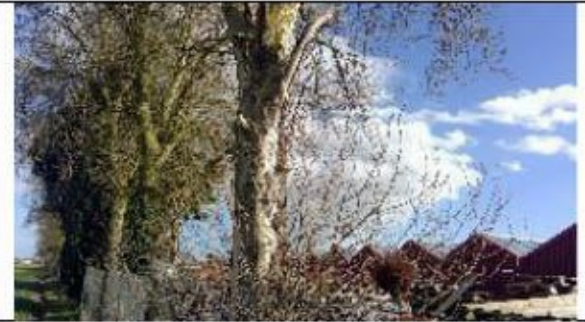
T18 - Poplar (Hybrid Black)

1.4.4 Hybrid Poplar trees are also known to sucker from their roots, have basal epicormic growth and moderate to high amounts of crown deadwood. They are also susceptible to limb failure as they mature and reach the end of their safe useful life expectancy. Currently basic crown maintenance is recommended only as crown reduction once started requires repeated works every 2-3 years.
