**The Thatched Cottage,
Bradfield,
Essex**

Historic Building Record

May 2021

The Thatched Cottage, Wix Road, Bradfield, Essex

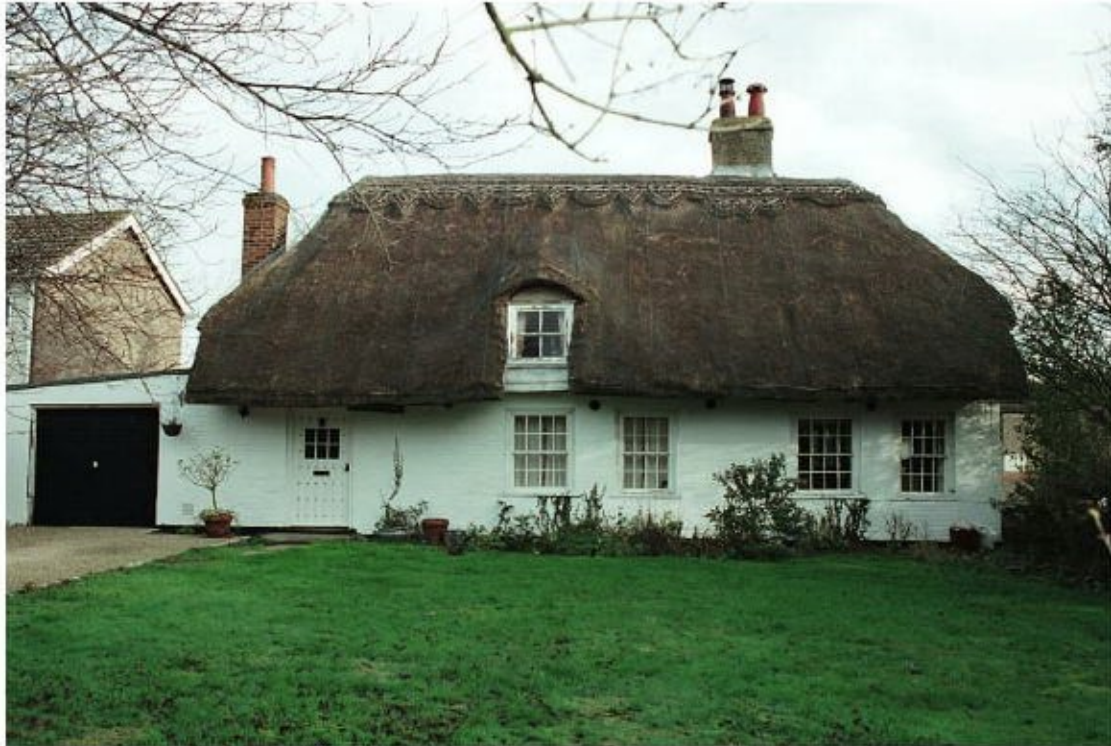
Figure 8
The south-western facade before the fire, taken in 2004 (top) and from Fine & Country's sales particulars of 2016.

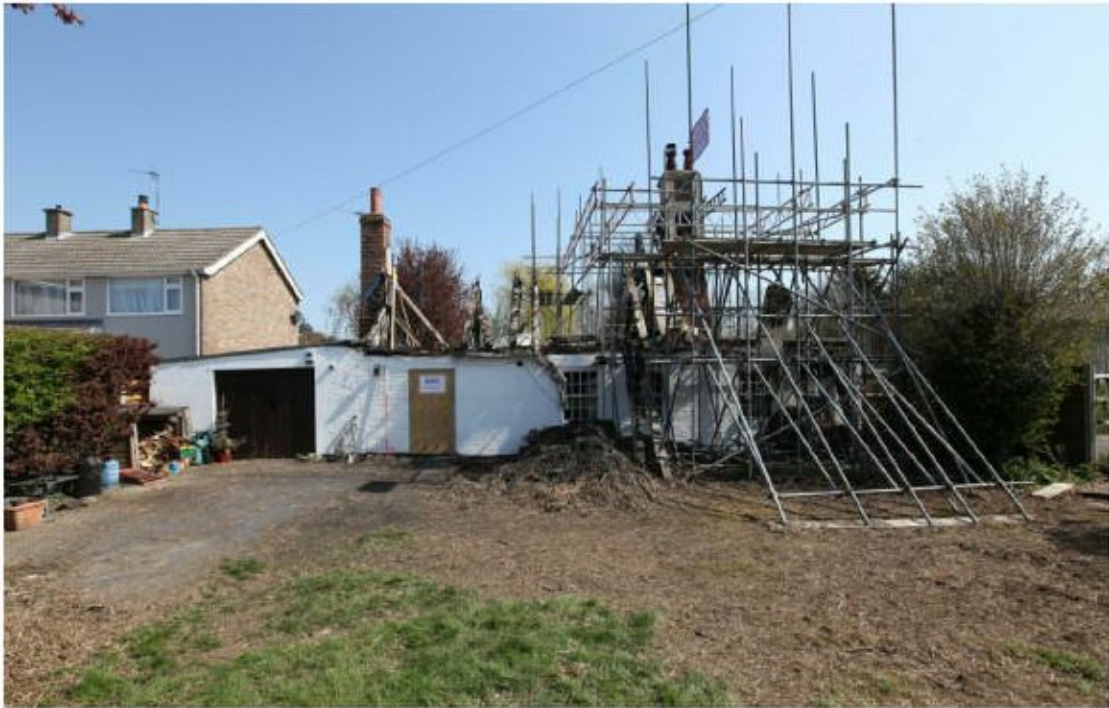
Illus. 1. The south-western facade with the 20th century garage and the 19th century chimney against the original north-western gable to the left.

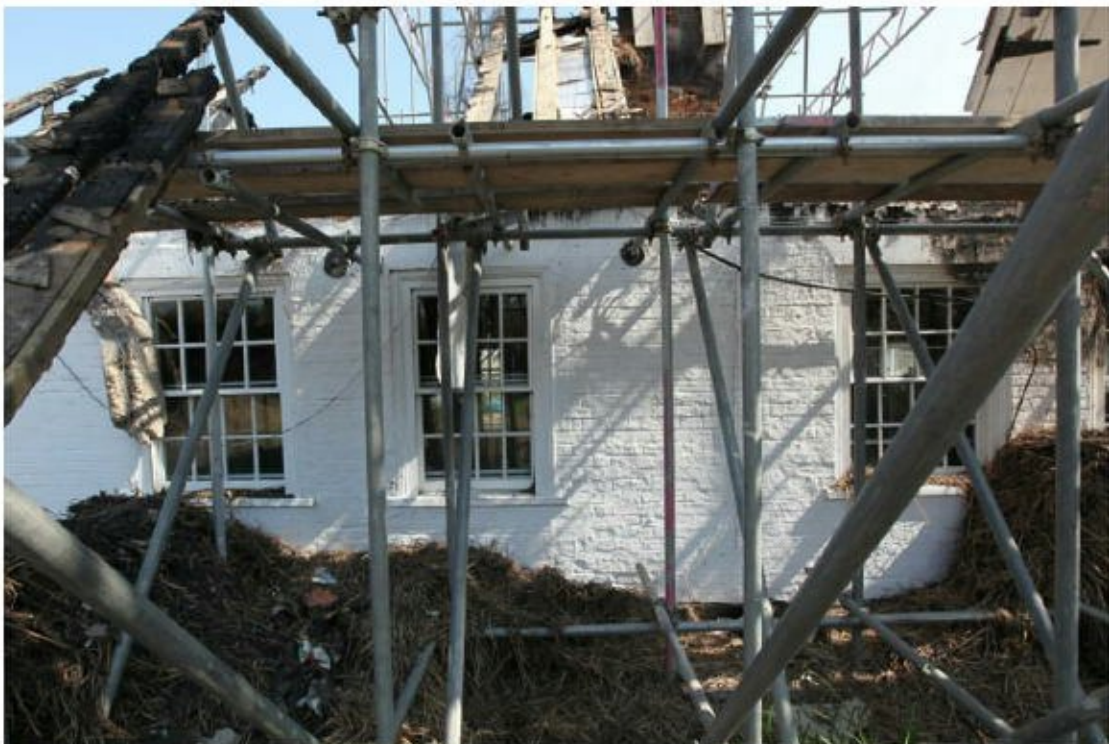
Illus. 2. A detail of the south-western facade showing its painted Flemish Bond 19th century brickwork and sash windows. The closers (quarter bricks) respecting the central window in this image continue to the ground alongside a vertical joint in the bonding, suggesting it occupies the position of an entrance that opened into the corner of the central door – corresponding to the path on the historic Ordnance Surveys and possibly indicating the location of the original entrance.

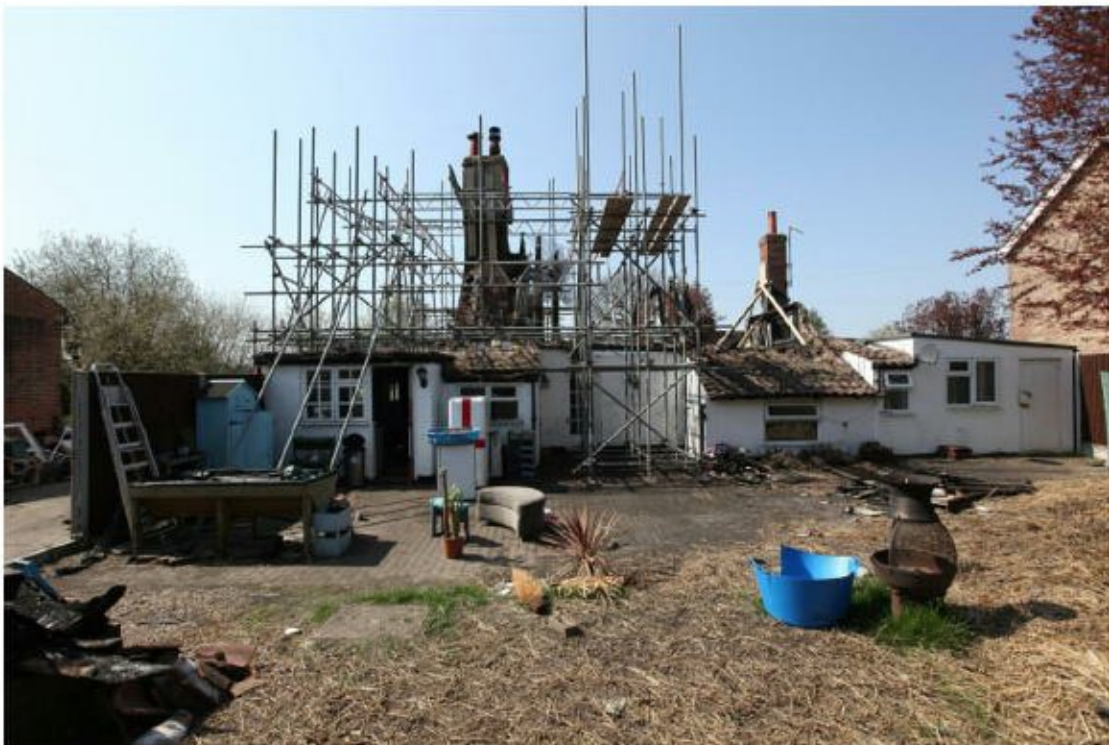
Illus. 4. The north-eastern elevation from the rear garden showing the two pantiled lean-to additions behind the modern kitchen in the parlour bay on the left and the original service bay to the right – much as shown on the 1875 Ordnance Survey. Most if not all of the garage to the extreme right is a 20th century extension.

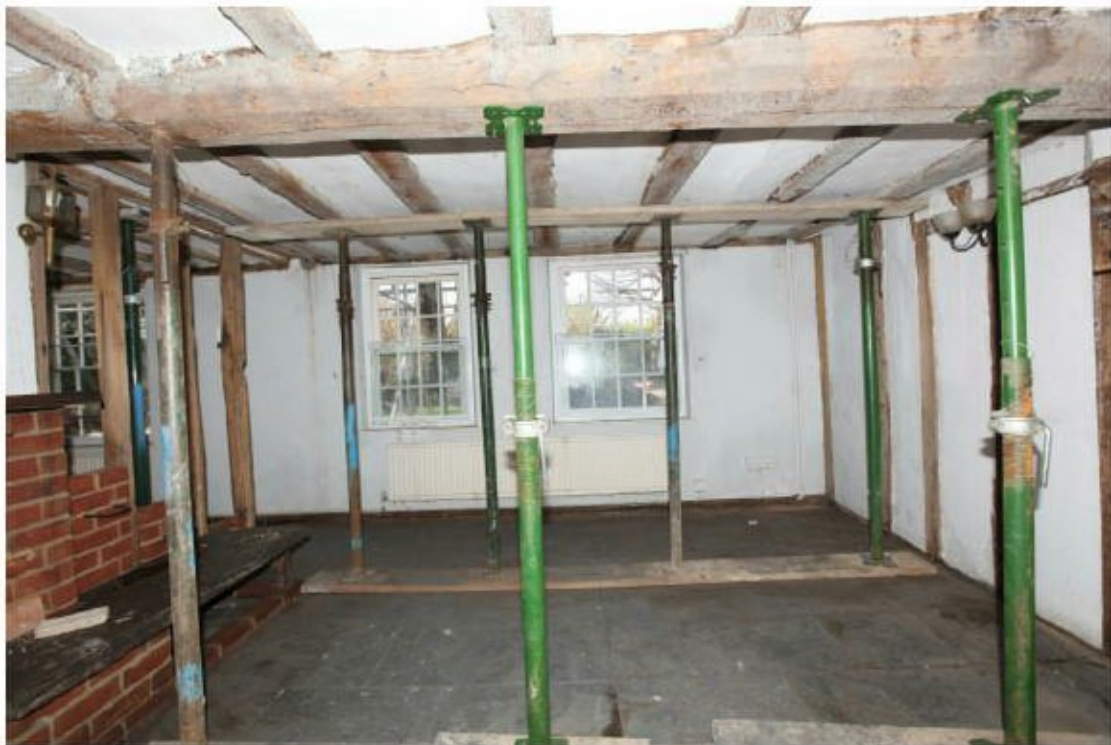
Illus. 6. The front (south-western) wall of the central hall showing its rendered brickwork and sash windows with the modern fireplace to the left. The hall extends to only 3.8 m in length (12.5 ft), but the original fabric of its external walls is either lost or hidden.

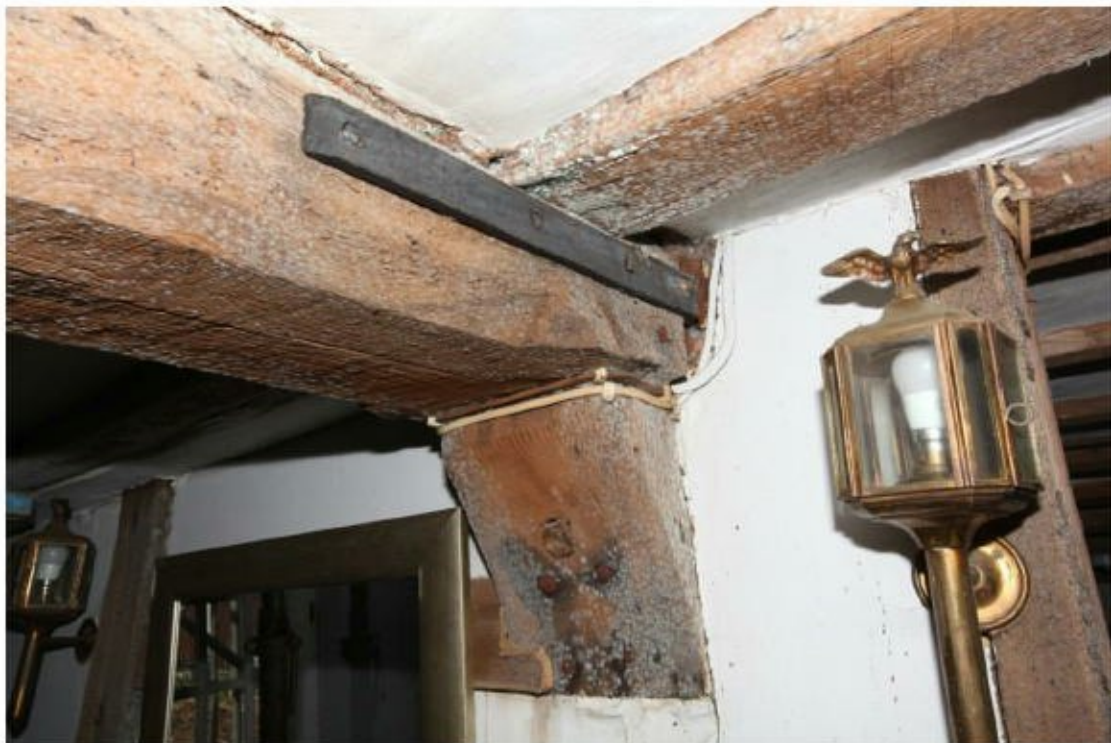
Illus. 8. A detail of the neatly curved chamfer stop to the south-eastern end of the hall's axial joist in the style of the late-16th and early-17th centuries. The joist is supported by a shaped and chip-carved bracket attached to the rendered brickwork of the chimney.

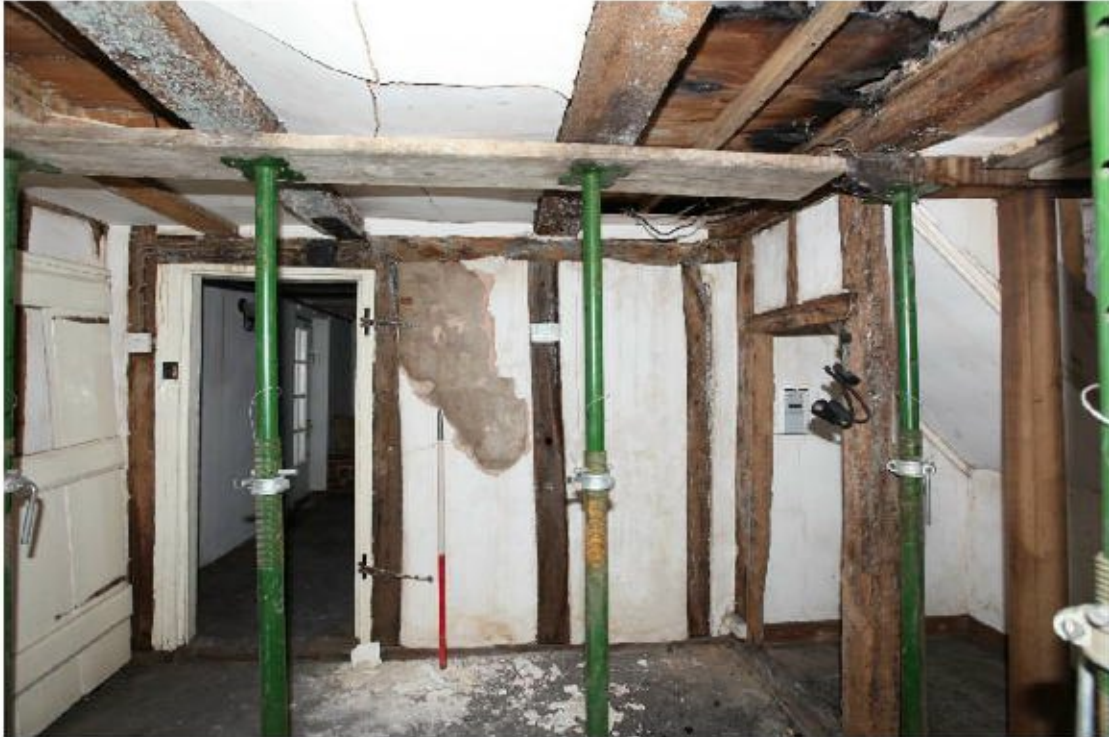
Illus. 13. The service bay from its rendered north-western gable showing the framed original door to the central hall on the left with an external door alongside. The wide spacing of the ceiling joists in front of the hall door indicates the position of a former stair but there is no firm evidence of an original stair trap.

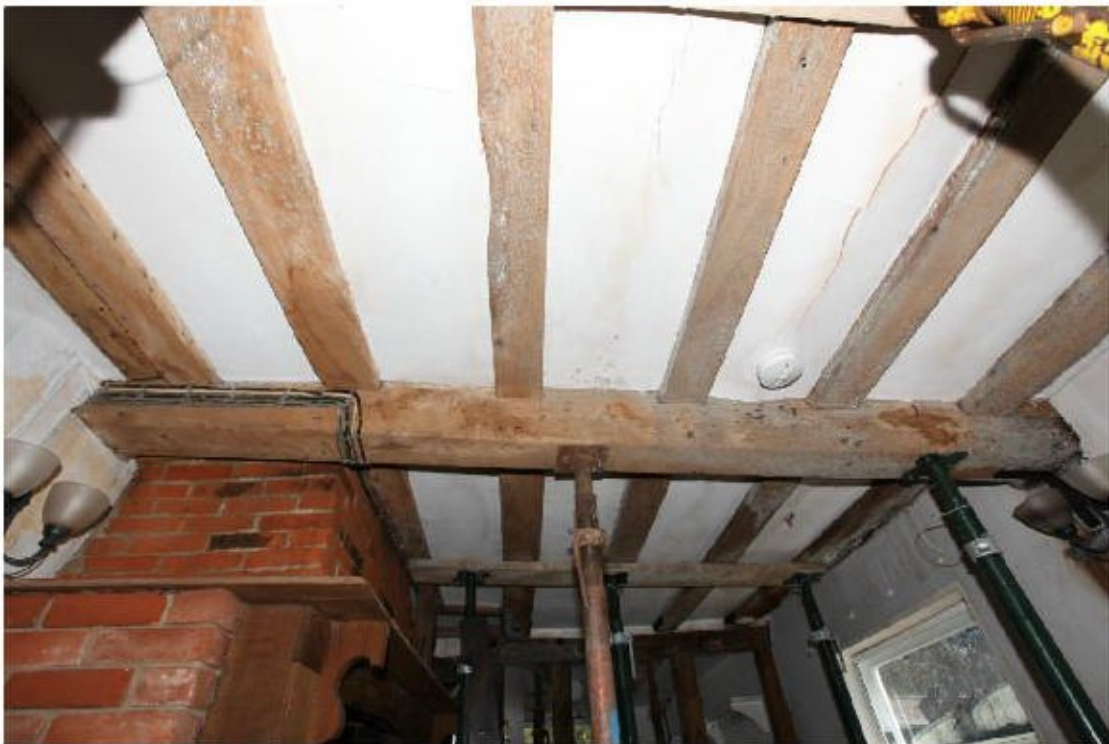
Illus. 16. The ostensibly original ceiling of the probable service bay showing its south-eastern gable on the right and the 19th century chimney to the left. The chamfered and stopped axial joist respects the original chimney to the extreme left and appears to be tenoned to the remains of a central post in the gable on the right.

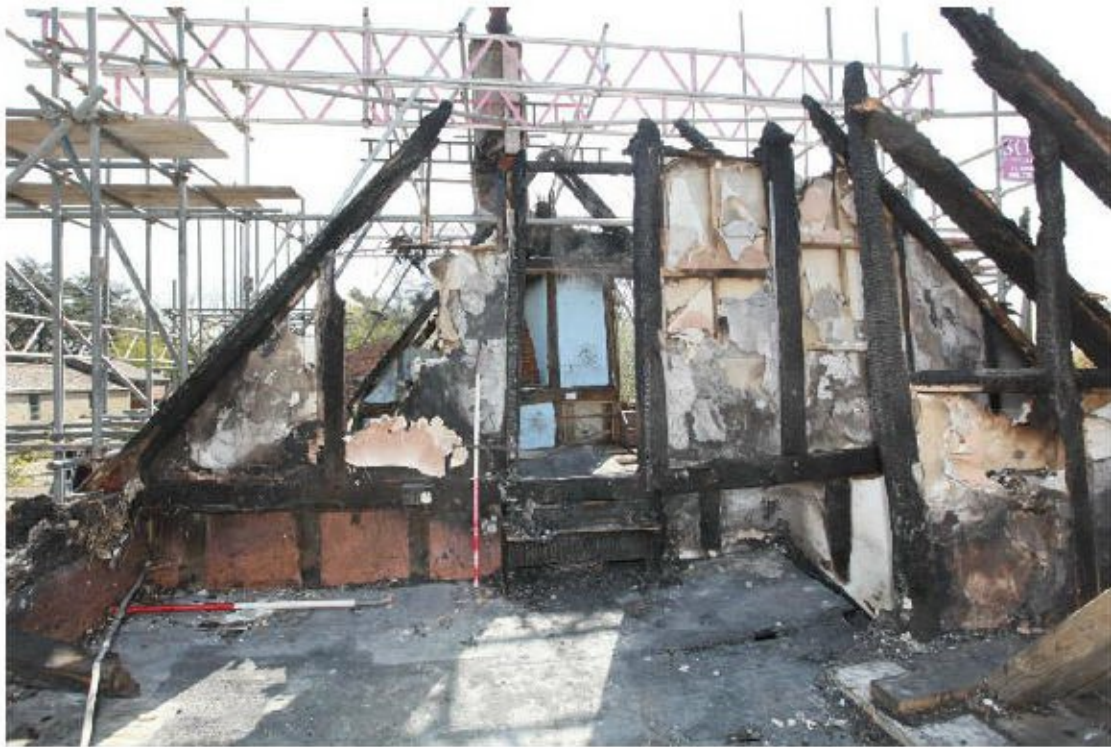
Illus. 25. The chamber above the probable parlour from its gable to the north-west showing the fully framed partition adjoining the central hall chamber. The jamb of the original ground-floor door lies close to the storey post on the left with a pegged short stud above the lintel and the first-floor door is an insertion between to original studs. The floorboards consist of recent softwood throughout the upper storey with no evidence of earlier boards beneath.

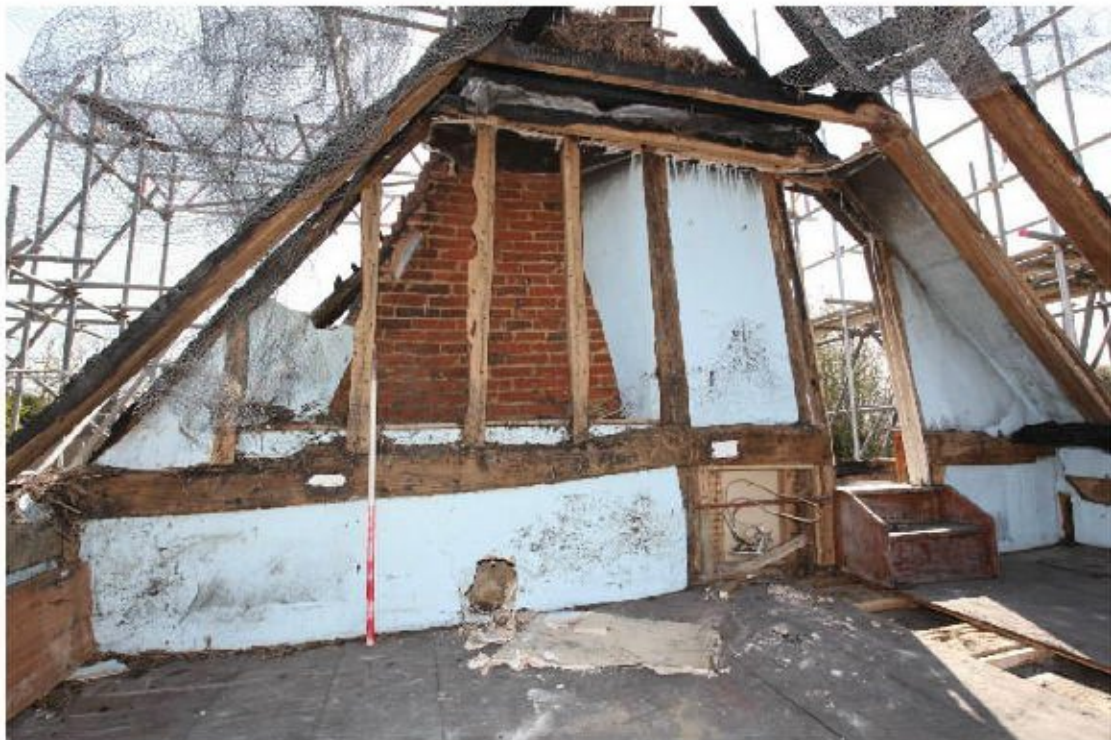
Illus. 30. The partition against the chimney at the south-eastern end of the hall chamber with an inserted door to the parlour chamber cutting the tie-beam on the right. The tie-beam contains pegged mortices for original studs with wider gaps for an original ground-floor door or doors to the right. The present studs above the tie are later insertions but it contains pegged mortices for original framing at least in the centre. See figure 14.

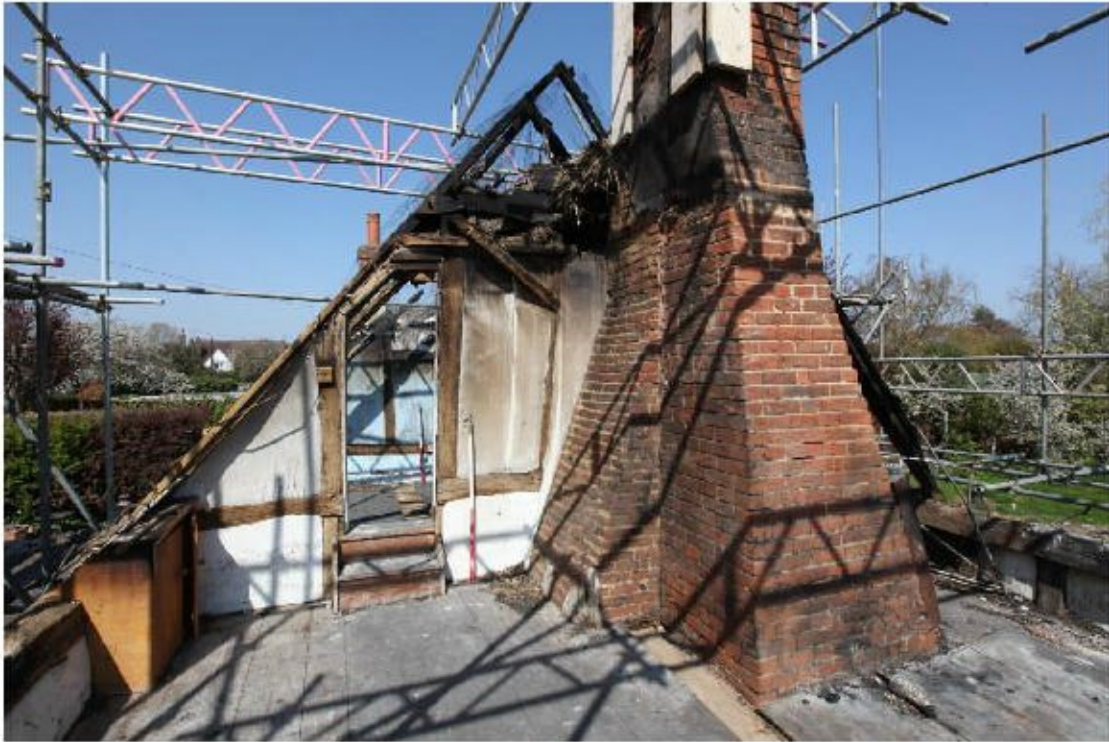
Illus. 31. The probable service chamber from its south-eastern gable showing the 19th century brick chimney against its late-16th or early-17th century predecessor. Part of the probably original roof structure survives to the left of the chimney as shown in illustration 32.

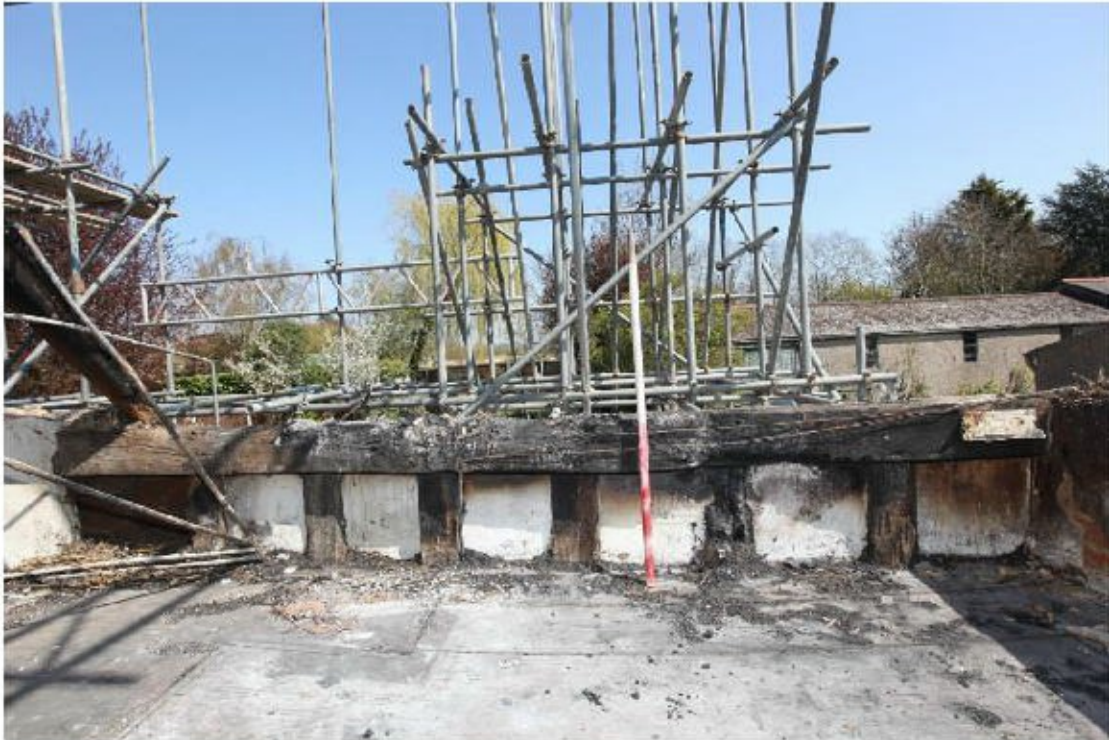
Illus. 35. The exposed original framing of the rear, north-eastern wall of the probable service chamber, immediately above the ground-floor window shown in illustration 19. The chamber would have been lit by a window in its missing gable matching that of the north-western chamber. A dovetail joint for a missing tie-beam that defined a narrow bay for the original chimney is visible on the left (illustration 36).
