STRUCTURAL REPORT

Conversion of redundant farm buildings to form a single dwelling

Field House Farm

30 April 2021

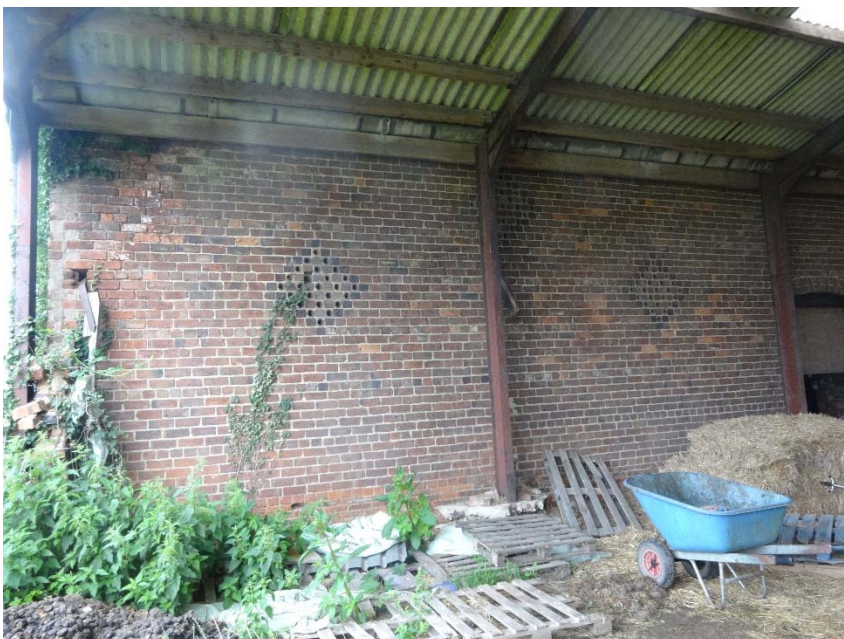
The northerly gable brickwork is shown above internally.

It is evident that the timber lintel over the opening which gives access from the two storey area to the single storey area has over its life deflected. This is shown by the repaired brickwork. There is a subsequent diagonal crack rising from the rise hand side rising up towards the ridge level.

The structural repairs are straight forward, steel lintels should be provided to the inner supporting leaf in place of existing timbers.

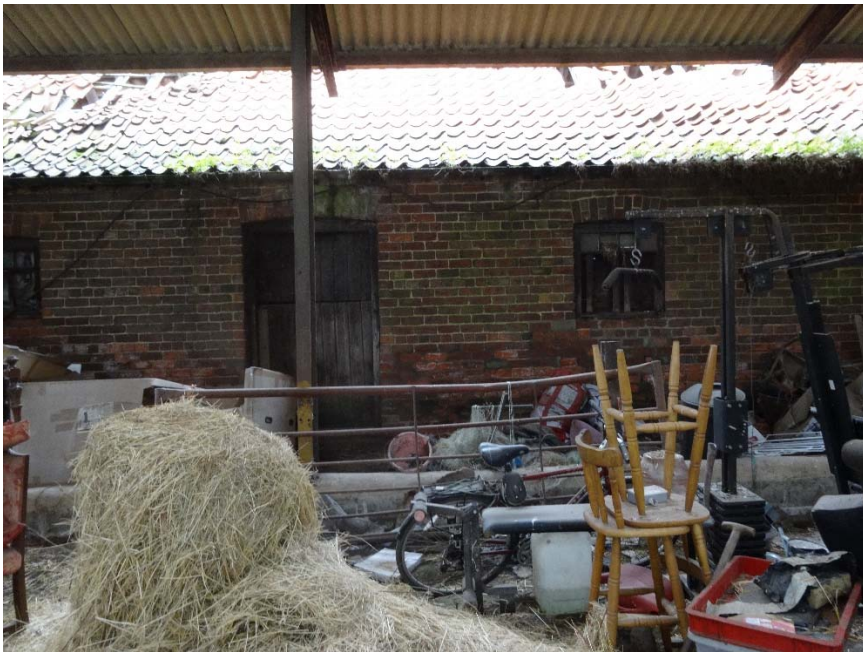
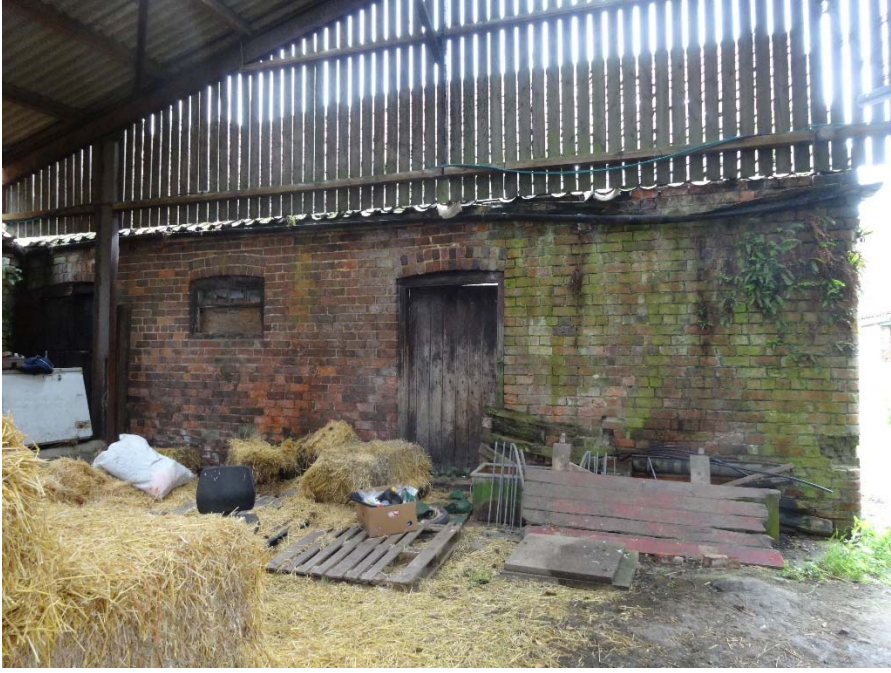
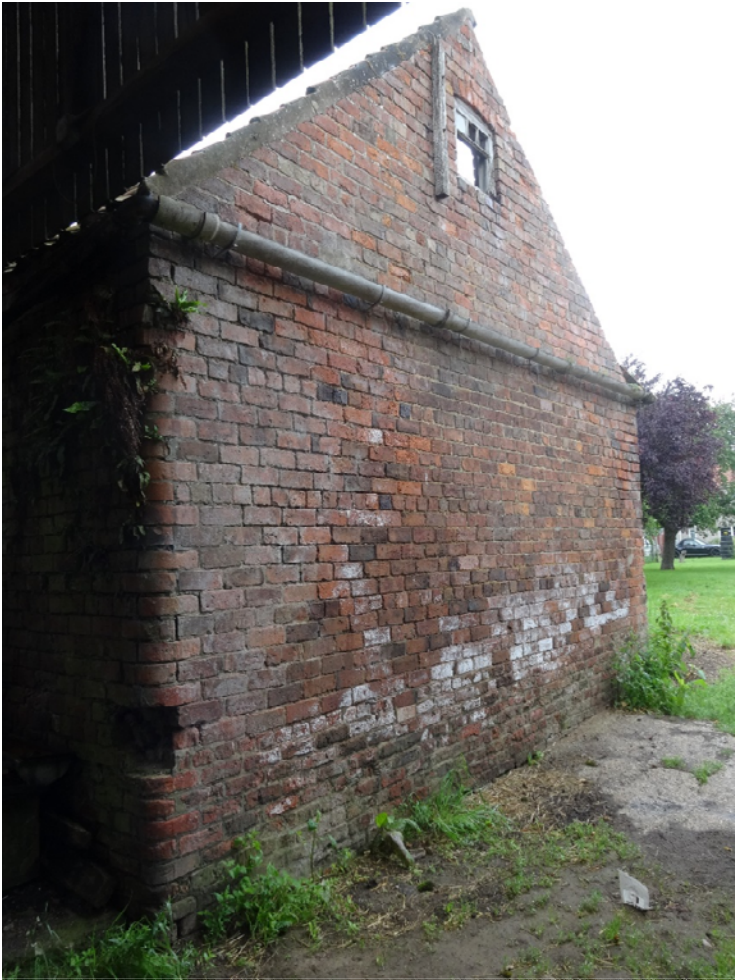
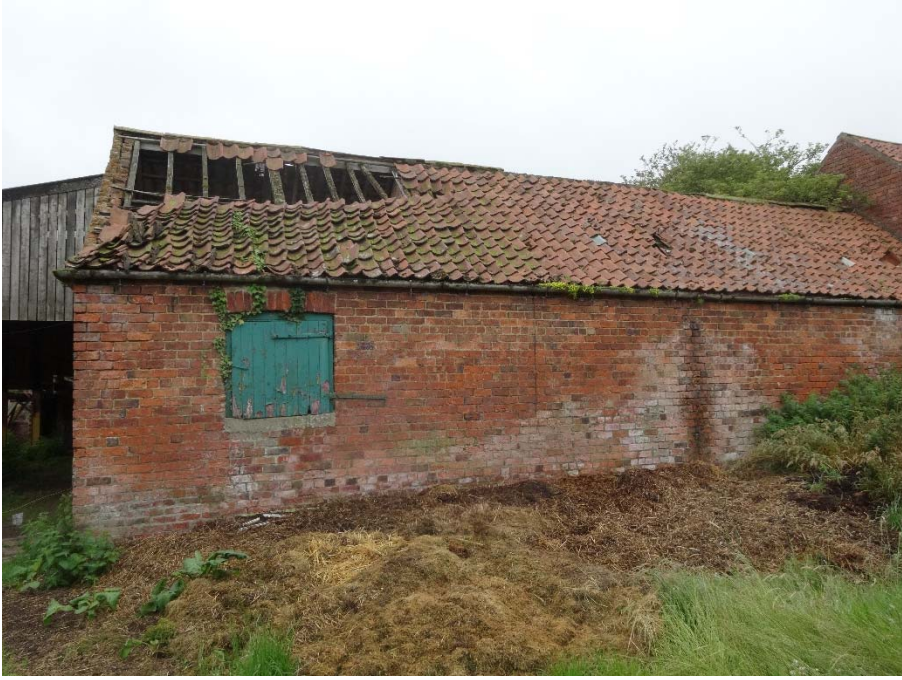
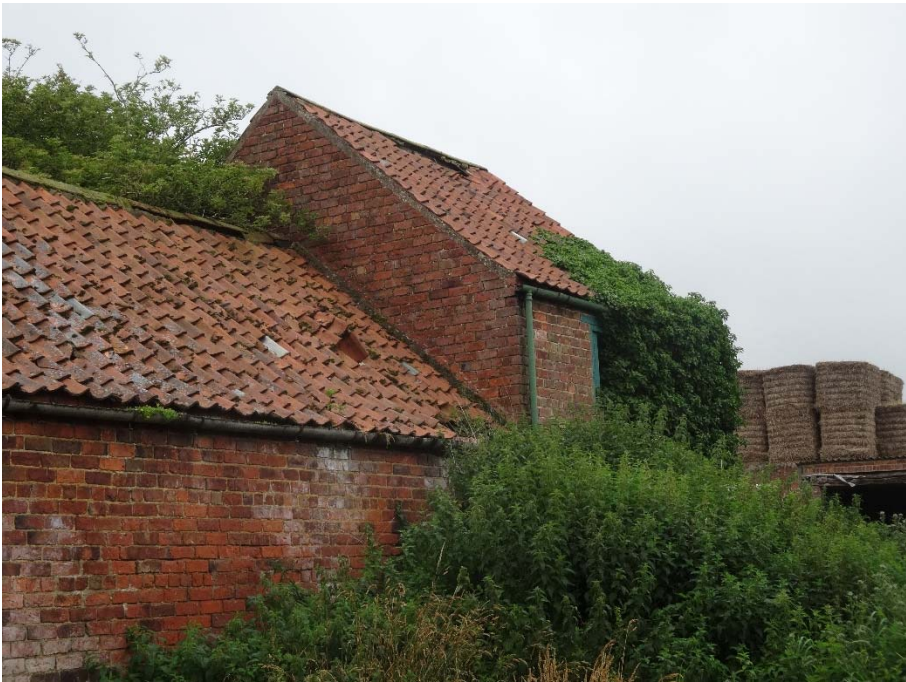
The following set of pictures show that the brickwork and structure is generally in good condition unfortunately misled by the amount of waste in the areas.

Note the window and door head brick arches all appear to be in good condition with no signs of fracture cracks.

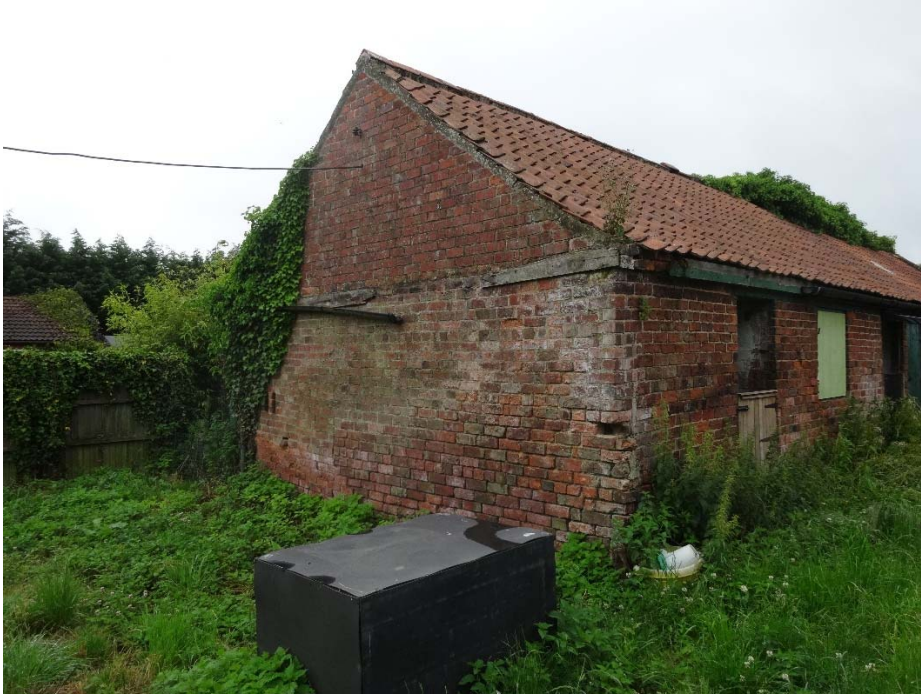
The stable block is in good condition. Note the straightness of the ridge.
