ASBESTOS REFURBISHMENT SURVEY

Client	Twenty Five
Site	Lodge Farm, High Catton, York, North Yorkshire, YO41 1EW
Date started	23 Jun 2021
Date completed	23 Jun 2021
Date report issued	25 Jun 2021
Survey reference	J616986
Lead surveyor	Adam Martin
Assistant surveyor	N/A
UPRN	N/A

ASBESTOS SURVEY OF LODGE FARM, HIGH CATTON, YORK, NORTH YORKSHIRE

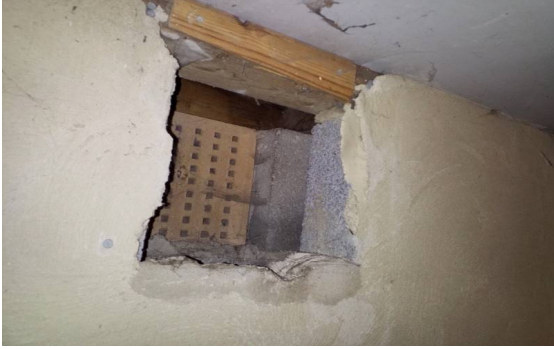
Item Reference	J616986 #1
	Sample reference number	
	Client name	Twenty Five
	Site address	Lodge Farm, High Catton, York, North Yorkshire, YO41 1EW
	Date surveyed	23/06/21
	Date analysed	
	Building	Lodge Farm, High Catton, York, North Yorkshire, YO41 1EW
	Floor level	External
	Room	Workshop
	Position	
	Item description	Intrusive inspection
	Condition / damage	
	Surface treatment	
	Product type	
	Asbestos Type	No Asbestos Identified
Extent		
Recommended Action	Disturbance location	
Comments:	Occupant activity	
	Time in area	
	Frequency of use	
Maintenance activity	Accessibility	
Maintenance frequency	Priority assessment score	
Number of occupants	Material assessment score	
Overall assessment score	Risk code

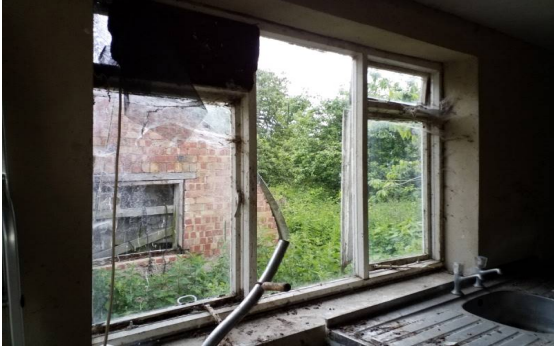
Item Reference	J616986 #3
	Sample reference number	PC000744
	Client name	Twenty Five
	Site address	Lodge Farm, High Catton, York, North Yorkshire, YO41 1EW
	Date surveyed	23/06/21
	Date analysed	June 24 2021
	Building	Lodge Farm, High Catton, York, North Yorkshire, YO41 1EW
	Floor level	External
	Room	Workshop
	Position	To window
	Item description	Mastic
	Condition / damage	
	Surface treatment	
	Product type	
Asbestos Type	No Asbestos Detected	
Extent		
Recommended Action	None required	Disturbance location
Comments:		Occupant activity
		Time in area
		Frequency of use
		Accessibility
Maintenance activity		Priority assessment score
Maintenance frequency		Material assessment score
Number of occupants		Risk code
Overall assessment score

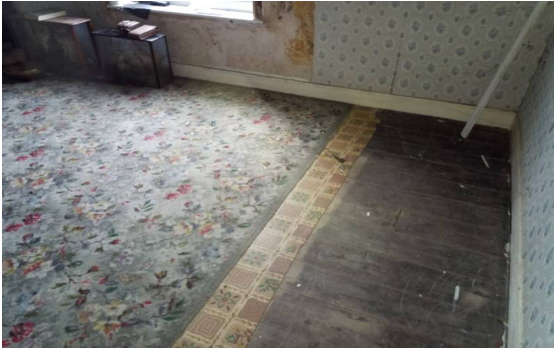
Item Reference	J616986 #4
	Sample reference number	PC000745
	Client name	Twenty Five
	Site address	Lodge Farm, High Catton, York, North Yorkshire, YO41 1EW
	Date surveyed	23/06/21
	Date analysed	June 24 2021
	Building	Lodge Farm, High Catton, York, North Yorkshire, YO41 1EW
	Floor level	1st Floor
	Room	Farmhouse - Bedroom/Study
	Position	To floor below carpet
	Item description	Brown Patterned vinyl floor covering
	Condition / damage	
	Surface treatment	
	Product type	
Asbestos Type	No Asbestos Detected	
Extent		
Recommended Action	None required	Disturbance location
Comments:		Occupant activity
		Time in area
		Frequency of use
		Accessibility
Maintenance activity		Priority assessment score
Maintenance frequency		Material assessment score
Number of occupants		Risk code
Overall assessment score

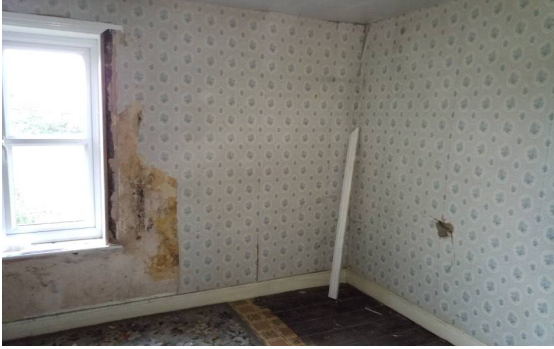
Item Reference	J616986 #5
	Sample reference number	
	Client name	Twenty Five
	Site address	Lodge Farm, High Catton, York, North Yorkshire, YO41 1EW
	Date surveyed	23/06/21
	Date analysed	
	Building	Lodge Farm, High Catton, York, North Yorkshire, YO41 1EW
	Floor level	1st Floor
	Room	Farmhouse - Bedroom/Study
	Position	
	Item description	Intrusive inspection
	Condition / damage	
	Surface treatment	
	Product type	
	Asbestos Type	No Asbestos Identified
Extent		
Recommended Action	Disturbance location	
Comments:	Occupant activity	
	Time in area	
	Frequency of use	
Maintenance activity	Accessibility	
Maintenance frequency	Priority assessment score	
Number of occupants	Material assessment score	
Overall assessment score	Risk code

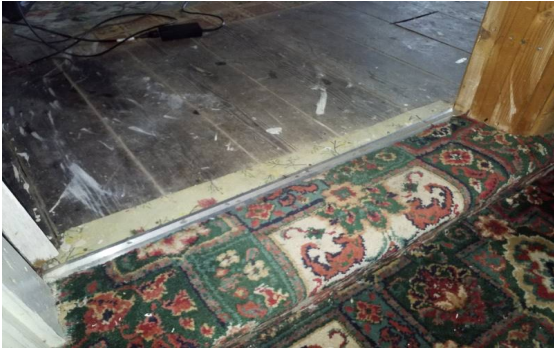
Item Reference	J616986 #6	
	Sample reference number	PC000746	
	Client name	Twenty Five	
	Site address	Lodge Farm, High Catton, York, North Yorkshire, YO41 1EW	
	Date surveyed	23/06/21	
	Date analysed	June 24 2021	
	Building	Lodge Farm, High Catton, York, North Yorkshire, YO41 1EW	
	Floor level	1st Floor	
	Room	Farmhouse - Bedroom/Study	
	Position	To floor adjacent doorway	
	Item description	Green patterned vinyl floor covering	
	Condition / damage		
	Surface treatment		
	Product type		
	Asbestos Type	No Asbestos Detected	
Extent			
Recommended Action	None required	Disturbance location	
Comments:	Occupant activity		
	Time in area		
	Frequency of use		
Maintenance activity		Accessibility	
Maintenance frequency		Priority assessment score	
Number of occupants		Material assessment score	
Overall assessment score		Risk code

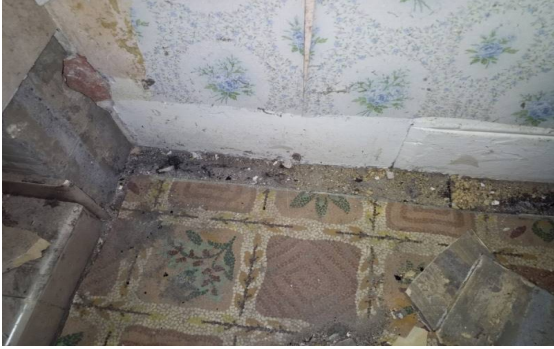
Item Reference	J616986 #7
	Sample reference number	PC000747
	Client name	Twenty Five
	Site address	Lodge Farm, High Catton, York, North Yorkshire, YO41 1EW
	Date surveyed	23/06/21
	Date analysed	June 24 2021
	Building	Lodge Farm, High Catton, York, North Yorkshire, YO41 1EW
	Floor level	1st Floor
	Room	Farmhouse - Bedroom/Study
	Position	To hearth of fireplace
	Item description	Bitumen
	Condition / damage	
	Surface treatment	
	Product type	
Asbestos Type	No Asbestos Detected	
Extent		
Recommended Action	None required	Disturbance location
Comments:		Occupant activity
		Time in area
		Frequency of use
Maintenance activity		Accessibility
Maintenance frequency		Priority assessment score
Number of occupants		Material assessment score
Overall assessment score		Risk code

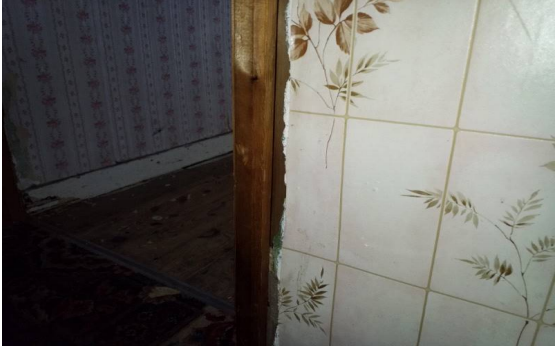
Item Reference	J616986 #9
	Sample reference number	
	Client name	Twenty Five
	Site address	Lodge Farm, High Catton, York, North Yorkshire, YO41 1EW
	Date surveyed	23/06/21
	Date analysed	
	Building	Lodge Farm, High Catton, York, North Yorkshire, YO41 1EW
	Floor level	1st Floor
	Room	Stairs lobby
	Position	
	Item description	Intrusive inspection.
	Condition / damage	
	Surface treatment	
	Product type	
Asbestos Type		
Extent		
Recommended Action	Disturbance location	
Comments:	Occupant activity	
	Time in area	
	Frequency of use	
Maintenance activity	Accessibility	
Maintenance frequency	Priority assessment score	
Number of occupants	Material assessment score	
Overall assessment score	Risk code

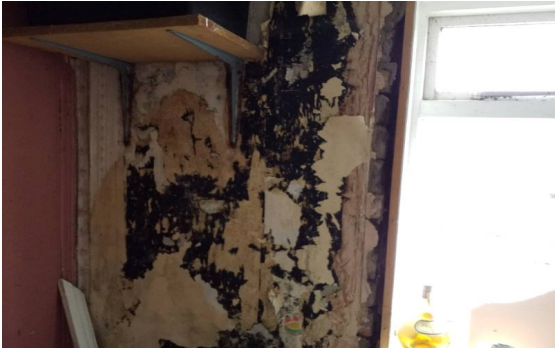
Item Reference	J616986 #10
	Sample reference number	
	Client name	Twenty Five
	Site address	Lodge Farm, High Catton, York, North Yorkshire, YO41 1EW
	Date surveyed	23/06/21
	Date analysed	
	Building	Lodge Farm, High Catton, York, North Yorkshire, YO41 1EW
	Floor level	1st Floor
	Room	Farmhouse - Toilet
	Position	
	Item description	Intrusive inspection.
	Condition / damage	
	Surface treatment	
	Product type	
Asbestos Type		
Extent		
Recommended Action	Disturbance location	
Comments:	Occupant activity	
	Time in area	
	Frequency of use	
Maintenance activity	Accessibility	
Maintenance frequency	Priority assessment score	
Number of occupants	Material assessment score	
Overall assessment score	Risk code

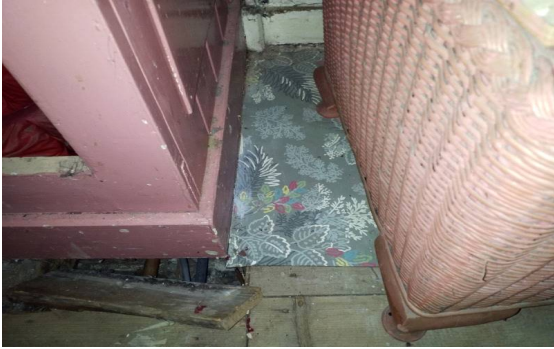
Item Reference	J616986 #12	
	Sample reference number	PC000749	
	Client name	Twenty Five	
	Site address	Lodge Farm, High Catton, York, North Yorkshire, YO41 1EW	
	Date surveyed	23/06/21	
	Date analysed	June 24 2021	
	Building	Lodge Farm, High Catton, York, North Yorkshire, YO41 1EW	
	Floor level	1st Floor	
	Room	Farmhouse - Toilet	
	Position	To floor adjacent cupboard	
	Item description	Grey patterned vinyl floor covering	
	Condition / damage		
	Surface treatment		
	Product type		
Asbestos Type	No Asbestos Detected		
Extent			
Recommended Action	None required	Disturbance location	
Comments:		Occupant activity	
		Time in area	
		Frequency of use	
Maintenance activity		Accessibility	
Maintenance frequency		Priority assessment score	
Number of occupants		Material assessment score	
Overall assessment score		Risk code

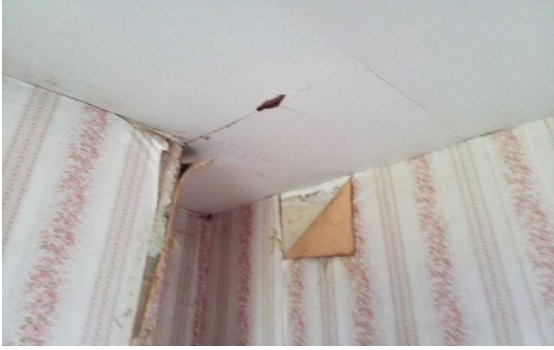
Item Reference	J616986 #13
	Sample reference number	
	Client name	Twenty Five
	Site address	Lodge Farm, High Catton, York, North Yorkshire, YO41 1EW
	Date surveyed	23/06/21
	Date analysed	
	Building	Lodge Farm, High Catton, York, North Yorkshire, YO41 1EW
	Floor level	1st Floor
	Room	Farmhouse - Bedroom
	Position	
	Item description	Intrusive inspection.
	Condition / damage	
	Surface treatment	
	Product type	
Asbestos Type		
Extent		
Recommended Action	Disturbance location	
Comments:	Occupant activity	
	Time in area	
	Frequency of use	
Maintenance activity	Accessibility	
Maintenance frequency	Priority assessment score	
Number of occupants	Material assessment score	
Overall assessment score	Risk code

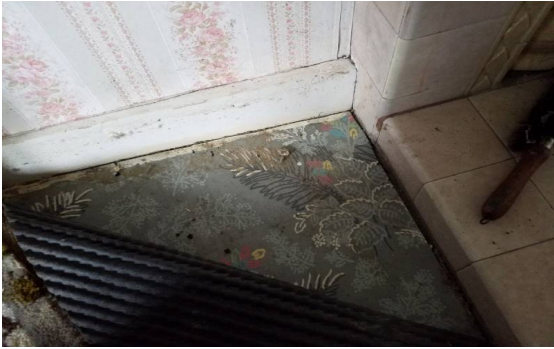
Item Reference	J616986 #14
	Sample reference number	As Sample PC000749
	Client name	Twenty Five
	Site address	Lodge Farm, High Catton, York, North Yorkshire, YO41 1EW
	Date surveyed	23/06/21
	Date analysed	
	Building	Lodge Farm, High Catton, York, North Yorkshire, YO41 1EW
	Floor level	1st Floor
	Room	Farmhouse - Bedroom
	Position	To floor below carpet
	Item description	Grey patterned vinyl floor covering
	Condition / damage	
	Surface treatment	
	Product type	
Asbestos Type	No Asbestos Detected	
Extent		
Recommended Action	None required	Disturbance location
Comments:	Occupant activity	
	Time in area	
	Frequency of use	
Maintenance activity	Accessibility	
Maintenance frequency	Priority assessment score	
Number of occupants	Material assessment score	
Overall assessment score	Risk code

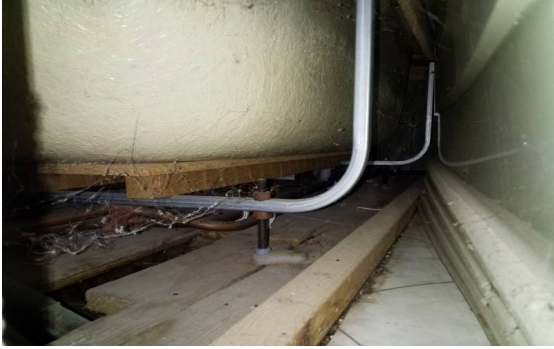
Item Reference	J616986 #15
	Sample reference number	
	Client name	Twenty Five
	Site address	Lodge Farm, High Catton, York, North Yorkshire, YO41 1EW
	Date surveyed	23/06/21
	Date analysed	
	Building	Lodge Farm, High Catton, York, North Yorkshire, YO41 1EW
	Floor level	1st Floor
	Room	Farmhouse - Bathroom
	Position	
	Item description	Intrusive inspection.
	Condition / damage	
	Surface treatment	
	Product type	
Asbestos Type		
Extent		
Recommended Action	Disturbance location	
Comments:	Occupant activity	
	Time in area	
	Frequency of use	
Maintenance activity	Accessibility	
Maintenance frequency	Priority assessment score	
Number of occupants	Material assessment score	
Overall assessment score	Risk code

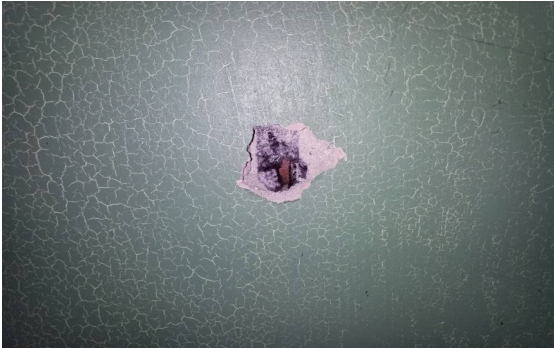
Item Reference	J616986 #16	
	Sample reference number	PC000750	
	Client name	Twenty Five	
	Site address	Lodge Farm, High Catton, York, North Yorkshire, YO41 1EW	
	Date surveyed	23/06/21	
	Date analysed	June 24 2021	
	Building	Lodge Farm, High Catton, York, North Yorkshire, YO41 1EW	
	Floor level	Ground Floor	
	Room	Farmhouse - Toilet	
	Position	Within wall cavities throughout	
	Item description	Bitumen damp proof membrane	
	Condition / damage		
	Surface treatment		
	Product type		
Asbestos Type	No Asbestos Detected		
Extent			
Recommended Action	None required	Disturbance location	
Comments: Presumed to run within walls throughout	Occupant activity		
	Time in area		
	Frequency of use		
Maintenance activity	Accessibility		
Maintenance frequency	Priority assessment score		
Number of occupants	Material assessment score		
Overall assessment score	Risk code

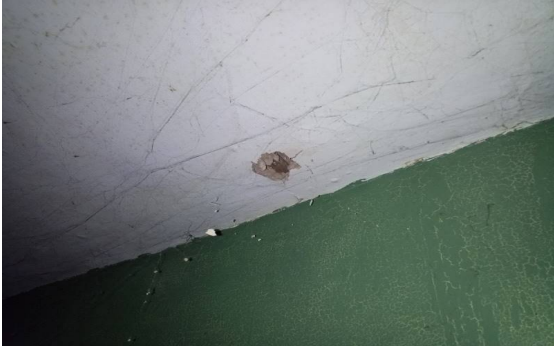
Item Reference	J616986 #17
	Sample reference number	
	Client name	Twenty Five
	Site address	Lodge Farm, High Catton, York, North Yorkshire, YO41 1EW
	Date surveyed	23/06/21
	Date analysed	
	Building	Lodge Farm, High Catton, York, North Yorkshire, YO41 1EW
	Floor level	Ground Floor
	Room	Farmhouse - Toilet
	Position	
	Item description	Intrusive inspection
	Condition / damage	
	Surface treatment	
	Product type	
Asbestos Type	No Asbestos Identified	
Extent		
Recommended Action	Disturbance location	
Comments:	Occupant activity	
	Time in area	
	Frequency of use	
Maintenance activity	Accessibility	
Maintenance frequency	Priority assessment score	
Number of occupants	Material assessment score	
Overall assessment score	Risk code

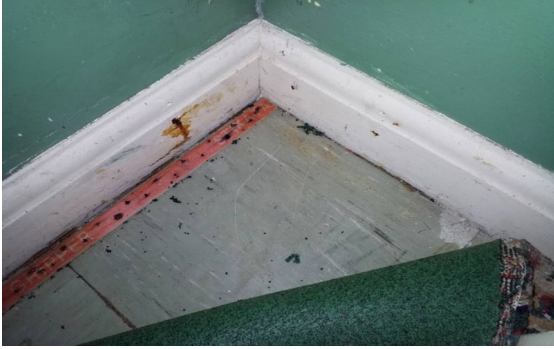
Item Reference	J616986 #18	
	Sample reference number	PC000751	
	Client name	Twenty Five	
	Site address	Lodge Farm, High Catton, York, North Yorkshire, YO41 1EW	
	Date surveyed	23/06/21	
	Date analysed	June 24 2021	
	Building	Lodge Farm, High Catton, York, North Yorkshire, YO41 1EW	
	Floor level	Ground Floor	
	Room	Farmhouse - Toilet	
	Position	To floor below carpet	
	Item description	Light green vinyl floor tiles plus adhesives	
	Condition / damage		
	Surface treatment		
	Product type		
Asbestos Type	No Asbestos Detected		
Extent			
Recommended Action	None required	Disturbance location	
Comments:	Occupant activity		
	Time in area		
	Frequency of use		
Maintenance activity		Accessibility	
Maintenance frequency		Priority assessment score	
Number of occupants		Material assessment score	
Overall assessment score		Risk code

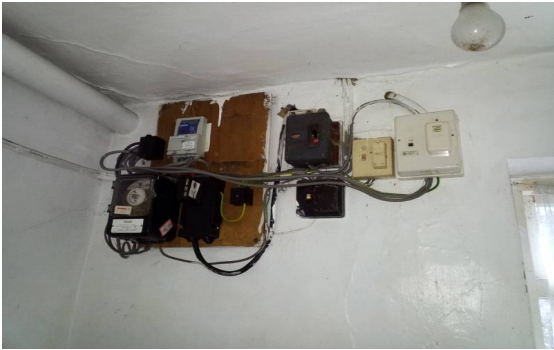
Item Reference	J616986 #20	
	Sample reference number		
	Client name	Twenty Five	
	Site address	Lodge Farm, High Catton, York, North Yorkshire, YO41 1EW	
	Date surveyed	23/06/21	
	Date analysed		
	Building	Lodge Farm, High Catton, York, North Yorkshire, YO41 1EW	
	Floor level	Ground Floor	
	Room	Farmhouse - Store	
	Position	Within live electrics

Item description	Textiles	
	Condition / damage	(1) Low Damage	
	Surface treatment	(2) Unsealed AIB, encapsulated lagging and sprays, ropes, textiles, paper	
	Product type	Textiles	
Asbestos Type	Presumed Amosite		
Extent	5no.		
Recommended Action	Monitor and manage	Disturbance location	Rooms up to 100m ²
Comments: Not accessed due to live		Occupant activity	Rare disturbance - (e.g. little used store room)
		Time in area	<1 hour - toilets
		Frequency of use	Infrequent
Maintenance activity	Minor disturbance - e.g. possibility of contact when gaining access	Accessibility	Low
Maintenance frequency	<1 per year	Priority assessment score	3
Number of occupants	1 to 3	Material assessment score	7
Overall assessment score	10	Risk code	Risk code D

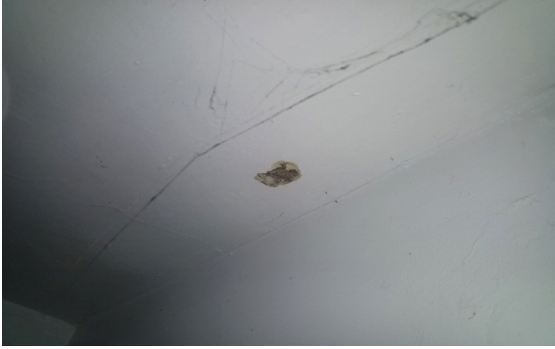
Item Reference	J616986 #21
	Sample reference number	
	Client name	Twenty Five
	Site address	Lodge Farm, High Catton, York, North Yorkshire, YO41 1EW
	Date surveyed	23/06/21
	Date analysed	
	Building	Lodge Farm, High Catton, York, North Yorkshire, YO41 1EW
	Floor level	Ground Floor
	Room	Farmhouse - Store
	Position	
	Item description	Intrusive inspection
	Condition / damage	
	Surface treatment	
	Product type	
Asbestos Type	No Asbestos Identified	
Extent		
Recommended Action	Disturbance location	
Comments:	Occupant activity	
	Time in area	
	Frequency of use	
Maintenance activity	Accessibility	
Maintenance frequency	Priority assessment score	
Number of occupants	Material assessment score	
Overall assessment score	Risk code

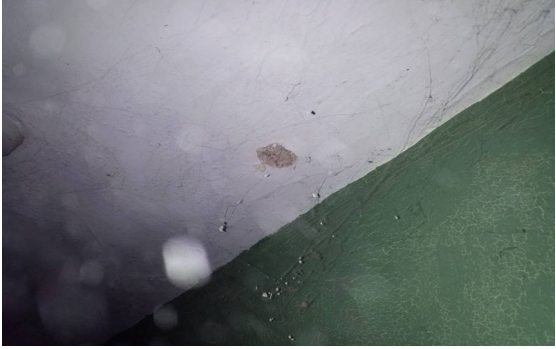
Item Reference	J616986 #23
	Sample reference number	
	Client name	Twenty Five
	Site address	Lodge Farm, High Catton, York, North Yorkshire, YO41 1EW
	Date surveyed	23/06/21
	Date analysed	
	Building	Lodge Farm, High Catton, York, North Yorkshire, YO41 1EW
	Floor level	Ground Floor
	Room	Farmhouse - Stairwell lobby
	Position	
	Item description	Intrusive inspection
	Condition / damage	
	Surface treatment	
	Product type	
Asbestos Type	No Asbestos Identified	
Extent		
Recommended Action	Disturbance location	
Comments:	Occupant activity	
	Time in area	
	Frequency of use	
Maintenance activity	Accessibility	
Maintenance frequency	Priority assessment score	
Number of occupants	Material assessment score	
Overall assessment score	Risk code

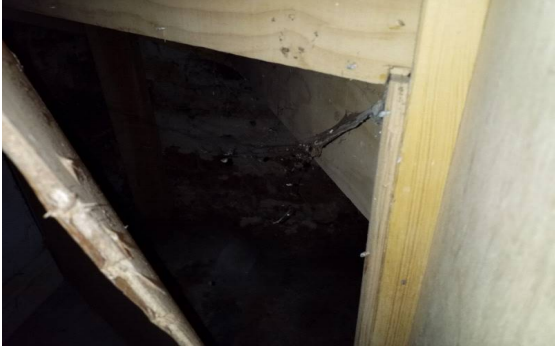
Item Reference	J616986 #24
	Sample reference number	
	Client name	Twenty Five
	Site address	Lodge Farm, High Catton, York, North Yorkshire, YO41 1EW
	Date surveyed	23/06/21
	Date analysed	
	Building	Lodge Farm, High Catton, York, North Yorkshire, YO41 1EW
	Floor level	Ground Floor
	Room	Understairs cupboard
	Position	
	Item description	Intrusive inspection
	Condition / damage	
	Surface treatment	
	Product type	
Asbestos Type	No Asbestos Identified	
Extent		
Recommended Action	Disturbance location	
Comments:	Occupant activity	
	Time in area	
	Frequency of use	
Maintenance activity	Accessibility	
Maintenance frequency	Priority assessment score	
Number of occupants	Material assessment score	
Overall assessment score	Risk code

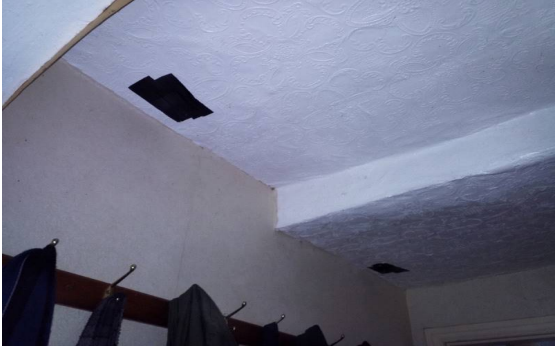
Item Reference	J616986 #25
	Sample reference number	
	Client name	Twenty Five
	Site address	Lodge Farm, High Catton, York, North Yorkshire, YO41 1EW
	Date surveyed	23/06/21
	Date analysed	
	Building	Lodge Farm, High Catton, York, North Yorkshire, YO41 1EW
	Floor level	Ground Floor
	Room	Farmhouse - Stairwell lobby
	Position	
	Item description	Intrusive inspection
	Condition / damage	
	Surface treatment	
	Product type	
Asbestos Type	No Asbestos Identified	
Extent		
Recommended Action	Disturbance location	
Comments:	Occupant activity	
	Time in area	
	Frequency of use	
Maintenance activity	Accessibility	
Maintenance frequency	Priority assessment score	
Number of occupants	Material assessment score	
Overall assessment score	Risk code

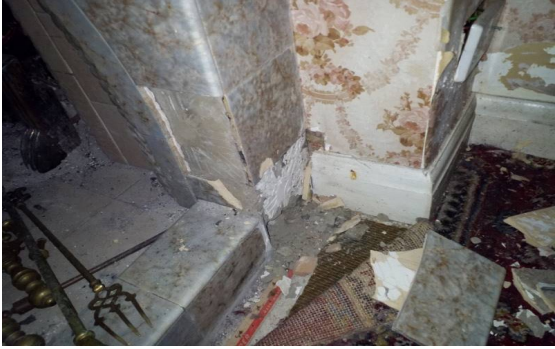
Item Reference	J616986 #26
	Sample reference number	
	Client name	Twenty Five
	Site address	Lodge Farm, High Catton, York, North Yorkshire, YO41 1EW
	Date surveyed	23/06/21
	Date analysed	
	Building	Lodge Farm, High Catton, York, North Yorkshire, YO41 1EW
	Floor level	Ground Floor
	Room	Farmhouse - Reception 2
	Position	
	Item description	Intrusive inspection
	Condition / damage	
	Surface treatment	
	Product type	
Asbestos Type	No Asbestos Identified	
Extent		
Recommended Action	Disturbance location	
Comments:	Occupant activity	
	Time in area	
	Frequency of use	
Maintenance activity	Accessibility	
Maintenance frequency	Priority assessment score	
Number of occupants	Material assessment score	
Overall assessment score	Risk code

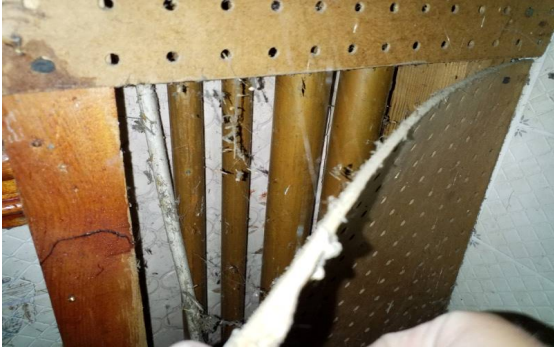
Item Reference	J616986 #27
	Sample reference number	As Sample PC000751
	Client name	Twenty Five
	Site address	Lodge Farm, High Catton, York, North Yorkshire, YO41 1EW
	Date surveyed	23/06/21
	Date analysed	
	Building	Lodge Farm, High Catton, York, North Yorkshire, YO41 1EW
	Floor level	Ground Floor
	Room	Farmhouse - Hallway
	Position	To floor
	Item description	Light green vinyl floor tiles plus adhesives
	Condition / damage	
	Surface treatment	
	Product type	
	Asbestos Type	No Asbestos Detected
Extent		
Recommended Action	None required	Disturbance location
Comments:		Occupant activity
		Time in area
		Frequency of use
		Accessibility
Maintenance activity		Priority assessment score
Maintenance frequency		Material assessment score
Number of occupants		Risk code
Overall assessment score

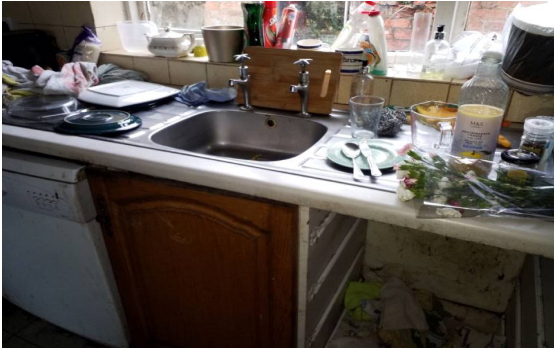
Item Reference	J616986 #29
	Sample reference number	As Sample PC000751
	Client name	Twenty Five
	Site address	Lodge Farm, High Catton, York, North Yorkshire, YO41 1EW
	Date surveyed	23/06/21
	Date analysed	
	Building	Lodge Farm, High Catton, York, North Yorkshire, YO41 1EW
	Floor level	Ground Floor
	Room	Farmhouse - Kitchen
	Position	To floor
	Item description	Light green vinyl floor tiles plus adhesives
	Condition / damage	
	Surface treatment	
	Product type	
	Asbestos Type	No Asbestos Detected
Extent		
Recommended Action	None required	Disturbance location
Comments:		Occupant activity
		Time in area
		Frequency of use
Maintenance activity		Accessibility
Maintenance frequency		Priority assessment score
Number of occupants		Material assessment score
Overall assessment score		Risk code

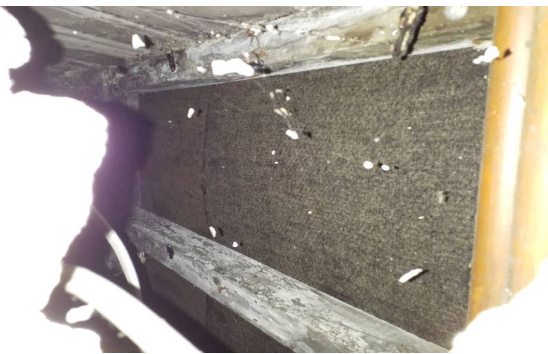
Item Reference	J616986 #30
	Sample reference number	PC000754
	Client name	Twenty Five
	Site address	Lodge Farm, High Catton, York, North Yorkshire, YO41 1EW
	Date surveyed	23/06/21
	Date analysed	June 24 2021
	Building	Lodge Farm, High Catton, York, North Yorkshire, YO41 1EW
	Floor level	Ground Floor
	Room	Farmhouse - Kitchen
	Position	To sink unit
	Item description	Bitumen pad
	Condition / damage	
	Surface treatment	
	Product type	
	Asbestos Type	No Asbestos Detected
Extent		
Recommended Action	None required	Disturbance location
Comments:		Occupant activity
		Time in area
		Frequency of use
Maintenance activity		Accessibility
Maintenance frequency		Priority assessment score
Number of occupants		Material assessment score
Overall assessment score		Risk code

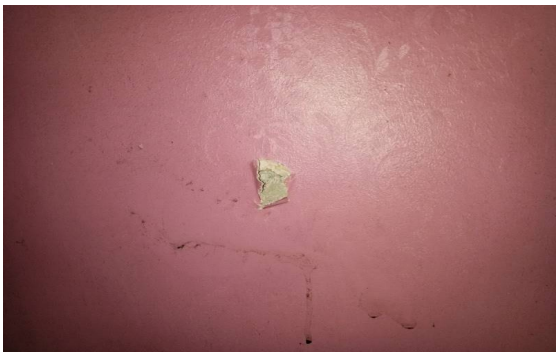
Item Reference	J616986 #31
	Sample reference number	
	Client name	Twenty Five
	Site address	Lodge Farm, High Catton, York, North Yorkshire, YO41 1EW
	Date surveyed	23/06/21
	Date analysed	
	Building	Lodge Farm, High Catton, York, North Yorkshire, YO41 1EW
	Floor level	Ground Floor
	Room	Farmhouse - Kitchen
	Position	
	Item description	Intrusive inspection
	Condition / damage	
	Surface treatment	
	Product type	
	Asbestos Type	No Asbestos Identified
Extent		
Recommended Action	Disturbance location	
Comments:	Occupant activity	
	Time in area	
	Frequency of use	
Maintenance activity	Accessibility	
Maintenance frequency	Priority assessment score	
Number of occupants	Material assessment score	
Overall assessment score	Risk code

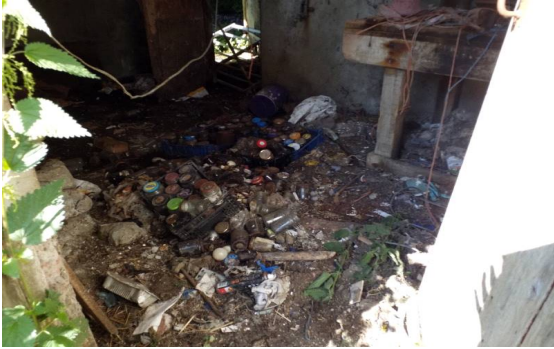
Item Reference	J616986 #39	
	Sample reference number	PC000760	
	Client name	Twenty Five	
	Site address	Lodge Farm, High Catton, York, North Yorkshire, YO41 1EW	
	Date surveyed	23/06/21	
	Date analysed	June 24 2021	
	Building	Lodge Farm, High Catton, York, North Yorkshire, YO41 1EW	
	Floor level	External	
	Room	External areas	
	Position	To floor adjacent to parking spaces

Item description	Cement debris	
	Condition / damage	(3) High Damage	
	Surface treatment	(1) Enclosed sprays and lagging, Sealed AIB, asbestos cement, textured coating, gasket	
	Product type	Asbestos Cement	
Asbestos Type	Chrysotile + Crocidolite		
Extent	1m ²		
Recommended Action	Remove	Disturbance location	External
Comments:	Spread over site	Occupant activity	Low disturbance - (e.g. office type activity)
		Time in area	<1 hour - toilets
		Frequency of use	Daily
Maintenance activity	Minor disturbance - e.g. possibility of contact when gaining access	Accessibility	Low
Maintenance frequency	ACM unlikely to be disturbed for maintenance	Priority assessment score	5
Number of occupants	1 to 3	Material assessment score	8
Overall assessment score	13	Risk code	Risk code E

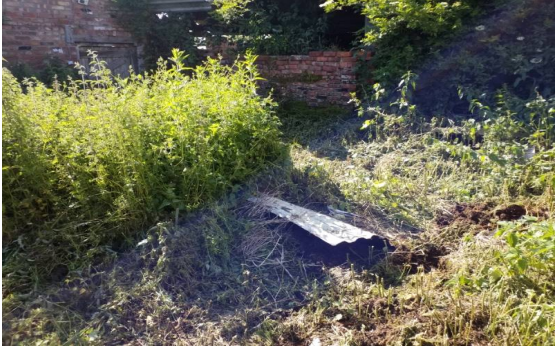
Item Reference	J616986 #40	
	Sample reference number		
	Client name	Twenty Five	
	Site address	Lodge Farm, High Catton, York, North Yorkshire, YO41 1EW	
	Date surveyed	23/06/21	
	Date analysed		
	Building	Lodge Farm, High Catton, York, North Yorkshire, YO41 1EW	
	Floor level	External	
	Room	Agricultural building 3	
	Position	Due to building condition and large amounts of debris on floor	
	Item description	Limited inspection	
	Condition / damage		
	Surface treatment		
	Product type		
Asbestos Type			
Extent			
Recommended Action		Disturbance location	
Comments:		Occupant activity	
		Time in area	
		Frequency of use	
Maintenance activity		Accessibility	
Maintenance frequency		Priority assessment score	
Number of occupants		Material assessment score	
Overall assessment score		Risk code

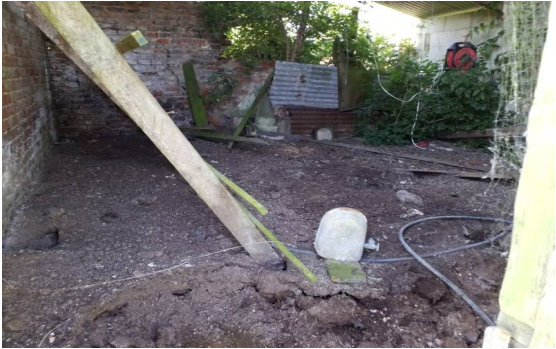
Item Reference	J616986 #41
	Sample reference number	
	Client name	Twenty Five
	Site address	Lodge Farm, High Catton, York, North Yorkshire, YO41 1EW
	Date surveyed	23/06/21
	Date analysed	
	Building	Lodge Farm, High Catton, York, North Yorkshire, YO41 1EW
	Floor level	External
	Room	Agricultural building 4
	Position	Due to building condition and full of debris and vegetation
	Item description	Limited inspection
	Condition / damage	
	Surface treatment	
	Product type	
Asbestos Type		
Extent		
Recommended Action	Disturbance location	
Comments:	Occupant activity	
	Time in area	
	Frequency of use	
Maintenance activity	Accessibility	
Maintenance frequency	Priority assessment score	
Number of occupants	Material assessment score	
Overall assessment score	Risk code

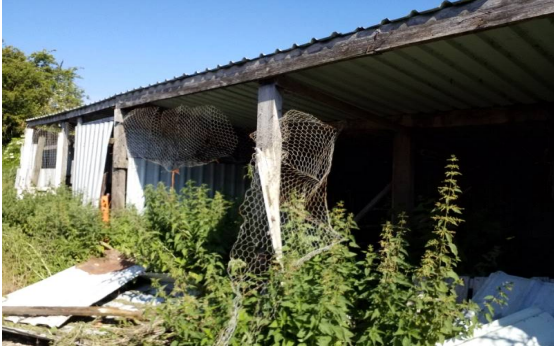
Item Reference	J616986 #42
	Sample reference number	
	Client name	Twenty Five
	Site address	Lodge Farm, High Catton, York, North Yorkshire, YO41 1EW
	Date surveyed	23/06/21
	Date analysed	
	Building	Lodge Farm, High Catton, York, North Yorkshire, YO41 1EW
	Floor level	External
	Room	Agricultural building 5
	Position	Due to building condition and full of debris and vegetation
	Item description	Limited inspection
	Condition / damage	
	Surface treatment	
	Product type	
Asbestos Type		
Extent		
Recommended Action	Disturbance location	
Comments:	Occupant activity	
	Time in area	
	Frequency of use	
Maintenance activity	Accessibility	
Maintenance frequency	Priority assessment score	
Number of occupants	Material assessment score	
Overall assessment score	Risk code

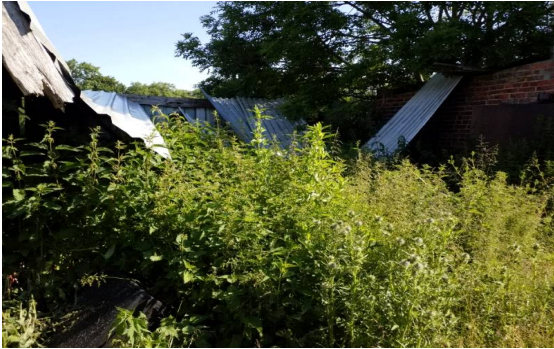
Item Reference	J616986 #43
	Sample reference number	
	Client name	Twenty Five
	Site address	Lodge Farm, High Catton, York, North Yorkshire, YO41 1EW
	Date surveyed	23/06/21
	Date analysed	
	Building	Lodge Farm, High Catton, York, North Yorkshire, YO41 1EW
	Floor level	External
	Room	Agricultural building 6
	Position	Due to building condition and full of debris and vegetation
	Item description	Limited inspection
	Condition / damage	
	Surface treatment	
	Product type	
	Asbestos Type	
Extent		
Recommended Action	Disturbance location	
Comments:	Occupant activity	
	Time in area	
	Frequency of use	
Maintenance activity	Accessibility	
Maintenance frequency	Priority assessment score	
Number of occupants	Material assessment score	
Overall assessment score	Risk code

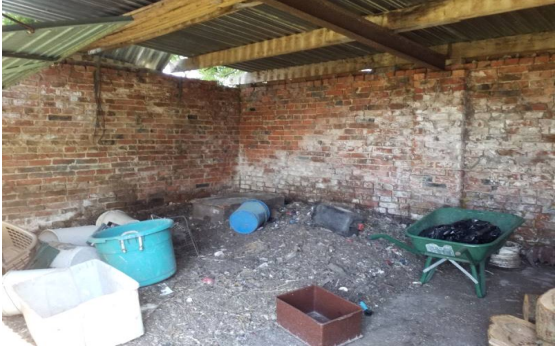
Item Reference	J616986 #44
	Sample reference number	
	Client name	Twenty Five
	Site address	Lodge Farm, High Catton, York, North Yorkshire, YO41 1EW
	Date surveyed	23/06/21
	Date analysed	
	Building	Lodge Farm, High Catton, York, North Yorkshire, YO41 1EW
	Floor level	External
	Room	Agricultural building 7
	Position	Due to building condition and full of debris and vegetation
	Item description	Limited inspection
	Condition / damage	
	Surface treatment	
	Product type	
	Asbestos Type	
Extent		
Recommended Action	Disturbance location	
Comments:	Occupant activity	
	Time in area	
	Frequency of use	
Maintenance activity	Accessibility	
Maintenance frequency	Priority assessment score	
Number of occupants	Material assessment score	
Overall assessment score	Risk code

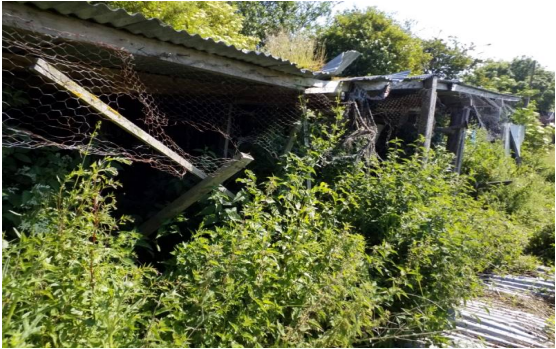
Item Reference	J616986 #45
	Sample reference number	
	Client name	Twenty Five
	Site address	Lodge Farm, High Catton, York, North Yorkshire, YO41 1EW
	Date surveyed	23/06/21
	Date analysed	
	Building	Lodge Farm, High Catton, York, North Yorkshire, YO41 1EW
	Floor level	External
	Room	Agricultural building 8
	Position	Due to full of debris
	Item description	Limited inspection
	Condition / damage	
	Surface treatment	
	Product type	
	Asbestos Type	
Extent		
Recommended Action	Disturbance location	
Comments:	Occupant activity	
	Time in area	
	Frequency of use	
Maintenance activity	Accessibility	
Maintenance frequency	Priority assessment score	
Number of occupants	Material assessment score	
Overall assessment score	Risk code

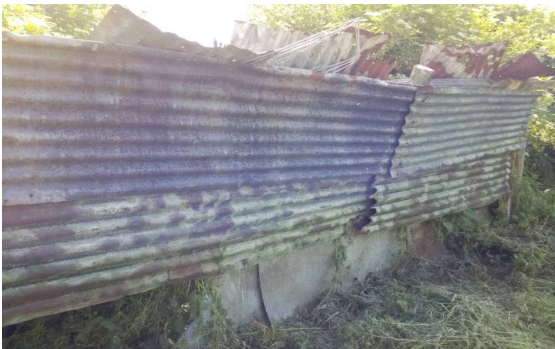
Item Reference	J616986 #49	
	Sample reference number	PC000763	
	Client name	Twenty Five	
	Site address	Lodge Farm, High Catton, York, North Yorkshire, YO41 1EW	
	Date surveyed	23/06/21	
	Date analysed	June 24 2021	
	Building	Lodge Farm, High Catton, York, North Yorkshire, YO41 1EW	
	Floor level	External	
	Room	Agricultural building 9	
	Position	To external walls

Item description	Cement sheets	
	Condition / damage	(1) Low Damage	
	Surface treatment	(1) Enclosed sprays and lagging, Sealed AIB, asbestos cement, textured coating, gasket	
Product type	Asbestos Cement		
Asbestos Type	Chrysotile		
Extent	8m ²		
Recommended Action	Monitor and manage	Disturbance location	External
Comments: One panel seems to be within undergrowth inside building		Occupant activity	Low disturbance - (e.g. office type activity)
		Time in area	<1 hour - toilets
		Frequency of use	Infrequent
Maintenance activity	Minor disturbance - e.g. possibility of contact when gaining access	Accessibility	Low
Maintenance frequency	ACM unlikely to be disturbed for maintenance	Priority assessment score	3
Number of occupants	1 to 3	Material assessment score	4
Overall assessment score	7	Risk code	Risk code E

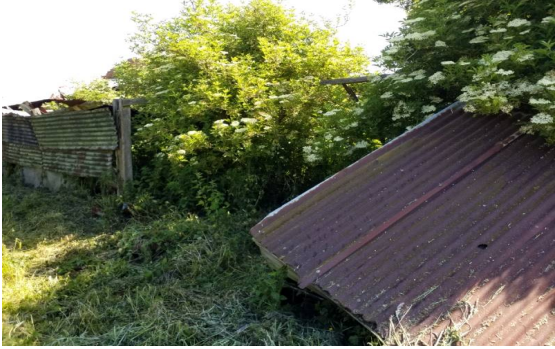
Item Reference	J616986 #50	
	Sample reference number	PC000764	
	Client name	Twenty Five	
	Site address	Lodge Farm, High Catton, York, North Yorkshire, YO41 1EW	
	Date surveyed	23/06/21	
	Date analysed	June 24 2021	
	Building	Lodge Farm, High Catton, York, North Yorkshire, YO41 1EW	
	Floor level	External	
	Room	Agricultural building 10	
	Position	To tin sheets	
	Item description	Galbestos	
	Condition / damage		
	Surface treatment		
Product type			
Asbestos Type	No Asbestos Detected		
Extent			
Recommended Action	None required	Disturbance location	
Comments: Some are in undergrowth in the close area		Occupant activity	
		Time in area	
		Frequency of use	
Maintenance activity		Accessibility	
Maintenance frequency		Priority assessment score	
Number of occupants		Material assessment score	
Overall assessment score		Risk code

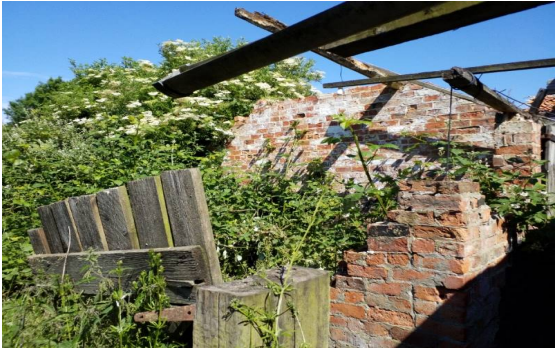
Item Reference	J616986 #51
	Sample reference number	
	Client name	Twenty Five
	Site address	Lodge Farm, High Catton, York, North Yorkshire, YO41 1EW
	Date surveyed	23/06/21
	Date analysed	
	Building	Lodge Farm, High Catton, York, North Yorkshire, YO41 1EW
	Floor level	External
	Room	Agricultural building 10
	Position	Due to building condition and full of debris and vegetation
	Item description	Limited inspection
	Condition / damage	
	Surface treatment	
	Product type	
Asbestos Type		
Extent		
Recommended Action	Disturbance location	
Comments:	Occupant activity	
	Time in area	
	Frequency of use	
Maintenance activity	Accessibility	
Maintenance frequency	Priority assessment score	
Number of occupants	Material assessment score	
Overall assessment score	Risk code

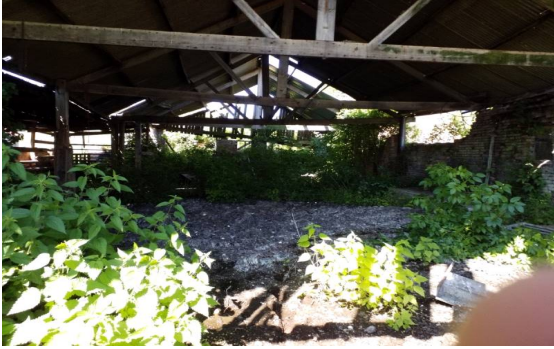
Item Reference	J616986 #52
	Sample reference number	
	Client name	Twenty Five
	Site address	Lodge Farm, High Catton, York, North Yorkshire, YO41 1EW
	Date surveyed	23/06/21
	Date analysed	
	Building	Lodge Farm, High Catton, York, North Yorkshire, YO41 1EW
	Floor level	External
	Room	Agricultural building 11
	Position	Due to building condition and full of debris and vegetation
	Item description	Limited inspection
	Condition / damage	
	Surface treatment	
	Product type	
Asbestos Type		
Extent		
Recommended Action	Disturbance location	
Comments:	Occupant activity	
	Time in area	
	Frequency of use	
Maintenance activity	Accessibility	
Maintenance frequency	Priority assessment score	
Number of occupants	Material assessment score	
Overall assessment score	Risk code

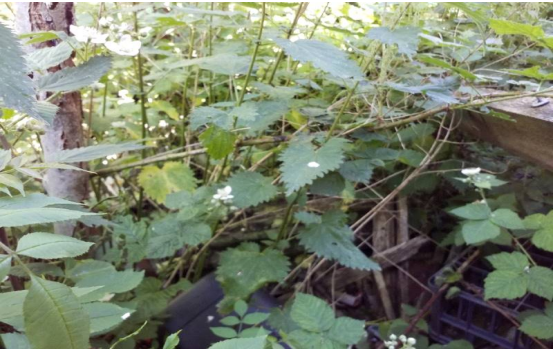
Item Reference	J616986 #54		
	Sample reference number	PC000765		
	Client name	Twenty Five		
	Site address	Lodge Farm, High Catton, York, North Yorkshire, YO41 1EW		
	Date surveyed	23/06/21		
	Date analysed	June 24 2021		
	Building	Lodge Farm, High Catton, York, North Yorkshire, YO41 1EW		
	Floor level	External		
	Room	Covered yard		
	Position	To floor to rear right hand side adjacent concrete ramp

Item description	Cement debris		
	Condition / damage	(3) High Damage		
	Surface treatment	(1) Enclosed sprays and lagging, Sealed AIB, asbestos cement, textured coating, gasket		
	Product type	Asbestos Cement		
Asbestos Type	Chrysotile + Crocidolite			
Extent	1m ²			
Recommended Action	Remove	Disturbance location	Rooms up to 100m ²	
Comments:	Spread over unit		Occupant activity	Low disturbance - (e.g. office type activity)
			Time in area	<1 hour - toilets
			Frequency of use	Infrequent
Maintenance activity	Minor disturbance - e.g. possibility of contact when gaining access	Accessibility	Low	
Maintenance frequency	ACM unlikely to be disturbed for maintenance	Priority assessment score	4	
Number of occupants	1 to 3	Material assessment score	8	
Overall assessment score	12	Risk code	Risk code E

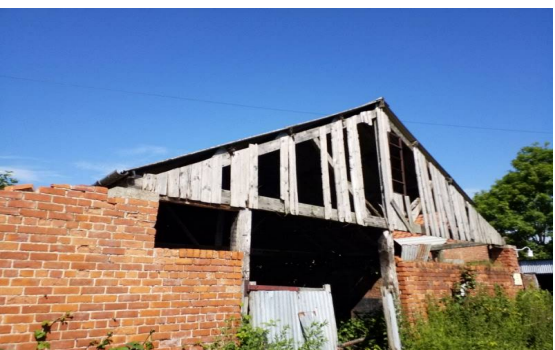
Item Reference	J616986 #55	
	Sample reference number	PC000766	
	Client name	Twenty Five	
	Site address	Lodge Farm, High Catton, York, North Yorkshire, YO41 1EW	
	Date surveyed	23/06/21	
	Date analysed	June 24 2021	
	Building	Lodge Farm, High Catton, York, North Yorkshire, YO41 1EW	
	Floor level	External	
	Room	Covered yard	
	Position	To front left hand side adjacent garage area

Item description	Cement debris	
	Condition / damage	(3) High Damage	
	Surface treatment	(1) Enclosed sprays and lagging, Sealed AIB, asbestos cement, textured coating, gasket	
	Product type	Asbestos Cement	
	Asbestos Type	Chrysotile + Crocidolite	
Extent	1m ²		
Recommended Action	Remove	Disturbance location	External
Comments: Spread over 30m ²		Occupant activity	Low disturbance - (e.g. office type activity)
		Time in area	<1 hour - toilets
		Frequency of use	Infrequent
Maintenance activity	Minor disturbance - e.g. possibility of contact when gaining access	Accessibility	Low
Maintenance frequency	ACM unlikely to be disturbed for maintenance	Priority assessment score	3
Number of occupants	1 to 3	Material assessment score	8
Overall assessment score	11	Risk code	Risk code E

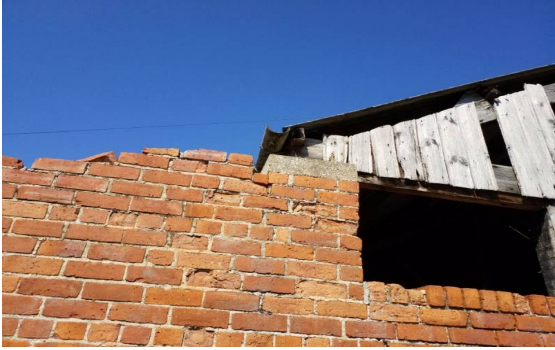
Item Reference	J616986 #56	
	Sample reference number	PC000767	
	Client name	Twenty Five	
	Site address	Lodge Farm, High Catton, York, North Yorkshire, YO41 1EW	
	Date surveyed	23/06/21	
	Date analysed	June 24 2021	
	Building	Lodge Farm, High Catton, York, North Yorkshire, YO41 1EW	
	Floor level	External	
	Room	Covered yard	
	Position	To roof

Item description	Cement roof	
	Condition / damage	(1) Low Damage	
	Surface treatment	(1) Enclosed sprays and lagging, Sealed AIB, asbestos cement, textured coating, gasket	
	Product type	Asbestos Cement	
	Asbestos Type	Chrysotile + Crocidolite	
Extent	300m ²		
Recommended Action	Remove	Disturbance location	External
Comments: A few small pieces have slipped and are laying on top of the adjacent tin roof and require removal, the remainder of the material can be managed in situ.		Occupant activity	Low disturbance - (e.g. office type activity)
		Time in area	<1 hour - toilets
		Frequency of use	Infrequent
Maintenance activity	Minor disturbance - e.g. possibility of contact when gaining access	Accessibility	Low
Maintenance frequency	ACM unlikely to be disturbed for maintenance	Priority assessment score	4
Number of occupants	1 to 3	Material assessment score	6
Overall assessment score	10	Risk code	Risk code E

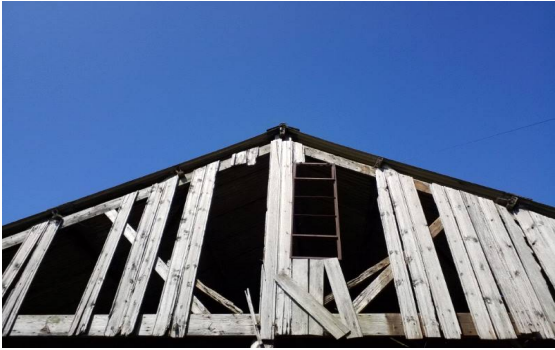
Item Reference	J616986 #57	
	Sample reference number	PC000768	
	Client name	Twenty Five	
	Site address	Lodge Farm, High Catton, York, North Yorkshire, YO41 1EW	
	Date surveyed	23/06/21	
	Date analysed	June 24 2021	
	Building	Lodge Farm, High Catton, York, North Yorkshire, YO41 1EW	
	Floor level	External	
	Room	Covered yard	
	Position	To eaves of roof

Item description	Cement gutter	
	Condition / damage	(1) Low Damage	
	Surface treatment	(1) Enclosed sprays and lagging, Sealed AIB, asbestos cement, textured coating, gasket	
Product type	Asbestos Cement		
Asbestos Type	Chrysotile		
Extent	10lm		
Recommended Action	Monitor and manage	Disturbance location	External
Comments:		Occupant activity	Low disturbance - (e.g. office type activity)
		Time in area	<1 hour - toilets
		Frequency of use	Infrequent
Maintenance activity	Minor disturbance - e.g. possibility of contact when gaining access	Accessibility	Low
Maintenance frequency	ACM unlikely to be disturbed for maintenance	Priority assessment score	3
Number of occupants	1 to 3	Material assessment score	4
Overall assessment score	7	Risk code	Risk code E

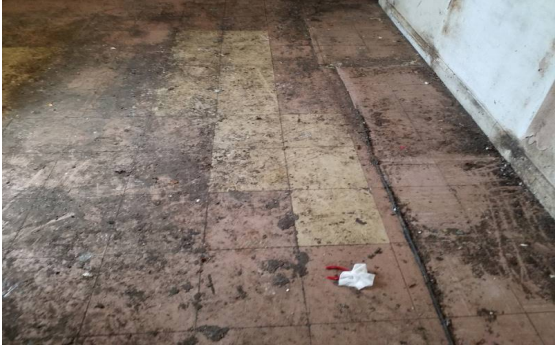
Item Reference	J616986 #59
	Sample reference number	PC000770
	Client name	Twenty Five
	Site address	Lodge Farm, High Catton, York, North Yorkshire, YO41 1EW
	Date surveyed	23/06/21
	Date analysed	June 24 2021
	Building	Lodge Farm, High Catton, York, North Yorkshire, YO41 1EW
	Floor level	External
	Room	Garage 1
	Position	To floor
	Item description	Pink vinyl floor tiles
	Condition / damage	
	Surface treatment	
	Product type	
Asbestos Type	No Asbestos Detected	
Extent		
Recommended Action	None required	Disturbance location
Comments:		Occupant activity
		Time in area
		Frequency of use
Maintenance activity		Accessibility
Maintenance frequency		Priority assessment score
Number of occupants		Material assessment score
Overall assessment score		Risk code

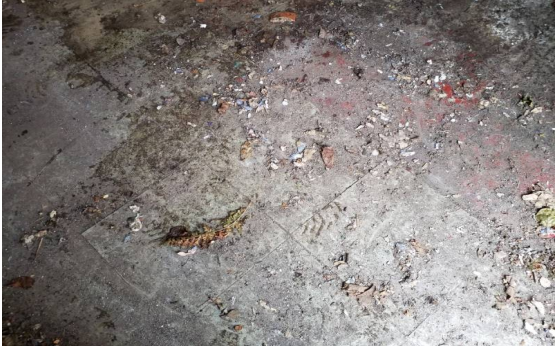
Item Reference	J616986 #62
	Sample reference number	PC000773
	Client name	Twenty Five
	Site address	Lodge Farm, High Catton, York, North Yorkshire, YO41 1EW
	Date surveyed	23/06/21
	Date analysed	June 24 2021
	Building	Lodge Farm, High Catton, York, North Yorkshire, YO41 1EW
	Floor level	External
	Room	Garage addition
	Position	To floor
	Item description	Light brown vinyl floor tiles
	Condition / damage	
	Surface treatment	
	Product type	
Asbestos Type	No Asbestos Detected	
Extent		
Recommended Action	None required	Disturbance location
Comments:		Occupant activity
		Time in area
		Frequency of use
		Accessibility
Maintenance activity		Priority assessment score
Maintenance frequency		Material assessment score
Number of occupants		Risk code
Overall assessment score

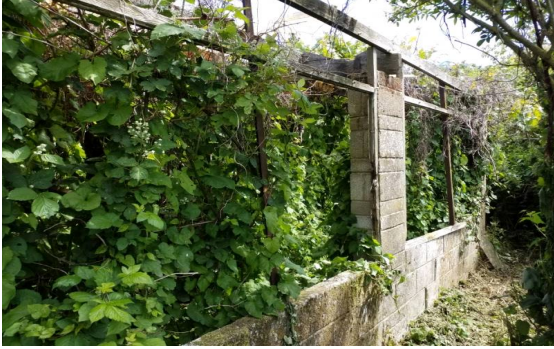
Item Reference	J616986 #64
	Sample reference number	PC000775
	Client name	Twenty Five
	Site address	Lodge Farm, High Catton, York, North Yorkshire, YO41 1EW
	Date surveyed	23/06/21
	Date analysed	June 24 2021
	Building	Lodge Farm, High Catton, York, North Yorkshire, YO41 1EW
	Floor level	External
	Room	Garage 2
	Position	To windows
	Item description	Mastic
	Condition / damage	
	Surface treatment	
	Product type	
	Asbestos Type	No Asbestos Detected
Extent		
Recommended Action	None required	Disturbance location
Comments:		Occupant activity
		Time in area
		Frequency of use
		Accessibility
Maintenance activity		Priority assessment score
Maintenance frequency		Material assessment score
Number of occupants		Risk code
Overall assessment score

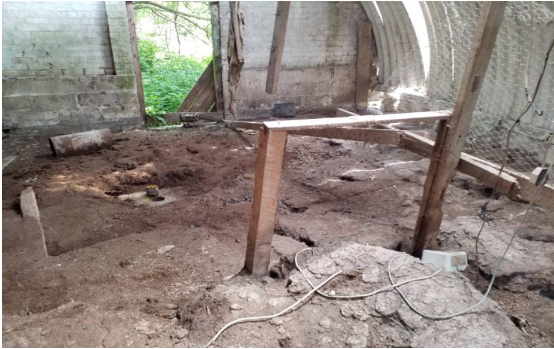
Item Reference	J616986 #65
	Sample reference number	
	Client name	Twenty Five
	Site address	Lodge Farm, High Catton, York, North Yorkshire, YO41 1EW
	Date surveyed	23/06/21
	Date analysed	
	Building	Lodge Farm, High Catton, York, North Yorkshire, YO41 1EW
	Floor level	External
	Room	Garage 2
	Position	Due to building condition and full of debris and vegetation
	Item description	Limited inspection
	Condition / damage	
	Surface treatment	
	Product type	
Asbestos Type		
Extent		
Recommended Action	Disturbance location	
Comments:	Occupant activity	
	Time in area	
	Frequency of use	
Maintenance activity	Accessibility	
Maintenance frequency	Priority assessment score	
Number of occupants	Material assessment score	
Overall assessment score	Risk code

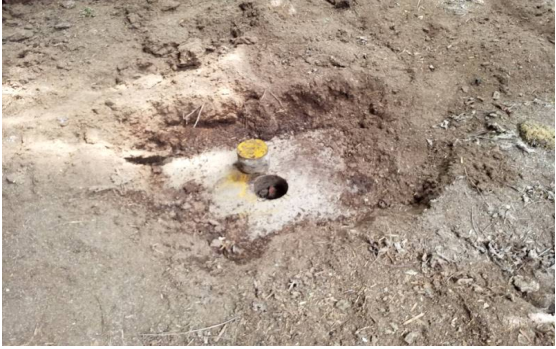
Item Reference	J616986 #66
	Sample reference number	
	Client name	Twenty Five
	Site address	Lodge Farm, High Catton, York, North Yorkshire, YO41 1EW
	Date surveyed	23/06/21
	Date analysed	
	Building	Lodge Farm, High Catton, York, North Yorkshire, YO41 1EW
	Floor level	External
	Room	Agricultural building 2
	Position	Due to building condition and full of debris and vegetation
	Item description	Limited inspection
	Condition / damage	
	Surface treatment	
	Product type	
Asbestos Type		
Extent		
Recommended Action	Disturbance location	
Comments:	Occupant activity	
	Time in area	
	Frequency of use	
Maintenance activity	Accessibility	
Maintenance frequency	Priority assessment score	
Number of occupants	Material assessment score	
Overall assessment score	Risk code

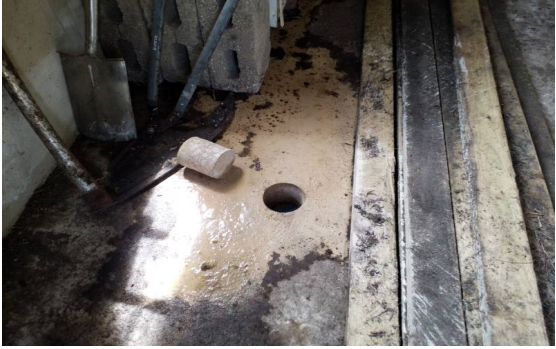
Item Reference	J616986 #67
	Sample reference number	
	Client name	Twenty Five
	Site address	Lodge Farm, High Catton, York, North Yorkshire, YO41 1EW
	Date surveyed	23/06/21
	Date analysed	
	Building	Lodge Farm, High Catton, York, North Yorkshire, YO41 1EW
	Floor level	External
	Room	Agricultural building 2
	Position	Floor slab
	Item description	Core inspection
	Condition / damage	
	Surface treatment	
	Product type	
Asbestos Type		
Extent		
Recommended Action	Disturbance location	
Comments:	Occupant activity	
	Time in area	
	Frequency of use	
Maintenance activity	Accessibility	
Maintenance frequency	Priority assessment score	
Number of occupants	Material assessment score	
Overall assessment score	Risk code

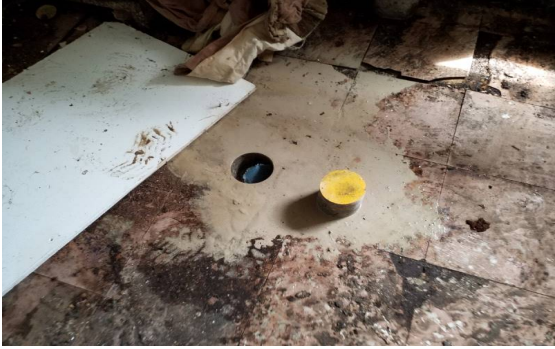
Item Reference	J616986 #68
	Sample reference number	
	Client name	Twenty Five
	Site address	Lodge Farm, High Catton, York, North Yorkshire, YO41 1EW
	Date surveyed	23/06/21
	Date analysed	
	Building	Lodge Farm, High Catton, York, North Yorkshire, YO41 1EW
	Floor level	External
	Room	Workshop
	Position	Floor slab
	Item description	Core inspection
	Condition / damage	
	Surface treatment	
	Product type	
Asbestos Type		
Extent		
Recommended Action	Disturbance location	
Comments:	Occupant activity	
	Time in area	
	Frequency of use	
Maintenance activity	Accessibility	
Maintenance frequency	Priority assessment score	
Number of occupants	Material assessment score	
Overall assessment score	Risk code

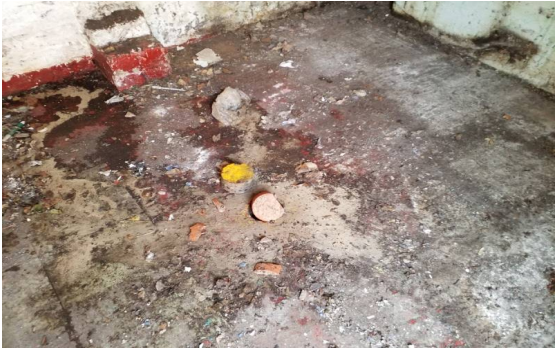
Item Reference	J616986 #69
	Sample reference number	
	Client name	Twenty Five
	Site address	Lodge Farm, High Catton, York, North Yorkshire, YO41 1EW
	Date surveyed	23/06/21
	Date analysed	
	Building	Lodge Farm, High Catton, York, North Yorkshire, YO41 1EW
	Floor level	External
	Room	Garage 1
	Position	2 cores to Floor slab
	Item description	Core inspection
	Condition / damage	
	Surface treatment	
	Product type	
Asbestos Type		
Extent		
Recommended Action	Disturbance location	
Comments:	Occupant activity	
	Time in area	
	Frequency of use	
Maintenance activity	Accessibility	
Maintenance frequency	Priority assessment score	
Number of occupants	Material assessment score	
Overall assessment score	Risk code

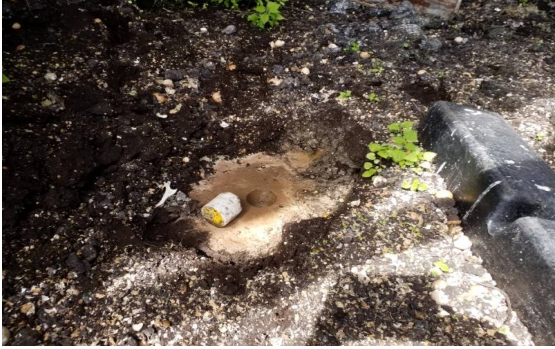
Item Reference	J616986 #70
	Sample reference number	
	Client name	Twenty Five
	Site address	Lodge Farm, High Catton, York, North Yorkshire, YO41 1EW
	Date surveyed	23/06/21
	Date analysed	
	Building	Lodge Farm, High Catton, York, North Yorkshire, YO41 1EW
	Floor level	External
	Room	Garage addition
	Position	2 core holes to floor slab
	Item description	Core inspection
	Condition / damage	
	Surface treatment	
	Product type	
Asbestos Type		
Extent		
Recommended Action	Disturbance location	
Comments:	Occupant activity	
	Time in area	
	Frequency of use	
Maintenance activity	Accessibility	
Maintenance frequency	Priority assessment score	
Number of occupants	Material assessment score	
Overall assessment score	Risk code

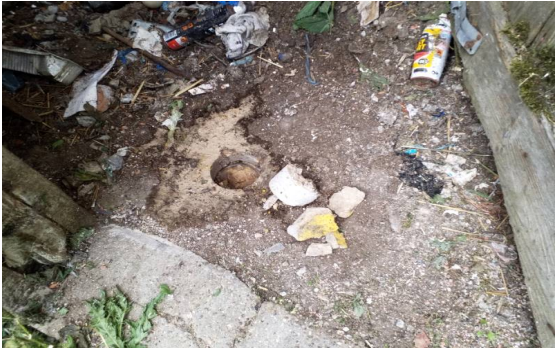
Item Reference	J616986 #71
	Sample reference number	
	Client name	Twenty Five
	Site address	Lodge Farm, High Catton, York, North Yorkshire, YO41 1EW
	Date surveyed	23/06/21
	Date analysed	
	Building	Lodge Farm, High Catton, York, North Yorkshire, YO41 1EW
	Floor level	External
	Room	Covered yard
	Position	Floor slab
	Item description	Core inspection
	Condition / damage	
	Surface treatment	
	Product type	
Asbestos Type		
Extent		
Recommended Action	Disturbance location	
Comments:	Occupant activity	
	Time in area	
	Frequency of use	
Maintenance activity	Accessibility	
Maintenance frequency	Priority assessment score	
Number of occupants	Material assessment score	
Overall assessment score	Risk code

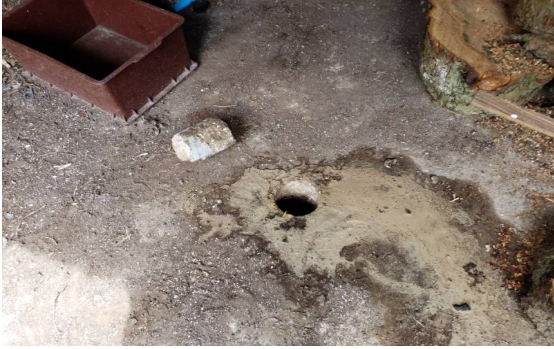
Item Reference	J616986 #72
	Sample reference number	
	Client name	Twenty Five
	Site address	Lodge Farm, High Catton, York, North Yorkshire, YO41 1EW
	Date surveyed	23/06/21
	Date analysed	
	Building	Lodge Farm, High Catton, York, North Yorkshire, YO41 1EW
	Floor level	External
	Room	Agricultural building 3
	Position	Floor slab
	Item description	Core inspection
	Condition / damage	
	Surface treatment	
	Product type	
Asbestos Type		
Extent		
Recommended Action	Disturbance location	
Comments:	Occupant activity	
	Time in area	
	Frequency of use	
Maintenance activity	Accessibility	
Maintenance frequency	Priority assessment score	
Number of occupants	Material assessment score	
Overall assessment score	Risk code

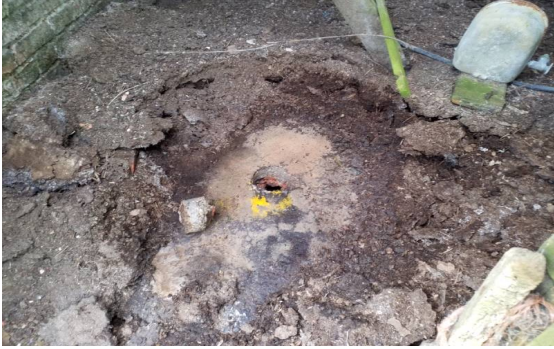
Item Reference	J616986 #73
	Sample reference number	
	Client name	Twenty Five
	Site address	Lodge Farm, High Catton, York, North Yorkshire, YO41 1EW
	Date surveyed	23/06/21
	Date analysed	
	Building	Lodge Farm, High Catton, York, North Yorkshire, YO41 1EW
	Floor level	External
	Room	Agricultural building 8
	Position	Floor slab
	Item description	Core inspection
	Condition / damage	
	Surface treatment	
	Product type	
Asbestos Type		
Extent		
Recommended Action	Disturbance location	
Comments:	Occupant activity	
	Time in area	
	Frequency of use	
Maintenance activity	Accessibility	
Maintenance frequency	Priority assessment score	
Number of occupants	Material assessment score	
Overall assessment score	Risk code
