ASBESTOS REFURBISHMENT SURVEY

Client	Twenty Five
Site	Lodge Farm, High Catton, York, North Yorkshire, YO41 1EW
Date started	23 Jun 2021
Date completed	23 Jun 2021
Date report issued	25 Jun 2021
Survey reference	J616986
Lead surveyor	Adam Martin
Assistant surveyor	N/A
UPRN	N/A

ASBESTOS SURVEY OF LODGE FARM, HIGH CATTON, YORK, NORTH YORKSHIRE

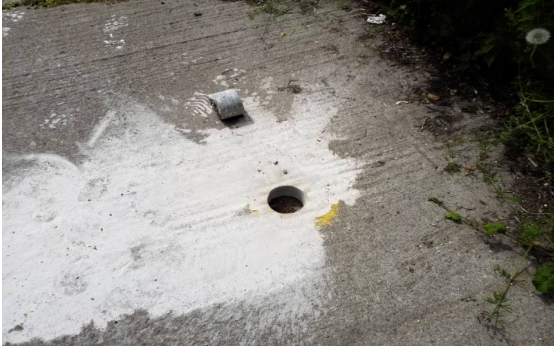
Item Reference	J616986 #74
	Sample reference number	
	Client name	Twenty Five
	Site address	Lodge Farm, High Catton, York, North Yorkshire, YO41 1EW
	Date surveyed	23/06/21
	Date analysed	
	Building	Lodge Farm, High Catton, York, North Yorkshire, YO41 1EW
	Floor level	External
	Room	Agricultural building 5
	Position	Floor slab
	Item description	Core inspection
	Condition / damage	
	Surface treatment	
	Product type	
Asbestos Type		
Extent		
Recommended Action	Disturbance location	
Comments:	Occupant activity	
	Time in area	
	Frequency of use	
Maintenance activity	Accessibility	
Maintenance frequency	Priority assessment score	
Number of occupants	Material assessment score	
Overall assessment score	Risk code
