BAT PRESENCE / ABSENCE SURVEY

Land off Cropper Road

Blackpool

UES reference: UES03391/04

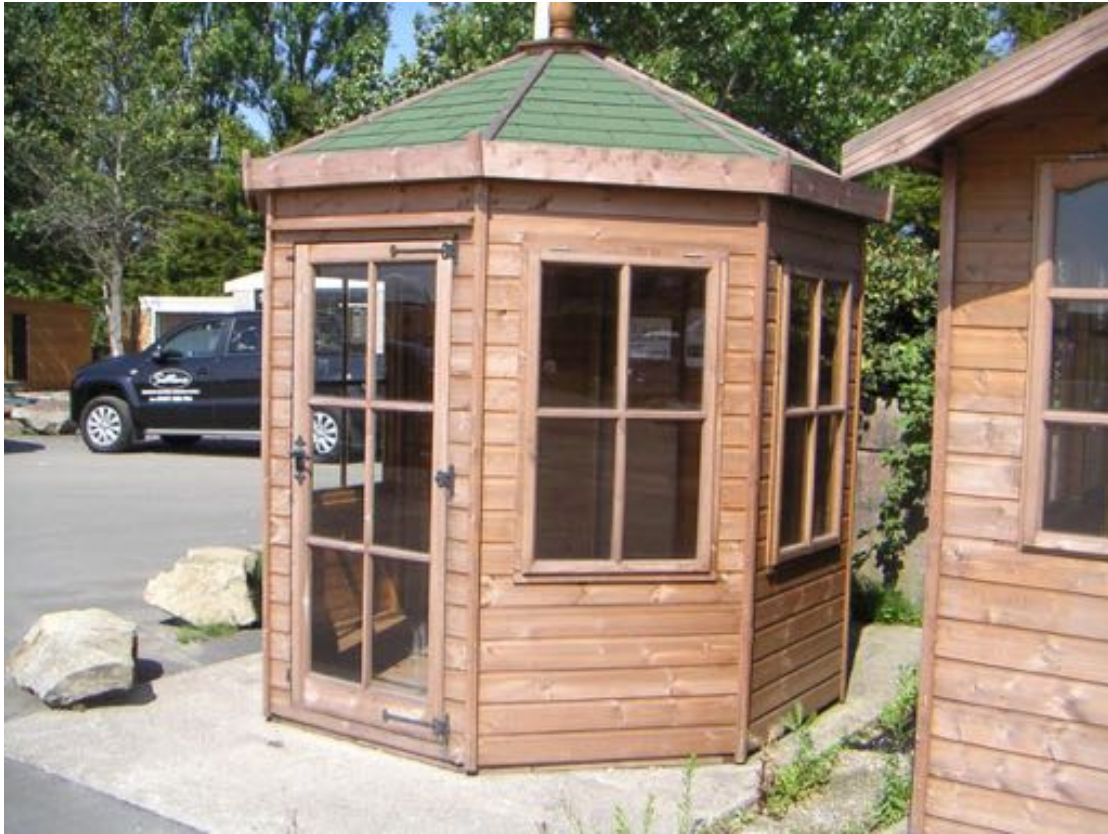
Buildings 3 and 4 are wooden summer houses which are currently on sale. Building 3 is similar to Building 1 in design and construction, but approximately 3m x 4m (Photo 4). Building 4 is a hexagon shaped shed constructed from wood with decorative bitumen felt roof tiles (Photo 5). The buildings are in excellent condition, with no suitable PRFs for bats. Furthermore, the buildings are located within the eastern section of the site and this area is extremely well lit with large floodlights, further reducing the suitability of the building for roosting bats.

Photo 5 – Southern aspect of Building 4.

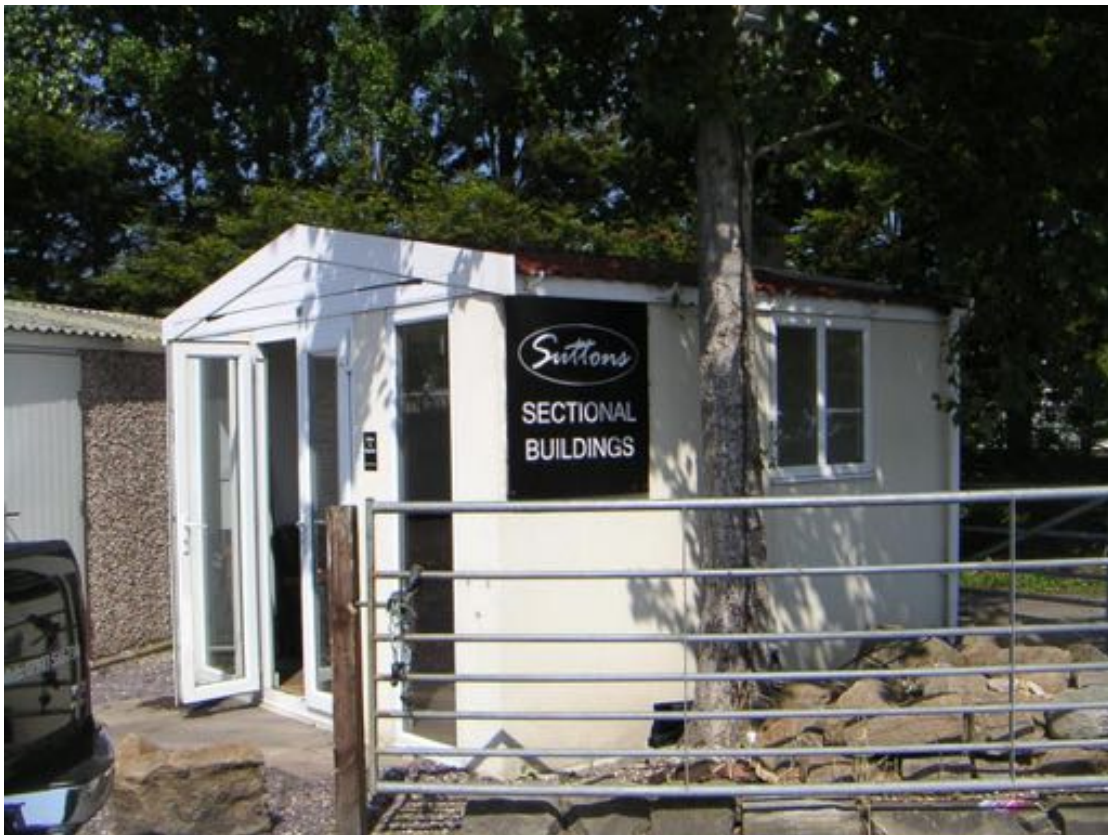
Buildings 5, 6 and 7 are concrete garages and garden rooms which are currently on display (Photos 6, 7 and 8). The buildings are pre-fabricated and constructed from concrete which has been rendered. The roofs are pitched and constructed from corrugated metal sheeting. There are plastic barge boards present on all aspects of the buildings, all of which are tightly sealed. The two garage buildings have metal roller shutter doors, while the garden room has UPVC doors and windows. Overall, the buildings are in excellent condition with no PRFs noted. Furthermore, the buildings are located within the eastern section of the site and this area is extremely well lit with large floodlights, further reducing the suitability of the building for roosting bats.

Photo 6 – Southern and eastern aspects of Building 5.

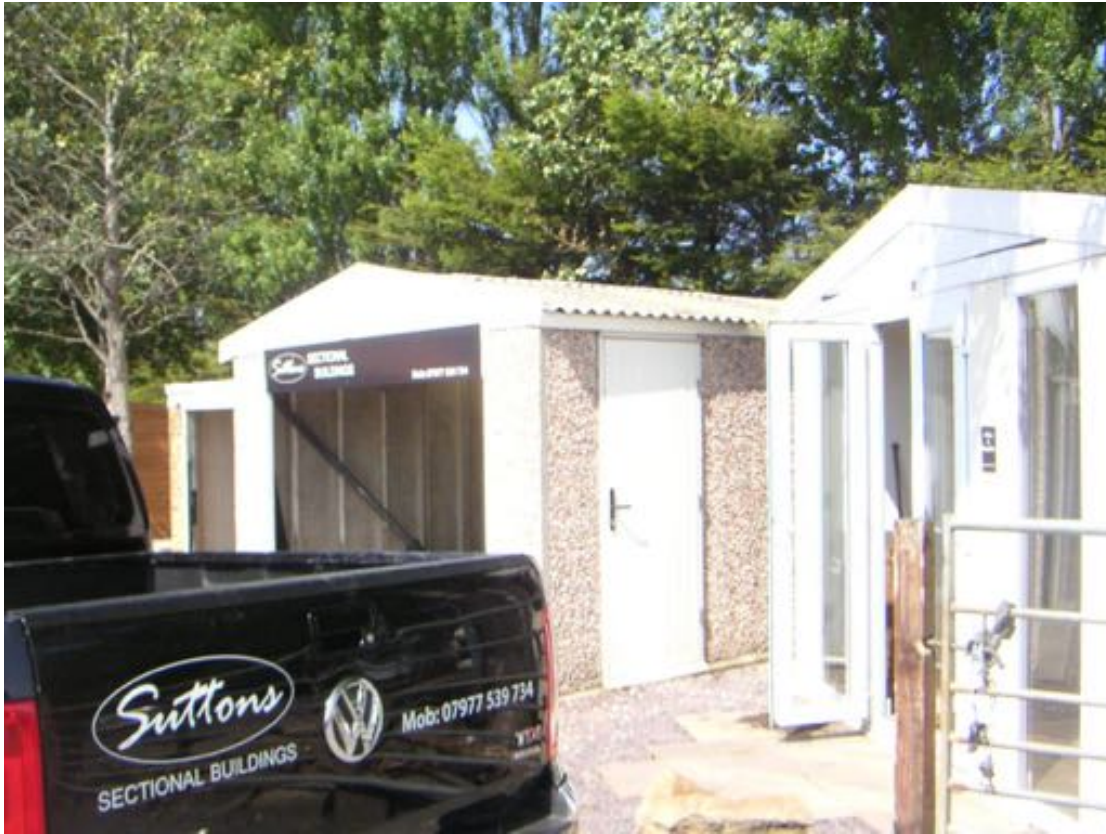
Photo 7 – Southern aspects of Building 5, 6 and 7.

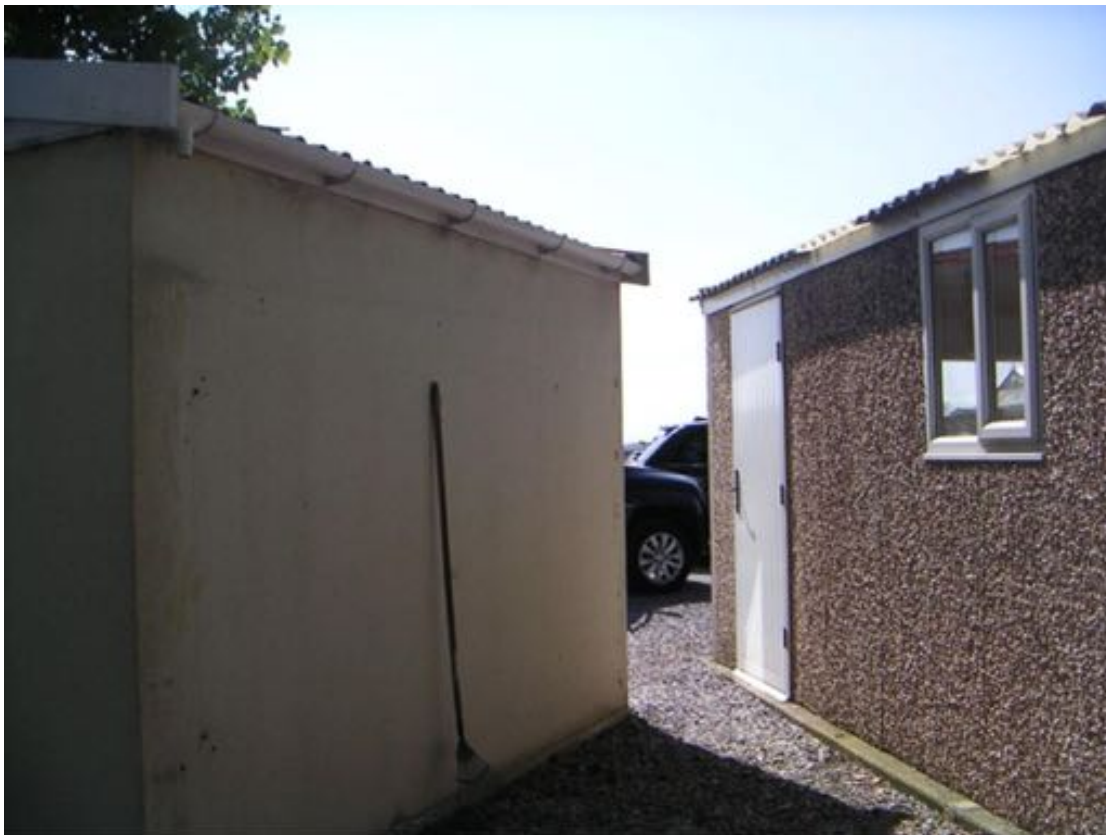
Photo 8 – Northern aspects of Building 5 and 6.

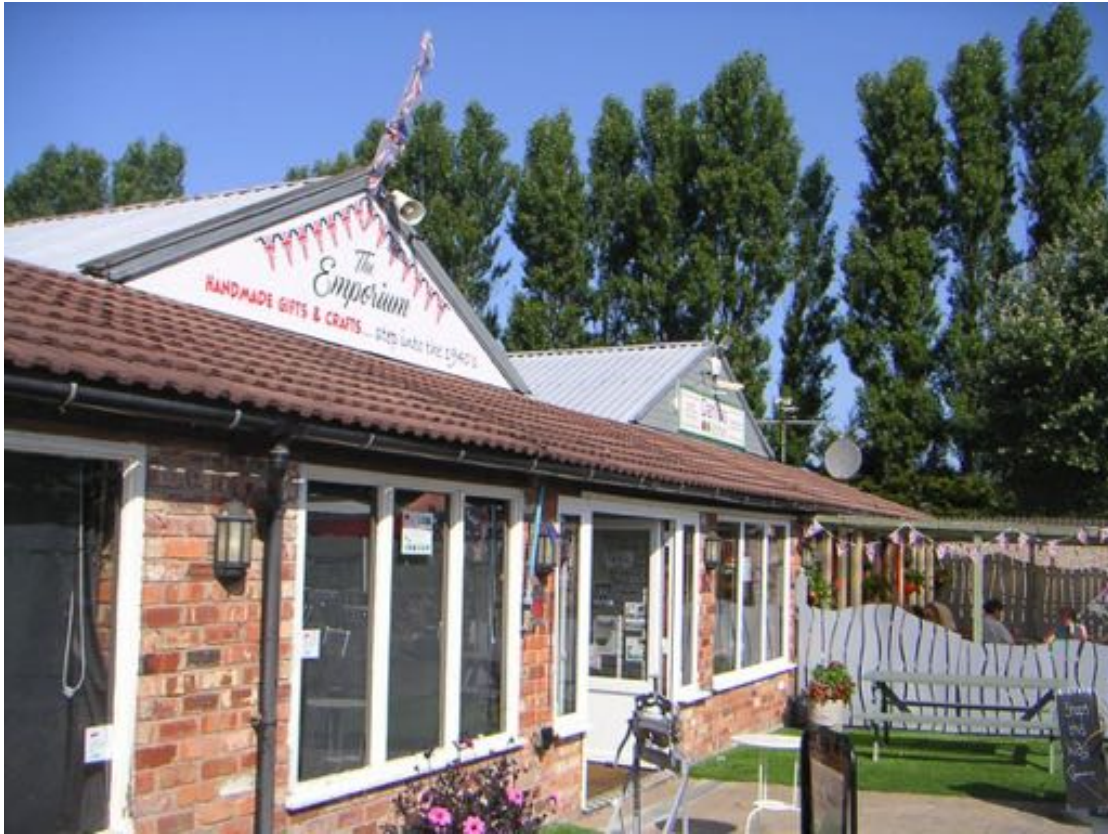
Building 10 is constructed from a mixture of brick and breeze block. The building has three pitched roofs, which are clad with corrugated metal sheeting (Photo 15). The most southern roof is constructed from plastic sheeting and metal poles, to form a polytunnel style roof (Photo 16). The walls on the western aspect are clad with wooden timber cladding (Photo 17), which is tightly sealed and in excellent condition. There is a single storey extension on the eastern aspect of the building. The extension has a mono-pitched roof which is clad with concrete, inter-locking tiles which are in excellent condition and tightly sealed. The walls of the building are in excellent condition with no PRFs noted. The eastern aspect of the building is extremely well-lit due to the presence of large floodlights within the adjacent car park, further reducing its suitability for use by roosting bats.

Photo 15 – Eastern aspect of Building 10.

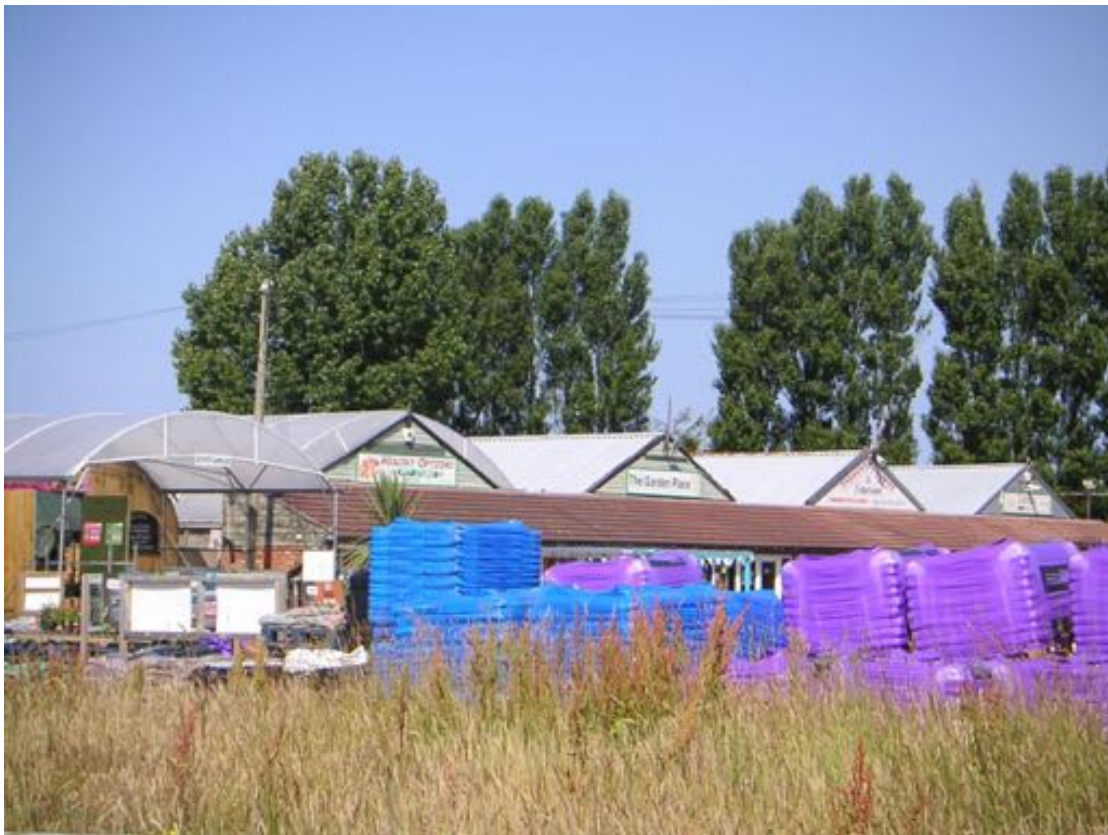
Photo 16 – Eastern aspect of Building 10.

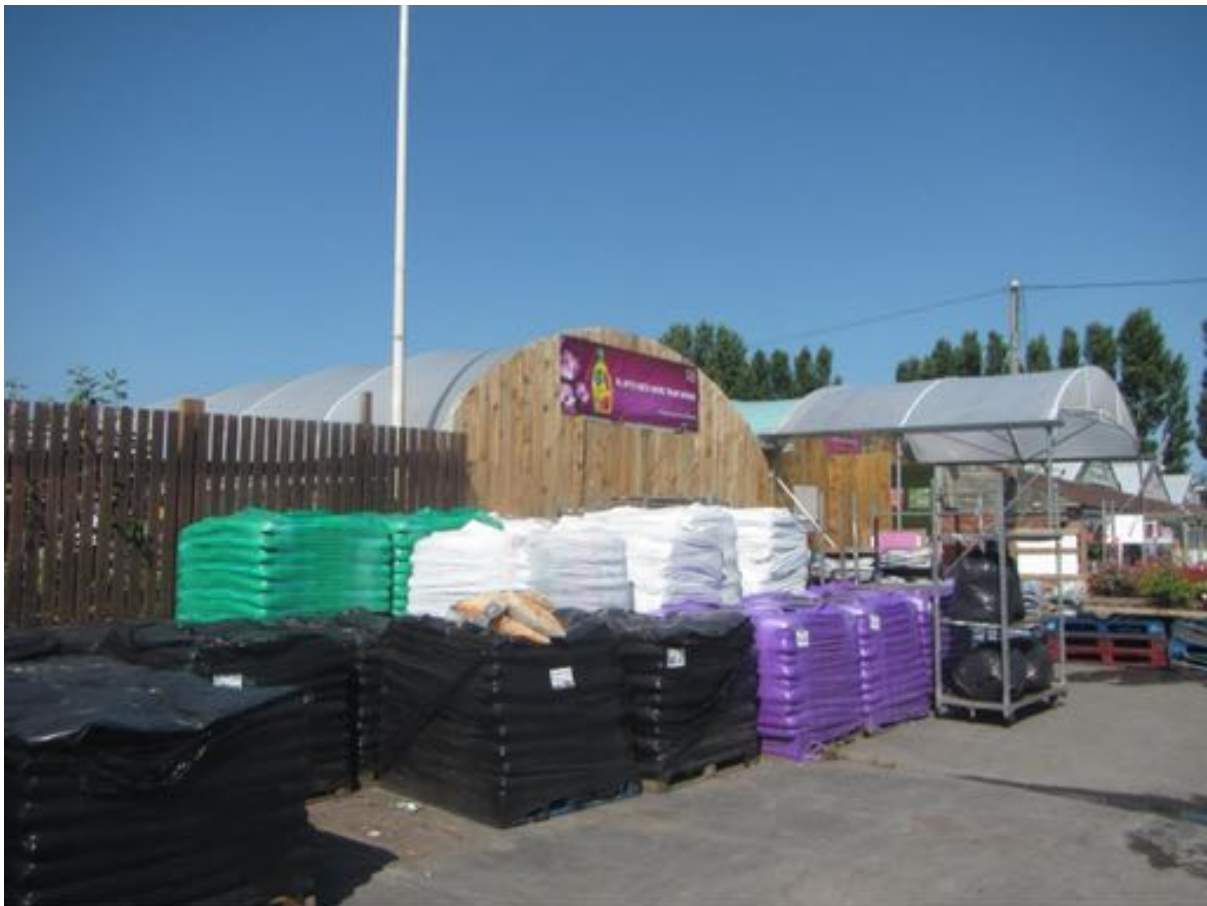
Building 11 is a garden centre, attached to the southern aspect of Building 10. The two roofs are constructed from plastic sheeting and metal poles, to form polytunnel style roofs (Photos 18 and 19). The eastern and western aspects have wooden timber walls, which are in excellent condition. The northern and southern aspects are constructed from metal poles and either glass or plastic. The building is in excellent condition with no PRFs noted.

Photo 18 – Eastern aspect of Building 11.

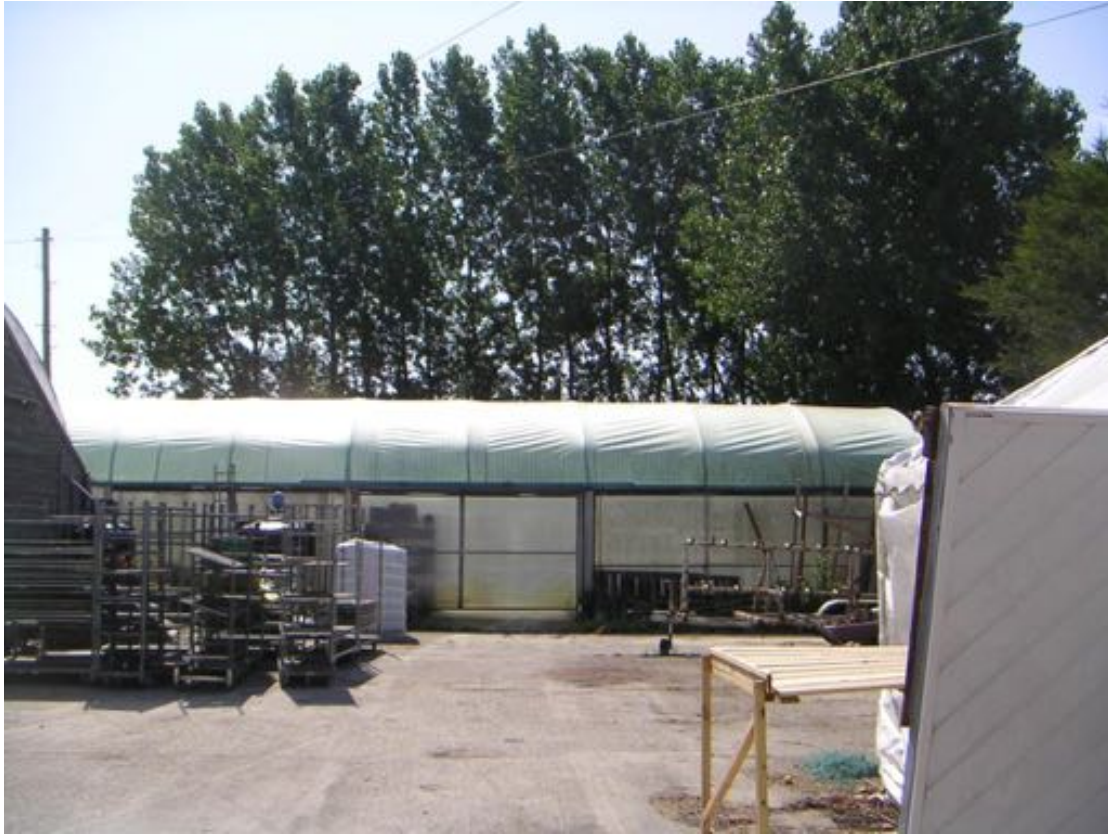
Photo 19 – Northern aspect of Building 11.

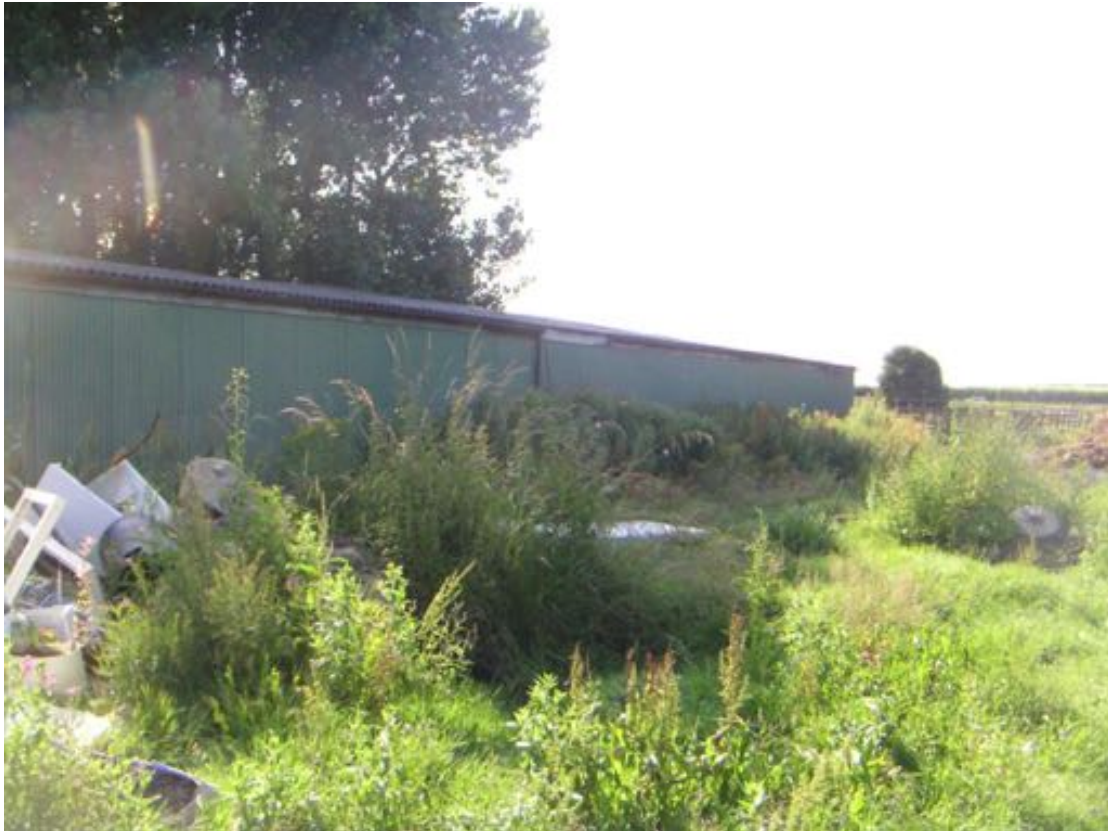
Building 12 is a single storey horse stables located within the western section of the site. The building is currently used to house horses and as such, is subject to regular disturbance. The building is constructed from a timber frame with corrugated metal exteriors, see Photo 20 and 21. The roof is lined with a mixture of wooden cladding and corrugated asbestos sheets, some of which are slightly lifted. As such, there are small cavities between the wooden cladding and corrugated asbestos sheets. These gaps provide some roosting opportunities for bats, however the roosting potential of these features is limited due to their small size, the exposure to light and frequent disturbance. There is bitumen flashing present on the southern aspect of the building which is slightly lifted and will provide opportunities for a small number of bats to roost occasionally. Furthermore, there are wooden barge boards present on the western aspect of the building which are slightly lifted; these were fully inspected with a high powered torch and no evidence of roosting bats was recorded. The eastern aspect of the building is open fronted with large open doorways and windows, allowing access into the internal areas of the building (Photo 22).

Photo 20 – Western aspect of Building 12.

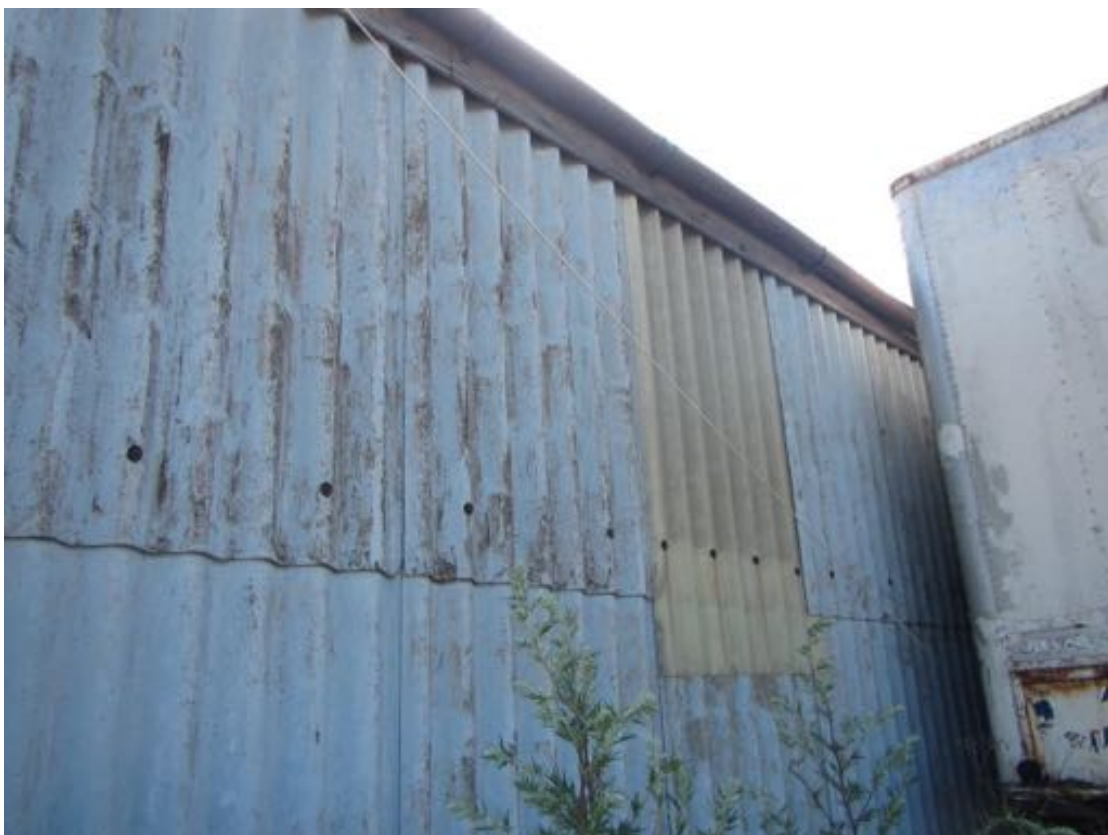
Building 13 is a large barn constructed from corrugated metal sheeting with a corrugated metal roof (Photo 23). The roof is generally in good condition but there is asbestos flashing present on the northern and southern aspects of the building, which are slightly lifted and may provide occasional roosting opportunities for a small number of bats. There are wooden barge boards present on the western and eastern aspects of the building which are also lifted in places (Photo 24). Finally, there are small gaps where the corrugated metal sheet walls overlap; these were fully inspected and no evidence of roosting bats was identified. There are no windows in the building and the door is a large wooden sliding barn door, which is tightly sealed.

Photo 24 – Western aspect of Building 13.

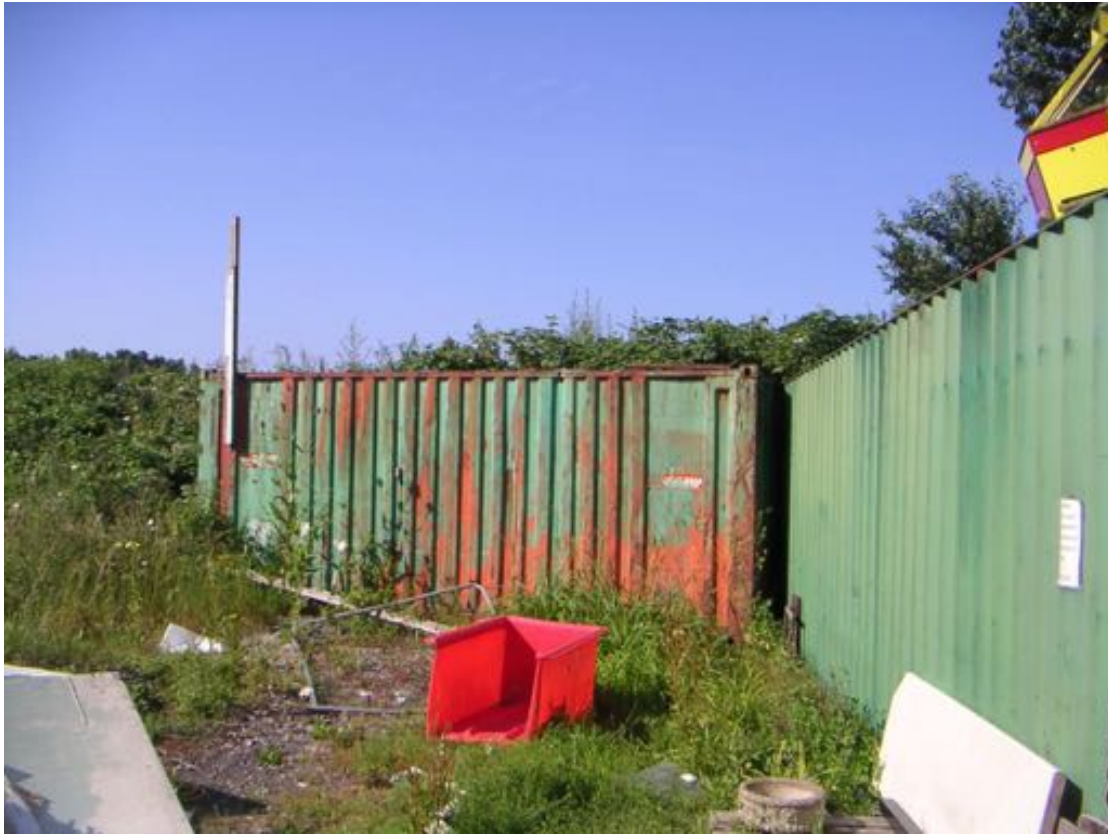
Buildings 14 and 15 are two metal steel storage containers (Photos 25 and 26). The buildings have flat roofs constructed from corrugated metal. Metal roller doors are present on the northern aspect of Building 14 and eastern aspect of Building 15. The buildings are in excellent condition and tightly sealed with no PRFs noted for bats.

Photo 25 – Building 14, located immediately adjacent to the western site boundary.

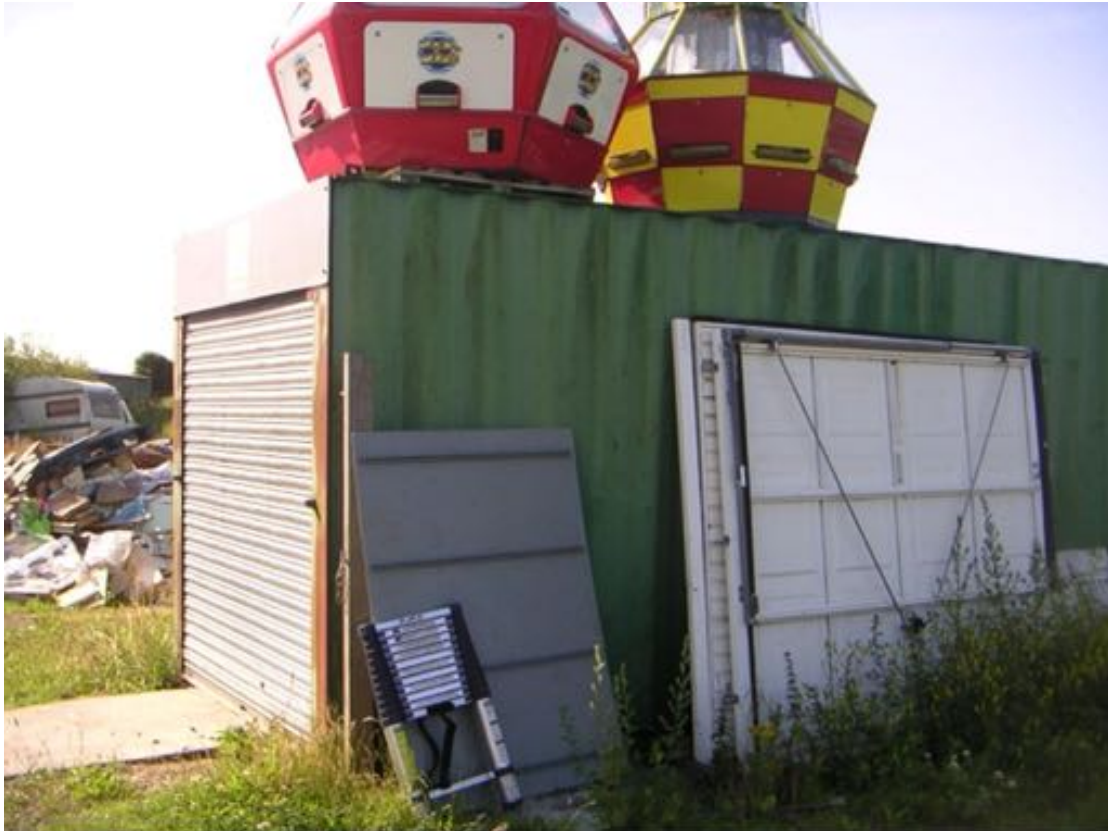
Photo 26 – Building 15, located immediately adjacent to the western site boundary.

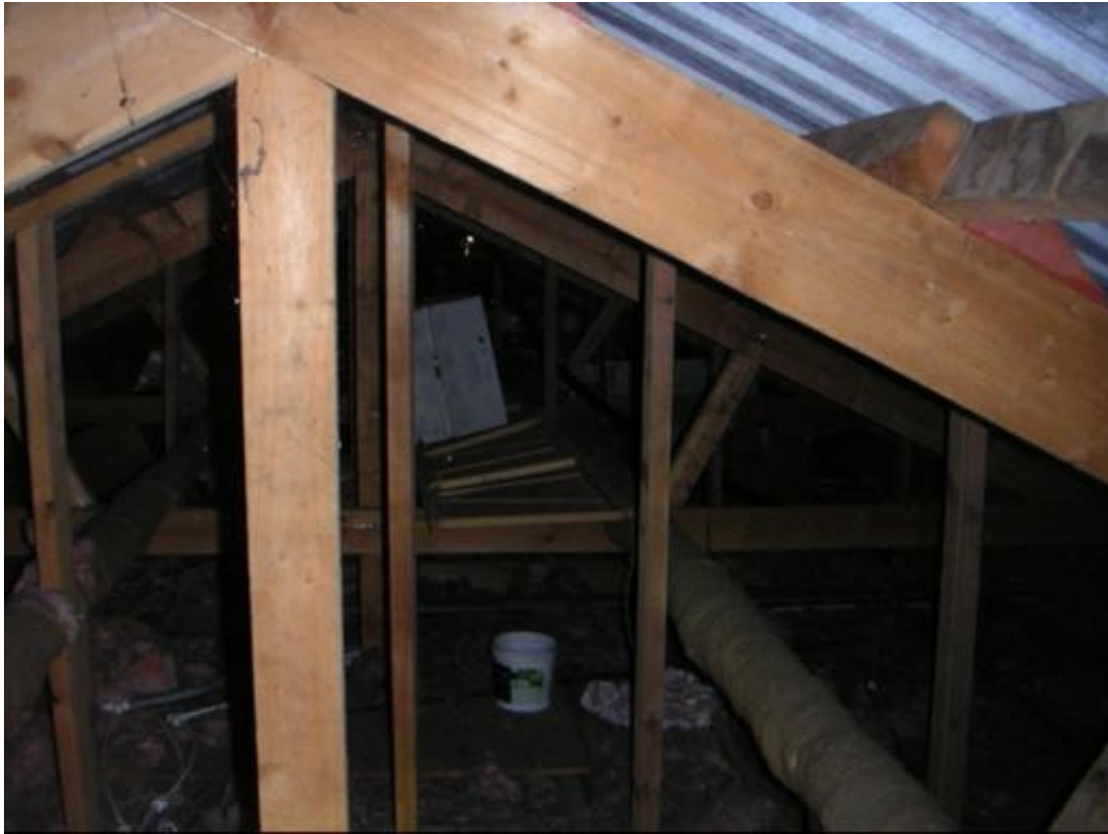
Photo 29 – Internal view of the northern section of Building 10.
