EXISTING STEPS NO.02 - URN AND PIER

HABERDASHER'S SCHOOL Job No: 9756-1 9756-1 P(0)1001 May 2021 1:50 & 1:20 @A3 Checked: GQ NCB 7 BISHOP'S TERRACE LONDON SE11 4UE GILES QUARME ARCHITECTS
(Chartered Architects)

PLAN WITH REPAIRS/REBUILDING - 1:50@A3

**EXISTING TERRACE STEPS NO.02:**

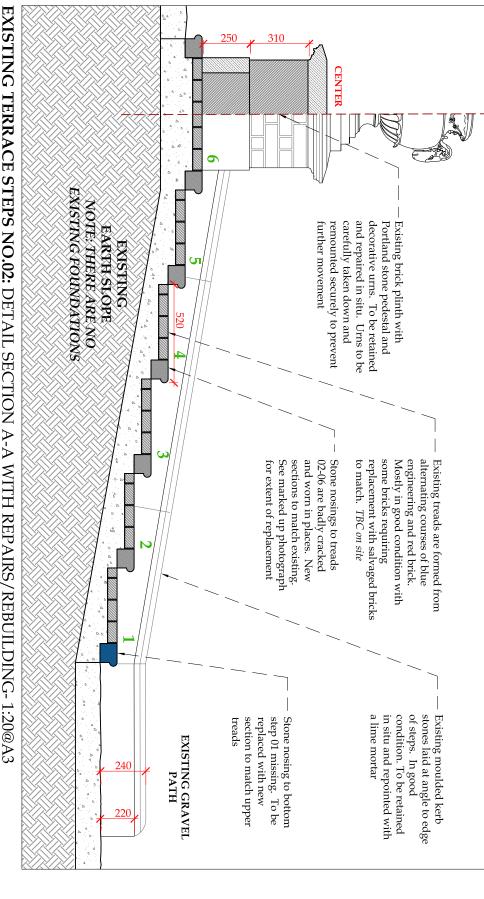
> sections to match and worn. New Stone nosings to treads 02-06 are badly cracked

generally in good condition and are to

Existing engineering brick treads are

step 01 missing. Stone nosing to bottom

percentage of replacement TBC on site

nosings shown hatched blue at c.40% replacement

blue engineering and red brick. Mostly in good condition with

some bricks requiring replacement with

missing to tread no.1. Limestone nosing 840

existing. See marked up

photograph opposite for

extent of replacement

Replacement stone
