Proposed Repair Works
209 Gilesgate
Durham City DH1 1QN
for Dr M. Judson

As Existing & As Proposed

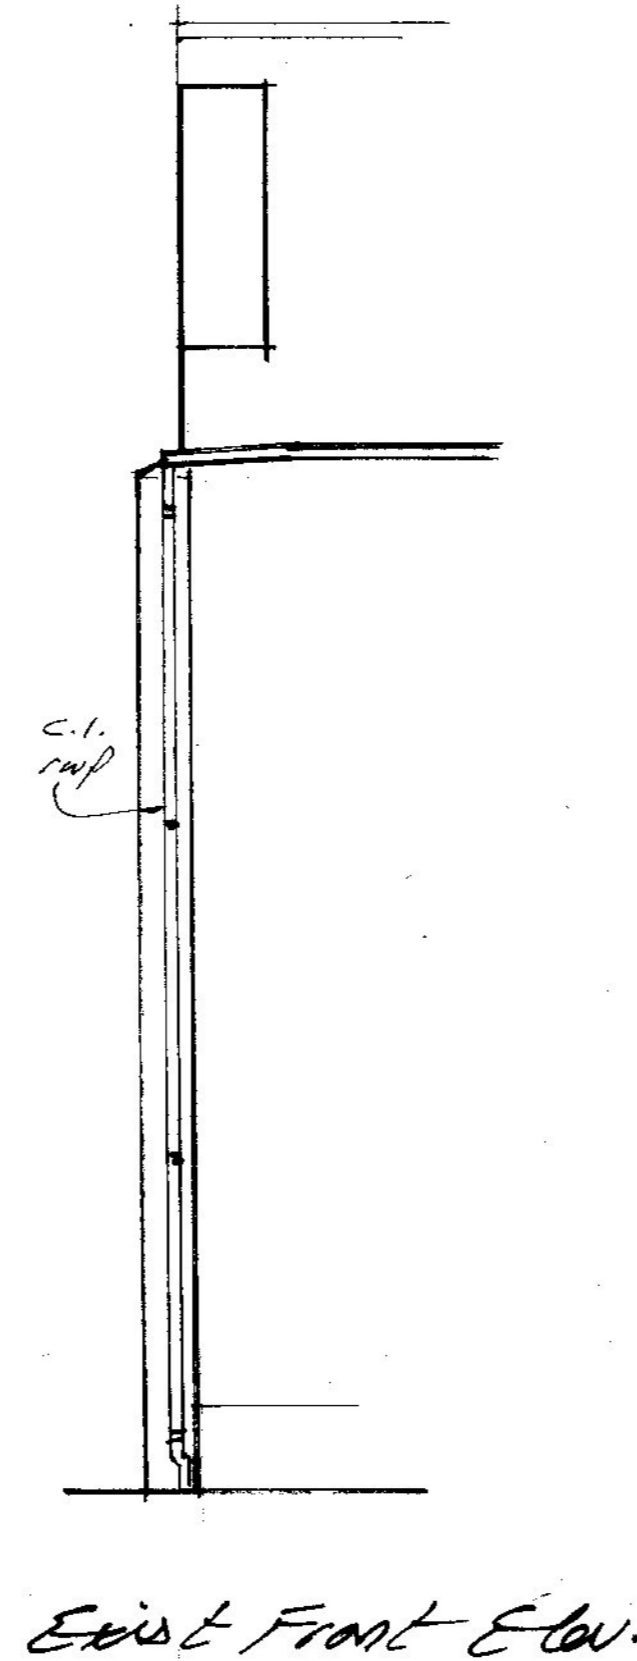
Note: - Outer brick skin is in a dangerous condition and is curling away from original house wall

Remove & re-install existing timber windows

- Remove brick outer skin
- Remove existing render (hammer & chisel)
- Re-render gable with a 5-1-1 lime mortar mix (5 sand, 1 cement, 1 hydrated lime)
- Once render has dried out, apply masonry paint (off white)

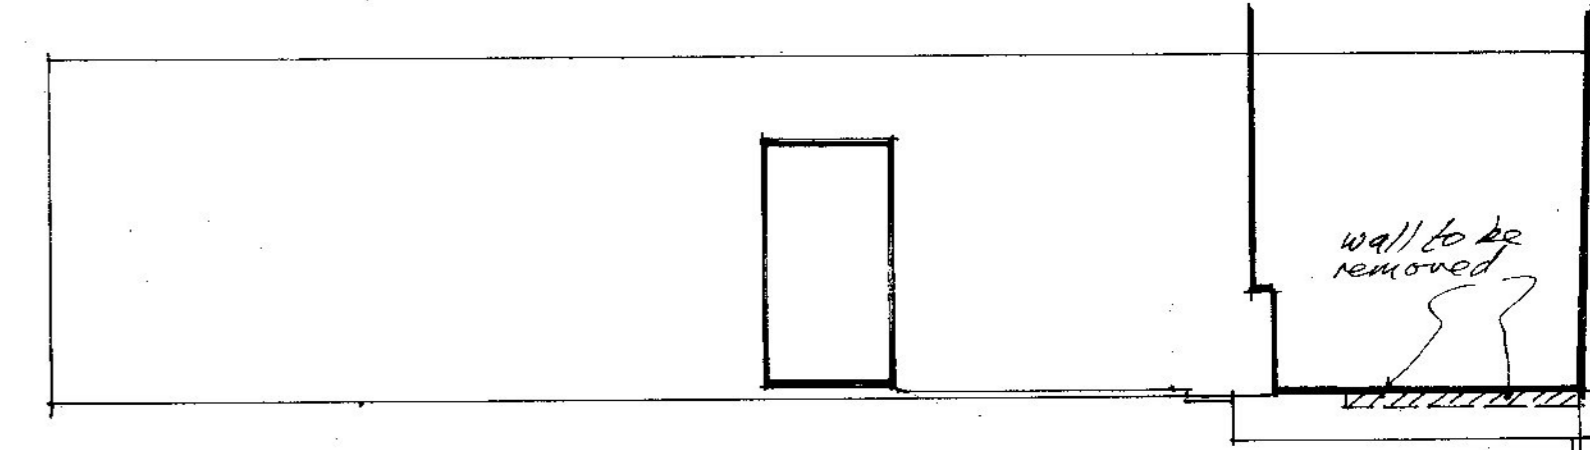
102mm brick skin in front of original wall with 200mm void

wall to be removed

Existing brick skin to be removed. If wall behind is showing any signs of structural defects a structural engineer is to inspect and advise

extend steps

install single size per gravel on 1200g virgin

re-site c.i. rwp
