# Extension and Refurbishment to 8 Addington Square London, SE5 7JZ

Design, Access and Heritage Statement

Ref: 281

September 2021

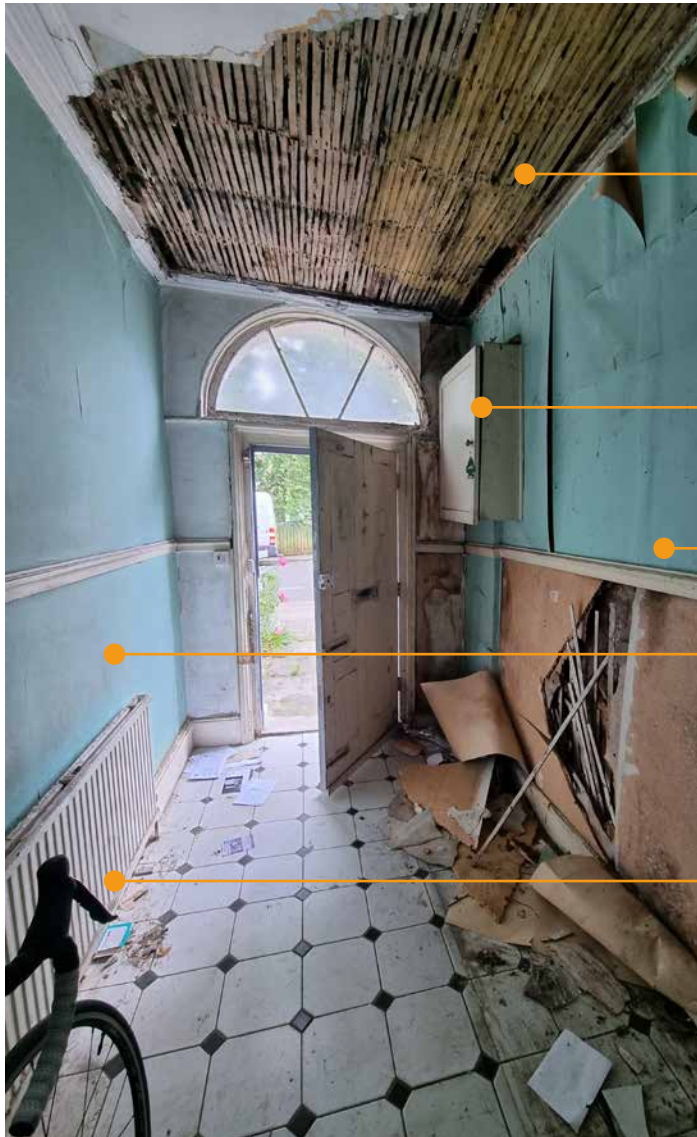
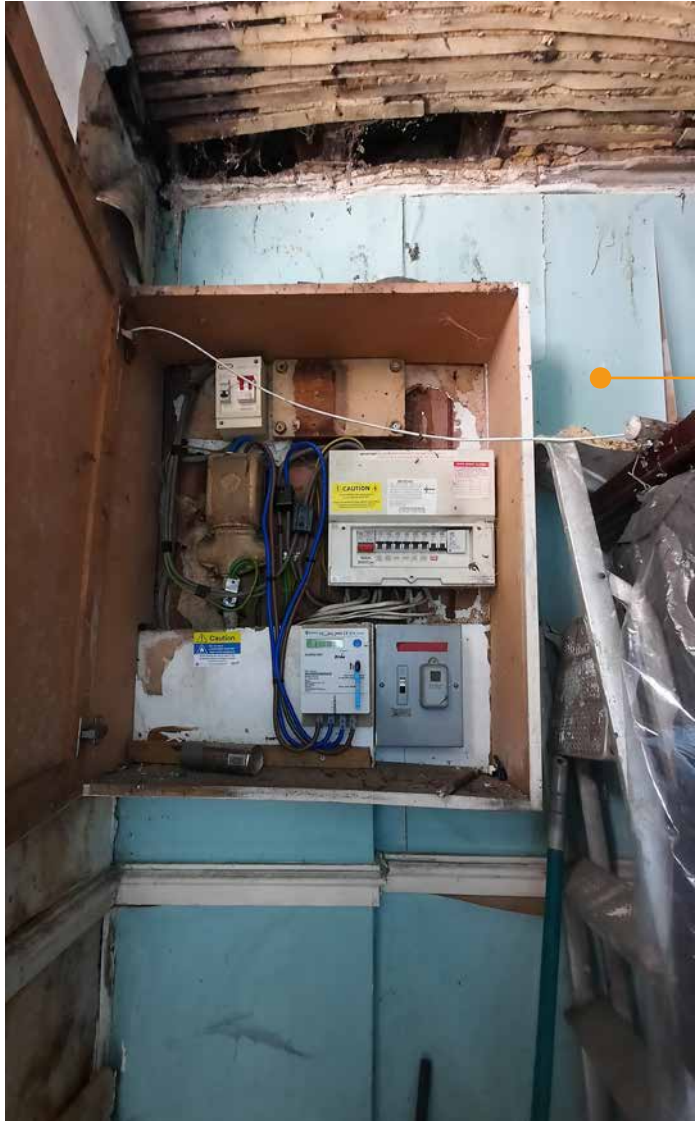
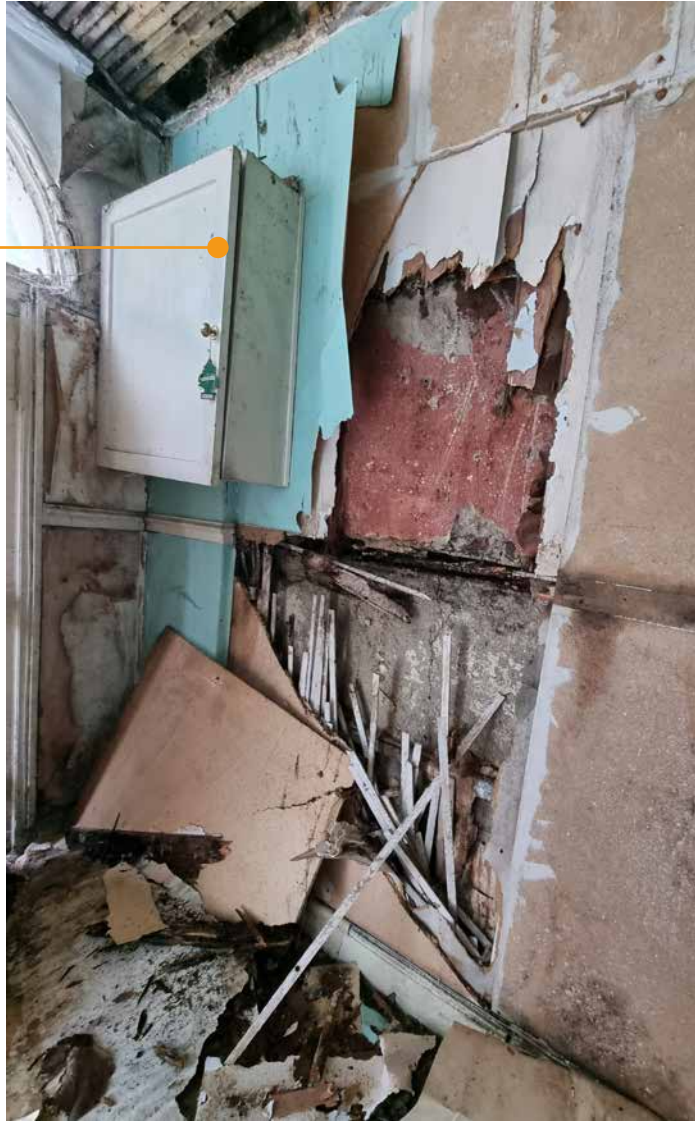
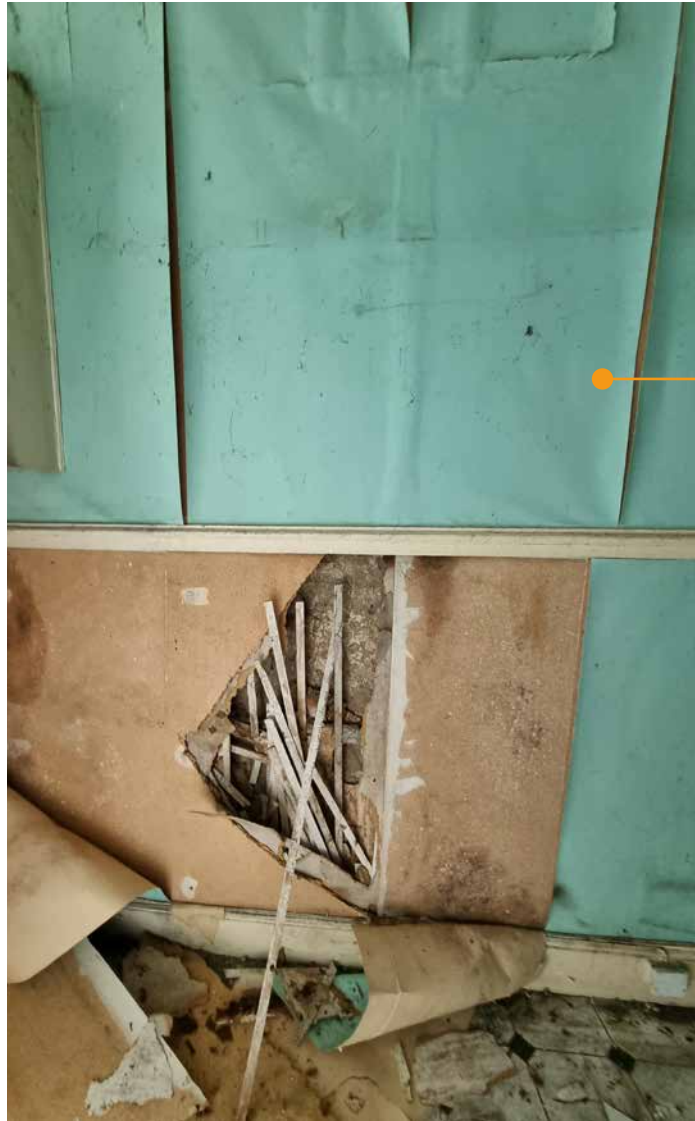
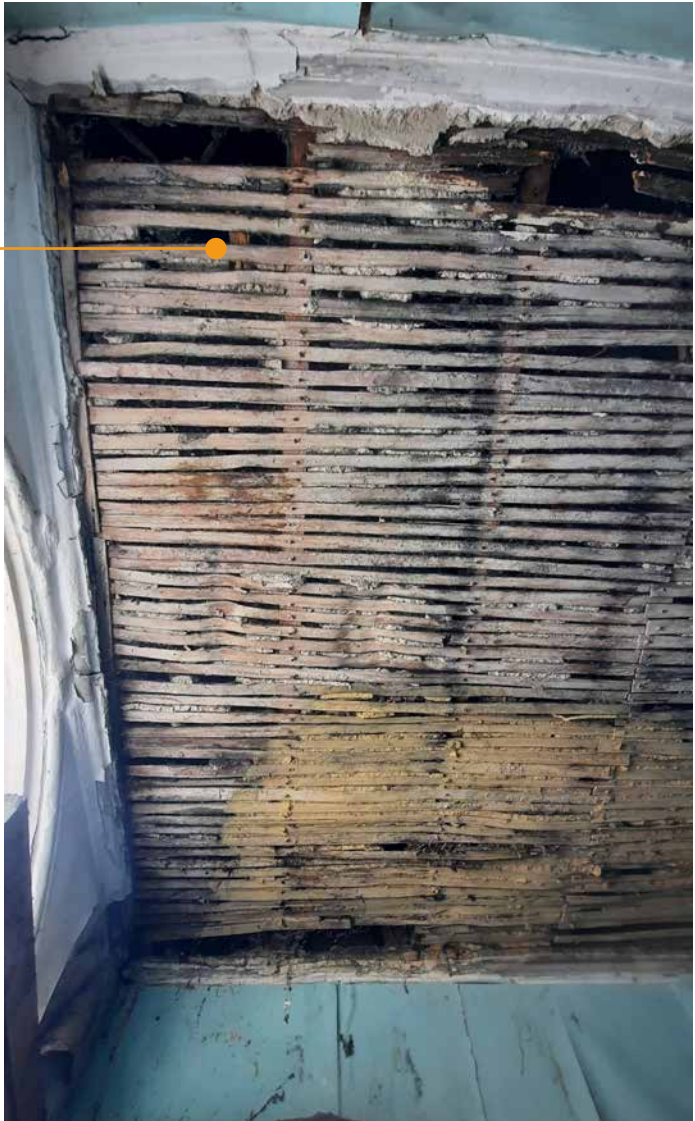
# 1.1 Entrance Hall - Photographs

Item	Description	Condition	Proposal
1	Ceilings	water damaged loss of approx 40% of plaster	Rebuild ground floor flat roof and parapet.
2	Wall	painted and papered	remove paper and assess plaster repair damaged areas with lime plaster and paint.
3	External Wall	poor and saturated	Rebuild failing east and south walls of entrance hall. South wall to be rebuilt for entire width of ground floor flatroof, up to 2 storey first floor bathroom.
4	Floor Tiles	damaged and dirty	remove tiles assess structure below and replace with new ones
5	Electrics/Fuse Board	out dated	replace with new compliant system relocate electricity meter to utility room.
6	Radiator	rusted	replace with new column radiator

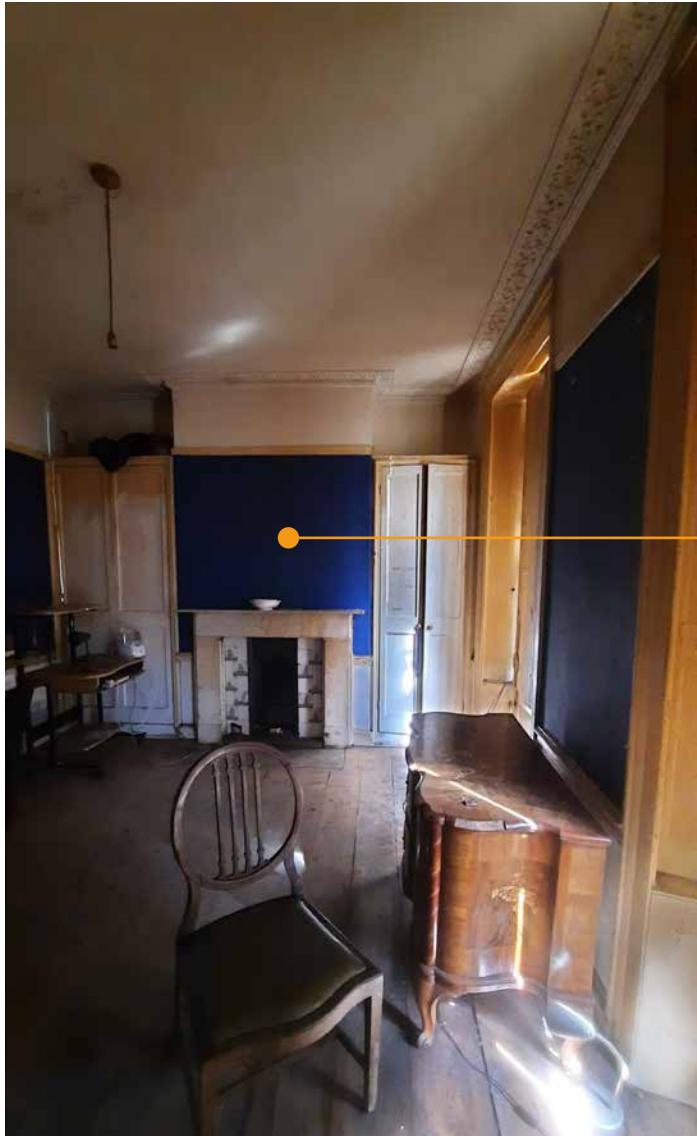
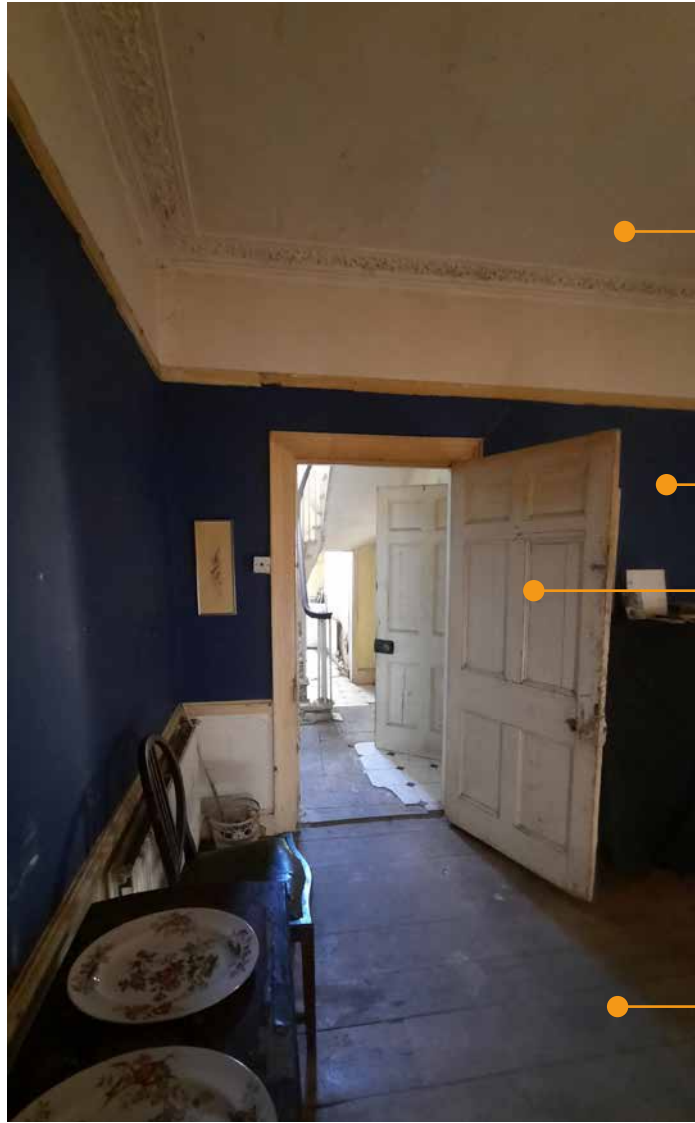
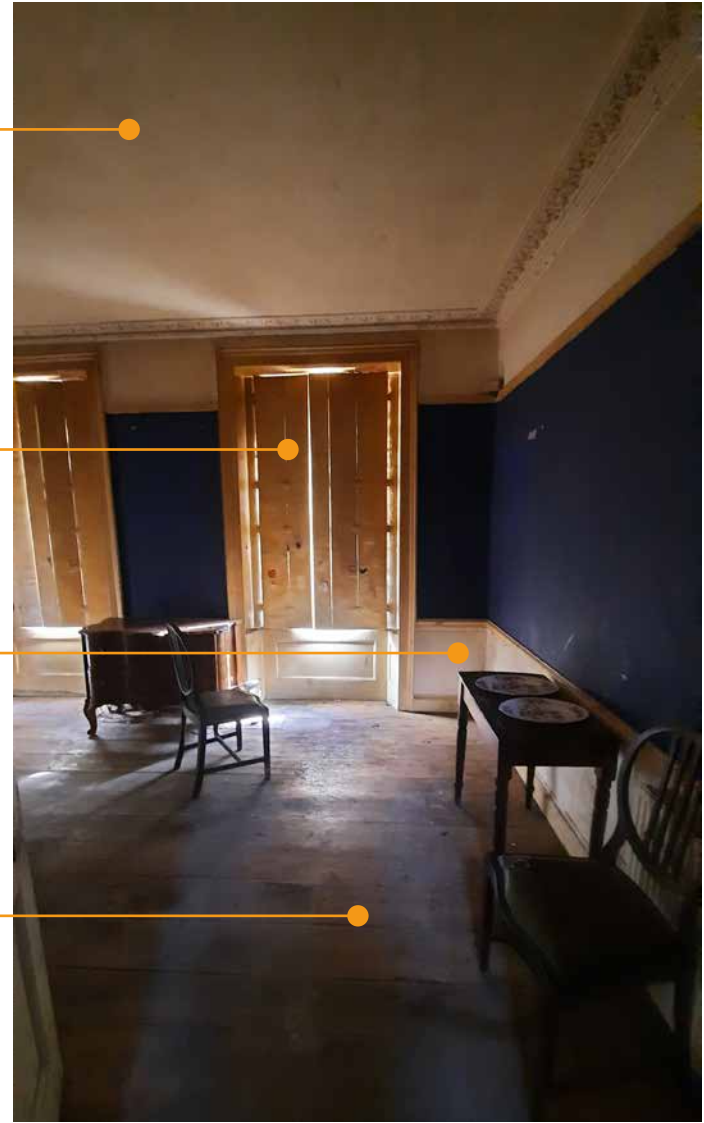
## 2.1 Reception Room - Photographs

Item	Description	Condition	Proposal
1	Ceilings	peeling paper	remove damaged plaster and repair with lime plaster
2	Walls	papered	remove paper and assess plaster repair damaged areas with lime plaster and paint
3	Shutter	poor	remove and refurbish and reinstate
4	Floors	timber boards	sand and treat
5	Wooden panelling	badly refurbished	remove chipboard and reinstate new timber paint
6	Door	poor	remove damaged plaster and repair with lime plaster

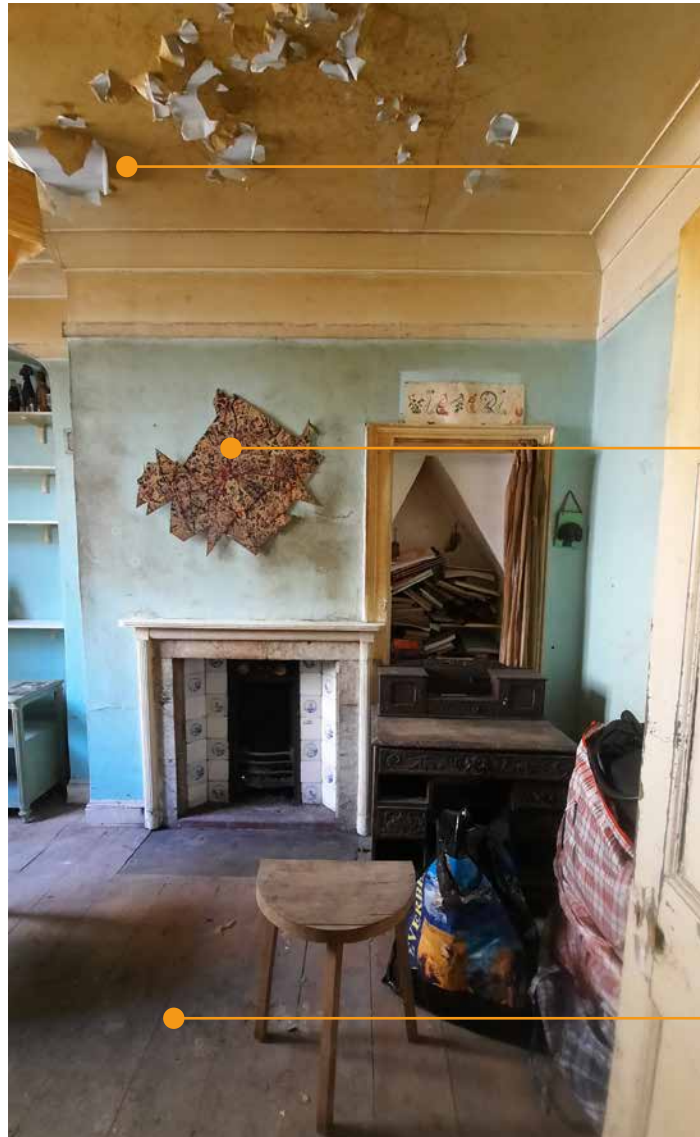
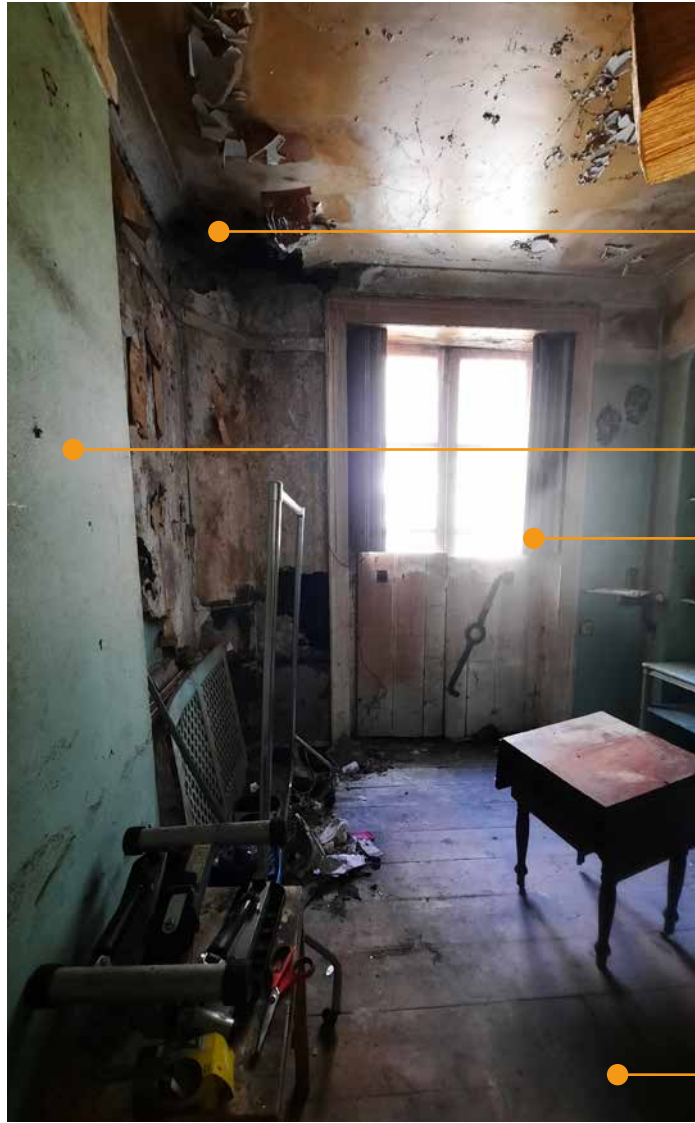
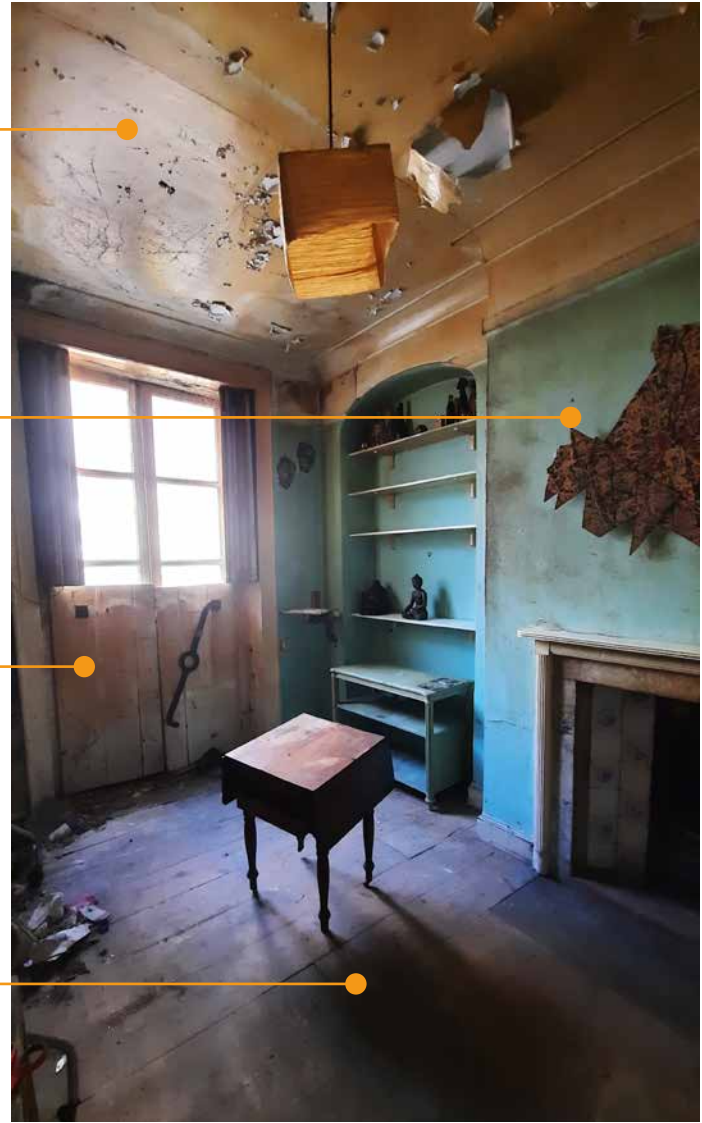
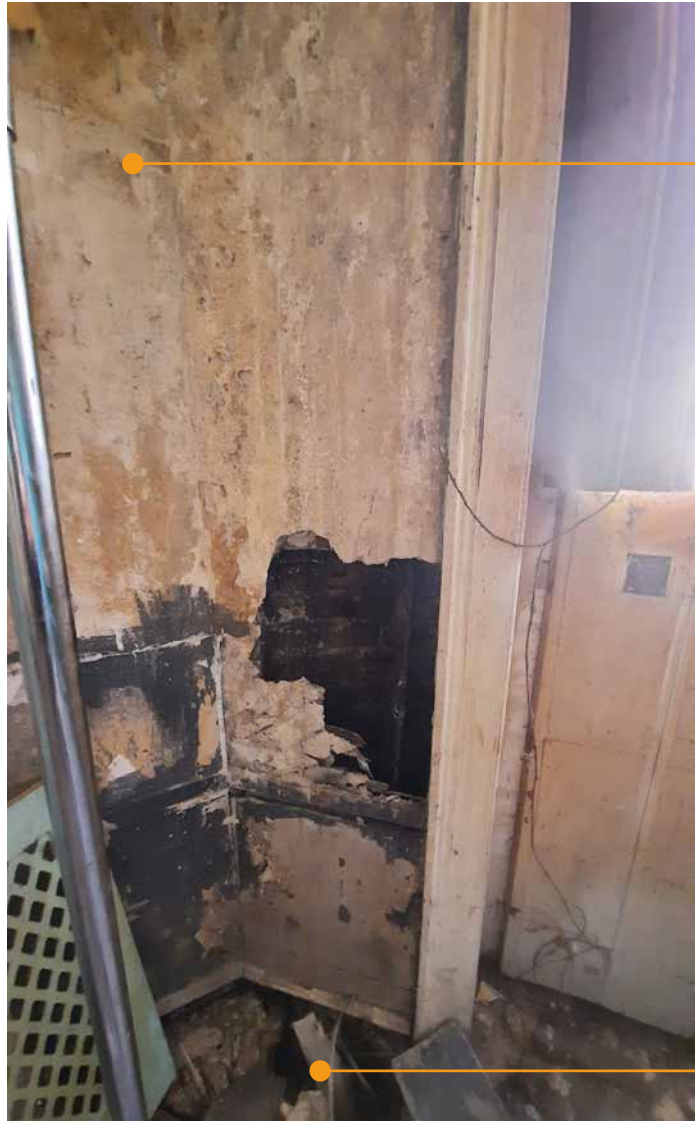
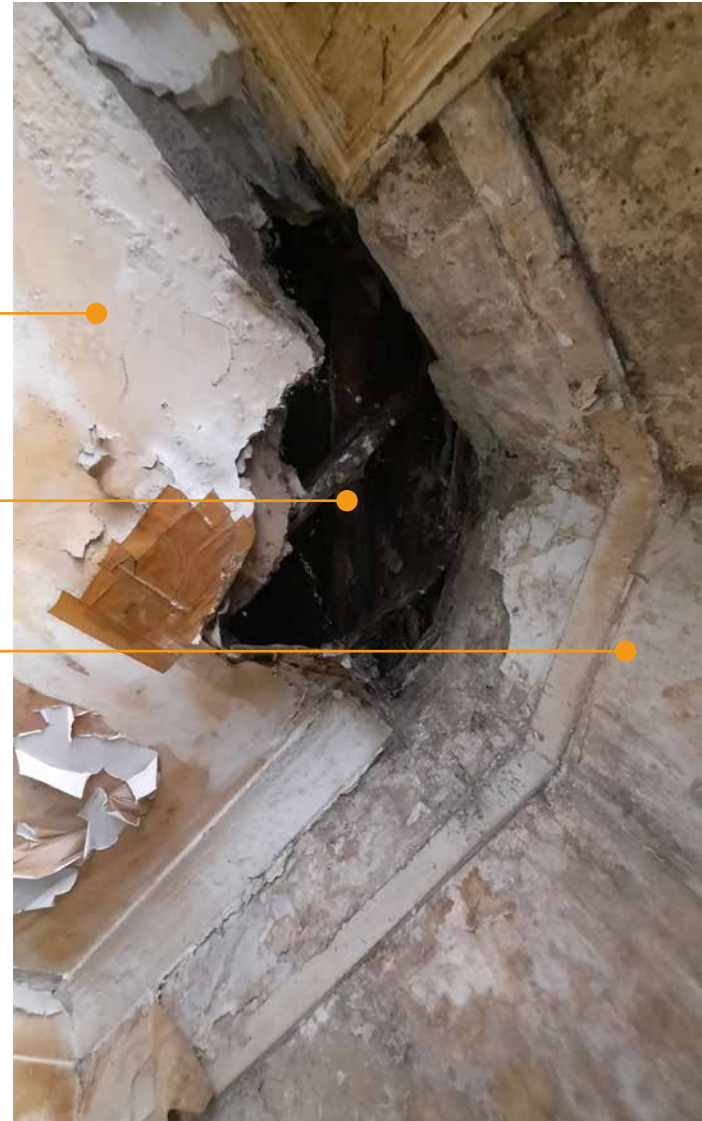
# 4.1 Study - Photographs

Item	Description	Condition	Proposal
1	Ceiling	tiled and needs repair	remove paint, patch, replace decayed non-original coving with new egg-dart coving style and repaint
2	Hole in ceiling	tiled and needs repair	remove damaged plasterboard, apply new one and skin and paint
3	Walls	overboarded with plasterboard and spotlights	remove paper and assess plaster repair damaged areas with lime plaster and paint
4	Water damaged wall	poor condition	remove and replace rotten timber, new traditional plaster walls
5	Floors	fair condition	sand repair and new coating
6	Hole in Floor	poor condition and rotten timbers	remove rotten timbers and replace floorboards to match
7	Radiator	rusty modern radiator	replace with column radiator
8	Double doors	rotten throughout	replace with new doors to match

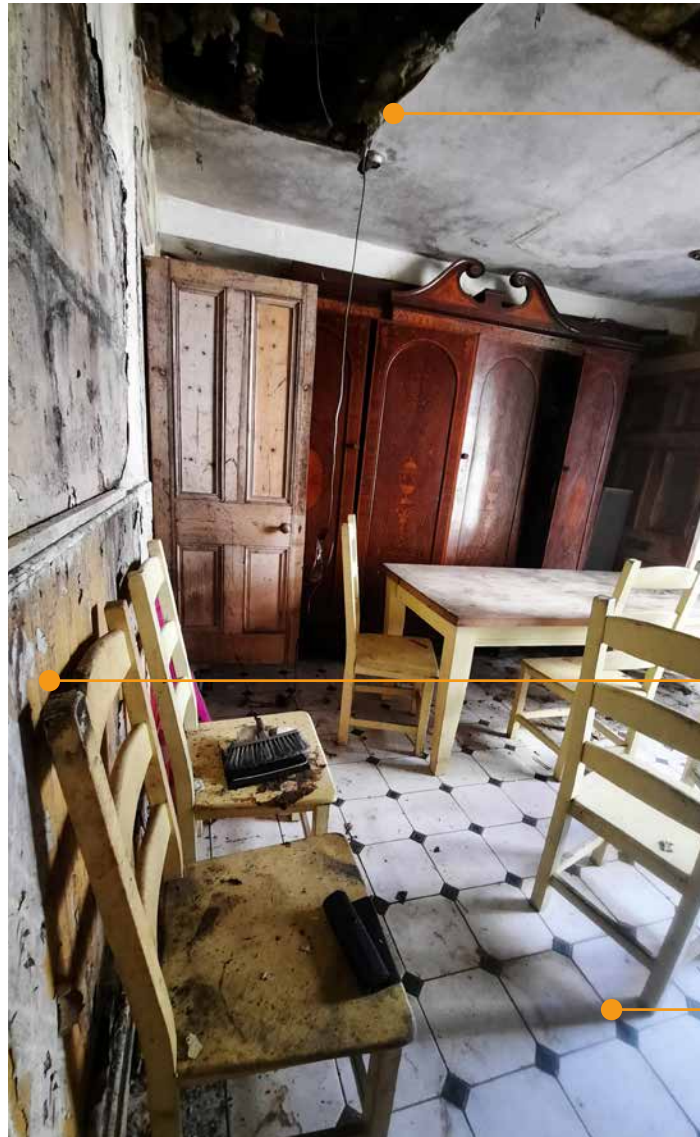
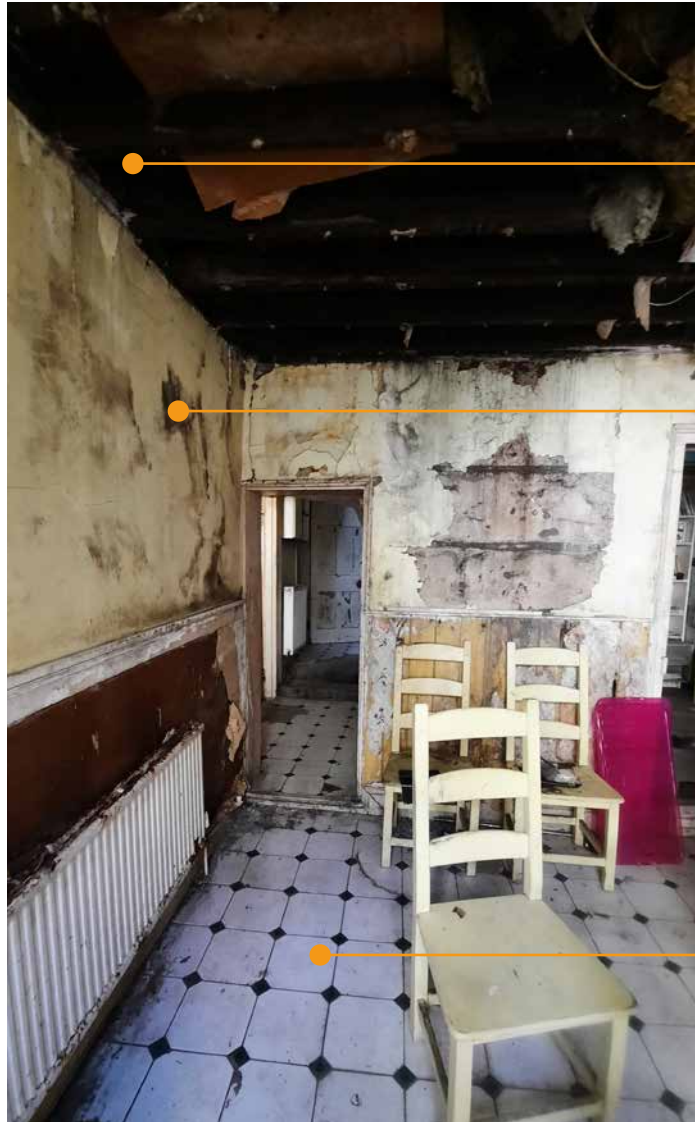
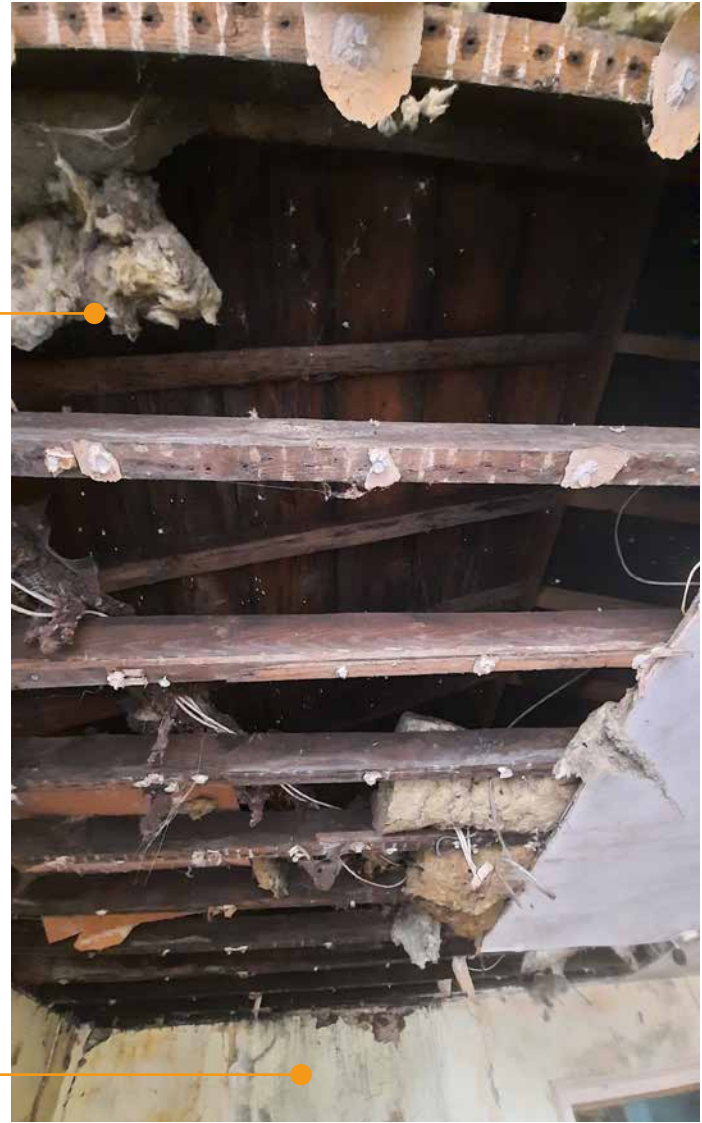
# 5.1 Dining - Photographs

Item	Description	Condition	Proposal
1	Floor	tiled and poor condition	remove and assess floor below, new installation substrate under floor heating and tiles
2	Walls	generally in poor conditio, part saturated	retain and repair where possible within new scheme, skimmed and painted
3	Roof / Ceiling	damaged and rotten	remove and replace with new timbers, insulation and flat roof system
4	Window Rooflight	rotten	decayed element to be replaced like for like Create opening and installation of lantern roof light above island

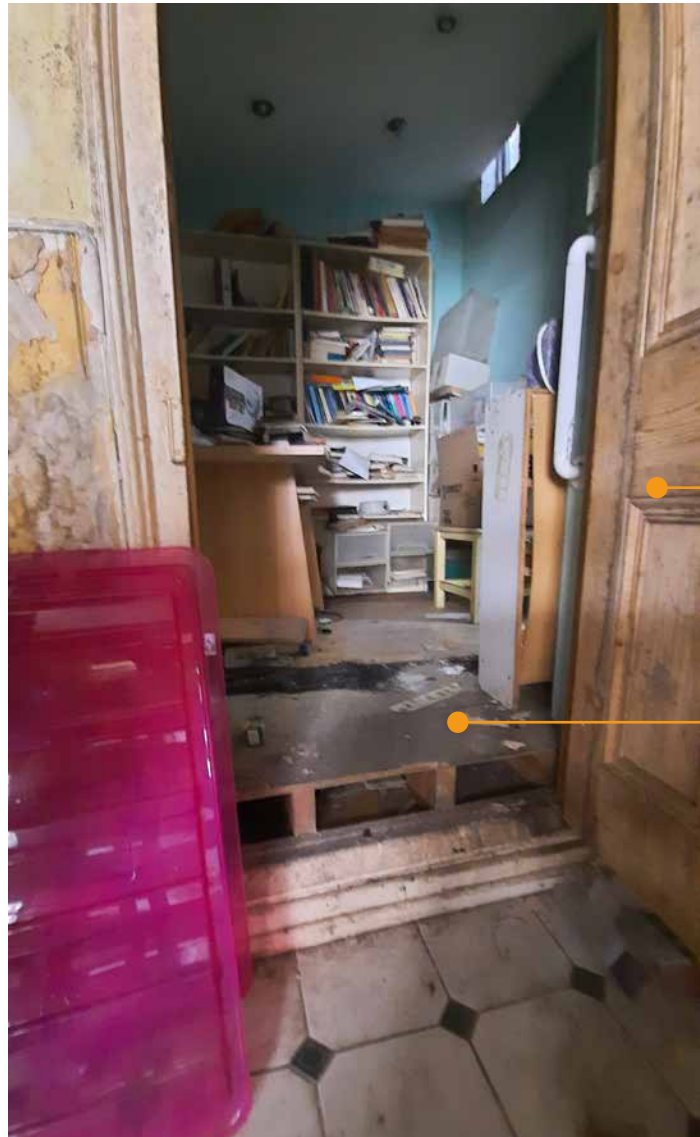
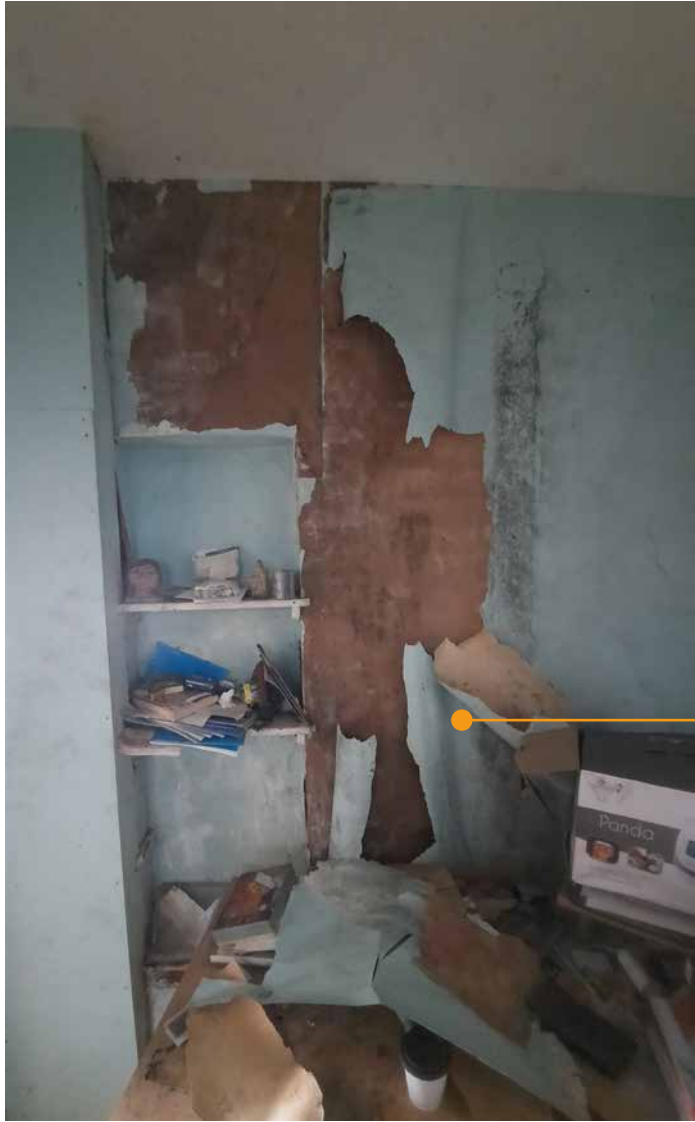
# 6.1 Office - Photographs

Item	Description	Condition	Proposal
1	Ceilings	new plasterboard dropped ceiling with spots	remove and replace with new plasterboard and light fittings
2	Walls	papered and painted, damp issues	strip paper, allow to dry repair plaster and paint
3	Floors	boarded over with new joists and chipboard	remove new structure and assess existing
4	Doors	poor condition	fit new door to dining, enlarge opening to new extension
5	Window	poor condition - half in ceiling	remove
6	Door to Entrance Hall		Remove and make good

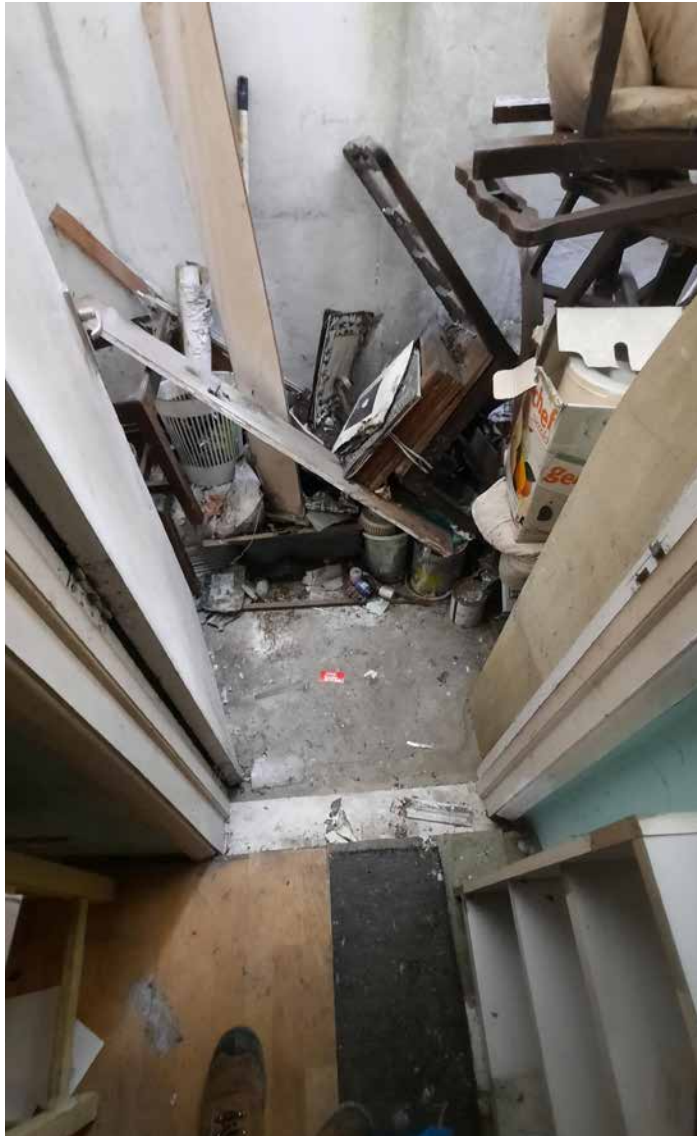
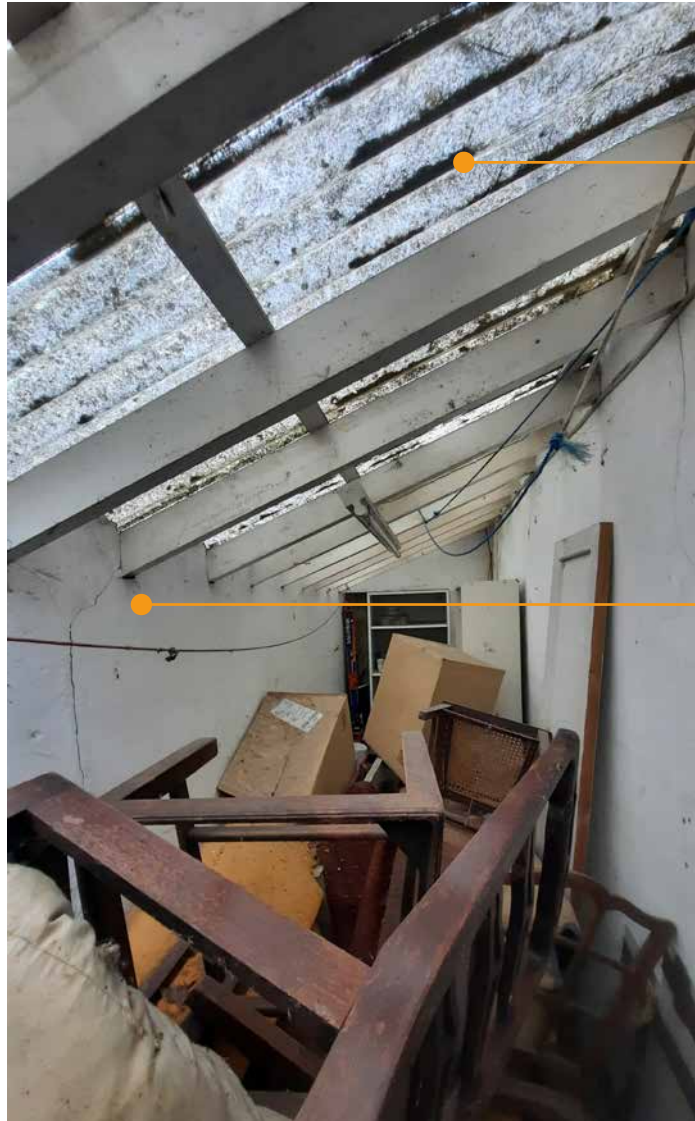
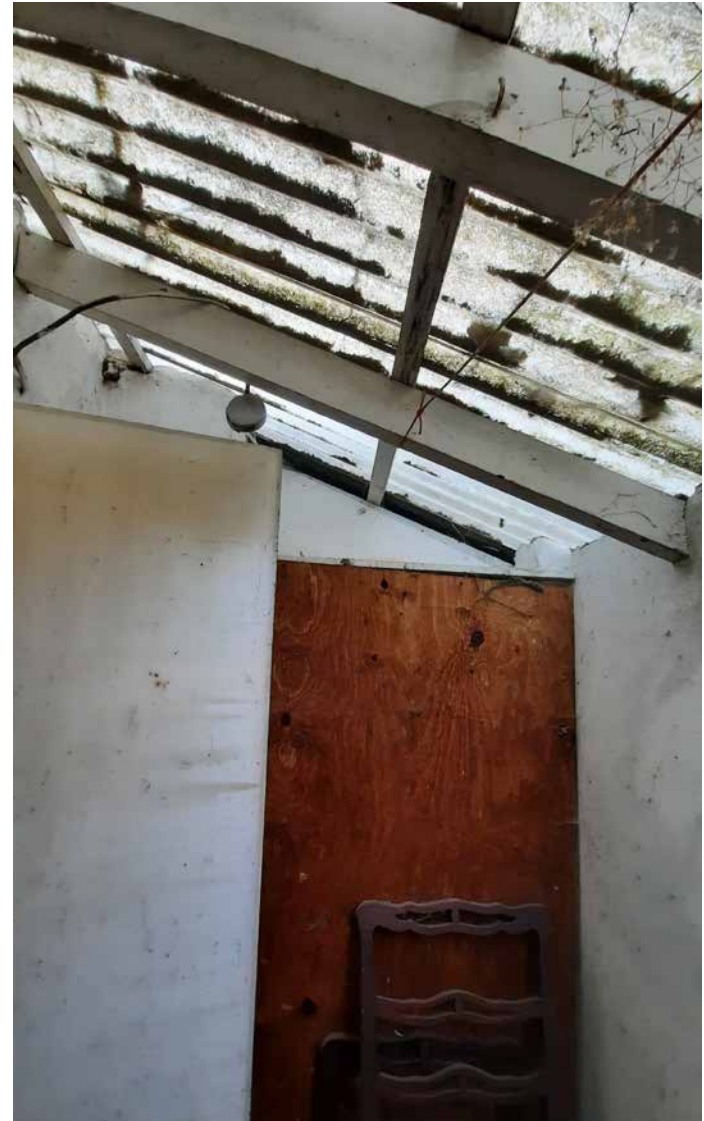
## 7.1 Store - Photographs

Item	Description	Condition	Proposal
1	Plastic roof	in need of clean and repair	remove and replace with new flat roof
2	Boundary wall	leaning and bowing	demolish and replace with new brick wall

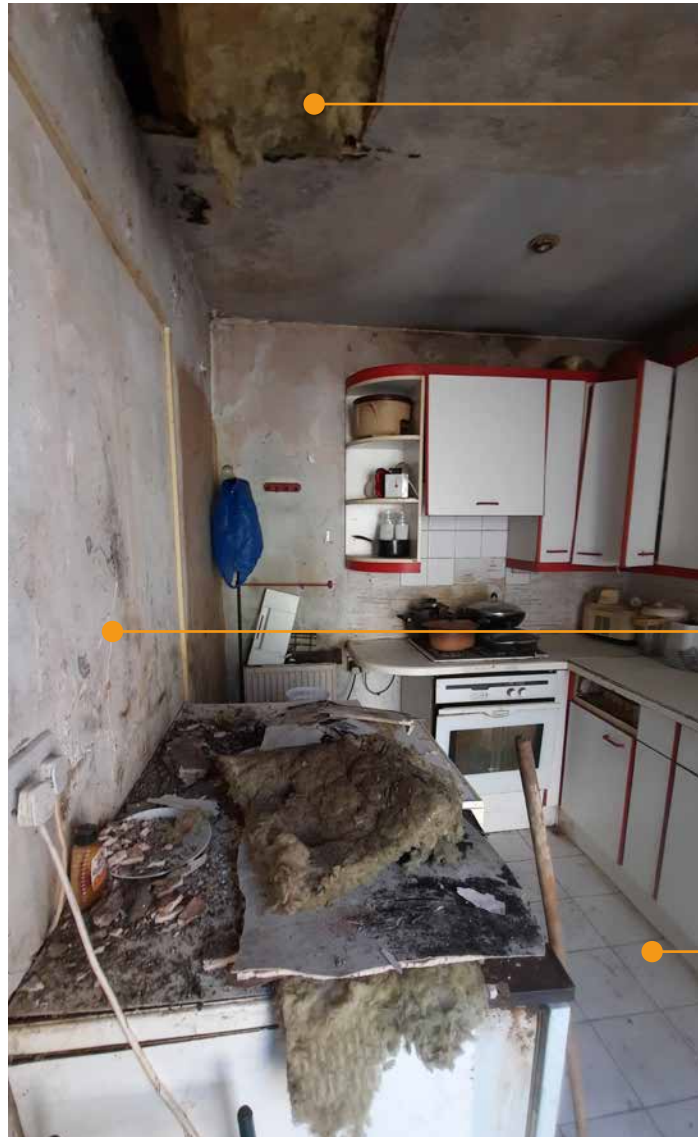
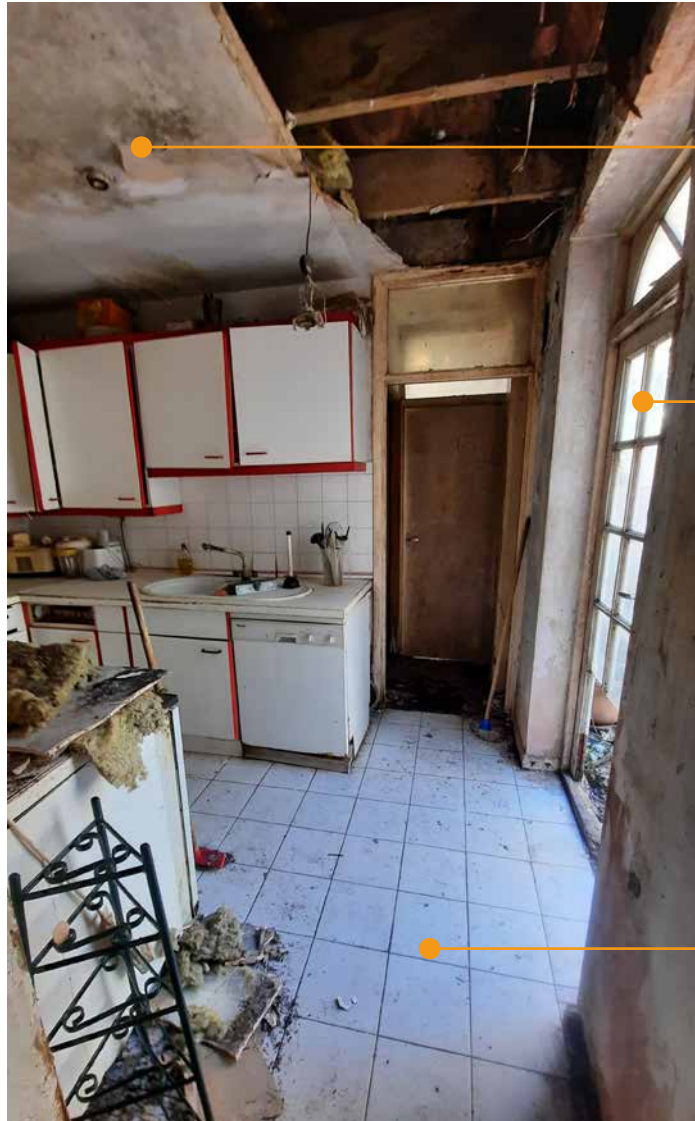
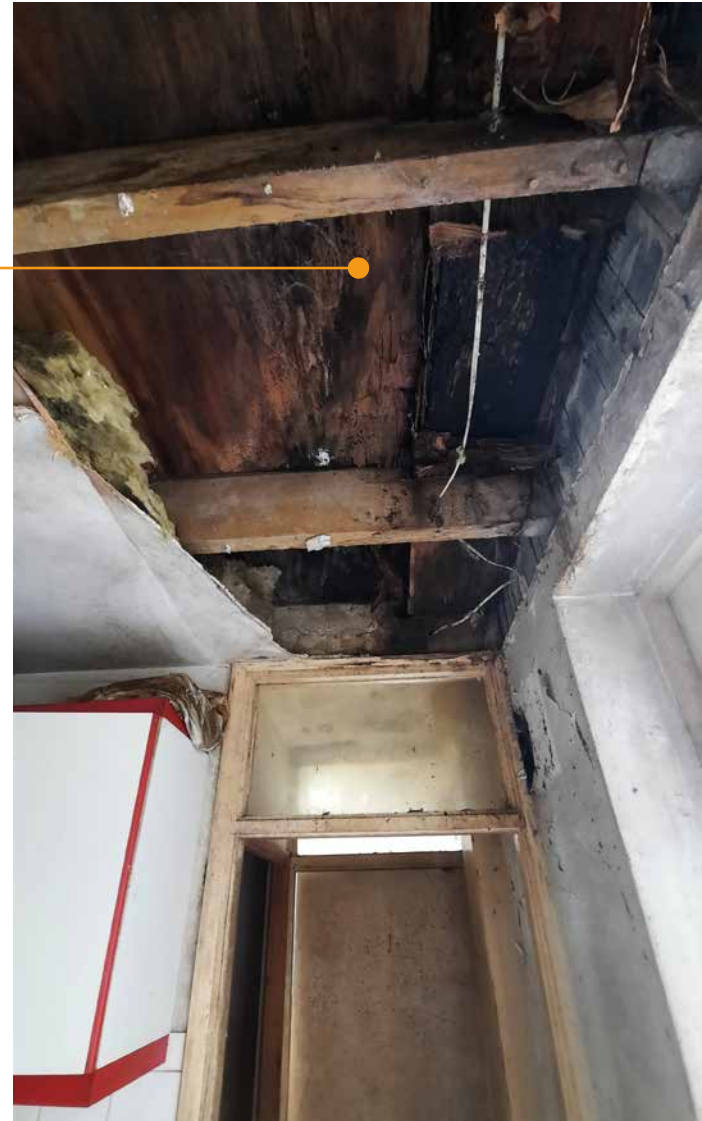
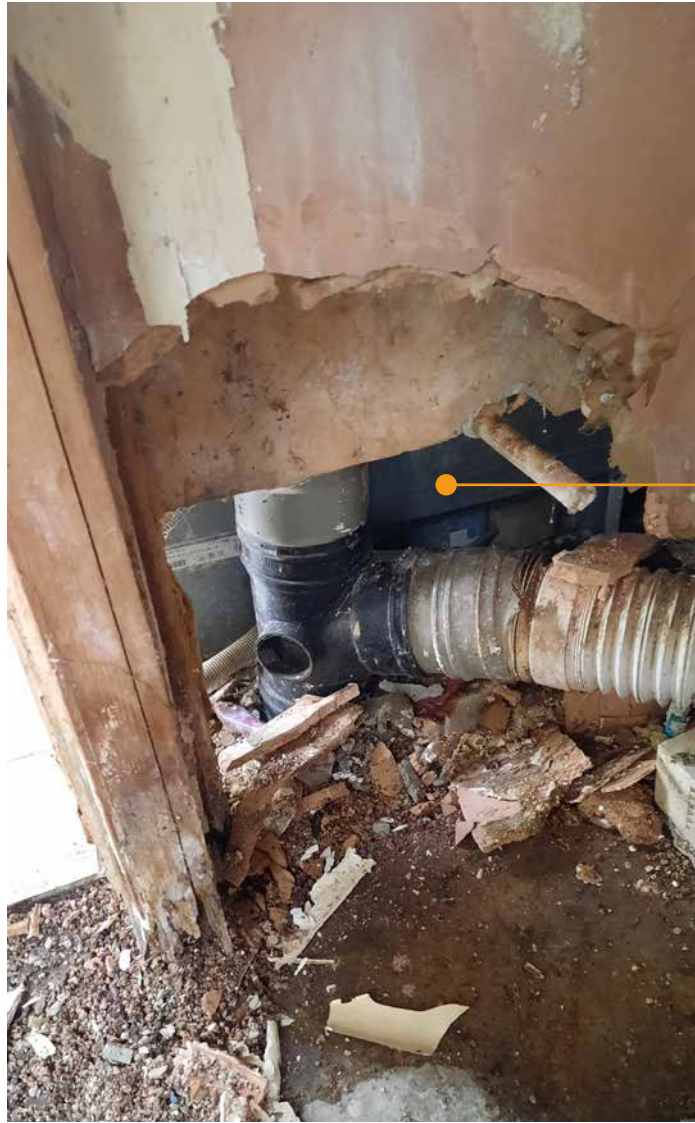
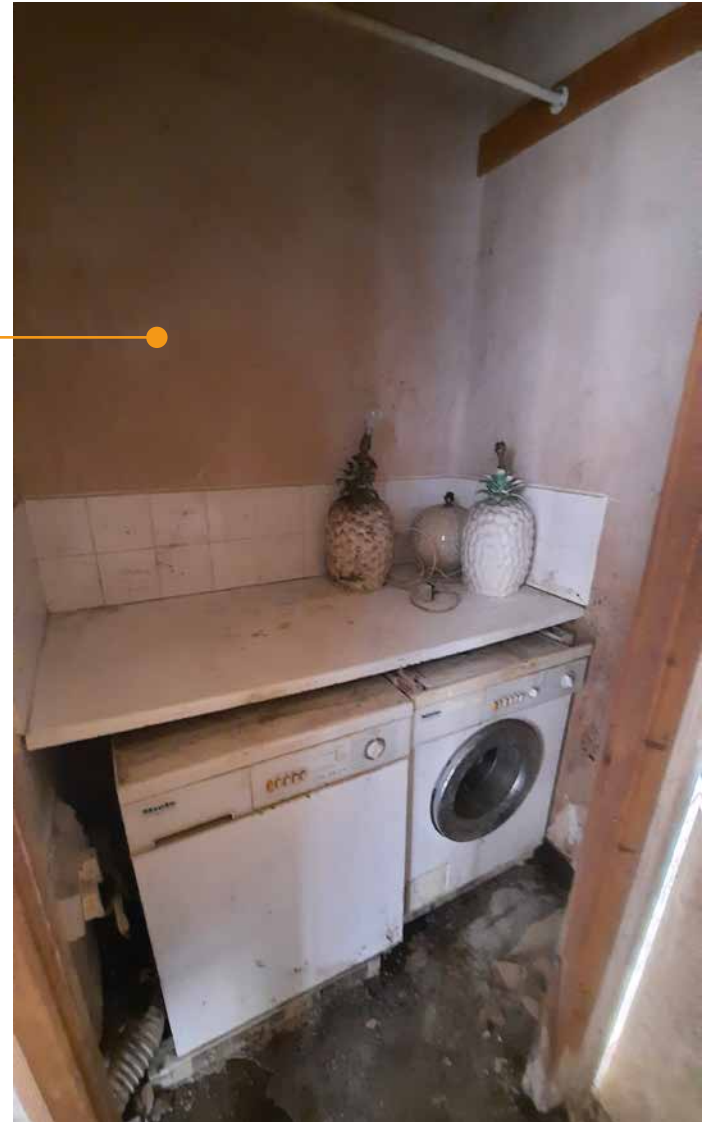
# 8.1 Kitchen & Utility - Photographs

Item	Description	Condition	Proposal
1	Floor	tiled and poor condition	remove and assess floor below, new installation substrate wood flooring
2	Walls	generally in poor condition, part saturated	retain and repair where possible within new scheme, skimmed and painted
3	Roof / Ceiling	damaged and rotten	remove and replace with new timbers, insulation and flat roof system
4	Doors	rotten	remove and replace wall with crittal style glazing
