# Extension and Refurbishment to 8 Addington Square London, SE5 7JZ

Design, Access and Heritage Statement

Ref: 281

September 2021

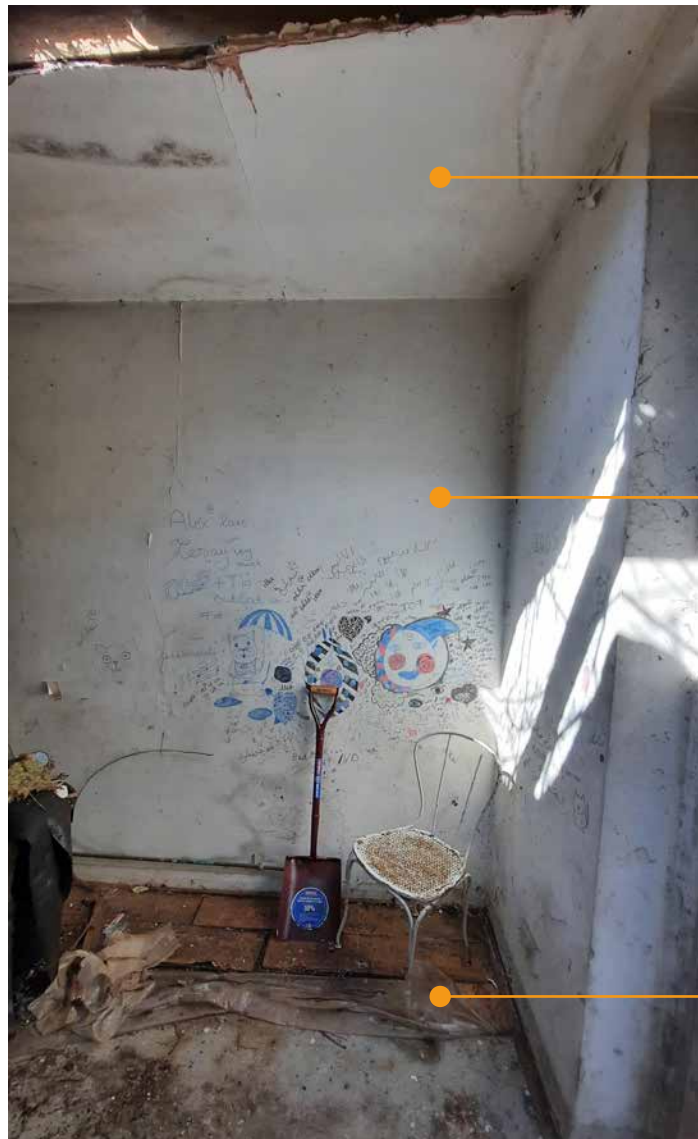
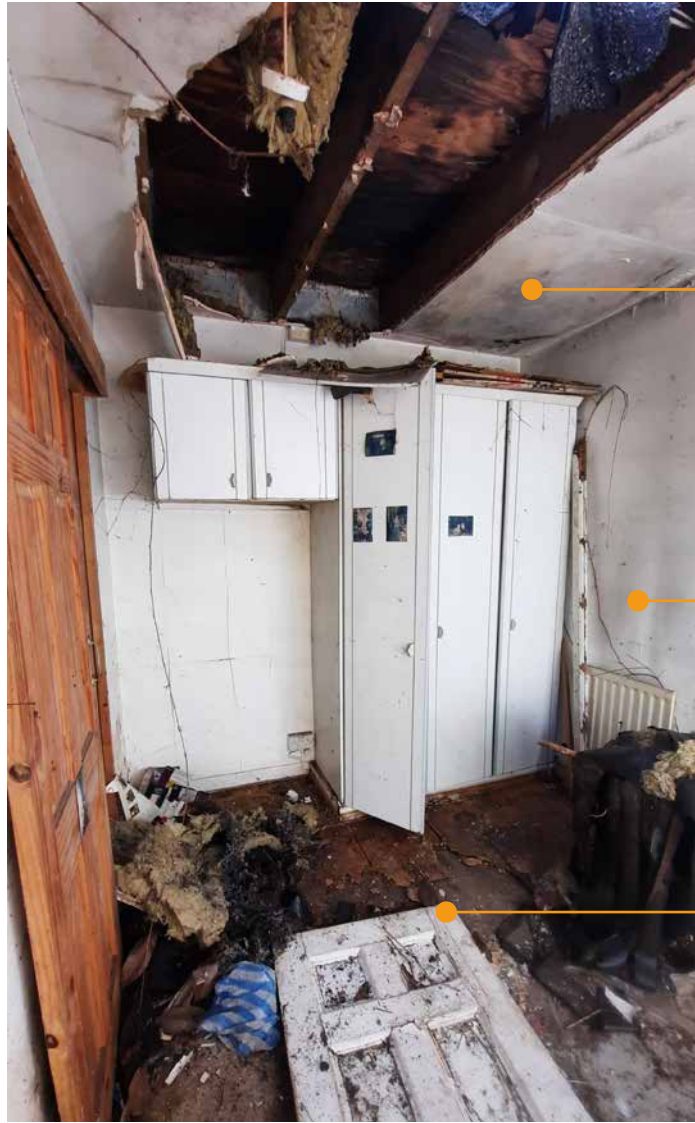
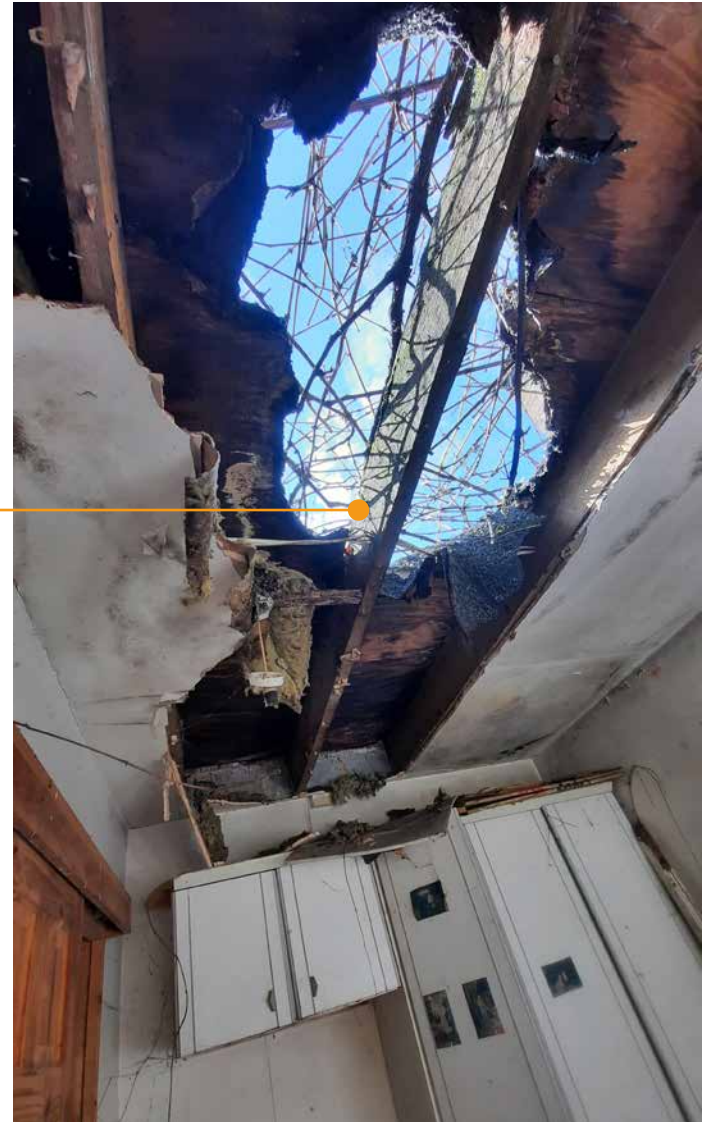
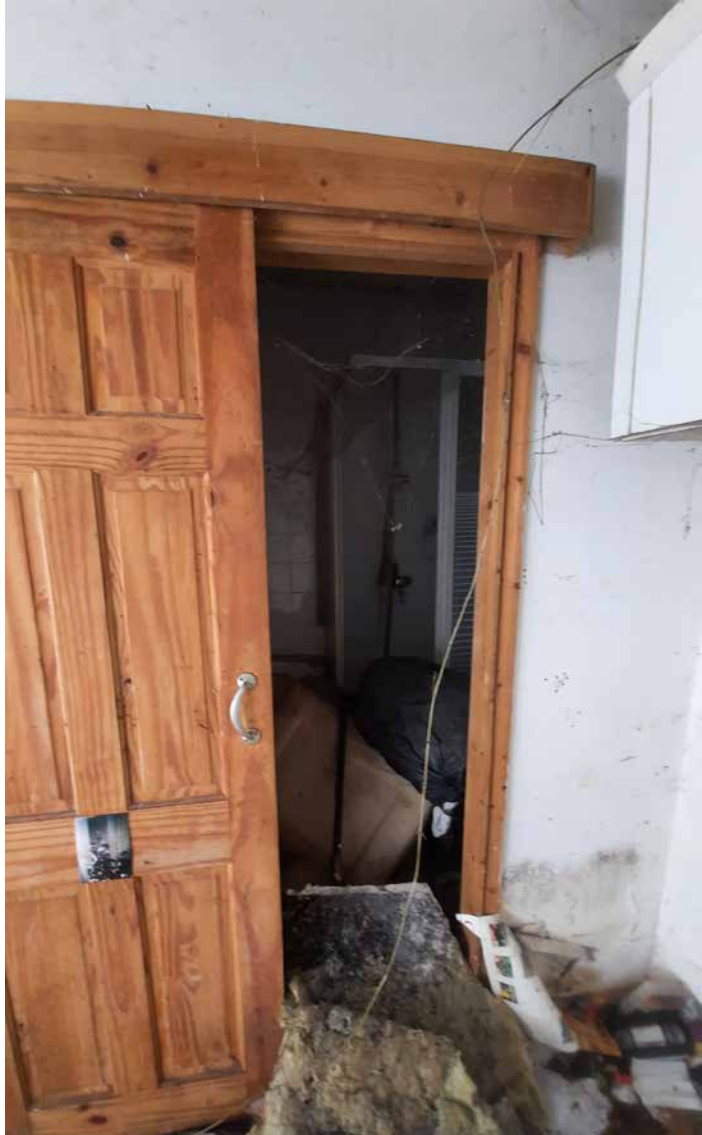
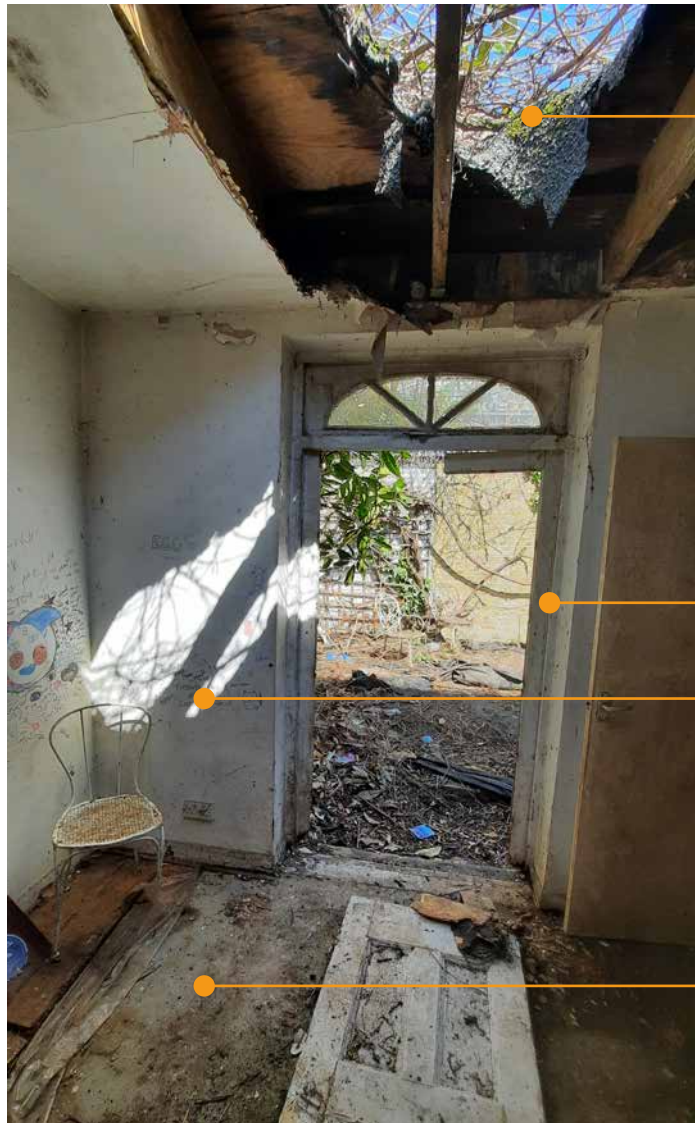
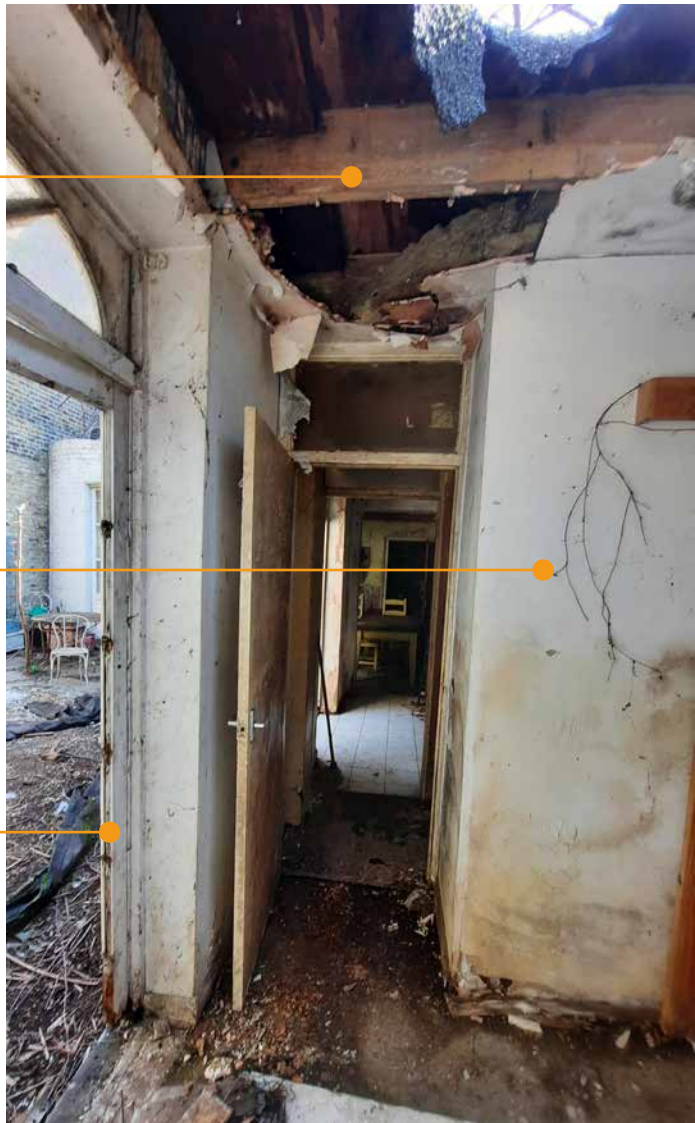
# 9.1 Bedroom 05 & Shower - Photographs

Item	Description	Condition	Proposal
1	Floor	tiled and poor condition	remove and assess floor below, new installation substrate new wooden floor
2	Walls	generally in poor conditio, part saturated	retain and repair where possible within new scheme, skimmed and painted
3	Roof / Ceiling	damaged and rotten	remove and replace with new timbers, insulation and flat roof system
4	Doors	rotten	remove and replace wall with crittal style glazing

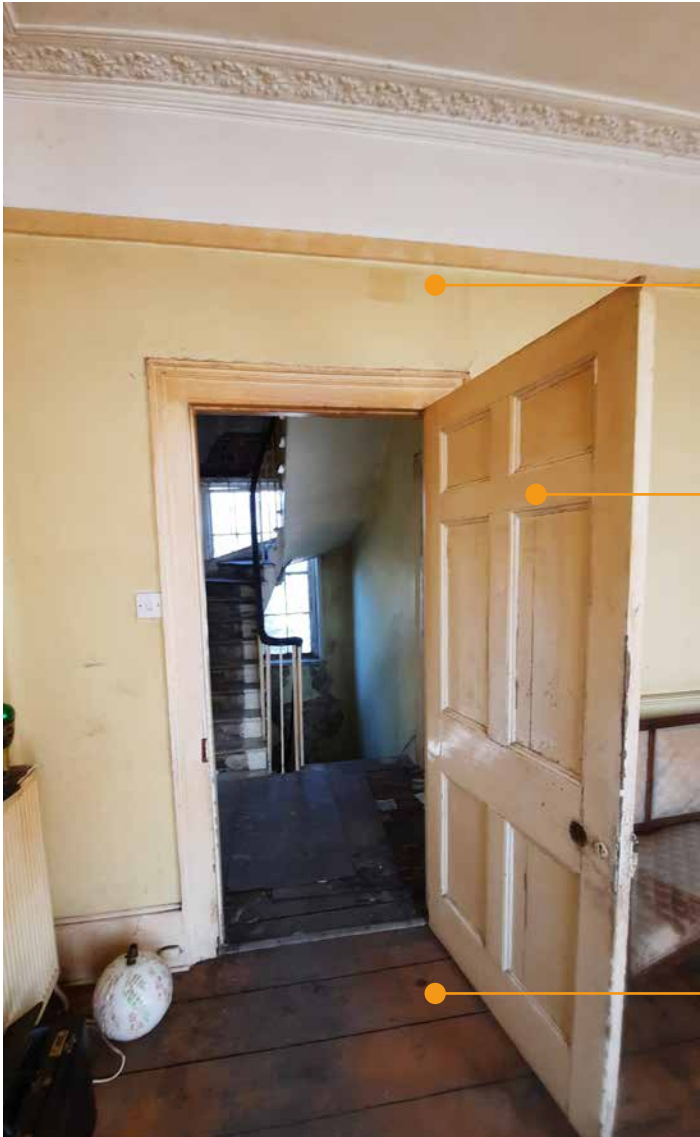
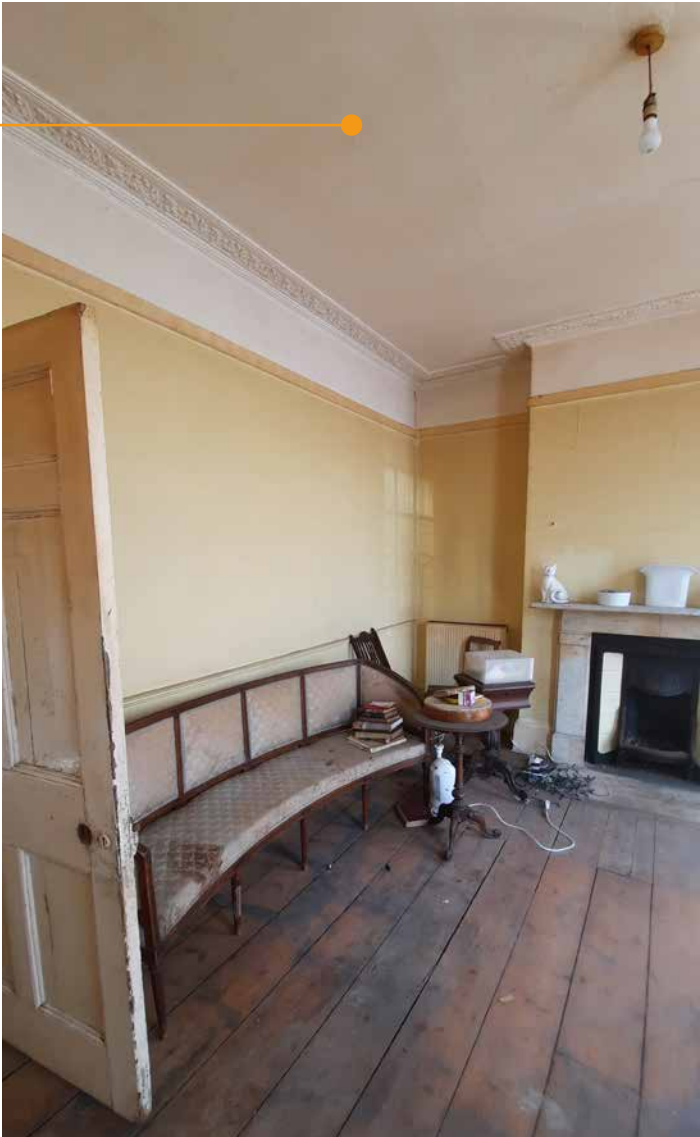
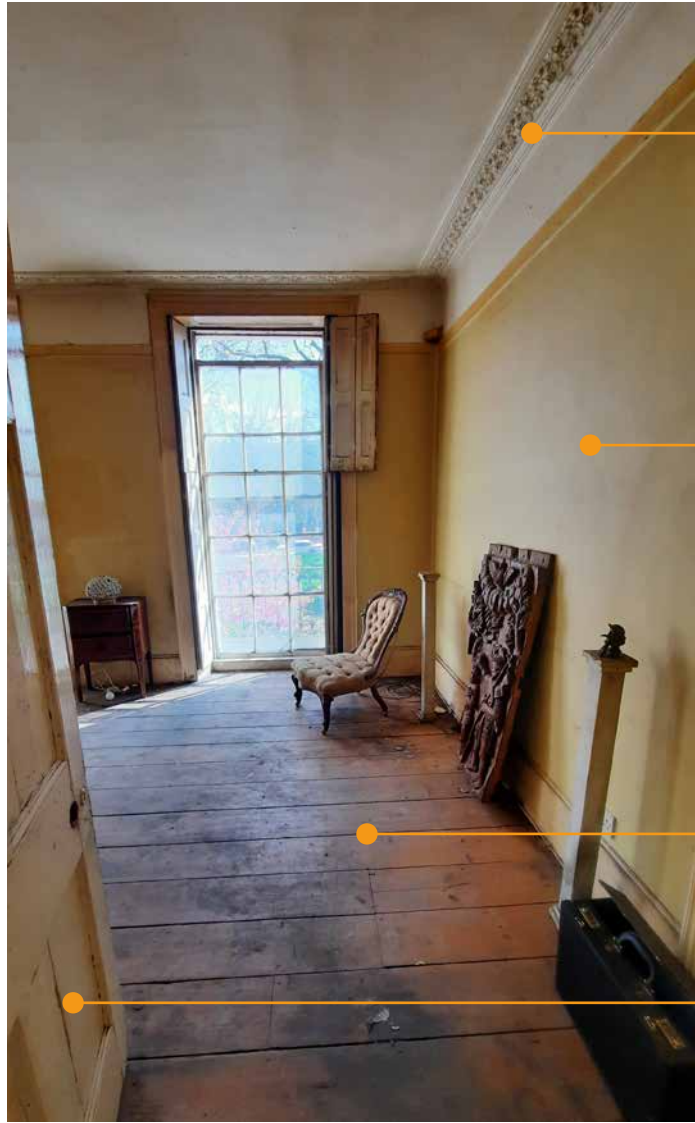
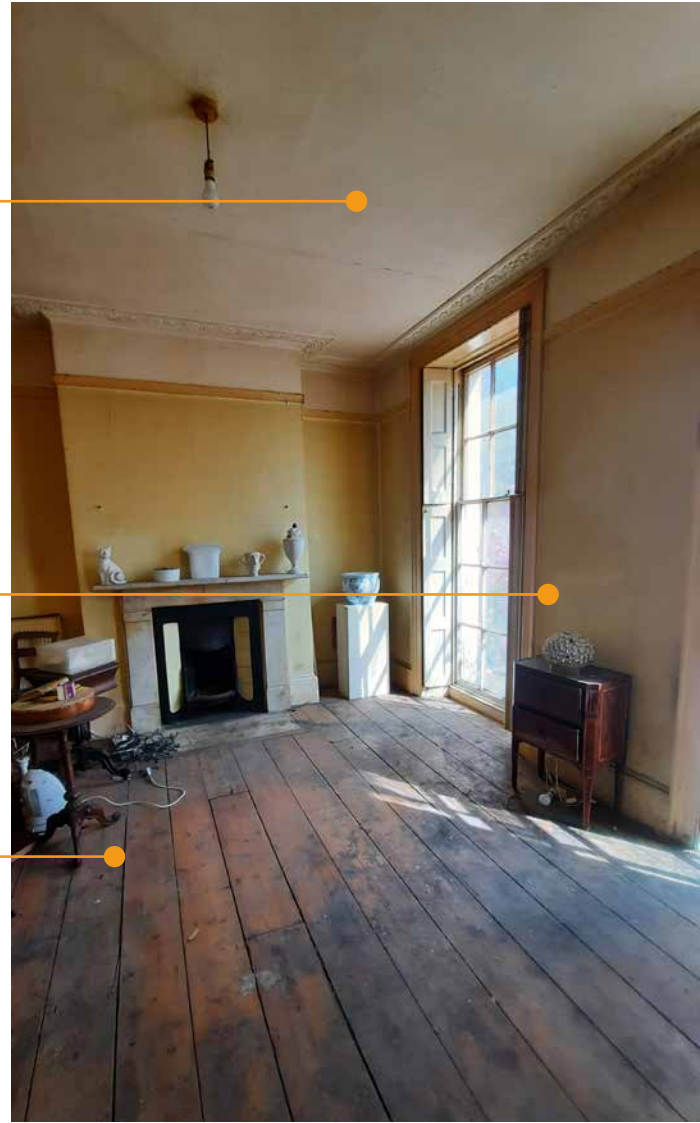
# 10.1 Bedroom 01 - Photographs

Item	Description	Condition	Proposal
1	Ceilings	peeling paper	remove damaged plaster and repair with lime plaster
2	Walls	papered	remove paper, repair damaged areas with lime plaster and paint
3	Shutter	poor	remove and refurbish and reinstate
4	Floors	timber boards	sand and treat
5	Door	poor	Retain original door and architrave, repair and fill any cracks and paint white
6	Radiator	rusted modern radiator	replace with column radiator

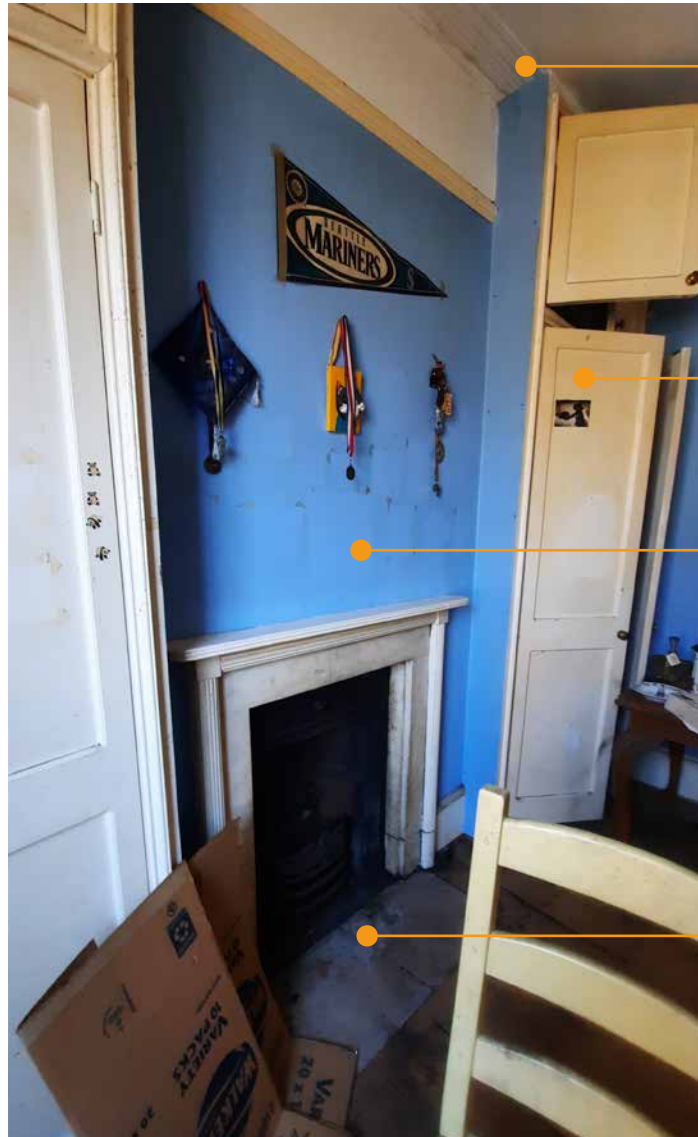
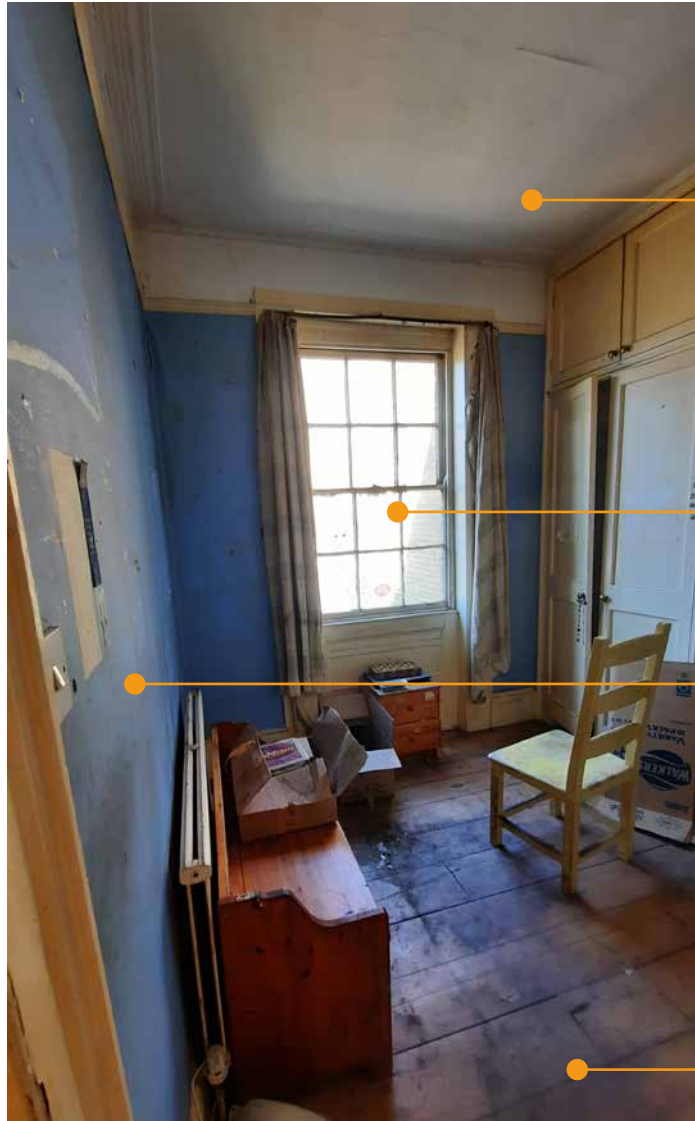
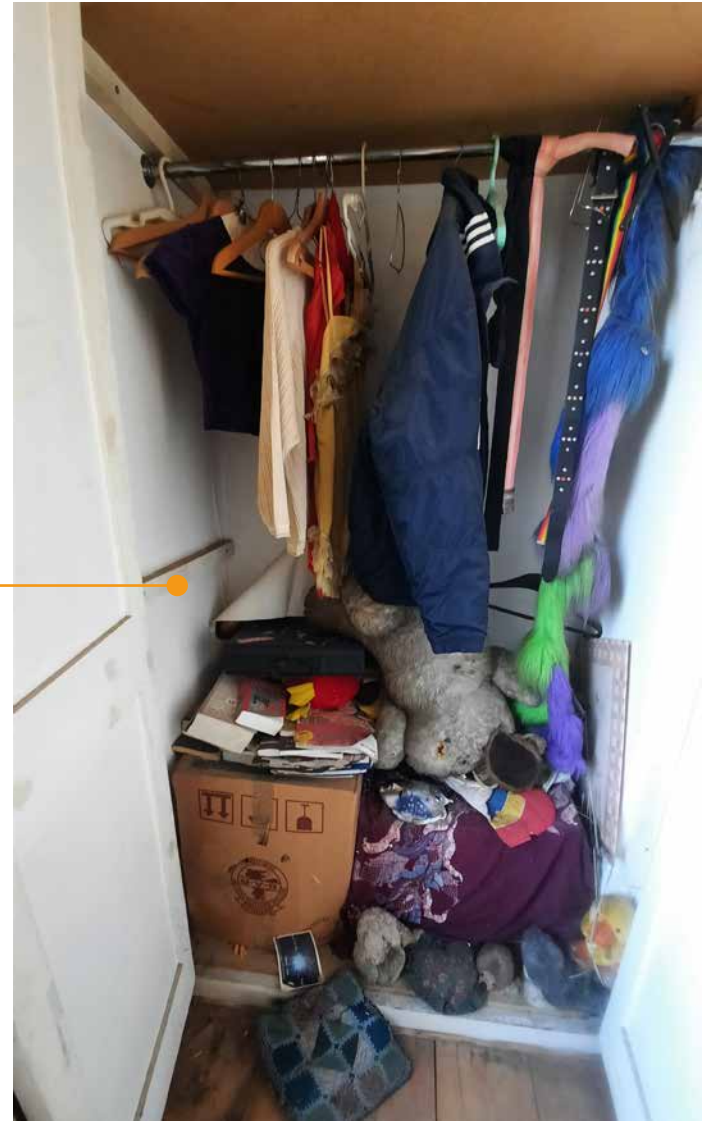
# 11.1 Bedroom 02 - Photographs

Item	Description	Condition	Proposal
1	Ceilings	peeling paper	remove damaged plaster and repair with lime plaster
2	Walls	papered	remove paper and assess plaster repair damaged areas with lime plaster and paint
3	Shutter	poor	remove and refurbish and reinstate
4	Floors	timber boards	sand and treat
5	Wooden panelling	badly refurbished	remove chipboard and reinstate new timber paint
6	Door	poor	remove damaged plaster and repair with lime plaster
7	Radiator	rusted modern radiator	replace with column radiator

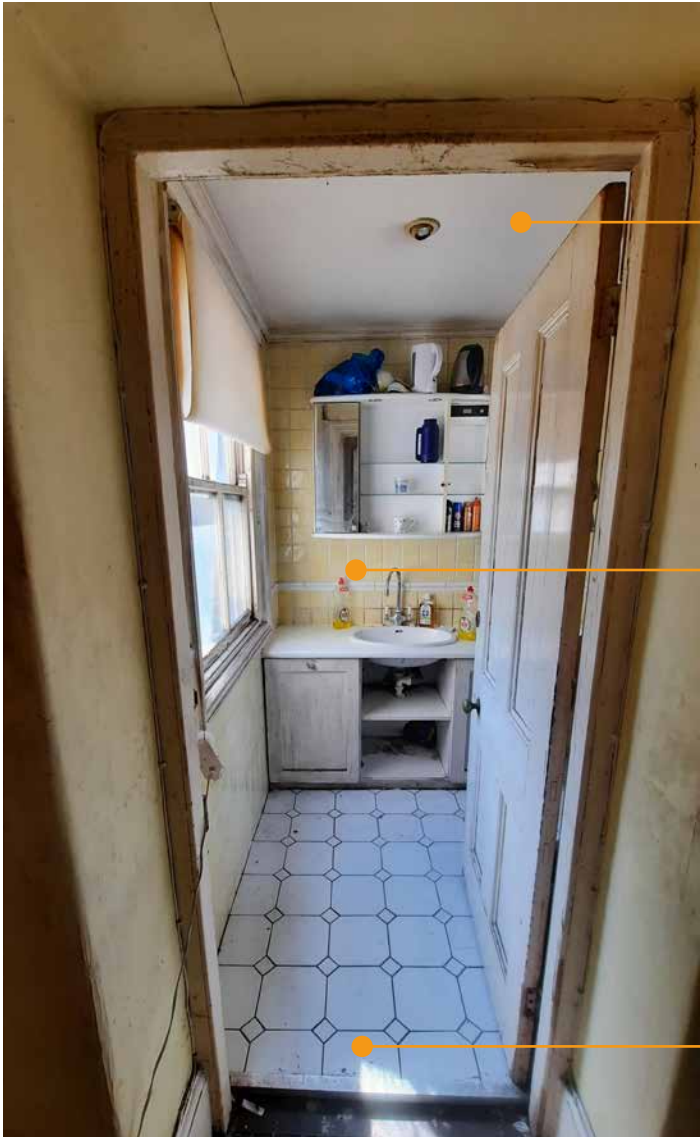
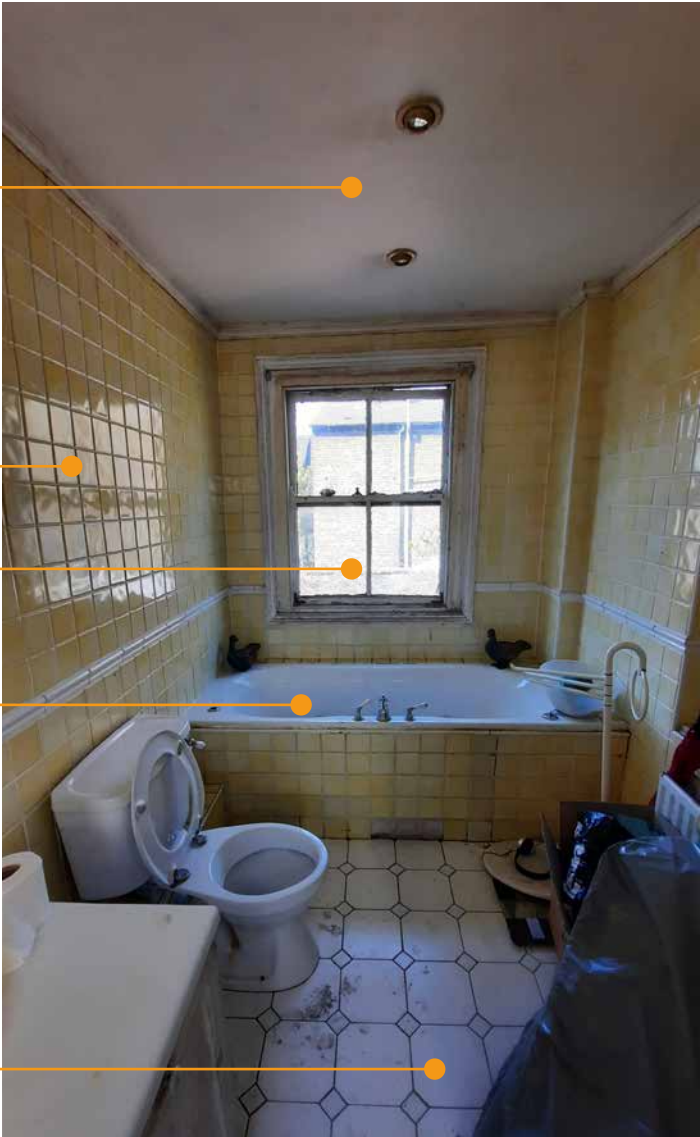
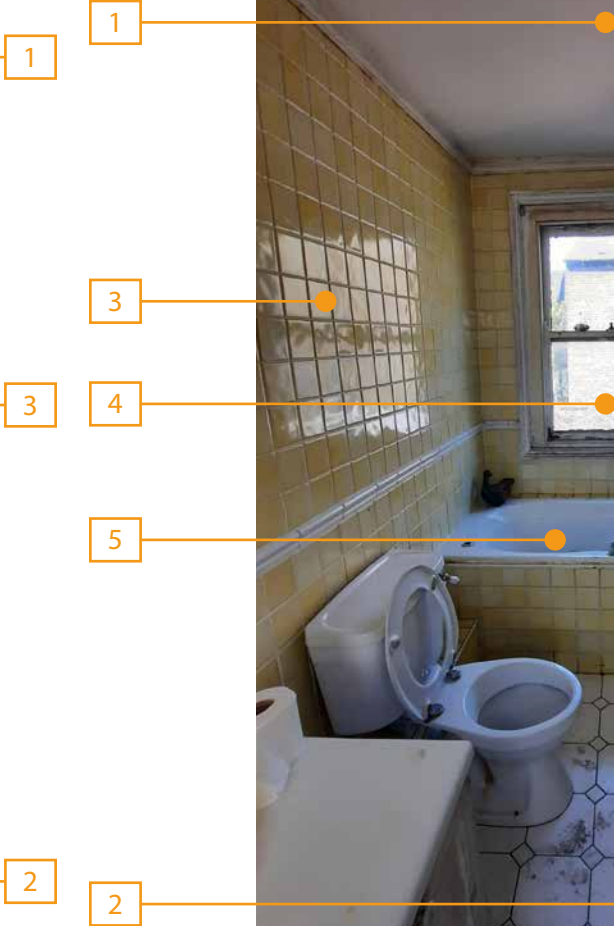
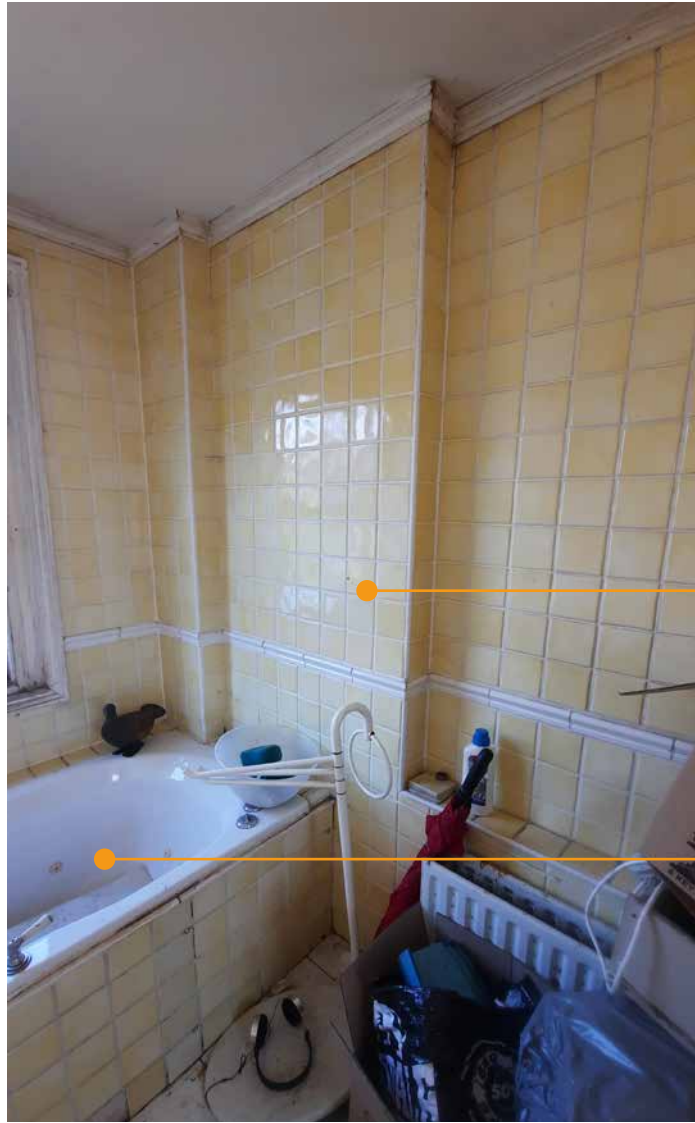
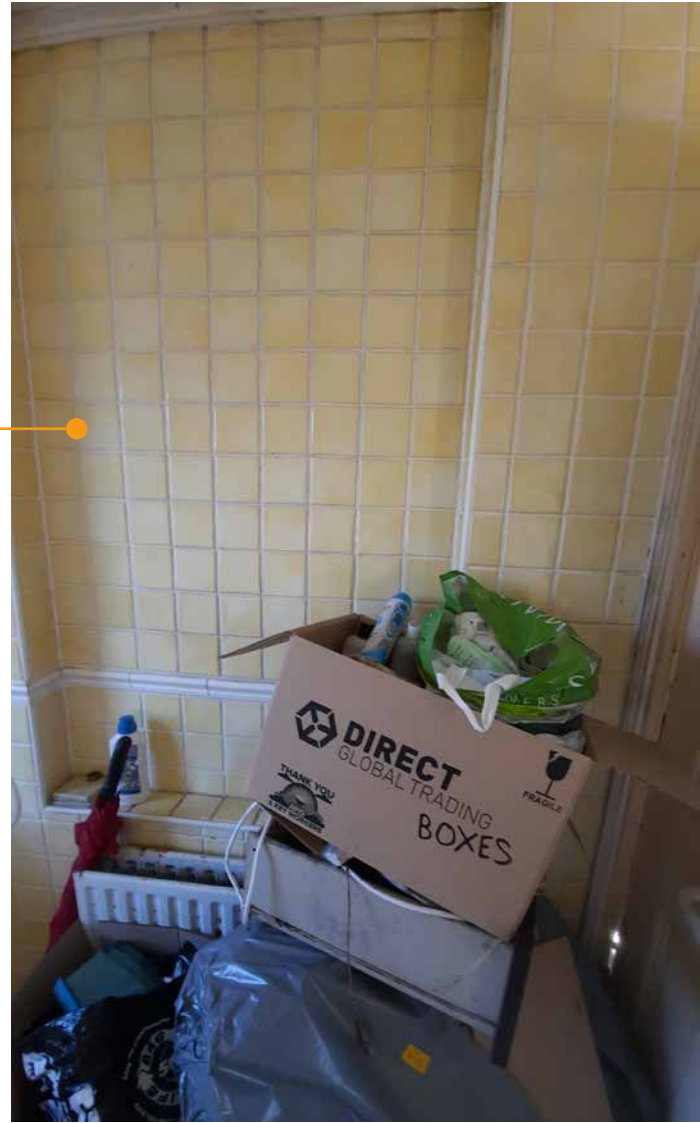
# 12.1 Bathroom - Photographs

Item	Description	Condition	Proposal
1	Ceiling	modern plaster board and spotlights	remove ceiling and replace with new plasterboard with insulation above
2	Floors	tiled	decayed timbers and wall plates to be replaced, replace tiles with new one
3	Walls	tiled	remove and replace tiles with new insulation, tiles, mechanical extract
4	Windows	rotten	replace with new timber sash windows
5	Furniture	damaged	replace with new
6	Door		Retain original door and architrave, repair and fill any cracks and paint white.

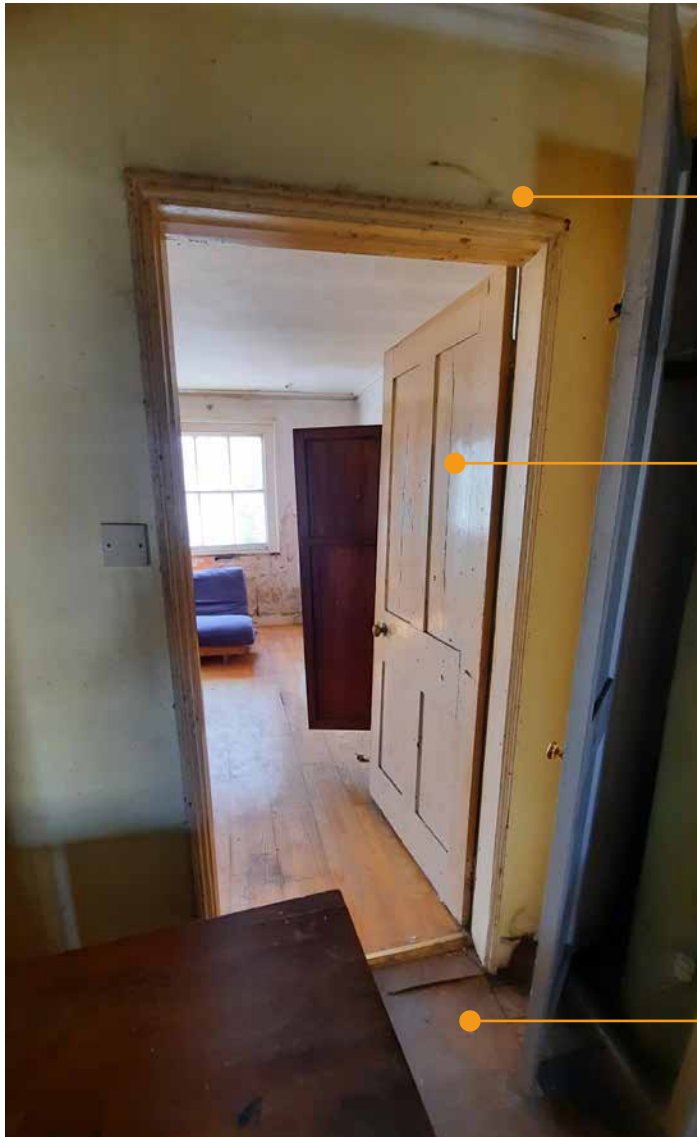
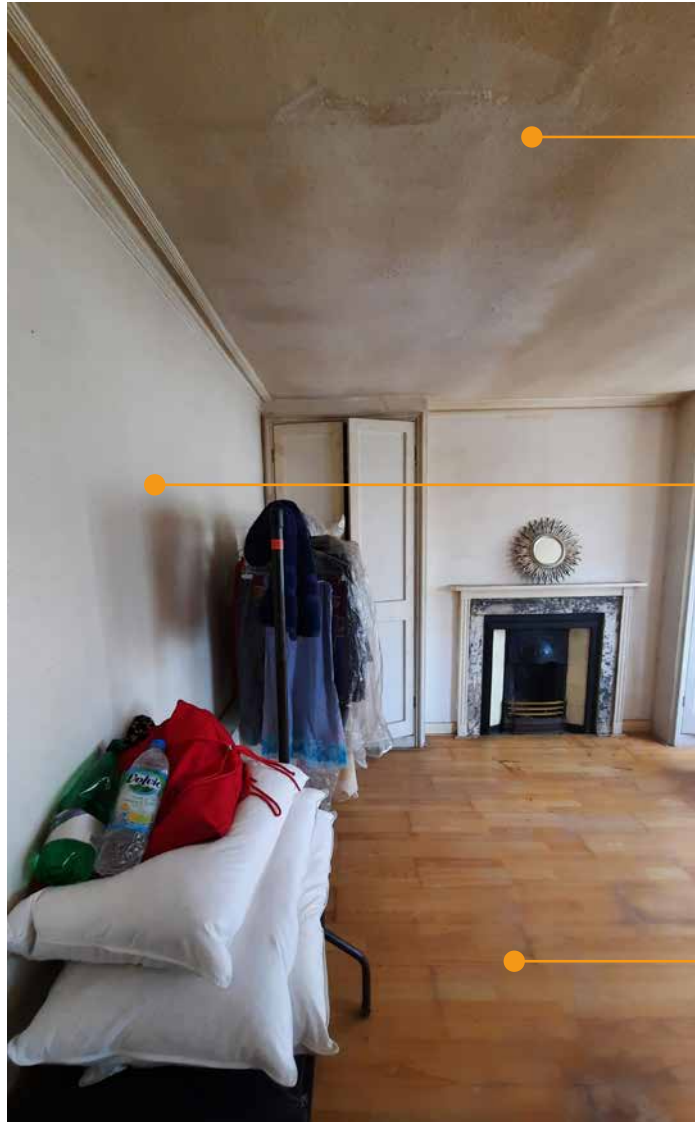
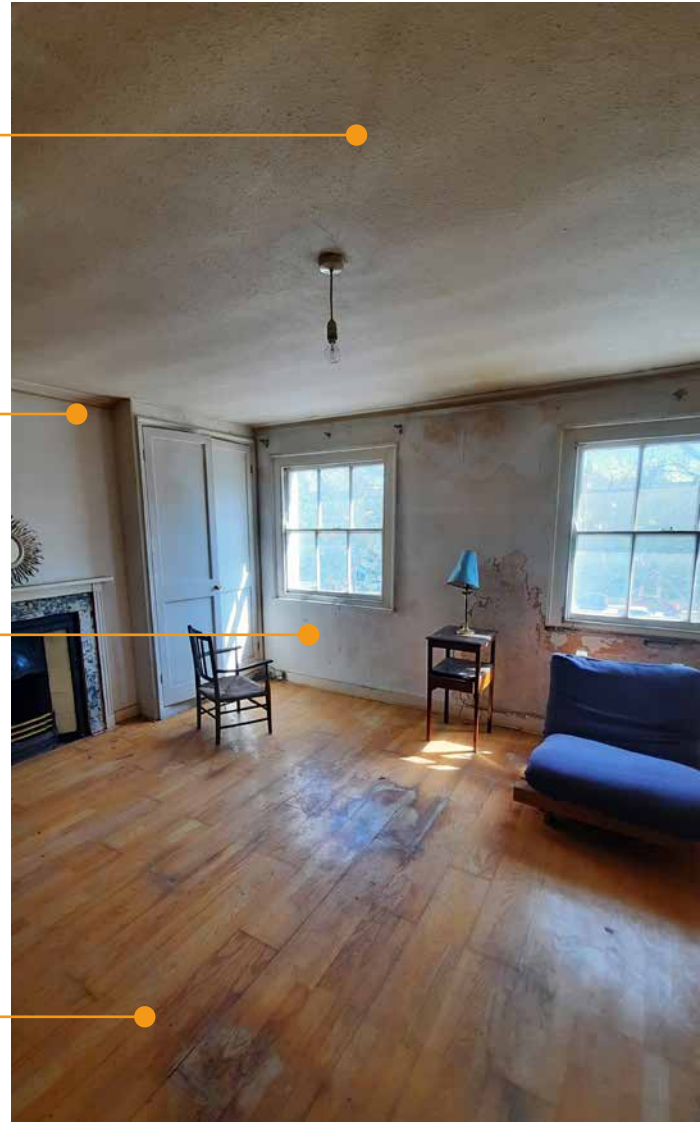
# 13.1 Bedroom 03 - Photographs

Item	Description	Condition	Proposal
1	Ceilings	peeling paper	Remove plasterboard and replace with new plasterboard and skim. Modern unoriginal coving to be replaced with egg dart style coving
2	Walls	papered	Remove plaster/plasterboard and replace with new plasterboard and skim
3	Floors	timber boards	Repair cracked boards, to be covered with underlay and carpet
4	Door	poor	Retain original door and architrave, repair and fill any cracks and paint white. Move internal door location to accommodate 2nd floor shower room
5	Radiator	rusted modern radiator	replace with 2 new column radiators under windows

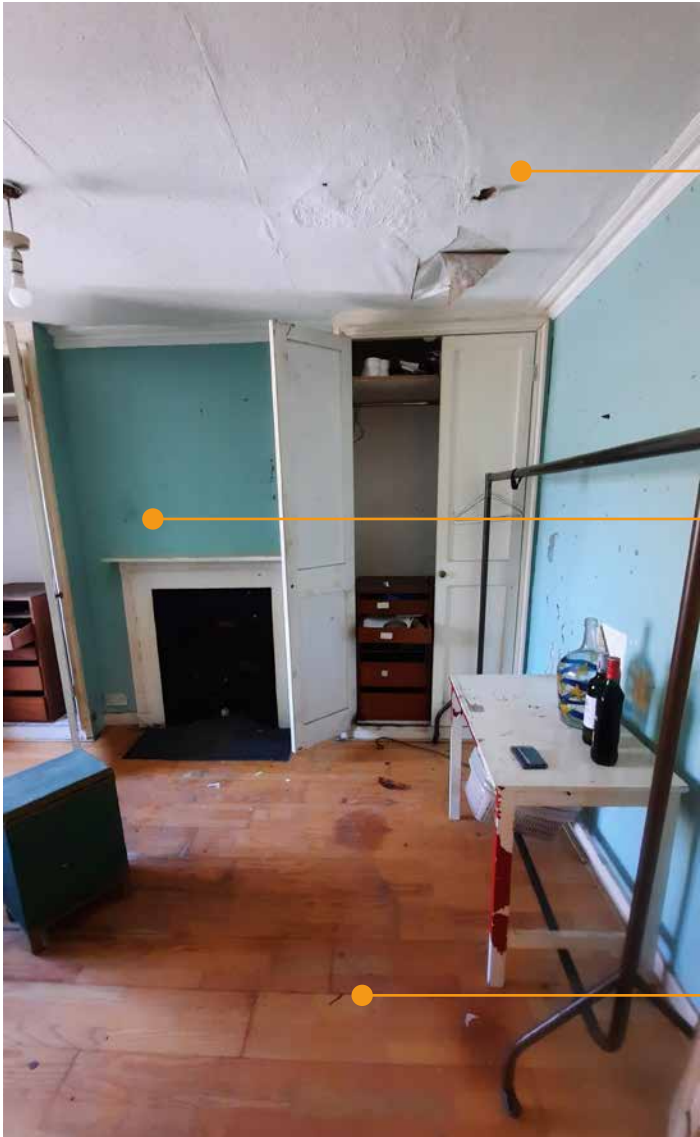
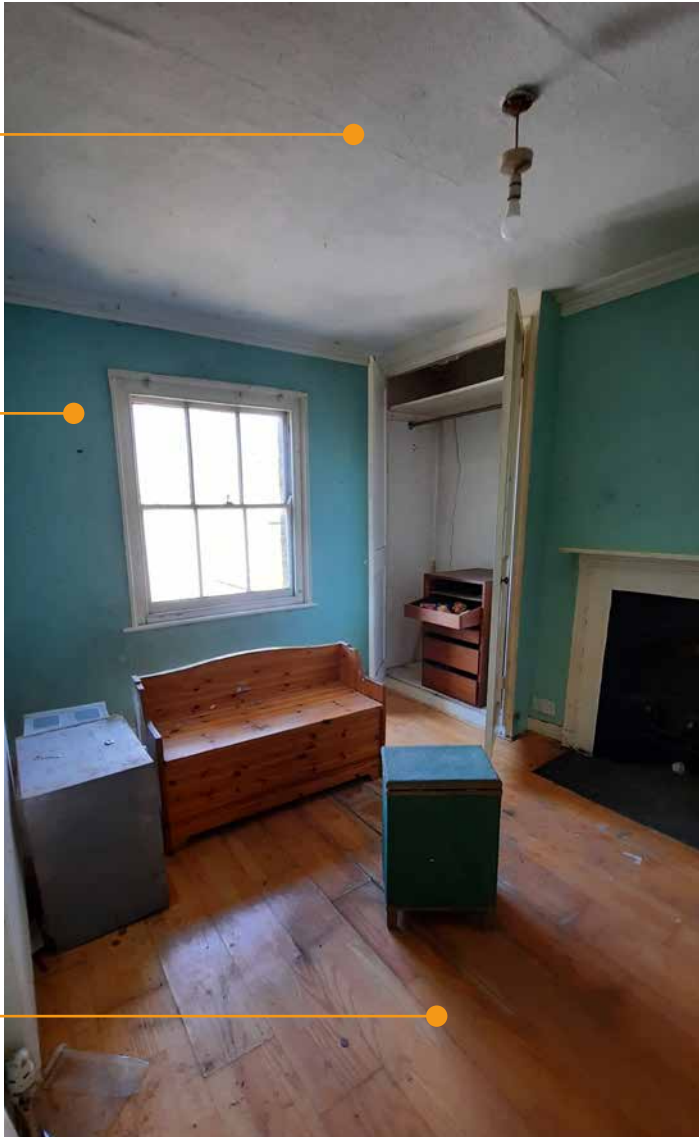
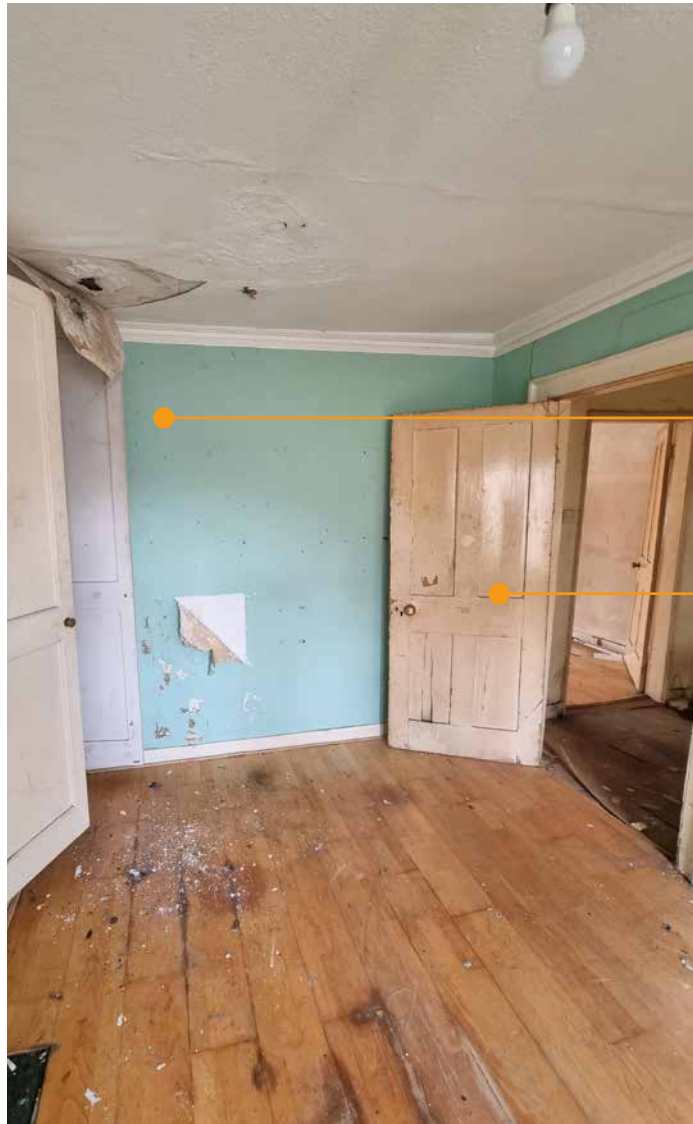
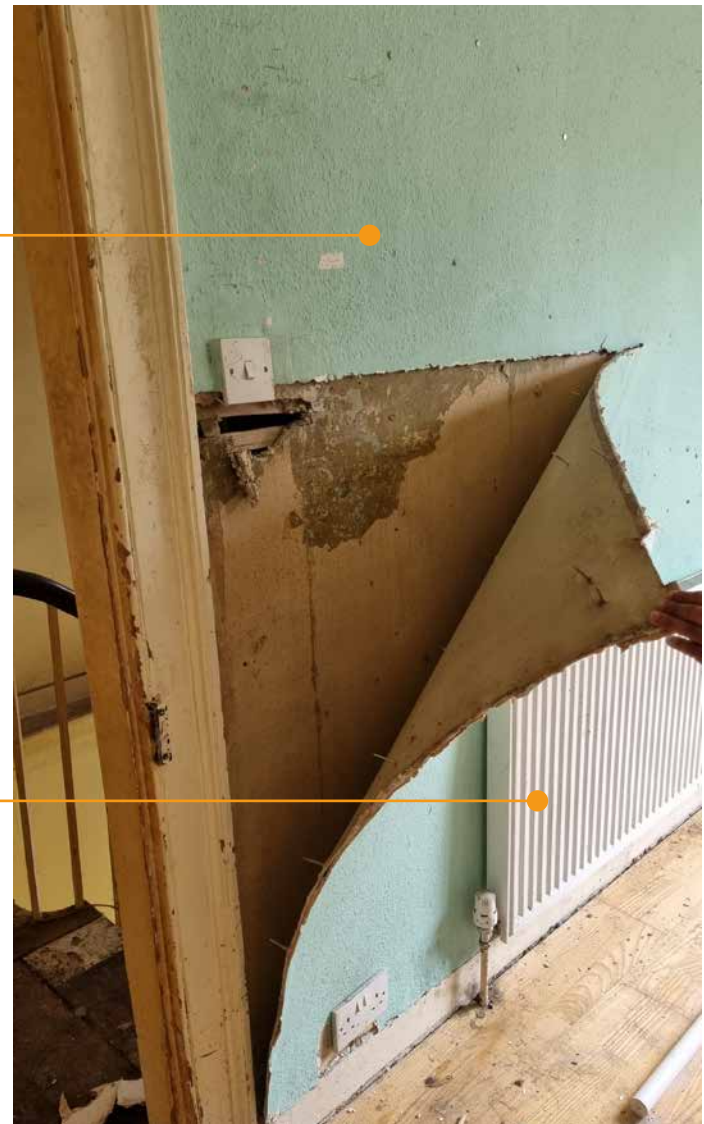
# 14.1 Bedroom 04 - Photographs

Item	Description	Condition	Proposal
1	Ceilings	peeling paper	Remove plaster/plasterboard and replace with new plasterboard and skim. Non-original modern coving to be replaced by Georgian egg dart style coving
2	Walls	papered	Remove plaster/plasterboard and replace with new plasterboard and skim
3	Floors	timber boards	Repair cracked boards, to be covered with underlay and carpet
4	Door	poor	Retain original door and architrave, repair and fill any cracks and paint white. Move internal door location to accommodate 2nd floor shower room
5	Radiator	rusted modern radiator	replace with column radiator
