# Extension and Refurbishment to 8 Addington Square London, SE5 7JZ

Design, Access and Heritage Statement

Ref: 281

September 2021

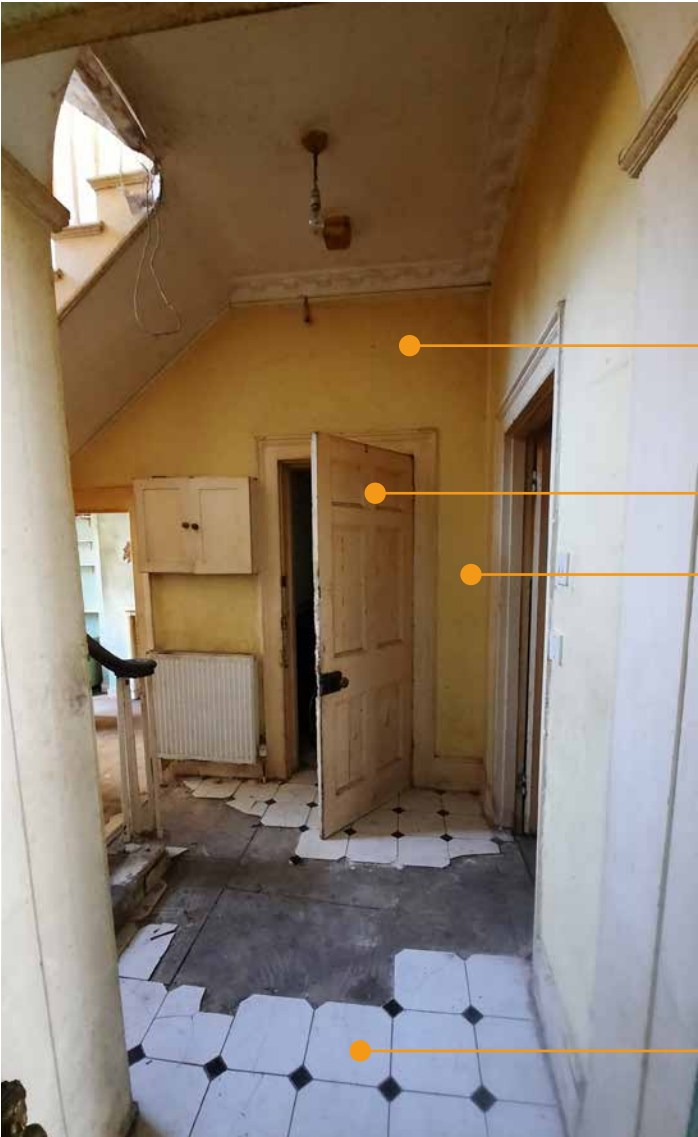
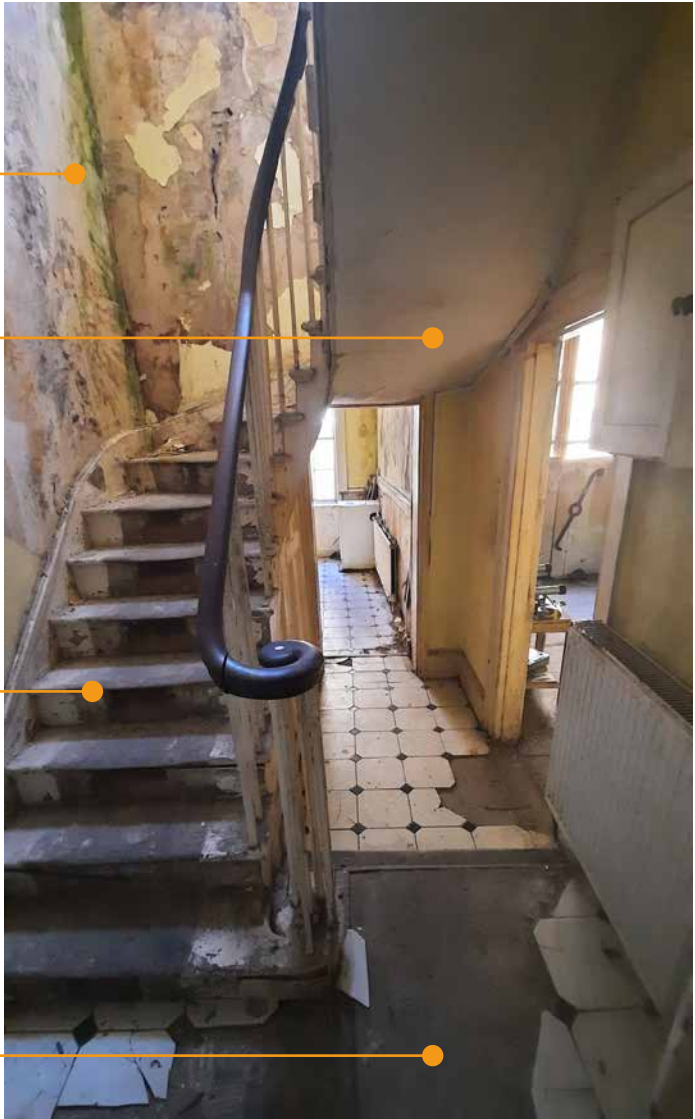
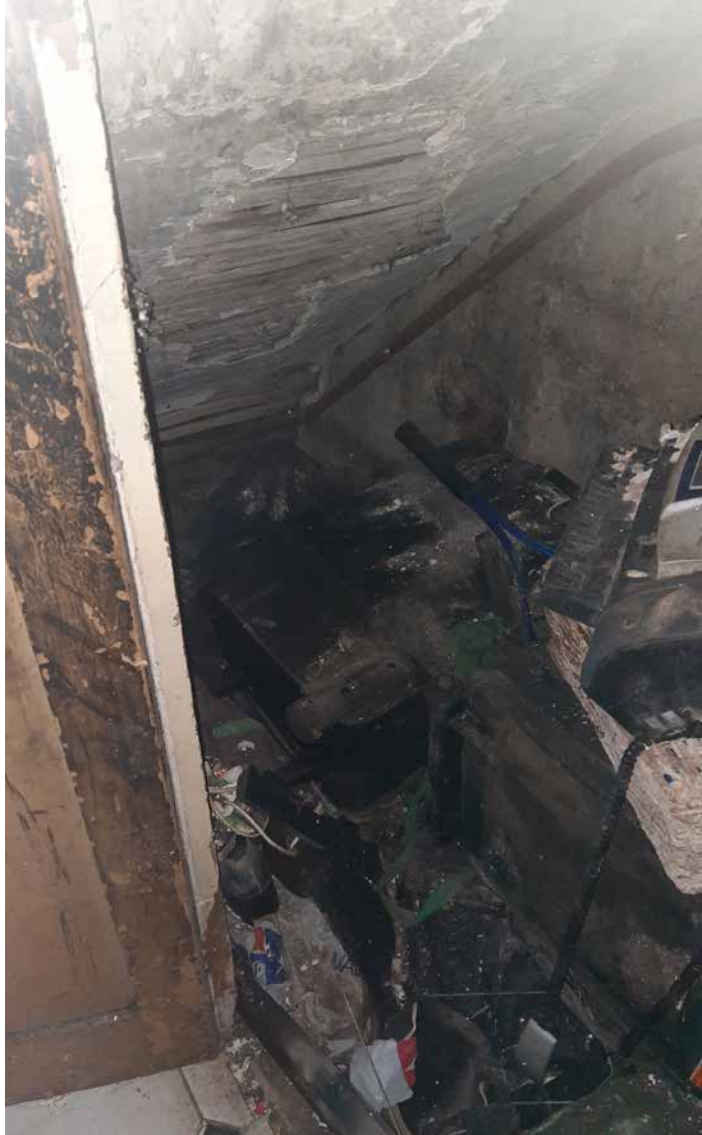
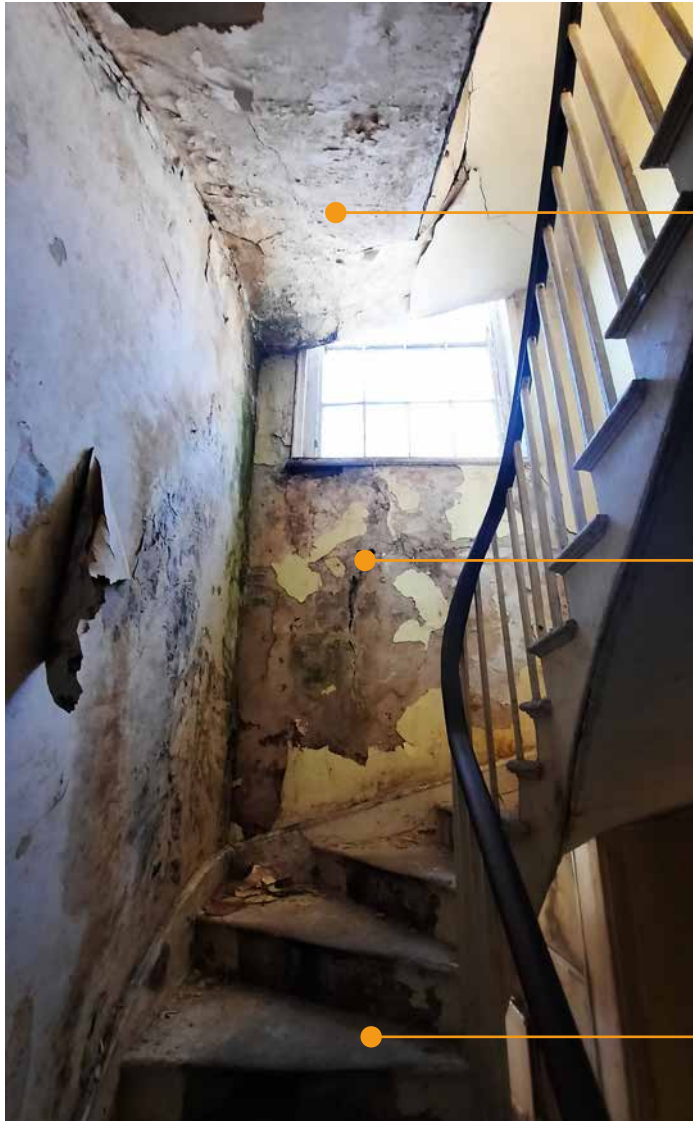
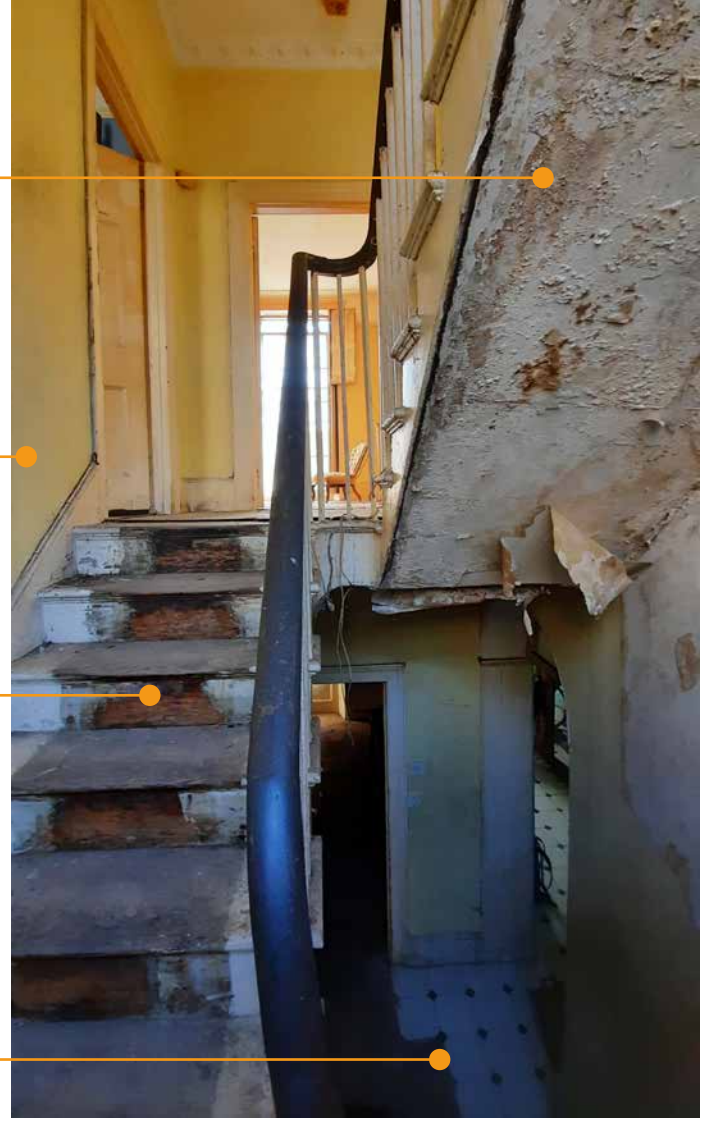
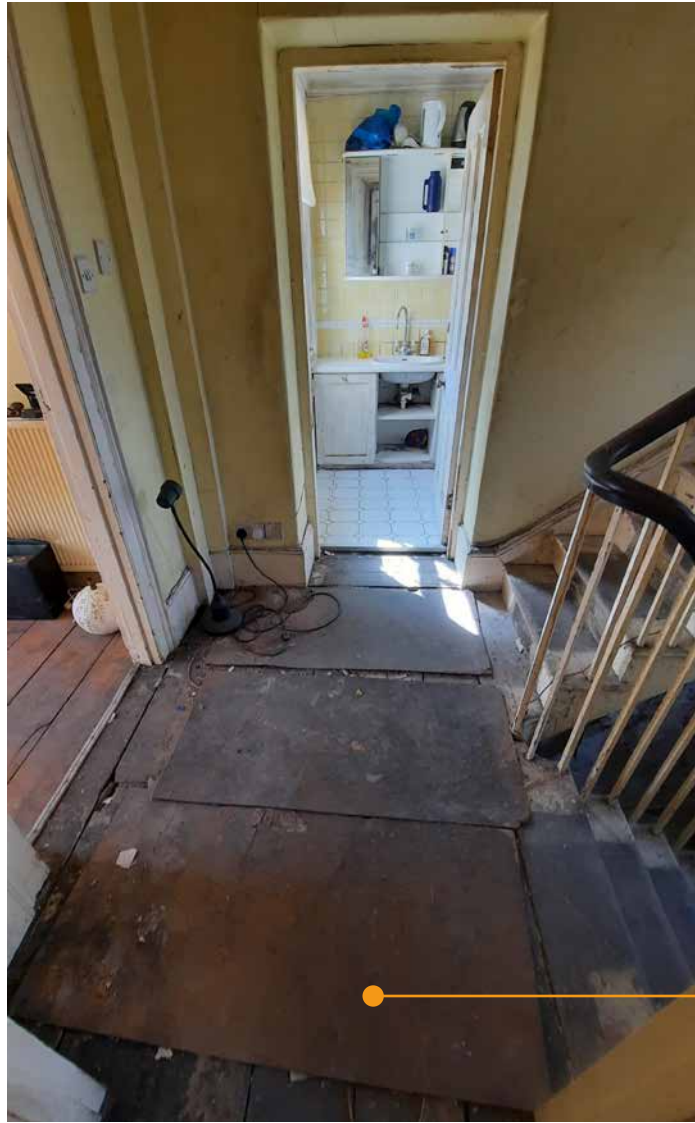
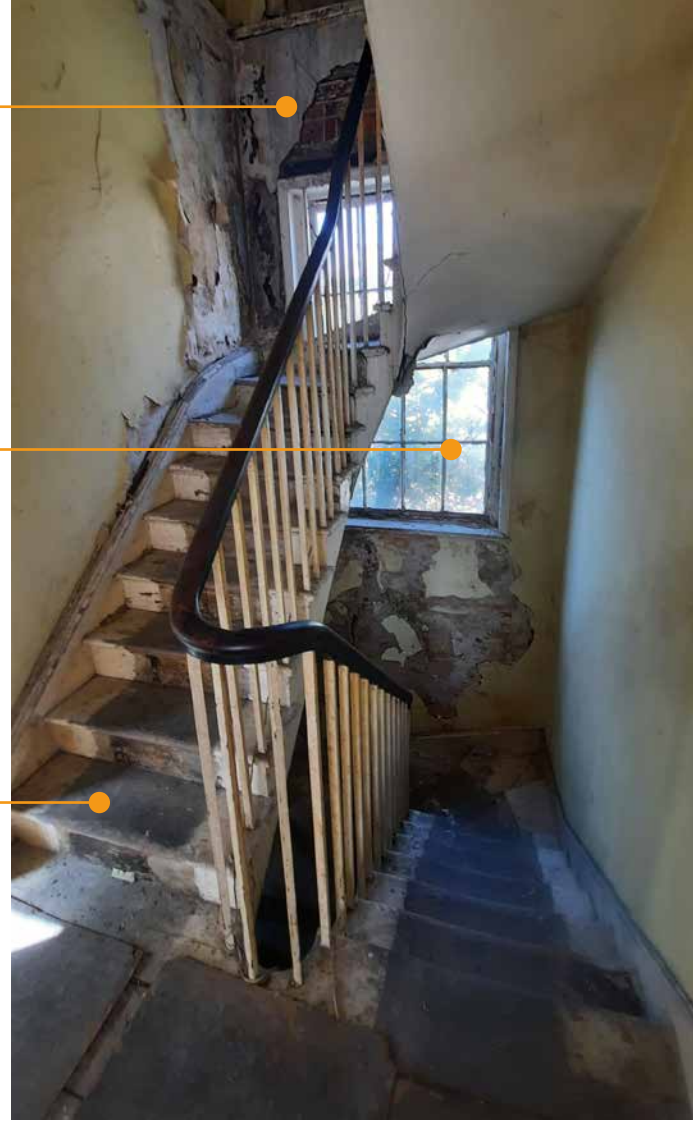
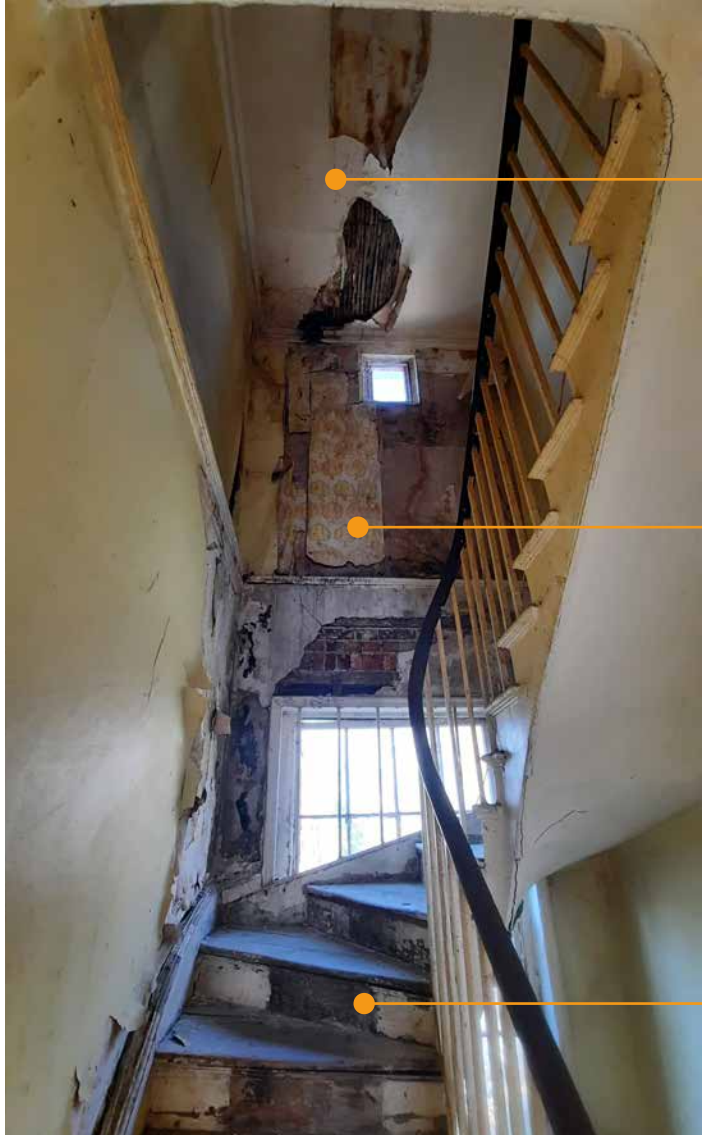
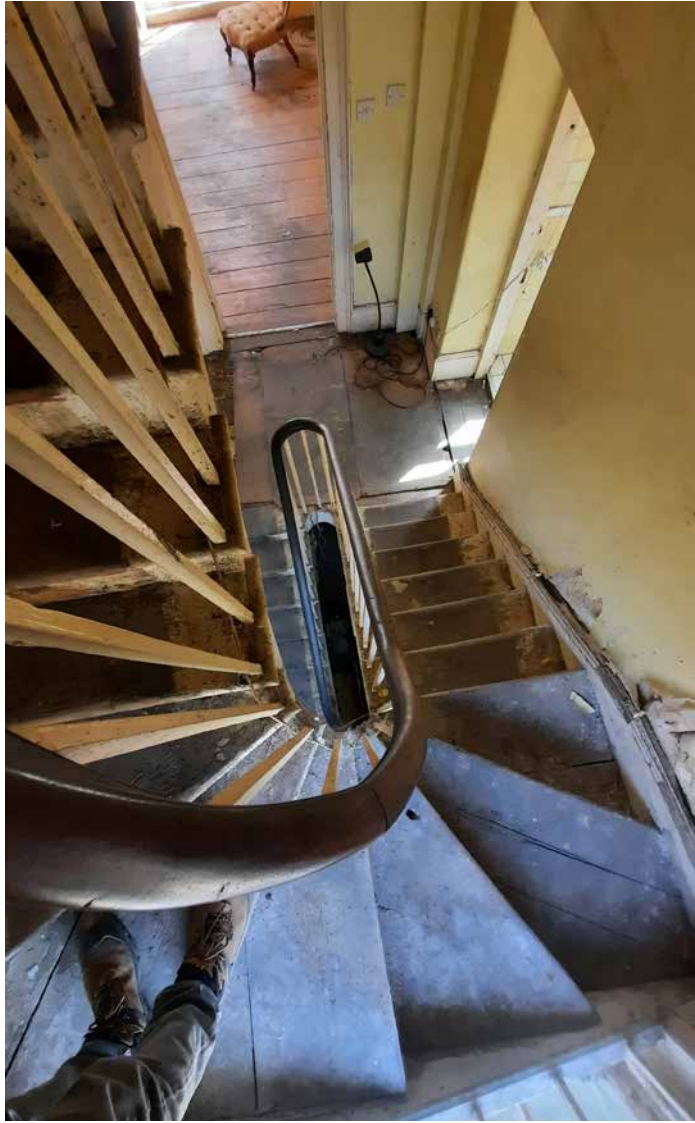
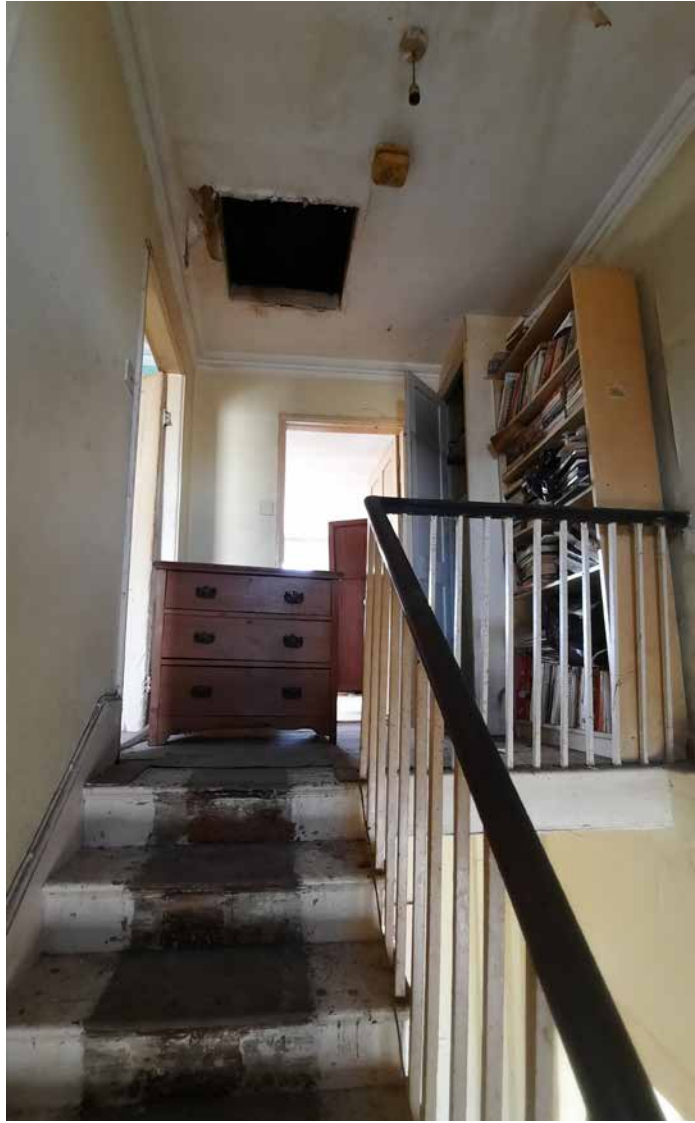
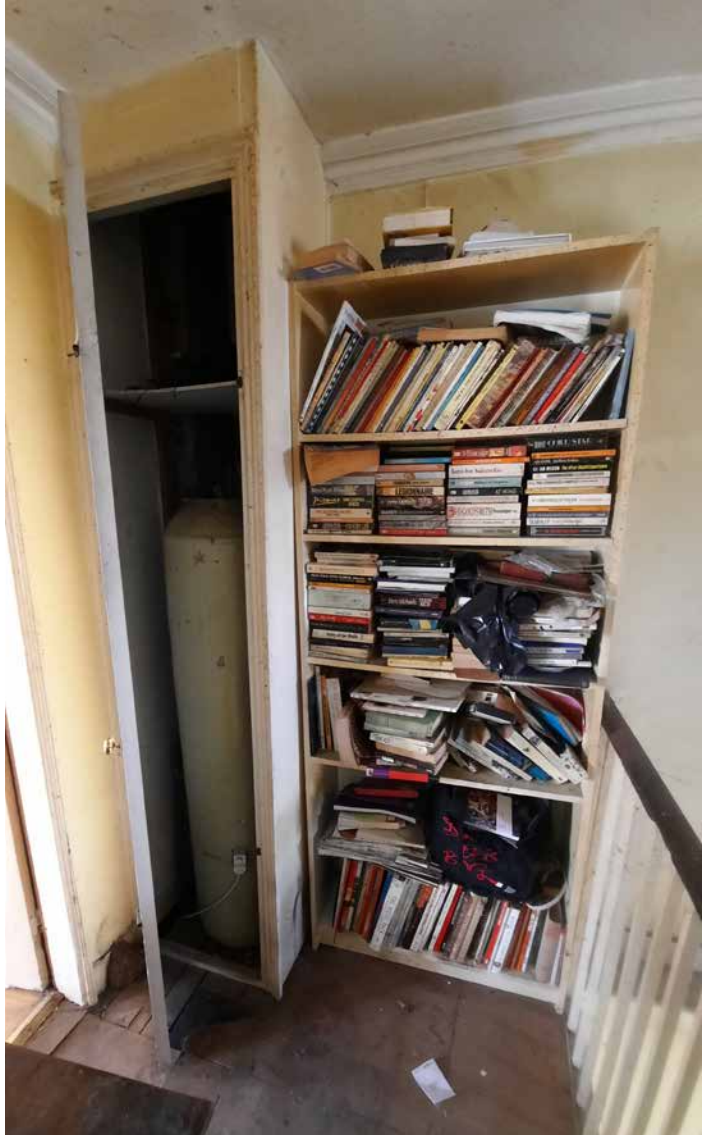
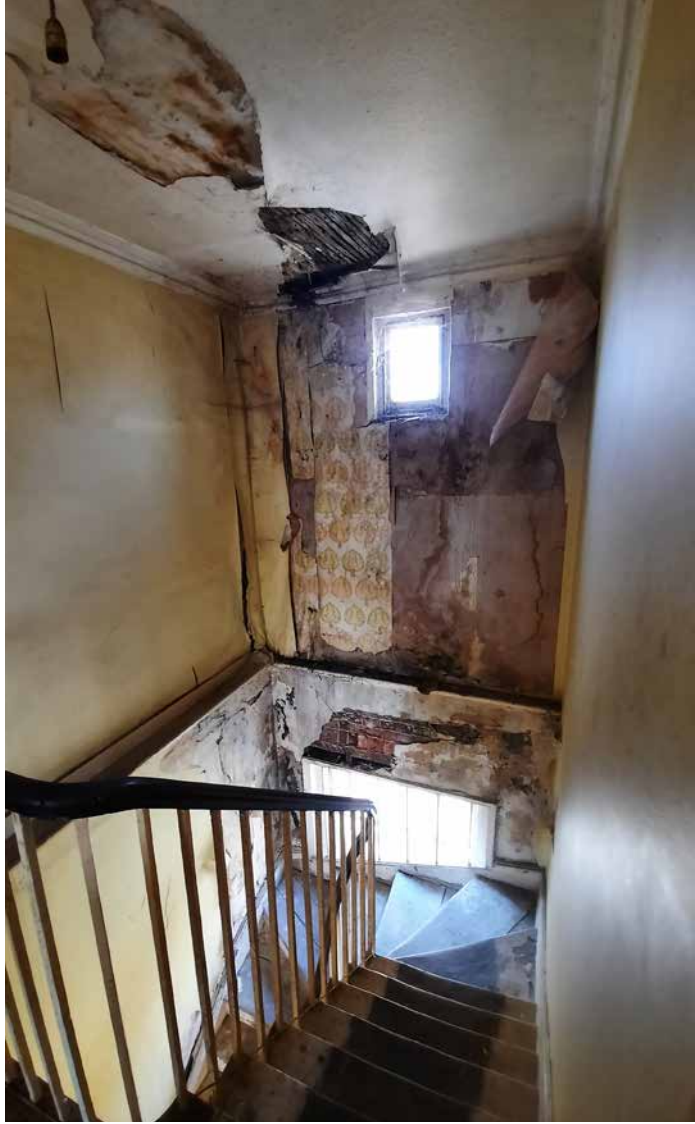
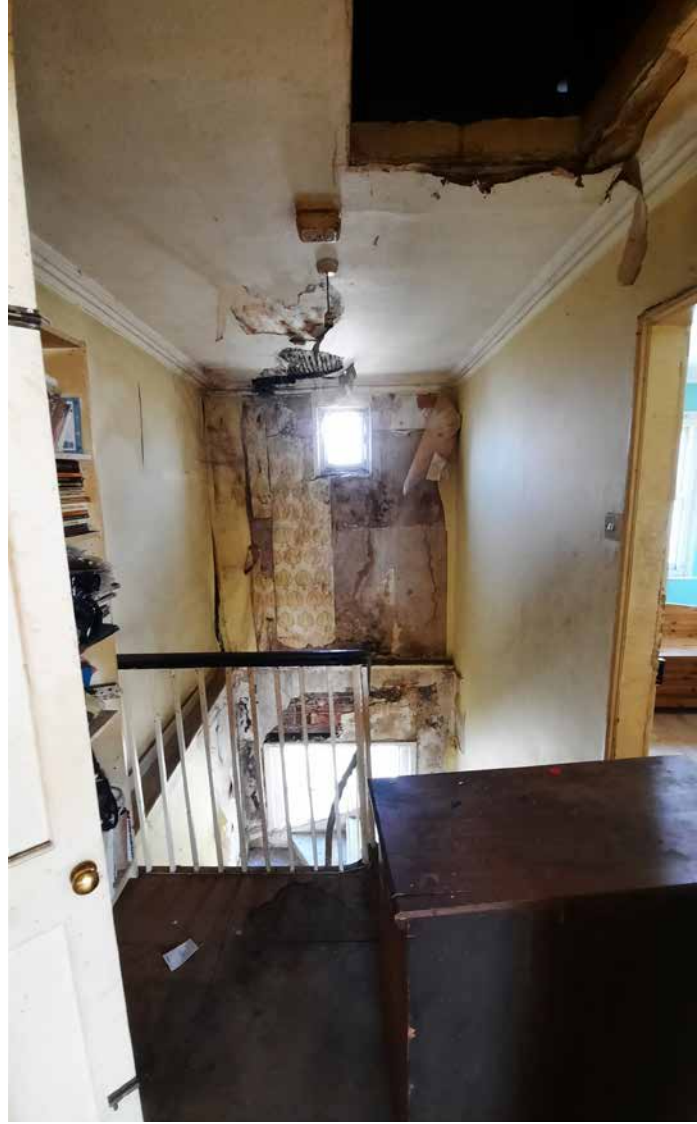
# 15.1 Stairwell - Photographs

Item	Description	Condition	Proposal
1	Walls	water damage and blown plaster throughout	remove all damaged plaster to allow structure to dry and new lime plaster, painted with breathable paint, remove paper and repair, repaint elsewhere
2	Ground Floor	tiled over chipboard	remove tiles and repair/replace substrate where required, new tiles over
3	First Floor	timber sheets over original floor boards	remove sheets, repair, replace floor boards
4	Stair Soffit	blown, damaged and damp plaster	remove damaged plaster for structural inspection
5	Staircase	coming away from wall	Retain Staircase and make structural repairs to decayed elements
6	Ceiling	damaged plaster	remove damaged plaster and repair with lime plaster

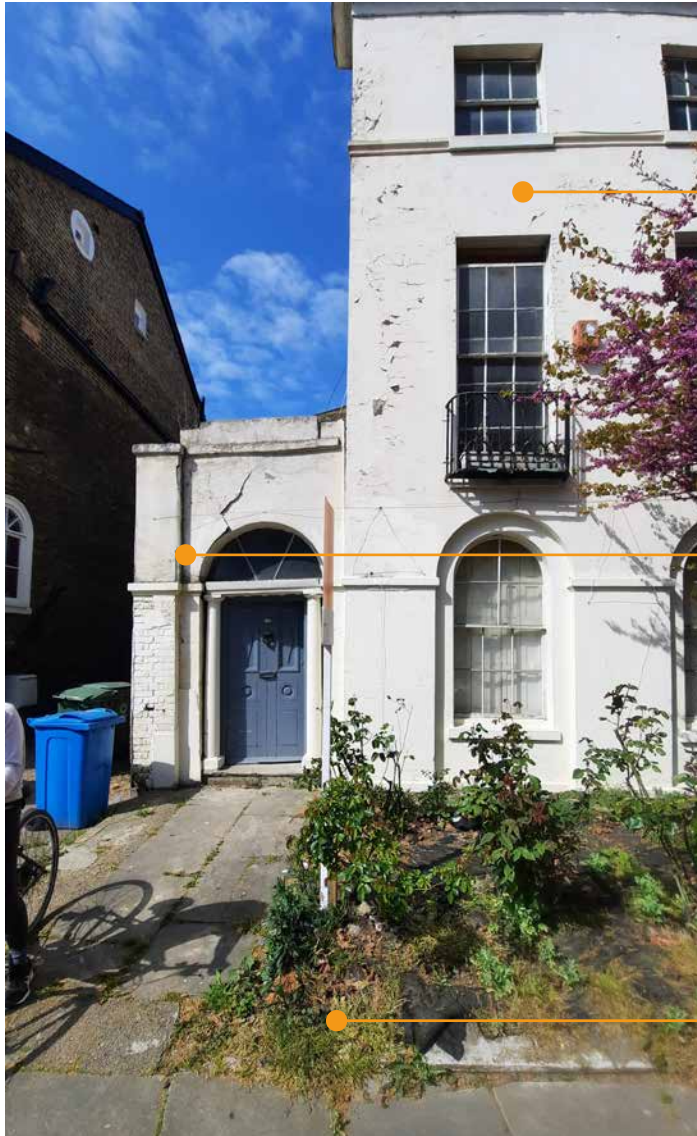
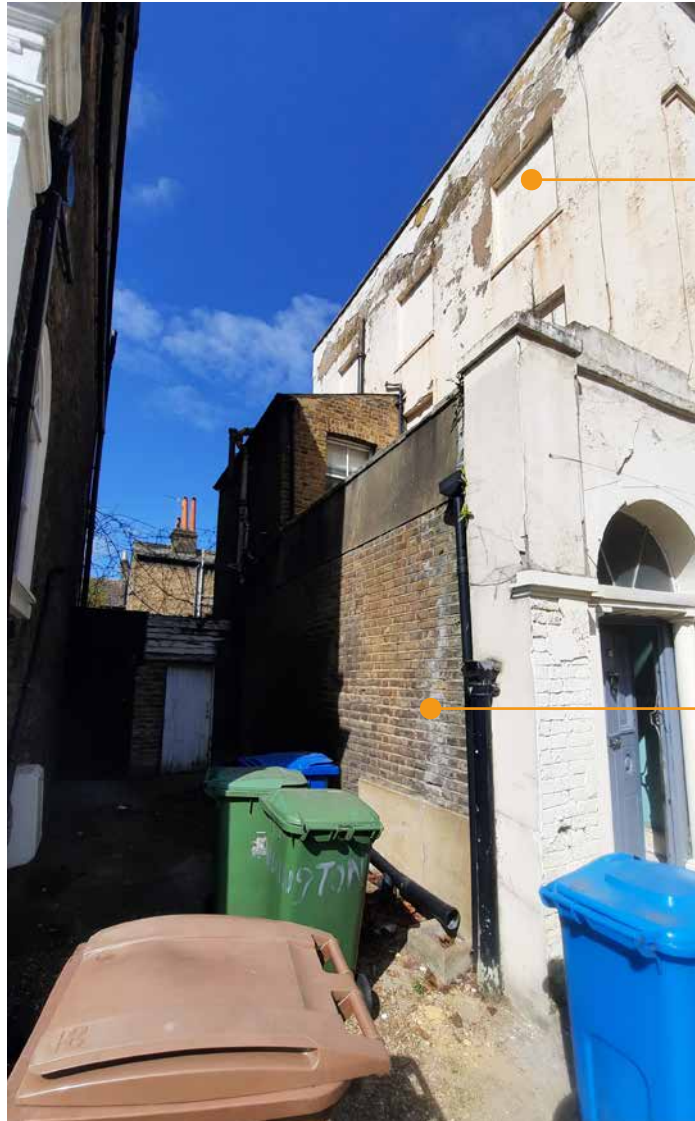
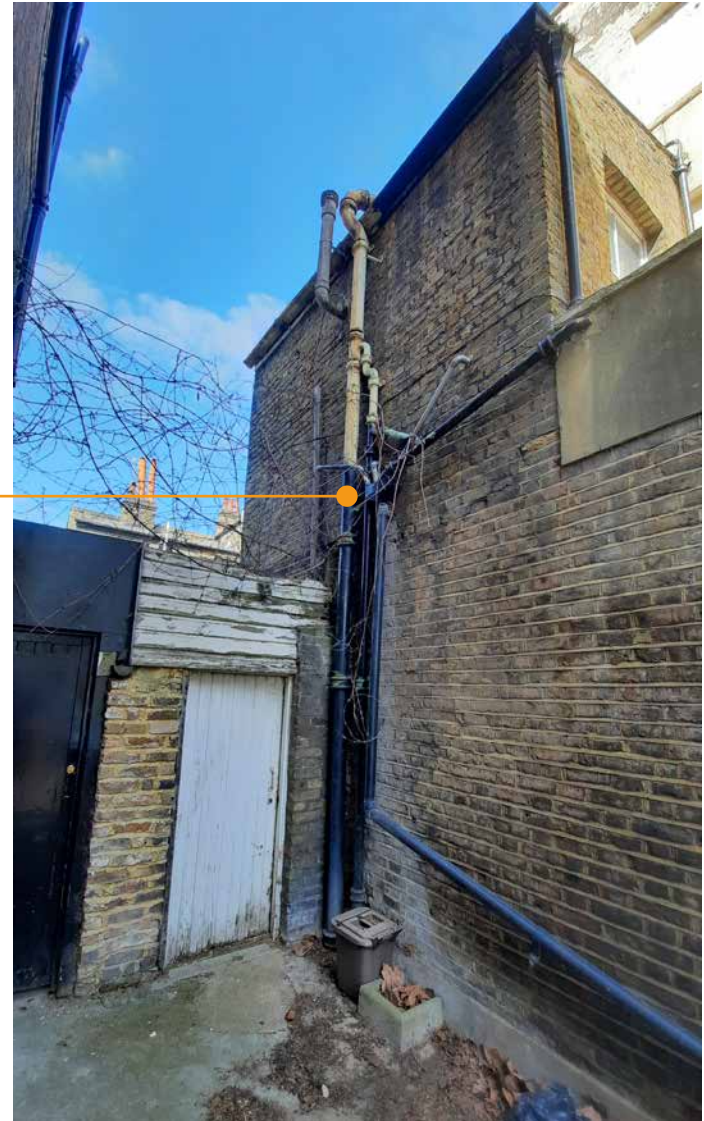
# 16.1 External Works - Front - Photographs

Item	Description	Condition	Proposal
1	Paintwork	peeling off	remove and repair render, repaint with breathable paint
2	Railings	removed	reinstate railing to match adjacent
3	Structural Damage to Porch	water damage	South and East walls of porch to be rebuilt on guidance from structural engineer
4	Brickwork	degraded	remove any cement mortar, clean and re-point with lime mortar
5	Waste / Soil piper	various stages of degradation	remove and replace with black metal, scheme to be designed

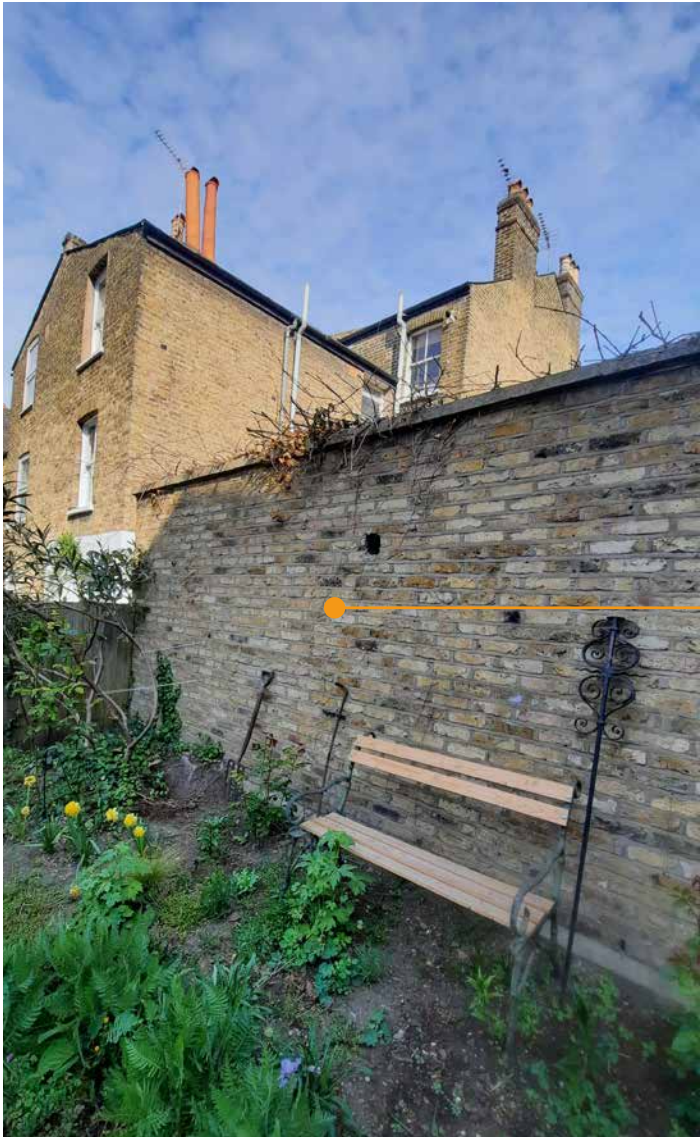
Item	Description	Condition	Proposal
1	New Extension Wall	Generally good condition. Some soil over slab edge	Retain and re-point where required
2	Store Wall	Water damaged, wall bowing	Remove and re-build with new cavity wall with London stock bricks to match

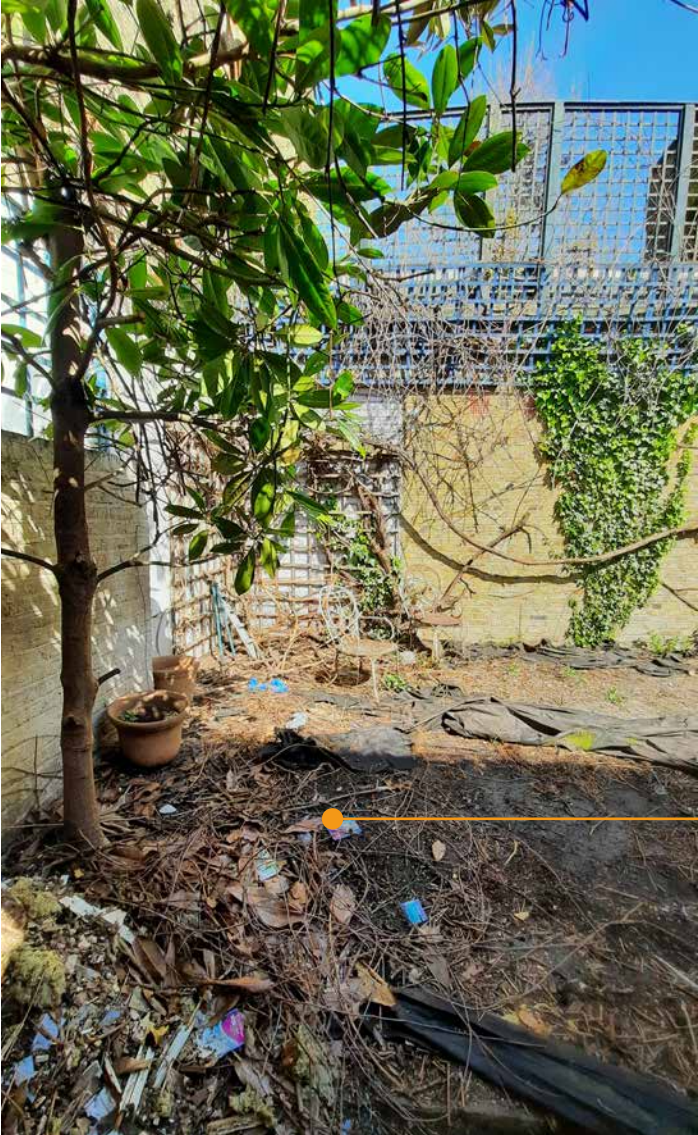
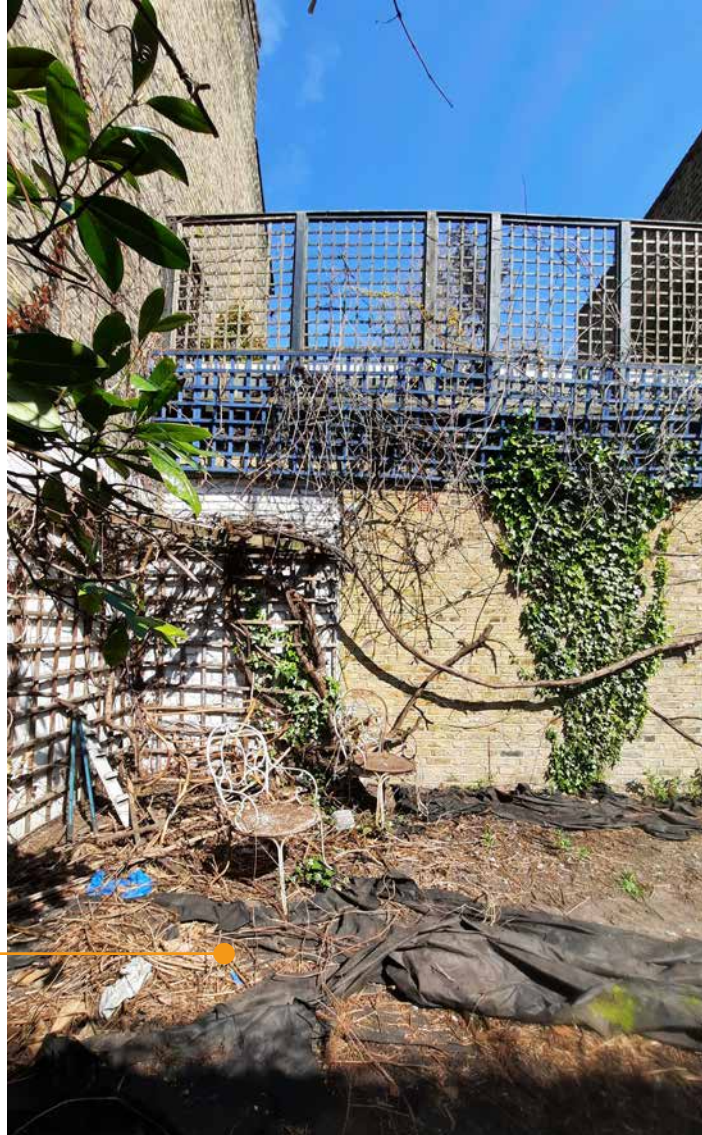
Item	Description	Condition	Proposal
1	Courtyard	Full of debris and over grown plants	remove debris and plants in anticipation of new scheme
2	Brickwork main dwelling	Water damaged	remove loose mortar and re-point with lime mortar
3	Rain water pipe	Blocked	clear and repair
4	Painted Brickwork	poor condition	remove all loose paint and repaint with breathable paint

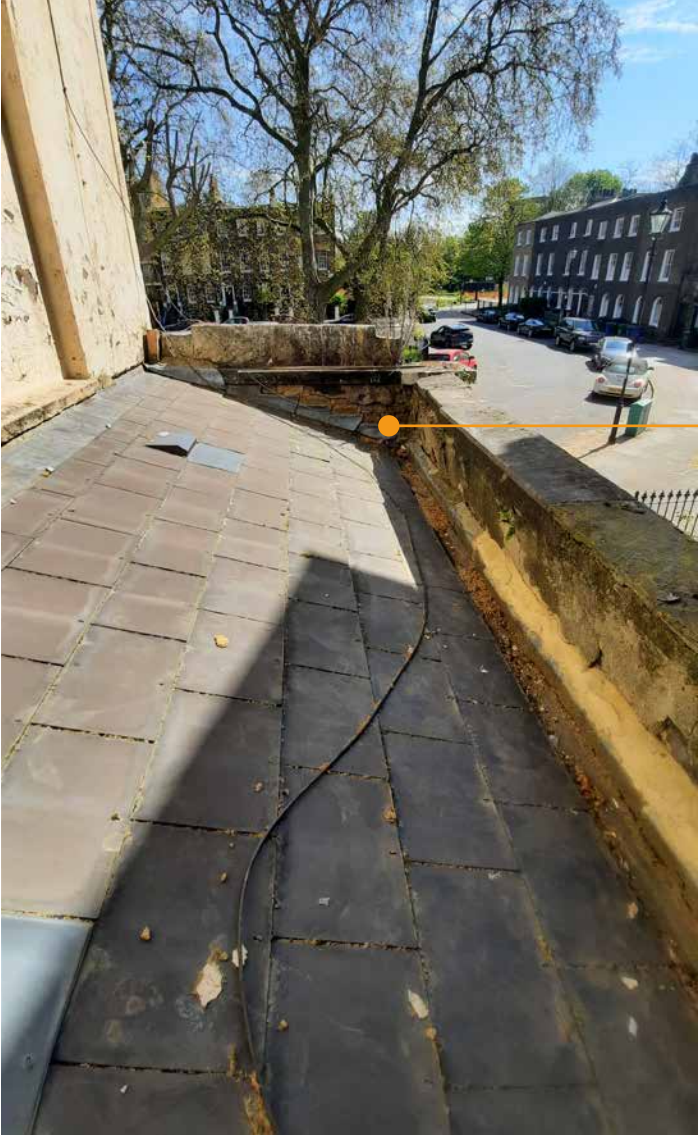
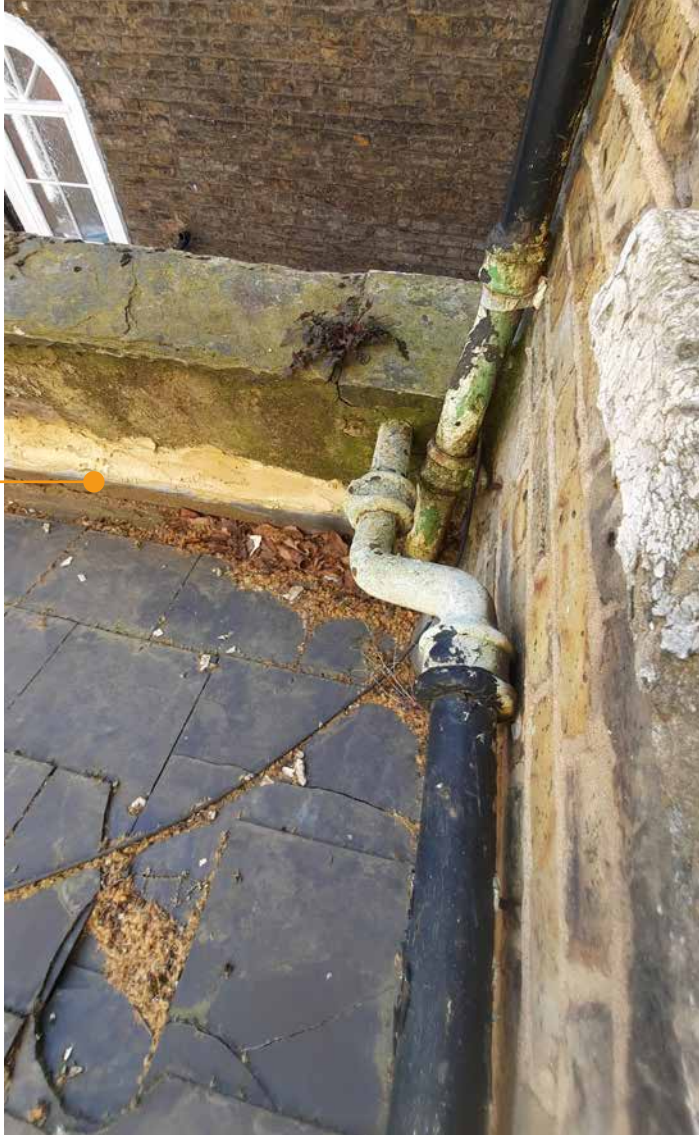
Item	Description	Condition	Proposal
1	Parapets	Saturated with water - crumbling brickwork and leaning.	Parapets to be rebuilt as per structural engineer guidance

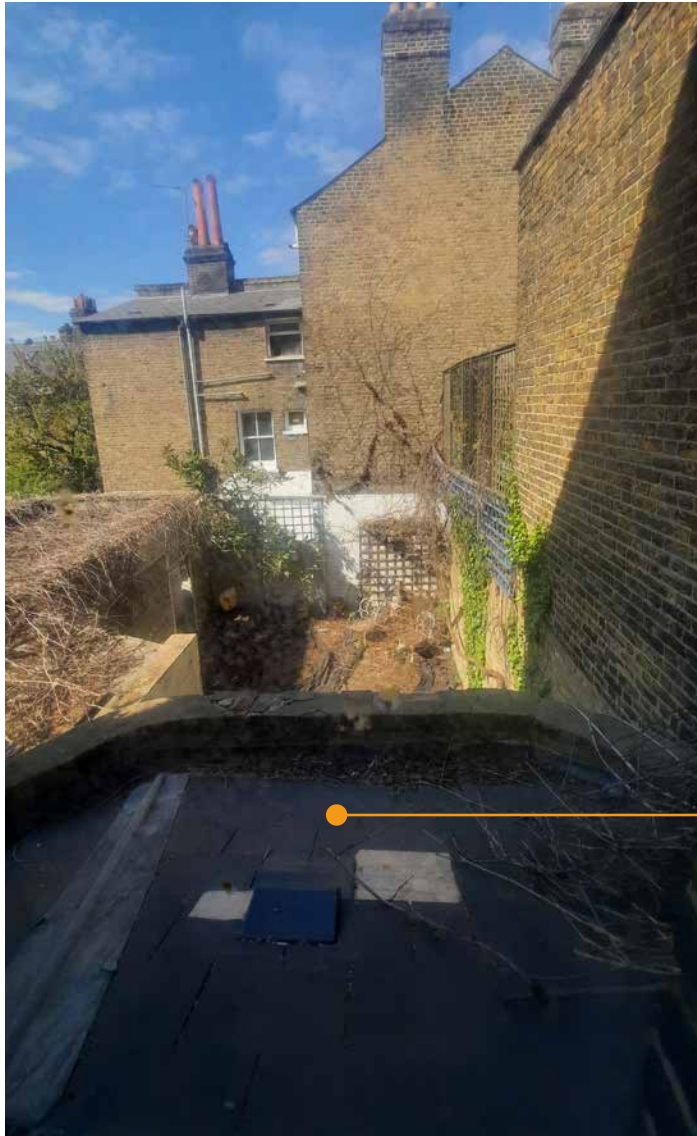
Item	Description	Condition	Proposal
1	Slates	Fair condition	retain if possible remove debris and vegetation

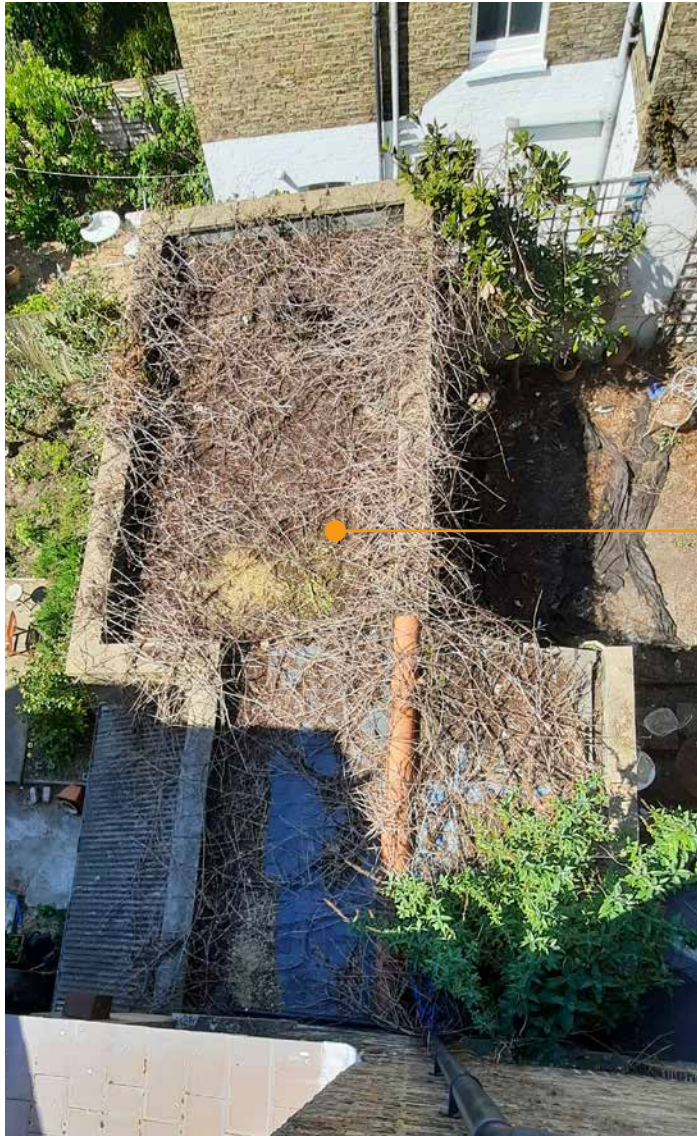
Item	Description	Condition	Proposal
1	Roof covering and structure	Generally poor condition - rotten structure in places	remove coverings and remaining structure, build new flat roof with insulation

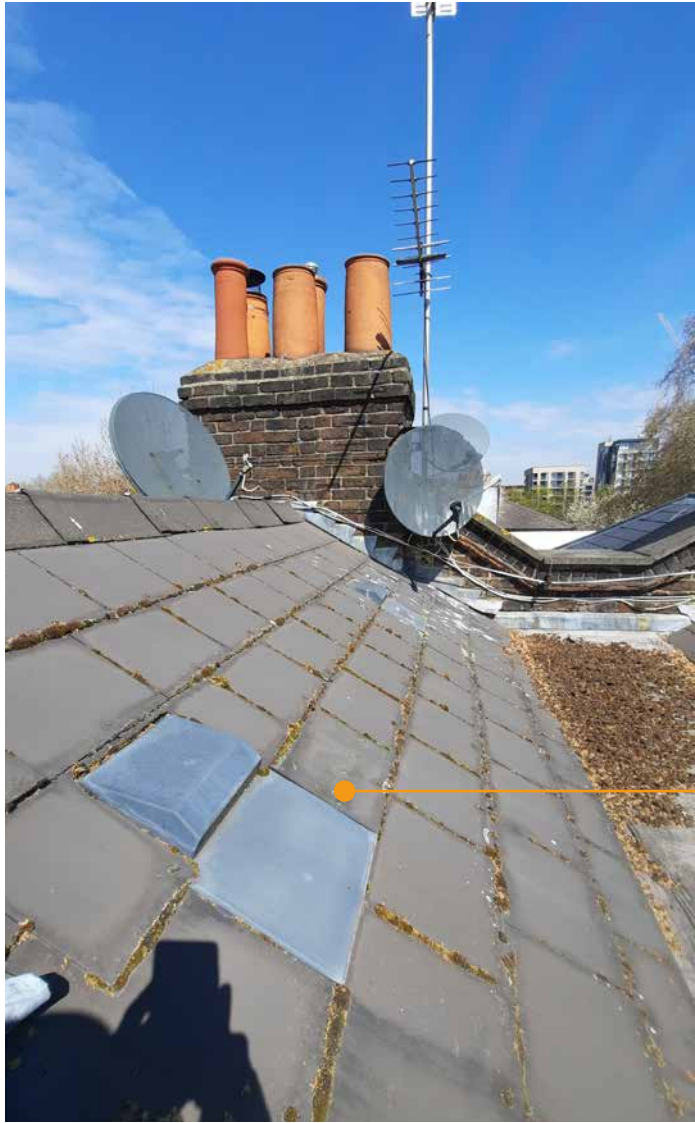
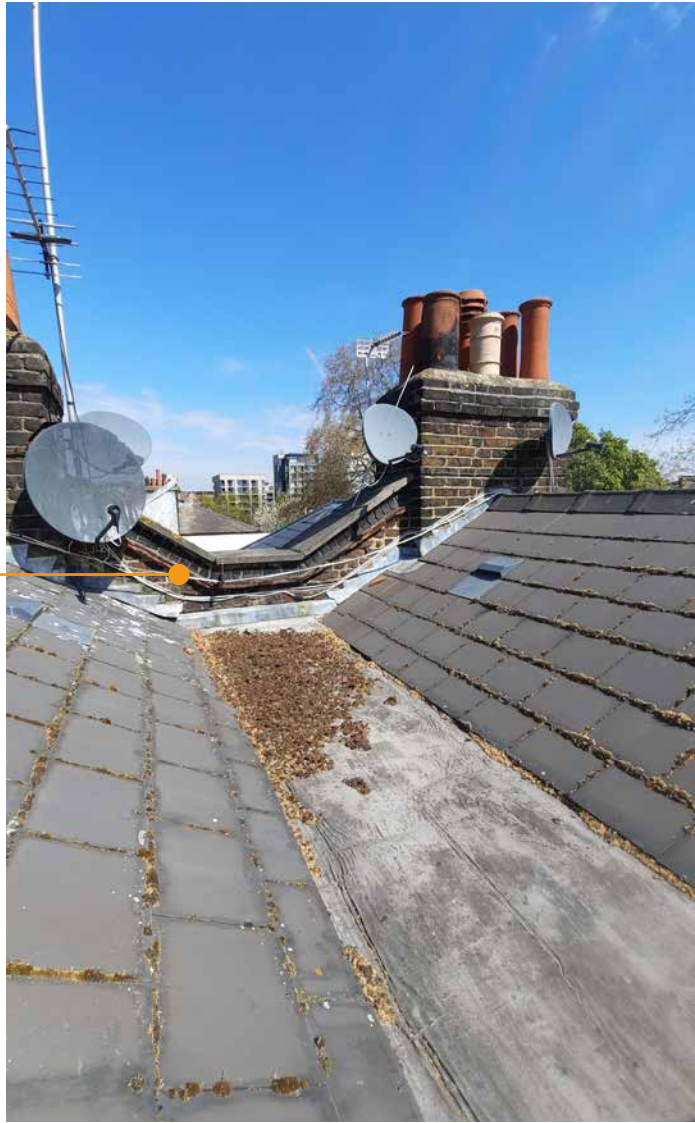
Item	Description	Condition	Proposal
1	Roof Covering	Generally good condition, signs of water damage in below	retain and repair
2	Parapets	Concrete coping	remove and replace with painted render system
