# **Preliminary Roost Assessment Survey**

Dower House, Dunthrop Road, Heythrop, Chipping Norton, Oxfordshire OX7 5TL

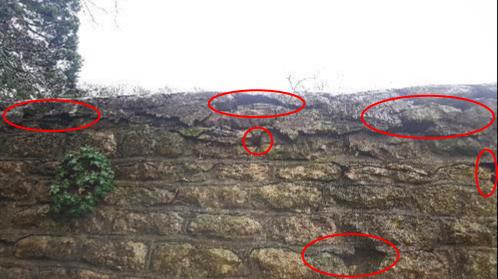
B1 – north west elevation (pictured opposite).

The photo opposite shows additional examples of gaps further north east along the wall, which again could be utilised by crevice dwelling bats. Similar gaps were also present lower down on the wall, although some of these may be situated too low down to be utilised by bats.

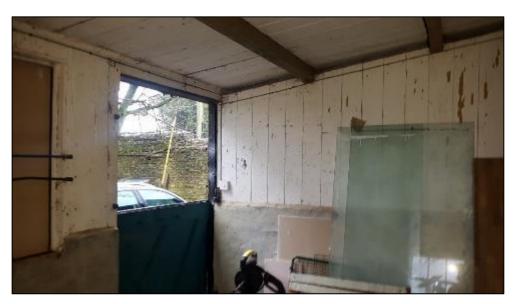
B1 – north east interior, facing north (pictured opposite).

The north east interior space is used for storage, and the presence of stored items made it easier to search for evidence of bats, which often accumulates on exposed surfaces where present. The circled corner corresponds with the gap between the stone and timber walls on the north east elevation, and shows daylight coming through which could allow bats access to the interior. However, the presence of a window results in the space being moderately well lit and therefore unlikely to be suitable as a day roost. No evidence indicative of a night feeding roost was present.

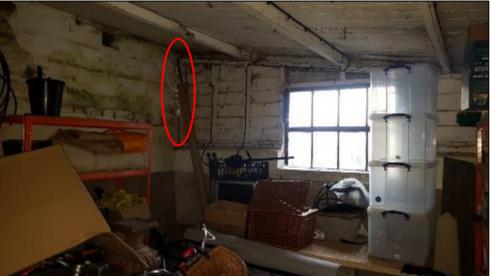
B1 – middle interior, facing north west (pictured opposite).

The middle interior space is used as a wood store and is similar in construction to the other two spaces. As with the other two spaces, open access to a ventilation duct was present. However, the space within the duct is likely to be too open to be used by crevice dwelling bats, and too enclosed to be suitable for void dwelling bats.

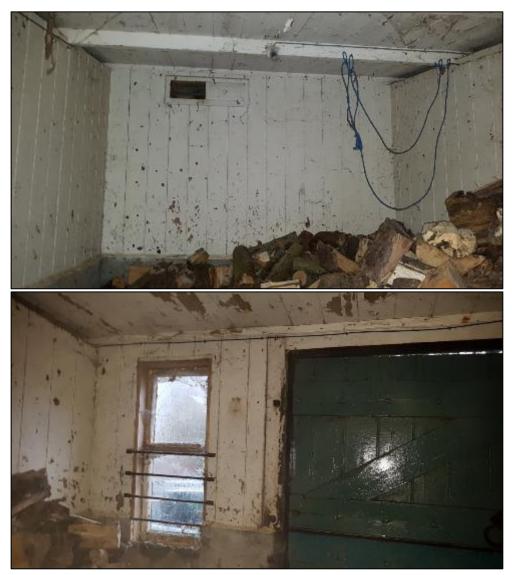
B1 – middle interior, facing south east (pictured opposite).

The middle interior space is dimly lit by one small window, limiting its suitability as a day roost for void dwelling bats. A Small gap is present along the top of the barn door which could possibly allow for bat access to the interior, although no evidence of roosting bats was present.

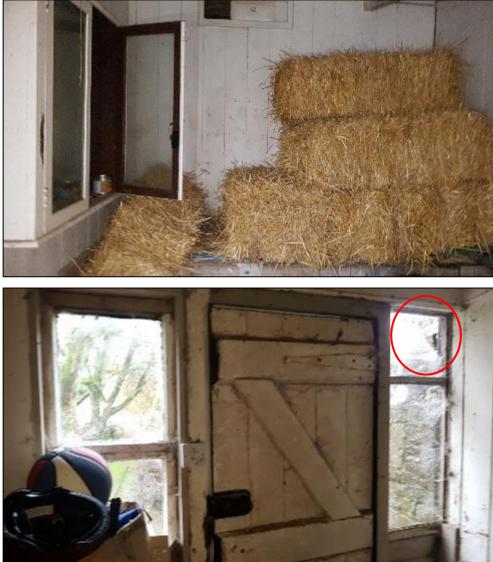
B1 – south west interior, facing south east (pictured opposite).

A broken windowpane was present which could allow void dwelling bats access to the south west interior space. However, the presence of two windows result in the space being well lit by daylight and therefore unsuitable as a day roost, and no evidence indicative of a night feeding roost was present.

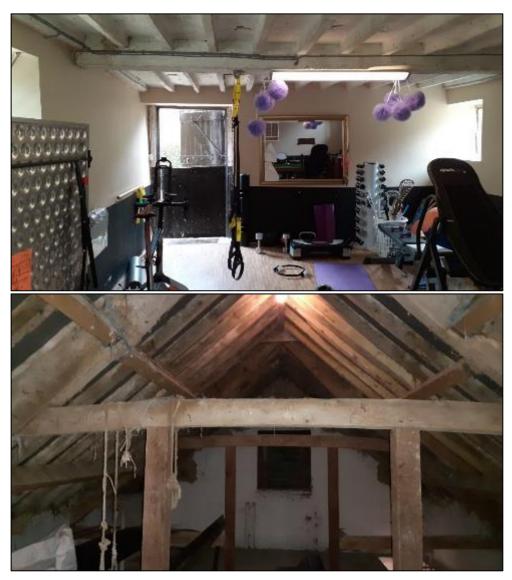
B2 – first floor interior, facing north west (pictured opposite).

The upper floor of the barn is open to roof height. The roof is constructed from timber beams and lined with bitumen felt which is intact, with no tears or gaps. The space has a timber floor and is used for storage. The floor, stored items, exposed beams and gable end walls were all searched for evidence of bats.

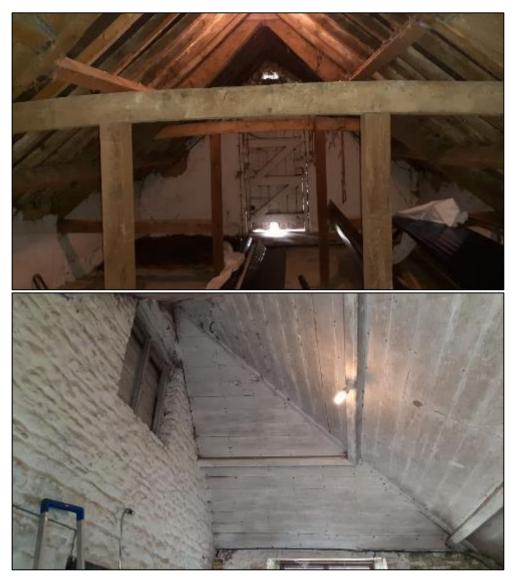
B2 – garage interior, facing south west (pictured opposite).

The adjoining garage is open to roof height, with an interior roof lining of timber beams present. The space is well lit by windows, reducing its suitability as a day roost for void dwelling bats, and no crevices were present within the interior space.

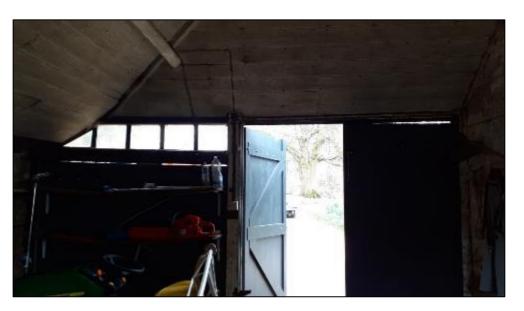
B2 – garage interior, facing north east (pictured opposite).

Void dwelling bats could gain access to the interior space via a dislodged windowpane as well as gaps above the main door. The interior space is used to store gardening equipment, and all exposed surfaces were searched for evidence of bats.

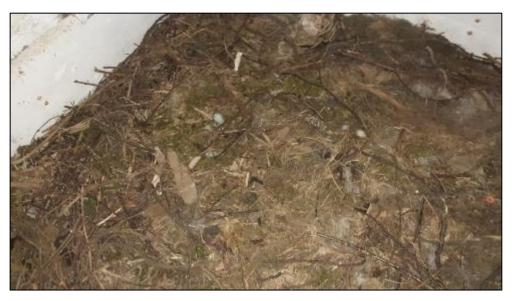
A large, sprawling bird nest was located in the east corner on the upper floor of the barn, and an egg was observed to be present within the nest at the time of the survey. The size of the nest and appearance of the egg suggest that this may be jackdaw nest. Other evidence of birds was present on the upper floor of the barn, including bird droppings on beams and the skeleton of a deceased bird.

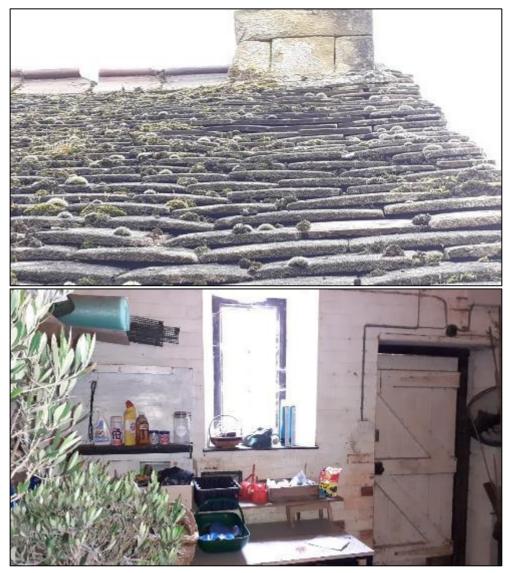
B3 – north east interior, facing north east (pictured opposite).

The interior space is divided into two rooms. The north eastern room is used to store gardening supplies and equipment and is well lit by an exterior window, reducing its suitability as a day roost for void dwelling bats. A minor gap occurring above the door is insufficient to allow bat access, and no other gaps were apparent.

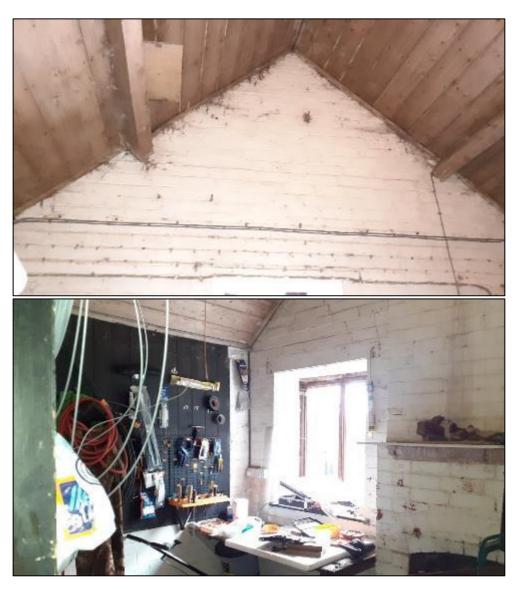
B3 – south west interior, facing south (pictured opposite).

The south west interior space is used for tool storage and is similarly well lit by an external window.

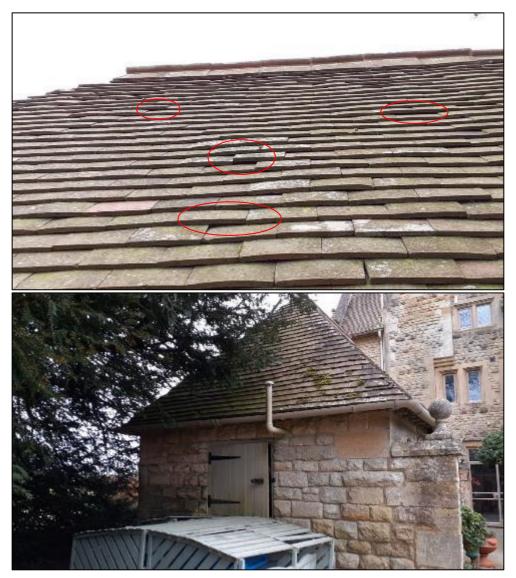
B4 – west elevation (pictured opposite).

The west elevation of B4 is partially obscured by an overhanging tree. Roosting features for crevice dwelling bats are present which are similar to those seen on the other elevations, with several raised tiles on the western roof pitch and gaps occurring under the eaves.

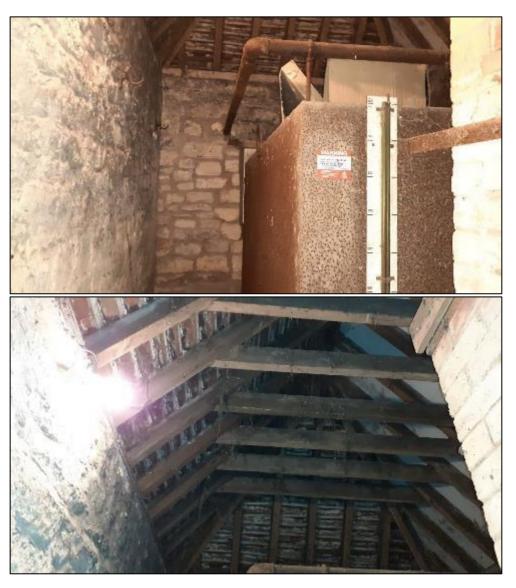
B4 – interior, facing west (pictured opposite).

The interior of B4 is open to roof height, with the roof constructed from timber beams. As previously noted, all but one of the roof pitches is unlined, with the undersides of roof tiles visible.
