WRDELW73274A\210603 sgh GSI (1/7)
3 June 2021

GENERAL STUCTURAL INSPECTION

The Barn, Parsons Farm
West End Green
Stratfield Saye
READING
RG7 2DP

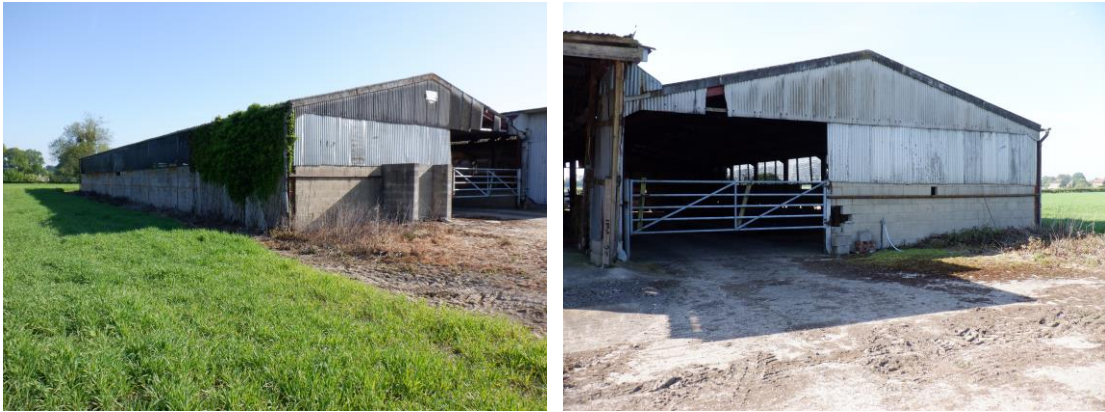
- 2.1** The barn is a large, steel, portal-framed building. It is about 12m wide by 36m long. The external walls are blockwork to half-height with a variety of cladding materials above and the roof is corrugated, fibre cement sheeting. It is estimated to be around 50 years old.
- 2.2** To the right side is a similar sized barn with a pre-cast concrete, portal frame and the space between these two has been covered over. It is proposed to demolish the concrete framed barn and link.
- 2.3** The barn structure comprises steel, portal frames spanning about 12m, with 203 x 133 UB columns and 178 x 102 UB rafters on a 13° pitch. The frames are spaced around 4.5 to 4.6m apart, there being 9 frames enclosing 8 bays.

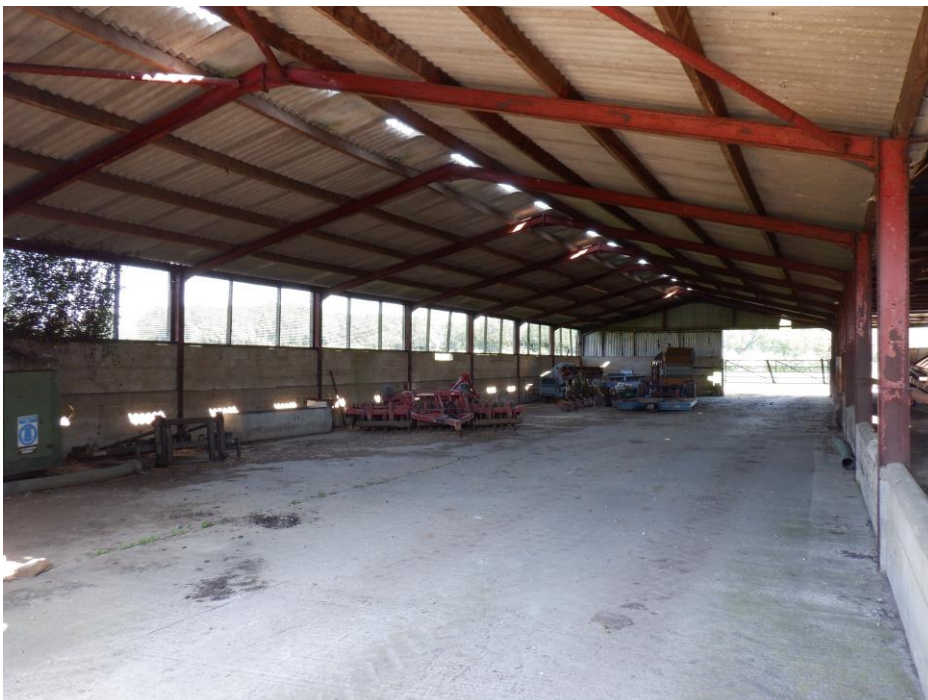
- 2.4 To the front and rear bays there is diagonal roof bracing to the rafter slopes formed with 80 CHS sections.
- 2.5 The columns are true and plumb, the rafters are straight and undistorted, and there are no signs of structural movement or structural distress.
- 2.6 The steelwork is painted with a red lead type protective coating but there is extensive failure of the paintwork exposing the bare steel. Surface corrosion of the steel is present throughout but no deep corrosion that would affect the structural integrity is present.
