**Bovill's Hall, St Osyth Road, Little Clacton, Essex CO16 9NN.**  
Description and analysis of NW of Bovill's Hall. Surveyed 30 06 2014.

This report details and analyses the fabric and form of The Barn and its attached buildings to preserve by record its current state, before it is altered, to English Heritage Level 3 as defined in 'Understanding Historic Buildings A guide to good recording practice by English Heritage 2006' (Page 14).

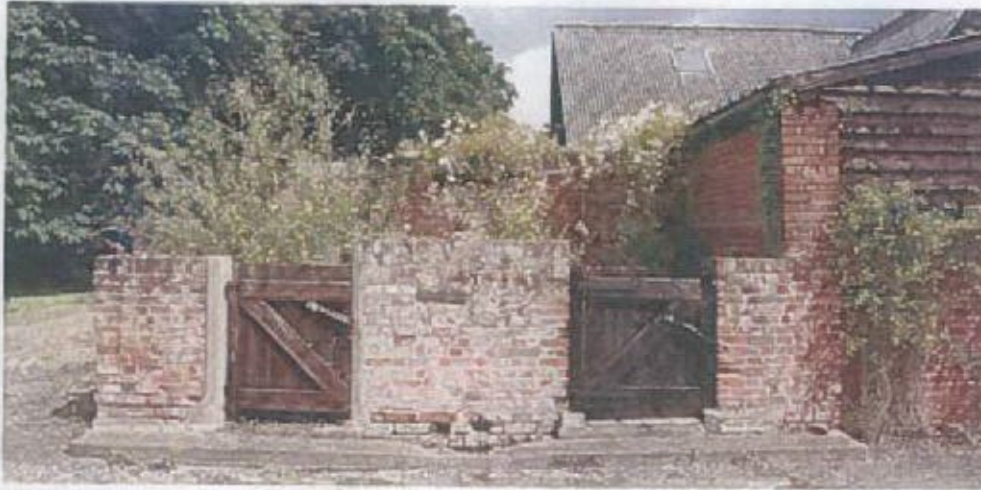
The southern elevation of the pig pens.

To the west of the site are two small brick built pig pens. Constructed of 65x105x215mm orange hand-made bricks with creased faces set in hard white lime mortar, the pens and pig houses are attached to the larger Shelter 1. The details of the brickwork are EC20th, lacking queen closers at the quoins. Historic mapping indicates the pig pens appeared between 1896 and 1923. The timber, gate and ledger doors are MC20th with later hardware fastened with Pozidriv screws.

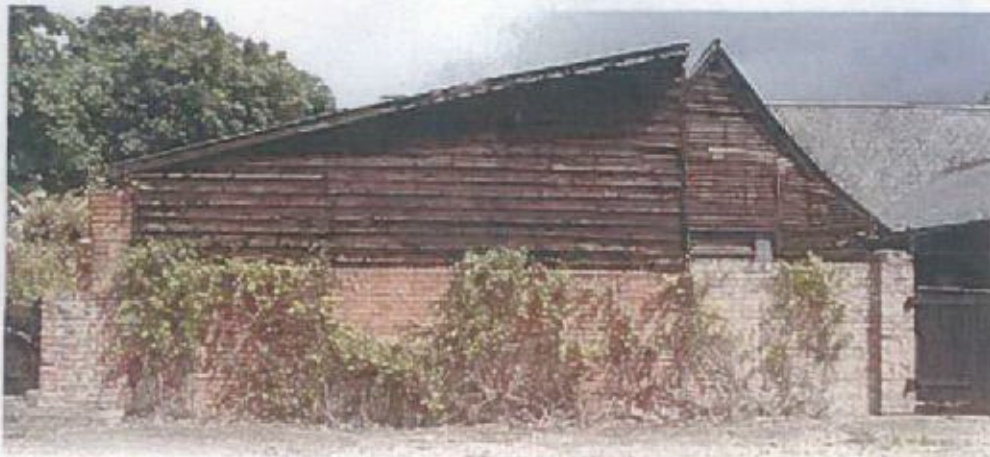
Shelter 1. Southern elevation.

Shelter 1 is built of 60-65x105x220x225mm orange hand-made bricks set in a hard lime mortar laid in Monk bond (that is two stretchers then a header etc). The southern wall is finished with a rowlock course which acts as a mid line for the western wall which is much taller. The upper wall is made of C20th machined studwork and clad with C20th weatherboards. Historic mapping indicates the shelter appeared between 1874 and 1896 and the construction details coincide with this period.

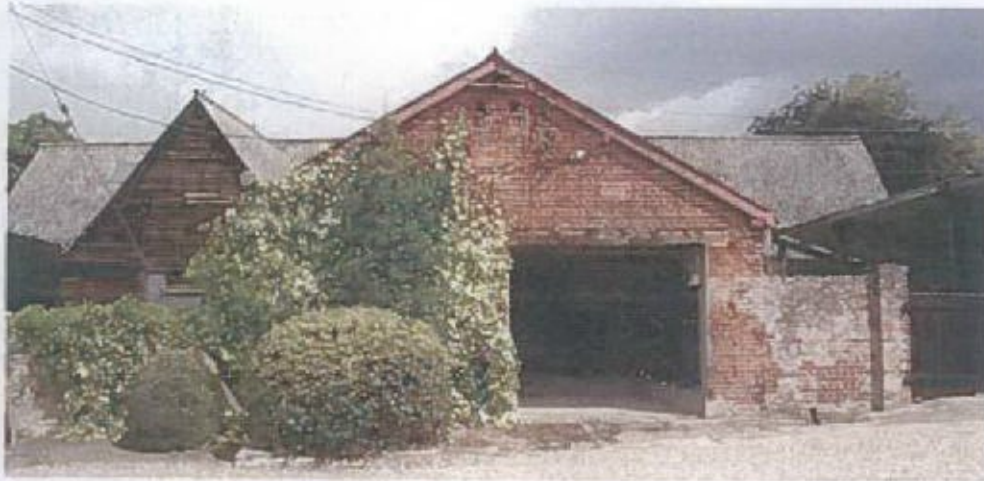
Double sided shelter with a brick spine wall.

Shelters 2 and 3 are formed under a single two pitched roof and separated by a brick spine wall. The brickwork is subtly different in that the bricks are 65x110x225mm reds set in beige lime mortar in English bond. Under the central rough gauged arch the brickwork changes to a stretcher course where the opening has been filled in. The cart opening has a timber lintel. The quoins are correctly closed but the cart doorway is inserted later without closers. At the apex there are lodges for doves. The gable has painted plain verge boards and exposed purlins. Map evidence shows it was built between 1839 and 1874.

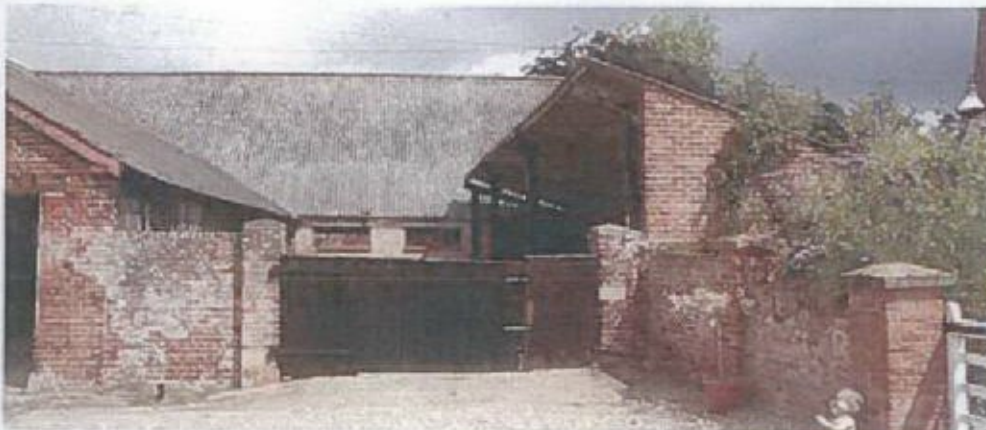
Brick walls and gates to the eastern yard.

The eastern yard is closed off with a brick wall of 65x110x225mm red bricks set in hard white mortar in a random bond close to English bond. Again the timber gates are LC20th. Shelter 4 is built of 60-65x105x225mm oranges and purple bricks laid in stretcher bond and was erected between 1896 and 1912 (photographed that year).

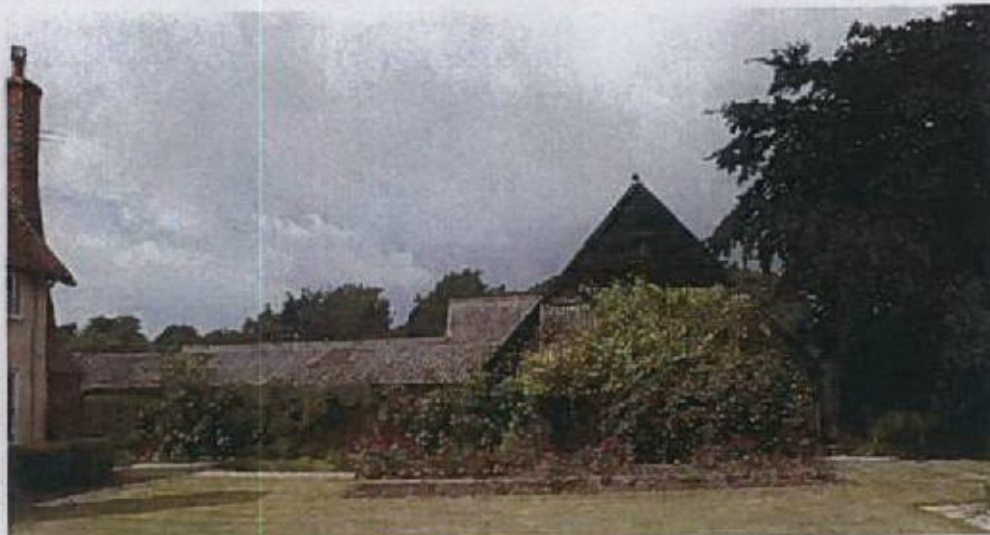
The eastern elevation from the garden.

The eastern elevation separates the farmyards from the garden. The brick wall forms the back of Shelter 4. The eastern end of the Barn is visible, clad in LC19th weather-boards and there is a lean-to with a corrugated roof.

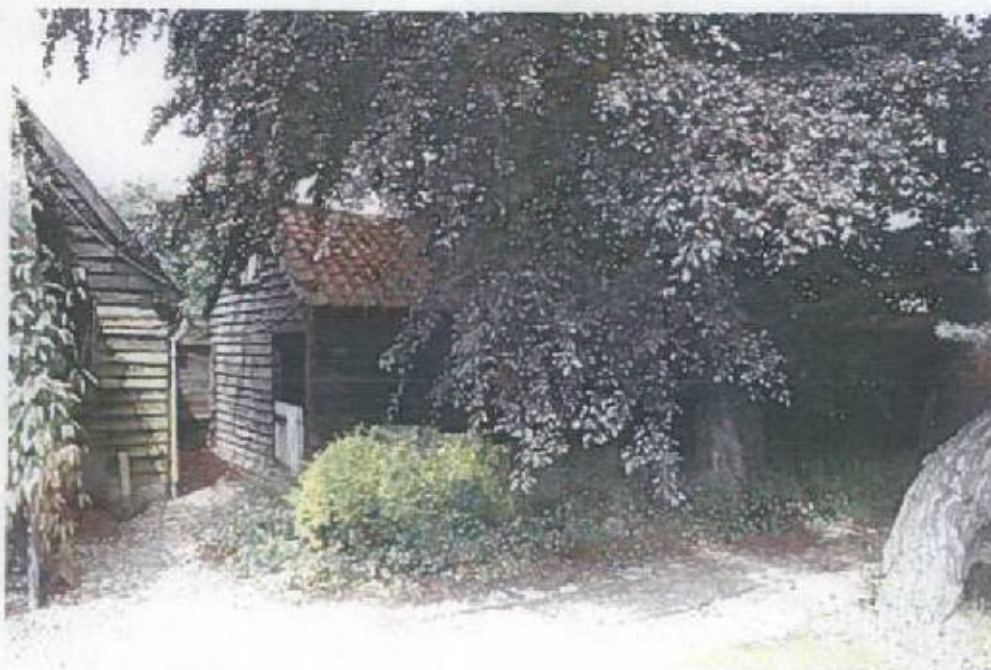
Freestanding Shed to the north of the Barn.

To the north of the Barn at the eastern end is a freestanding timber-framed Shed with a pantiled roof on the eastern side. Although it looks LC19th it does not appear on the site until after the 1958 OS map was made.

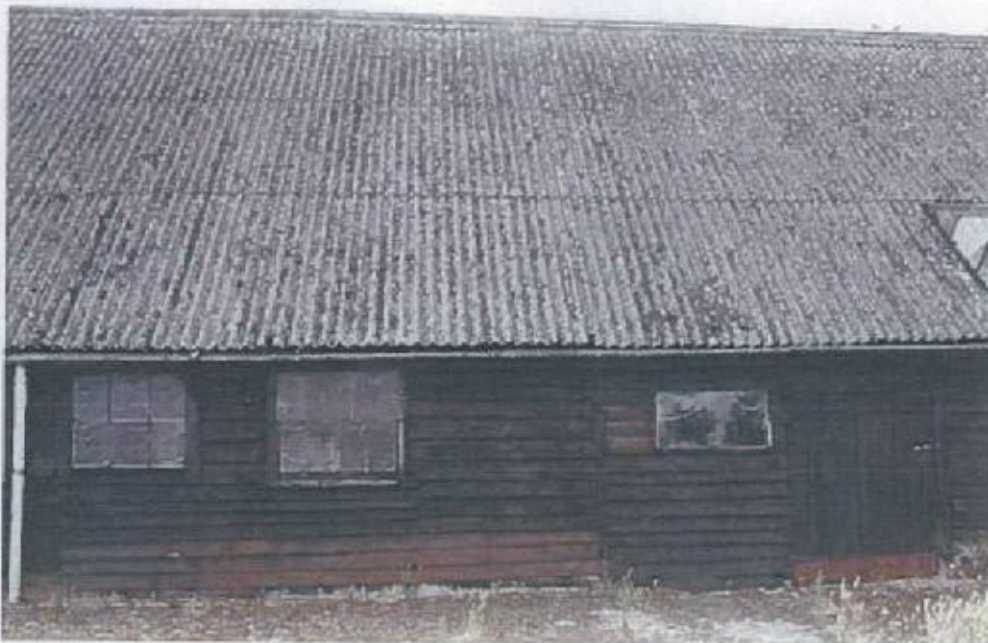
Detail of the C20th windows and C19th door.

The windows appear to be EC20th casements set in homemade frames. The smaller pedestrian doors have LC19th vertically boarded gate and ledger doors hung on wrought iron pintle hinges.

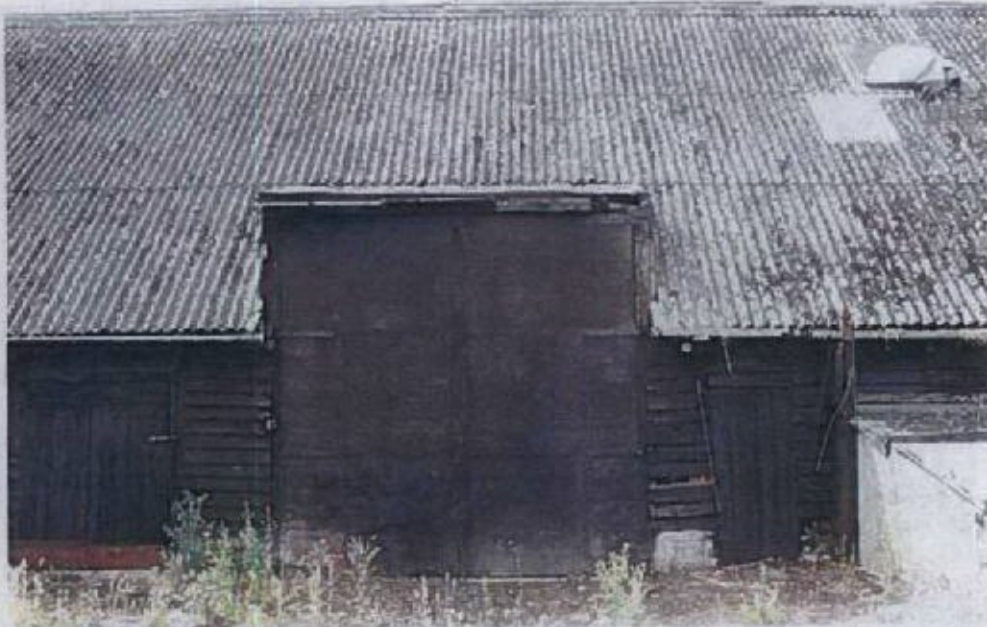
The double doors are LC20th marine ply replacements.

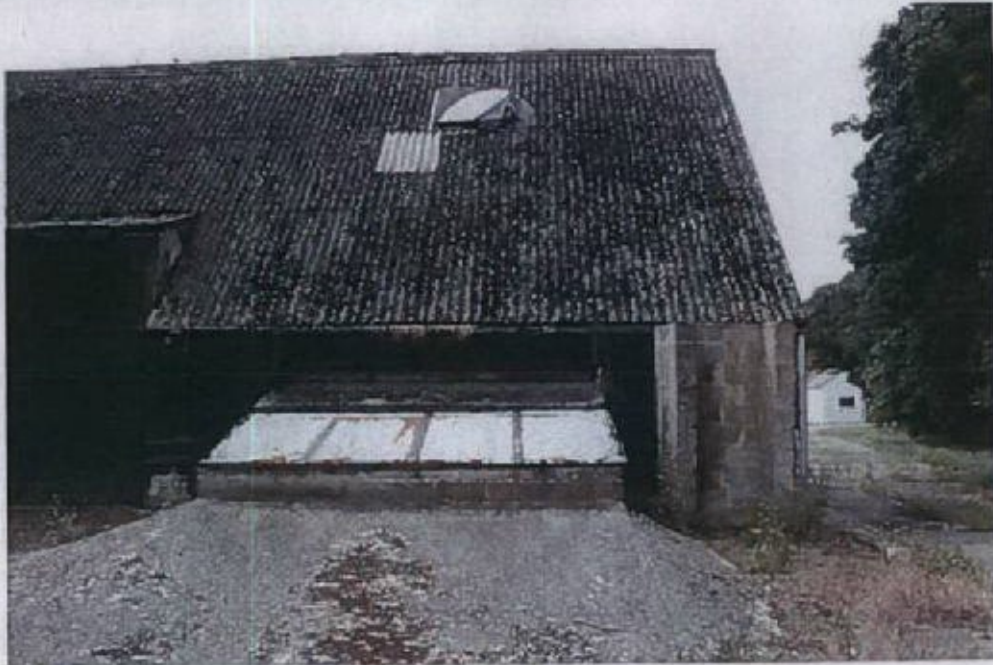
Concrete ramp and hopper to feed the pre-dresser.

There is a concrete ramp for the hopper that feeds the pre-dresser. Adjacent is a blockwork tower for a fuel tank that has been removed.

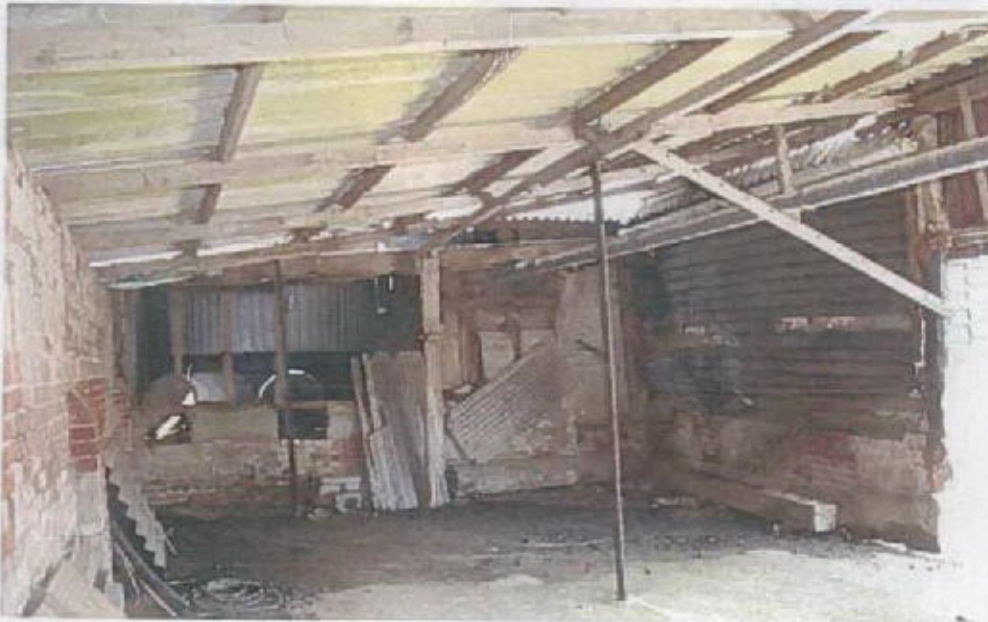
Looking north inside Shelter 1.

Shelter 1 has an LC20th plank built timber strut roof supported on scaffolding poles and clad with corrugated cement boards. It was erected in the 1970's off the original boundary wall. The floor is concrete. The southern gable is made of LC20th machined lightweight softwood timbers. The Shelter adjoins the south wall of the Barn and part of the timber frame has been removed to allow air to be drawn into the grain drying turbines.

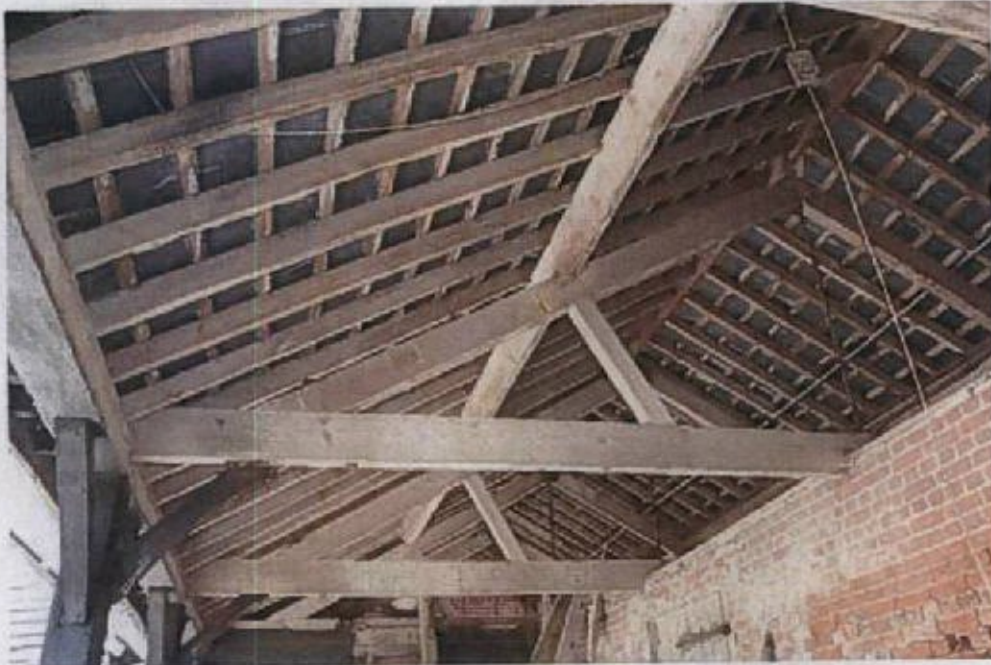
Looking NE inside Shelter 2.

Shelter 2 forms the western half of a single building divided with a spine brick wall. The roof is of machined softwood timbers with iron rods as king struts and iron bolts and apex gussets securing the joists. The roof has half-housed side purlins and the grey slates rest on wide, flat batons. The roof is supported on timber posts with nailed in spandrels. One of the purlins has an LC19th timber merchant's mark made with a race knife.

There are two C19th doors allowing connection to the other side. Both are inserted into the brickwork. There is an iron ladder to give access to the loft created above Shelter 3. The lower part of the walls is rendered in cement and the yard was used for keeping pigs in the LC20th.

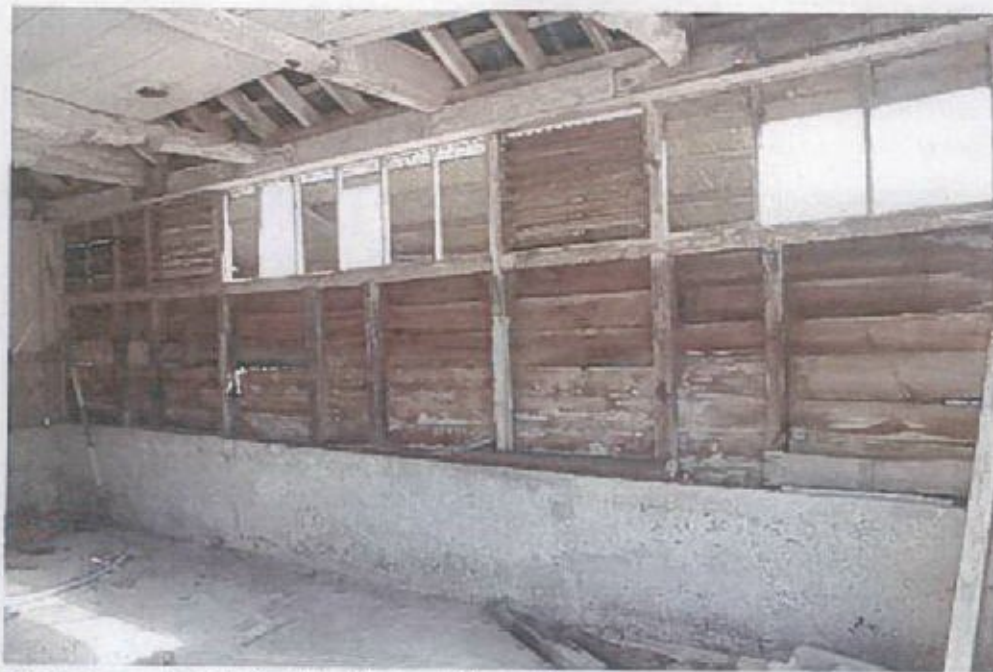
The eastern wall of Shelter 3 inside the milking parlour.

Shelter 3 has been divided with machined studwork to form a milking parlour that was built in the 1960's. The concrete floor is ramped up and the timber walls stood on a concrete plinth. There are holes in the ceiling for the milking pump pipes to drop through.

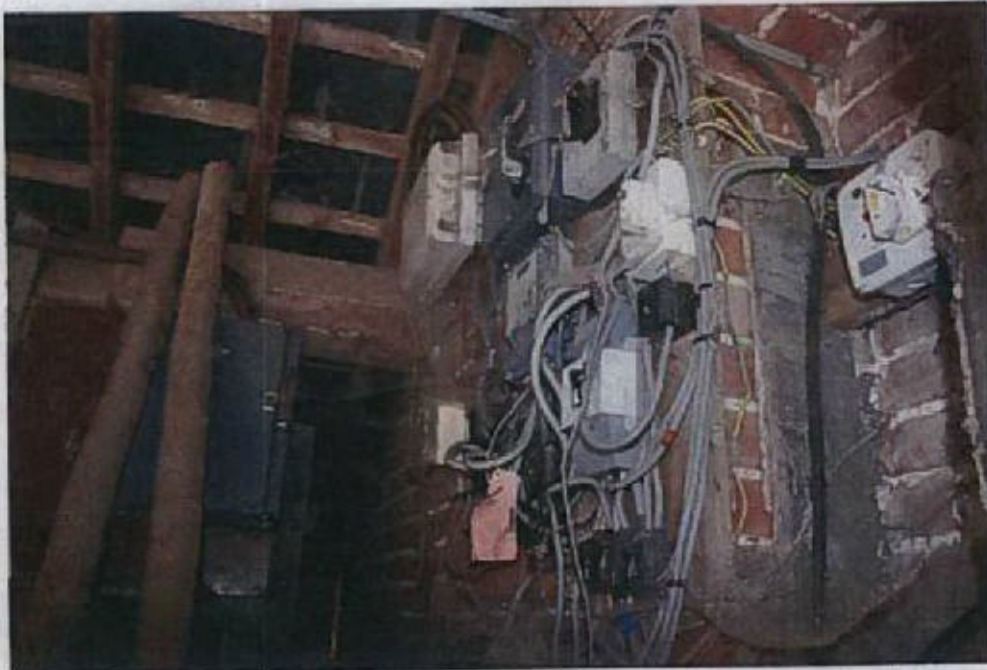
Old and current power boards above the milking parlour.

The roofspace above the milking parlour can be accessed by a permanent steel ladder and it can be seen that there is a hollow box beam which was part of the milking machinery (long ago removed) and extensive power boards and boxes to supply the electrical pumps. The live power to the building still enters here.

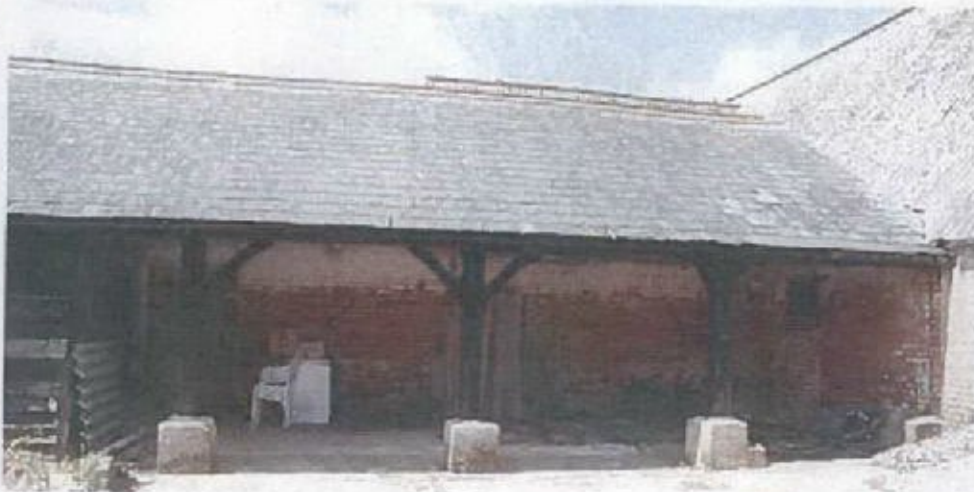
The open bays of Shelter 3.

The rest of the building comprising 3 ¼ bays remains open and shares the same details as Shelter 2. The upper section is lime-washed and it seem likely the lower part was panelled and had a manger and hayrack but no fittings remain. A doorway into the Barn has been bricked up in the LC20th.

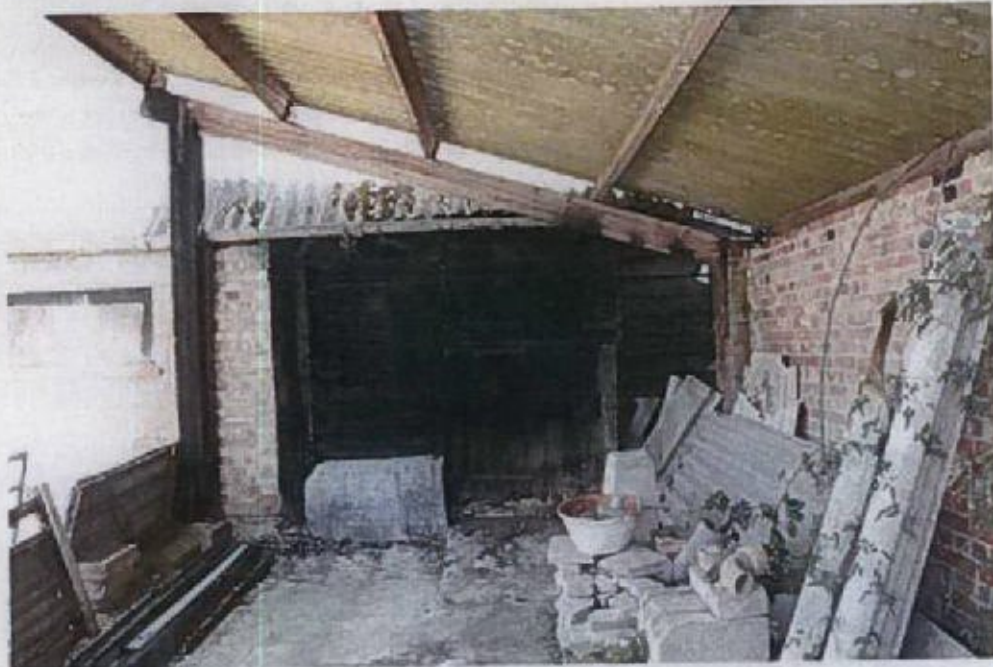
Looking N inside Shelter 4.

Shelter 4 is a LC20th lean-to construction of softwood timbers with plank purlins supporting a corrugated cement board roof. Of very simple bolt together construction is has no architectural merit. An historical photograph shows it replaced a similar shaped roof present in 1912.

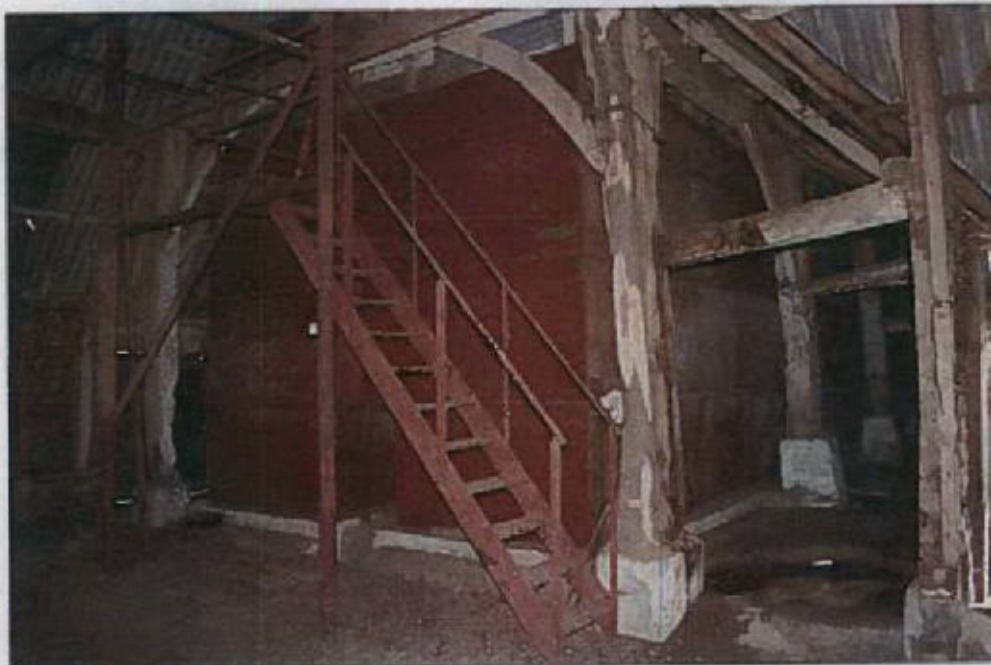
Truss 3 looking NE.

Trusses 1 to 5 are of the same form and come from a C16th style aisled barn that has been dismantled and re-erected making some changes to the bracing. On the north side, the horizontal aisle ties and passing braces have been removed for diagonal shores and on the south side the passing braces from the arcade posts to the wall post have been removed leaving the trenches and mortices to show where they were.

Each truss has been raised on timber sleepers on top of brick plinths that have been rendered in cement. The arcade posts have wide, deep jowls and are braced to the cambered tie-beams with curved spandrels, some of which are replacements. The frame has been reinforced with LC20th steel tie rods that pass parallel to the tie-beams.

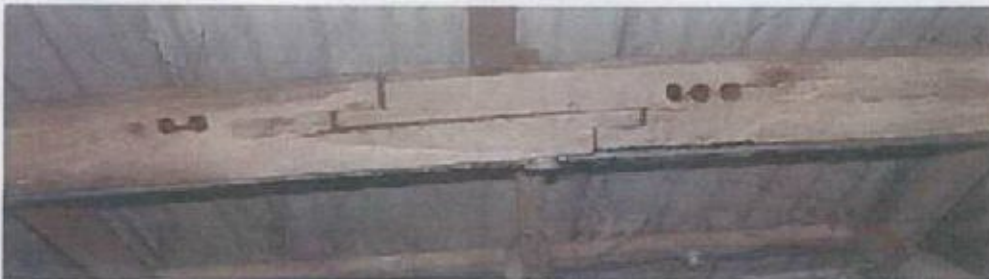
Scarf joint connecting the older frame to the C19th one. Note the holes for abandoned mortices.

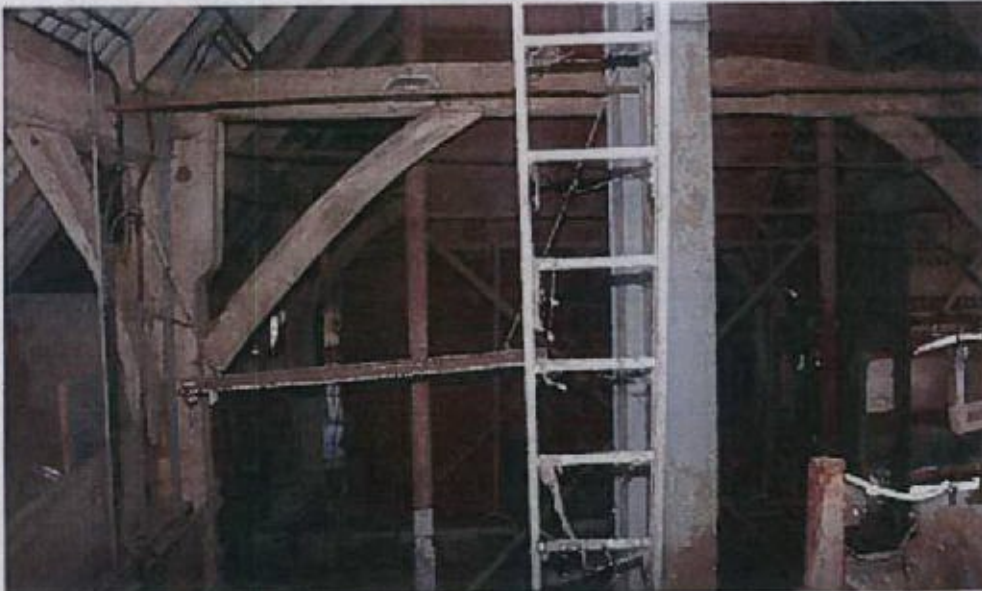
Detail of Truss 2 from the pre-dresser platform looking E. Note heavy jowl and spandrel.

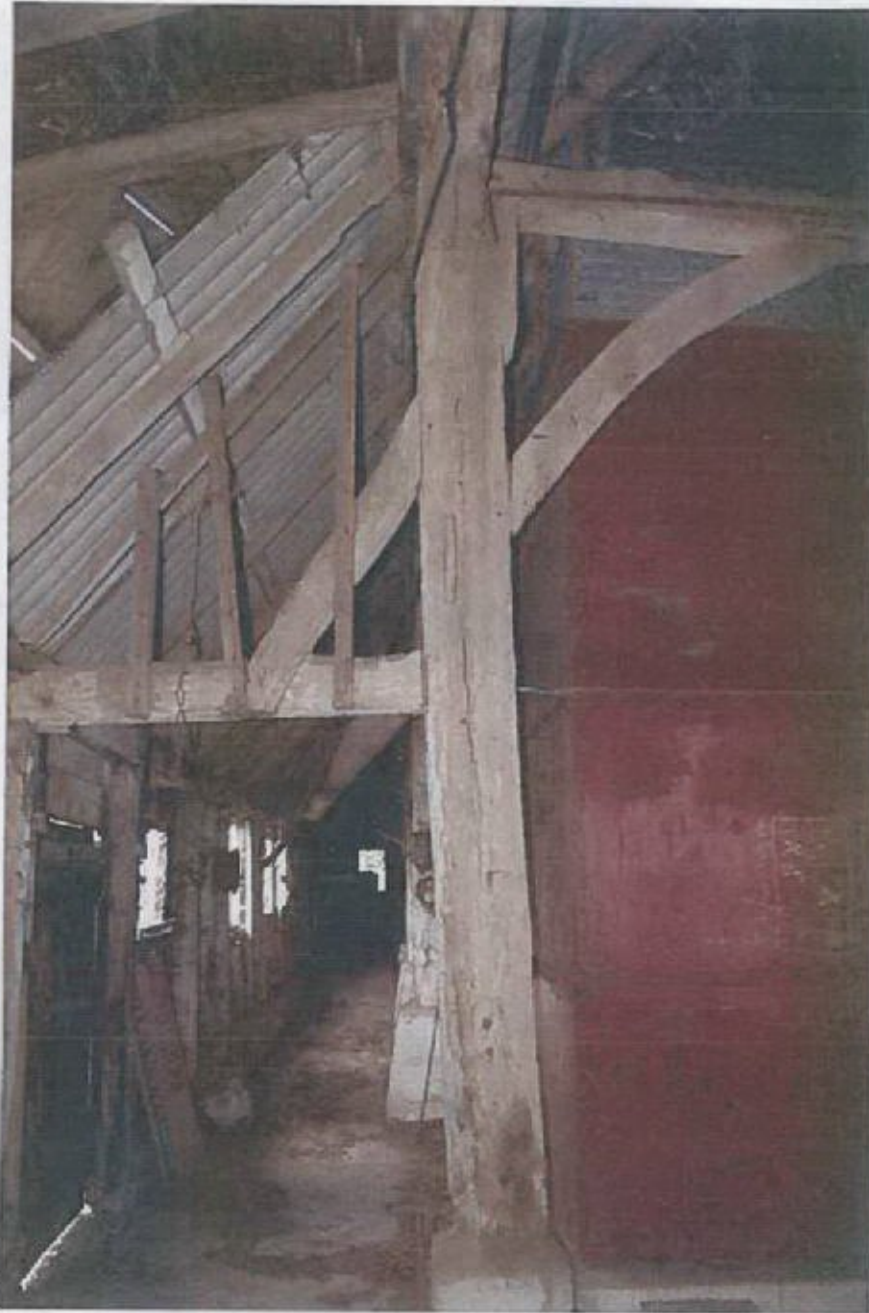
The roof structure above Truss 3. Looking E.

Apart from some timbers in the porch, the roof is LC20th and most likely dates to the late 1950's. The reason to suppose this is that the early graffiti concerning the yields for the machines date to 1962 and it is most likely the roof went on when the machinery was installed. The machines are certainly of that era. The 1958 OS shows the external hopper.
