# Aston Hall: Investigation of structural timber elements – South range barns

Site note 1 for March 2021, job no. 153.32

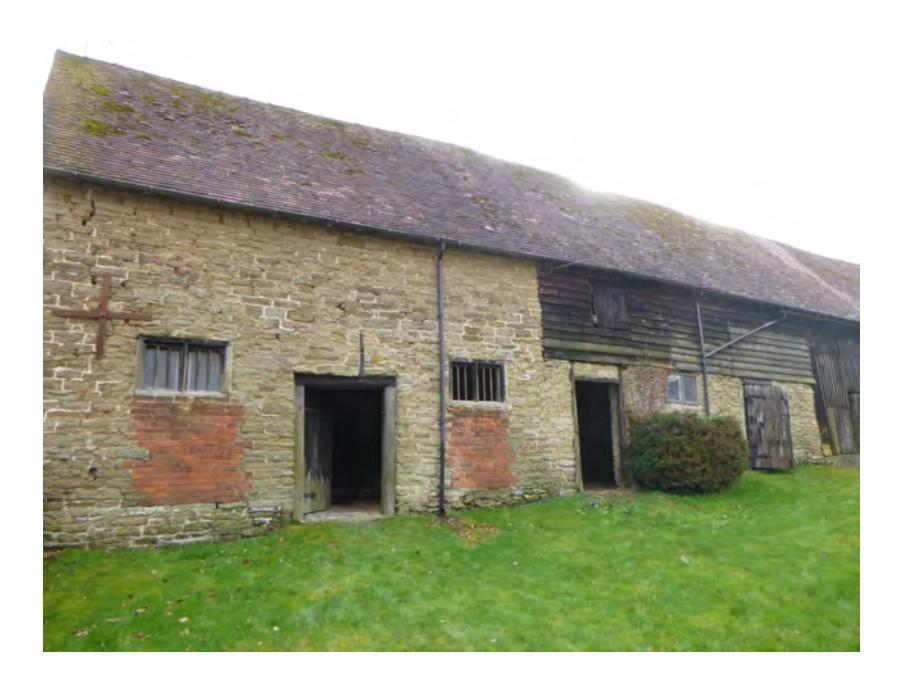
### Fig 1:

North elevation; showing a general view of the east part of the south barn

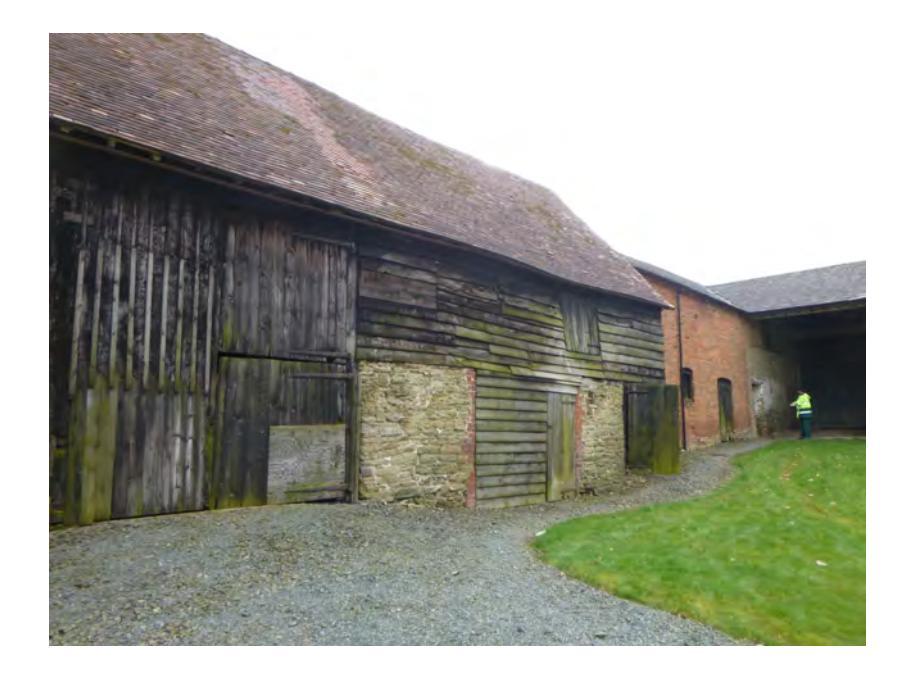
### Fig 2:

North elevation; showing a general view of the west part of the south barn

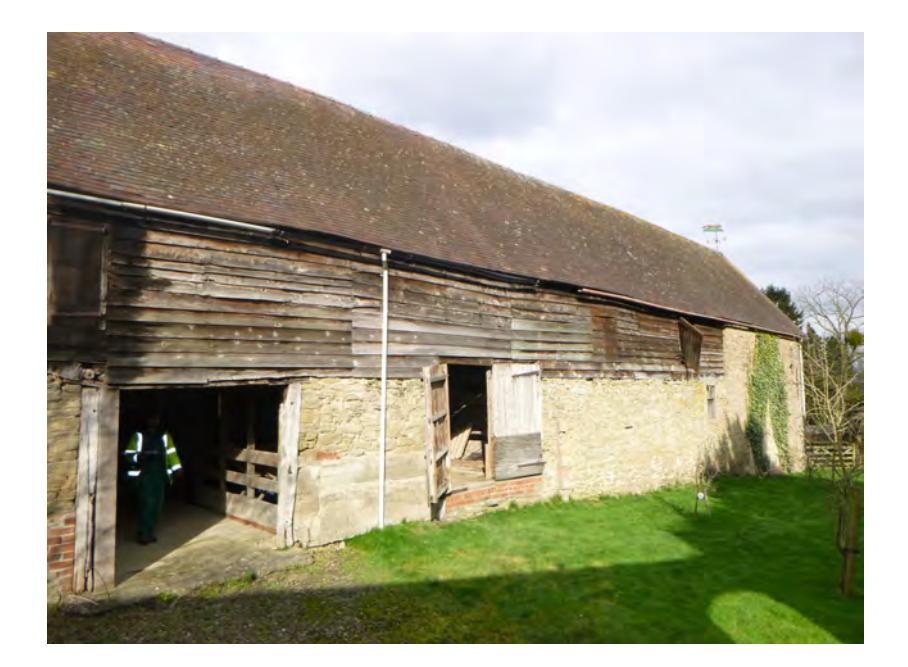
### Fig 3:

South elevation; showing a general view of the east part of the south barn

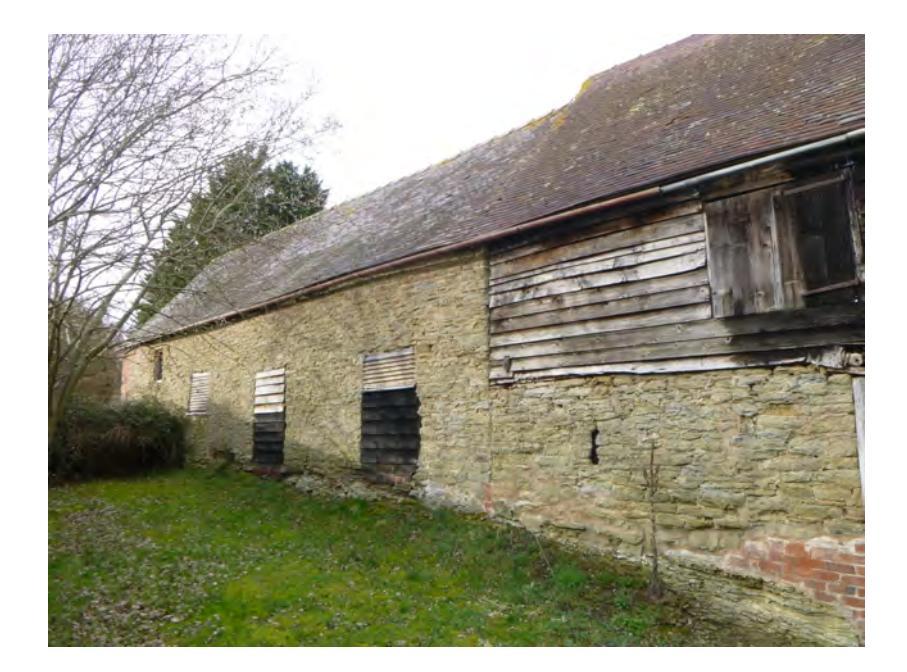
### Fig 4:

South elevation; showing a general view of the west part of the south barn

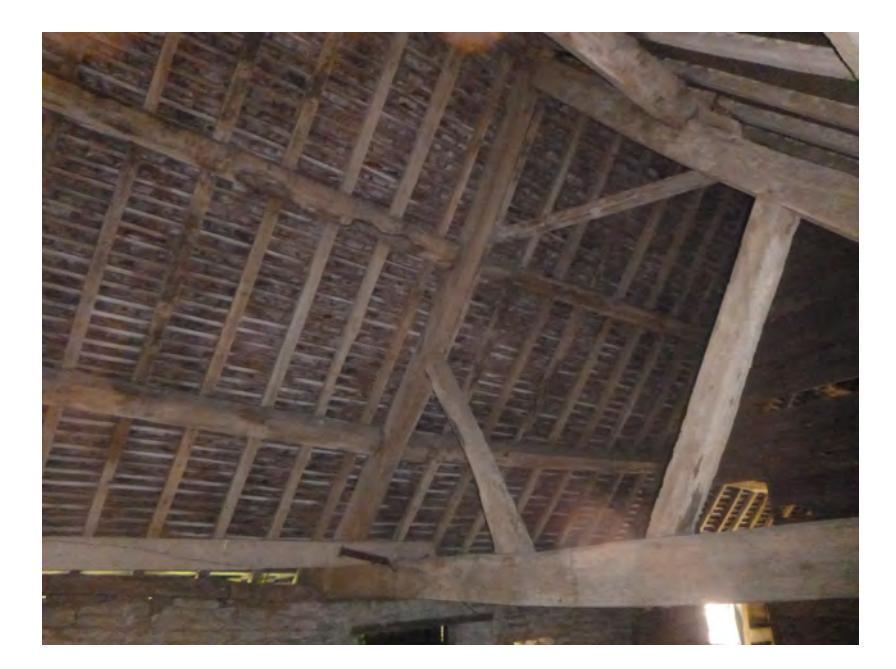
### Fig 5:

Bays 1 and 2; showing a general view of the roof structure

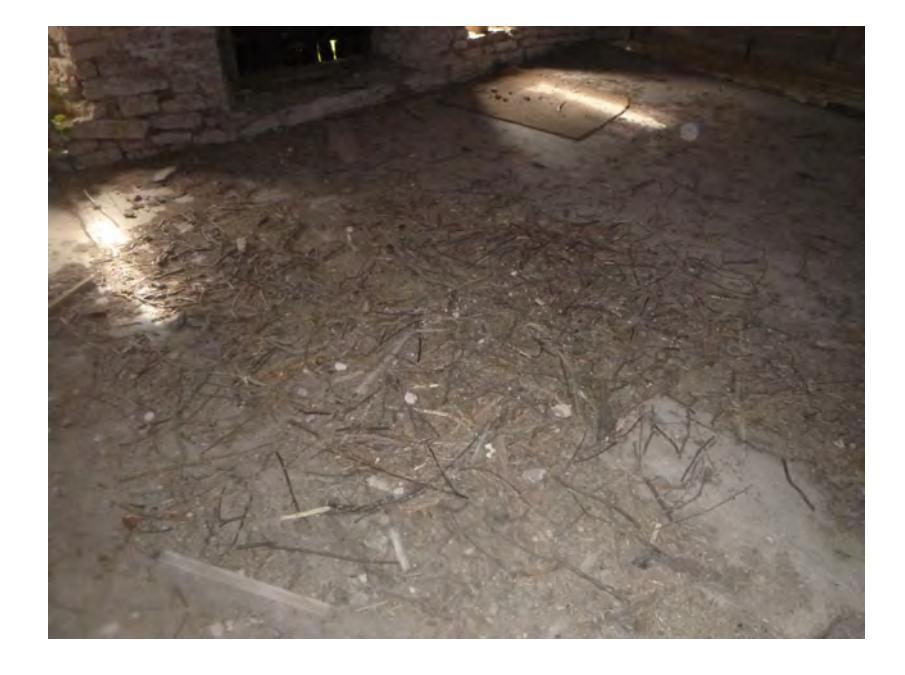
### Fig 6:

Bays 1 and 2; showing significant build -up of debris on the first floor structure within the loft space preventing ventilation and providing the conditions conducive to wood-boring beetle infestation, which was evident in a number of areas

All nesting material (and tent wall hangings) should be removed to allow for ventilation to structural timbers, eliminating the conditions in which wood-boring beetle and dampness can thrive. If the building is to be left for a significant period of time prior to refurbishment, installation of netting over holes in the facades should be considered to prevent further avian intrusion

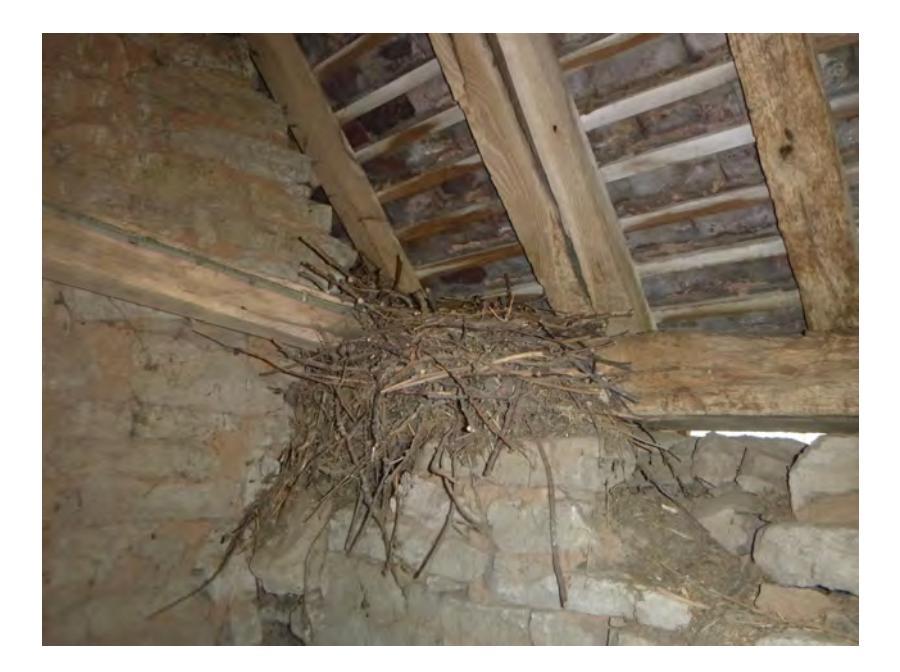
### Fig 7:

There were several large nests throughout the building, all of either magpie or jackdaw, evidenced by the typical large-diameter twig content and large piles of discarded feathers. These will locally reduce natural ventilation and provide the conditions for damp and decay and wood-boring beetle infestation of non-structural timbers

Bays 1 and 2; showing large nest in south-east corner of the east end, again, limiting ventilation around vulnerable structural timbers and may provide the conditions for damp and decay

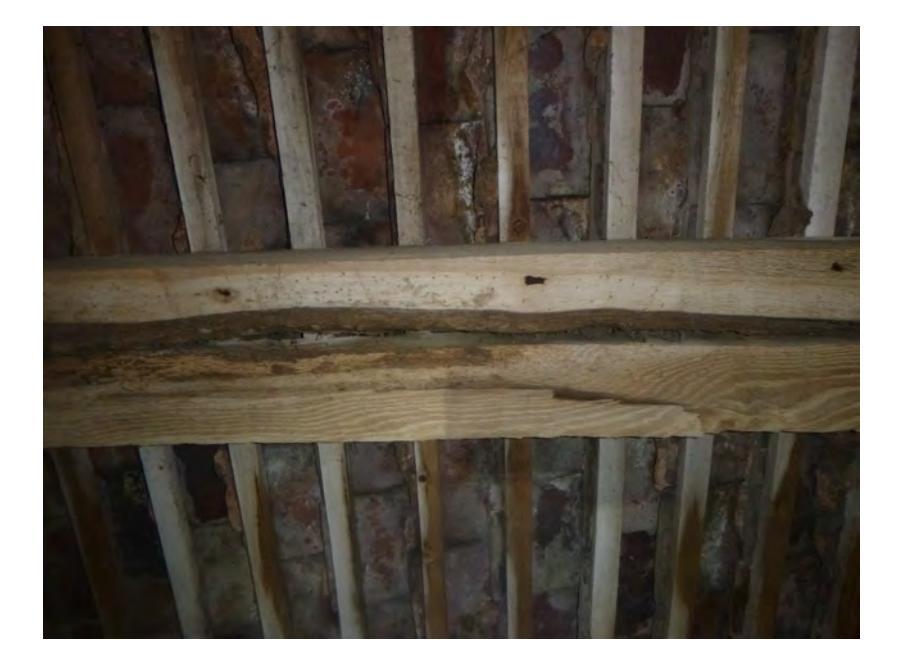
### Fig 8:

Bays 1 and 2; showing partnering of the purlin at the east end

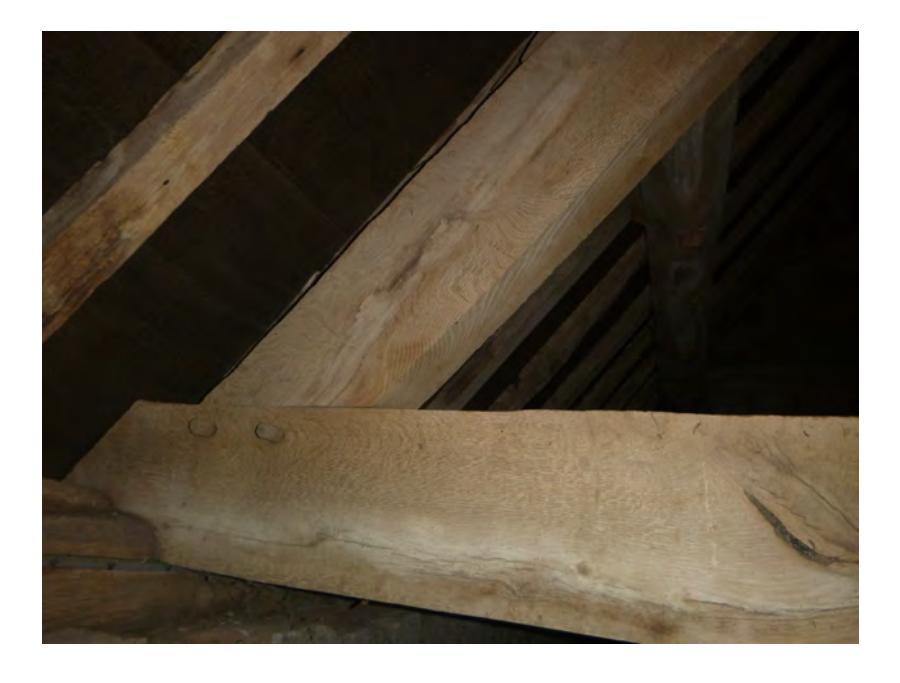
### Fig 10:

Bays 1 and 2; showing bearing end of truss 1. Note the relatively 'clean' face of the timber elements suggesting almost certain replacement in the past

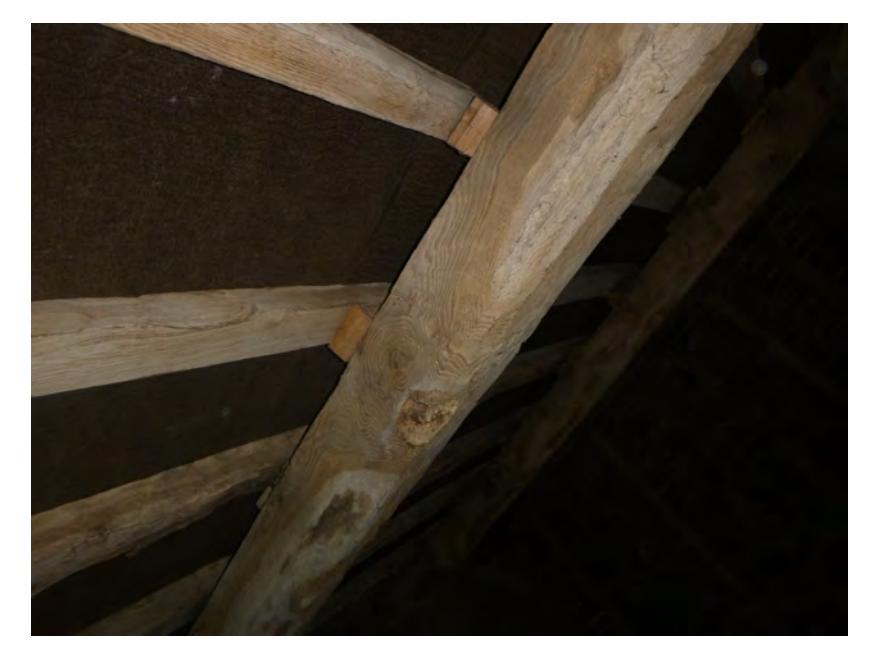
#### Fig 11:

Bays 1 and 2; showing the cross wall between bays 2 and 3. Boards were of historic oak timber, with hand sawn conversion markings throughout

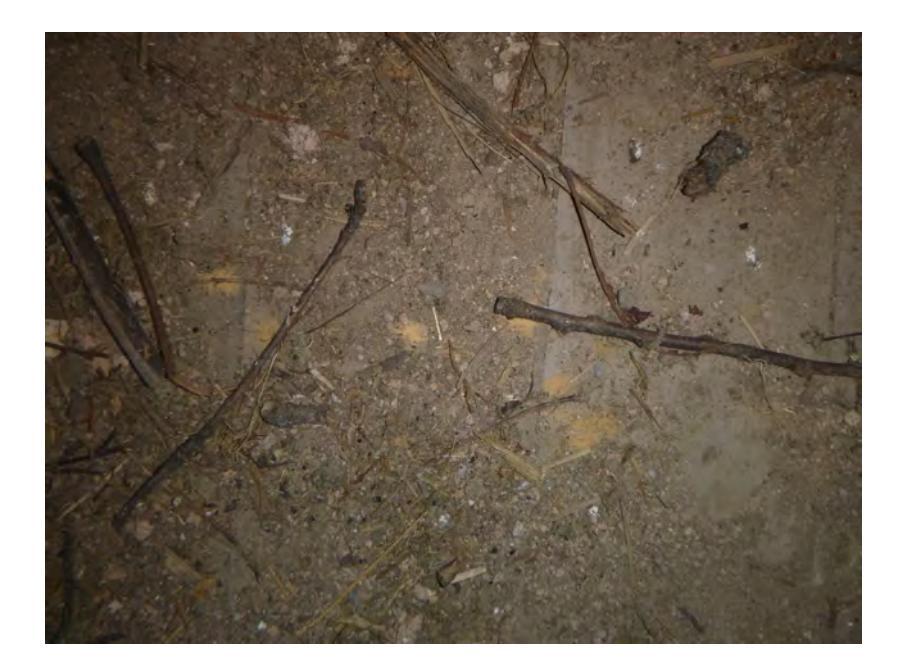
### Fig 13:

Bays 1 and 2; showing piles of woodboring beetle frass on the upper face of the softwood floorboards. Size and consistency of the frass was typical of Common furniture beetle (*Anobium punctatum*)

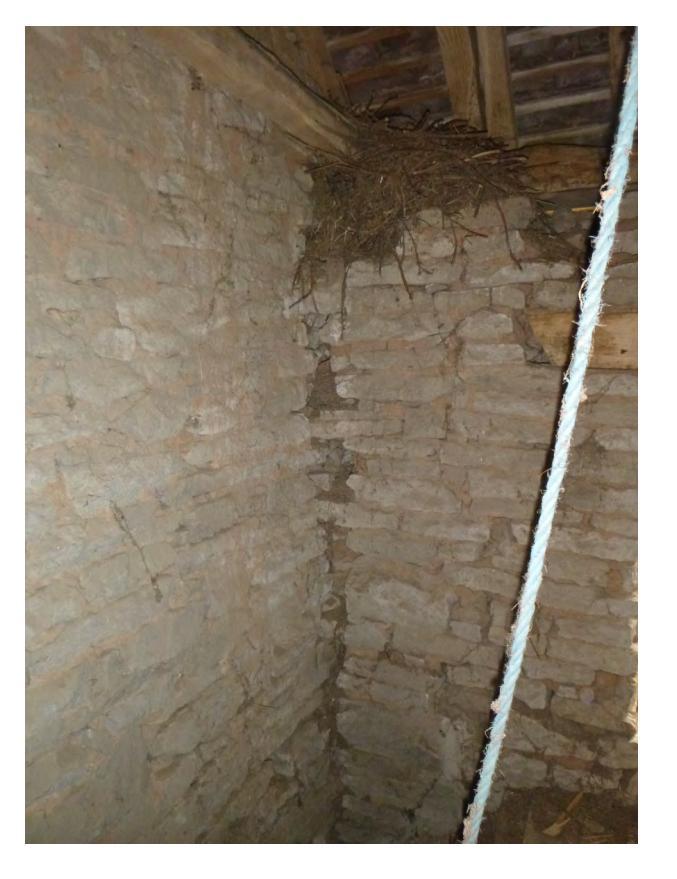
### Fig 14:

Two large cracks were noted at the south-east and north-east corners of the east part of the building, travelling downwards from the eaves to the approximate mid-point. An oak timber tie had been introduced, and large radial cuts from mechanised circular saw conversion suggested this was relatively recent, in an attempt to prevent further eastward structural movement, although it was not clear whether this had been successful or not. There was no evidence that the structural movement had resulted in timber decay as a consequence of water penetration, although may have caused localised racking of the roof and possible dislodgement of timbers embedded in the masonry wall

Bays 1 and 2; showing large crack in masonry in south-east corner of the building. This matched an equally large crack in the north-east corner, and should be assessed by the Structural Engineer for significance

Structural Engineer to comment on large cracks at north-east and south-east corners, although allowance should be made for significant works to prevent further outward (eastwards) movement of the east gable end

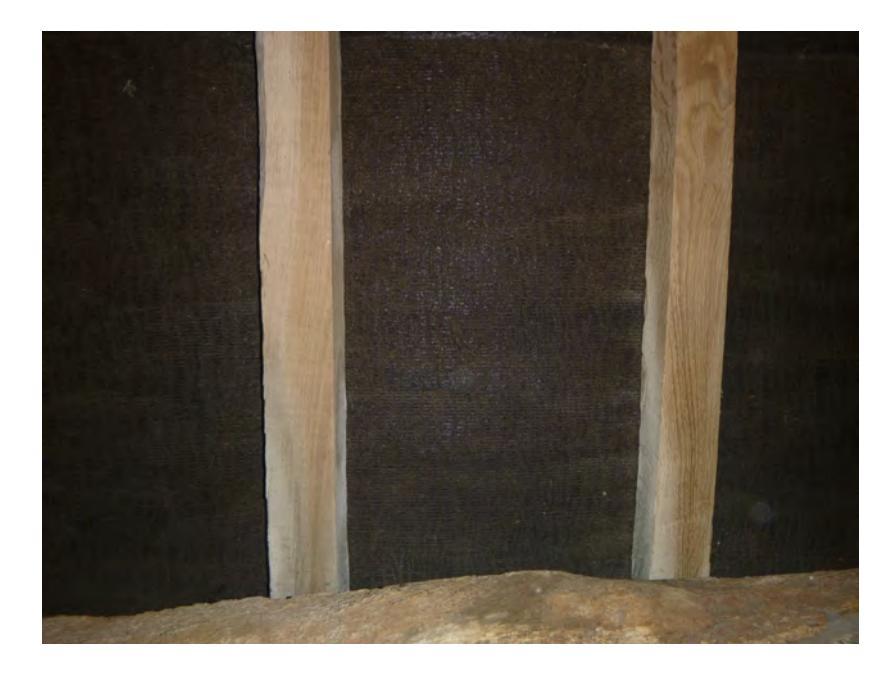
### Fig 15:

South wing, bay 1; showing example of suspected more recent hardwood intervention in the roof structure on the north side. Rafters generally square, more square than historic elements elsewhere

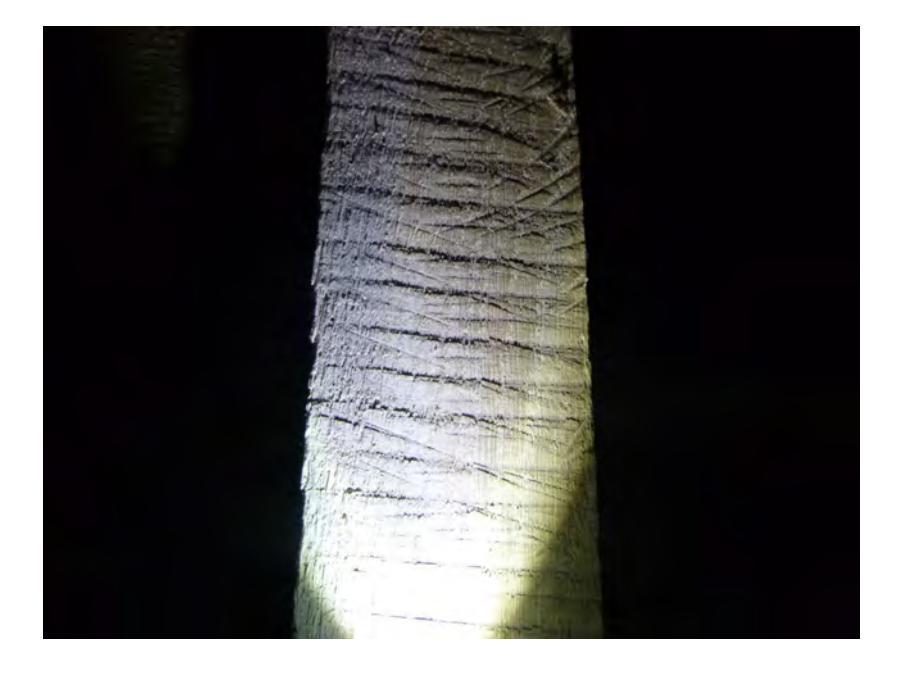
### Fig 16:

South wing, bay 1; showing handsaw timber conversion technique on face of suspected later hardwood intervention rafter

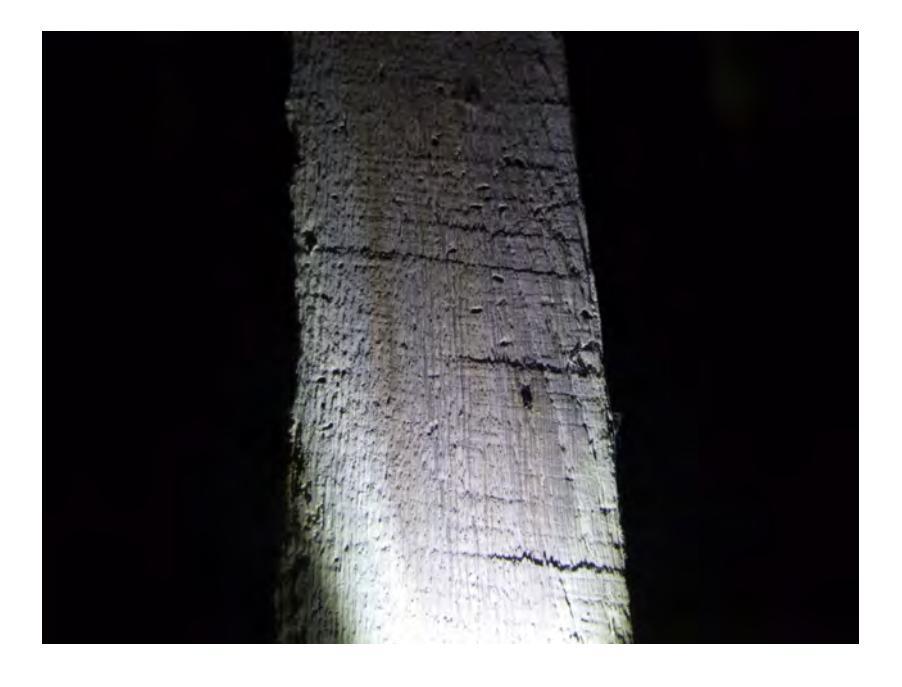
### Fig 17:

South wing, bay 1; showing typical slightly off perpendicular sawing marks on suspected original historic timber, consistent with pit sawn timber conversion

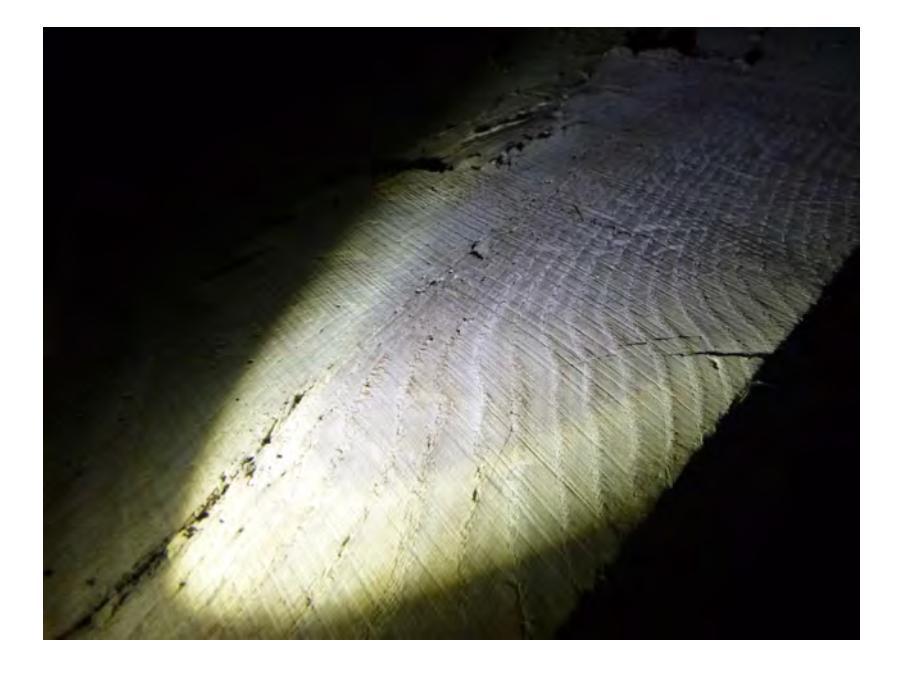
### Fig 18:

South wing, bay 1; showing typical off square pit sawn timber markings on west face of north principal rafter

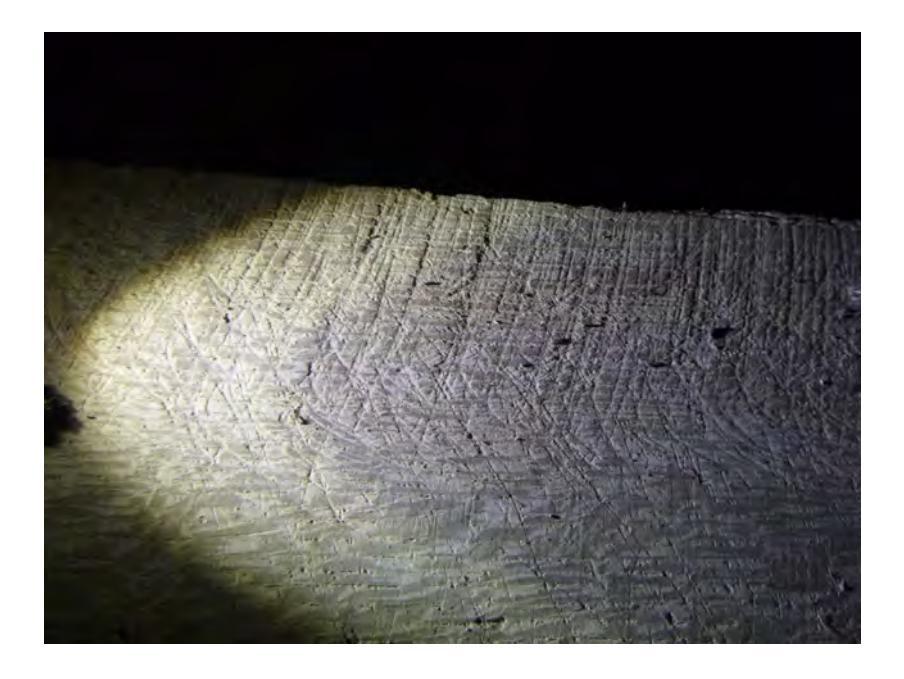
### Fig 19:

South wing, bay 2; showing typical off perpendicular pit sawn timber conversion techniques on tie beam at north end

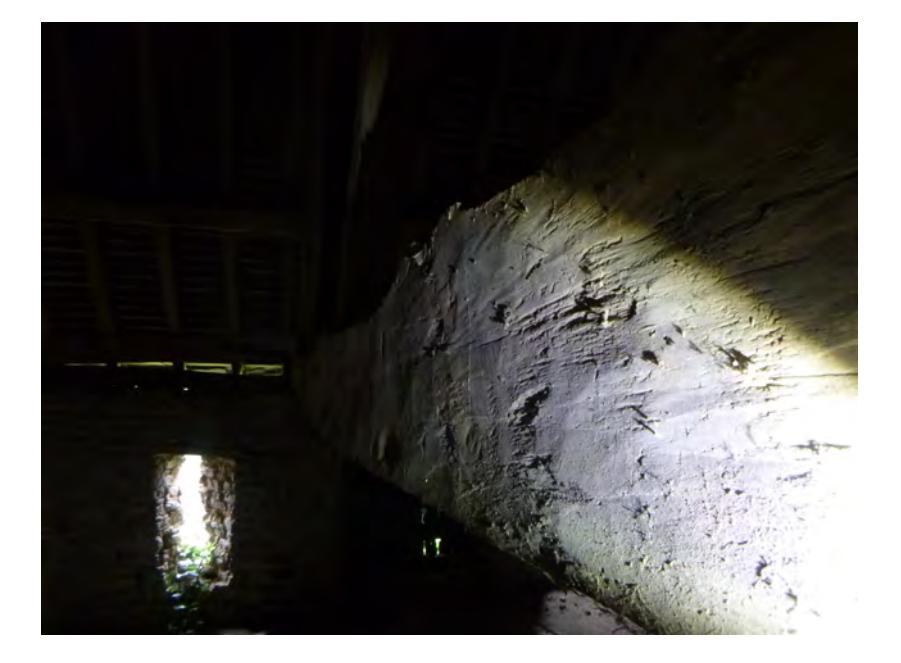
### Fig 20:

Bay 1, south wing; showing undulating markings on east face of tie beam of truss 1, typical with adze conversion use

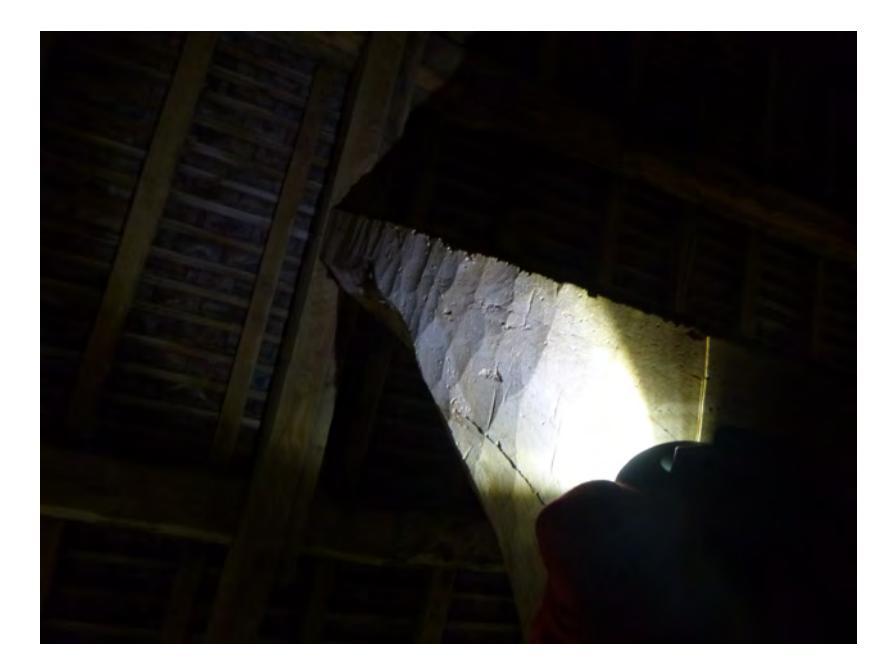
### Fig 21:

South wing, bay 1; showing adze conversion markings on east face of south strut for T1

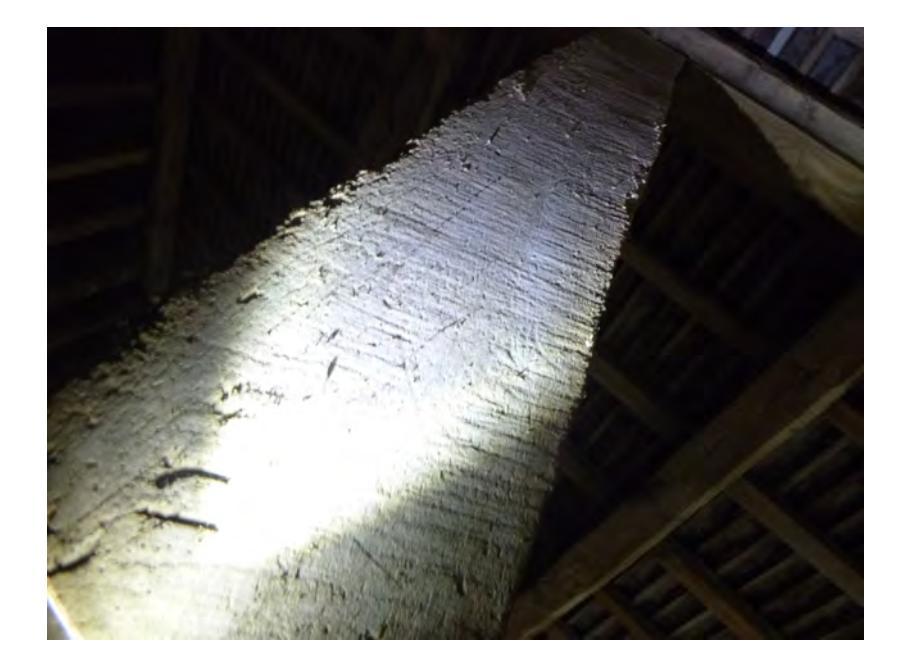
### Fig 22:

South wing, bay 1; showing pitsaw conversion markings on west face of south strut for T1

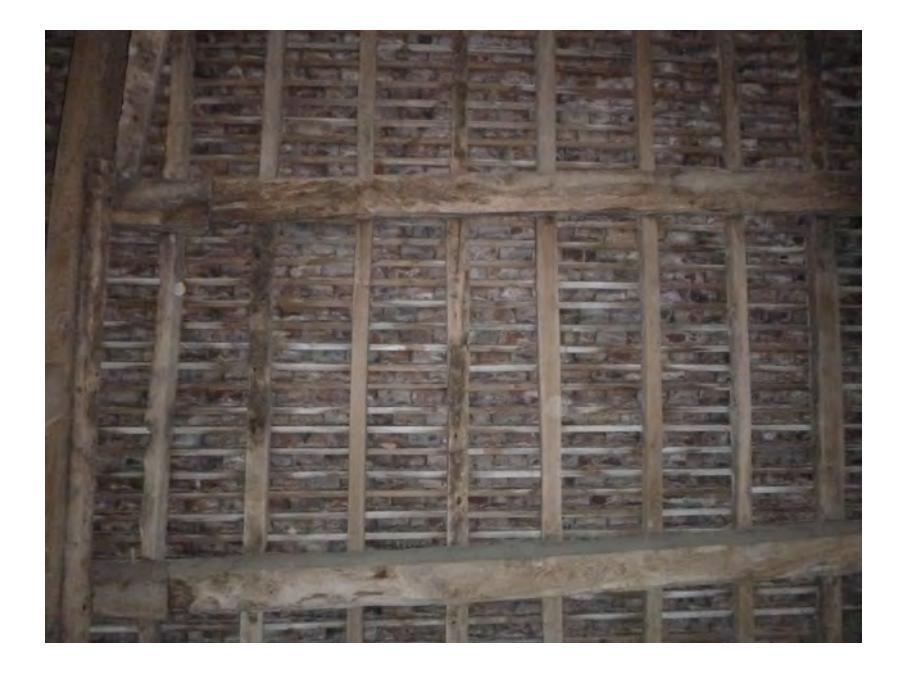
### Fig 23:

South wing, bay 2; showing roof structure between upper and lower purlins and marked difference between newer elements and original historic components

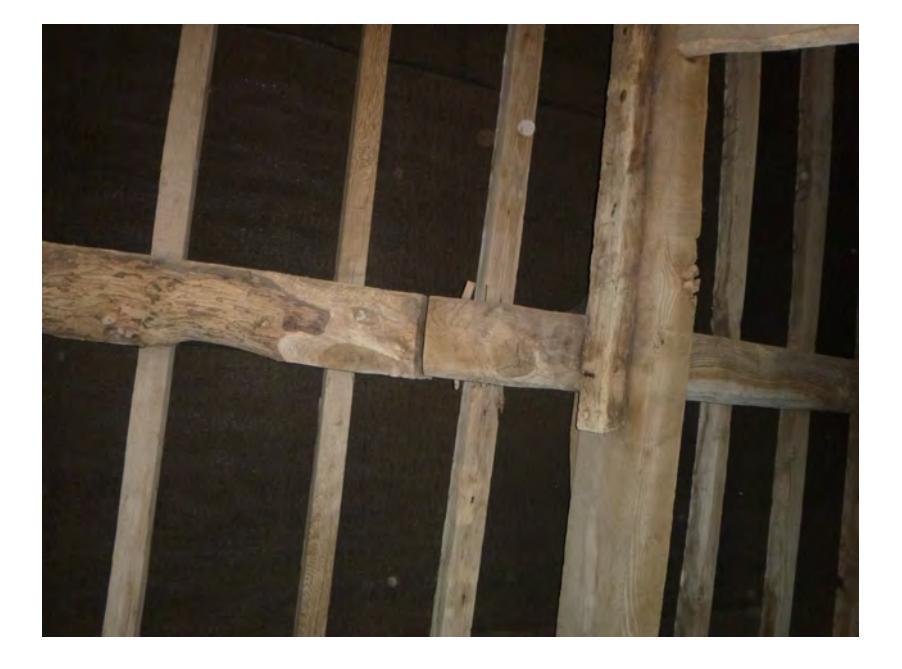
### Fig 24:

South wing, bay 2; showing relatively new oak pins at purlin joint on north pitch

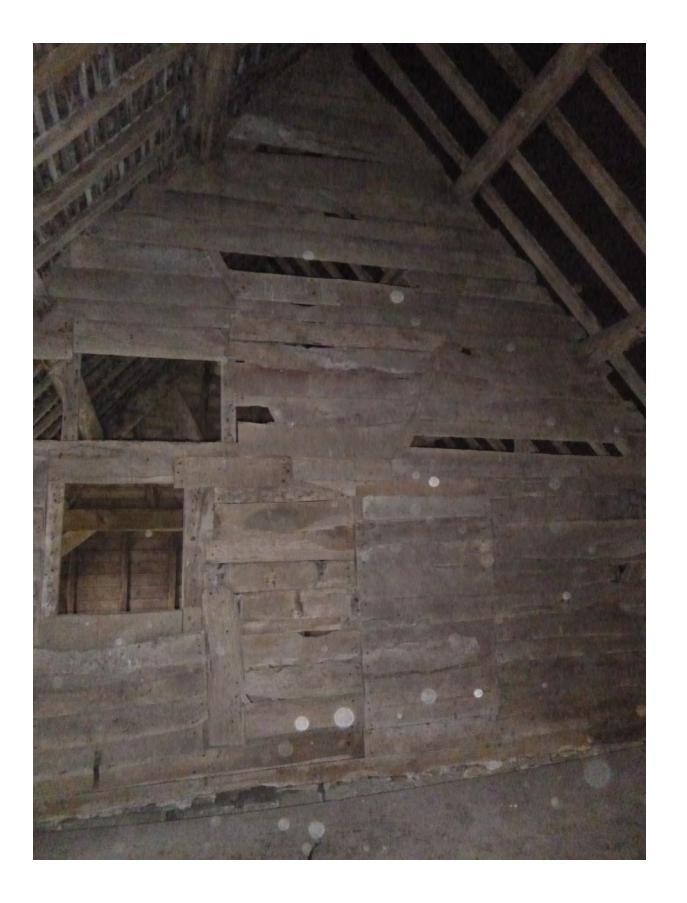
### Fig 25:

South wing, bay 2; showing cross wall between bays 2 and 3

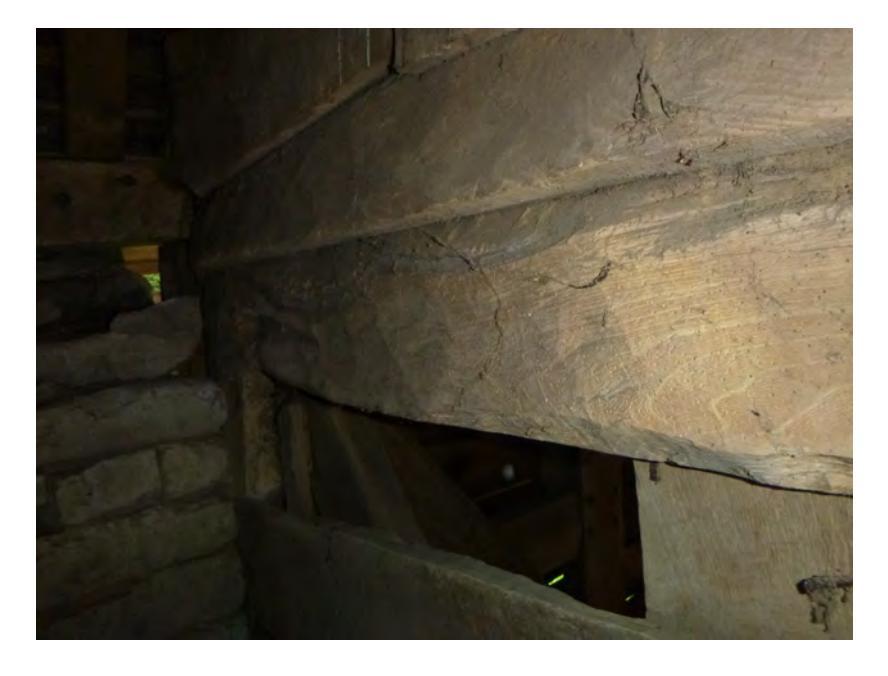
### Fig 26:

South wing, bay 2; showing adze shaping on face of larger board comprising cross wall between bay 2 and 3

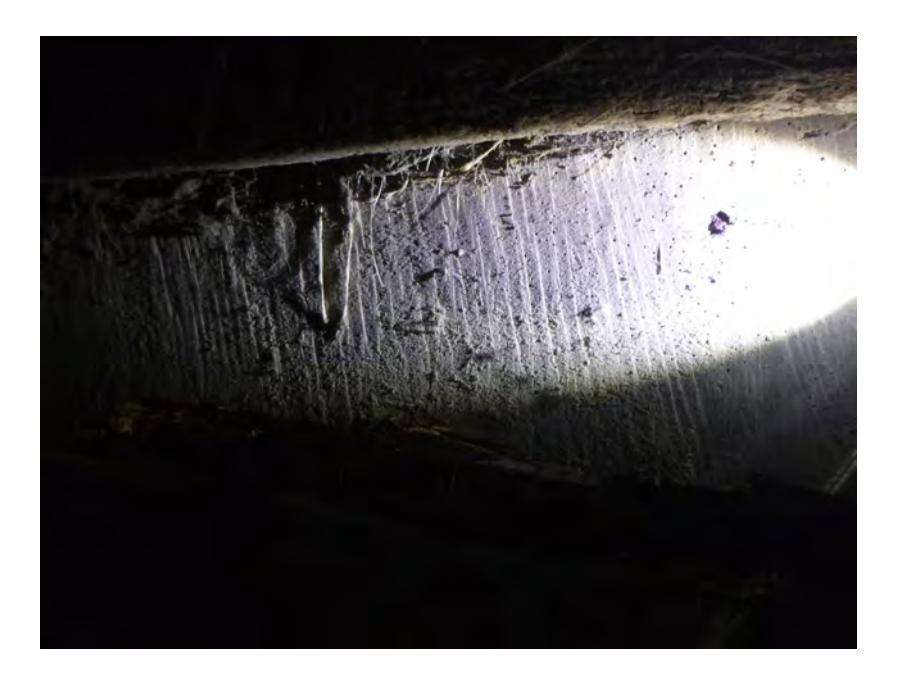
### Fig 27:

South wing, bay 2; showing hand sawn conversion markings on boards between bays 2 and 3

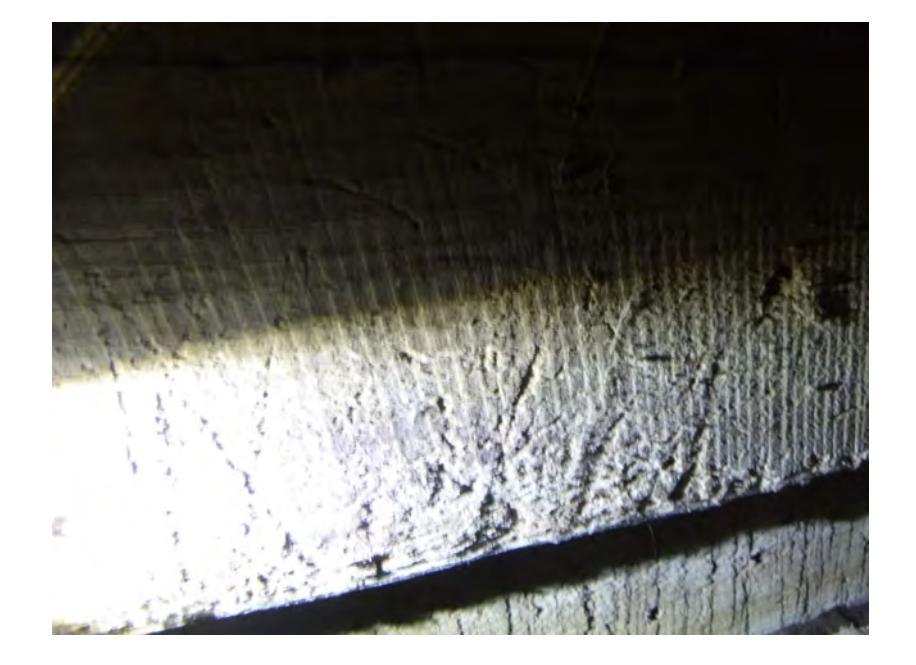
### Fig 28:

South wing, bay 2; showing clear irregular band saw markings on face of boards between bays 2 and 3, suggesting the boards may originate from varying stages of the past

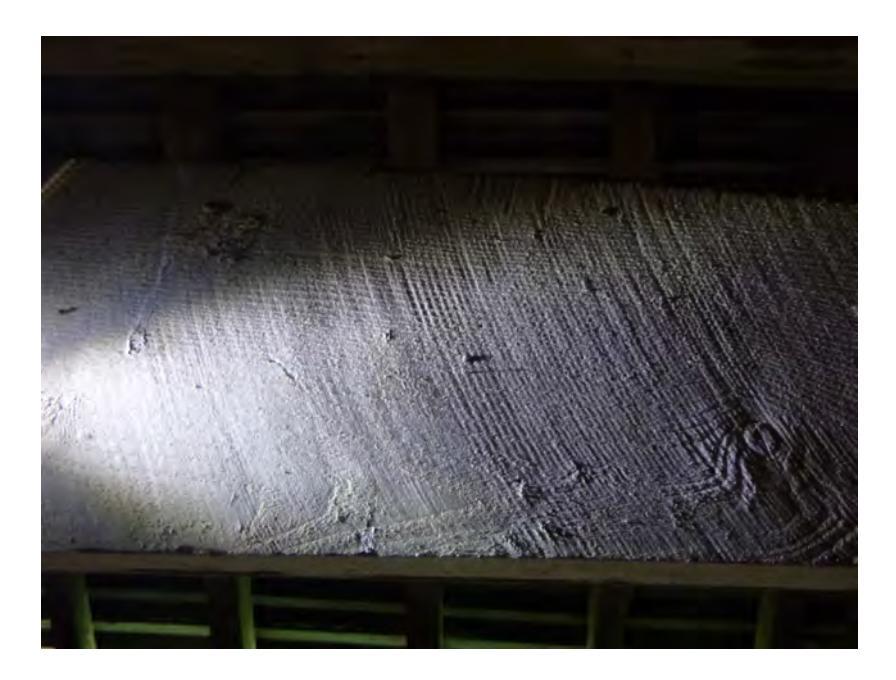
### Fig 29:

South wing, bay 1; showing clear circular saw markings on timber tie between truss 1 and extreme east masonry wall

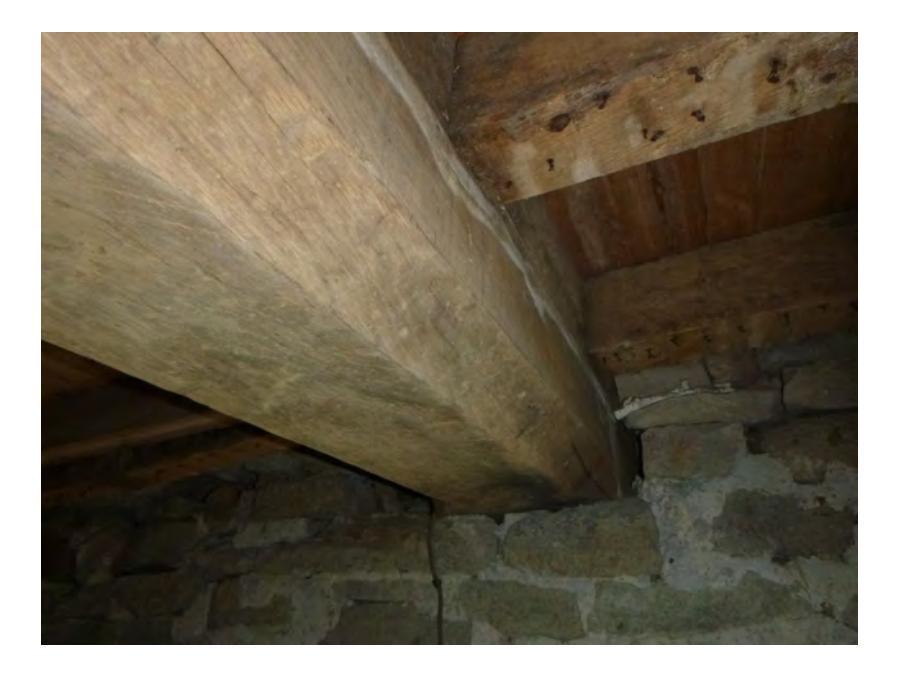
### Fig 30:

South wing, bay 1, ground floor; showing timber beam supporting the first floor joists and cleanly shaped to the underside and relatively straight clear lines, suggesting most likely from much later than original construction, although remains clear pit sawn timber conversion markings

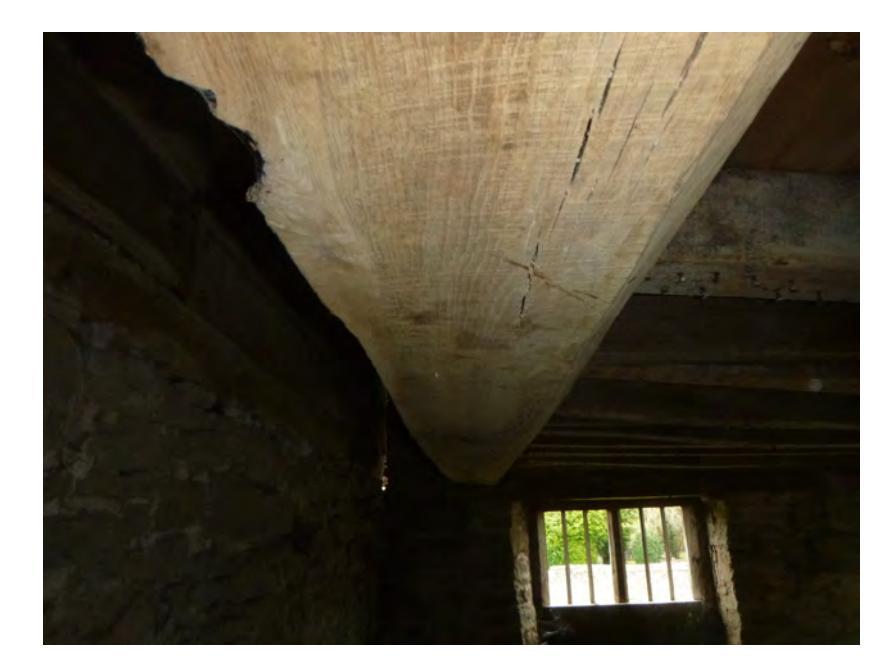
### Fig 31:

Ground floor, south wing, bay 2; showing floor beam to west side, again with clean chamfered edges but with also visible pit sawn timber markings

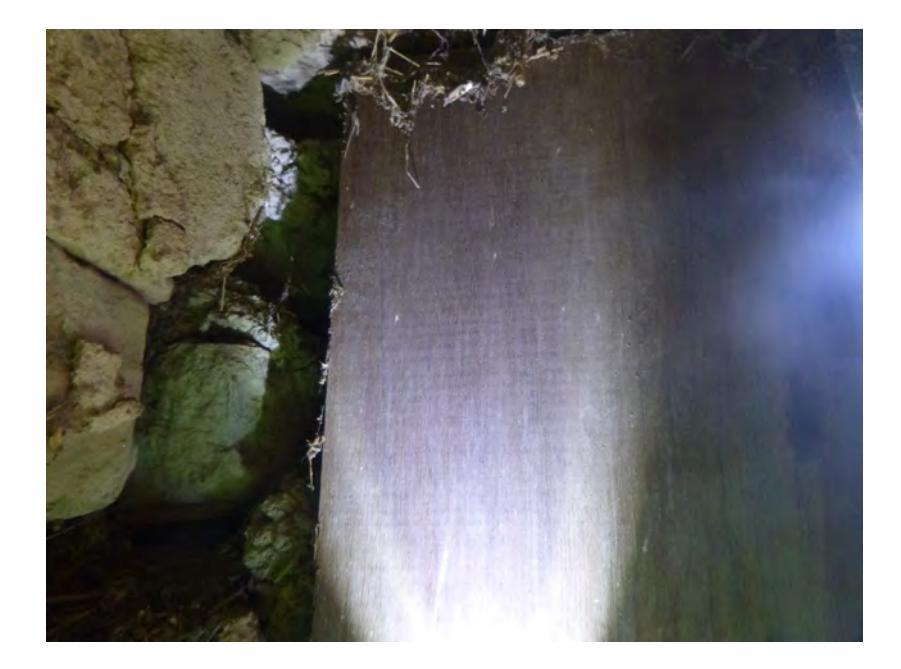
### Fig 32:

South wing, ground floor, bay 1; showing clear planer/thicknesser markings on door frame elements to east and west, showing much later hardwood intervention, most likely late 20<sup>th</sup> Century

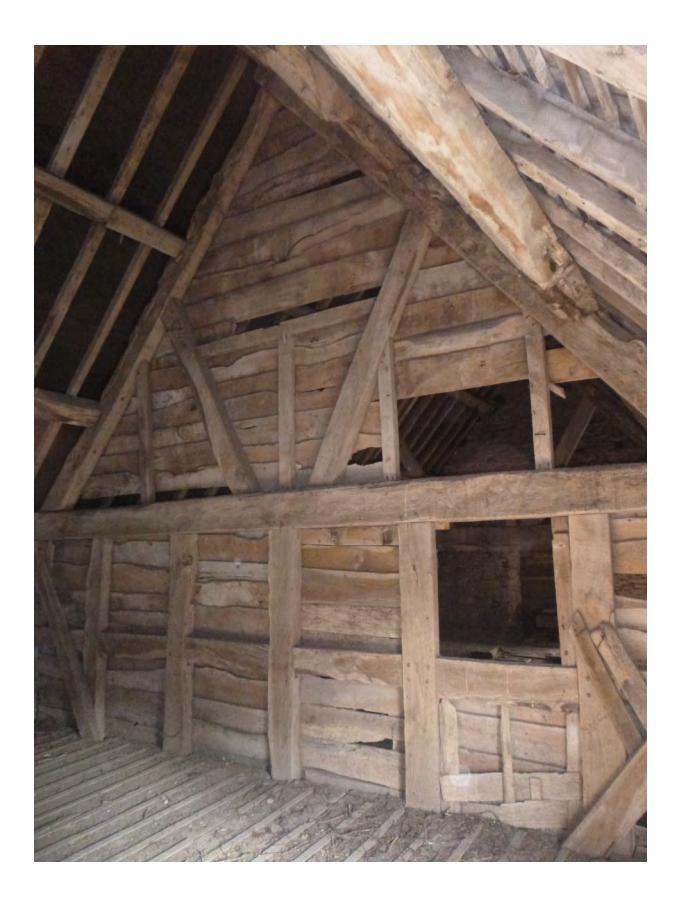
#### Fig 33:

Bay 3; showing a general view of th cross wall between bays 2 and 3 from the west side. Note the general squareness and patina of the timber studs above and below the tie-beam, suggesting intervention in the past

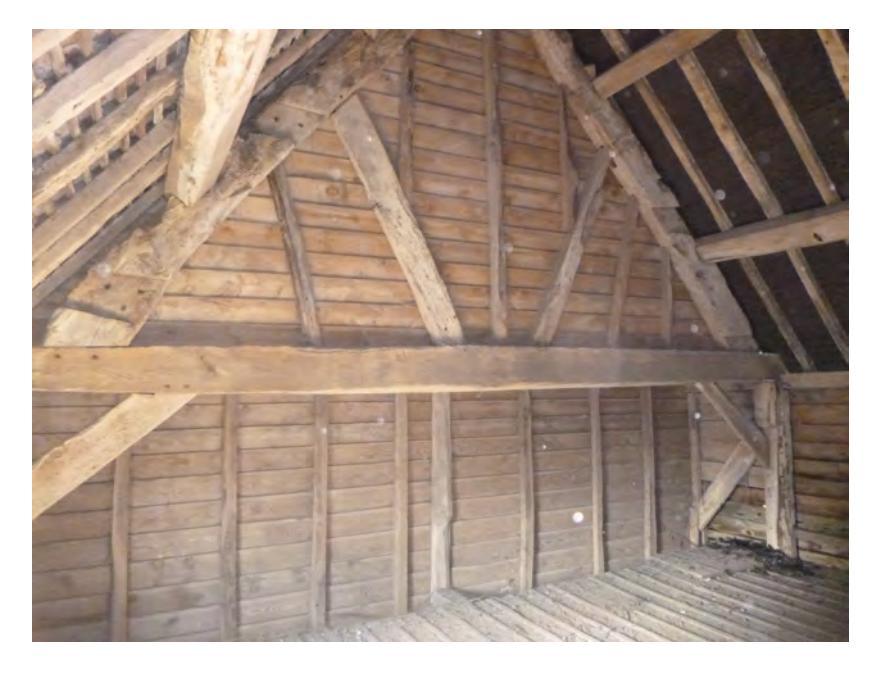
### Fig 34:

Bay 3; showing the cross wall between bays 3 and 4. All boards had been replaced relatively recently with new machined softwood timber. Note the large halvings on the principal rafters indicating re-use

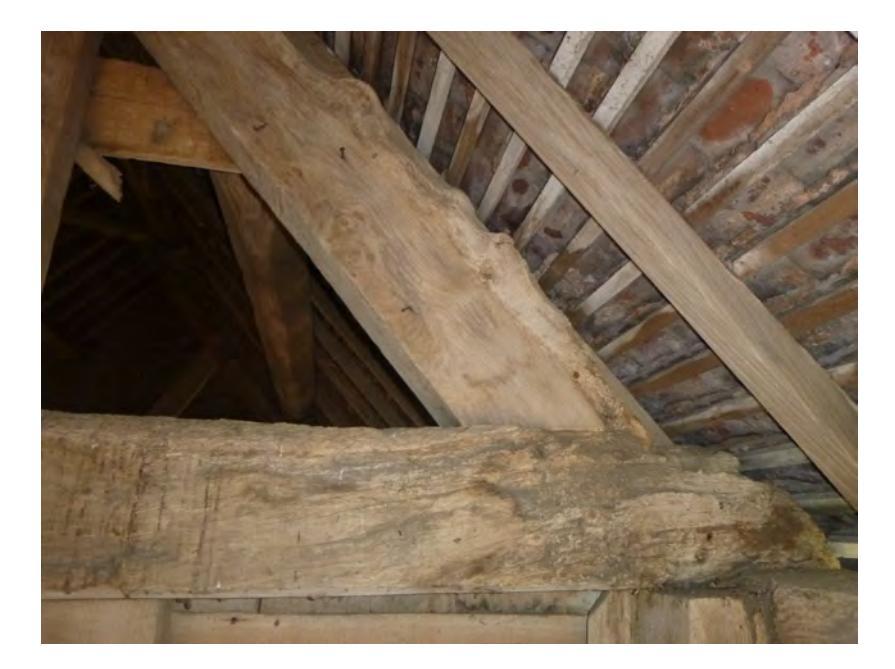
### Fig 35:

Bay 3; showing some loss of crosssection to the upper edge of the principal rafter of truss 2 although not sufficient to result in any structural significance

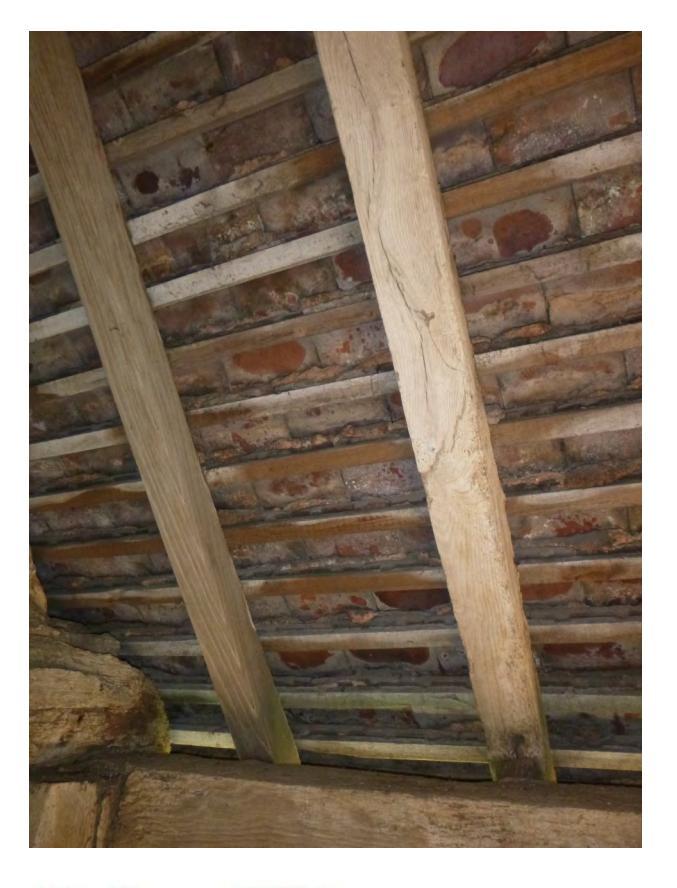
### Fig 36:

Bay 3; showing again, rafters generally square and clean suggesting likely intervention in the past

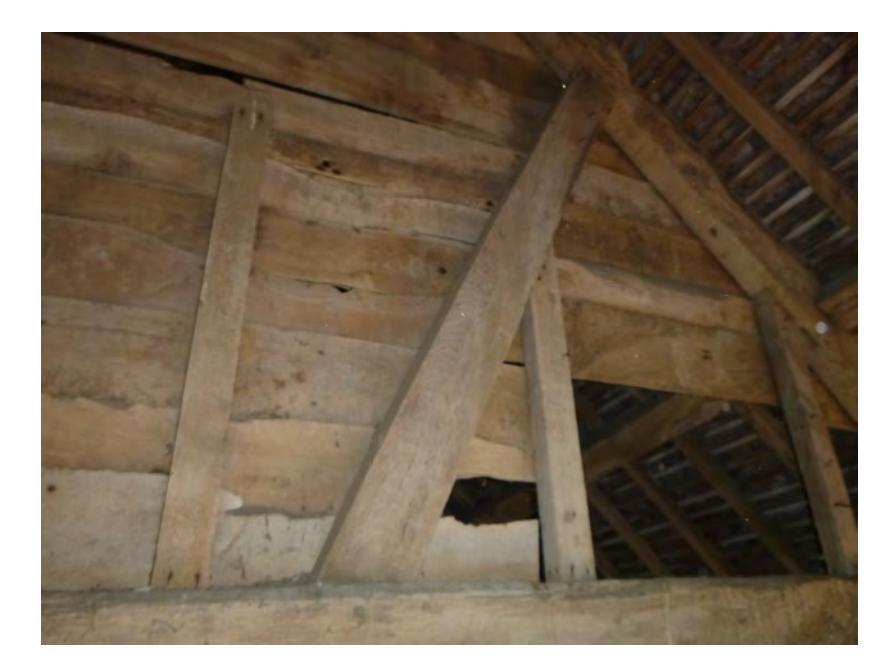
### Fig 37:

Bay 3; showing the cross wall between bays 2 and 3 and the relative squareness and good condition of the studwork above the tie-beam
