# Aston Hall: Investigation of structural timber elements – South range barns

Site note 1 for March 2021, job no. 153.32

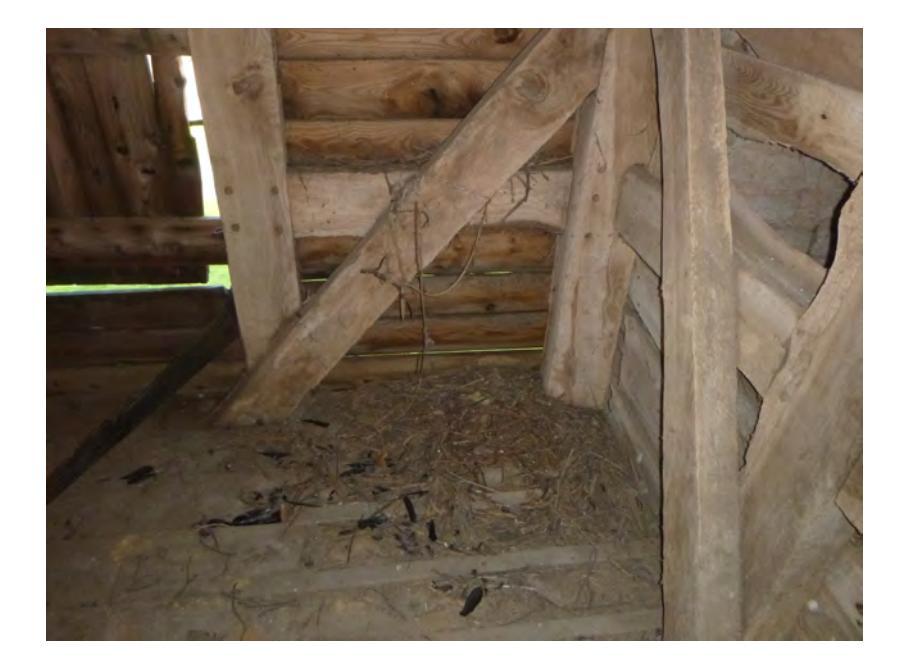
### Fig 38:

Bay 3; showing further nesting material (most likely jackdaws/magpies) in the north-east corner of the bay, locally reducing ventilation to vulnerable timber elements

All nesting material (and tent wall hangings) should be removed to allow for ventilation to structural timbers, eliminating the conditions in which wood-boring beetle and dampness can thrive. If the building is to be left for a significant period of time prior to refurbishment, installation of netting over holes in the facades should be considered to prevent further avian intrusion

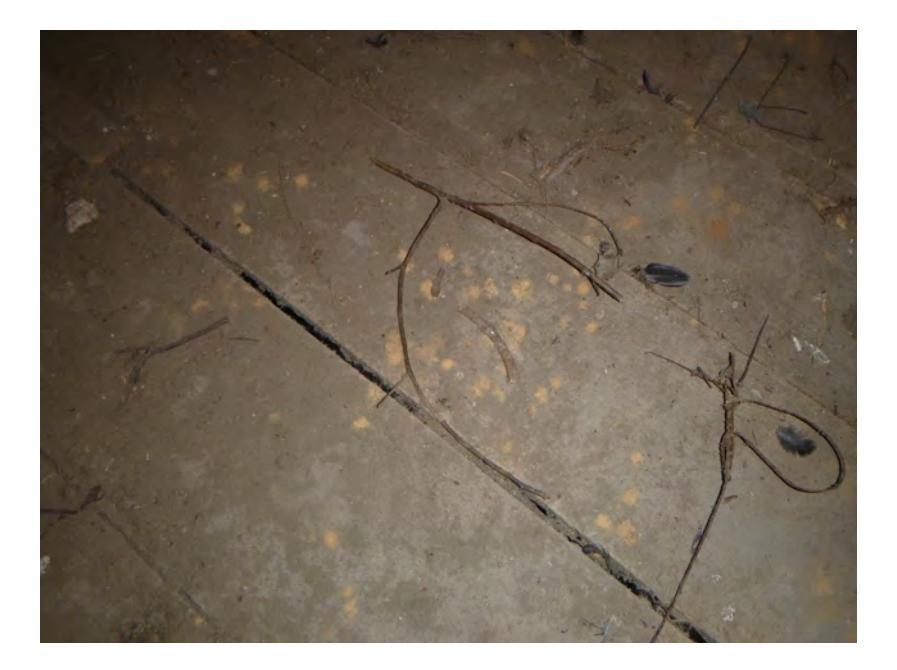
### Fig 39:

Bay 3; showing further small piles of frass consistent with Common furniture beetle, and although no structurally significant timber decay was detected, these localised areas will almost certainly extend if left unchecked

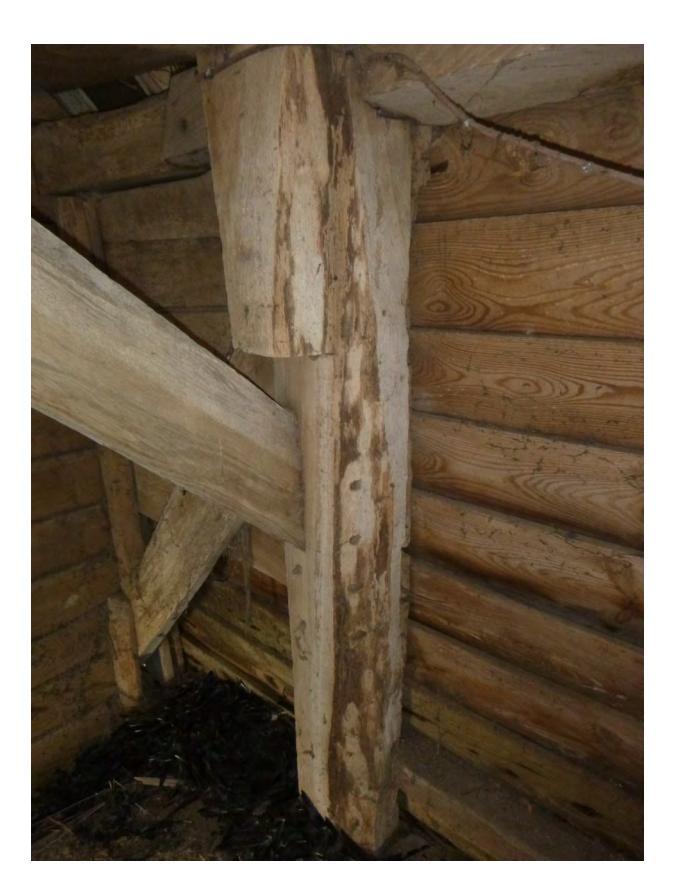
#### Fig 41:

Bay 3; showing north post of truss 4. No structural decay detected on drilling, and deep moisture content readings well below the decay threshold. No structural issues identified

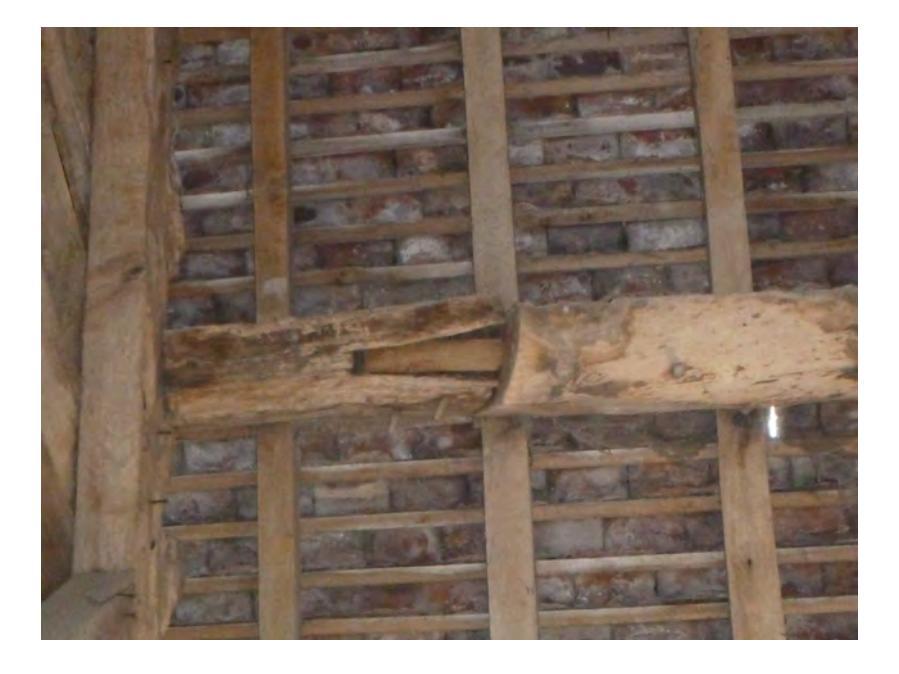
### Fig 42:

Bay 3; showing the separation of the bridle joint between the upper south pitch purlins. Pins remained in position, but may require strengthening with timber or steel to prevent further movement

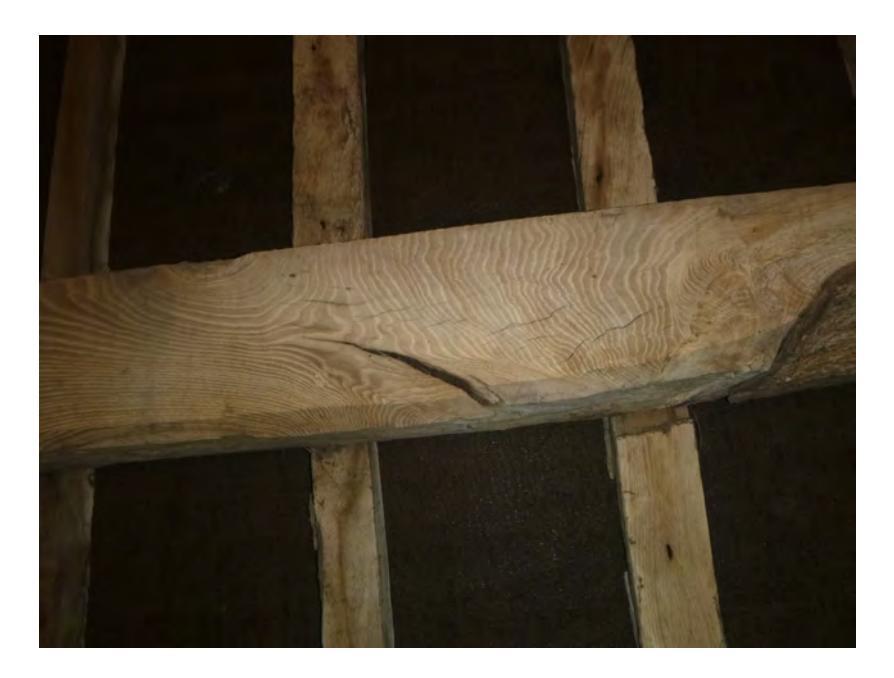
#### Fig 43:

Bay 3; showing a large fracture in the underside of the north pitch lower purlin. This was not considered a direct result of structural loadings, but more likely an inherent defect in the timber, exacerbated by the natural drying process

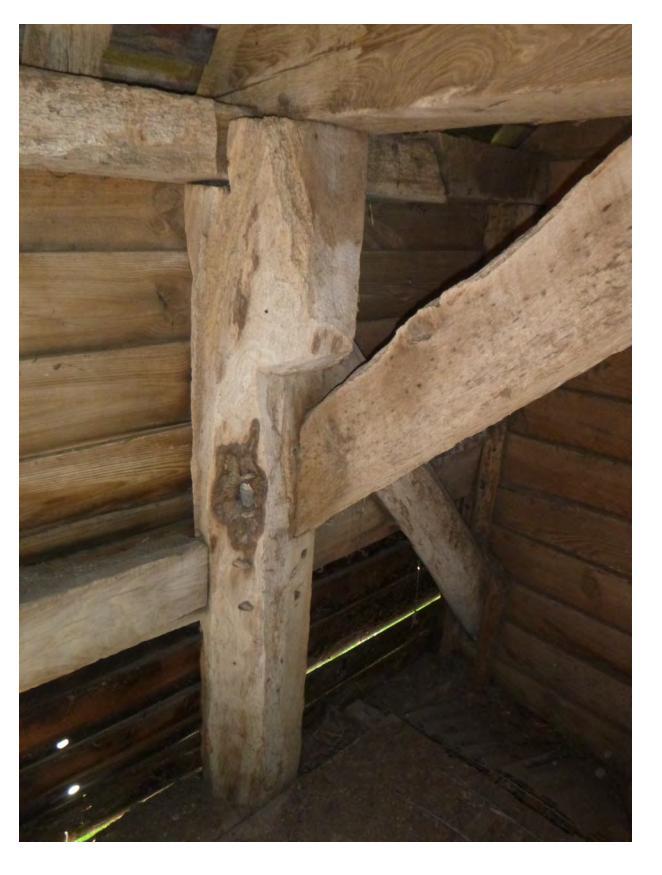
### Fig 44:

Bay 3; showing the south post of truss 4. No decay detected on drilling, although the element consisted of a high sapwood content and is therefore at elevated risk of wood-boring beetle infestation

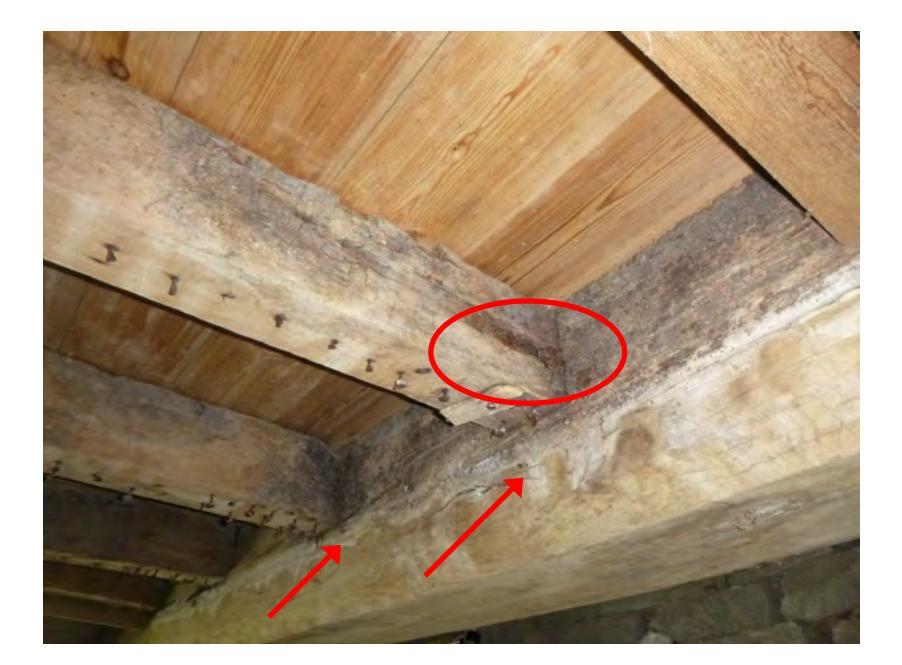
#### Fig 51:

Bay 1 ; showing localised decay to the bearing end of 1no. floor joist tenoned in to the floor beam

Also showing surface decay and water and salt staining to the face of the floor beam, caused by moisture tracking from damp masonry at the bearing ends of the beam

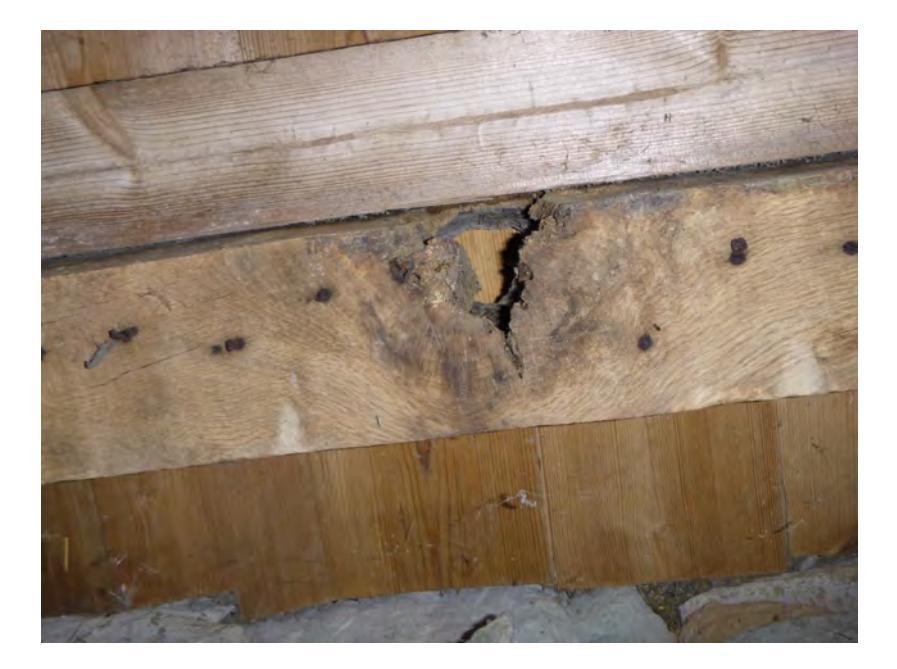
### Fig 53:

Bay 2; showing a structurally significant large knot defect to an oak floor joist

Note the softwood partner joist, solely installed to provide a level surface for the floor above

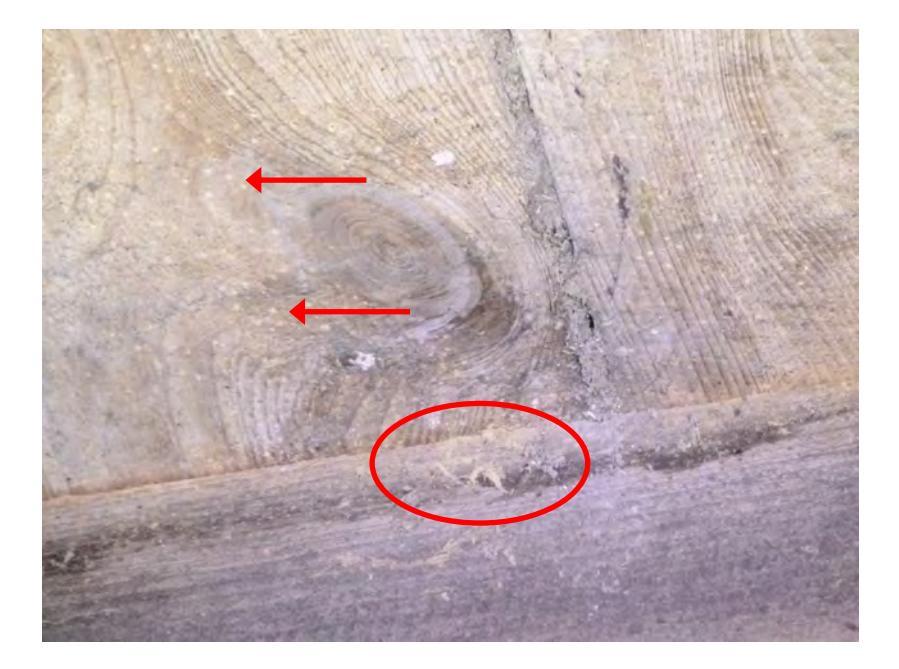
#### Fig 55:

Bay 3 ; showing flight holes of wood boring beetle filled with frass, as well as adjacent loose frass caught on the surface of the timbers, which collectively strongly suggests that there is active infestation

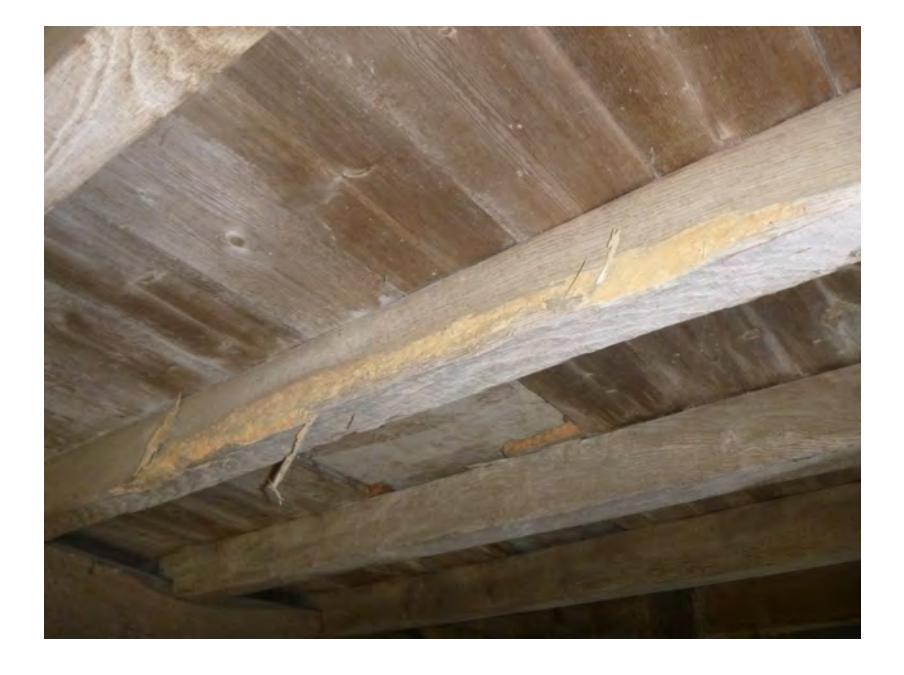
### Fig 58:

Bay 6; showing localised loss of sapwood from wood boring beetle to the face of a floor joist, not considered structurally significant

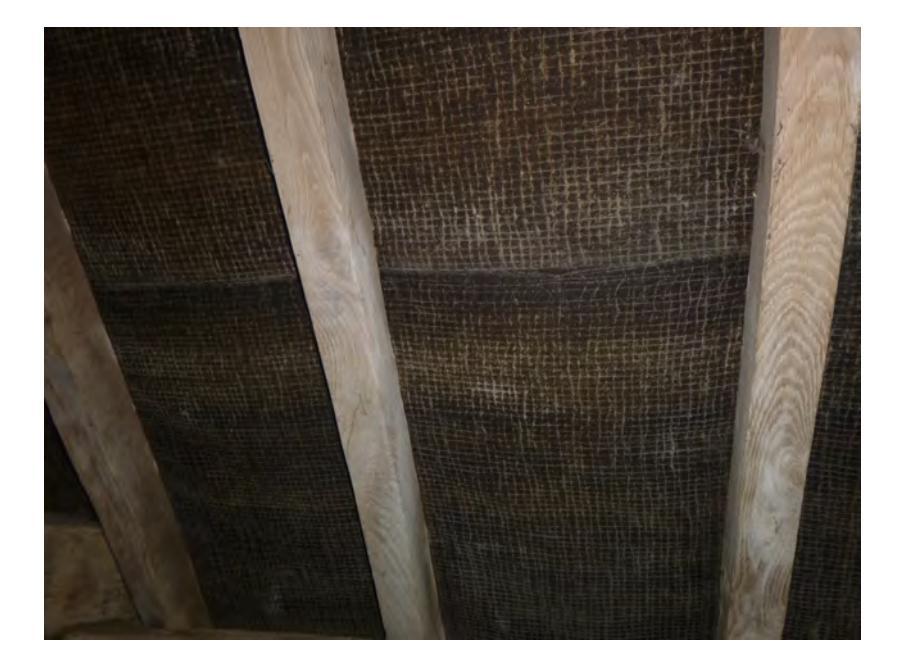
### Fig 60:

Bay 6; showing the bituminous roofing felt suspected to be a result of roof covering intervention during the 1980s

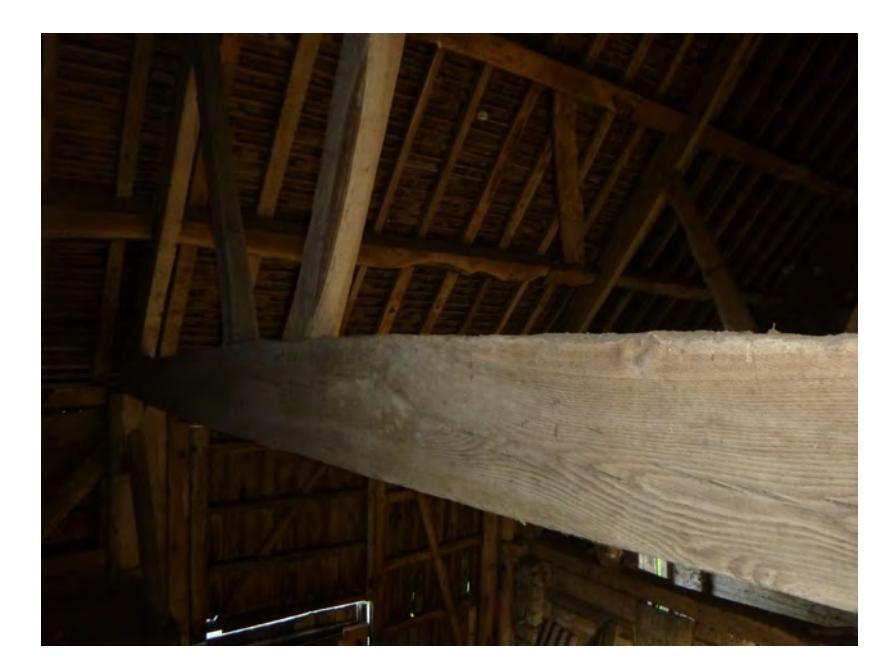
#### Fig 61:

Bay 6; showing the general condition of the tie-beam of truss 5. Again, pitsaw conversion markings were noted, as well as the patina suggesting introduction of the timber into the building well after initial construction

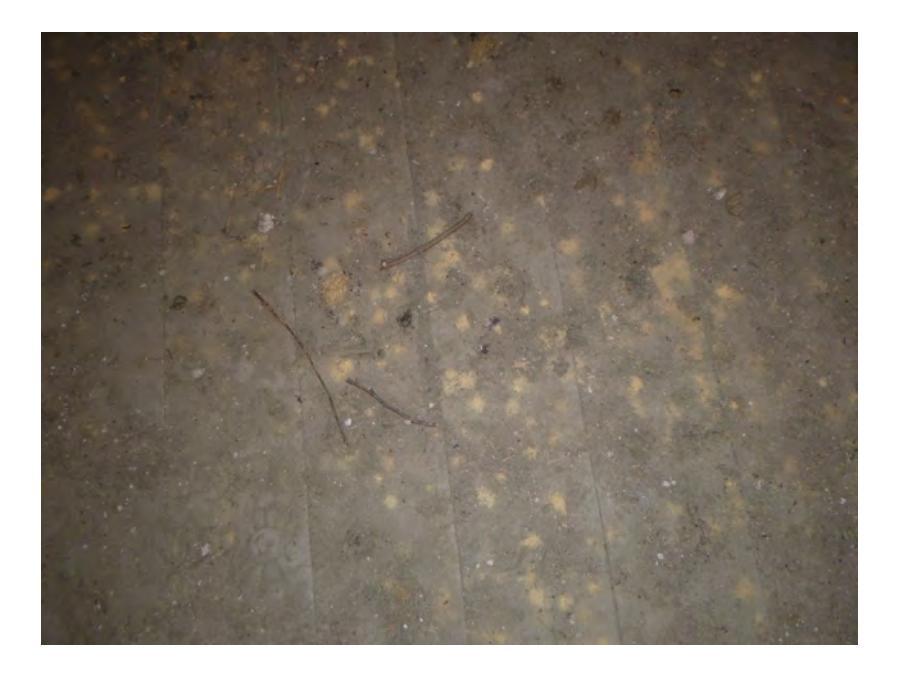
### Fig 62:

Bay 6; again showing widespread evidence of wood-boring beetle infestation of the softwood first floor coverings. Ambient moisture contents were generally high enough to support further infestation

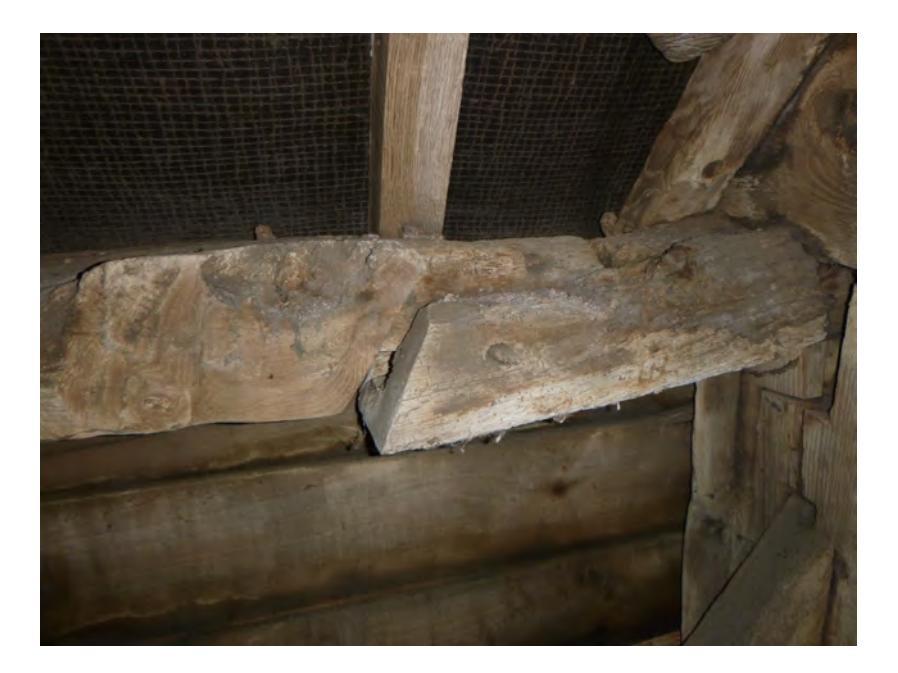
### Fig 63:

Bay 6; showing the south wall plate just to the east of truss 6. There was significant structural movement noted of the adjacent truss which was reflected in the separation of the purlin bridle joint and had resulted in snapping of the joint retention pins

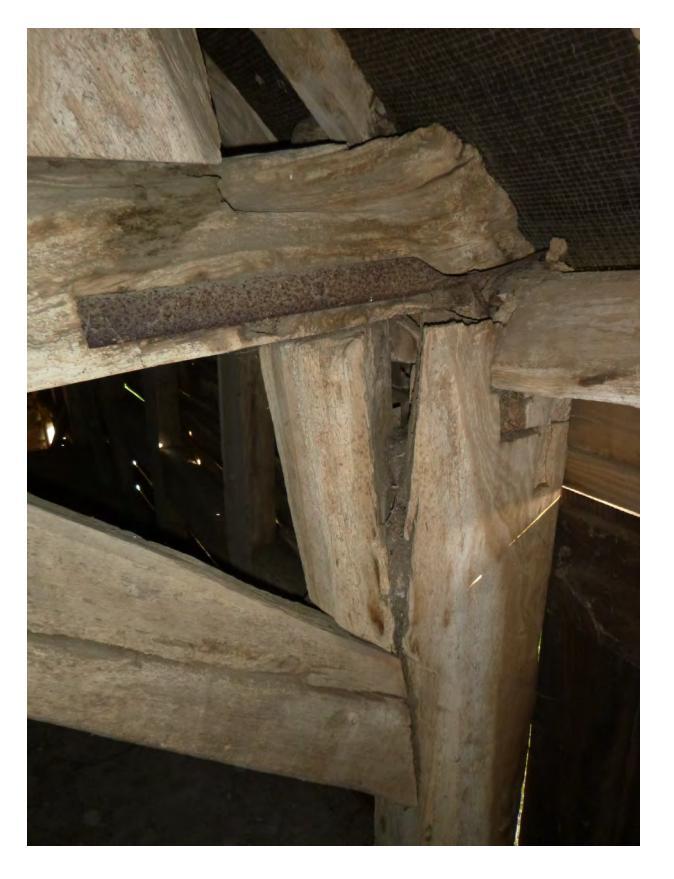
### Fig 64:

Bay 7; showing the south bearing end of truss 6 and the large fracture in the head of the main post. This was most likely a direct result of decay from water penetration at the north end of the truss tie-beam dragging the tiebeam away towards the north, fracturing the post

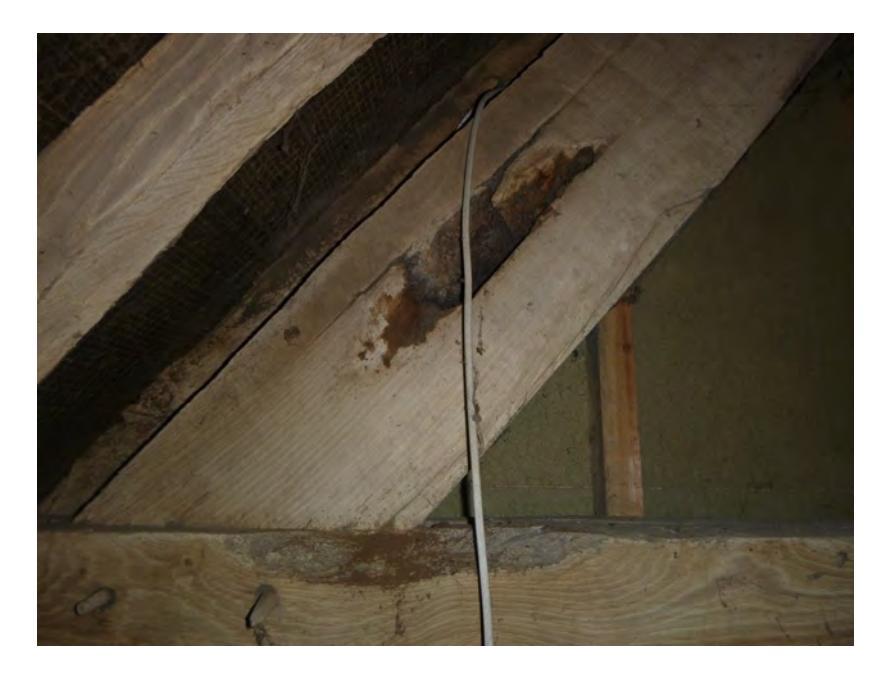
#### Fig 66:

Bay 7; showing a large pocket of decay at the bearing end of the south principal rafter. This was a result of localised wood-boring beetle (Deathwatch) infestation of vulnerable sapwood content. The north principal rafter was also noted to have a matching pocket of decay suggesting both elements had been converted from the same piece of timber

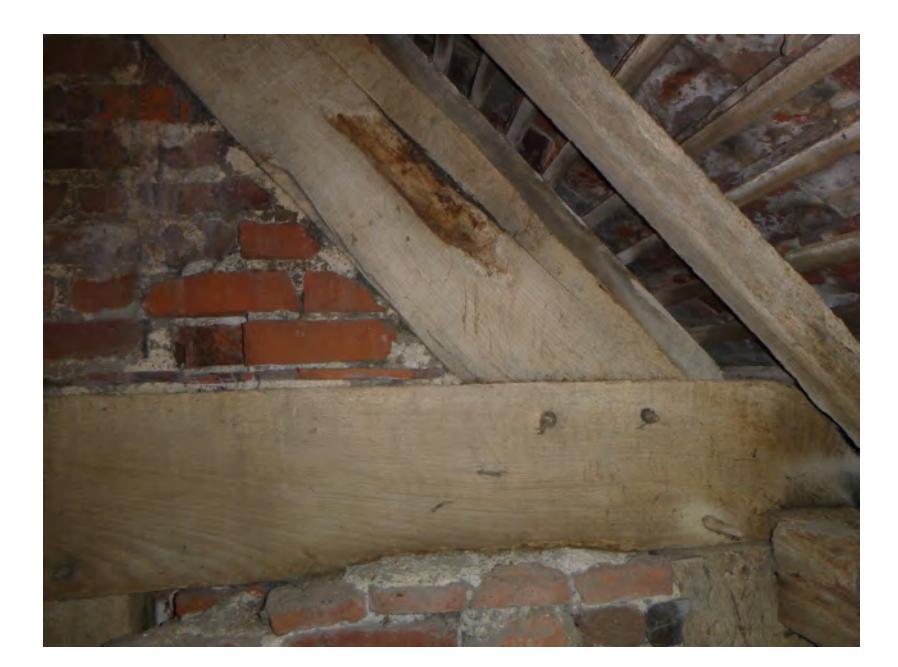
### Fig 67:

Bay 7; showing the pocket of decay at the bearing end of the north principal rafter

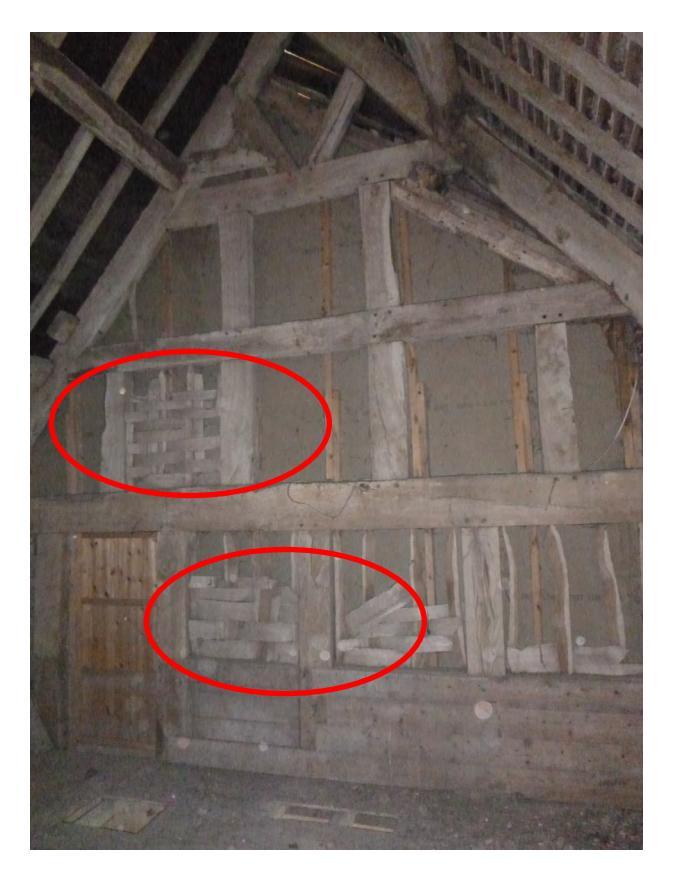
### Fig 68:

Bay 7; showing a general view of the cross wall between bays 7 and the west part of the barn (bike store). The over-sized lath construction panel in-fill is a local feature, removal of which should be in consultation with the Conservation Officer and may require detailed recording prior to refurbishment

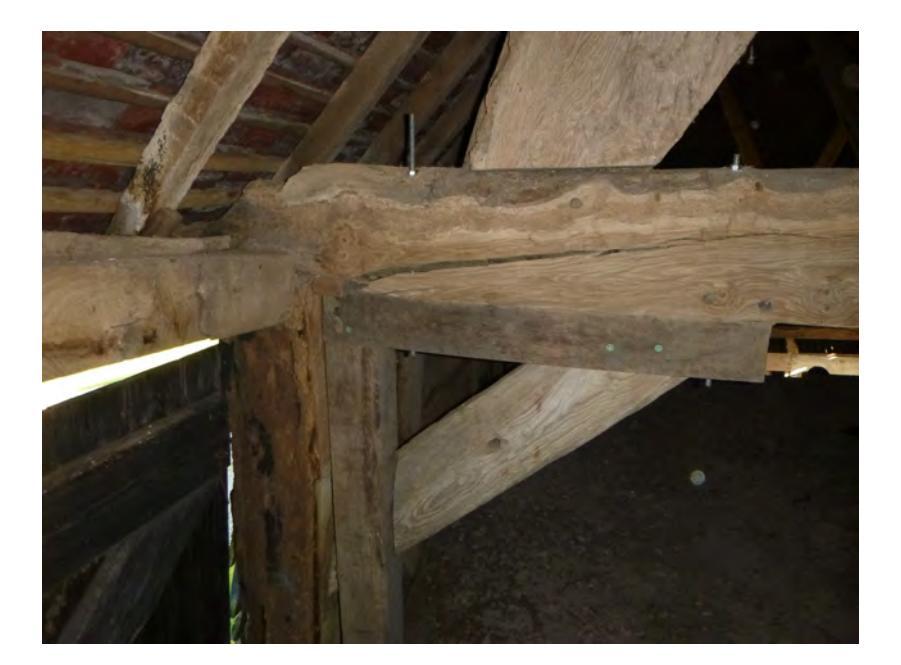
#### Fig 69:

Bay 7; showing the large fracture in the tie-beam at the north bearing end of truss 6. This was considered most likely a result of failure of structural elements below, particularly in the main post and the supporting plate, primarily from persistent rain water penetration and subsequent decay. Note remediation in the recent past using steel angle bracket, threaded rods, and softwood bracing

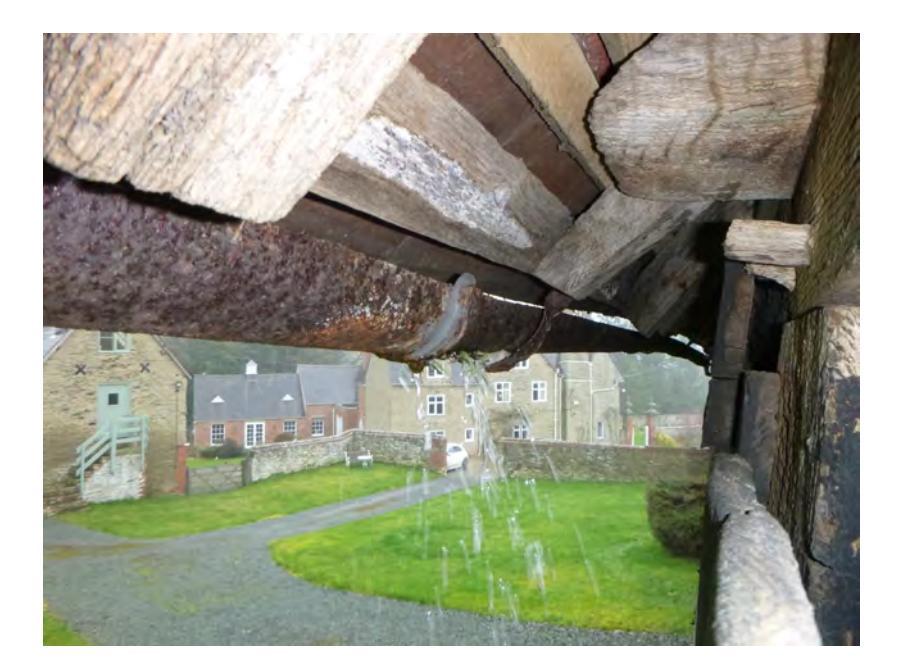
#### Fig 73:

Bay 6; showing failure of the rainwater drainage system at the time of survey resulting in saturation of external cladding and structural timber elements within

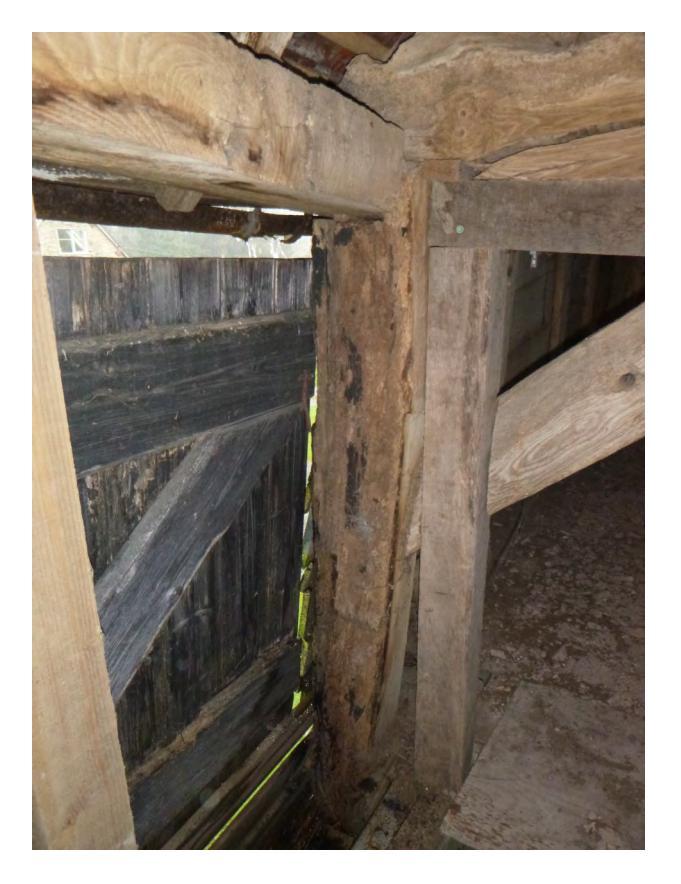
### Fig 74:

Bay 6; showing saturation of structural timber elements on the north side from inadequate rainwater drainage, which had clearly resulted in structural decay of elements in the past, and was considered likely to do so in the future unless remedied

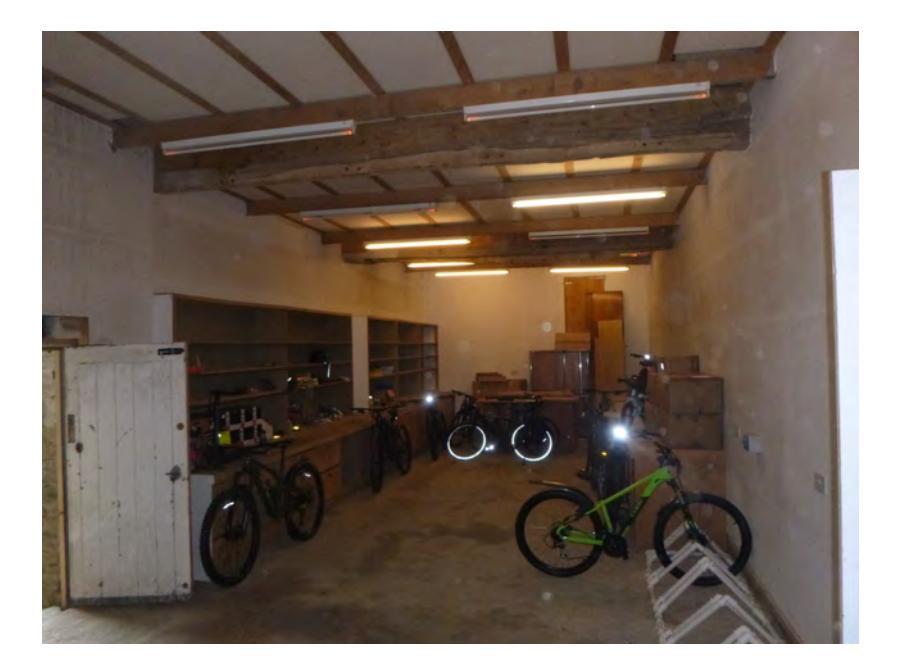
#### Fig 83:

West part of south barn; showing a general view of the area from the west. Note there was no access to assess the roof timbers due to no boarding being in place; however, tie-beams were visible from ground floor below and drilled and probed for decay and moisture content

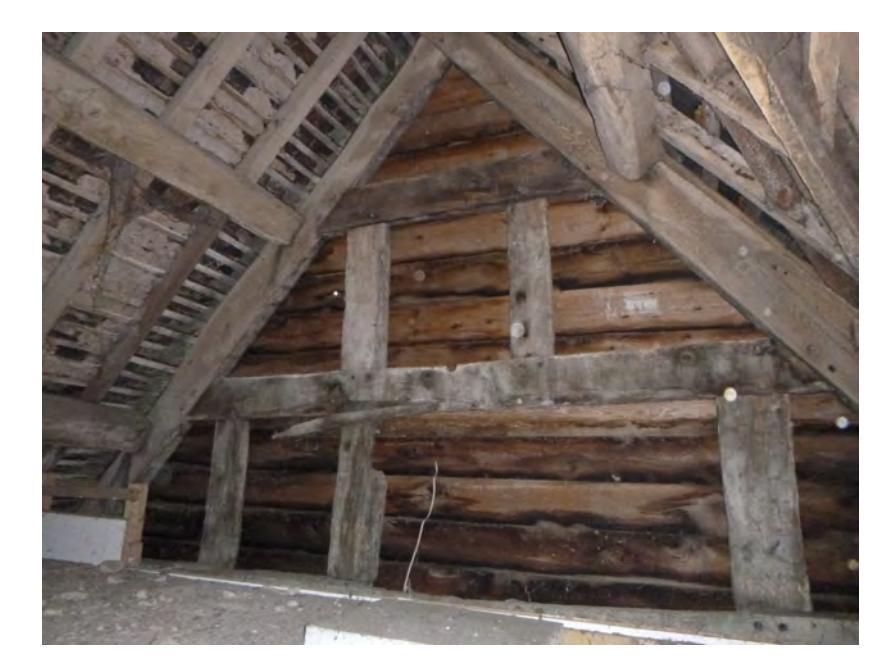
### Fig 85:

West part of south barn; showing the extreme west gable end where there were indications of water penetration, but no suggestion of structural timber decay as a result

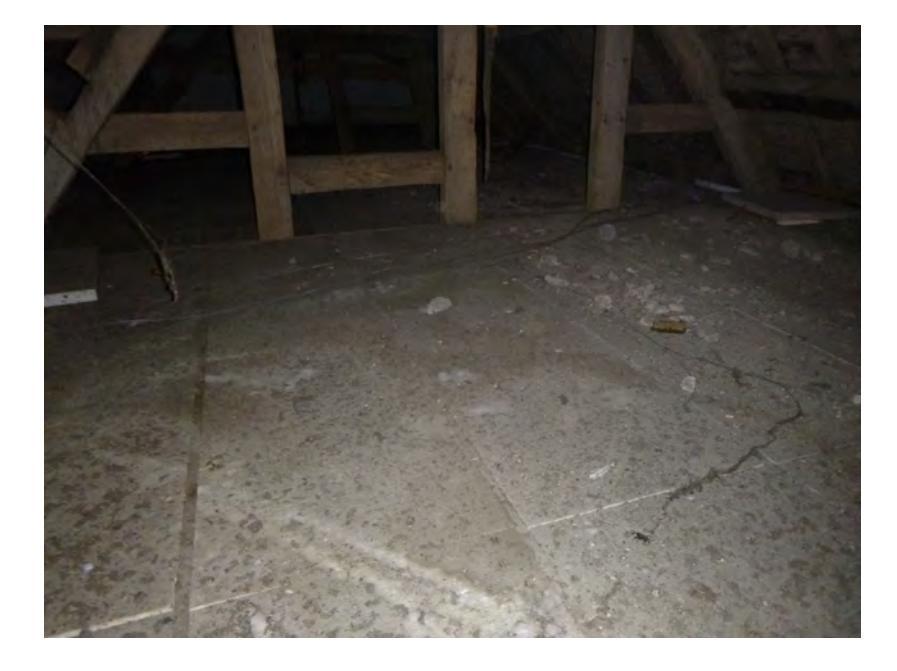
### Fig 86:

West part of south barn; showing the polystyrene ceiling boards and lack of walkboards for access to assess timber elements

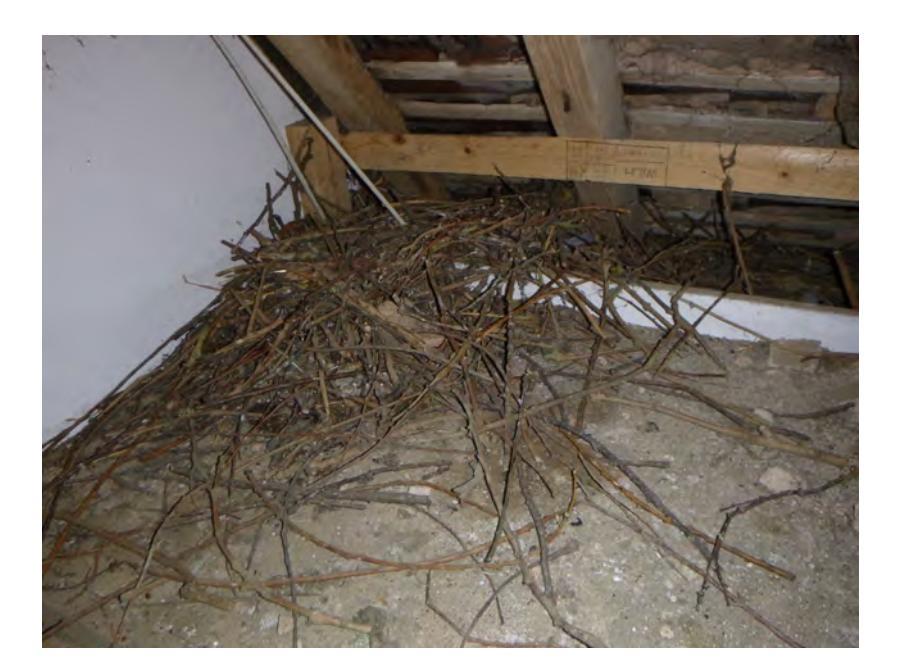
#### Fig 87:

West part of south barn; showing large area of nesting material in south-east corner of roof void, again, limiting ventilation to vulnerable structural timbers and providing the conditions conducive to wood-boring beetle infestation and decay

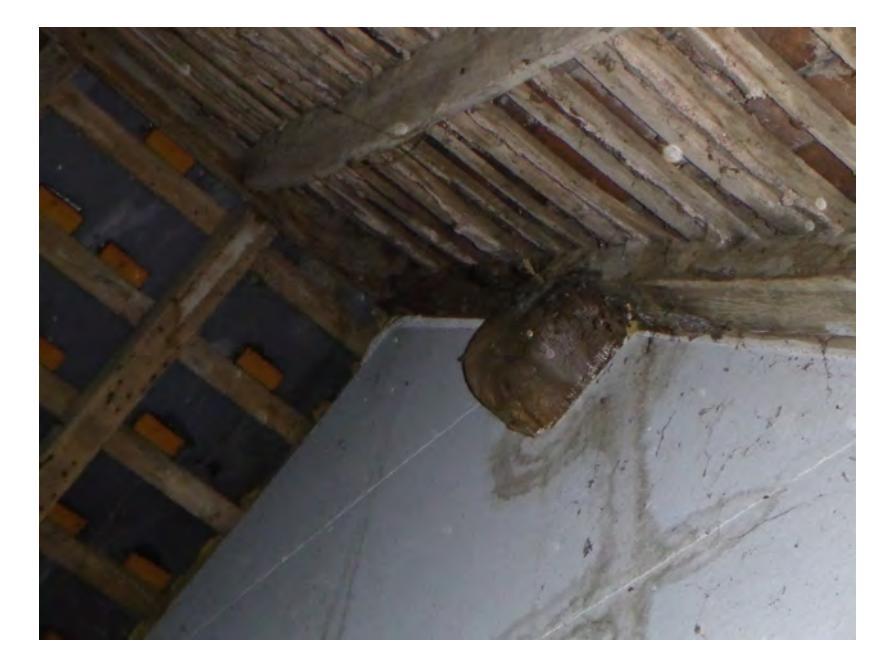
### Fig 88:

West part of south barn; showing evidence of water penetration at the interface between the main part of the south barn and the bike store area. Externally it was clear that flashings required replacement

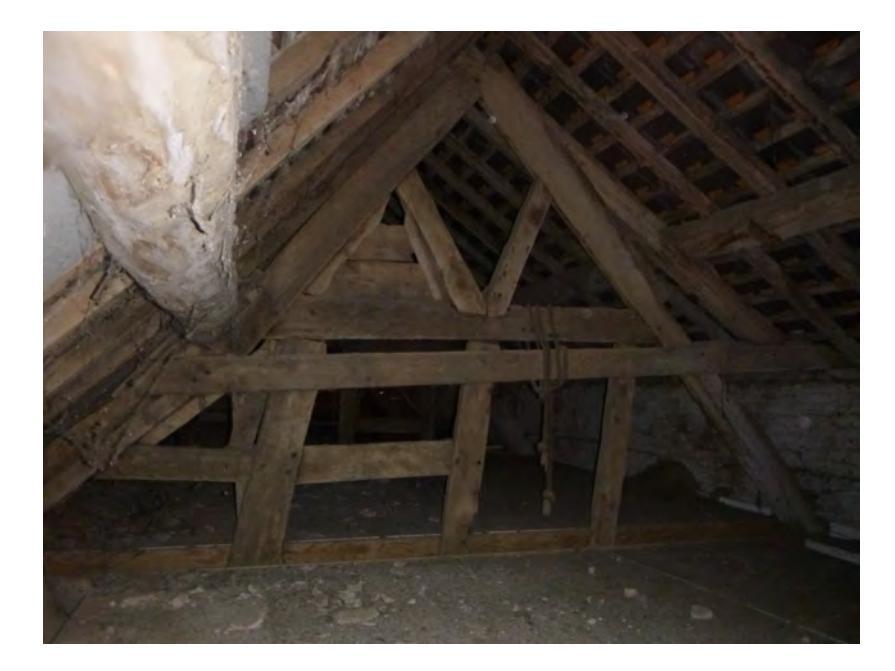
#### Fig 89:

West part of south barn; showing a general view of truss 8. Access was unavailable to inspect timbers in detail

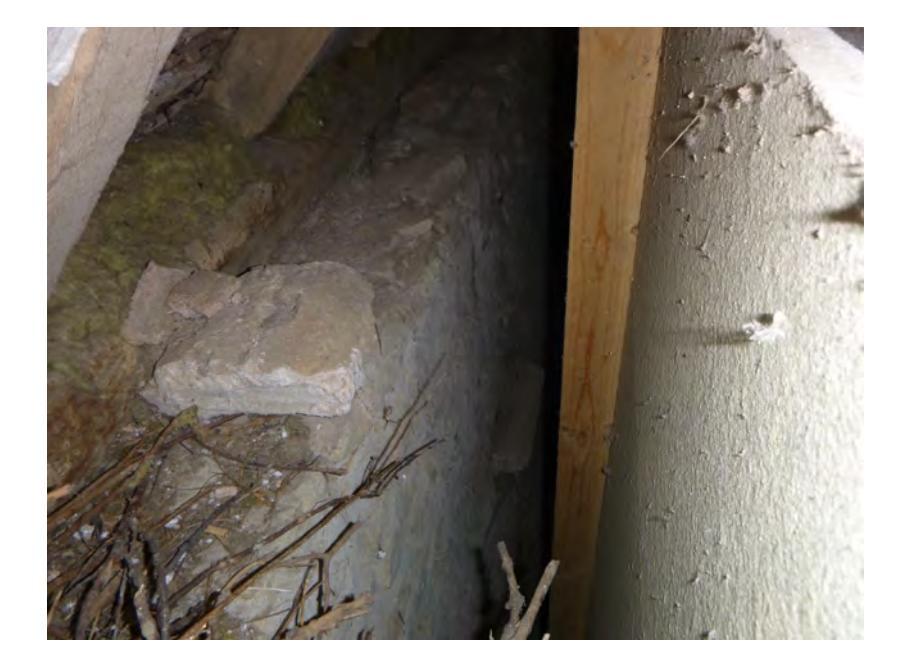
### Fig 90:

West part of south barn; showing the void formed by the dry-lining in this part of the barn, isolating the internal space from the external walls

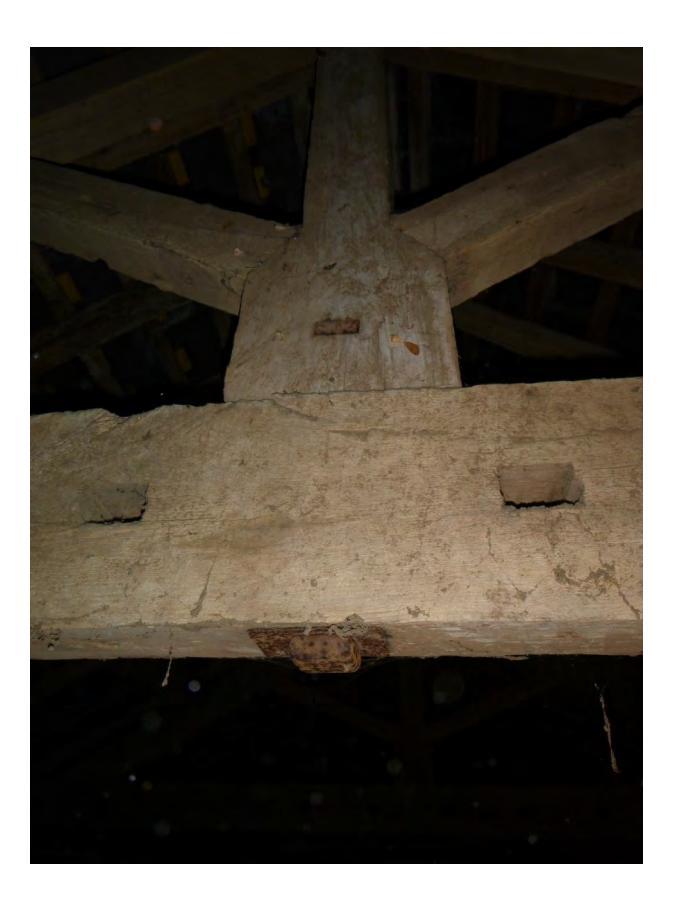
#### Fig 3:

Truss T1; showing the base of the central part of the truss. Note the embedded metalwork and the slot for the captured nut tying the tie-beam to the king-post, the only joint under tension rather than compression. Also note the historic mortices indicating previous possible use as floor beams, or previous installation of ceiling joists

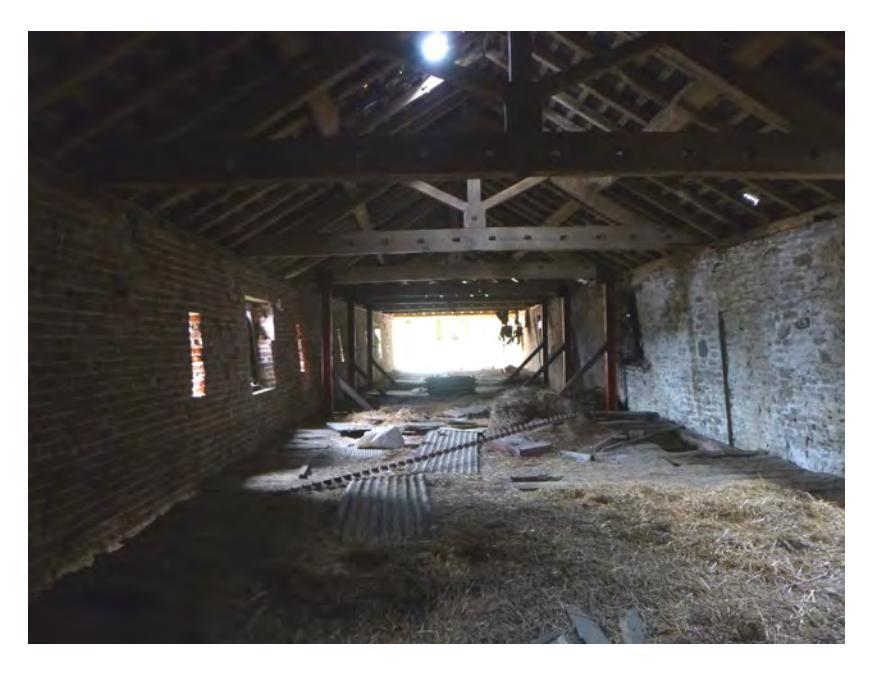
#### Fig 4:

Upper floor; showing general view towards the south. Note the floor below which was considered unstable and dangerous preventing inspection to a limited number of areas

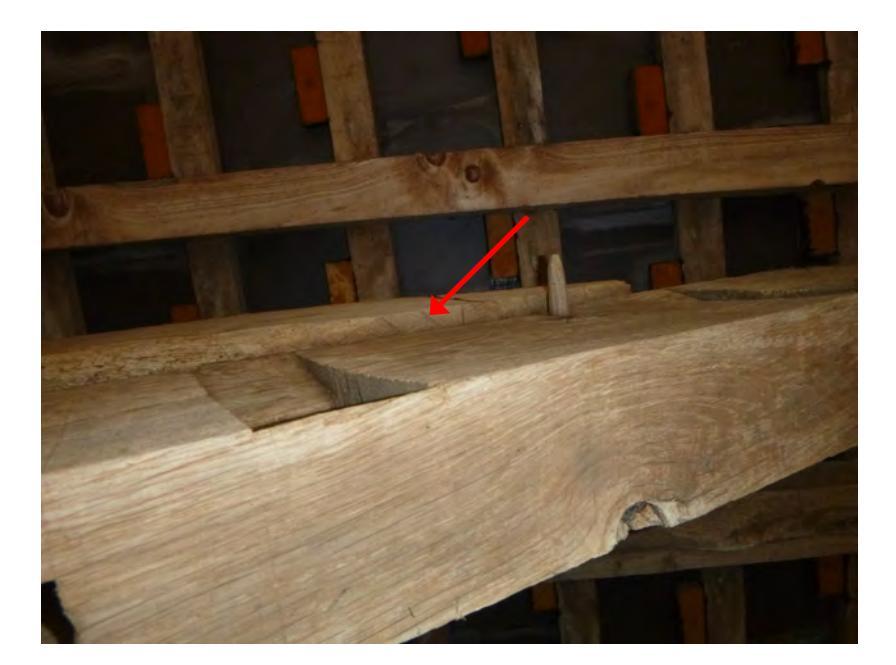
### Fig 5:

Truss T2; showing the thickness discrepancy between the tie-beam and the remaining truss elements, measured at ~10-15mm. Note the historic mortices are bevelled

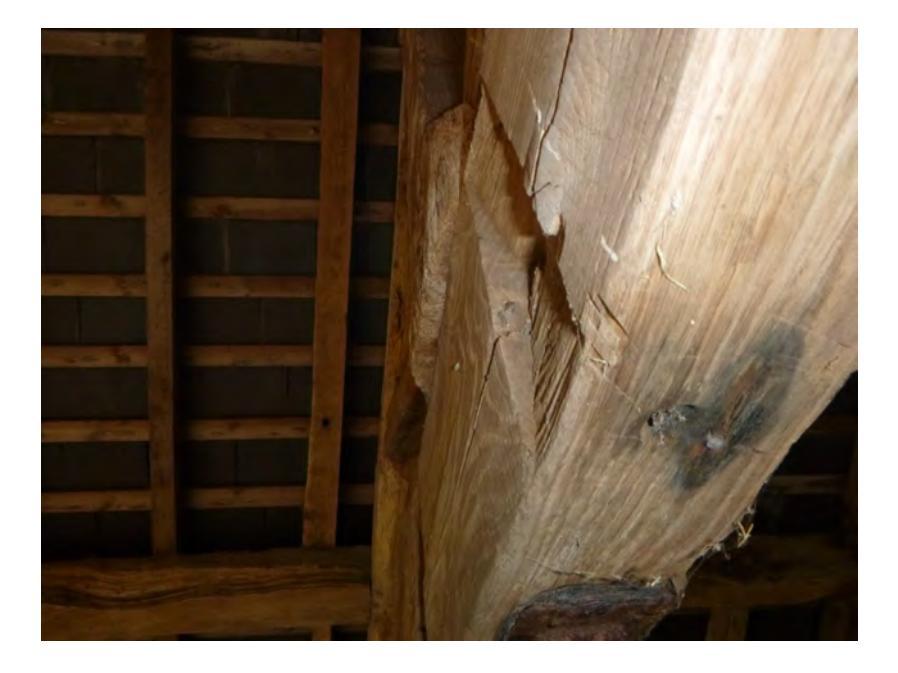
# Fig 6:

Truss T2; showing again the discrepancy in thickness between the tie-beam and the king post above, suggesting tie-beam replacement, or reuse of existing materials on original construction

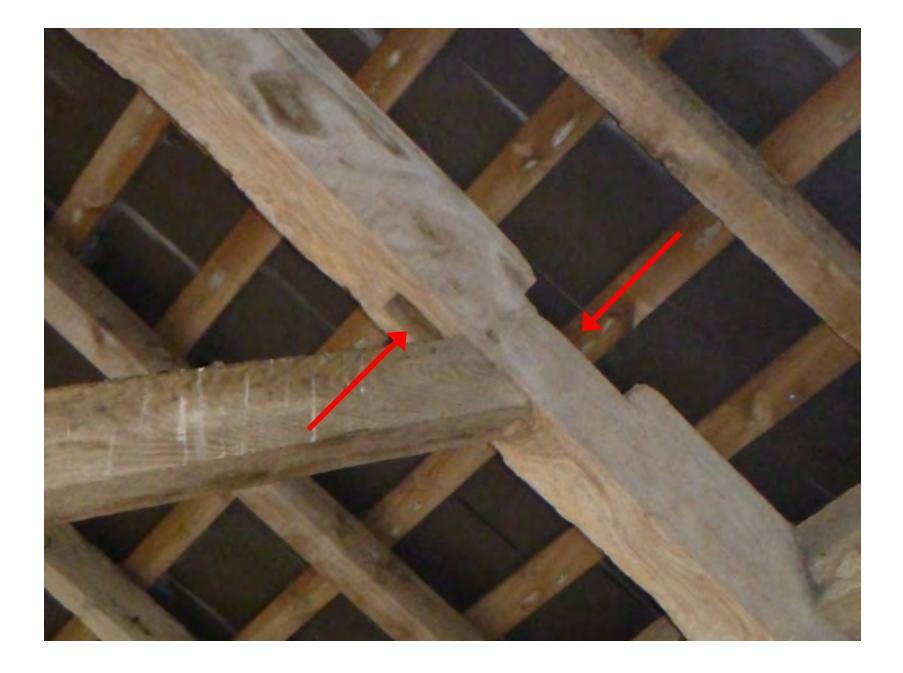
# Fig 8:

Truss T3; showing the overlarge brace strut mortice, indicating replacement of struts in the past, and the significant notch on the outer edge of the principal rafter, suggesting possible previous trenched purlins. Both indicating likely reuse or salvage of elements comprising trusses

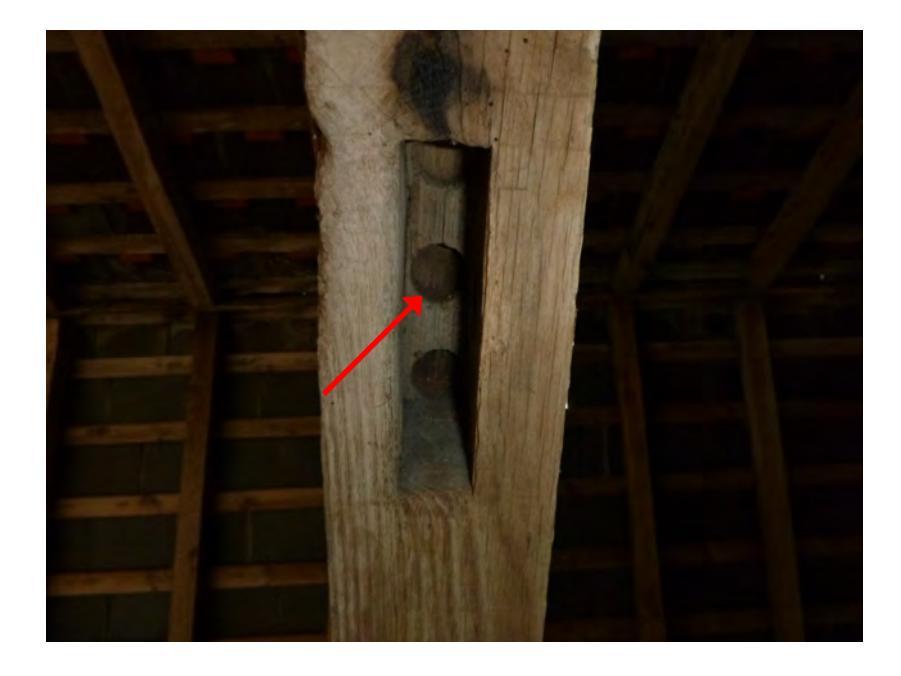
# Fig 9:

Truss T2; showing large notch in underside of tie-beam, likely for stud element in previous cross wall. Note circular markings left by brace and auger bit prior to chiselling out remaining 'meat'
