# Aston Hall: Investigation of structural timber elements – South range barns

Site note 1 for March 2021, job no. 153.32

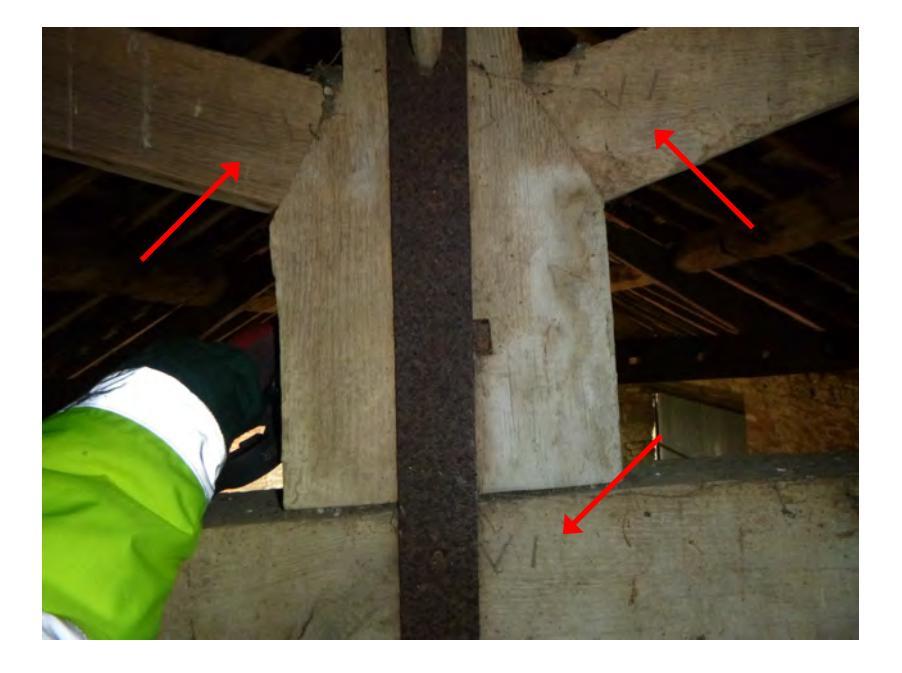
# Fig 12:

Truss T3; showing metal strapping on truss and carpenters markings on struts and tie-beam usually carved into timbers during construction and may indicate all elements were assembled concurrently, but using salvaged material

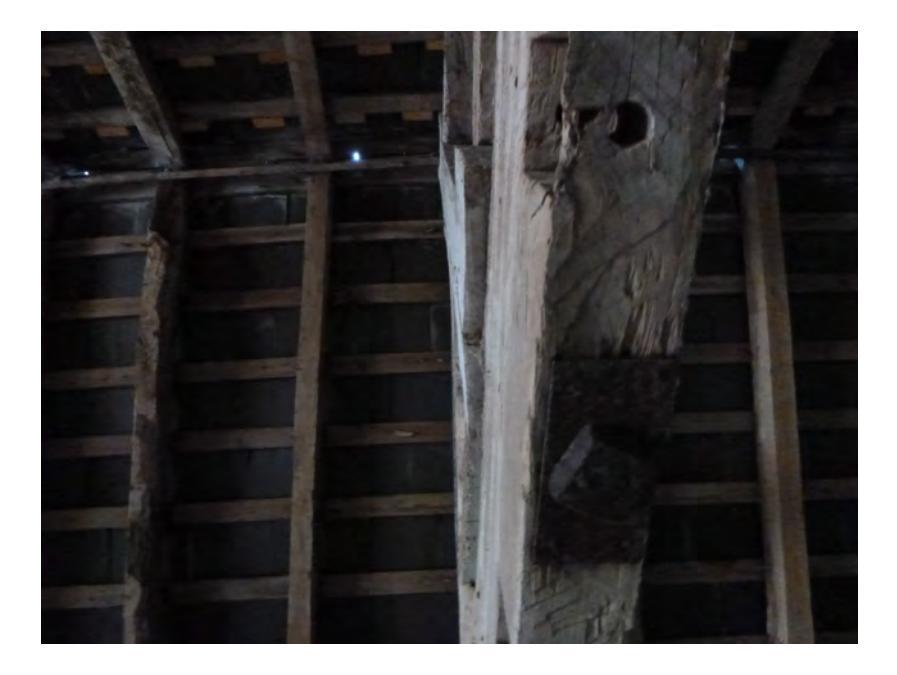
# Fig 15:

Roof structure, truss T4; again showing the discrepancy in thickness between the king-post and the tie-beam

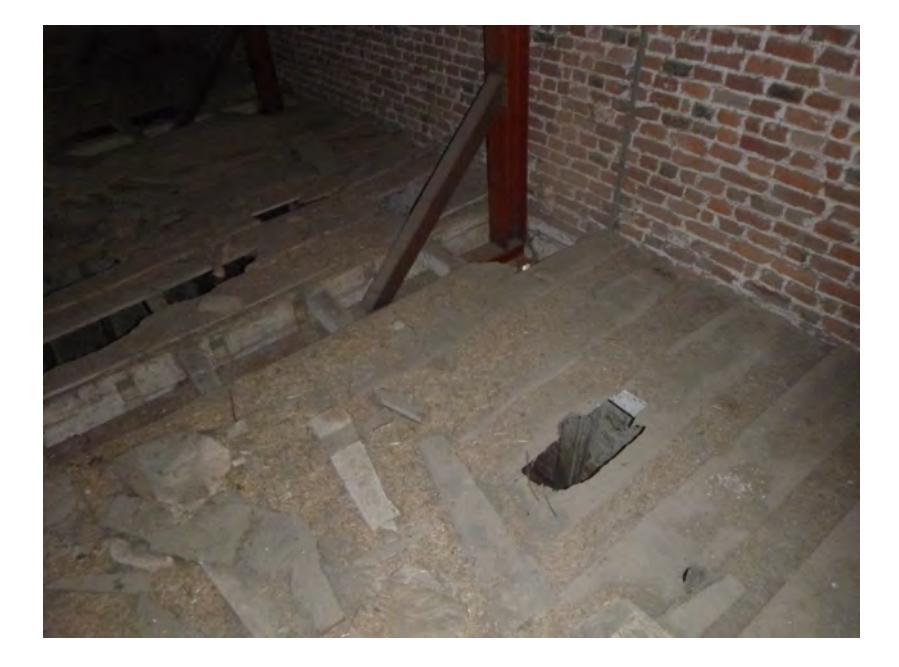
# Fig 16:

First floor; showing the overlapping floor boards which had been significantly damaged by widespread wood-boring beetle limiting safe access to inspect areas of roof structure

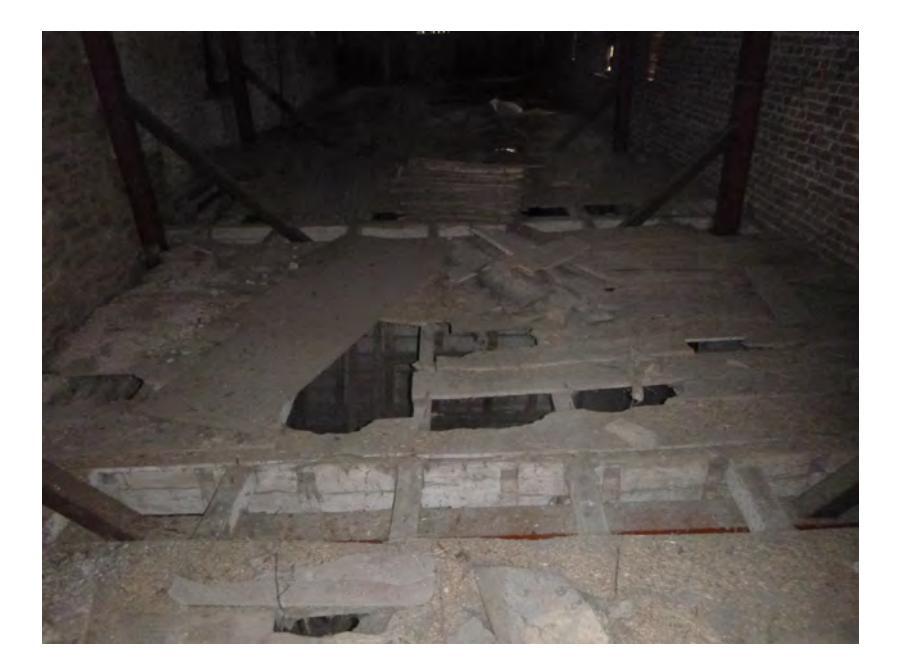
# Fig 17:

First floor; showing the overlapping floor boards which had been significantly damaged by widespread wood-boring beetle limiting safe access to inspect areas of roof structure

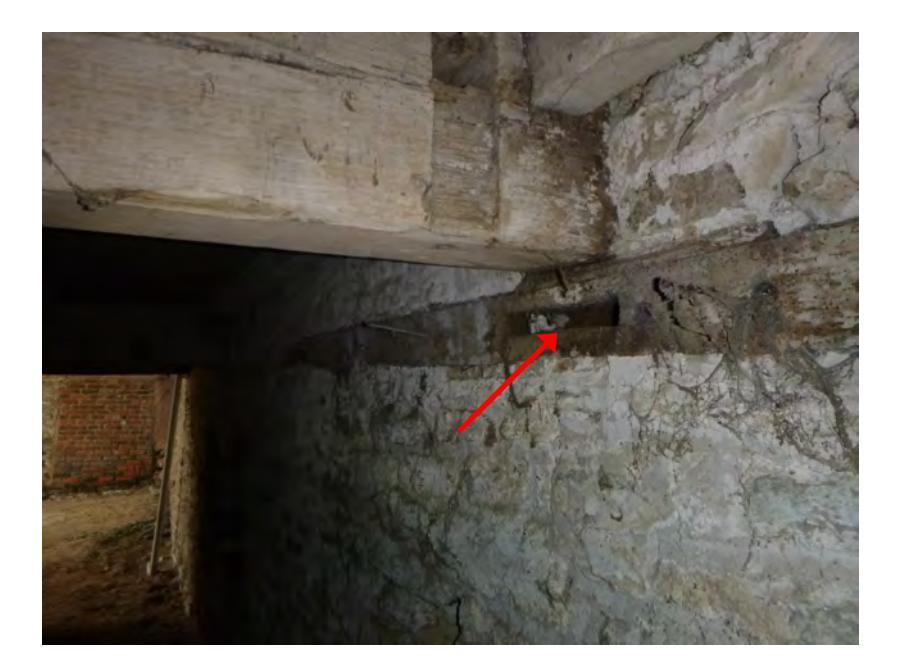
# Fig 21:

Ground floor; showing primary floor beam positioned directly over large mortice in timber pad embedded within masonry wall to west side of building. This may be structurally significant

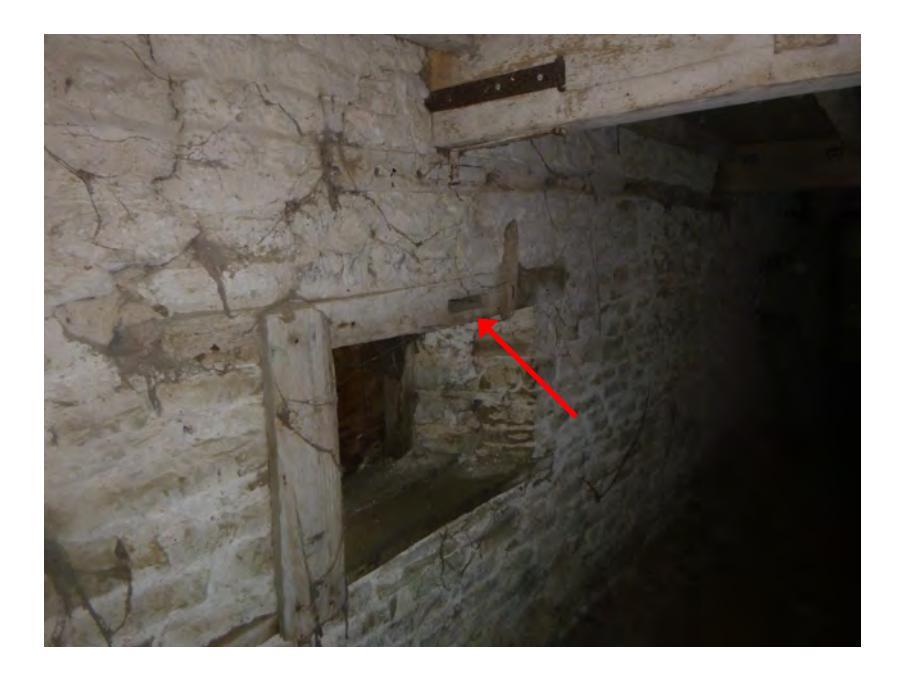
# Fig 23:

Ground floor; showing large mortice in lintel over window opening on west side of the building which may be structurally significant. Typical example of reuse of materials for lintels and bonding timbers

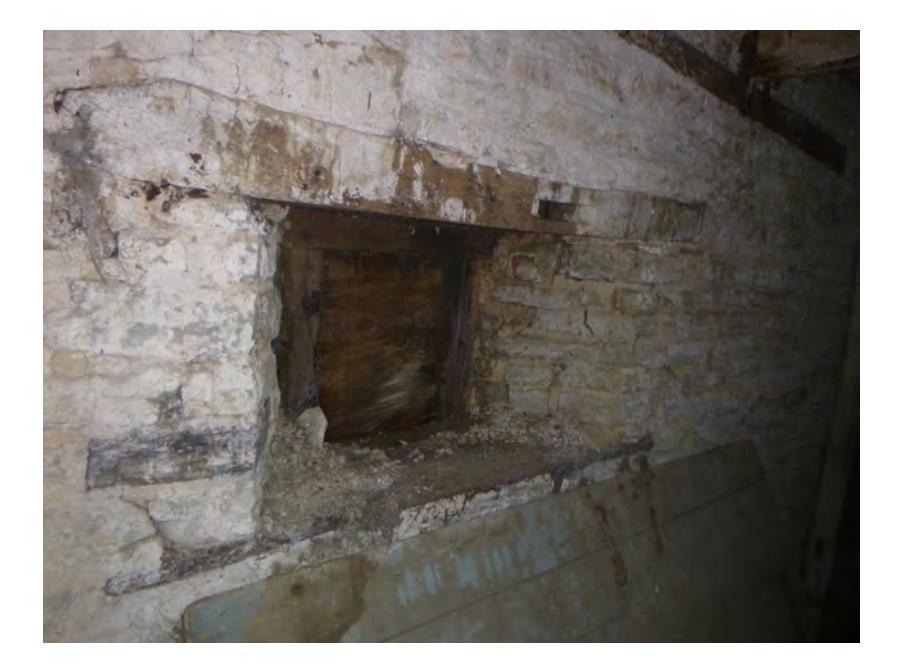
# Fig 25:

Ground floor; showing one of the decayed lintels over window openings on the west side of the building. Note again the mortice within the lintel which may be structurally significant. Also note the deflection occurring over the length

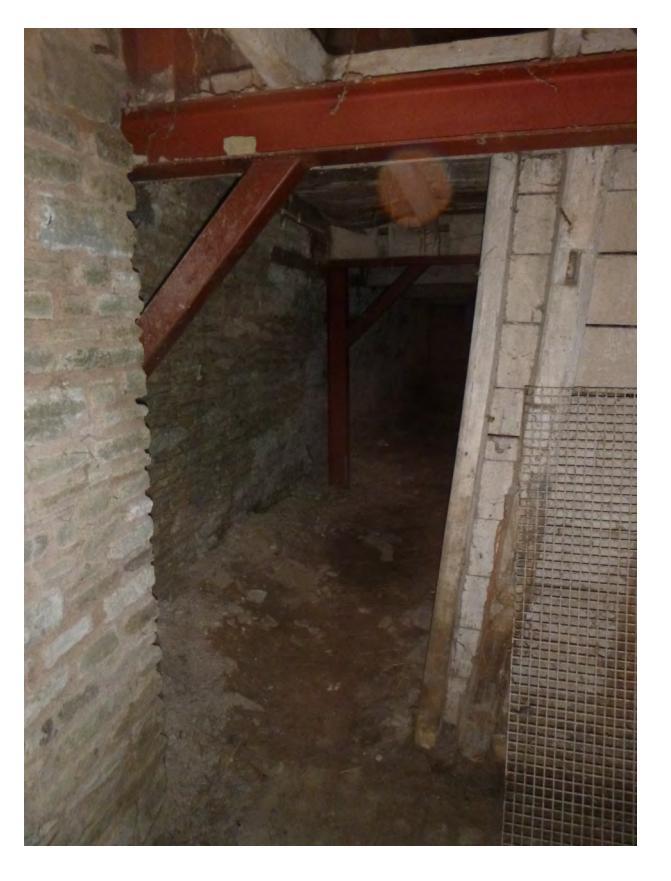
# Fig 26:

Ground floor; showing the steel structure installed to counter the outward movement at the top of the east masonry wall

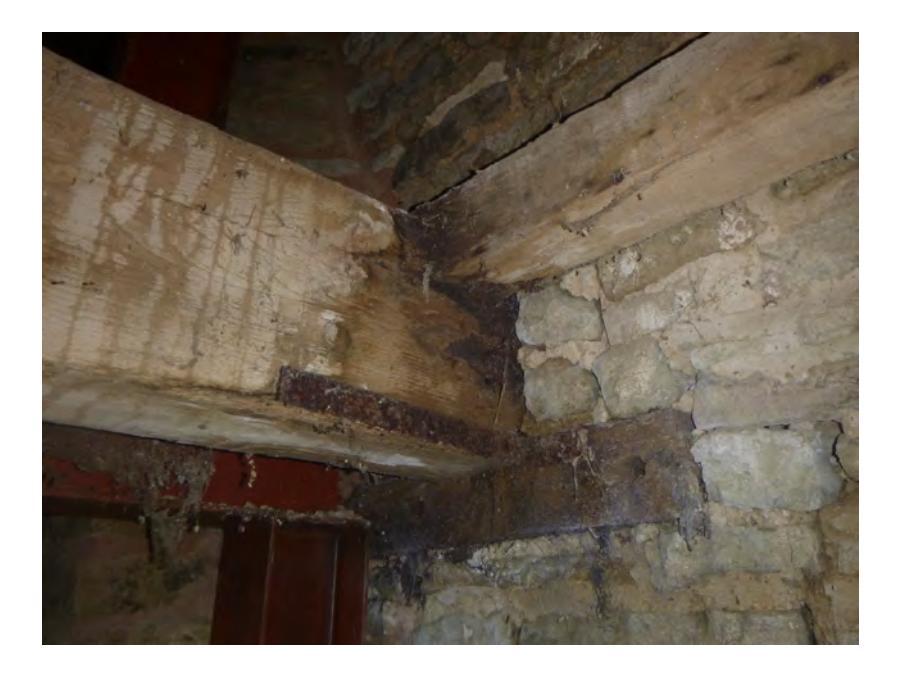
# Fig 27:

Ground floor; showing the bearing end of one of the primary beams. Note the water-staining and darkening of the timber suggesting ongoing issues with damp and decay. Moisture content readings taken from timbers on the west side were generally above the decay threshold

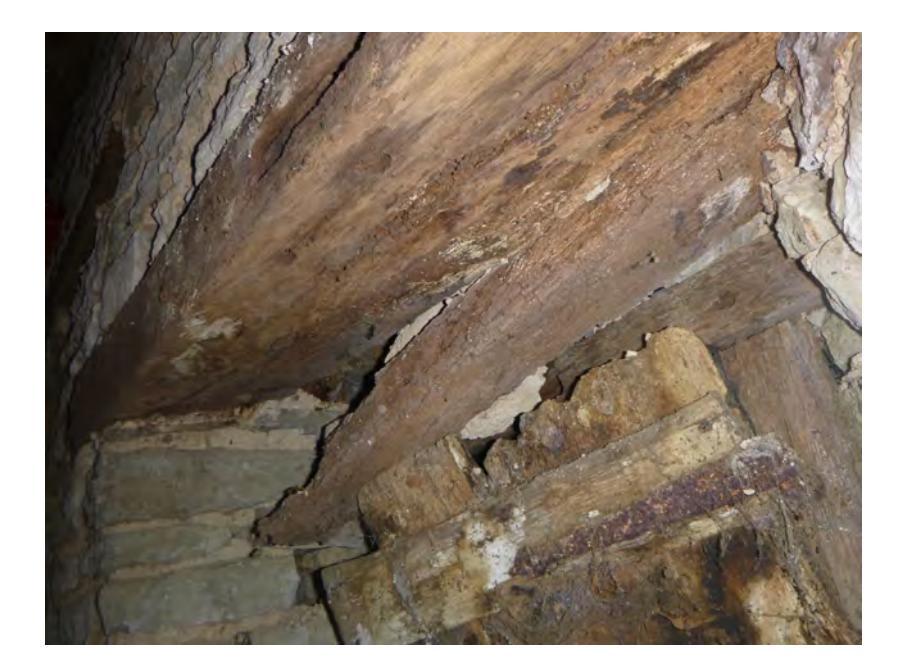
# Fig 29:

Ground floor; showing one of the decayed lintels on the west side. Note the two-part build-up and decay of the outermost element by wet rot and subsequent wood-boring beetle infestation

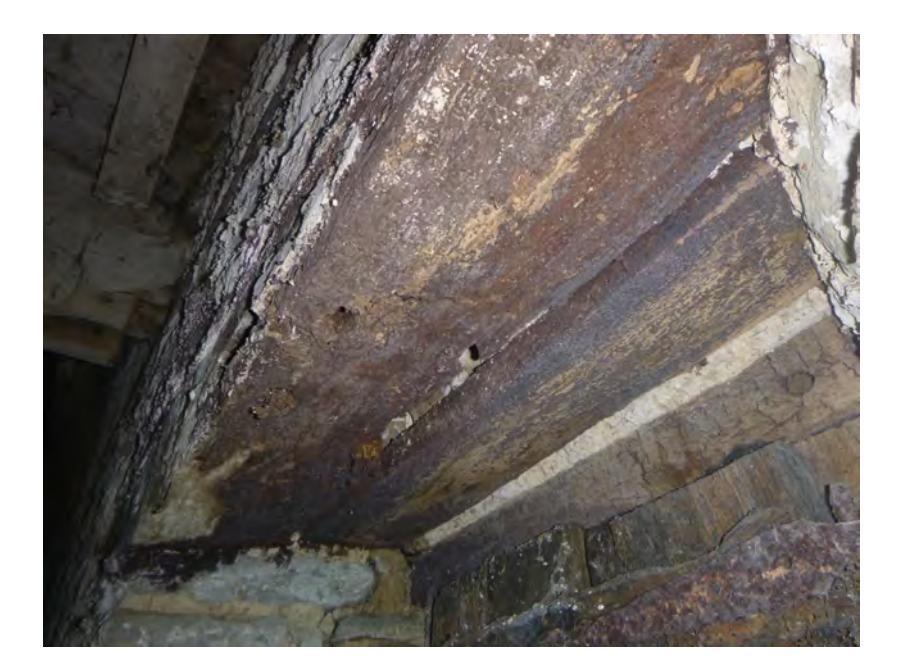
# Fig 31:

Ground floor; showing another of the decayed lintels on the west side. The innermost section was decayed by active wet rot and wood-boring beetle infestation

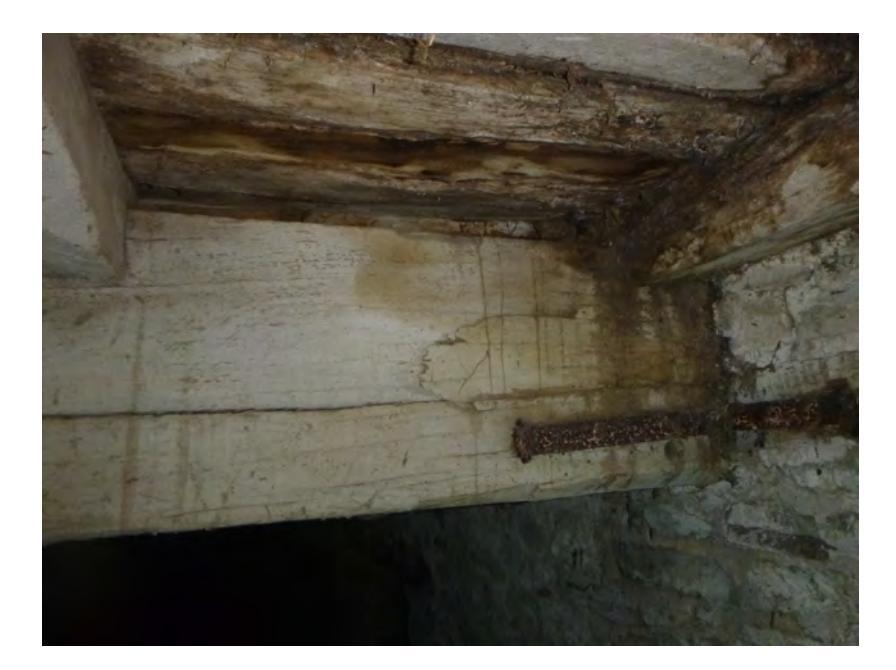
# Fig 33:

Ground floor; showing opposite side of beam in previous image, with crack clearly evident on both north and south sides

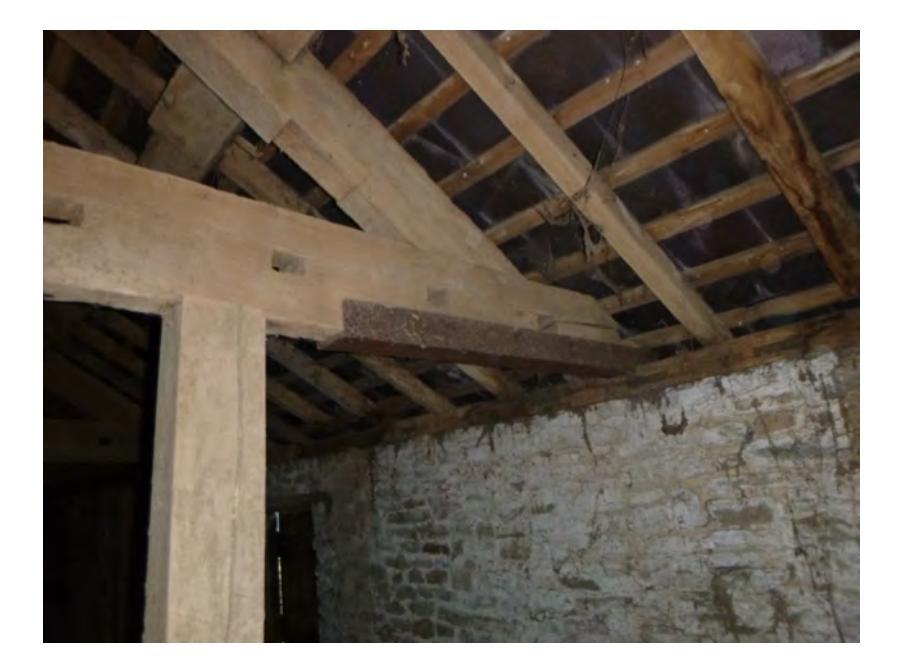
# Fig 34:

Ground floor; showing fracture in floor beam at north ed of historic section of barn. Crack travelled across thickness of beam and was considered likely to be structurally significant

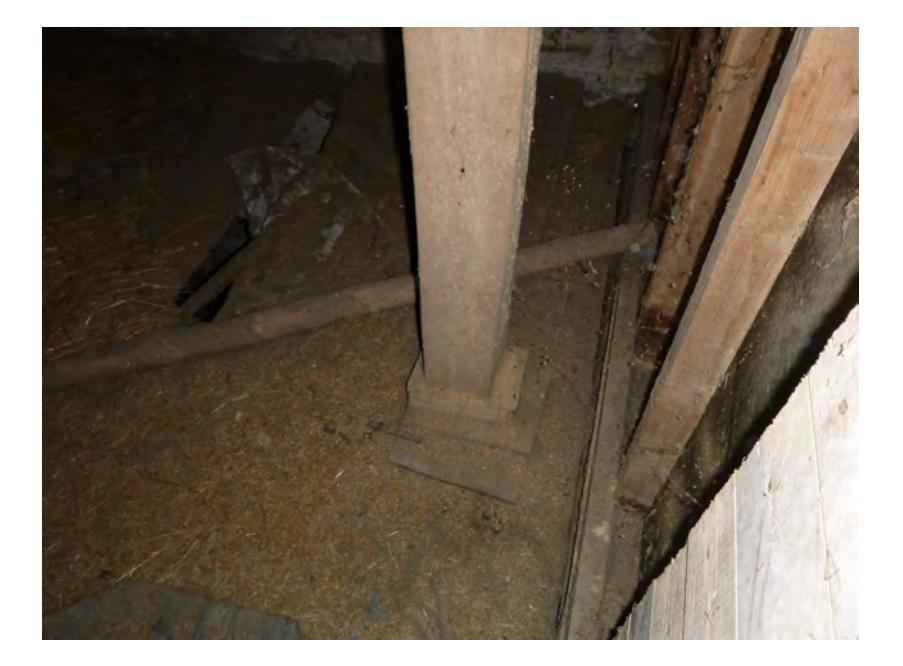
### Fig 35:

First floor; showing previous repairs to west bearing end of tie-beam at north end of the barn, re-supported on oak timber post. Post supported on floor structure below which may not be structurally adequate

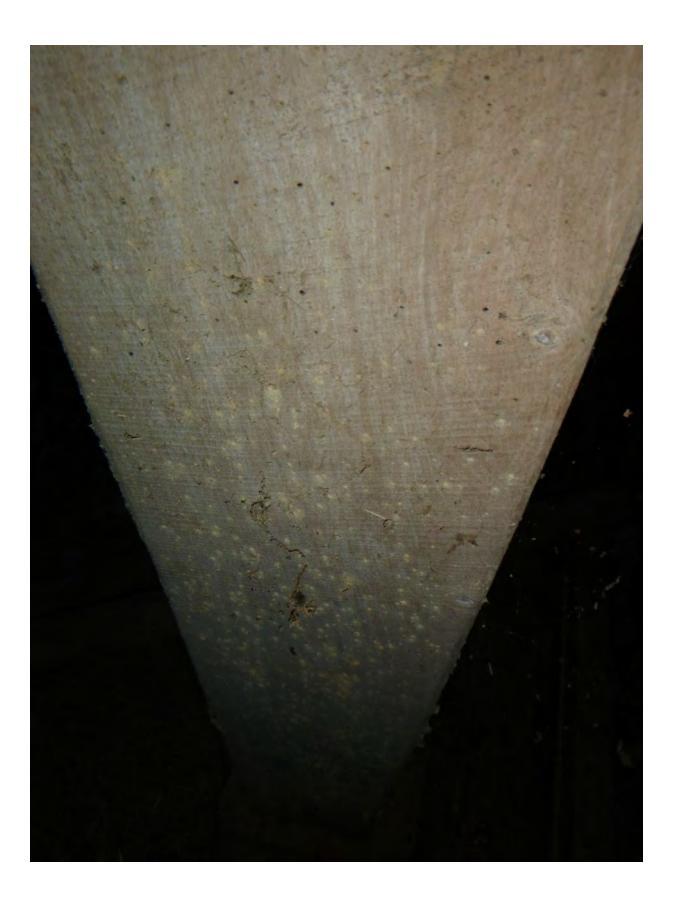
# Fig 36:

First floor; showing support post of truss shown in image above supported by floor structure below which may not be structurally adequate. Also post noted to be significantly infested with wood-boring beetle

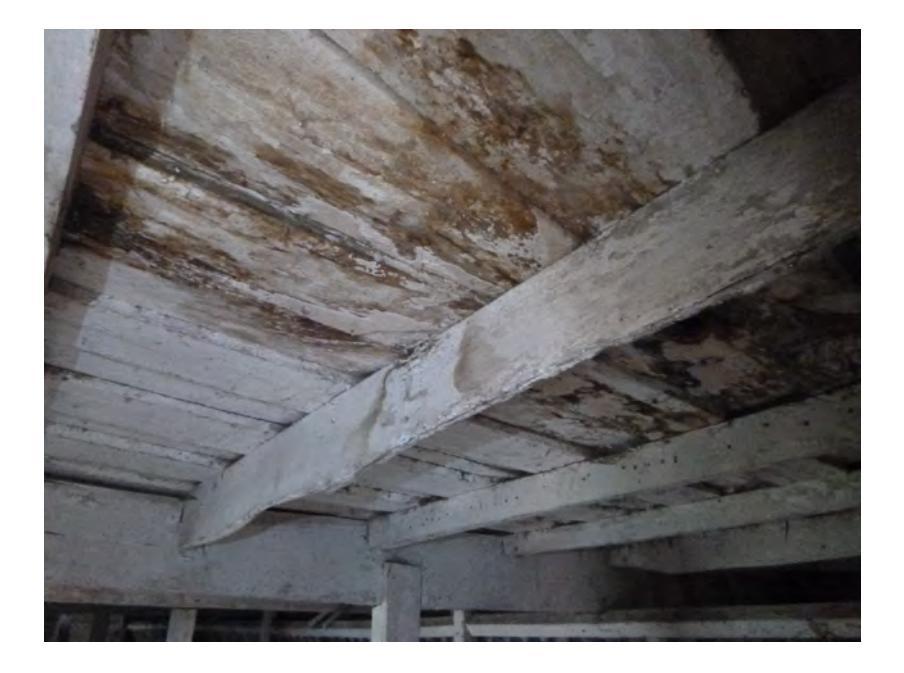
# Fig 40:

Ground floor; showing widespread water-staining marks to underside of floor boards of first floor above, indicating issues with water penetration in the past and the likely cause of the elevated moisture content readings supporting widespread wood-boring beetle infestation

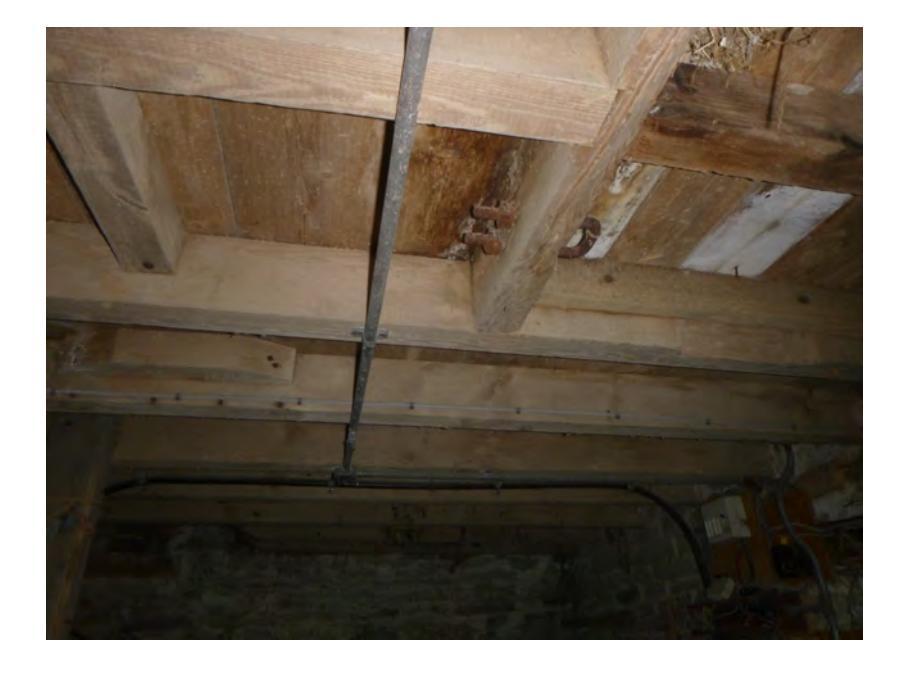
# Fig 42:

Ground floor; showing area of newer floor structure at north end of the building. There were areas of localised wood-boring beetle infestation of softwood floorboards above, although joists were mostly free of decay

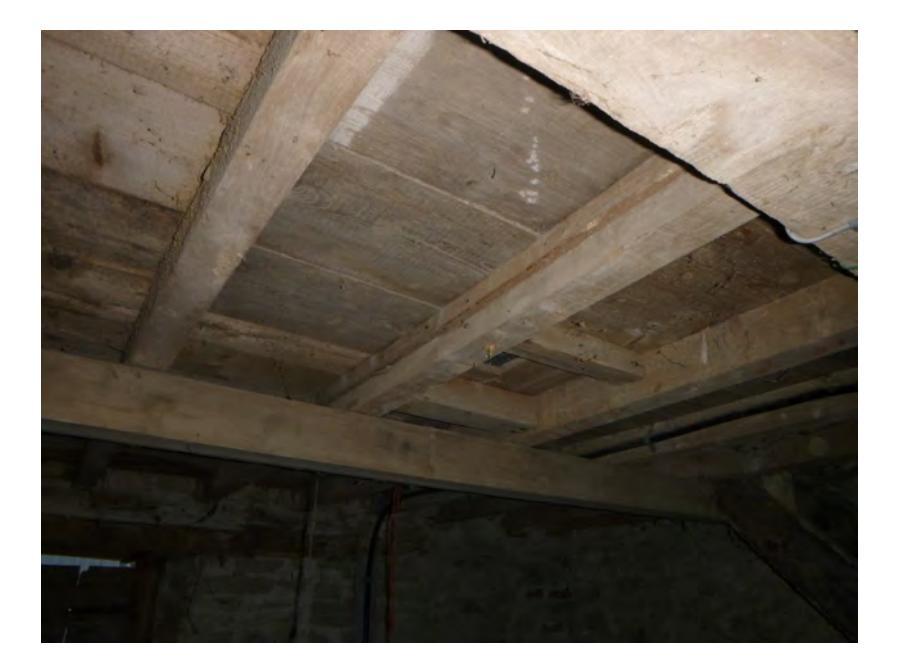
# Fig 43:

Ground floor; showing area in northwest corner of building, where historic oak timbers had been replaced with alternative hardwood material. Joists embedded within the west masonry wall were found to be decayed, and the lintel over the doorway to the west was also found to be decayed

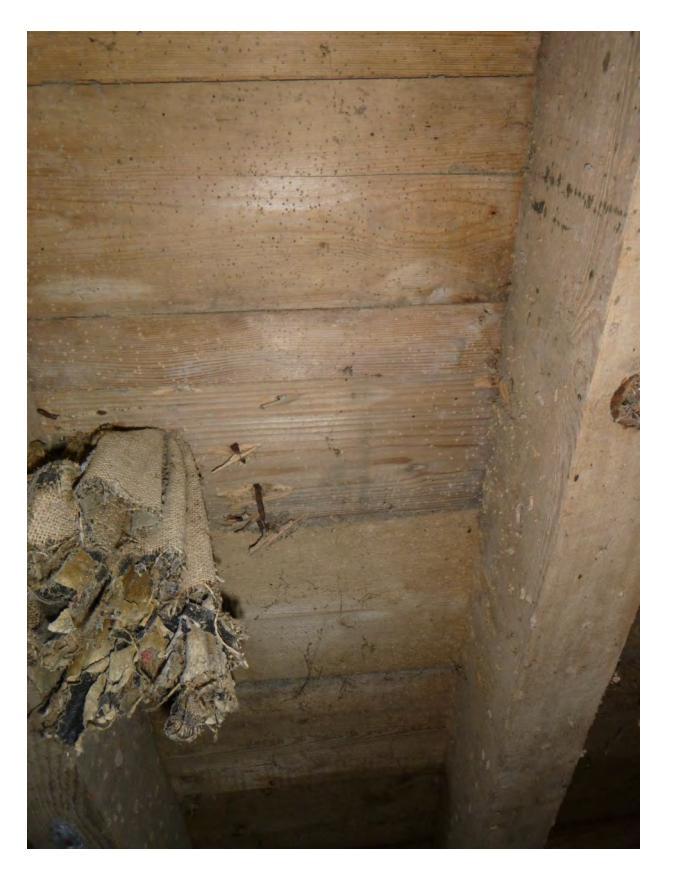
# Fig 44:

Ground floor; showing one of the areas of softwood floorboarding affected by wood-boring beetle infestation, at the north end of the barn, as shown on attached plans

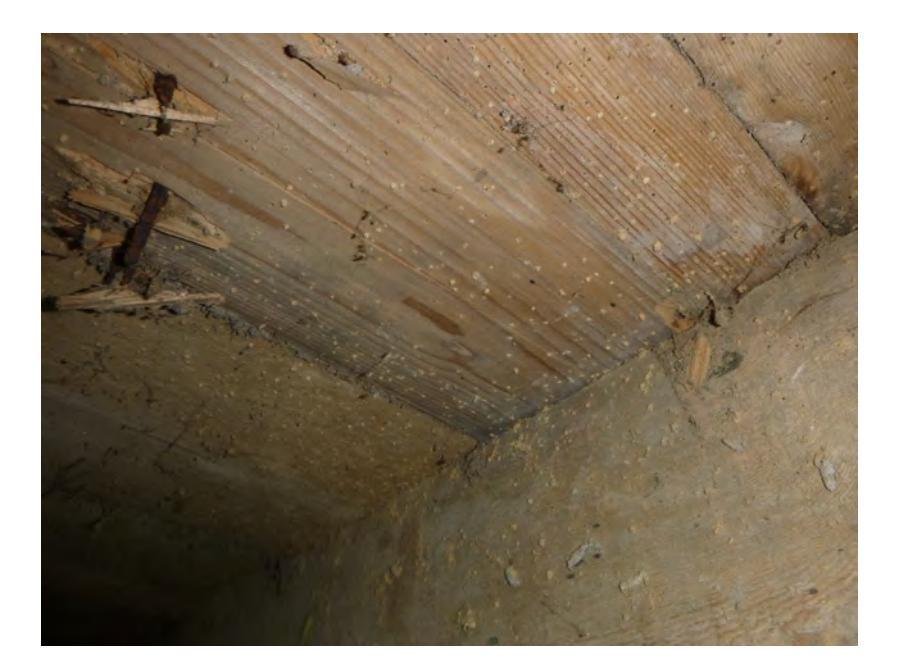
# Fig 45:

Ground floor; showing one of areas of softwood floorboarding affected by wood-boring beetle infestation, at the north end of the barn, as shown on attached plans

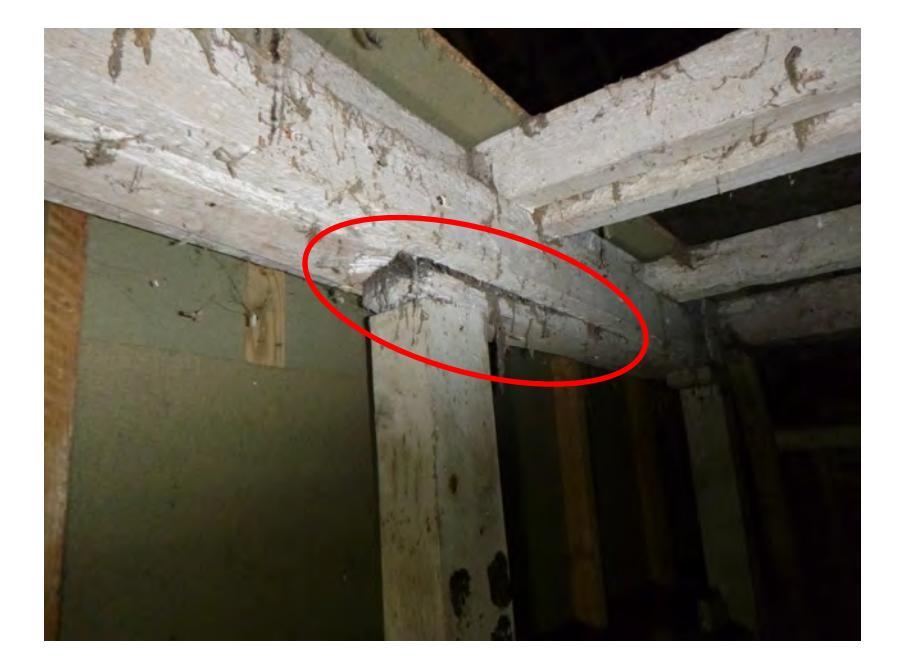
# Fig 50:

Floor structure; showing a critical fracture to the underside of a primary floor beam

Note this has been subject to remedial support including the timber post below and partner repairs along the face of the beam. Given the decay noted in Fig51 below, this arrangement was deemed structurally significant

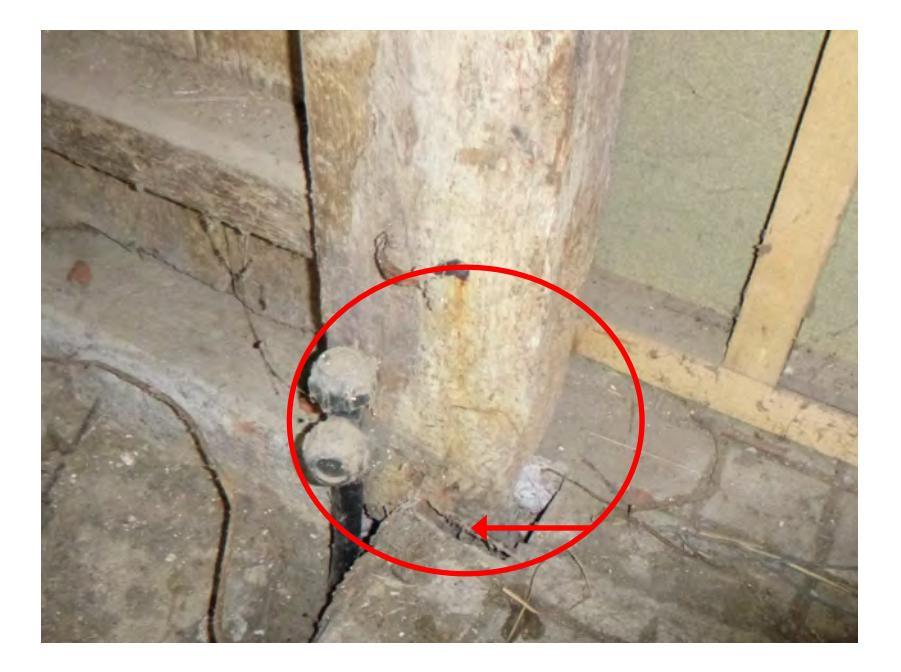
# Fig 51:

Floor structure; showing timber decay to the base of a supporting timber post of the primary beam in Fig50 above, affecting up to ~50 per cent of the cross section (arrowed)

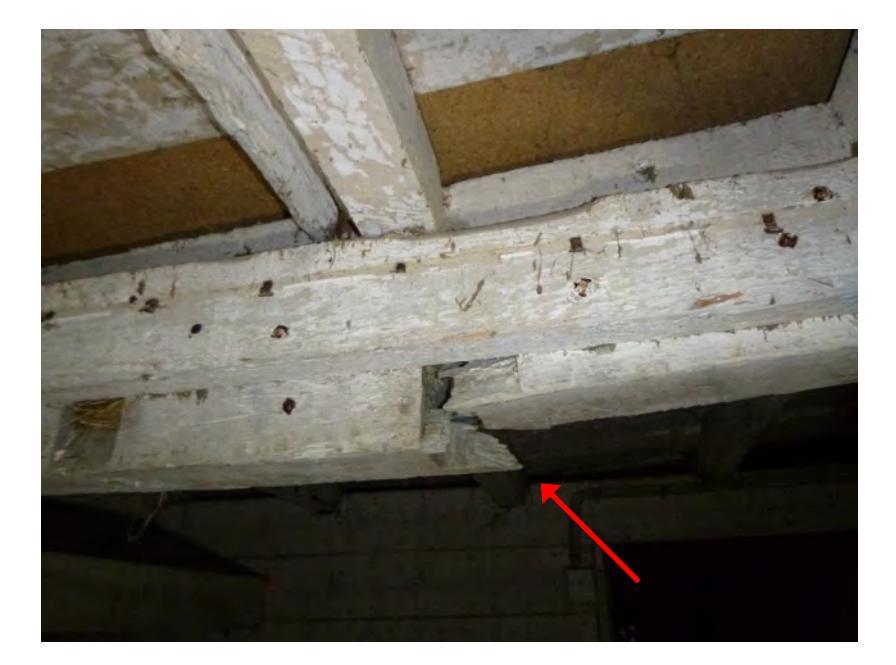
# Fig 53:

Floor structure; showing a critical fracture to the underside of a primary floor beam

Note this fracture has occurred at an old mortice where the beam is weaker, and has been subject to remedial partner repairs along the face of the beam

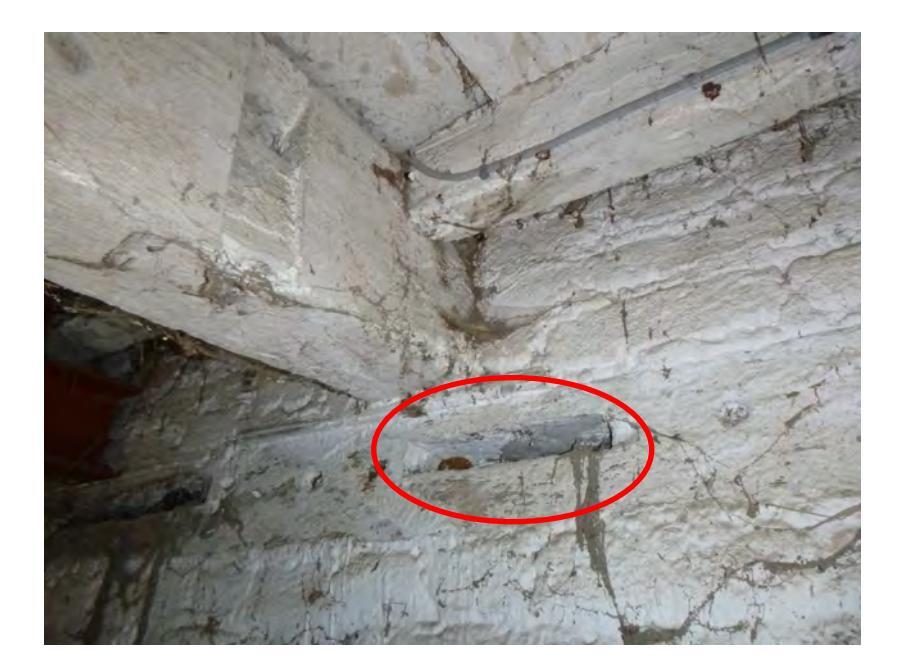
### Fig 55:

Floor structure; showing primary floor beam positioned directly over large mortice in timber pad embedded within masonry wall to east side of building. This may be structurally significant

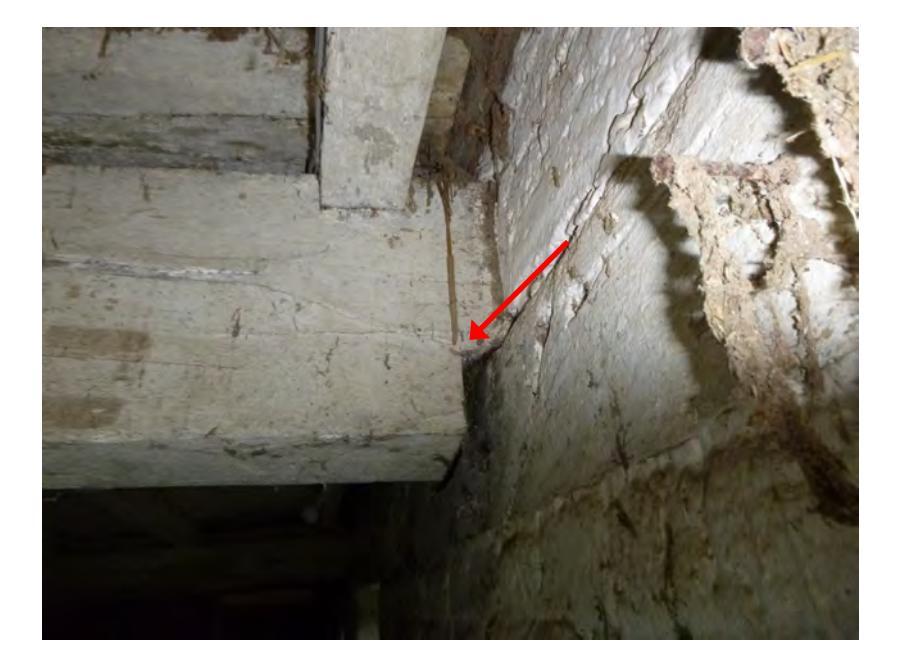
# Fig 56:

Floor structure; showing the opening up of gaps between the bearing ends of the beams and the east masonry wall, in this instance ~30mm

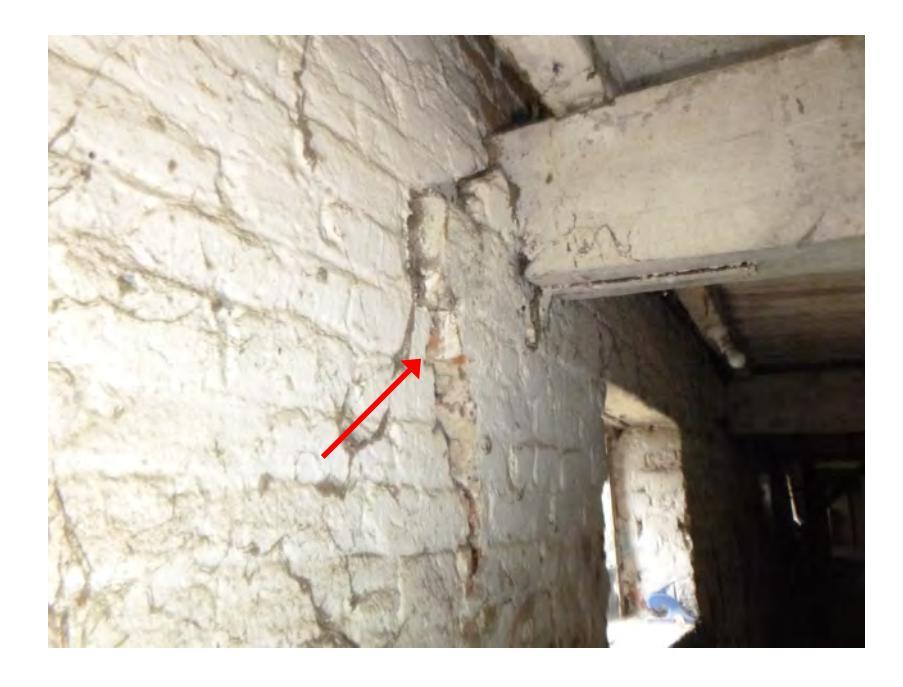
# Fig 58:

Floor structure; showing structurally significant outward movement of the east masonry wall

Note the floor beam has held itself and the masonry below it in its original position, whilst the majority of this section of wall has moved outwards, forming the crack observed

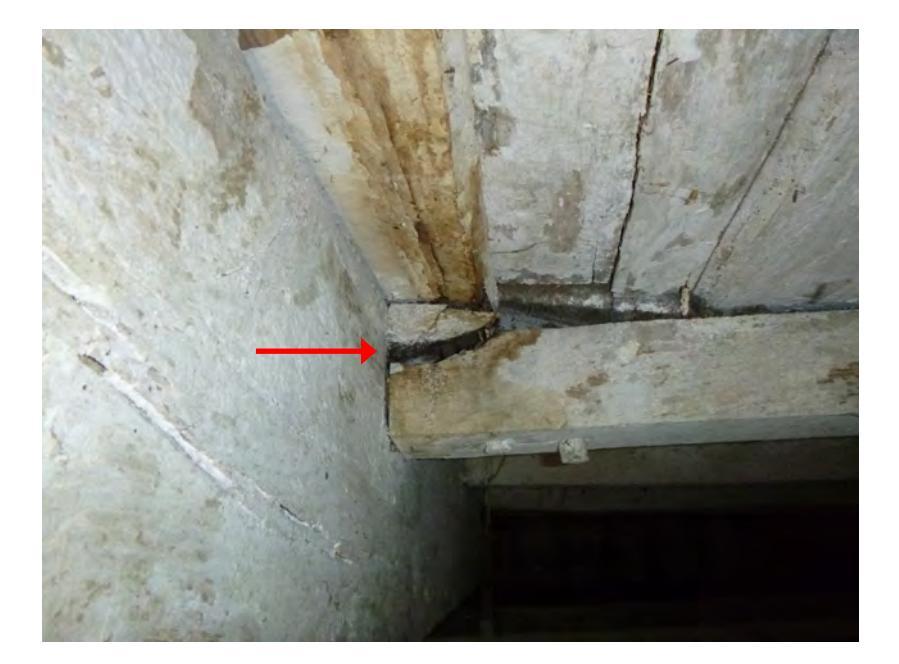
# Fig 59:

Floor structure; showing a critical fracture affecting the tenon of a floor joist

Note this arrangement, with the tenon at the top third of the joist and jointed near the top of the face of the beam, subjects the joist to high levels of compressive forces, which without a 'tusk', leaves only the thickness of the tenon to resist said forces, leading to shear fractures as seen here

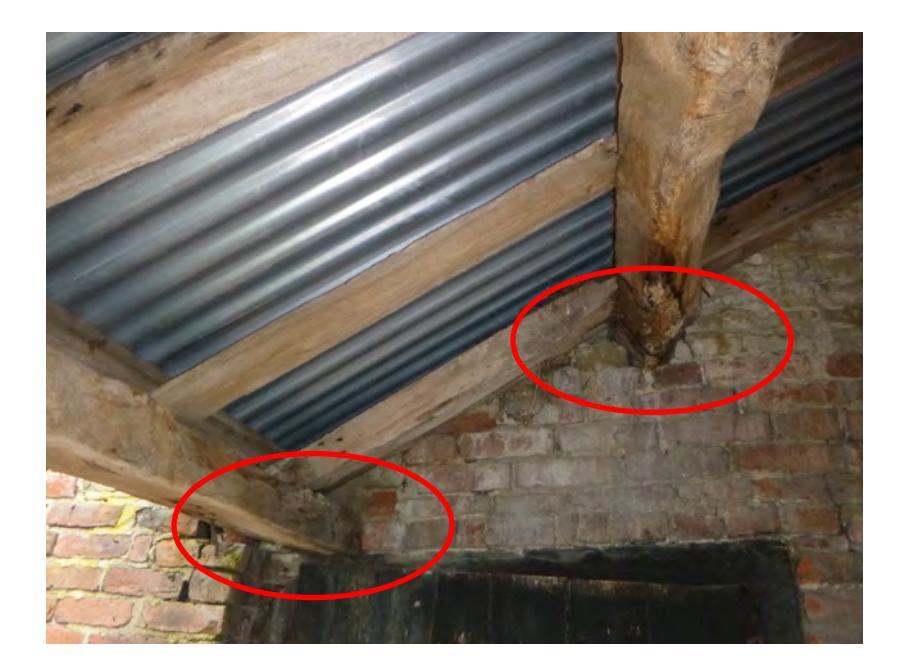
### Fig 3:

North stable block; showing structurally significant timber decay affecting bearing end of purlin on south pitch at west end. Also localised decay around wall plate embedded in west masonry wall

Purlins: Purlins were found to be structurally decayed at both the east and west ends where embedded within damp masonry pockets. The south pitch purlin was decayed for ~600mm at the west end, and decayed where embedded at the east. The north pitch purlin was only decayed at the east end, and only for the embedded depth. 3no. purlin sections were not supported at either end by an adjacent truss, and reliant solely on the condition of the pegged tabled scarf joints. No structural failure was noted as a result, but this arrangement may be structurally significant

Purlins were deemed suitable for retention on refurbishment at the discretion of the Structural Engineer who may wish to comment on the lack of purlin support in several of the bays. Allowance should be made for strengthening with metal strapping if necessary. The decayed sections of purlin at the east and west ends should be cut back to sound material and partner repaired or replaced with new or salvaged timber to match existing, i.e. oak (Quercus spp.). On reinstatement, it would be prudent to re-support the purlins on exposed stone corbels or steel brackets to prevent further decay, with provision for isolation from any masonry. Repairs to be directed by the Structural Engineer

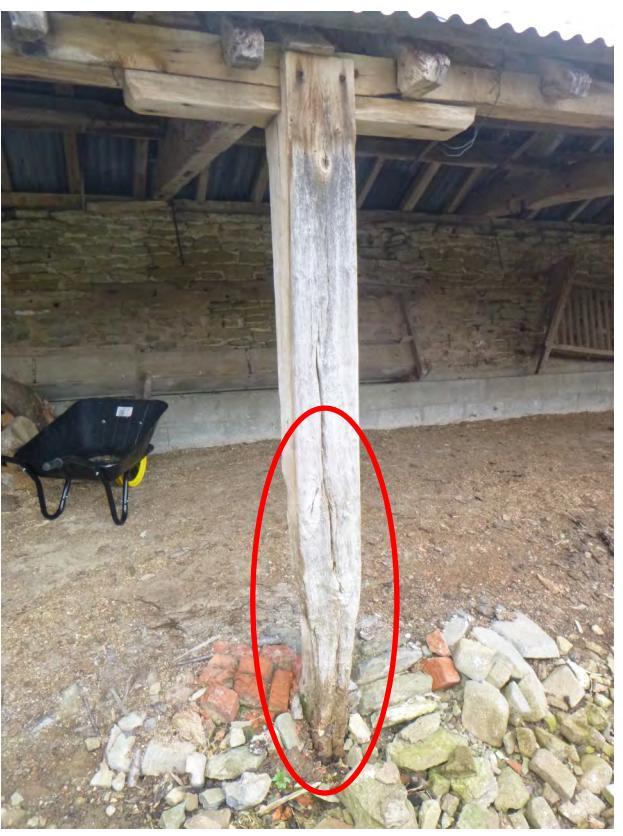
### Fig 6:

North stable block; showing oak timber post supporting south eaves between bays 2 and 3. Note almost over 50 per cent loss of cross section at base of post embedded in earth below and vulnerable to issues with decay and wood-boring beetle

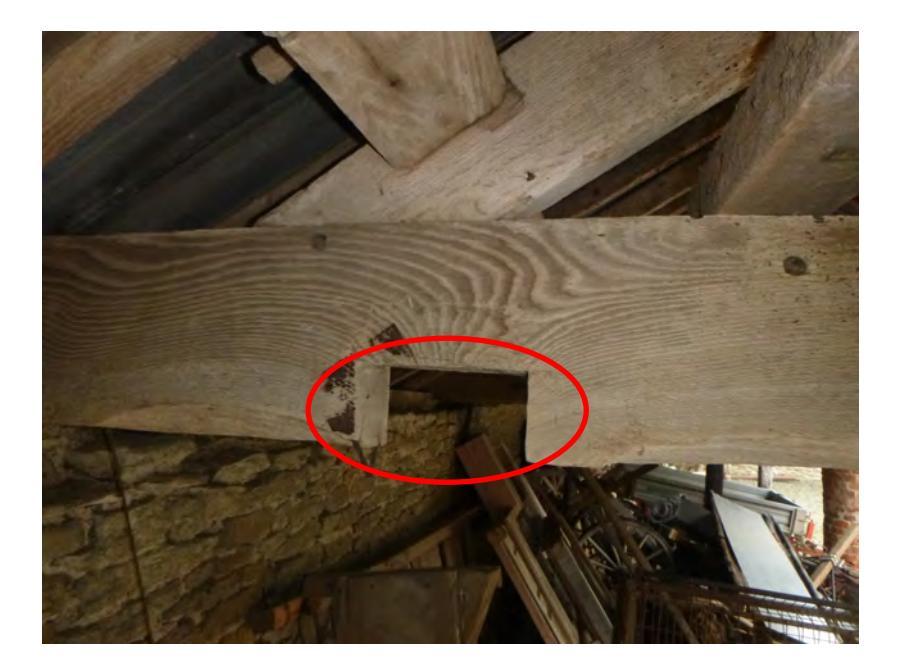
### Fig 7:

North stable block; showing large notch in north end of truss 3. May be structurally significant

No chemical treatment required. Truss elements were deemed suitable for retention at the discretion of the Structural Engineer who may wish to comment on the large notches apparent in the tie-beams. Allowance should be made for repair using timber to match existing so as to re-instate cross-section

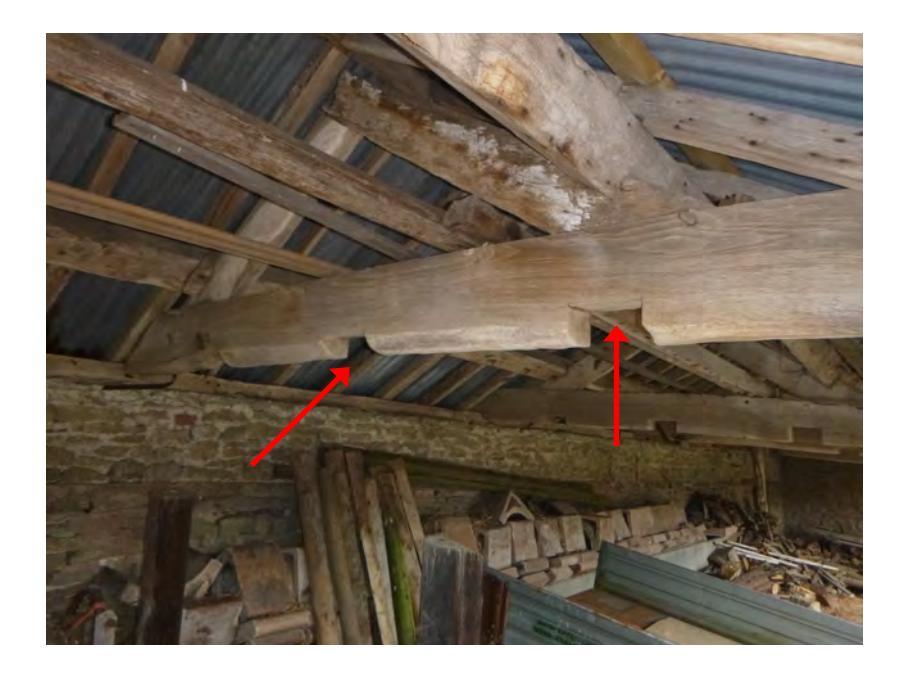
### Fig 9:

North stable block; showing relatively large notches on underside of tie beam of truss 5 which may be structurally significant

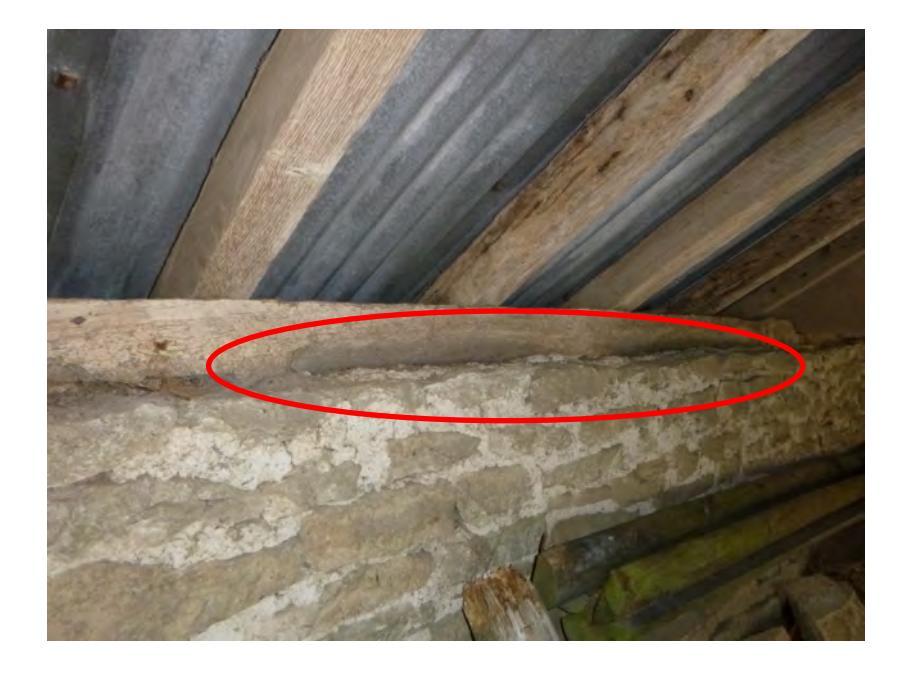
### Fig 10:

North stable block; showing localised loss of cross section of timber plate due to wood-boring beetle infestation of sapwood content. However, not likely to be structurally significant as wall plate is relatively substantial along north eaves

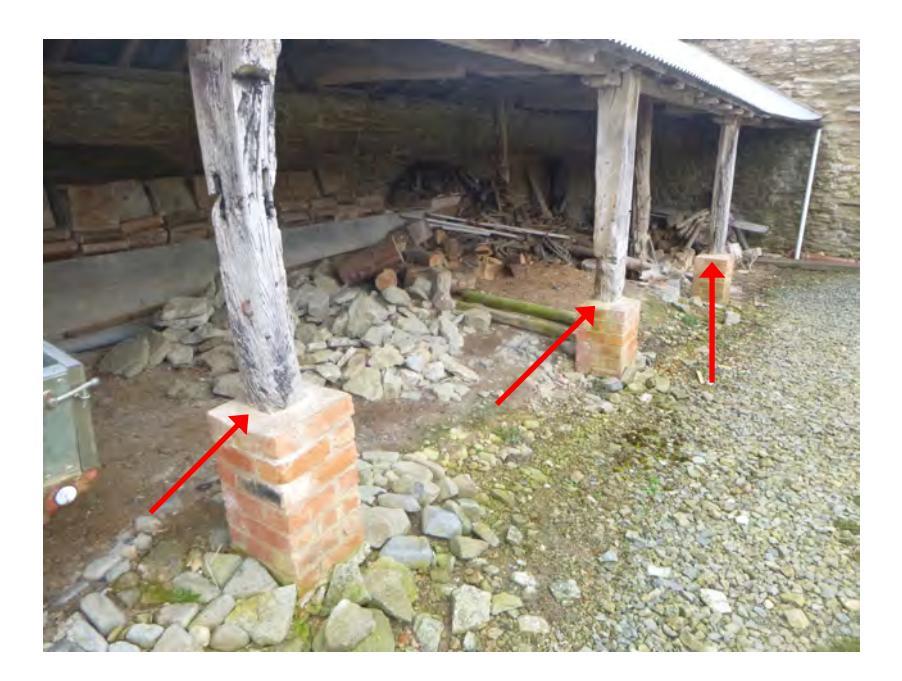
### Fig 11:

North stable block; showing support timber posts on brickwork plinths along south eaves at east end, likely to be a result of decay affecting bases of posts in the past. Now flaunched with cement at bases and resulting in localised timber decay from both wet rot and woodboring beetle

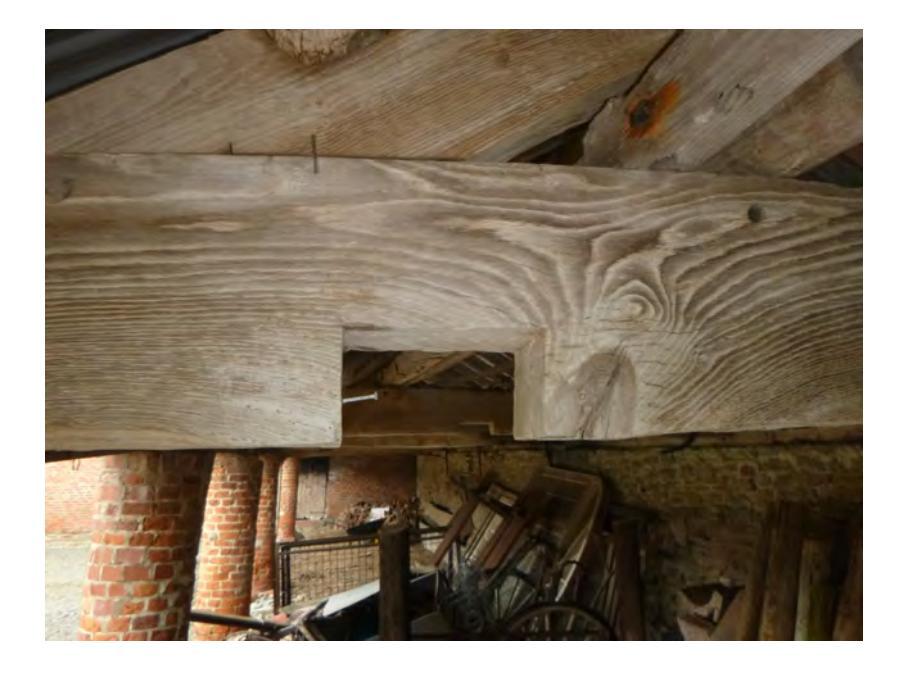
### Fig 12:

North stable block; showing large notch on underside of tie beam of truss 6, likely to be structurally significant, reducing overall cross section by approximately 40 per cent
