# Aston Hall: Investigation of structural timber elements – South range barns

Site note 1 for March 2021, job no. 153.32

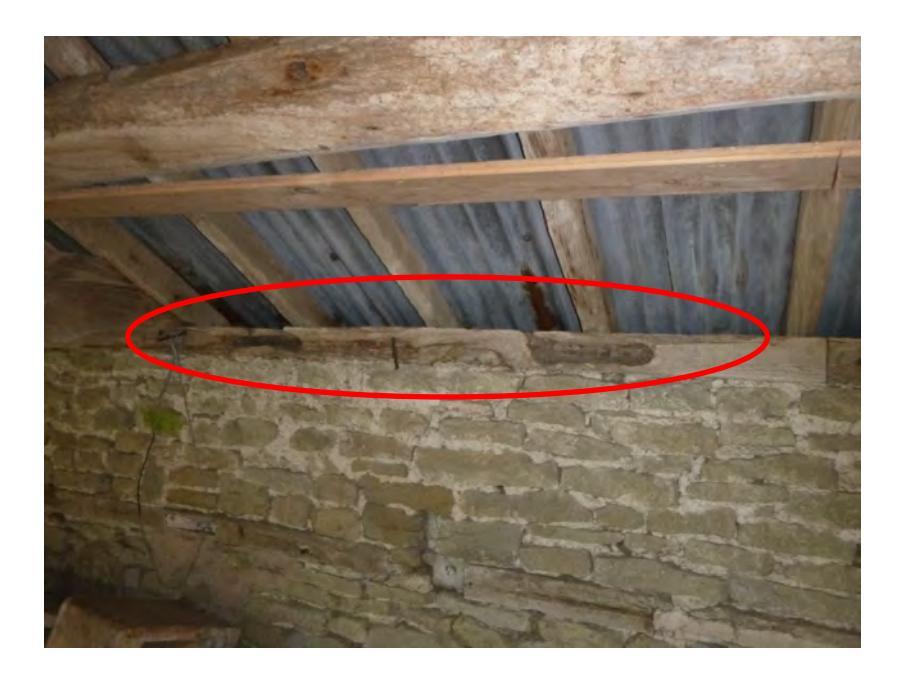
### Fig 13:

North stable block; showing large notches in wall plate. However, wall plate relatively substantial in this location, therefore, unlikely to be structurally significant

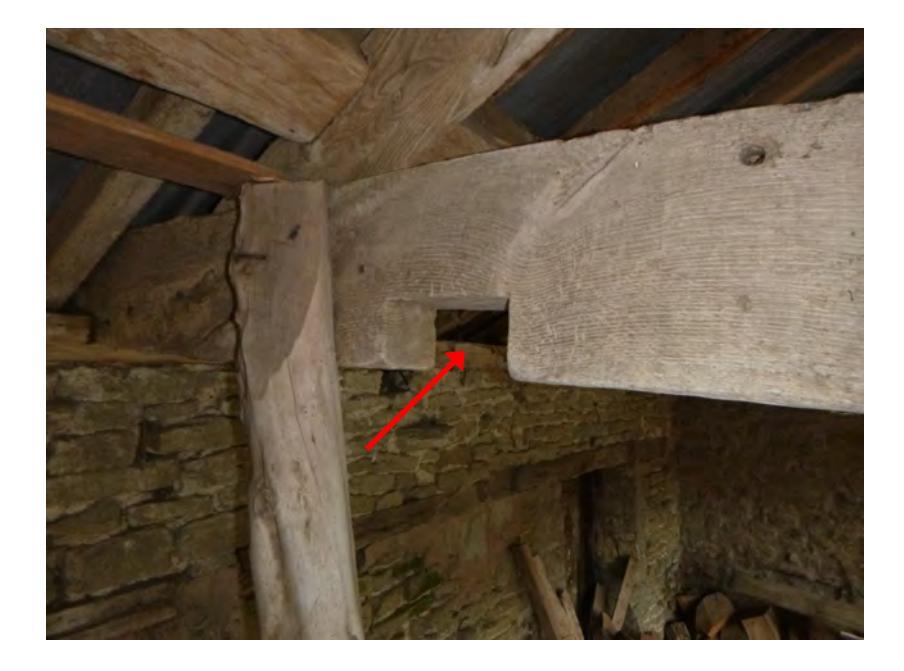
### Fig 14:

North stable block; showing large notch in tie beam of truss 8 at north end and notch also noted at south end, reducing overall cross section by 40 per cent, may be structurally significant

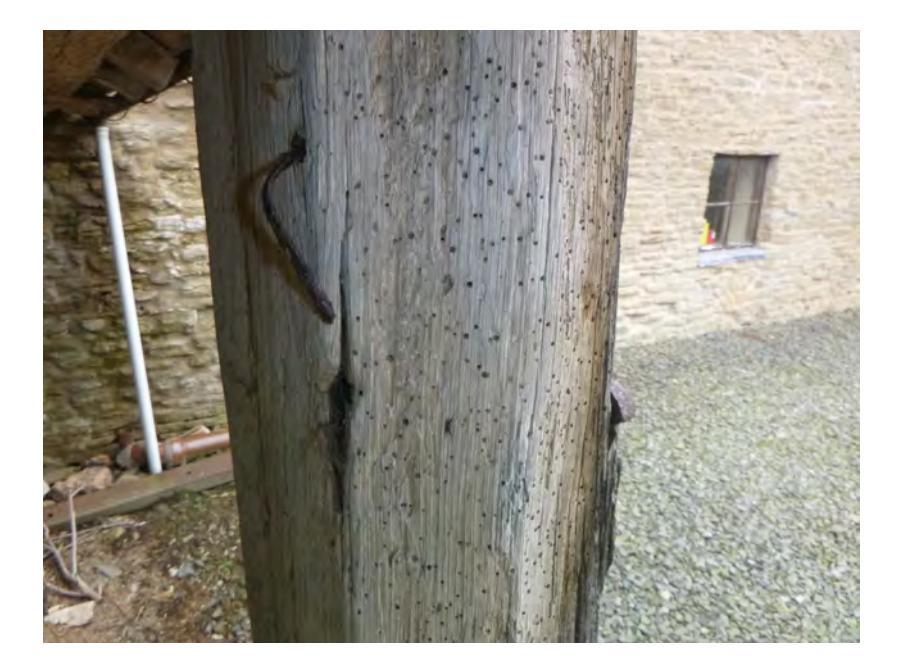
### Fig 15:

North stable block; showing widespread wood-boring beetle flight holes on post at south eaves of truss 8. No structurally significant timber decay detected on drilling

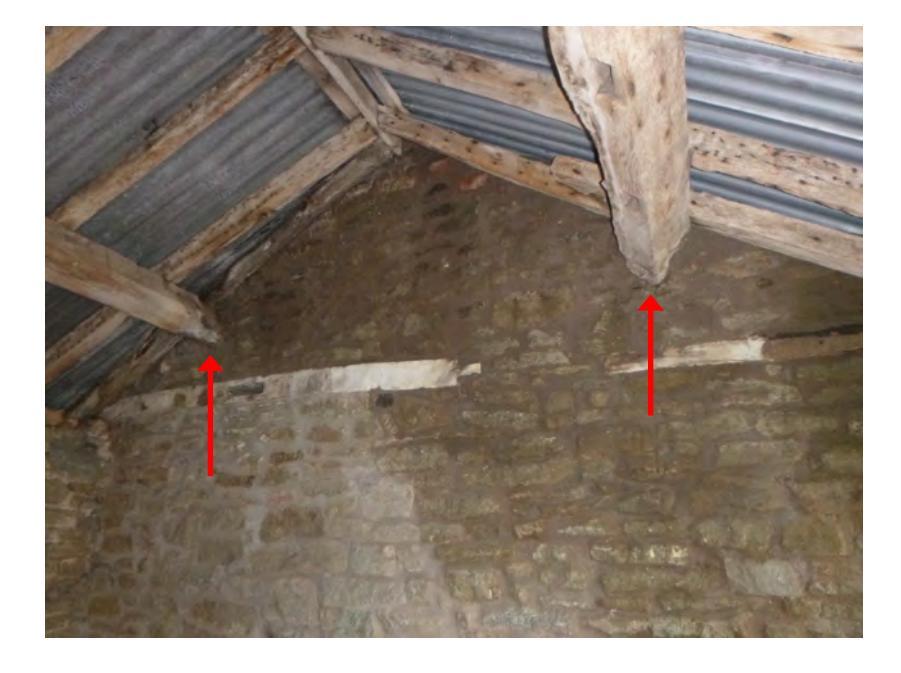
### Fig 16:

North stable block; showing extreme east end. Note visible dampness on face of masonry wall. Both purlins embedded in east wall were found to be structurally decayed on drilling

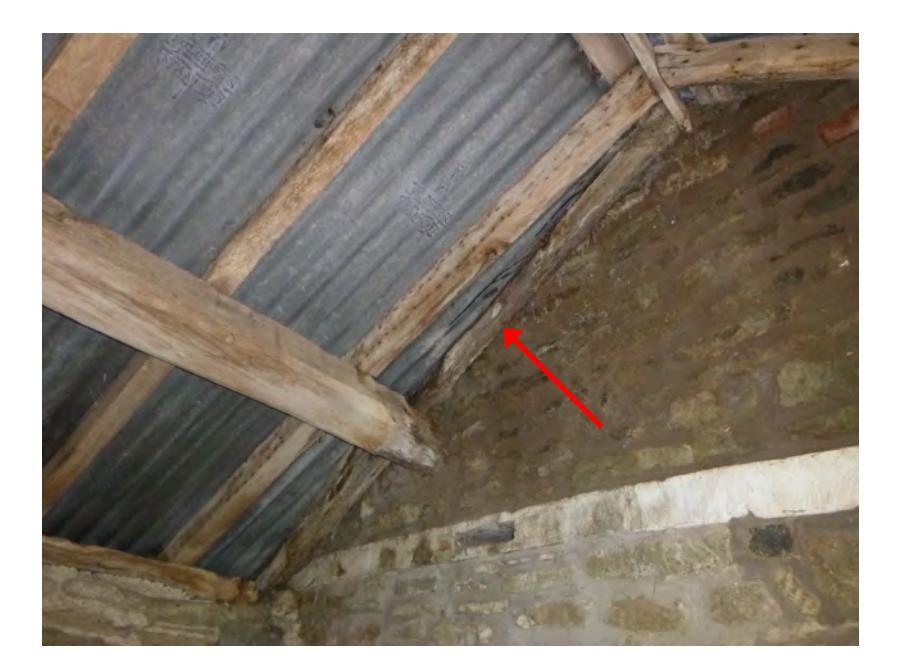
### Fig 17:

North stable block; showing structurally decayed common rafter on north pitch at east end

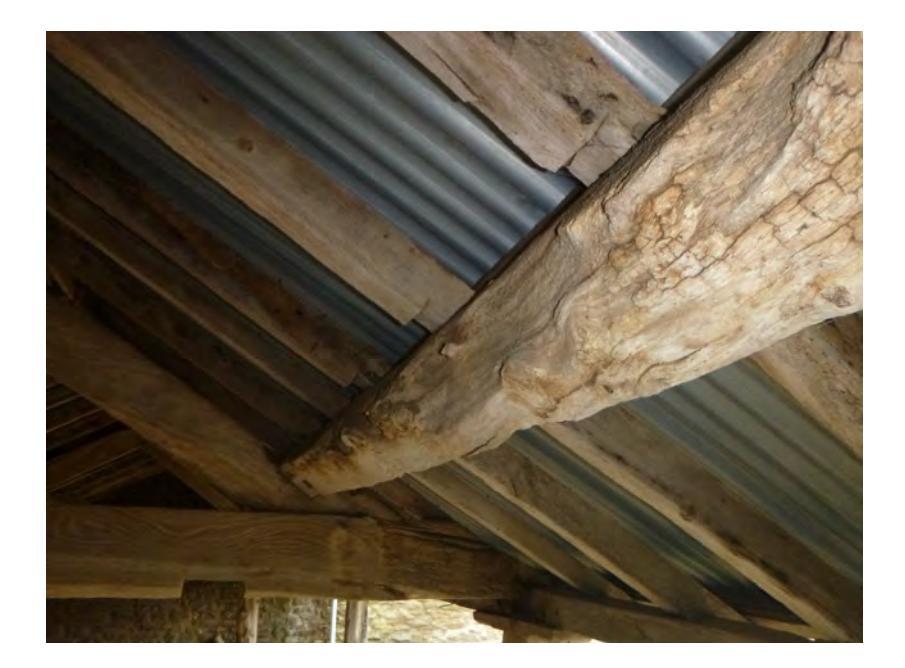
### Fig 19:

North stable block; showing localised loss of cross section from historic woodboring beetle to north side of purlin in bay 7

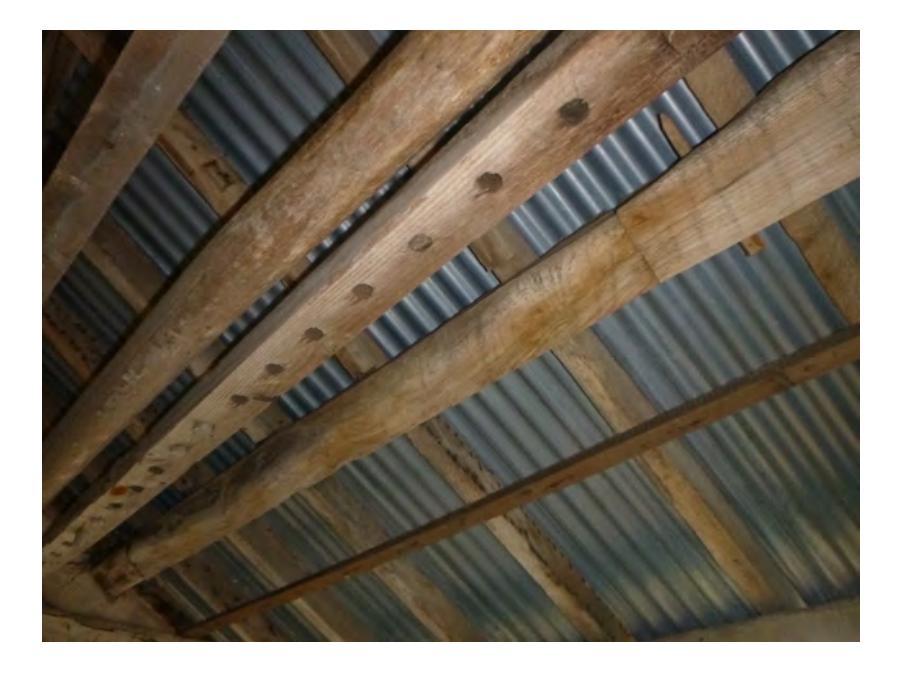
### Fig 20:

North stable block; showing section of purlin not supported at one or other ends by a truss, fully reliant on purlin bridled half lap. May be structurally significant

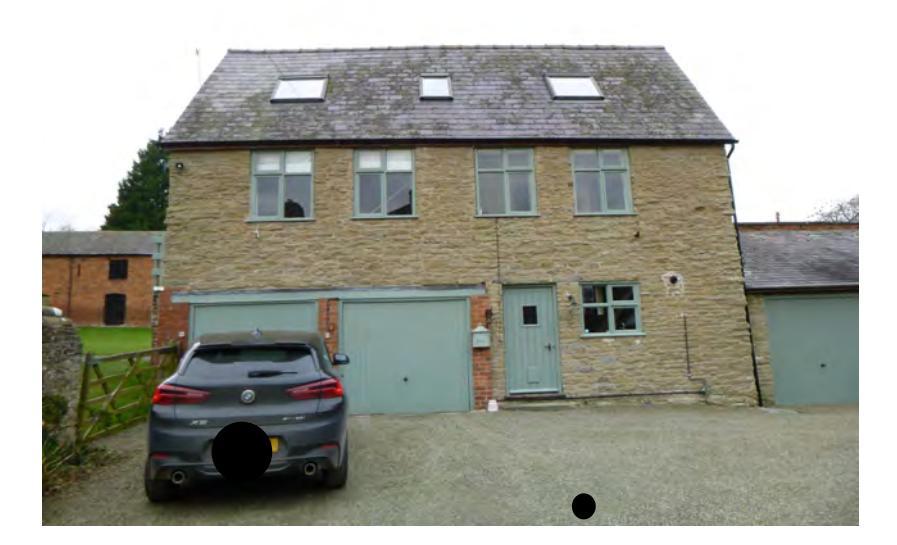
### Fig 1:

Exterior, east elevation; showing a general view of the property and of the joinery, which was in good, serviceable order

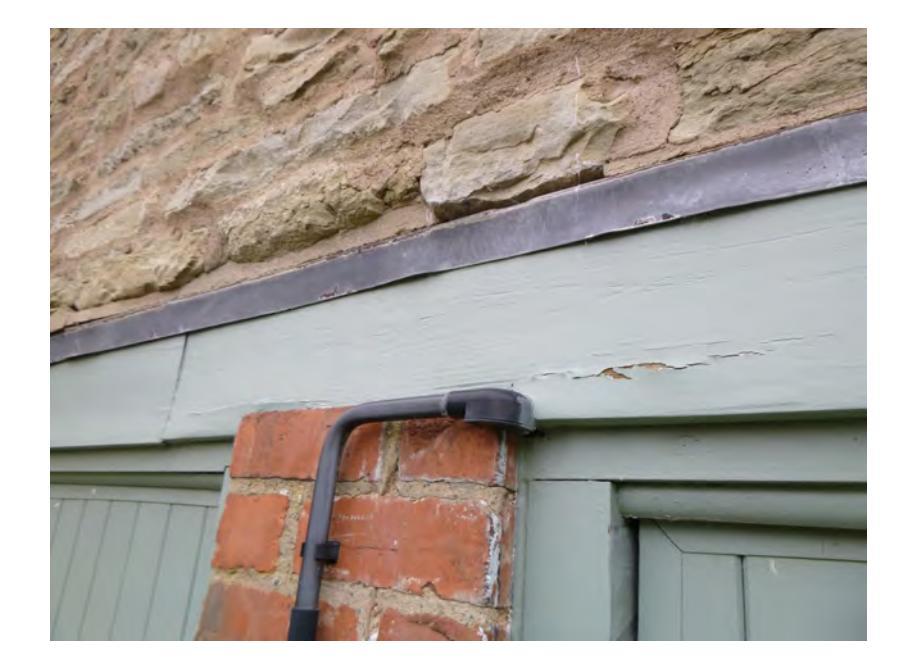
### Fig 2:

Exterior, east elevation; showing a localised area of cracking to the finish of the garage lintel fascia board

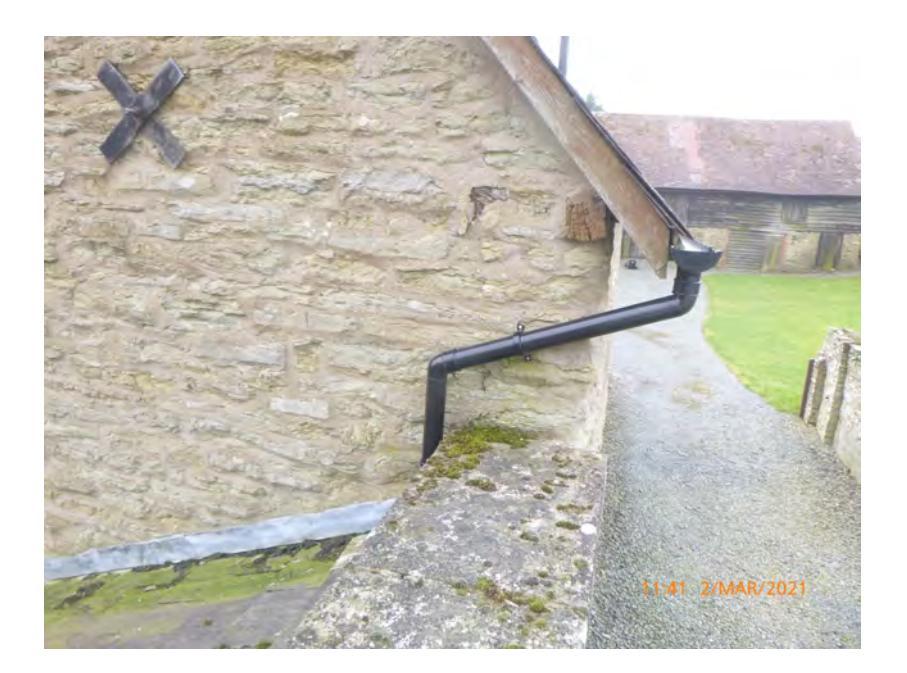
### Fig 7:

Exterior, north-west corner of coach house; showing a dog legged downpipe and configuration of wall head plates along west elevation with external rafter plate and tie beam plate on internal face of head of wall

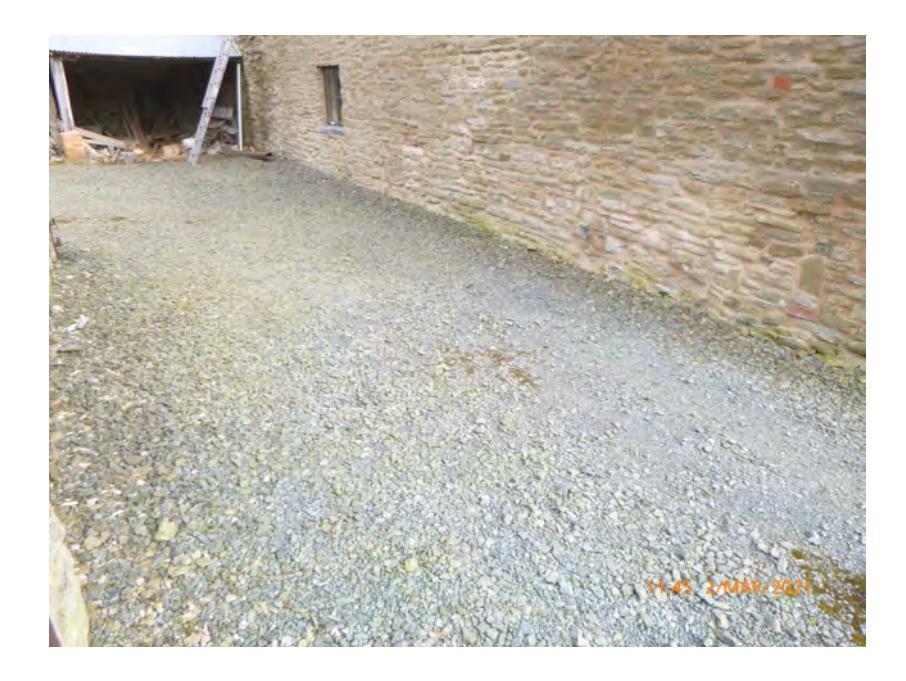
# Fig 9:

Exterior, stable yard driveway, west of cottage; showing depression in hardcore suggestive of ponding and perched water at base of cottage at south-west corner

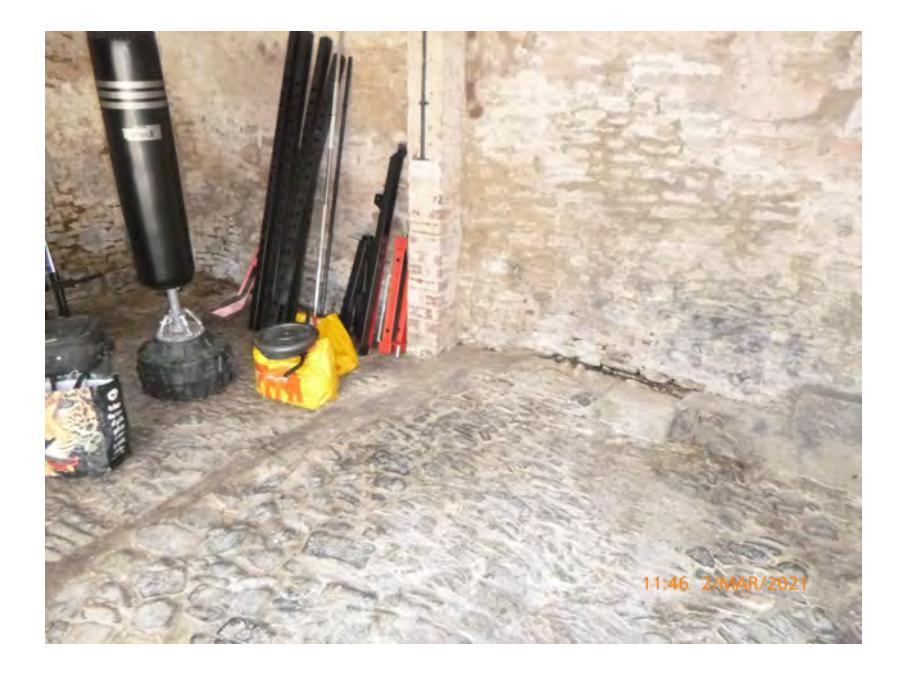
# Fig 10:

Interior, west wall base in coach house garages; showing signs of natural water penetration through wall/floor junction

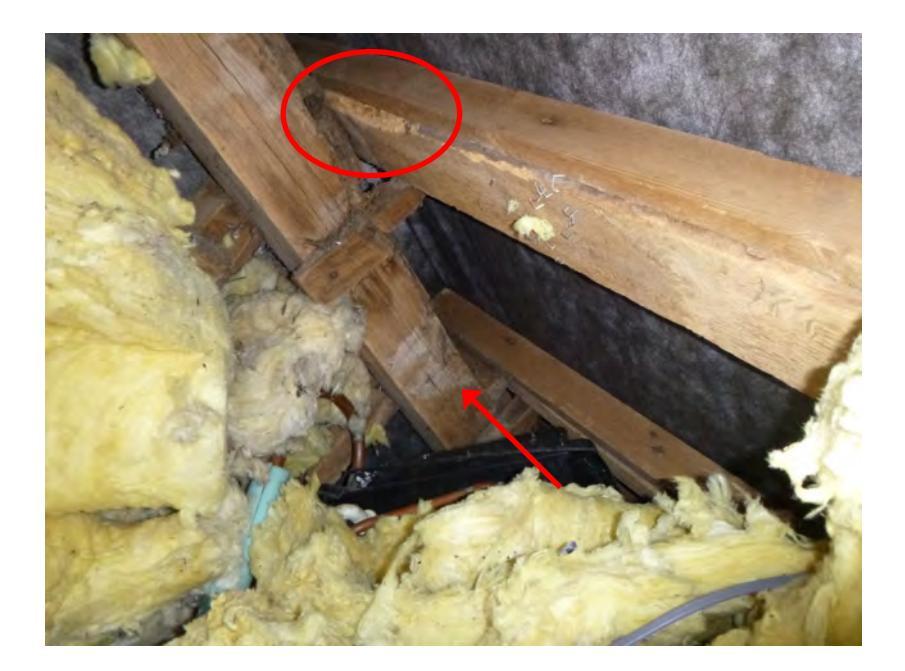
# Fig 11:

Interior, attic space; showing a limited view of the roof structure

Also showing superficial sapwood loss from beetle attack and historic water staining to the ridge beam

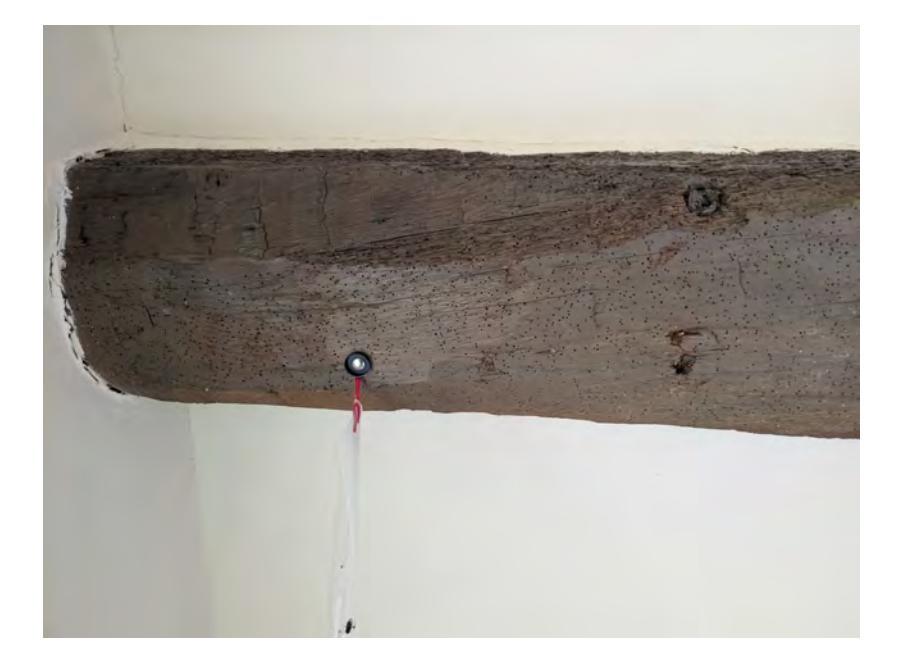
### Fig 14:

Interior, second floor; showing historic beetle attack at the south end of the west upper purlin, with flight holes consistent with Common furniture beetle

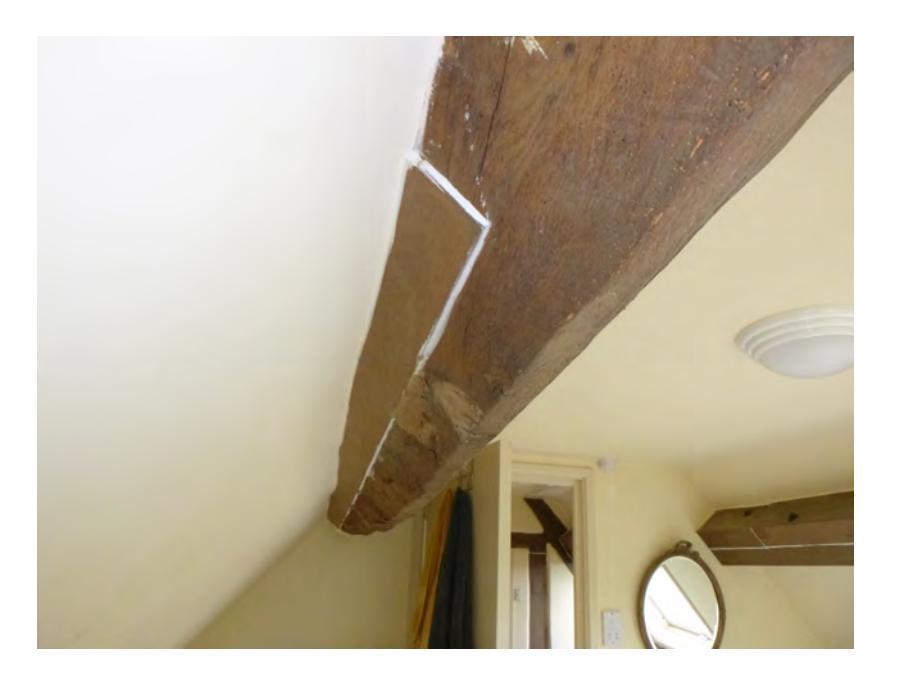
# Fig 15:

Interior, second floor; showing a face half-lap joint repair to the west upper purlin

Note roof finishes had likely failed in the past, allowing water penetration providing the conditions for decay to the upper face

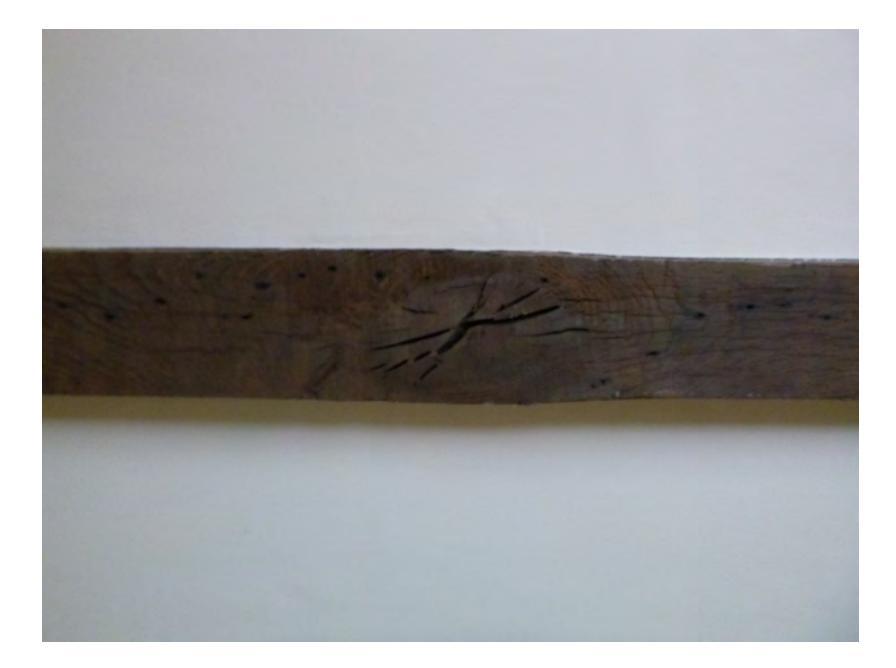
#### Fig 21:

Interior, first floor; showing a large knot covering ~90 per cent of the face of 1no. second floor joist, as seen in the living room. No action required

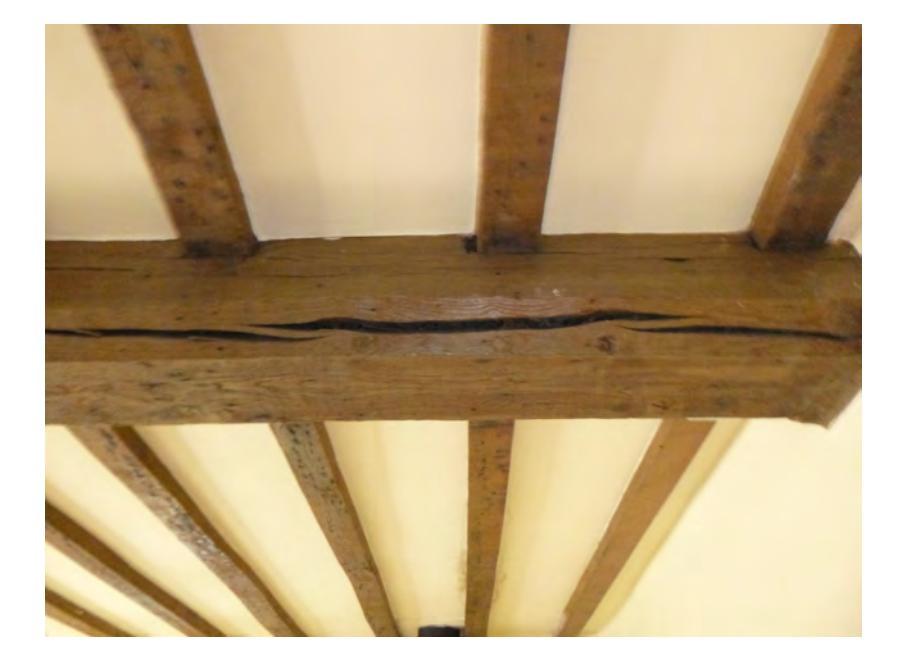
# Fig 22:

Interior, first floor; showing a particularly wide drying-out fissure on a second-floor beam, which is a natural defect and not considered to be an issue

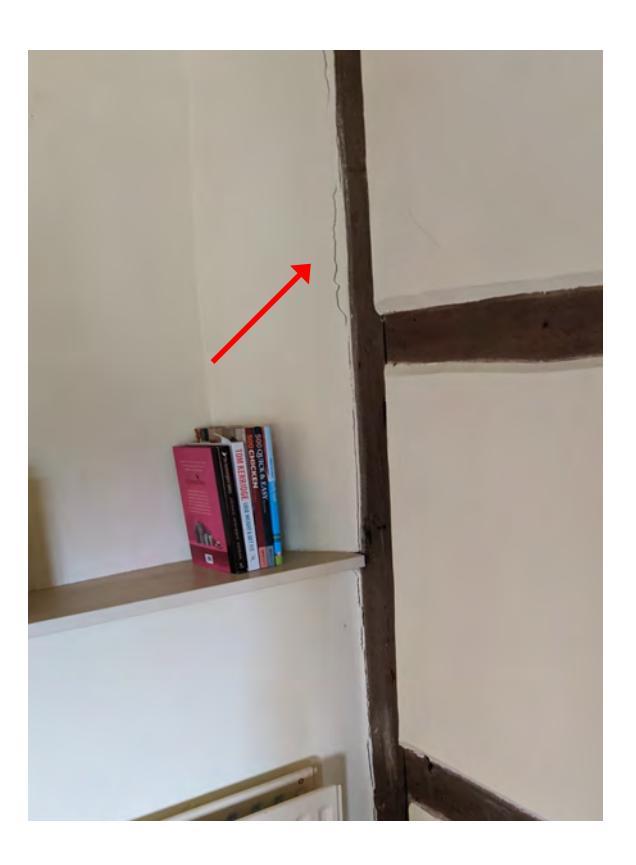
#### Fig 23:

Interior, first floor; showing hairline cracking to plaster near to the timber stud wall. Subtle movement of timbers and the plaster skim finished without a movement gap was thought to be the cause

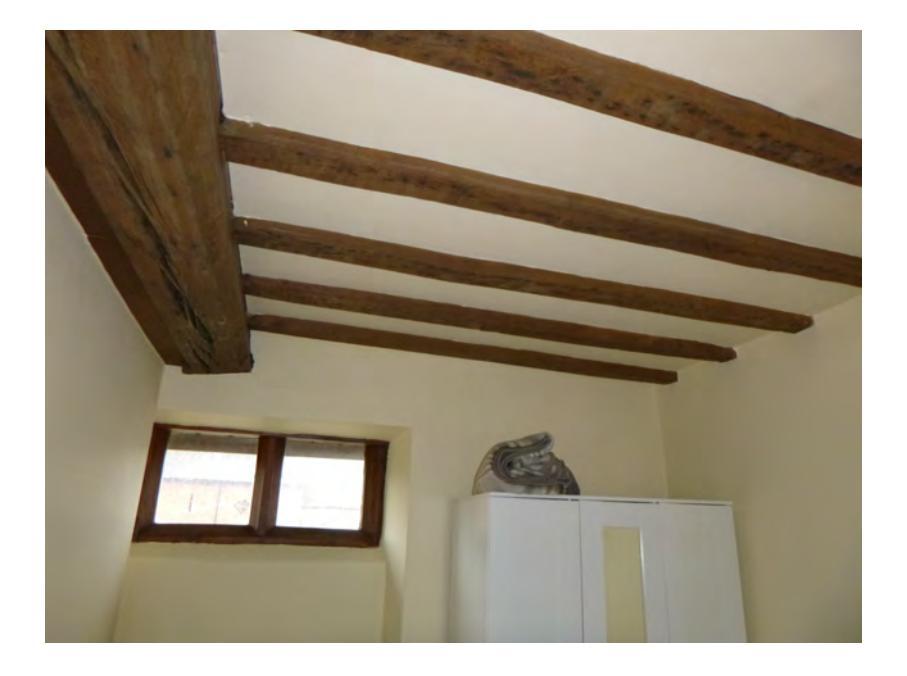
### Fig 27:

Interior, first floor; showing another general view of the second floor structure

Also note the drying-out fissure to the floor beam

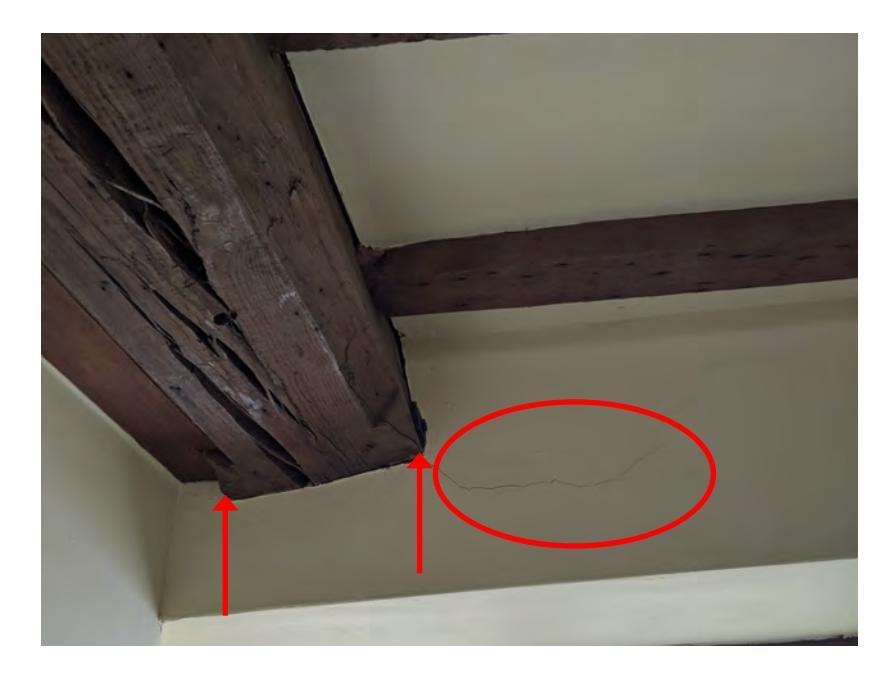
# Fig 28:

Interior, first floor; showing a view of the twisted floor beam and associated cracking to plaster. The movement was believed to have settled and was not deemed structurally significant

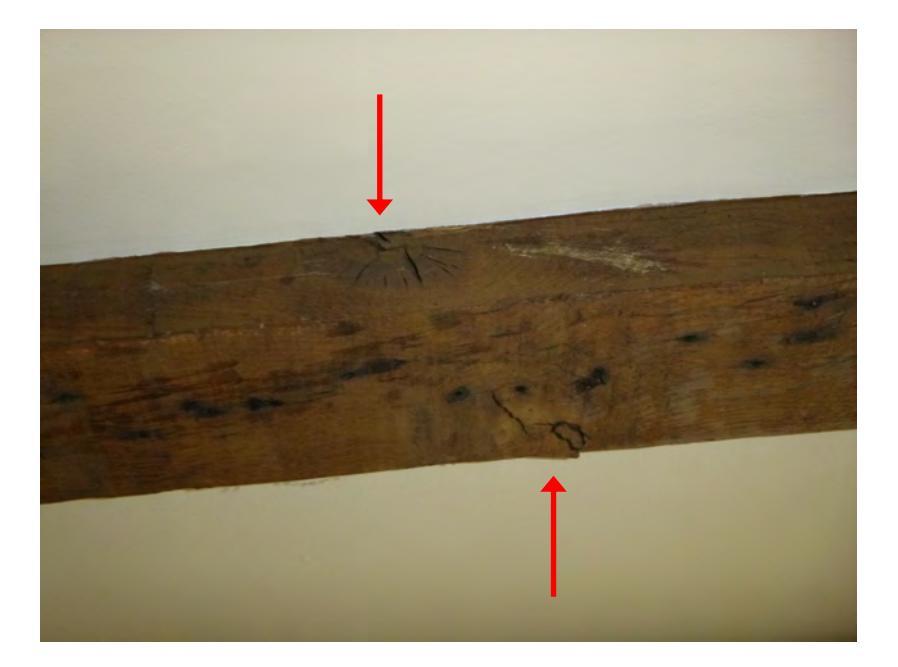
#### Fig 29:

Interior, first floor bedroom; showing 2 no. knots within 100mm of each other. No evidence of stress to the floor joist and so no action required

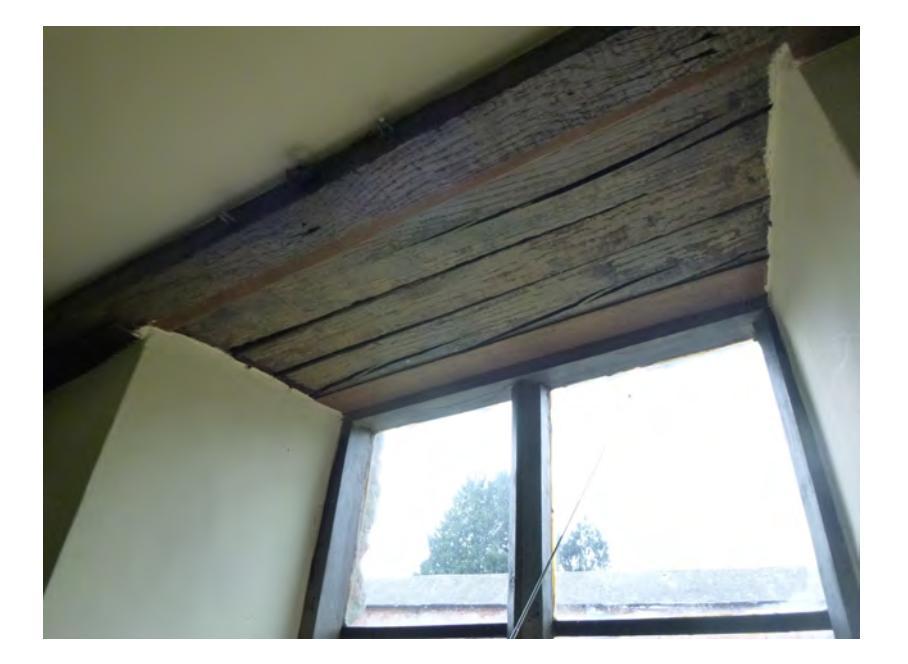
# Fig 32:

Interior, ground floor; showing the lintel arrangement made up of several smaller section timbers, no decay detected on drilling

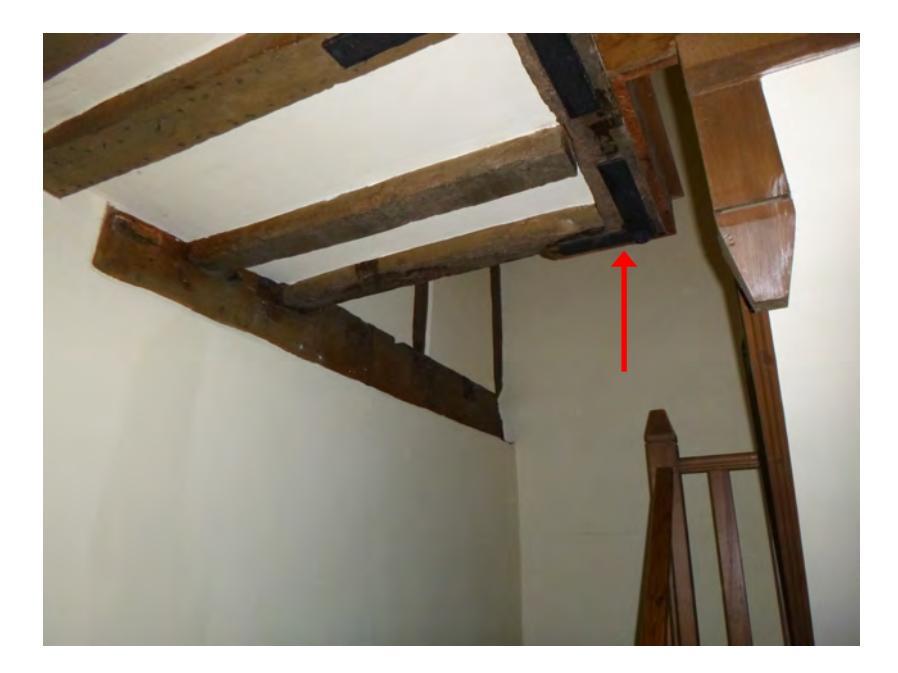
# Fig 33:

Interior, ground floor; showing metal reinforcement to the trimmer joist at the stair opening

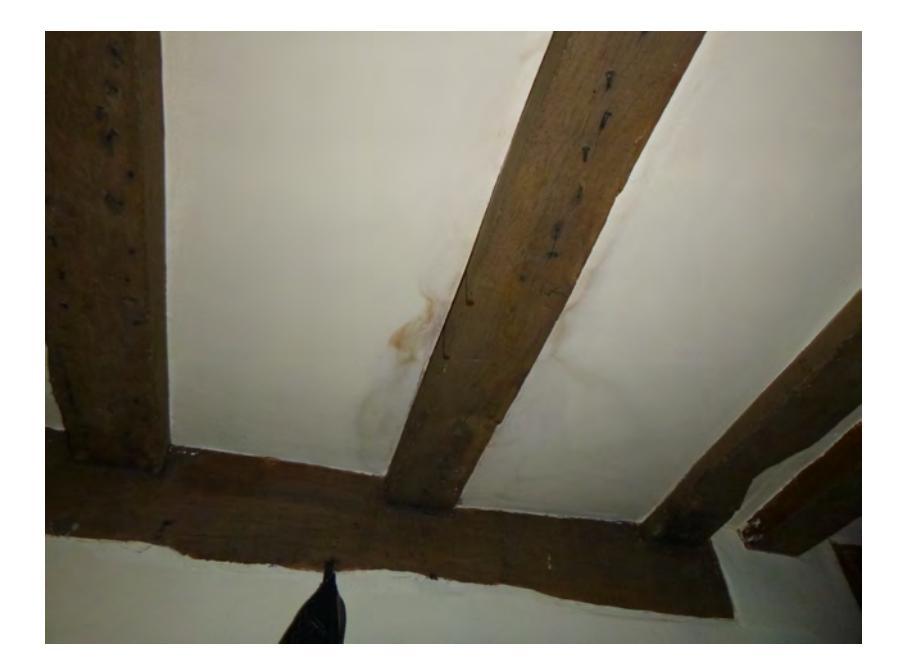
# Fig 34:

Interior, ground floor; showing a general view of the first floor structure as seen in the hallway

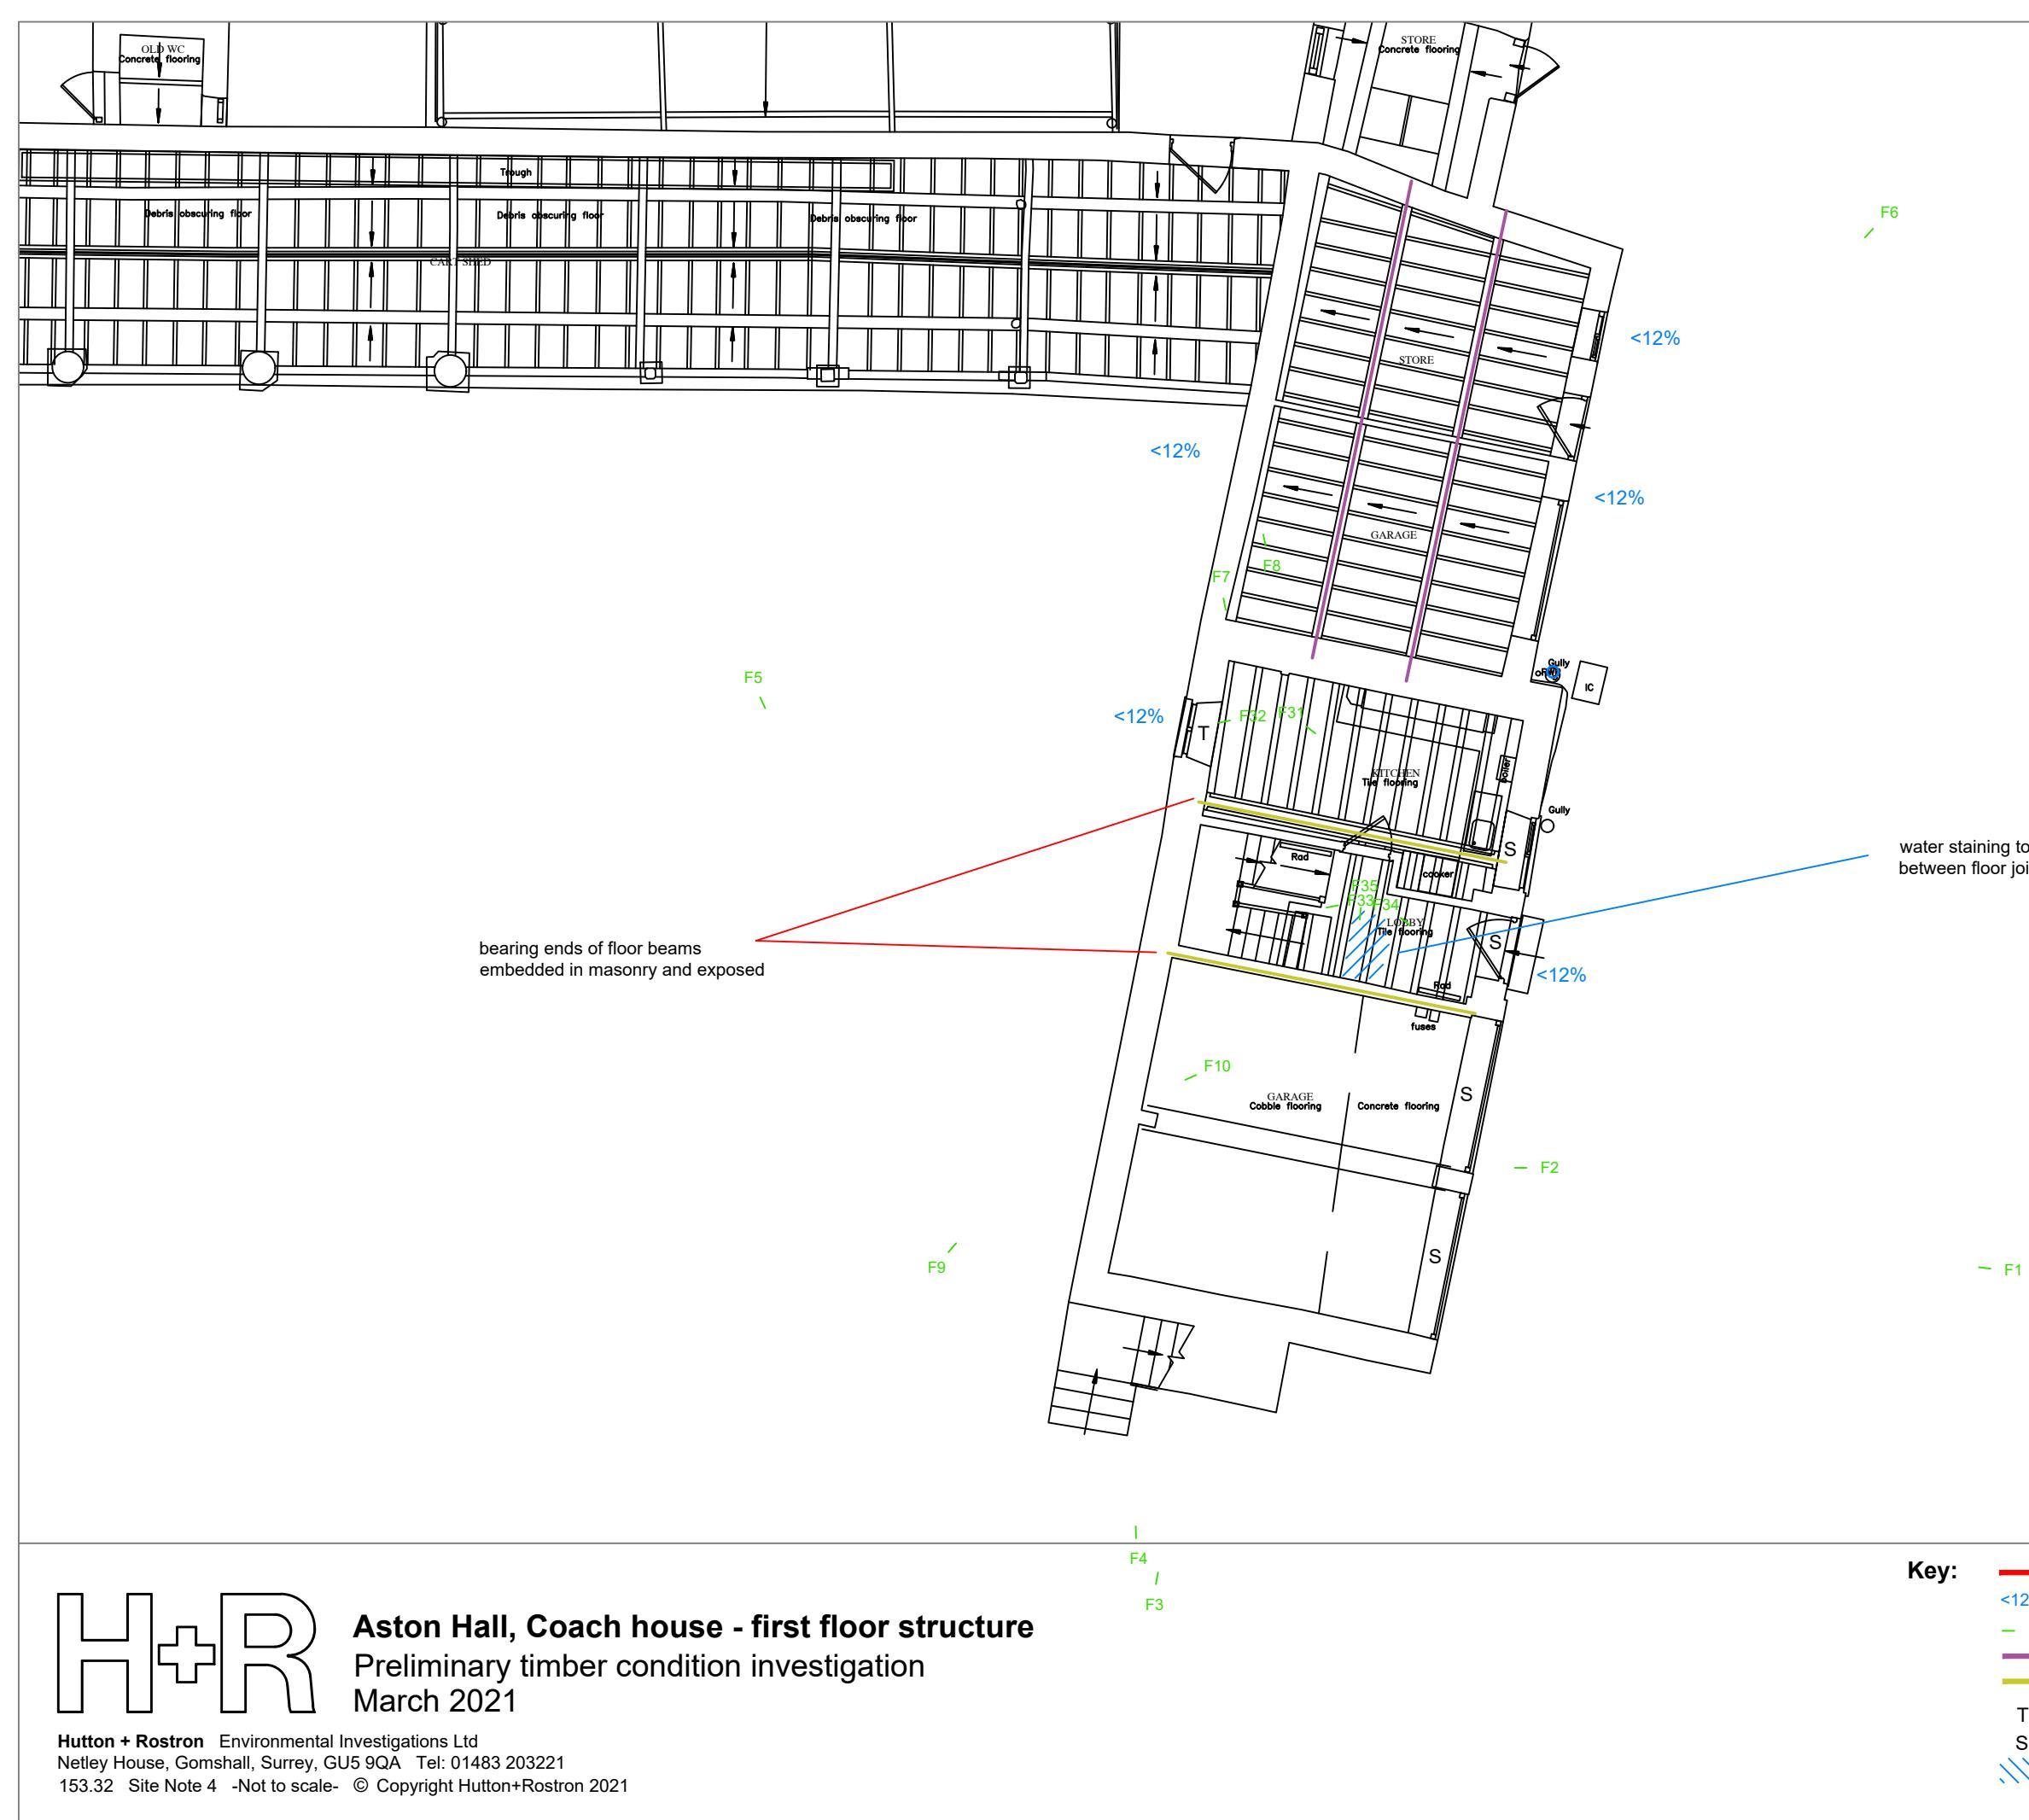
water staining to plaster and finishes between floor joists
