Aston Hall: Investigation of structural timber elements – South range barns

Site note 1 for March 2021, job no. 153.32

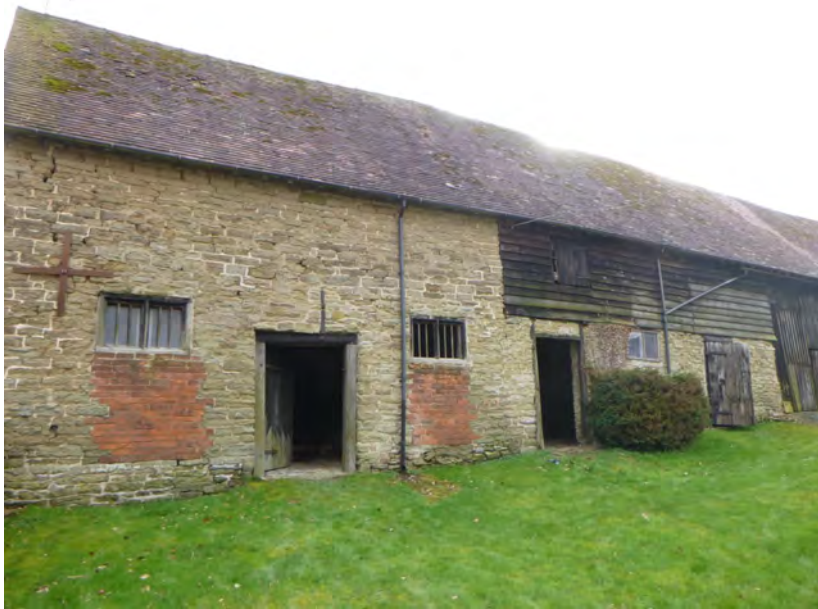
Fig 1:

North elevation; showing a general view of the east part of the south barn

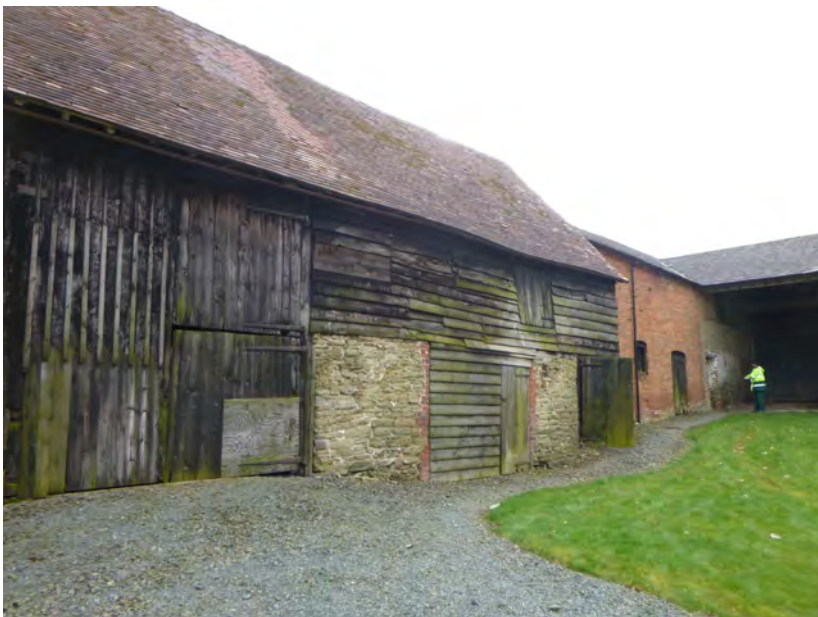
Fig 2:

North elevation; showing a general view of the west part of the south barn

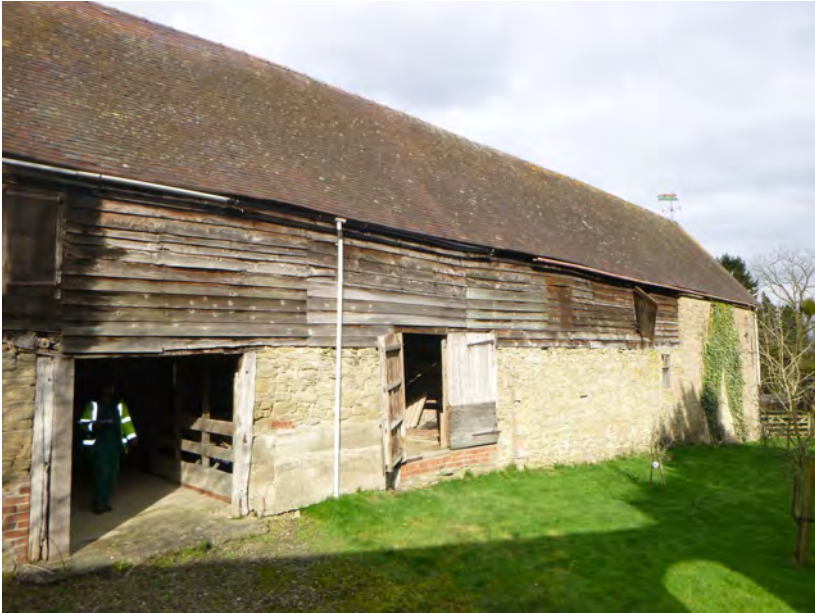
Fig 3:

South elevation; showing a general view of the east part of the south barn

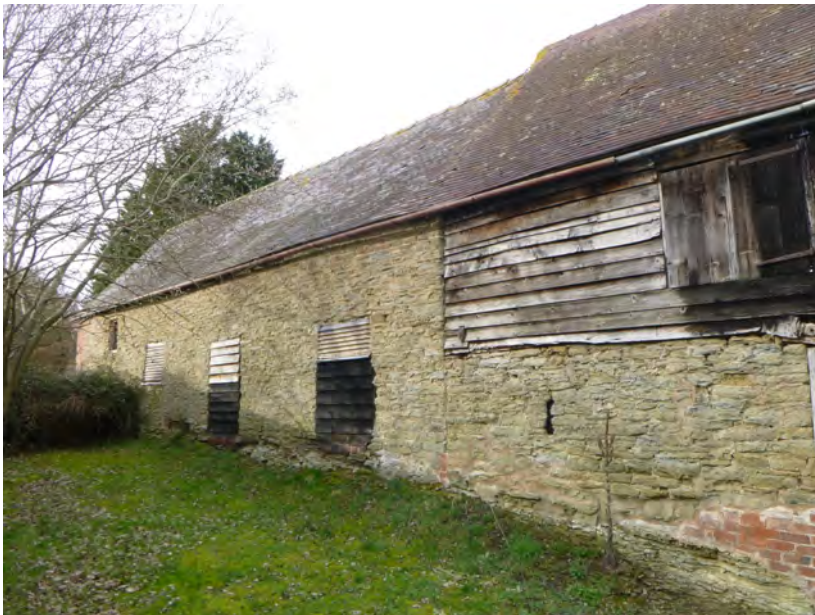
Fig 4:

South elevation; showing a general view of the west part of the south barn

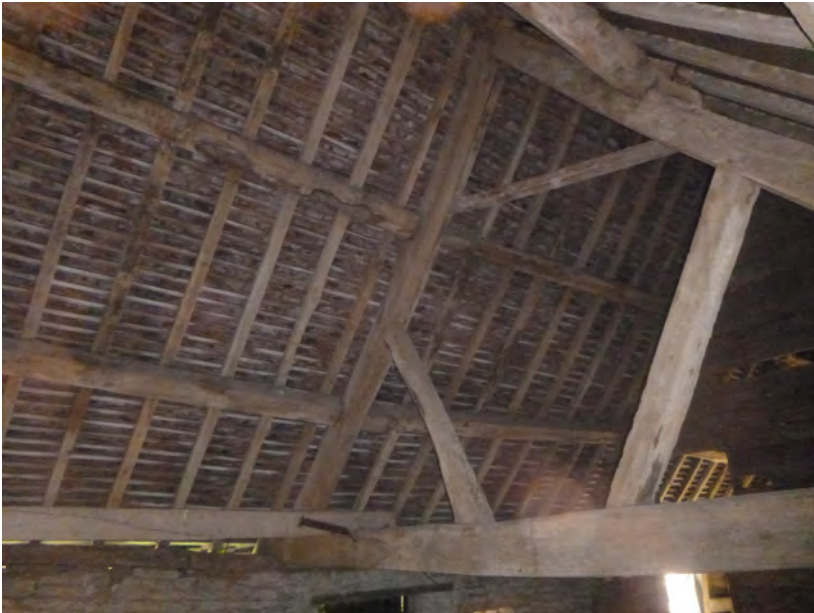
Fig 5:

Bays 1 and 2; showing a general view of the roof structure

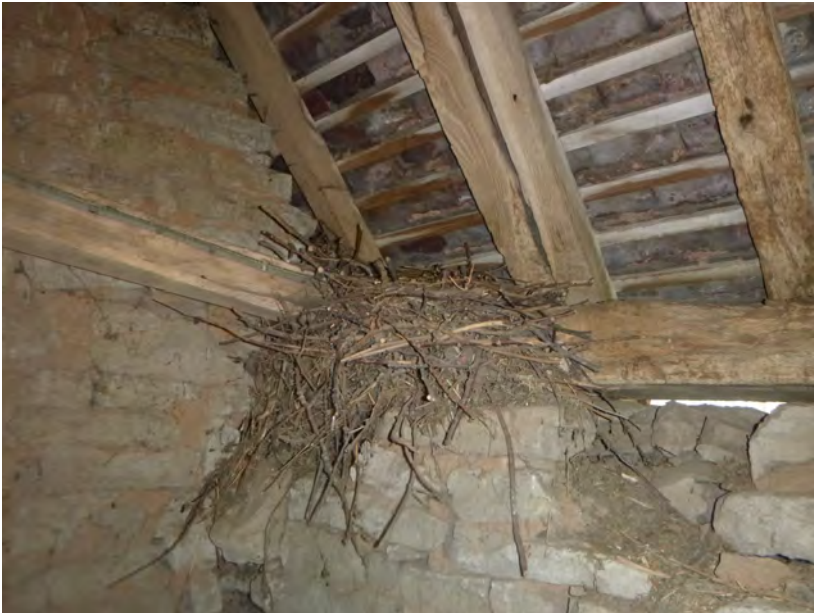
Fig 7:

There were several large nests throughout the building, all of either magpie or jackdaw, evidenced by the typical large-diameter twig content and large piles of discarded feathers. These will locally reduce natural ventilation and provide the conditions for damp and decay and wood-boring beetle infestation of non-structural timbers

Bays 1 and 2; showing large nest in south-east corner of the east end, again, limiting ventilation around vulnerable structural timbers and may provide the conditions for damp and decay

All nesting material (and tent wall hangings) should be removed to allow for ventilation to structural timbers, eliminating the conditions in which wood-boring beetle and dampness can thrive. If the building is to be left for a significant period of time prior to refurbishment, installation of netting over holes in the facades should be considered to prevent further avian intrusion

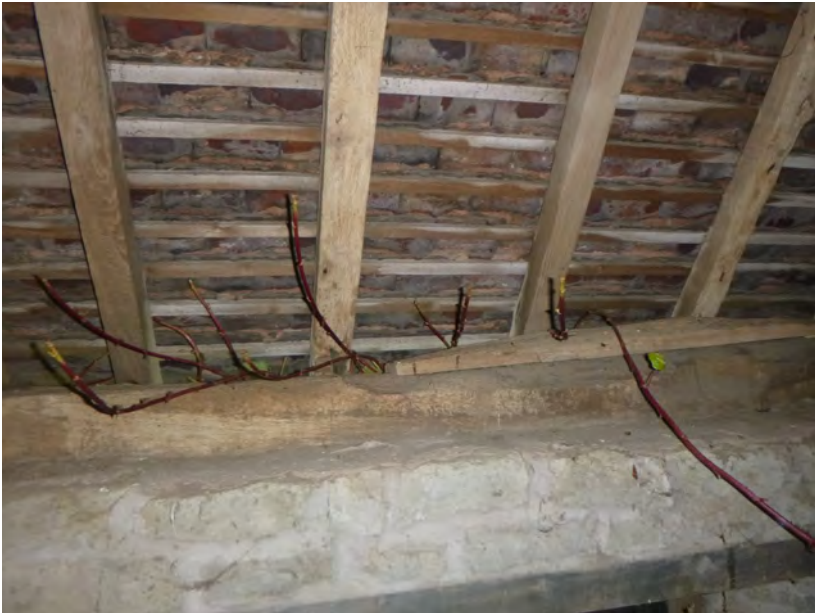
Fig 9:

Bays 1 and 2; showing significant and well-established plant growth emanating from between the structure and the external cladding, and penetrating the roof structure. This was not considered detrimental at the time of survey, but should be eliminated to prevent detachment of external boarding in the future

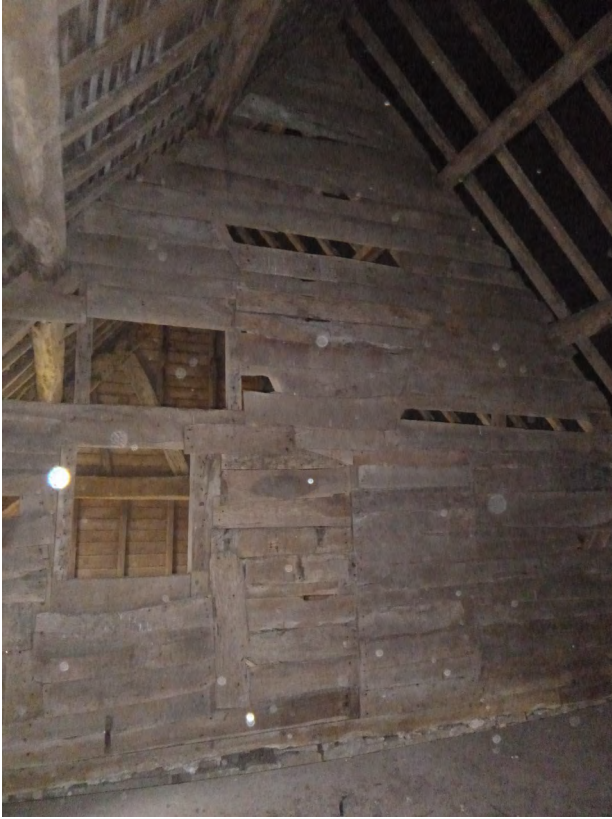
Fig 11:

Bays 1 and 2; showing the cross wall between bays 2 and 3. Boards were of historic oak timber, with hand sawn conversion markings throughout

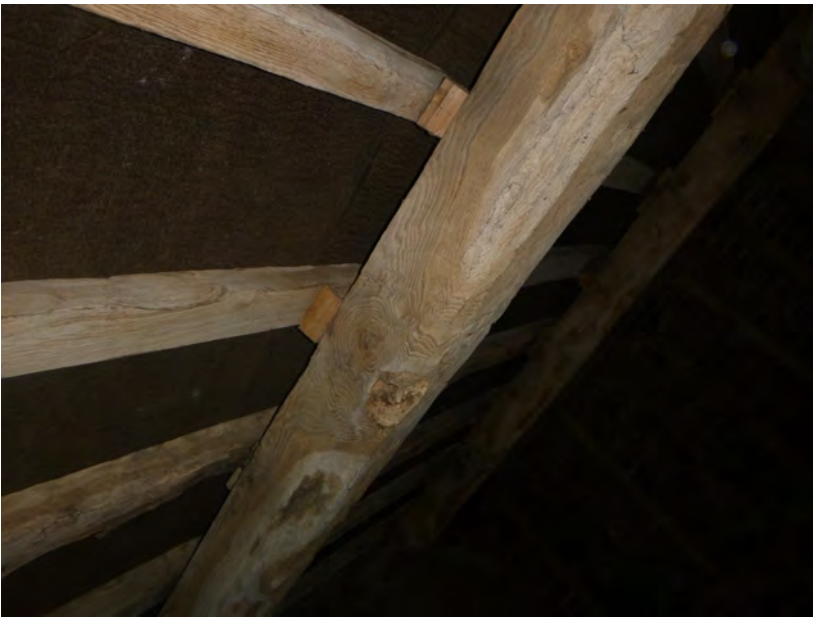
Fig 12:

Bays 1 and 2; showing softwood packing timbers between rafters and the purlin on the north pitch of bay 1, indicating relatively recent intervention to straighten the roof pitch, possibly during re-roofing works circa 1980s

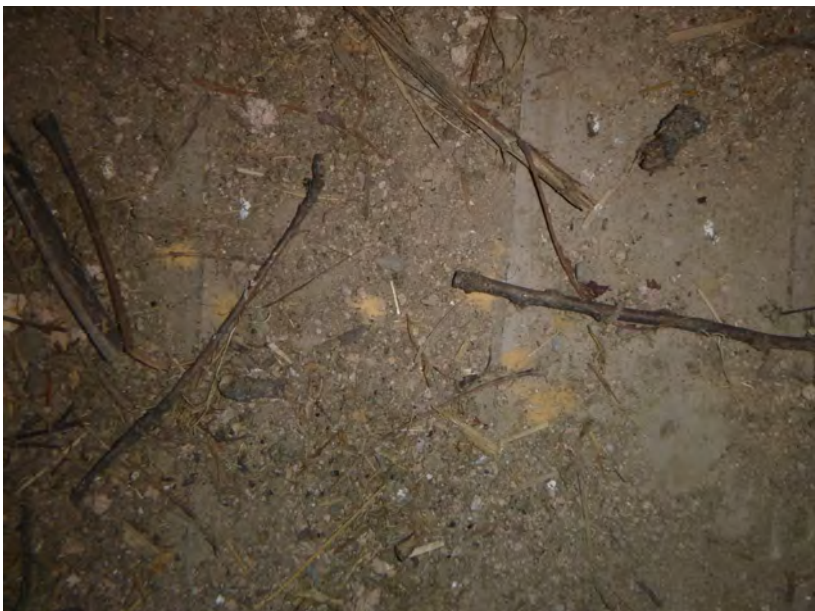
Fig 13:

Bays 1 and 2; showing piles of wood-boring beetle frass on the upper face of the softwood floorboards. Size and consistency of the frass was typical of Common furniture beetle (*Anobium punctatum*)

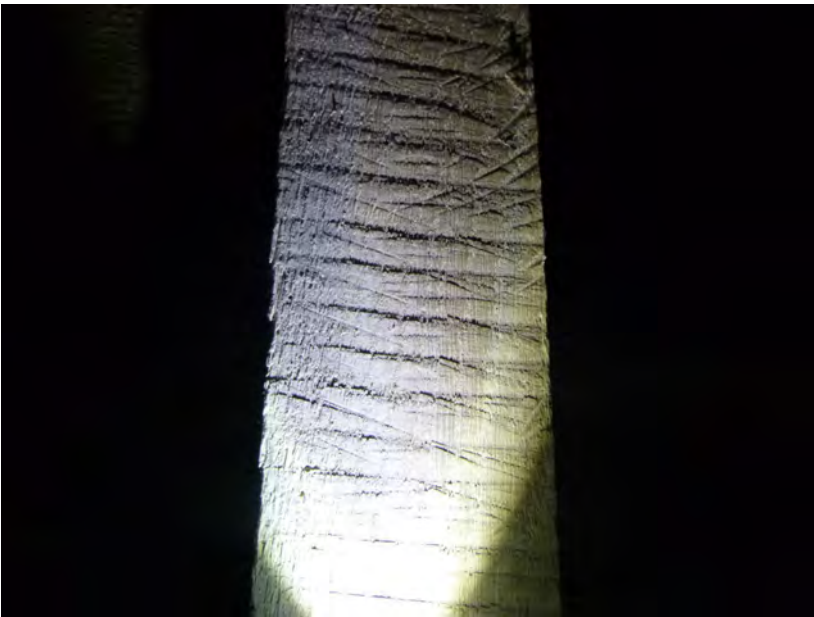
Fig 16:

South wing, bay 1; showing handsaw timber conversion technique on face of suspected later hardwood intervention rafter

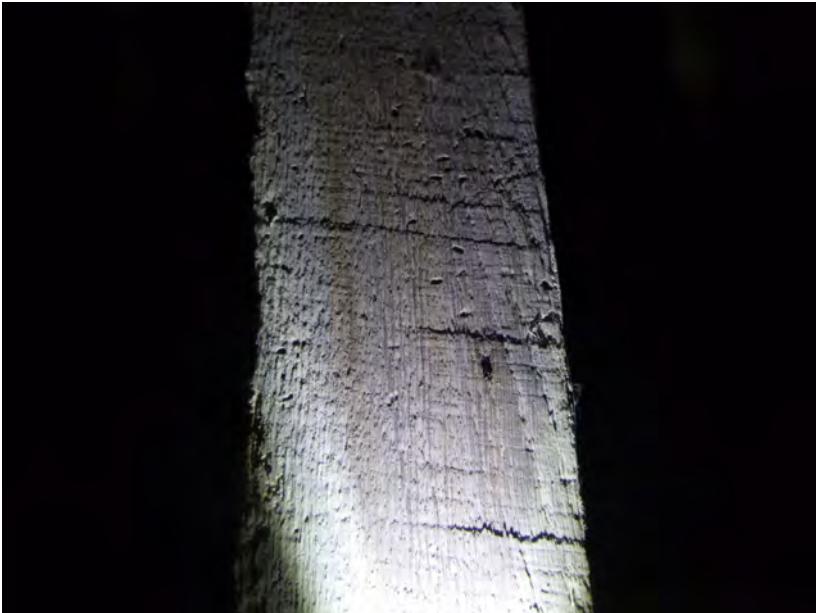
Fig 17:

South wing, bay 1; showing typical slightly off perpendicular sawing marks on suspected original historic timber, consistent with pit sawn timber conversion

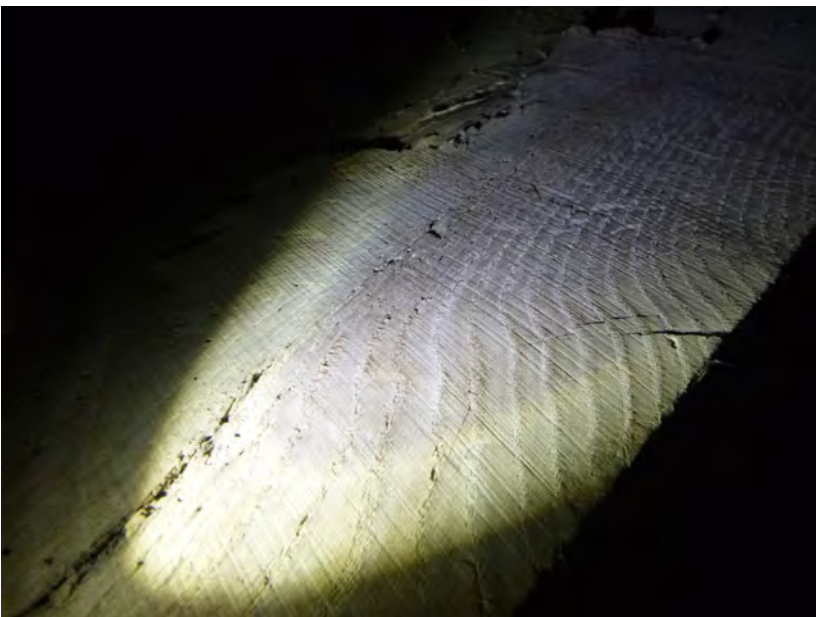
Fig 18:

South wing, bay 1; showing typical off square pit sawn timber markings on west face of north principal rafter

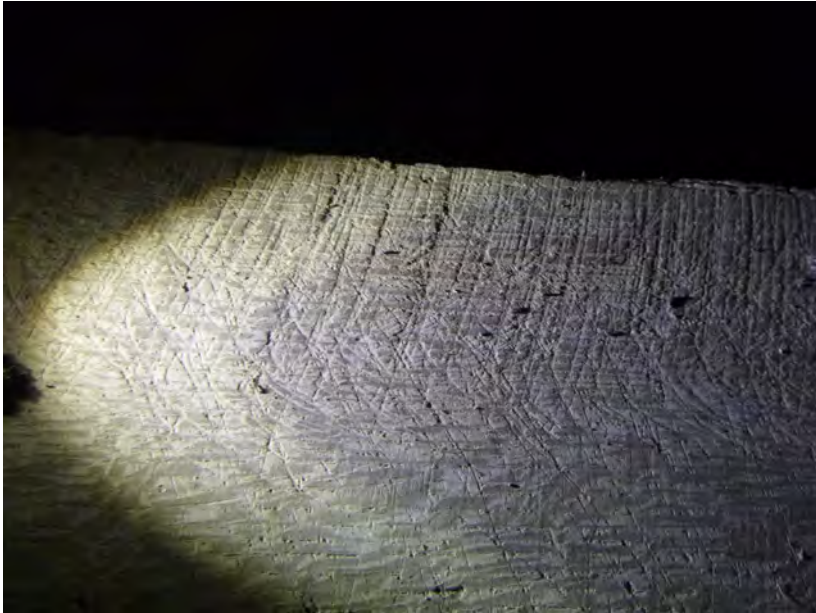
Fig 19:

South wing, bay 2; showing typical off perpendicular pit sawn timber conversion techniques on tie beam at north end

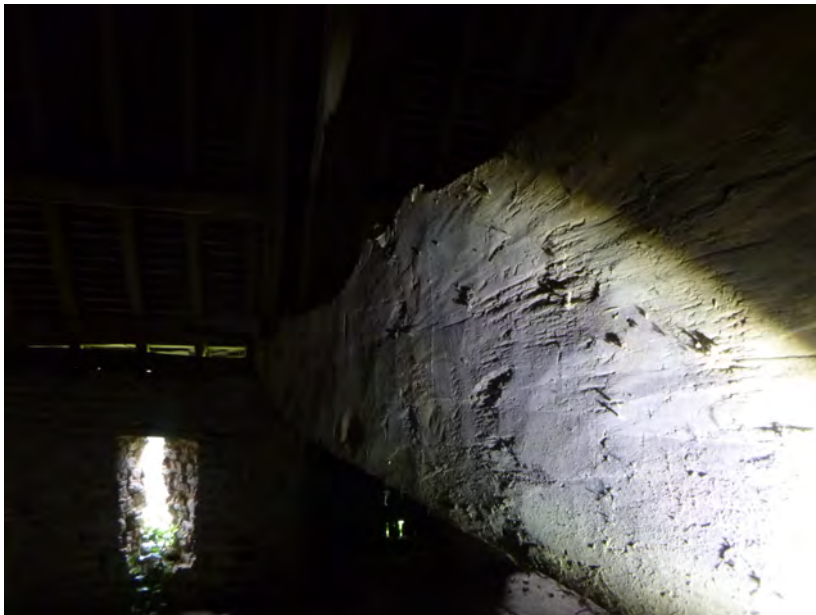
Fig 20:

Bay 1, south wing; showing undulating markings on east face of tie beam of truss 1, typical with adze conversion use

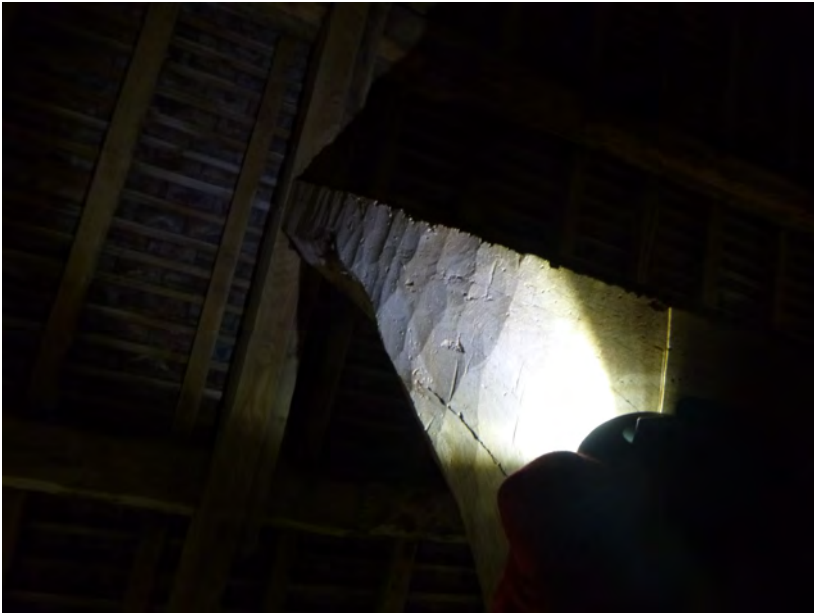
Fig 21:

South wing, bay 1; showing adze conversion markings on east face of south strut for T1

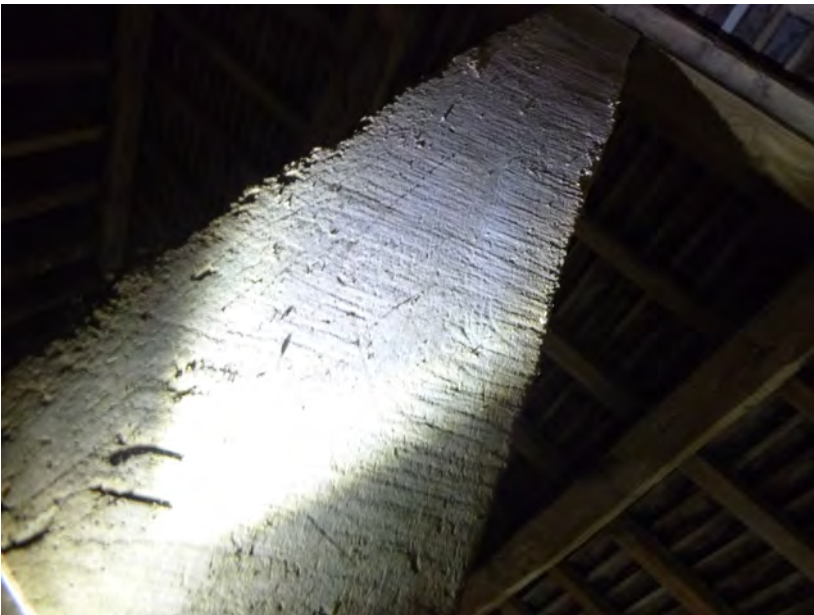
Fig 22:

South wing, bay 1; showing pitsaw conversion markings on west face of south strut for T1

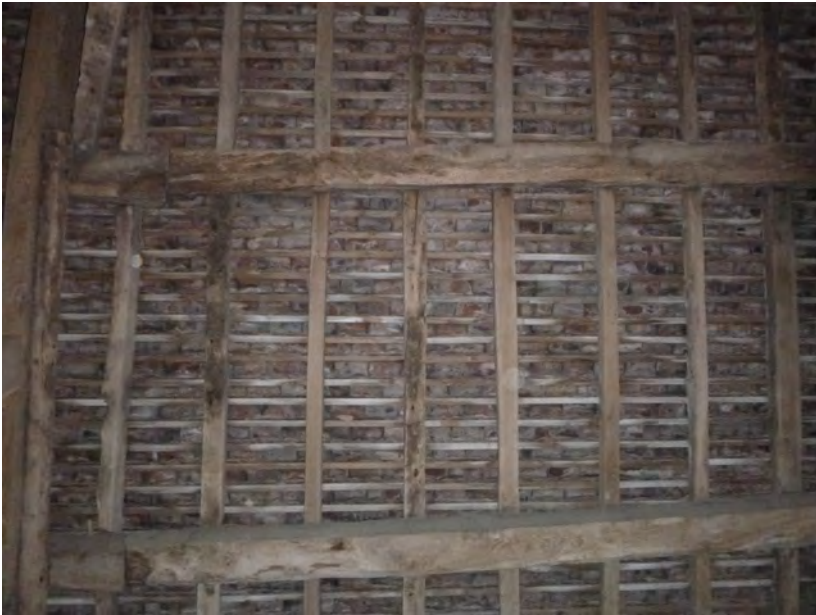
Fig 23:

South wing, bay 2; showing roof structure between upper and lower purlins and marked difference between newer elements and original historic components

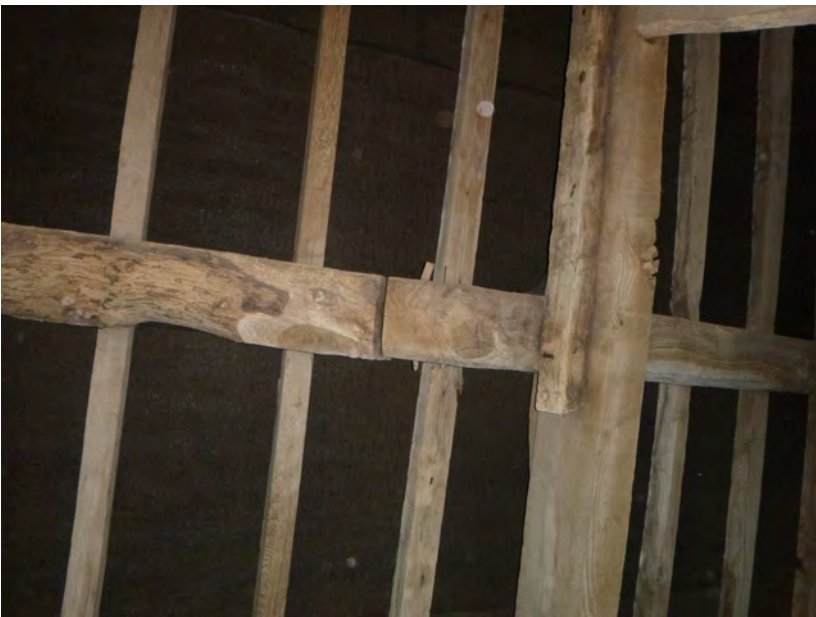
Fig 24:

South wing, bay 2; showing relatively new oak pins at purlin joint on north pitch

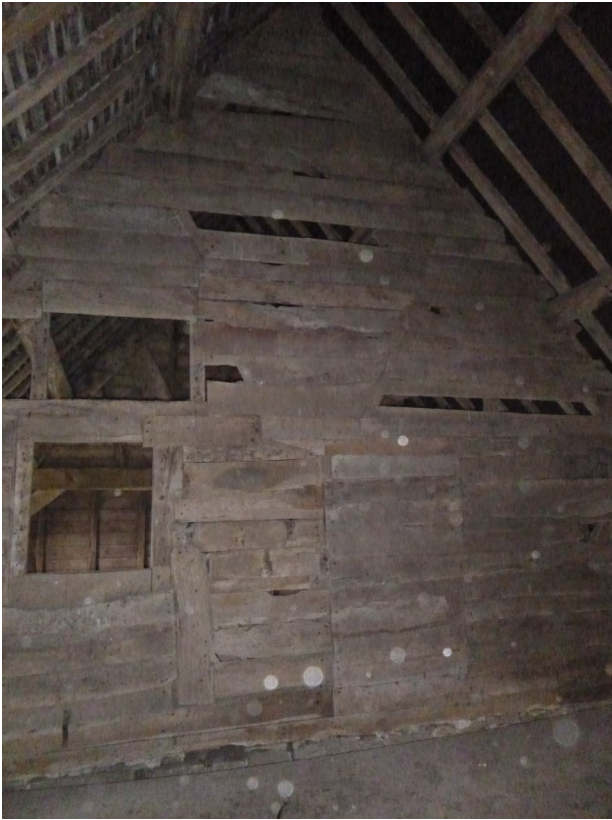
Fig 25:

South wing, bay 2; showing cross wall between bays 2 and 3

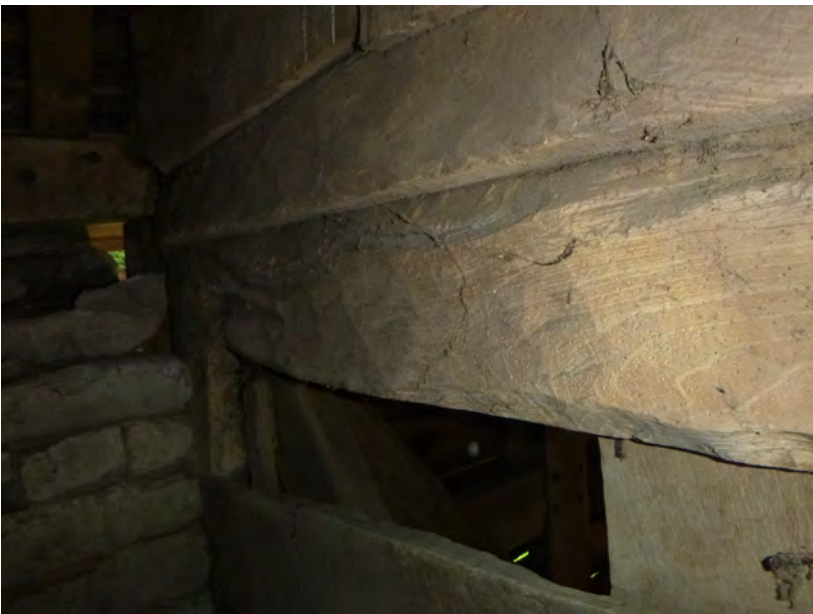
Fig 26:

South wing, bay 2; showing adze shaping on face of larger board comprising cross wall between bay 2 and 3

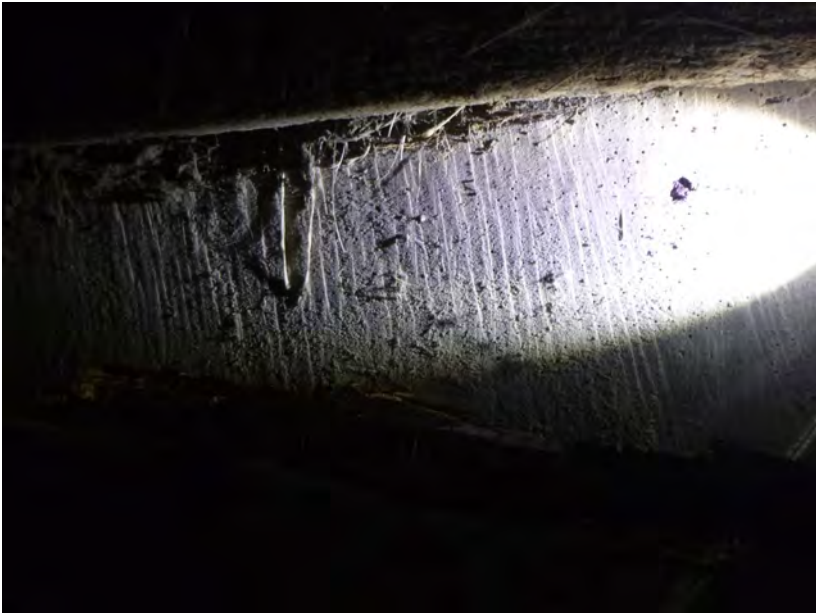
Fig 27:

South wing, bay 2; showing hand sawn conversion markings on boards between bays 2 and 3

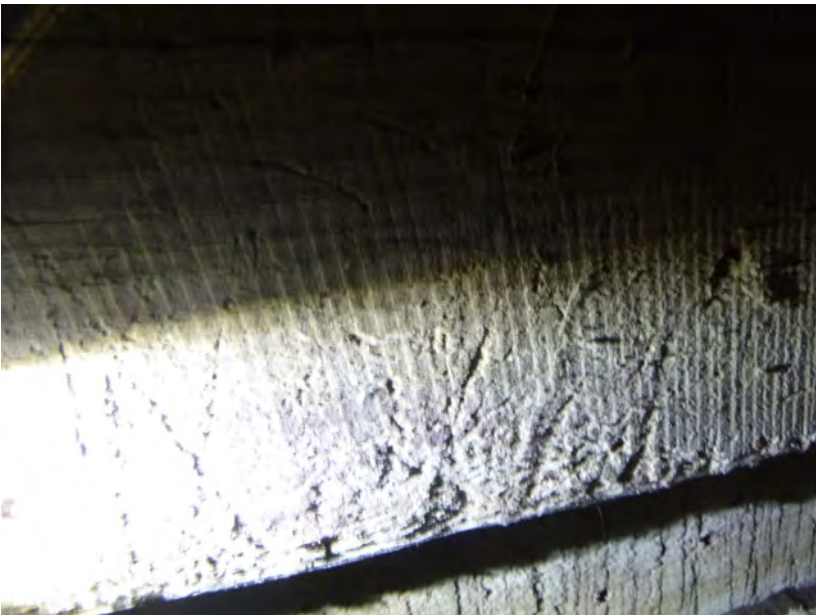
Fig 28:

South wing, bay 2; showing clear irregular band saw markings on face of boards between bays 2 and 3, suggesting the boards may originate from varying stages of the past

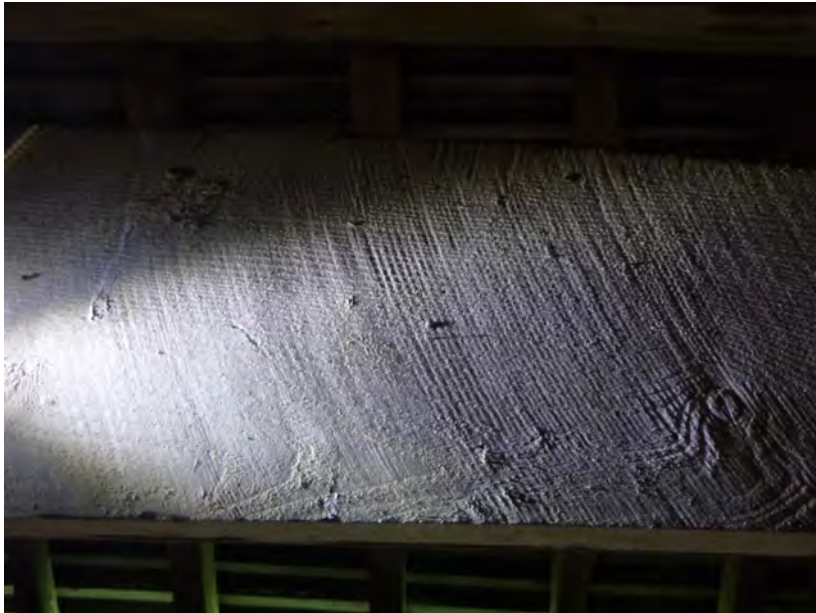
Fig 29:

South wing, bay 1; showing clear circular saw markings on timber tie between truss 1 and extreme east masonry wall

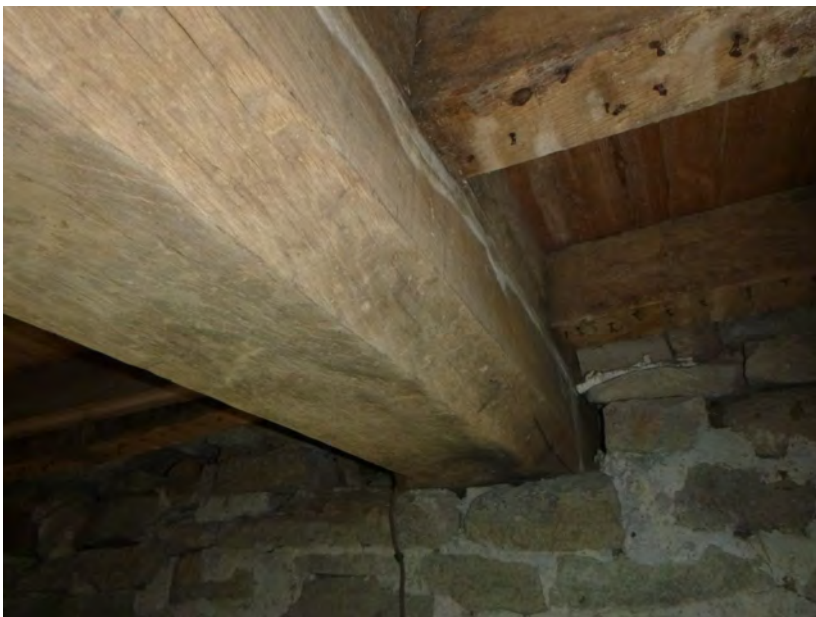
Fig 30:

South wing, bay 1, ground floor; showing timber beam supporting the first floor joists and cleanly shaped to the underside and relatively straight clear lines, suggesting most likely from much later than original construction, although remains clear pit sawn timber conversion markings

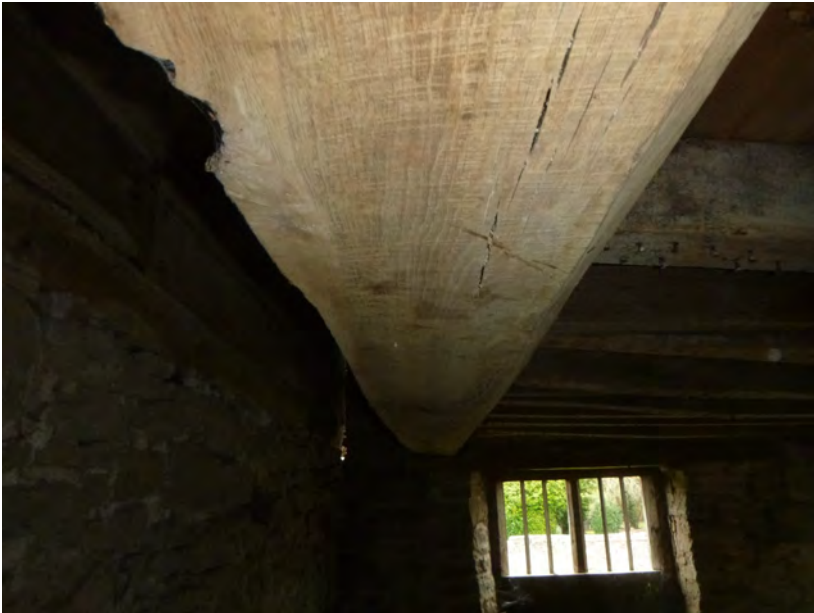
Fig 31:

Ground floor, south wing, bay 2; showing floor beam to west side, again with clean chamfered edges but with also visible pit sawn timber markings

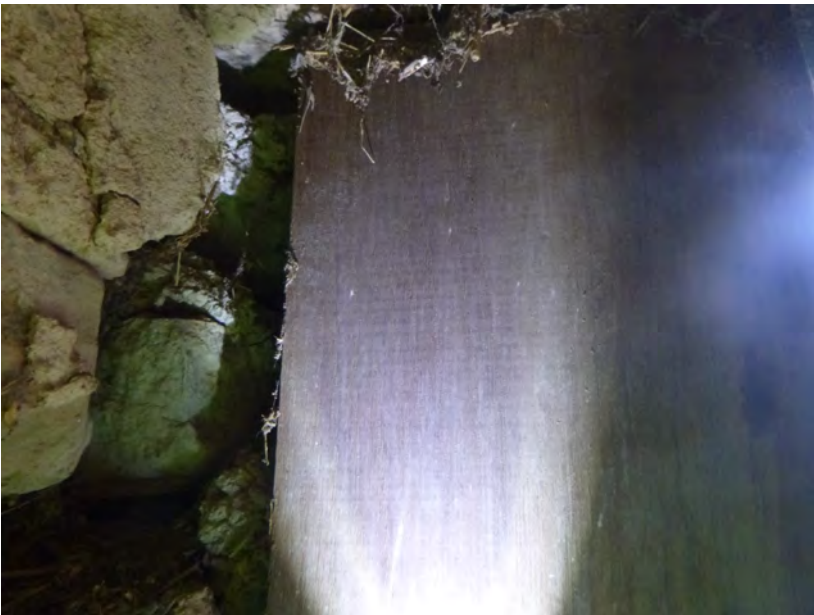
Fig 32:

South wing, ground floor, bay 1; showing clear planer/thicknesser markings on door frame elements to east and west, showing much later hardwood intervention, most likely late 20th Century

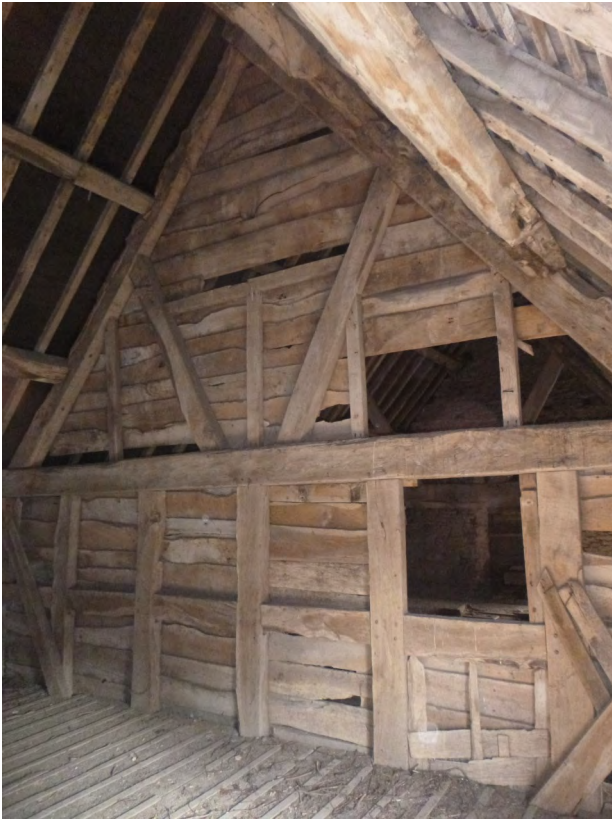
Fig 33:

Bay 3; showing a general view of the cross wall between bays 2 and 3 from the west side. Note the general squareness and patina of the timber studs above and below the tie-beam, suggesting intervention in the past

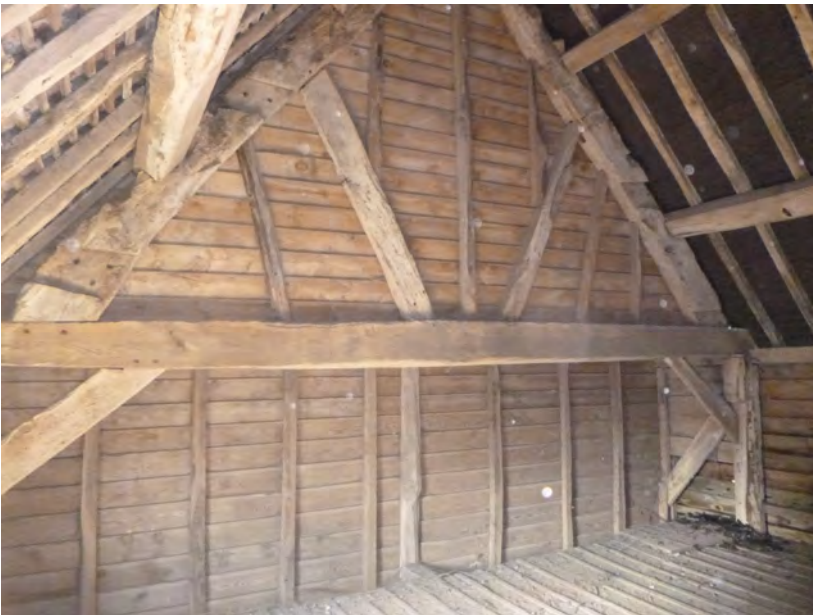
Fig 34:

Bay 3; showing the cross wall between bays 3 and 4. All boards had been replaced relatively recently with new machined softwood timber. Note the large halvings on the principal rafters indicating re-use

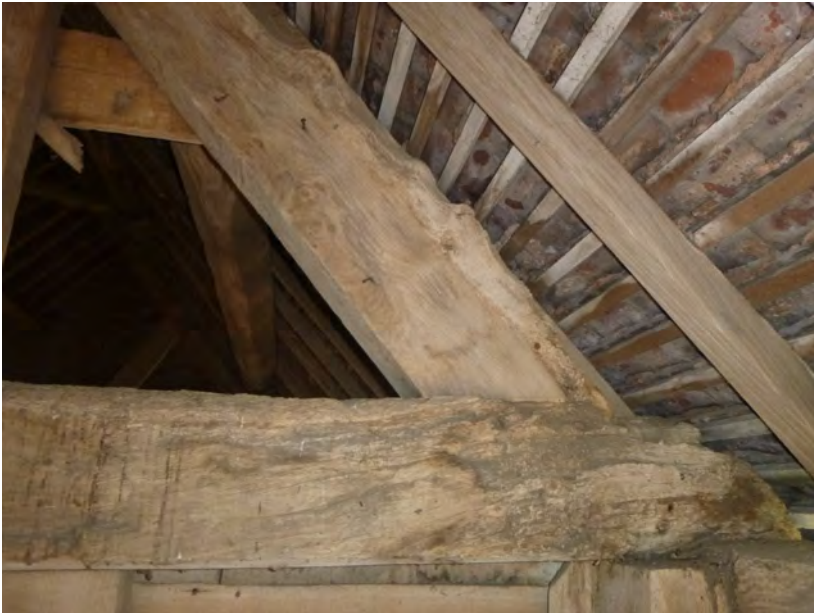
Fig 35:

Bay 3; showing some loss of cross-section to the upper edge of the principal rafter of truss 2 although not sufficient to result in any structural significance

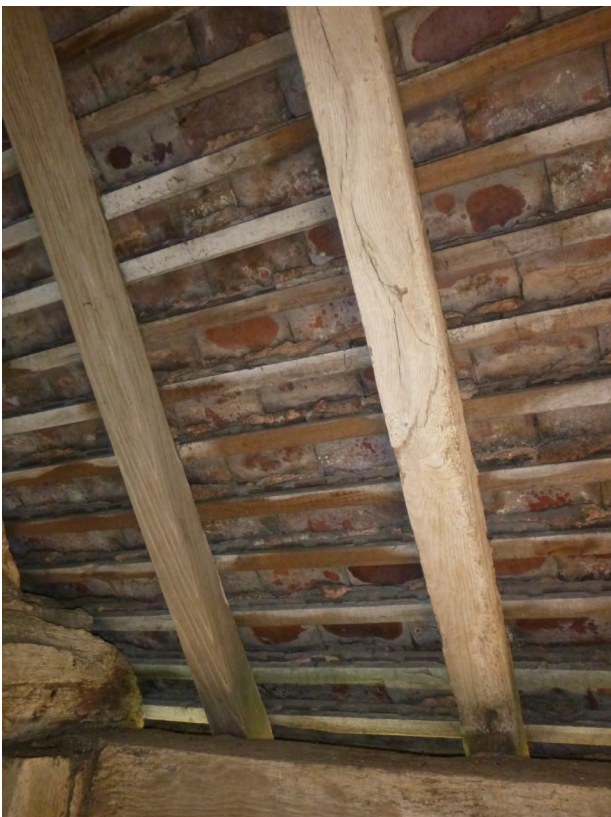
Fig 36:

Bay 3; showing again, rafters generally square and clean suggesting likely intervention in the past

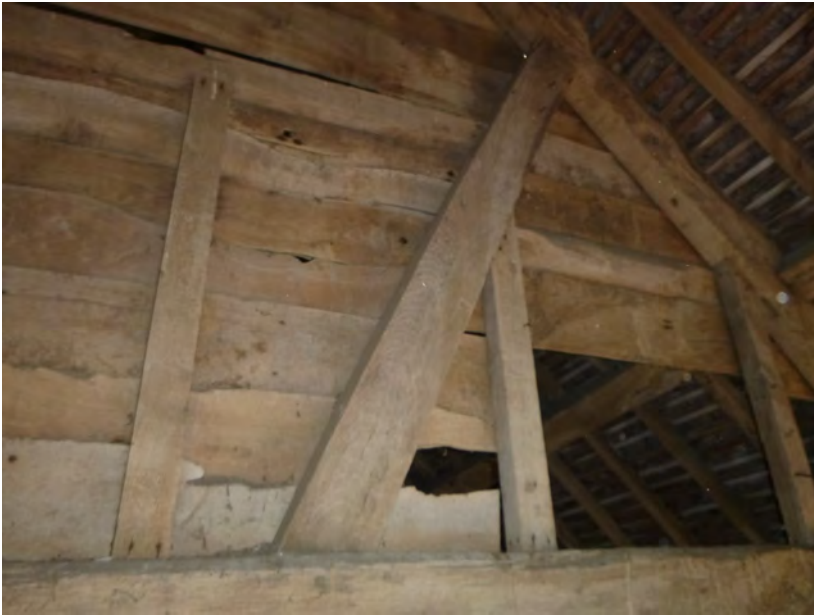
Fig 37:

Bay 3; showing the cross wall between bays 2 and 3 and the relative squareness and good condition of the studwork above the tie-beam

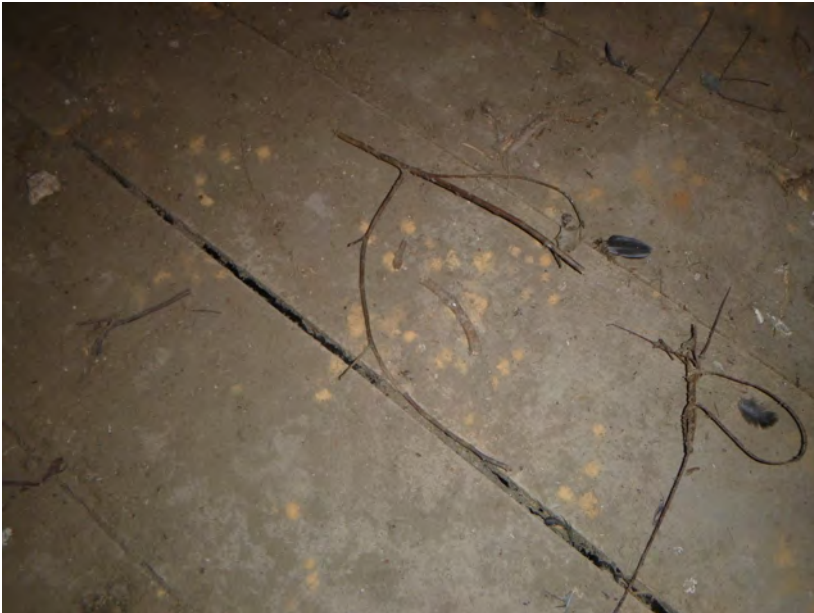
Fig 39:

Bay 3; showing further small piles of frass consistent with Common furniture beetle, and although no structurally significant timber decay was detected, these localised areas will almost certainly extend if left unchecked

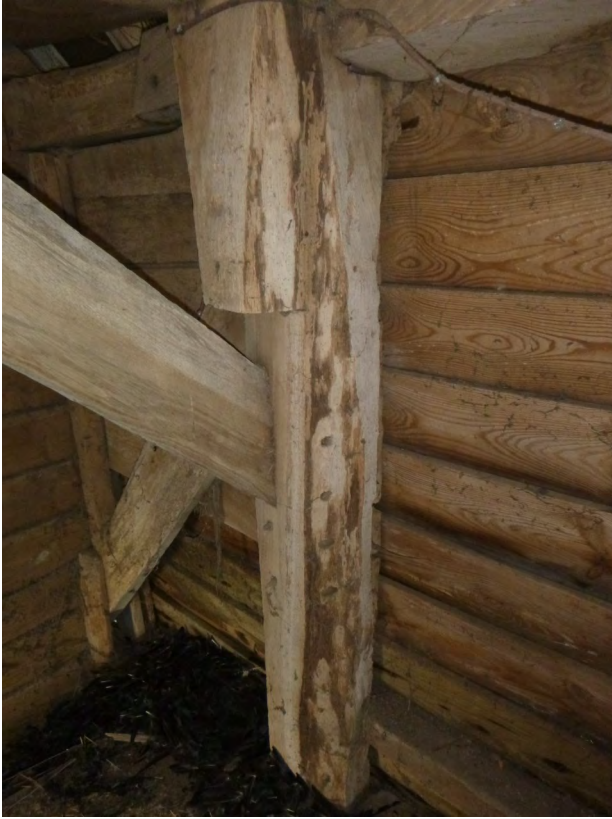
Fig 41:

Bay 3; showing north post of truss 4. No structural decay detected on drilling, and deep moisture content readings well below the decay threshold. No structural issues identified

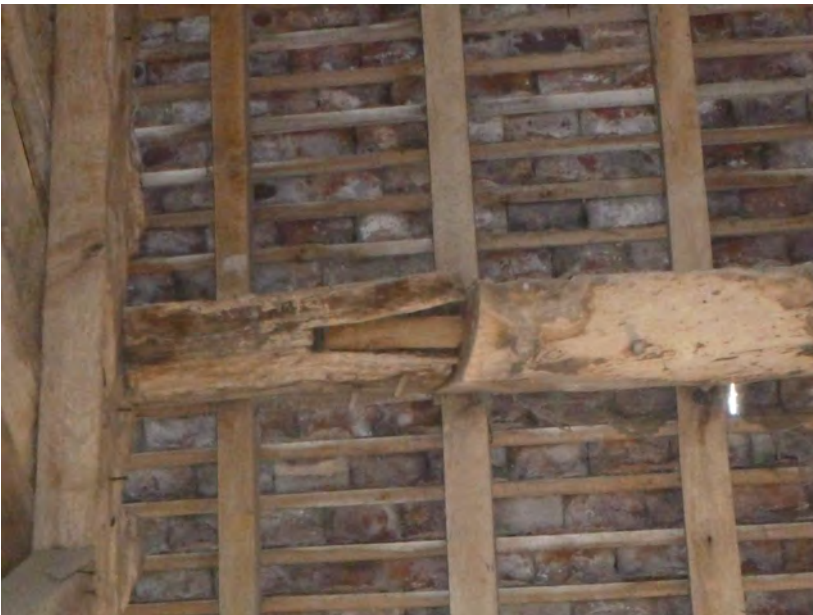
Fig 42:

Bay 3; showing the separation of the bridle joint between the upper south pitch purlins. Pins remained in position, but may require strengthening with timber or steel to prevent further movement

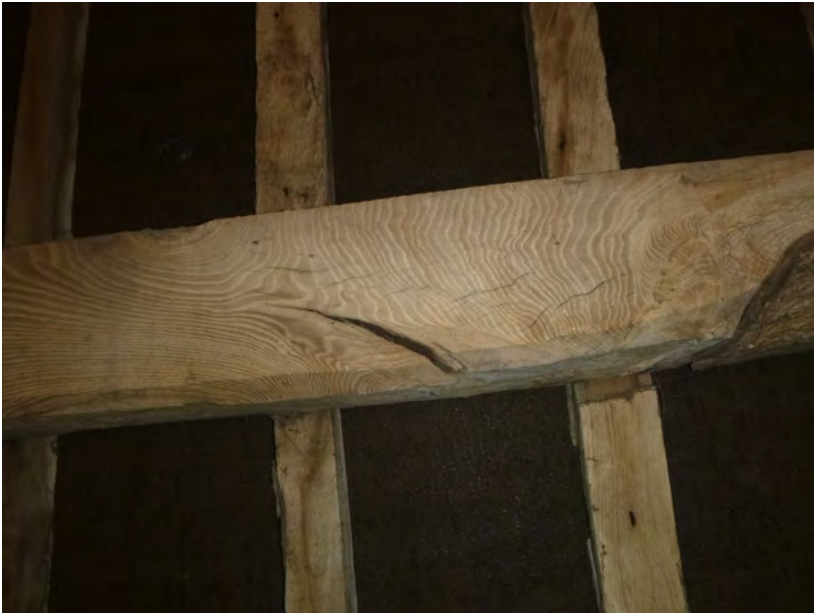
Fig 43:

Bay 3; showing a large fracture in the underside of the north pitch lower purlin. This was not considered a direct result of structural loadings, but more likely an inherent defect in the timber, exacerbated by the natural drying process

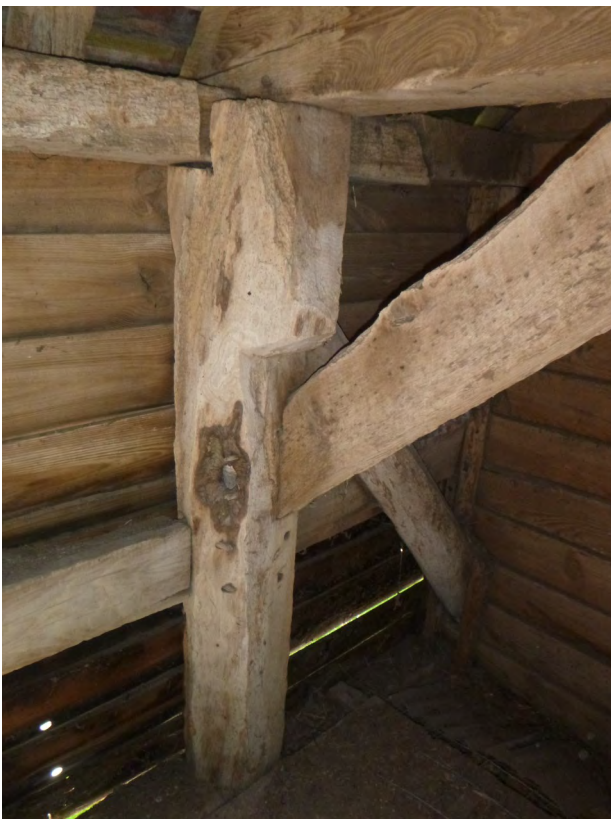
Fig 44:

Bay 3; showing the south post of truss 4. No decay detected on drilling, although the element consisted of a high sapwood content and is therefore at elevated risk of wood-boring beetle infestation

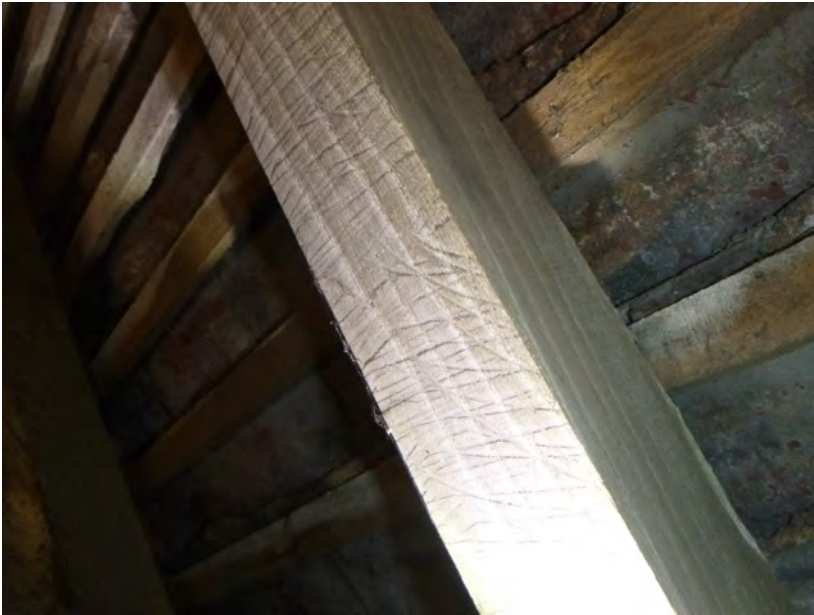
Fig 45:

Bay 3; showing the hand sawn conversion markings on the underside of a rafter on the south pitch

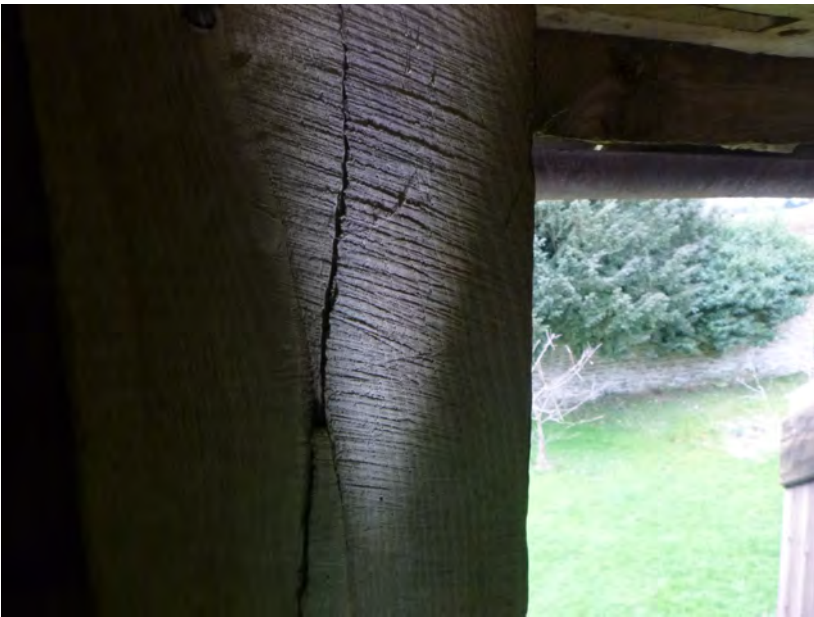
Fig 46:

Bay 3; showing pitsaw markings on the face of the large post to the east side of the south upper storey opening

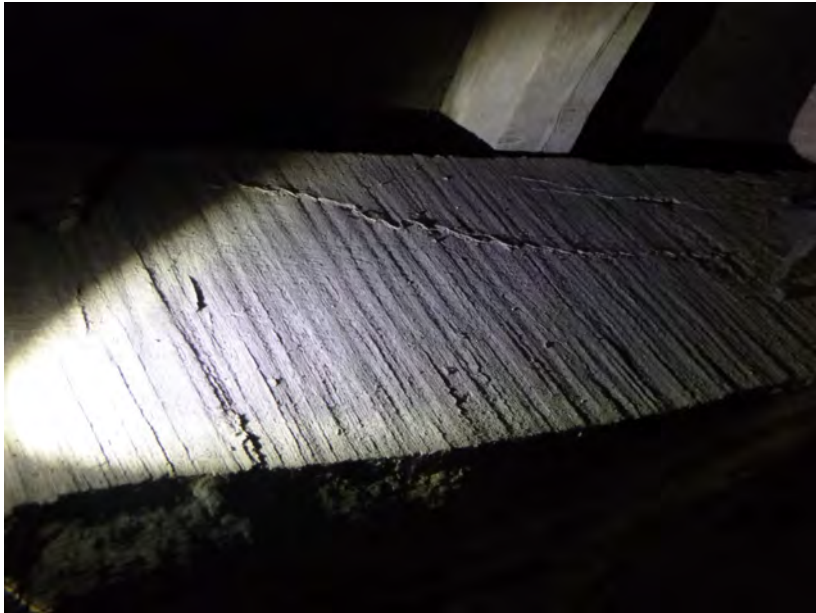
Fig 47:

Bay 3; showing pitsaw markings on the face of the north pitch lower purlin

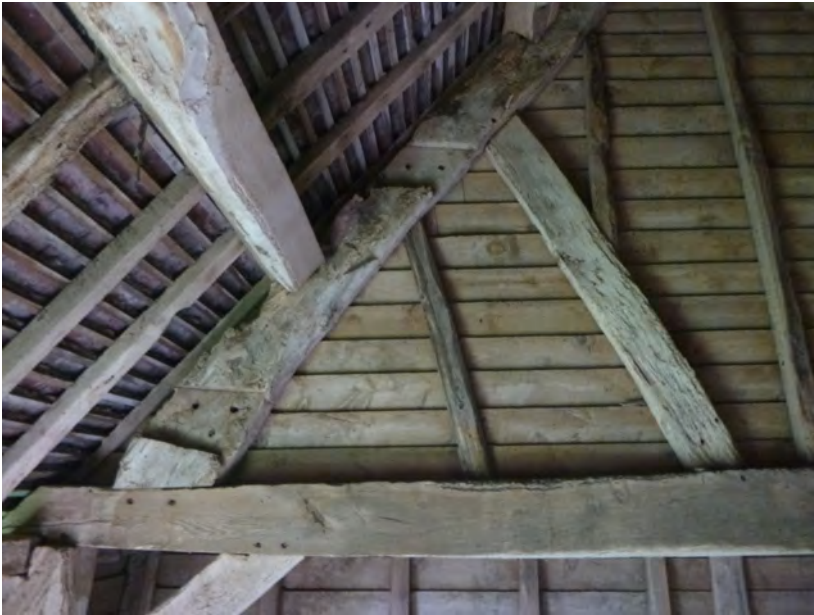
Fig 49:

Bay 3; showing the large halving on the east face of the south principal rafter consistent with re-use

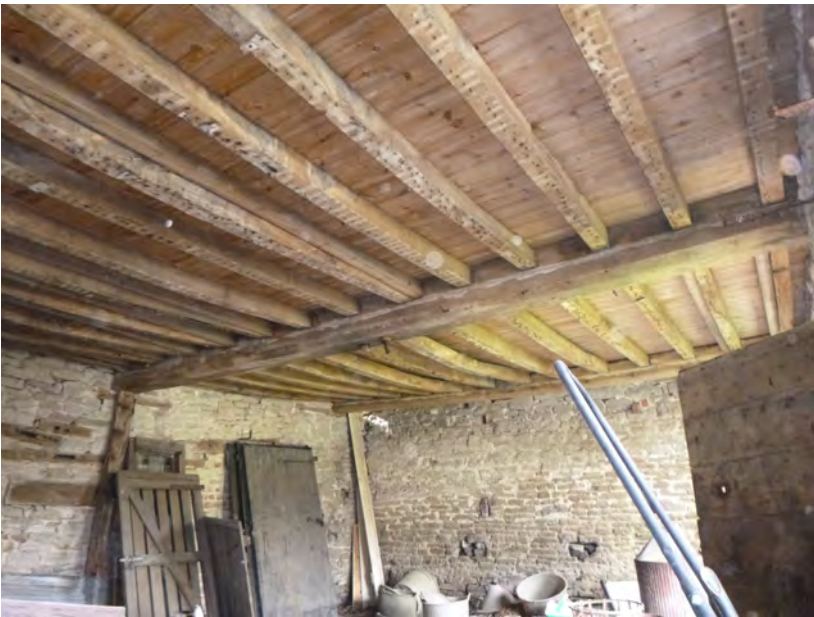
Fig 50:

Bay 1 ; showing a general view of the 1st floor structure spanning across bays 1 and 2
