Aston Hall: Investigation of structural timber elements – South range barns

Site note 1 for March 2021, job no. 153.32

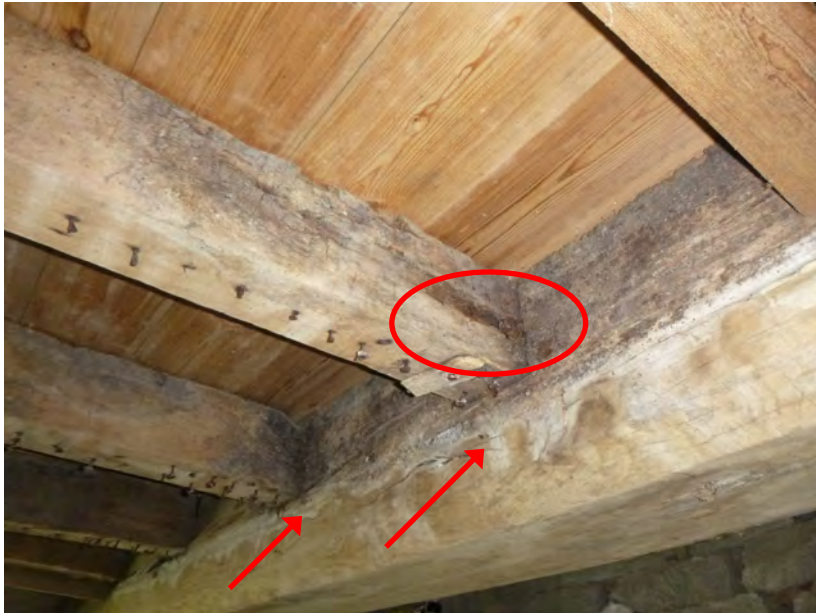
Fig 51:

Bay 1 ; showing localised decay to the bearing end of 1no. floor joist tenoned in to the floor beam

Also showing surface decay and water and salt staining to the face of the floor beam, caused by moisture tracking from damp masonry at the bearing ends of the beam

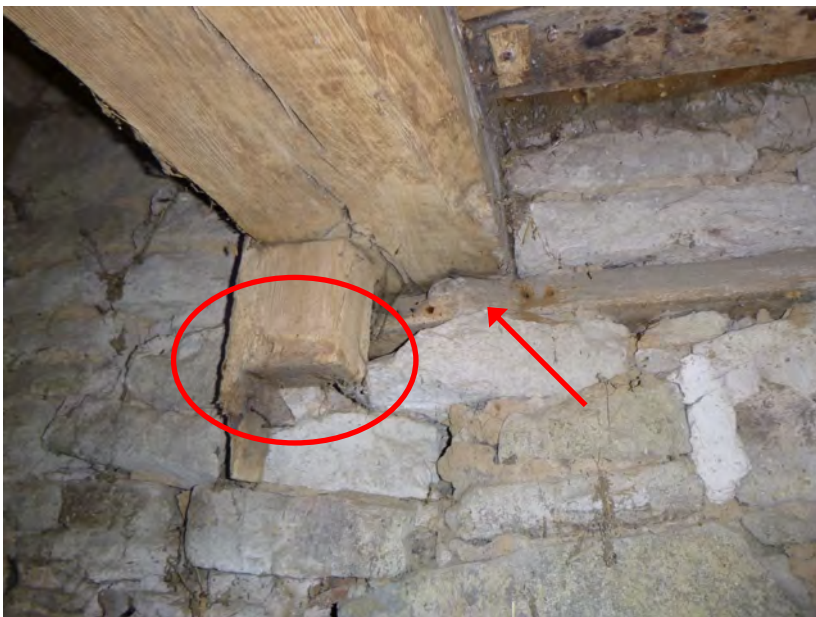
Fig 52:

Bay 1 ; showing a cut post and decayed embedded timber, which were supporting the floor beam above. Note the depth of bearing of the beam onto the embedded timber is slight. Collectively, this has made the floor beam structurally vulnerable

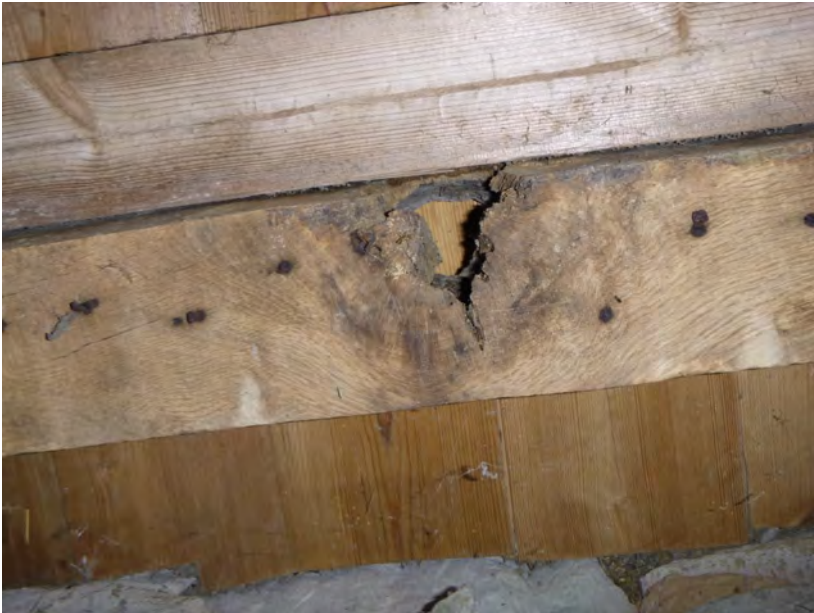
Fig 53:

Bay 2; showing a structurally significant large knot defect to an oak floor joist

Note the softwood partner joist, solely installed to provide a level surface for the floor above

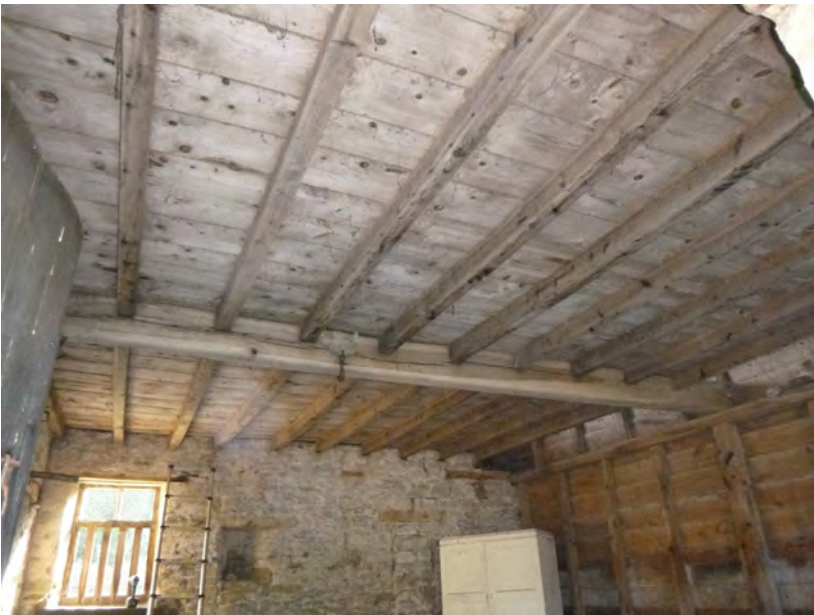
Fig 54:

Bay 3; showing a general view of the 1st floor structure

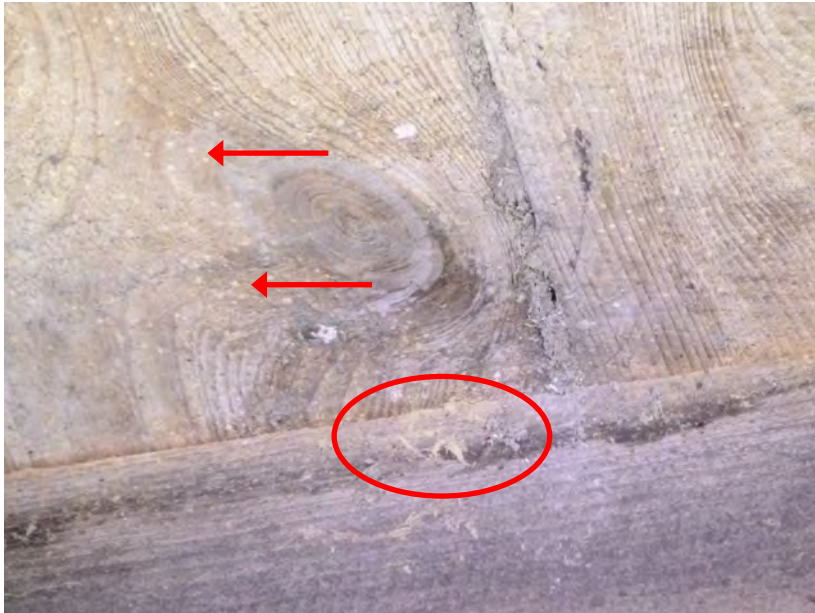
Fig 55:

Bay 3 ; showing flight holes of wood boring beetle filled with frass, as well as adjacent loose frass caught on the surface of the timbers, which collectively strongly suggests that there is active infestation

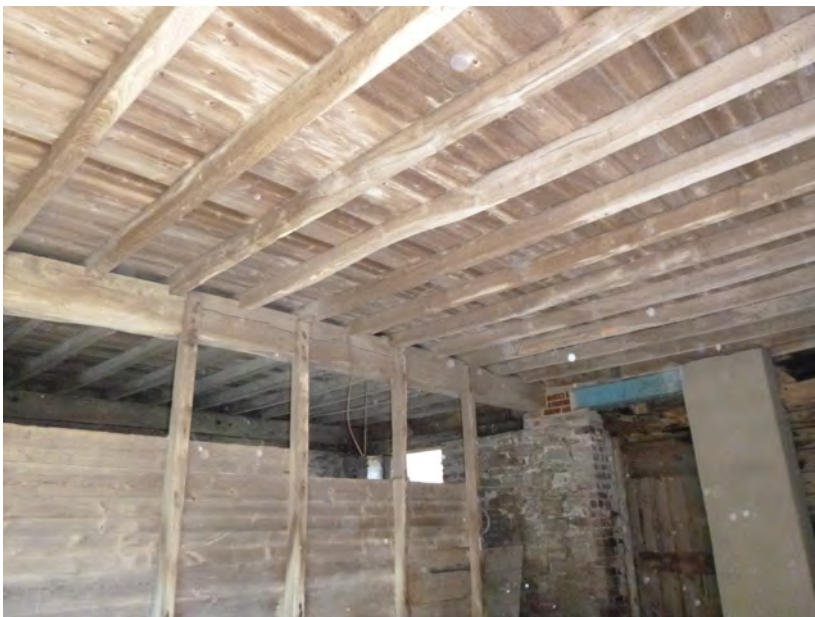
Fig 56:

Bay 6; showing a general view of the 1st floor structure spanning across bays 6 and 7

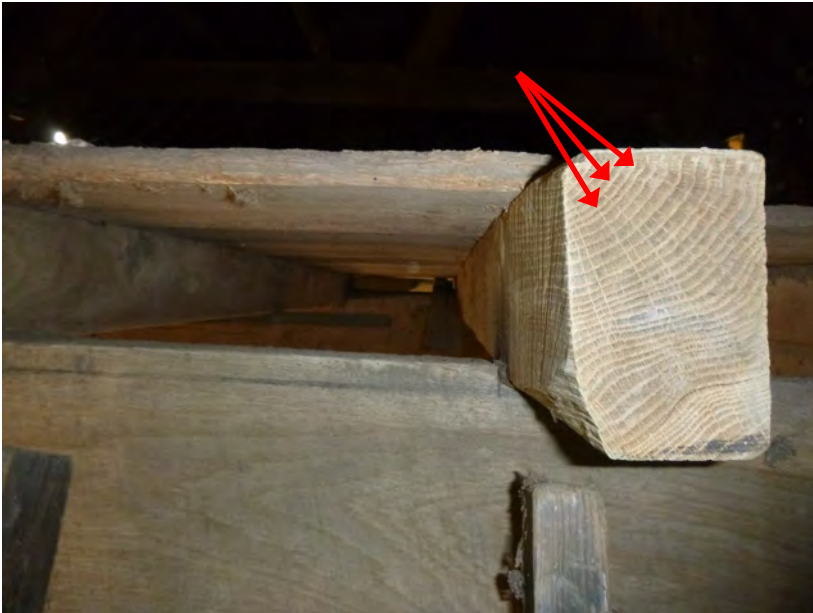
Fig 57:

Bay 5; showing medullary rays on the bearing end of the floor joist, which span out from the pith and are perpendicular to the growth rings. This is a key feature of oak (*Quercus* spp.) timber

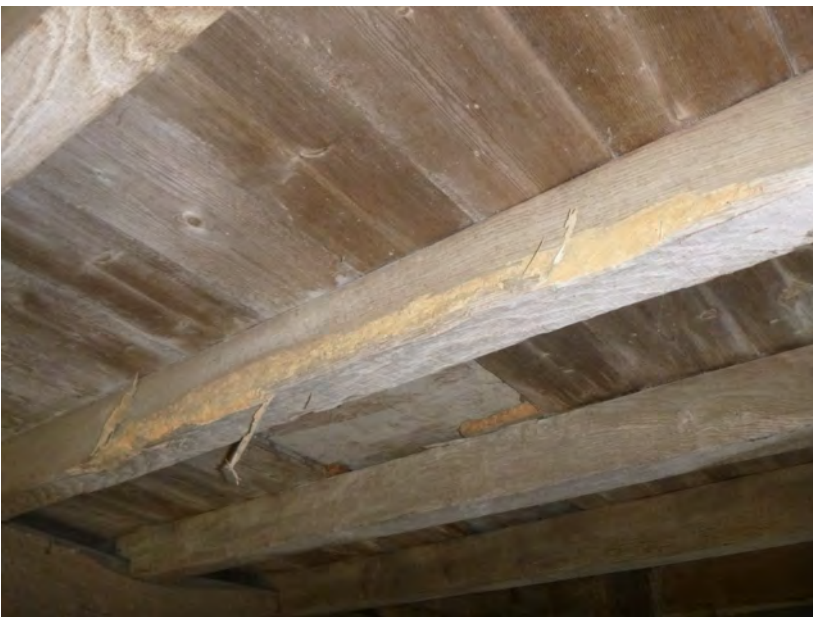
Fig 58:

Bay 6; showing localised loss of sapwood from wood boring beetle to the face of a floor joist, not considered structurally significant

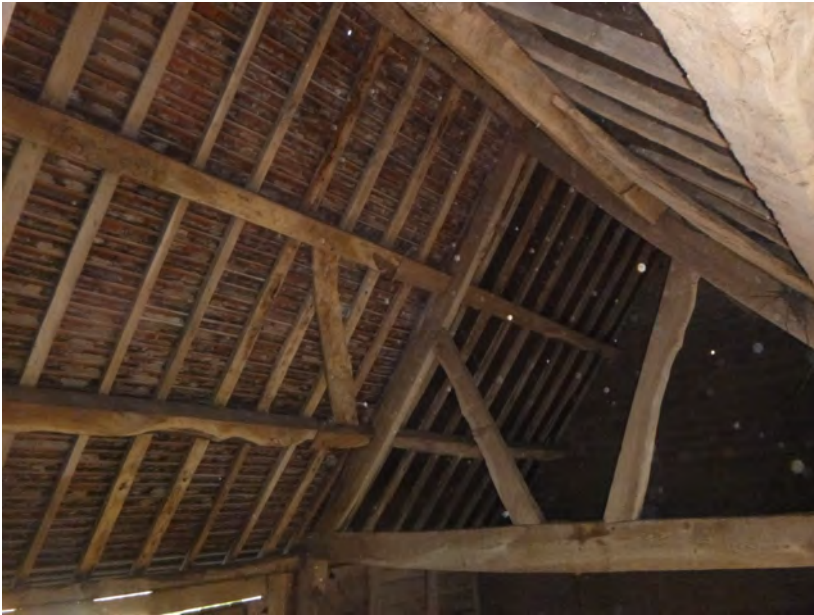
Fig 59:

Bay 5; showing a general view of the roof structure to the east side and Bay 4. Note the wind bracing in Bay 5, the only Bay to include this element

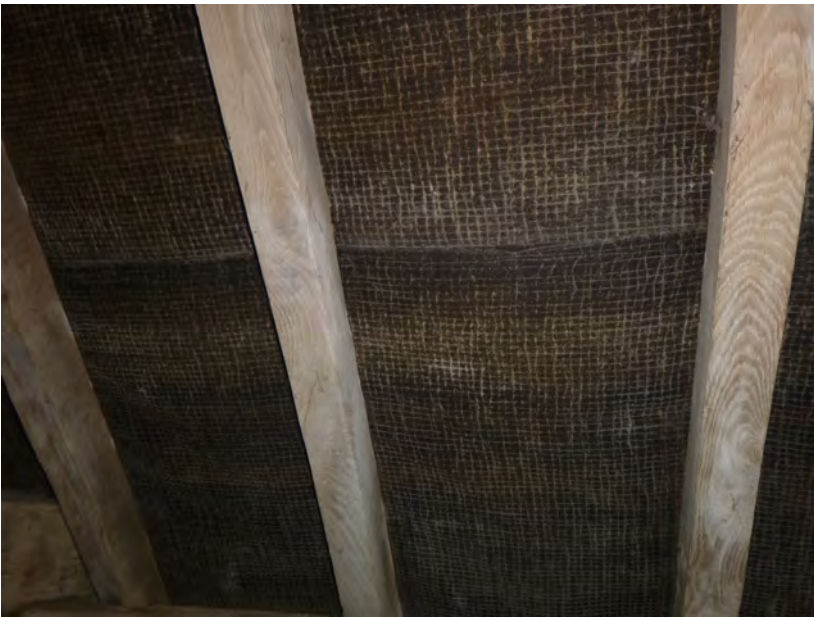
Fig 60:

Bay 6; showing the bituminous roofing felt suspected to be a result of roof covering intervention during the 1980s

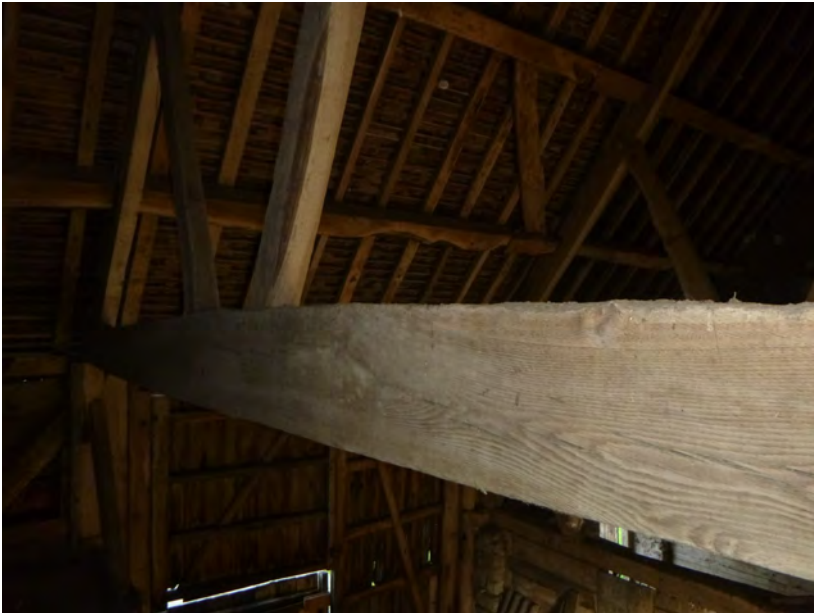
Fig 61:

Bay 6; showing the general condition of the tie-beam of truss 5. Again, pitsaw conversion markings were noted, as well as the patina suggesting introduction of the timber into the building well after initial construction

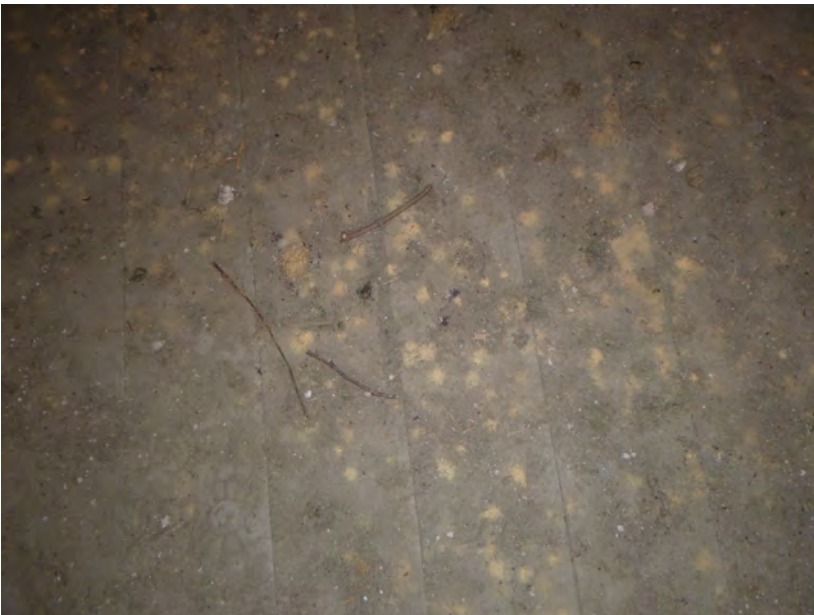
Fig 62:

Bay 6; again showing widespread evidence of wood-boring beetle infestation of the softwood first floor coverings. Ambient moisture contents were generally high enough to support further infestation

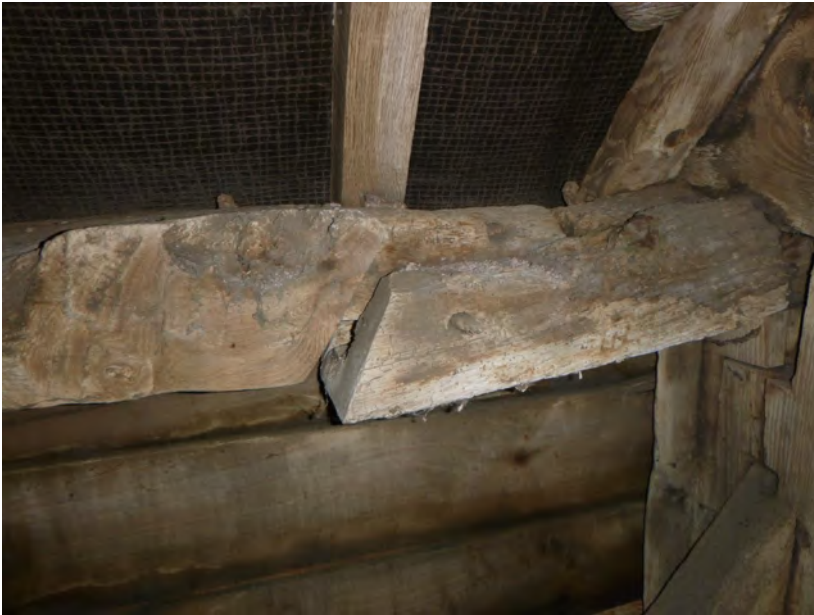
Fig 63:

Bay 6; showing the south wall plate just to the east of truss 6. There was significant structural movement noted of the adjacent truss which was reflected in the separation of the purlin/bridle joint and had resulted in snapping of the joint retention pins

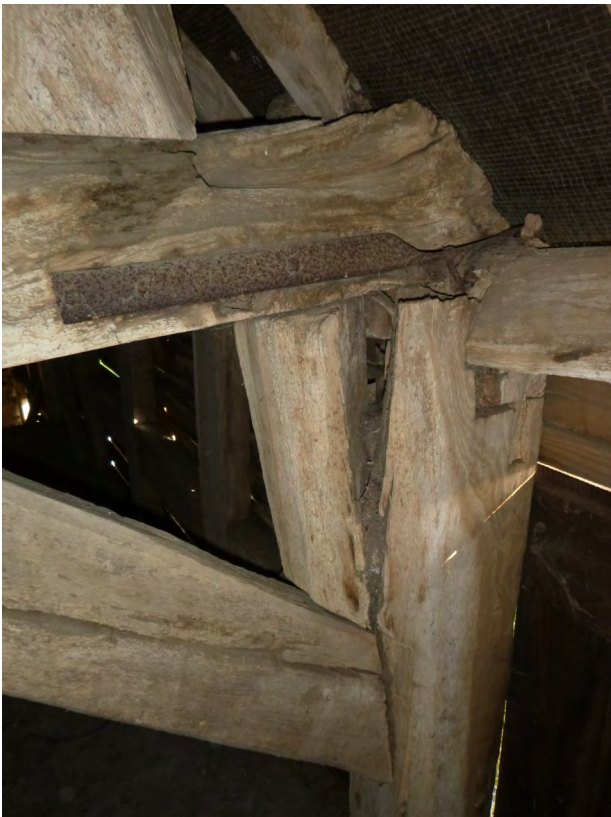
Fig 64:

Bay 7; showing the south bearing end of truss 6 and the large fracture in the head of the main post. This was most likely a direct result of decay from water penetration at the north end of the truss tie-beam dragging the tie-beam away towards the north, fracturing the post

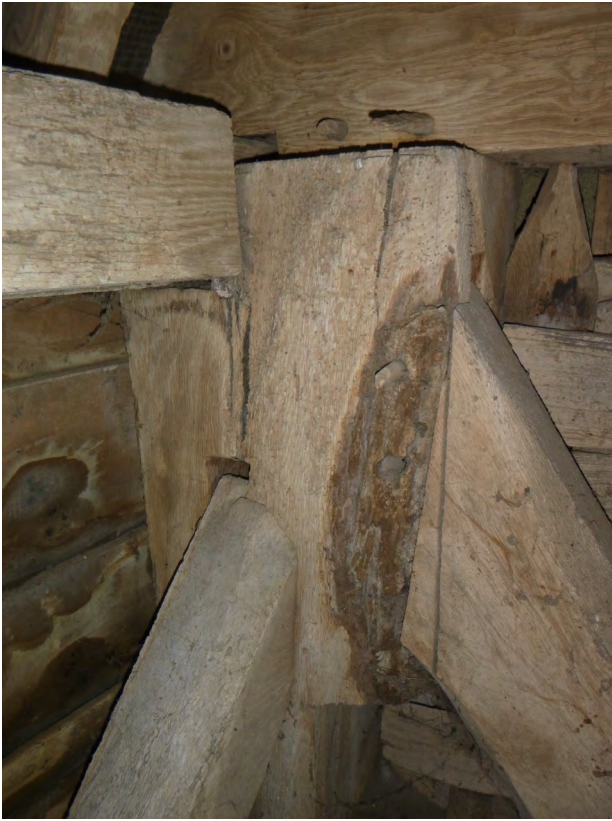
Fig 65:

Bay 7; showing the small fractures at the top of the main post for truss 7. These were not considered structurally significant but may require strengthening with steel to prevent further unwanted movement

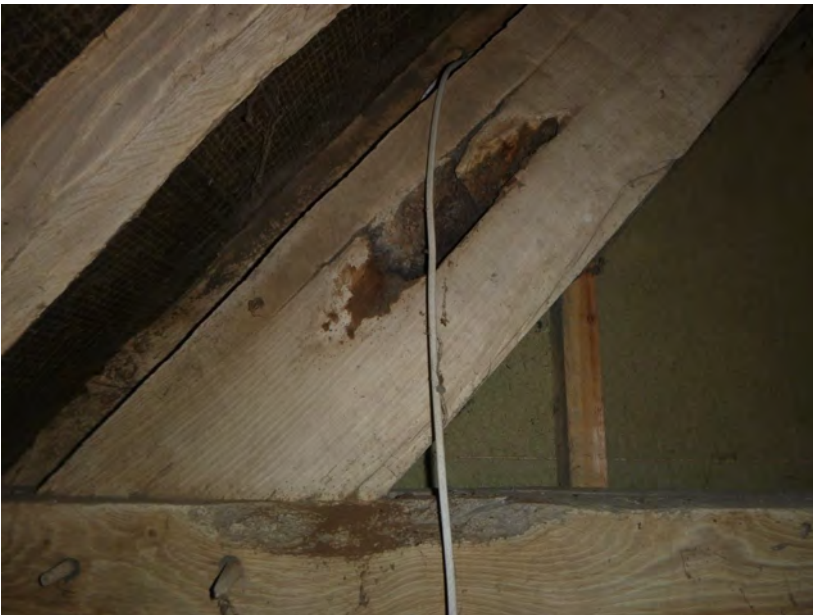
Fig 66:

Bay 7; showing a large pocket of decay at the bearing end of the south principal rafter. This was a result of localised wood-boring beetle (Deathwatch) infestation of vulnerable sapwood content. The north principal rafter was also noted to have a matching pocket of decay suggesting both elements had been converted from the same piece of timber

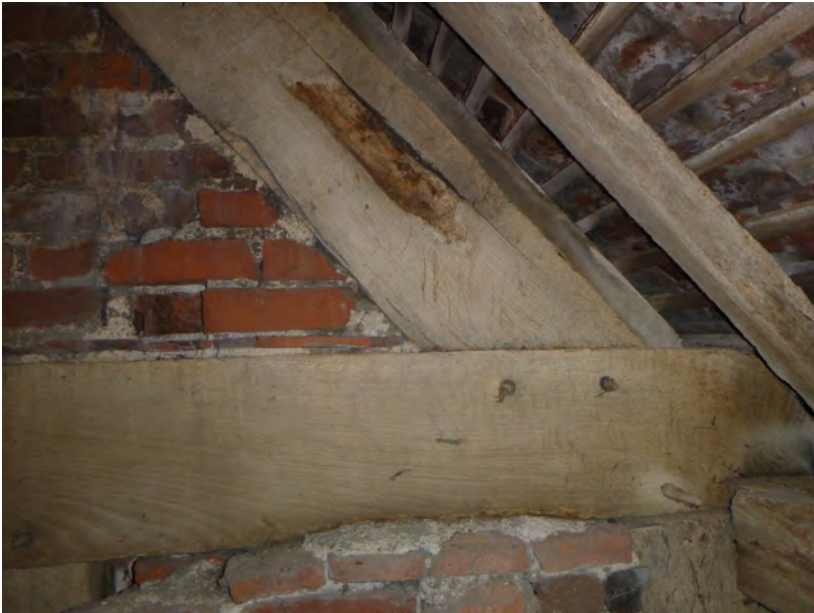
Fig 67:

Bay 7; showing the pocket of decay at the bearing end of the north principal rafter

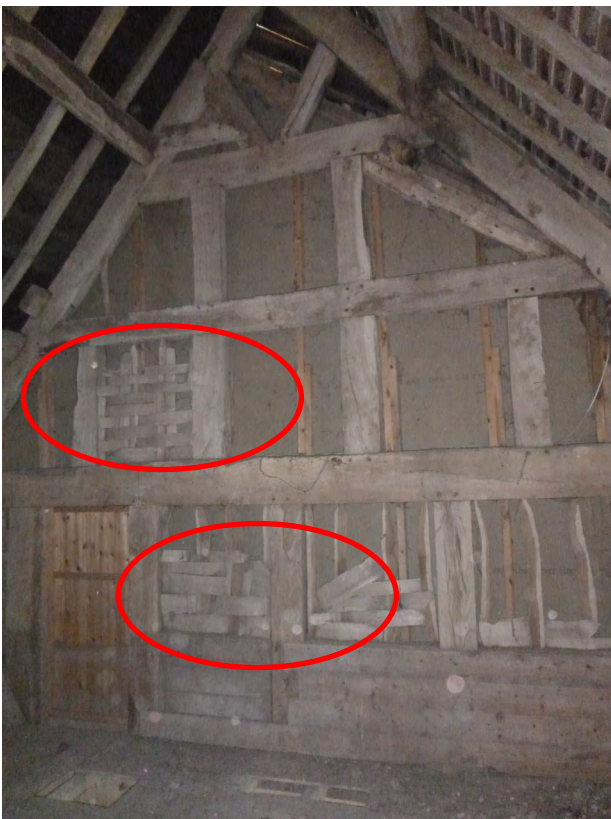
Fig 68:

Bay 7; showing a general view of the cross wall between bays 7 and the west part of the barn (bike store). The over-sized lath construction panel in-fill is a local feature, removal of which should be in consultation with the Conservation Officer and may require detailed recording prior to refurbishment

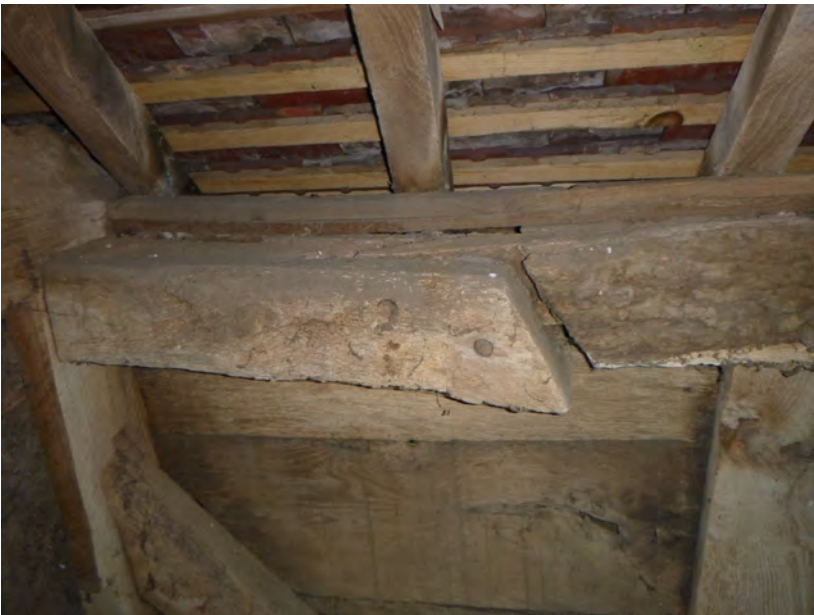
Fig 70:

Bay 6; showing the failure and separation of the north wall plate bridge joint to the east of truss 6

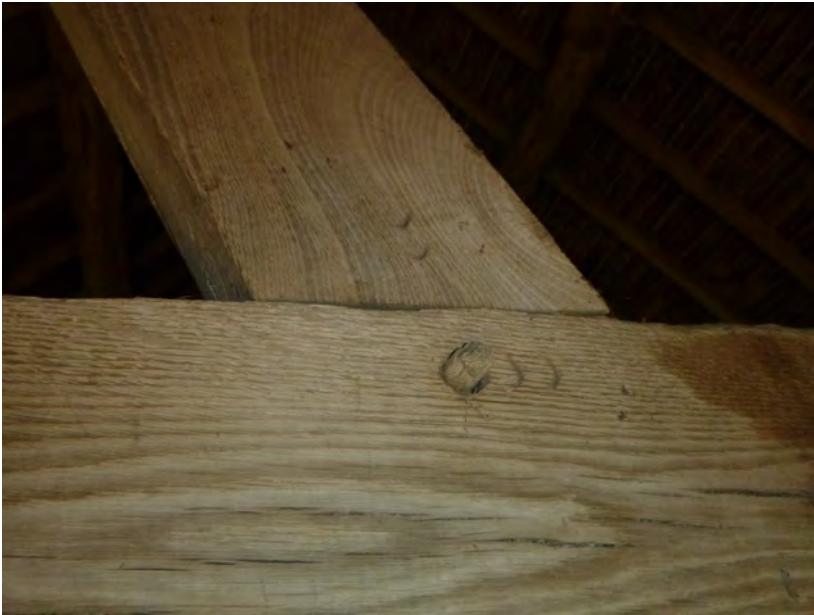
Fig 71:

Bay 6; showing carpenters markings on the east face of truss 6 tie-beam

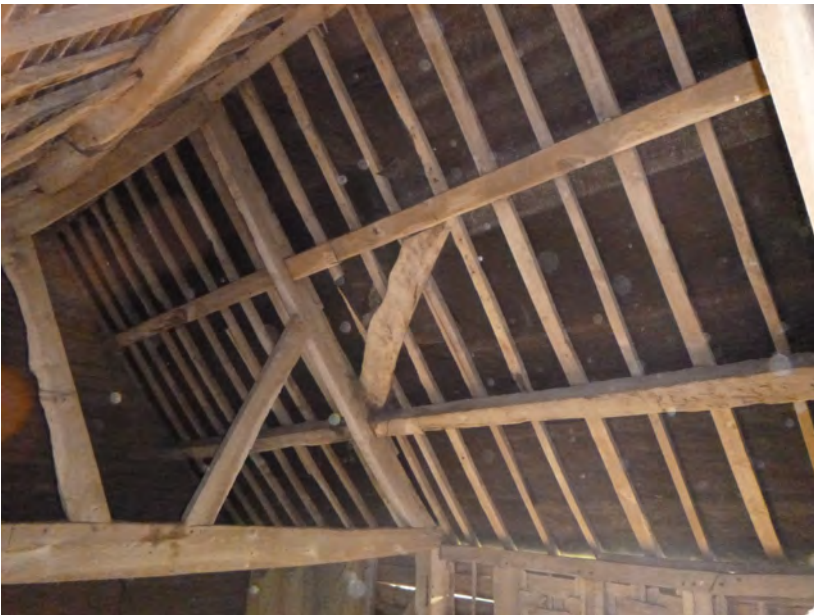
Fig 72:

Bay 5; showing a general view of the south pitch of the roof structure from the west. Again, note the wind brace which was a feature not seen elsewhere, but was most likely throughout on original construction

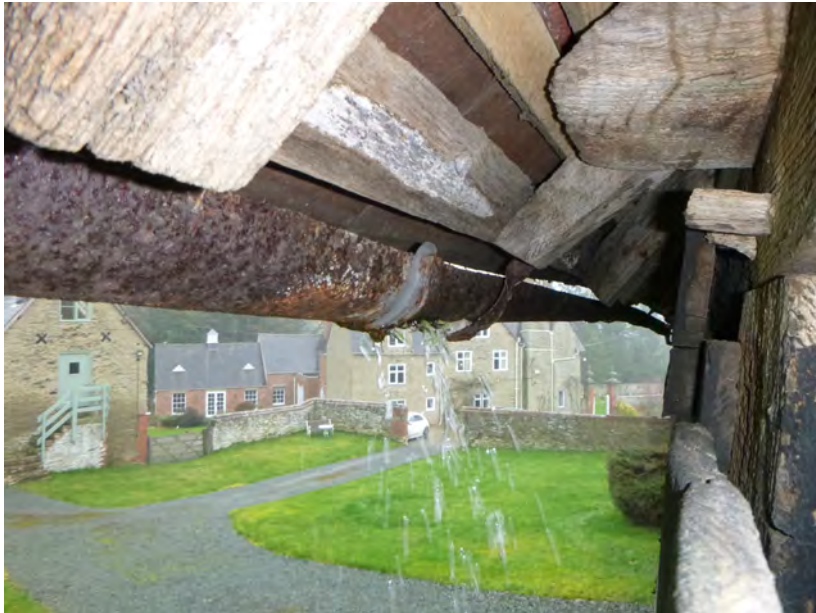
Fig 73:

Bay 6; showing failure of the rainwater drainage system at the time of survey resulting in saturation of external cladding and structural timber elements within

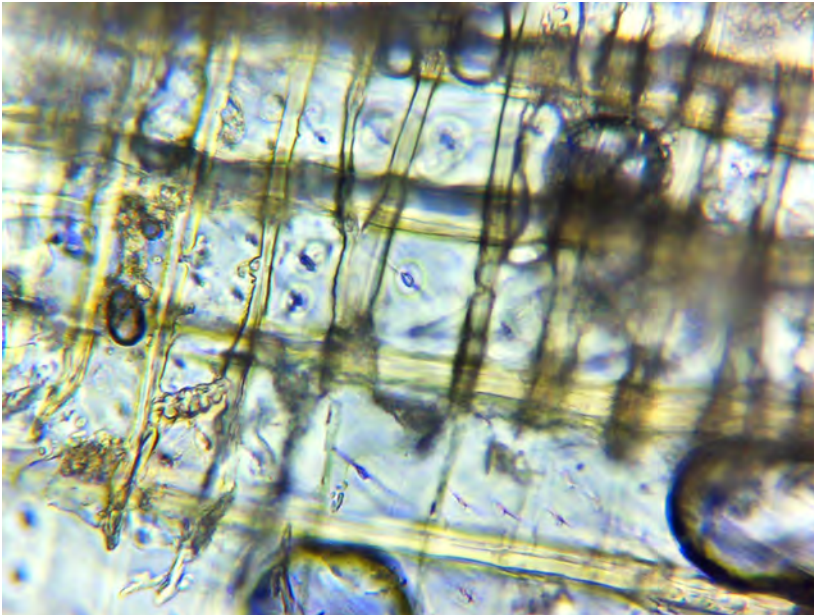
Fig 75:

Laboratory image; showing a microscopic image of a radial section cut from a floor joist in bay 3

Note the piceoid pitting in the cross-field typical of timber relating to Spruce (*Picea app.*)

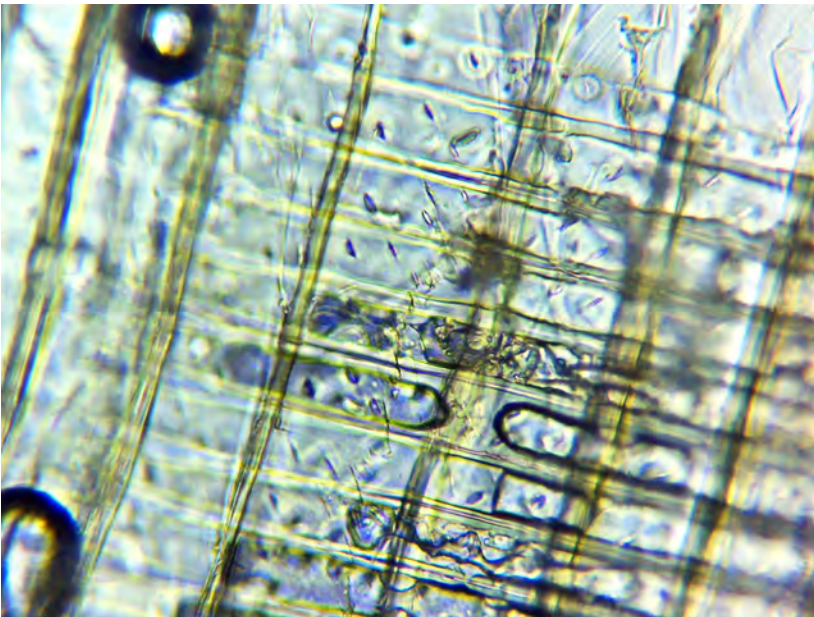
Fig 76:

Laboratory image; showing a microscopic image of a radial section cut from a tie-beam partner from truss 8

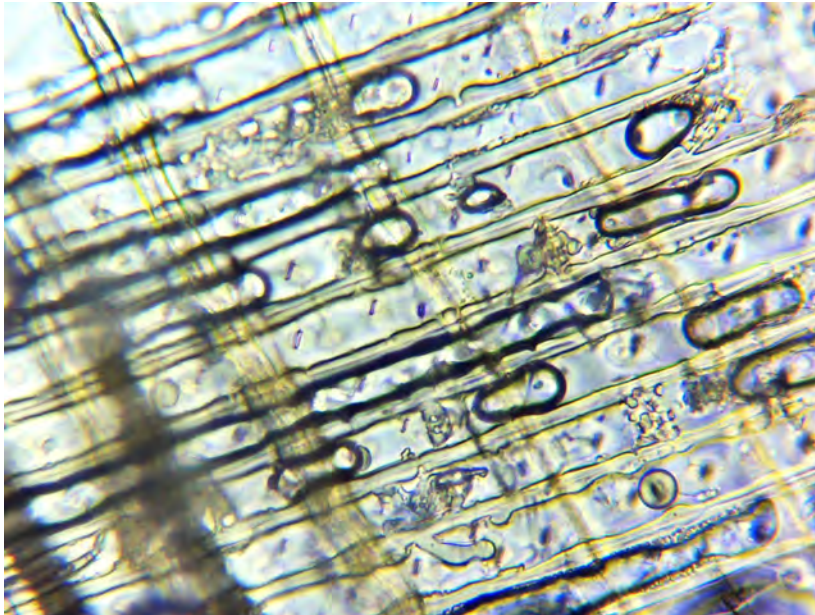
Fig 77:

Laboratory image; showing a microscopic image of a radial section cut from a sample retrieved from one of the studs of the cross-wall between bays 3 and 4

Note the piceoid pitting in the cross-field typical of timber relating to Spruce (*Picea app.*)

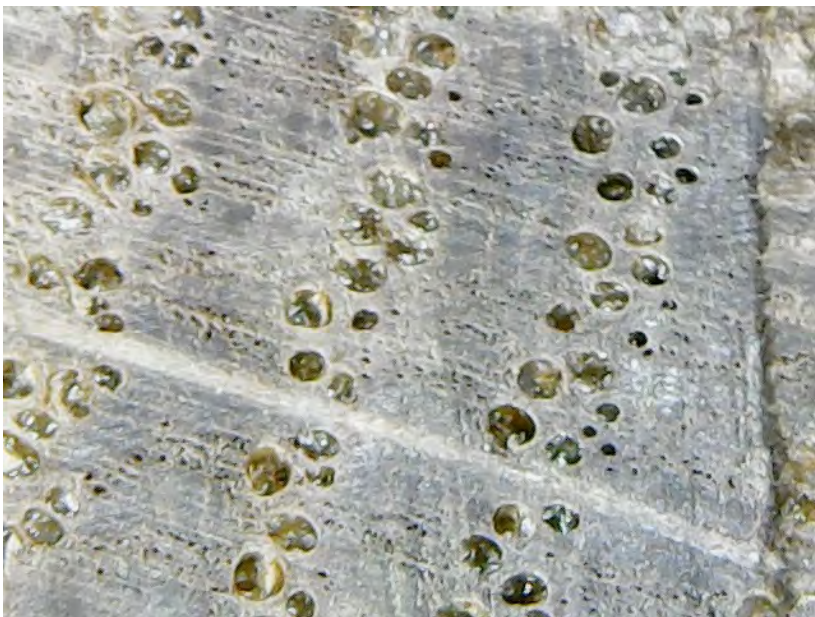
Fig 78:

Laboratory image; showing a microscopic image of a timber sample retrieved from a tie-beam at the time of survey

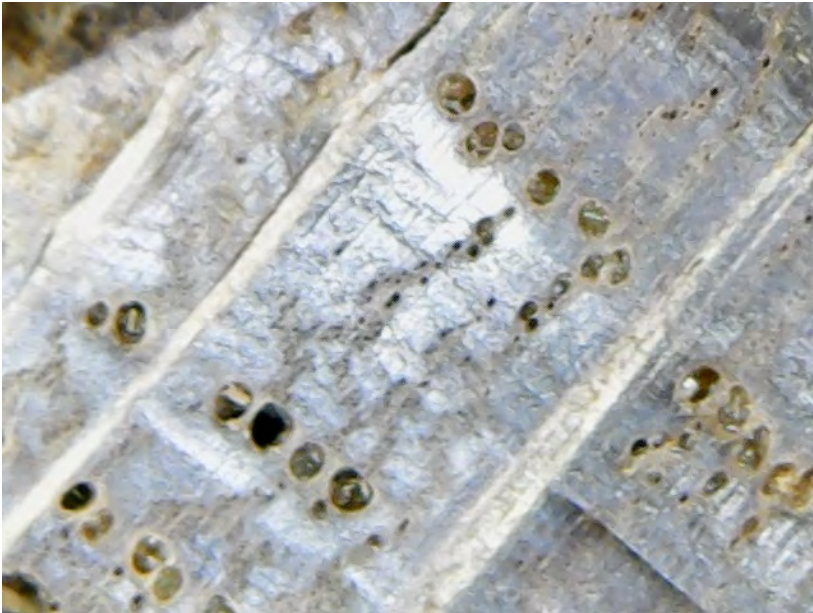
Fig 79:

Laboratory image; showing a microscopic image of a timber sample retrieved from a principal rafter at the time of survey

The ring-porous nature of the growth, and the strong medullary rays perpendicular to the growth rings are both features consistent with oak (*Quercus spp.*)

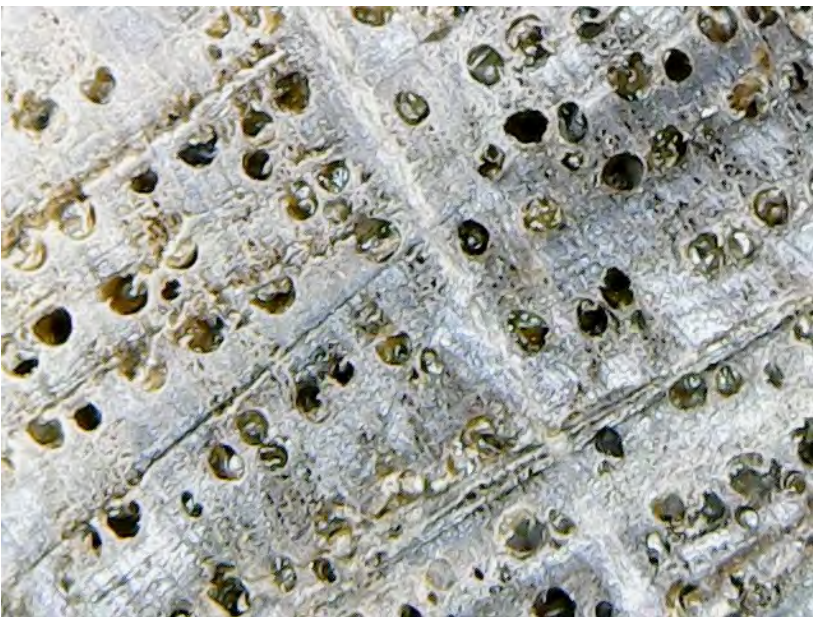
Fig 80:

Laboratory image; showing a microscopic image of a timber sample retrieved from a truss strut at the time of survey

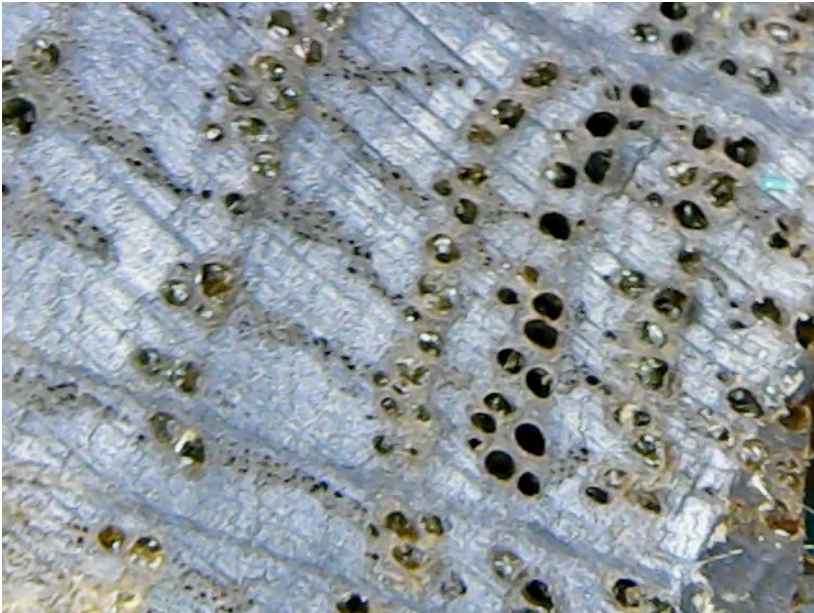
Fig 81:

Laboratory image; showing a microscopic image of a timber sample retrieved from a hardwood floor joist in bay 1 at the time of survey

The ring-porous nature of the growth, and the strong medullary rays perpendicular to the growth rings are both features consistent with oak (*Quercus spp.*)

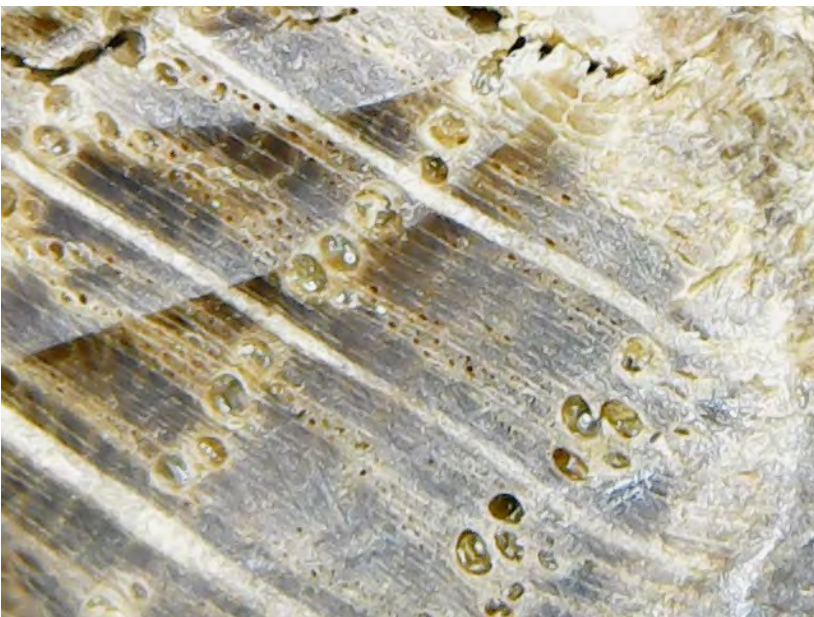
Fig 82:

Laboratory image; showing a microscopic image of a timber sample retrieved from a common rafter in bay 6 at the time of survey

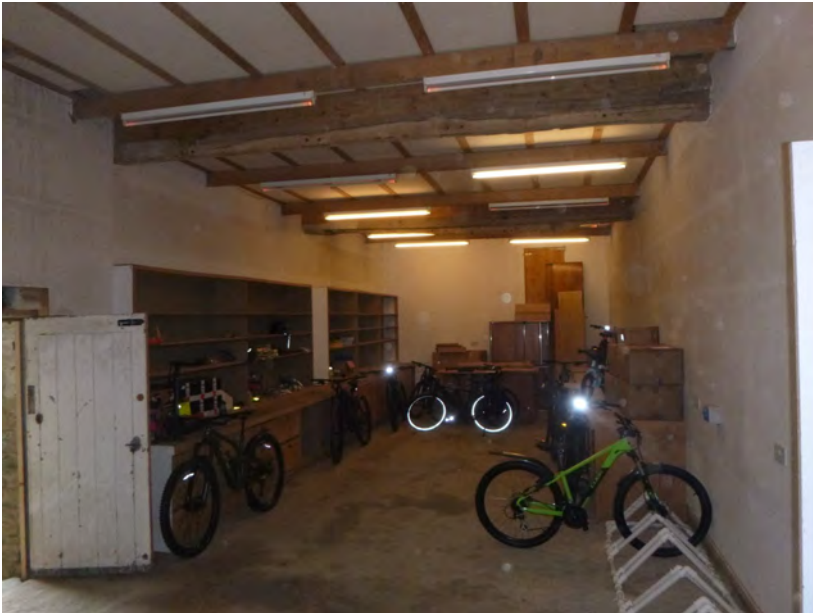
Fig 83:

West part of south barn; showing a general view of the area from the west. Note there was no access to assess the roof timbers due to no boarding being in place; however, tie-beams were visible from ground floor below and drilled and probed for decay and moisture content

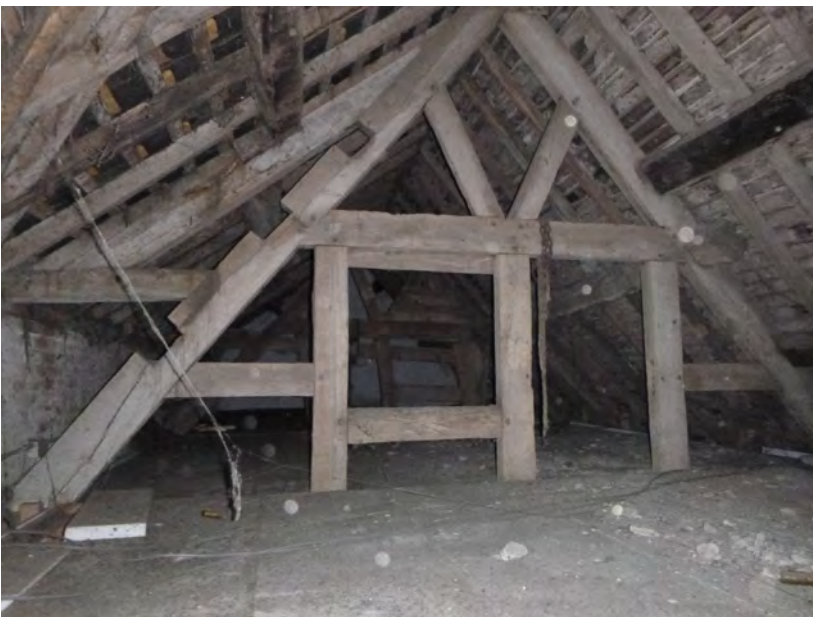
Fig 84:

West part of south barn; showing a general view of the roof structure and truss 10, from hatch in west end. Note the large notches in the upper edge of the principal rafter indicating either re-use or re-configuration of the structure (likely)

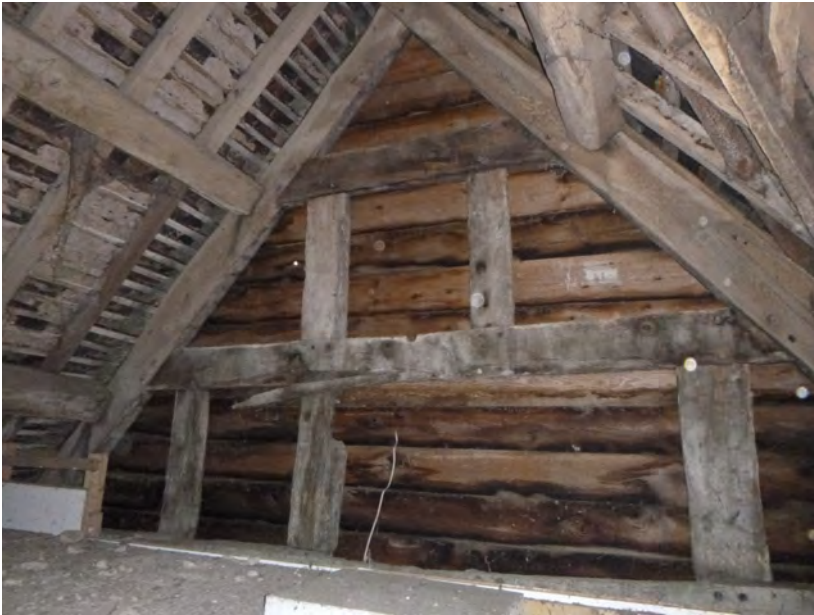
Fig 85:

West part of south barn; showing the extreme west gable end where there were indications of water penetration, but no suggestion of structural timber decay as a result

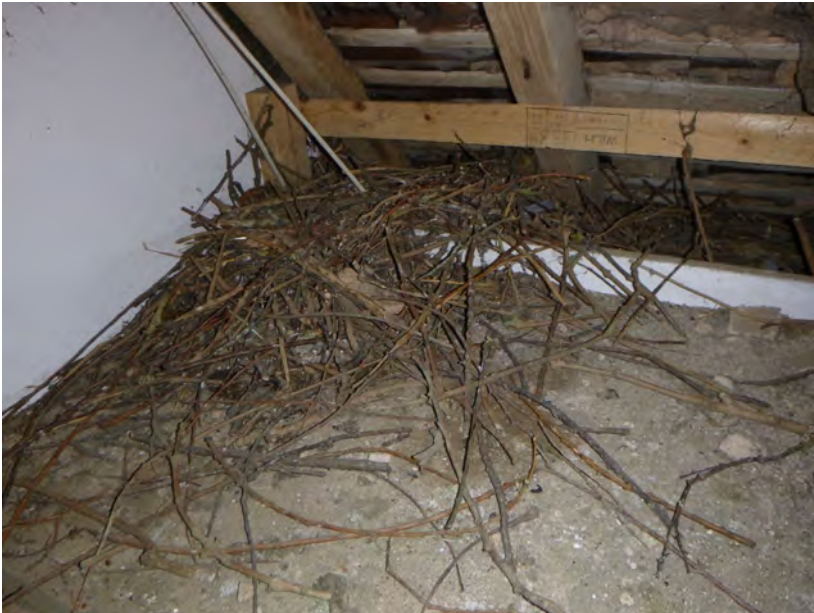
Fig 87:

West part of south barn; showing large area of nesting material in south-east corner of roof void, again, limiting ventilation to vulnerable structural timbers and providing the conditions conducive to wood-boring beetle infestation and decay

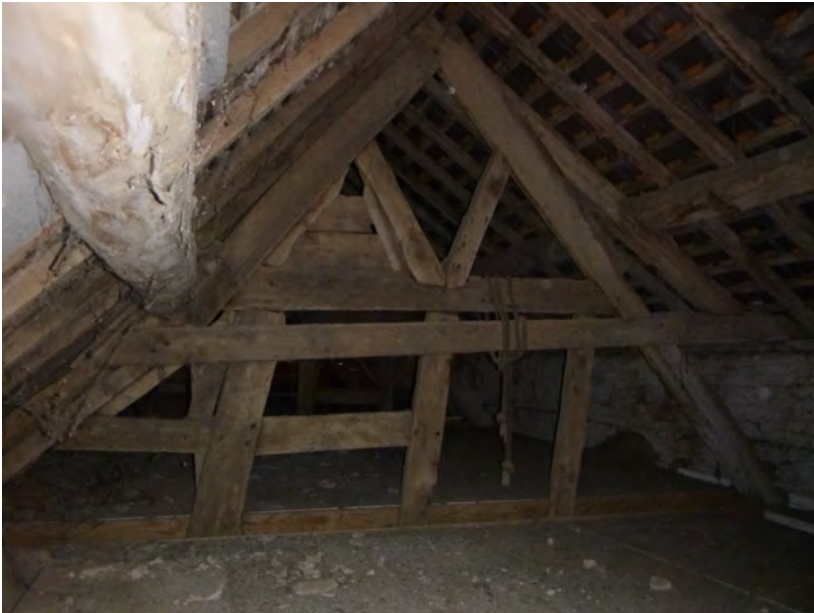
Fig 89:

West part of south barn; showing a general view of truss 8. Access was unavailable to inspect timbers in detail

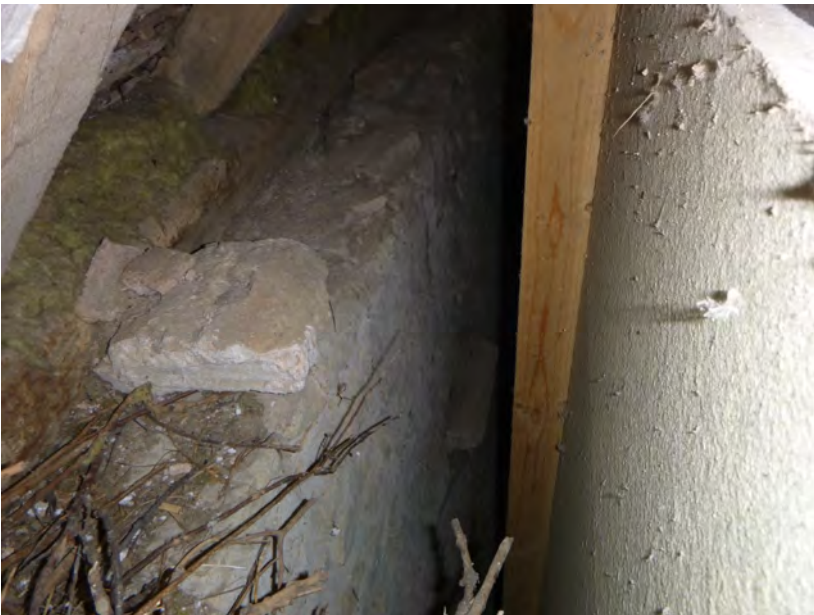
Fig 90:

West part of south barn; showing the void formed by the dry-lining in this part of the barn, isolating the internal space from the external walls

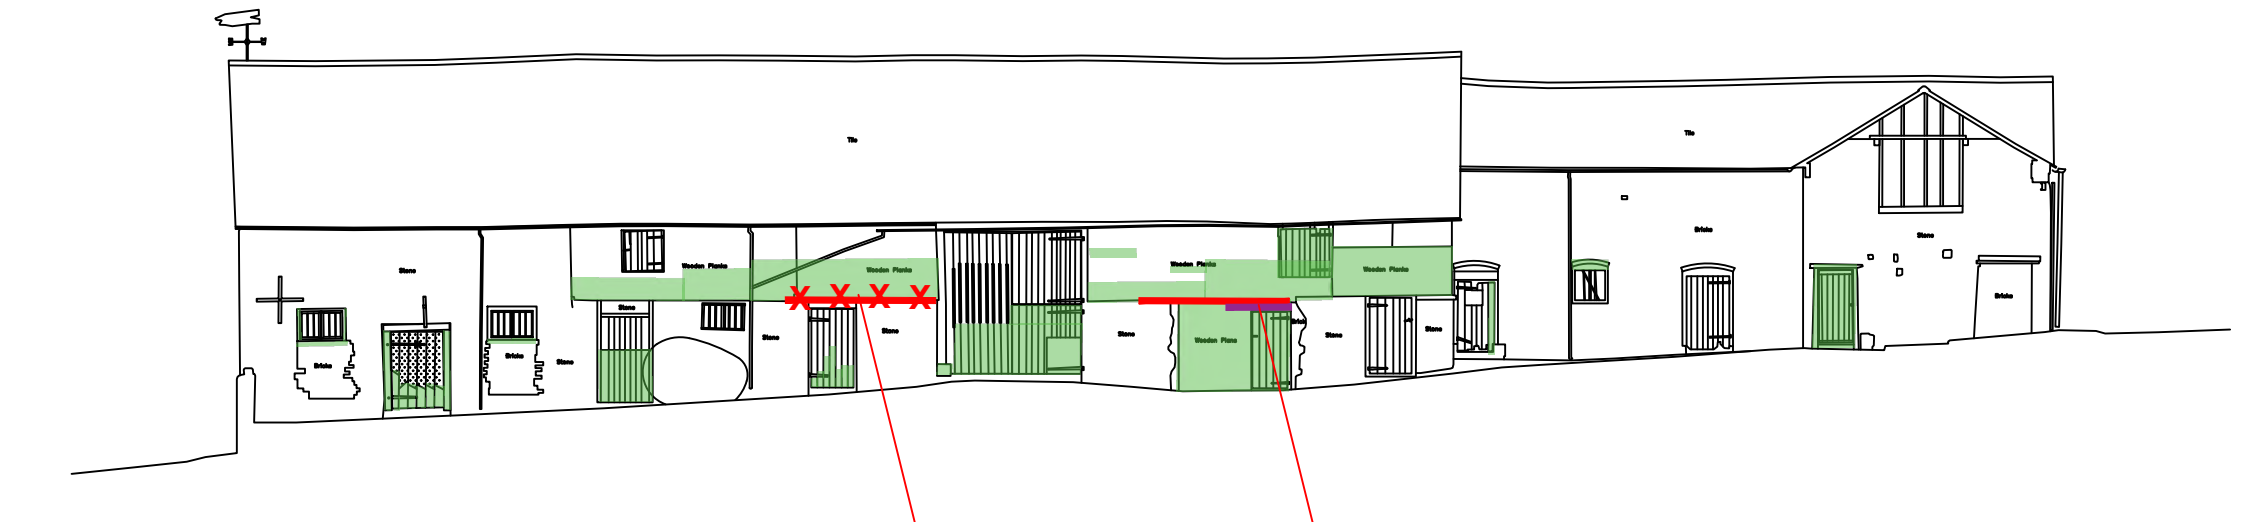
Elevation 3

Decayed mid-height sole plate/sill beam - concentrated at stud mortices with up to 75% loss of x-section (lower and exterior faces) Principal post tenon ok

Decayed/fractured mid-height sole plate/sill beam - twinned RSJ insertion on brick pier. Generally high superficial and 'dry' deep moisture content suggestive of past treatment or condensation conditions

Decayed mid-height sole plate/sill beam - 30% loss of x-section to east (underside) and compromised mortices - front face of joint decayed over 2 no. tenons. 1 no post bearing floating

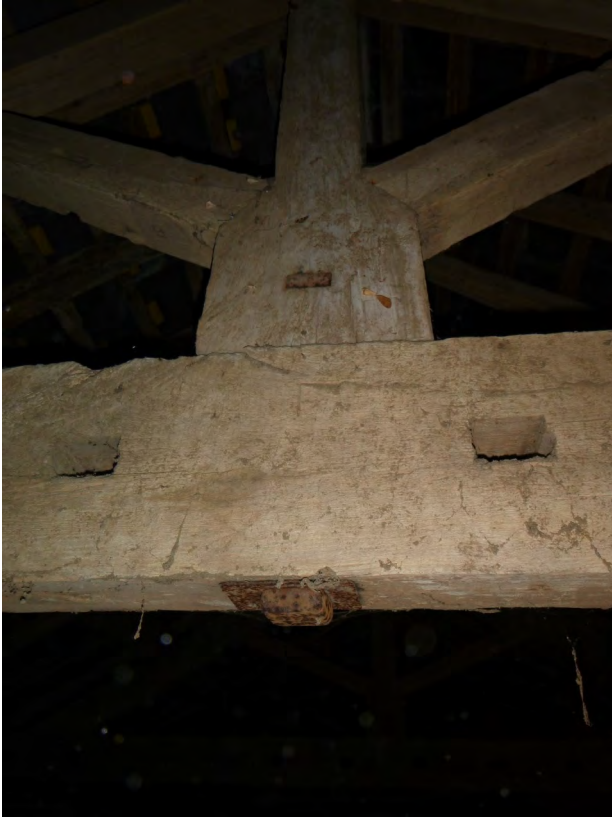
Fig 3:

Truss T1; showing the base of the central part of the truss. Note the embedded metalwork and the slot for the captured nut tying the tie-beam to the king-post, the only joint under tension rather than compression. Also note the historic mortices indicating previous possible use as floor beams, or previous installation of ceiling joists

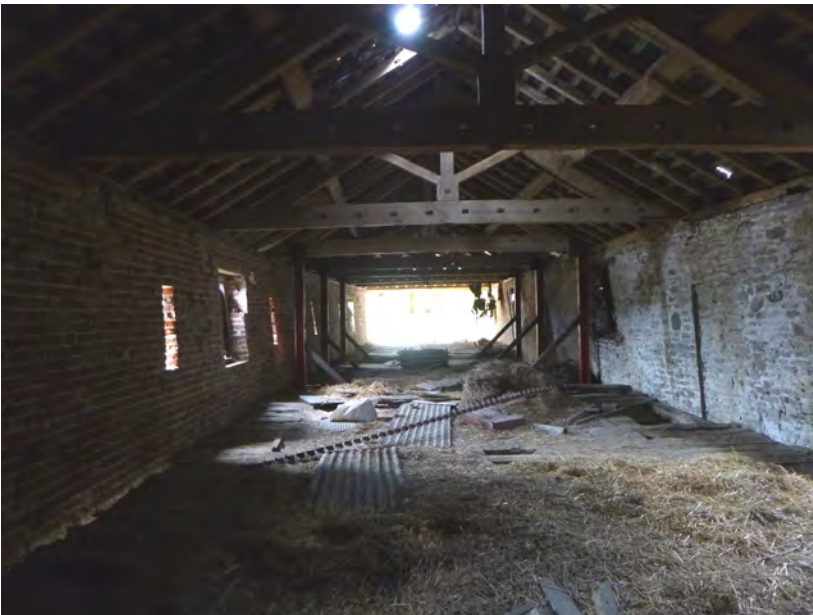
Fig 4:

Upper floor; showing general view towards the south. Note the floor below which was considered unstable and dangerous preventing inspection to a limited number of areas

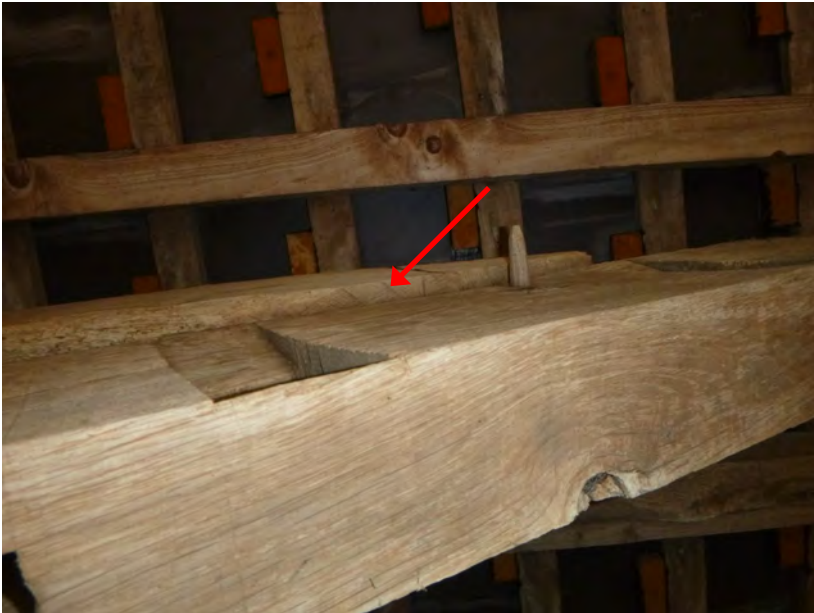
Fig 5:

Truss T2; showing the thickness discrepancy between the tie-beam and the remaining truss elements, measured at ~10-15mm. Note the historic mortices are bevelled
