Aston Hall: Investigation of structural timber elements – South range barns

Site note 1 for March 2021, job no. 153.32

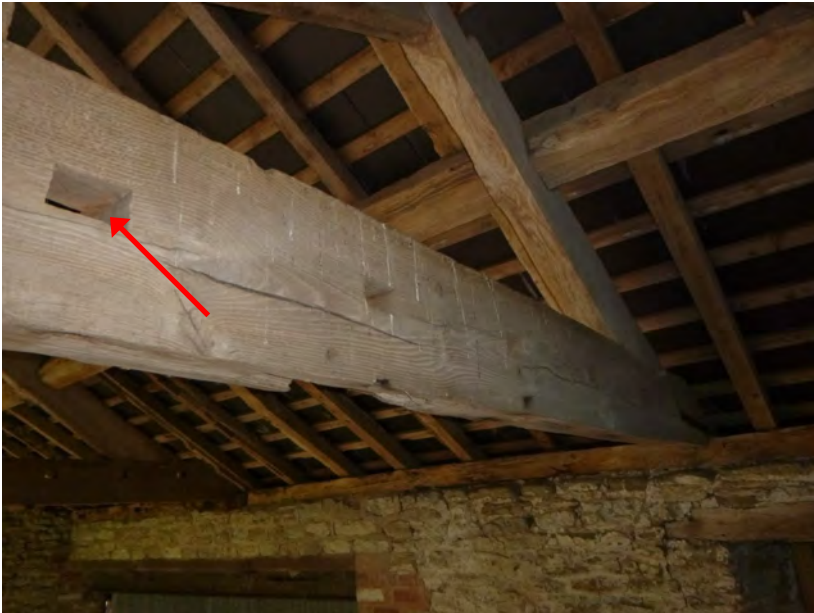
Fig 7:

Truss T3; showing general view of the truss and the historic mortices along the length

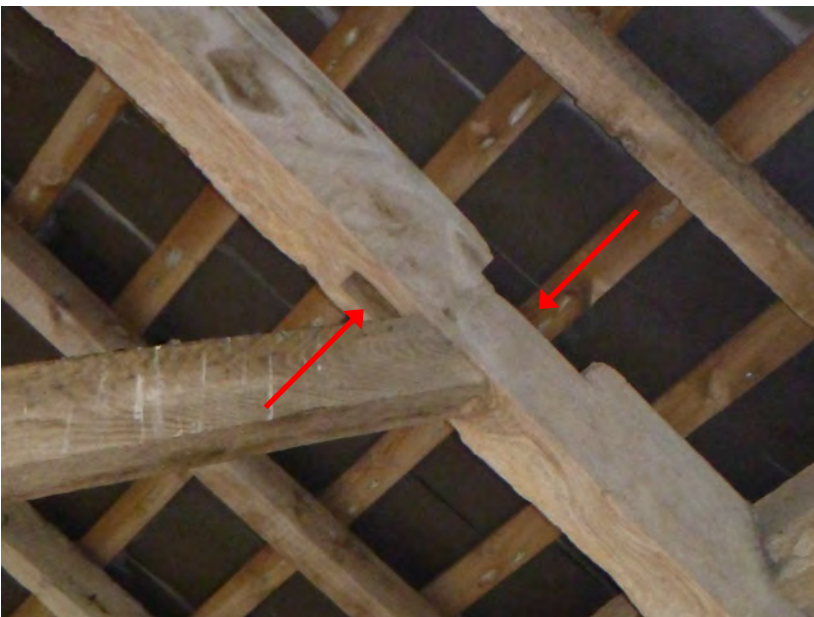
Fig 8:

Truss T3; showing the overlarge brace strut mortice, indicating replacement of struts in the past, and the significant notch on the outer edge of the principal rafter, suggesting possible previous trenched purlins. Both indicating likely reuse or salvage of elements comprising trusses

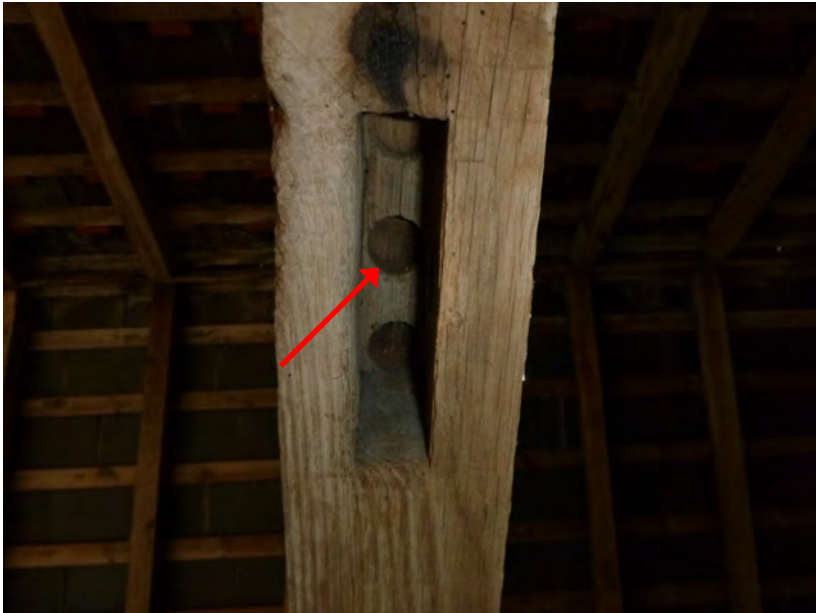
Fig 9:

Truss T2; showing large notch in underside of tie-beam, likely for stud element in previous cross wall. Note circular markings left by brace and auger bit prior to chiselling out remaining 'meat'

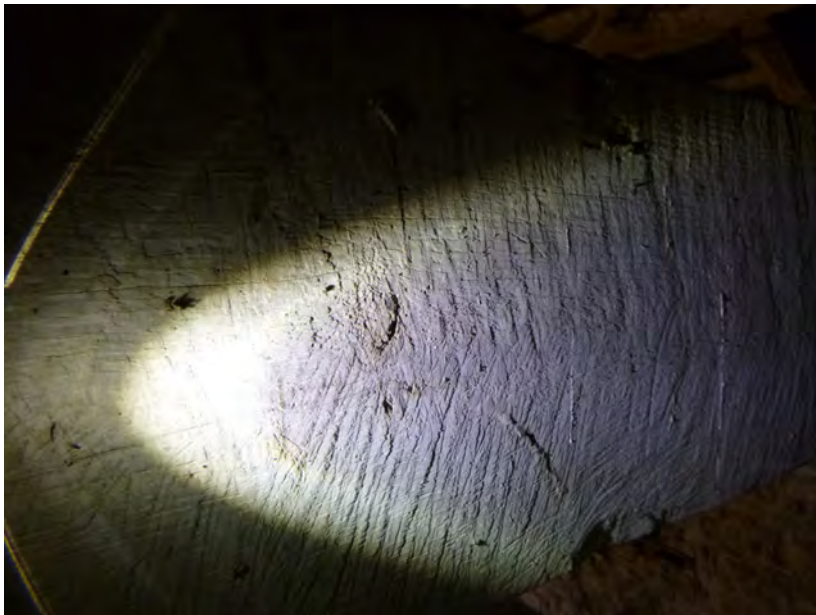
Fig 10:

Tie-beam of truss T3; showing typical pitsaw conversion markings

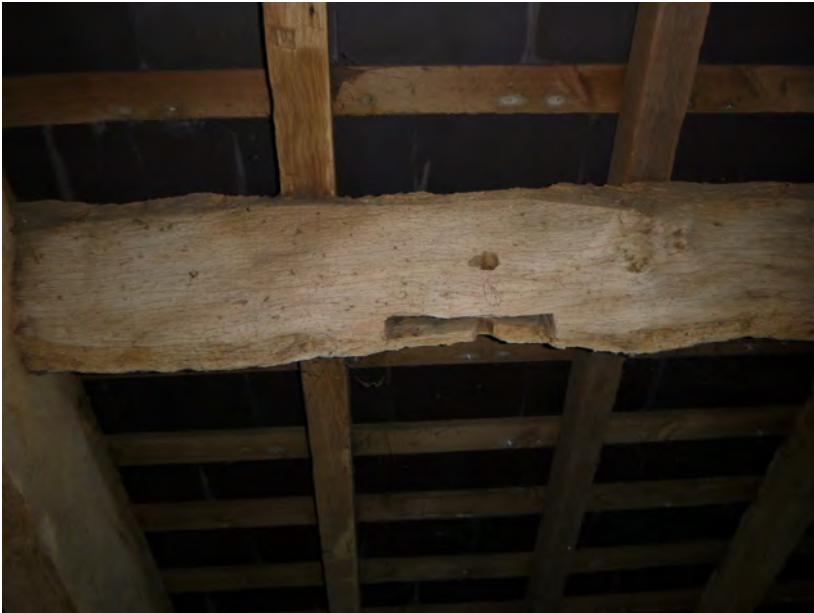
Fig 11:

Roof structure, bay 4; showing mortice in purlin for previous wind brace

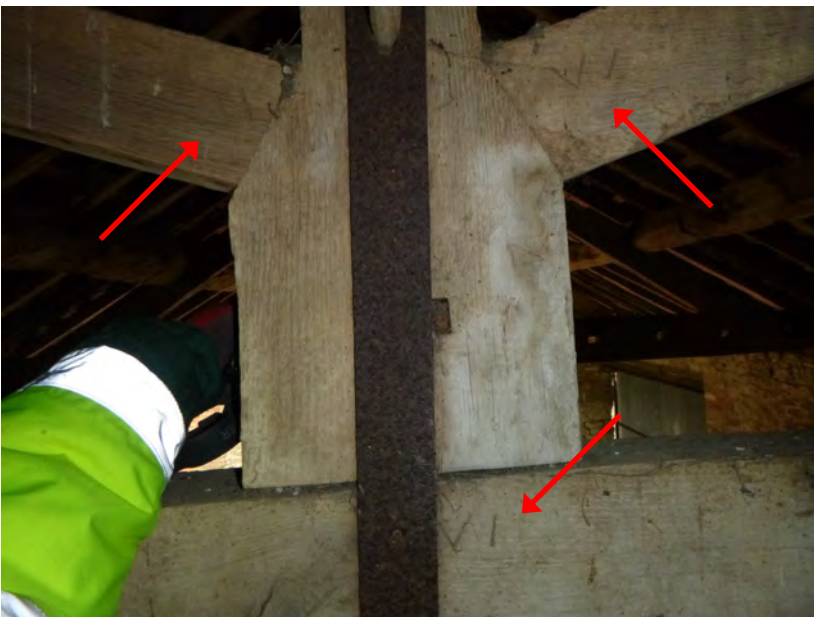
Fig 12:

Truss T3; showing metal strapping on truss and carpenters markings on struts and tie-beam usually carved into timbers during construction and may indicate all elements were assembled concurrently, but using salvaged material

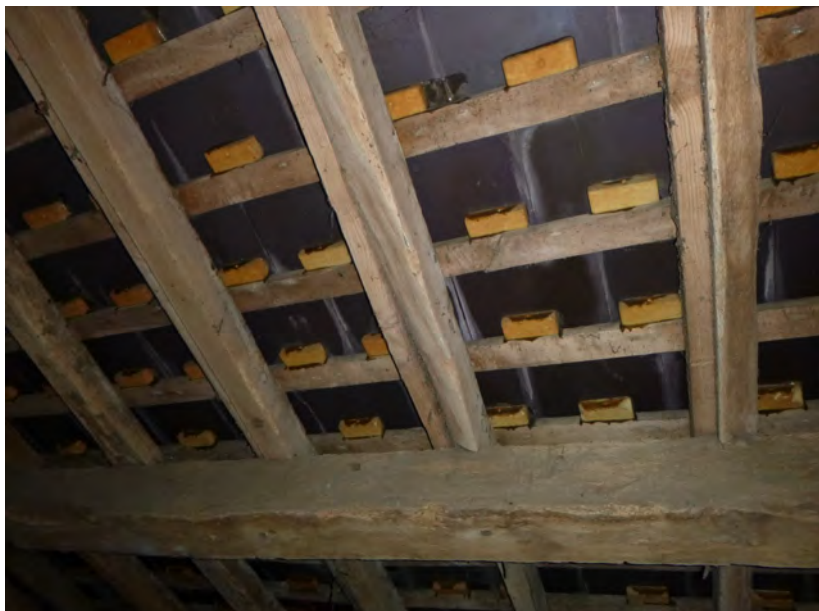
Fig 13:

Roof structure; showing foam pads glued to undersides of slates to prevent slippage

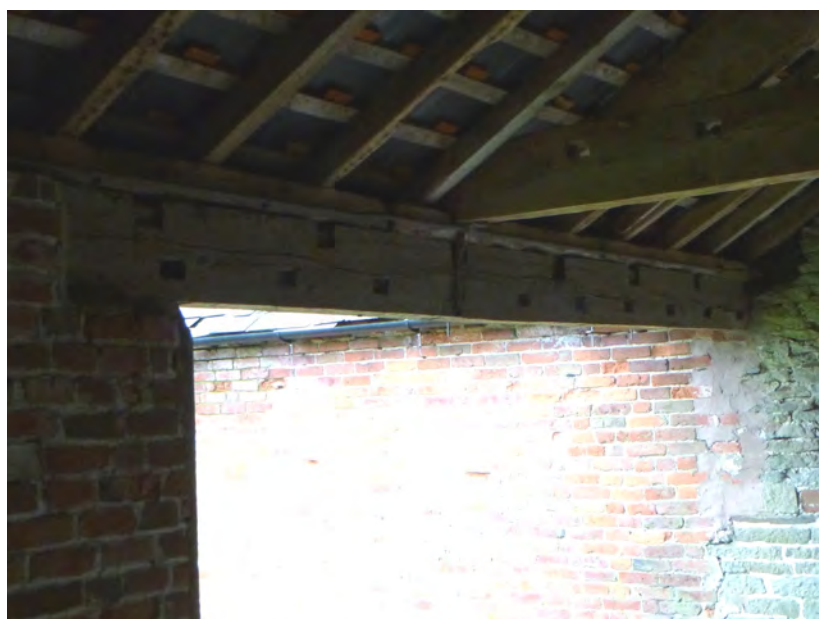
Fig 14:

Roof structure; showing the historic mortices in the large beam/lintel over the opening at the south end

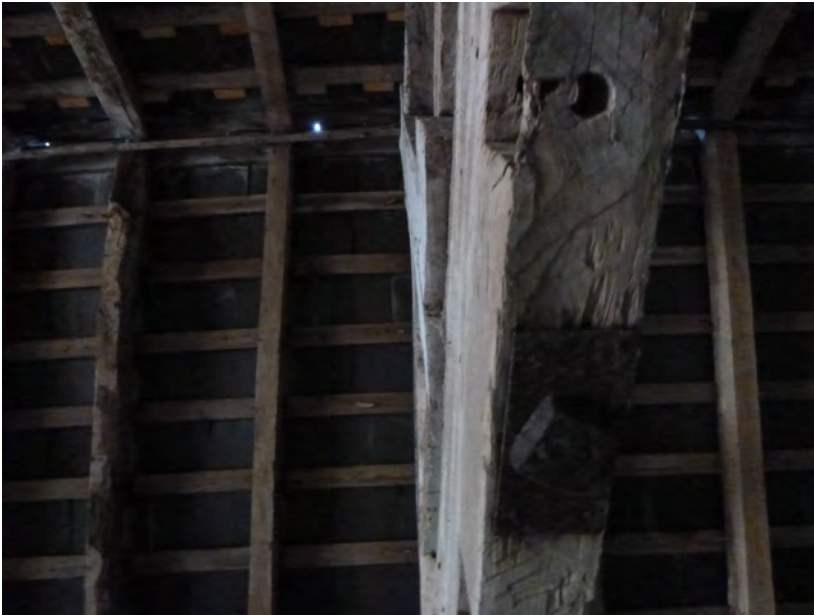
Fig 15:

Roof structure, truss T4; again showing the discrepancy in thickness between the king-post and the tie-beam

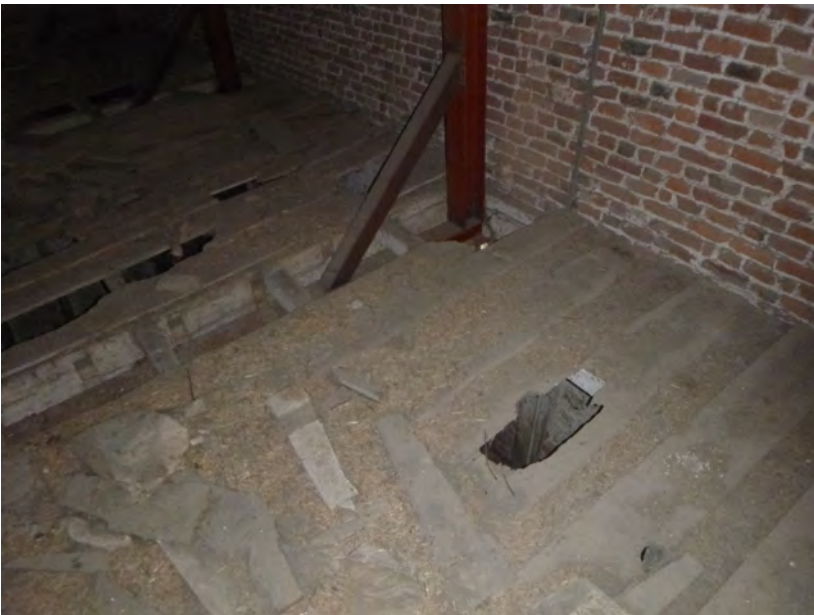
Fig 16:

First floor; showing the overlapping floor boards which had been significantly damaged by widespread wood-boring beetle limiting safe access to inspect areas of roof structure

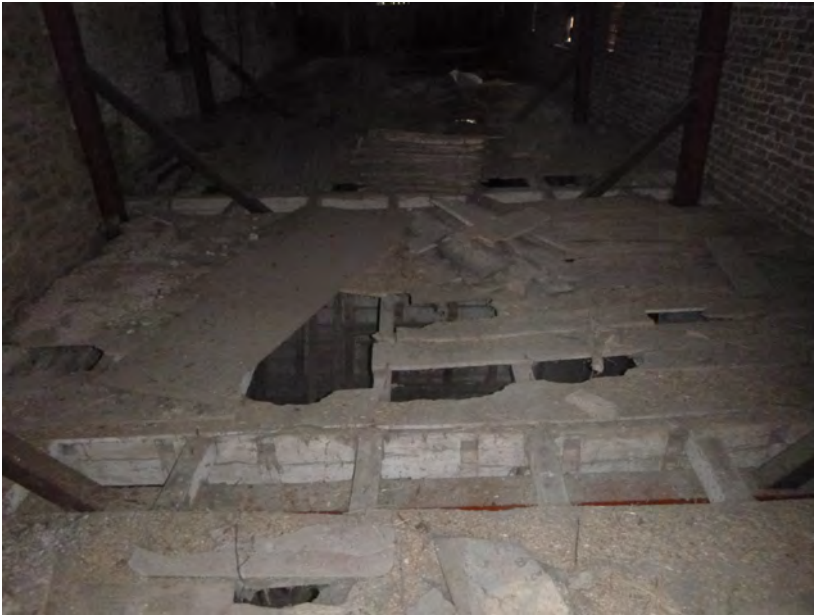
Fig 17:

First floor; showing the overlapping floor boards which had been significantly damaged by widespread wood-boring beetle limiting safe access to inspect areas of roof structure

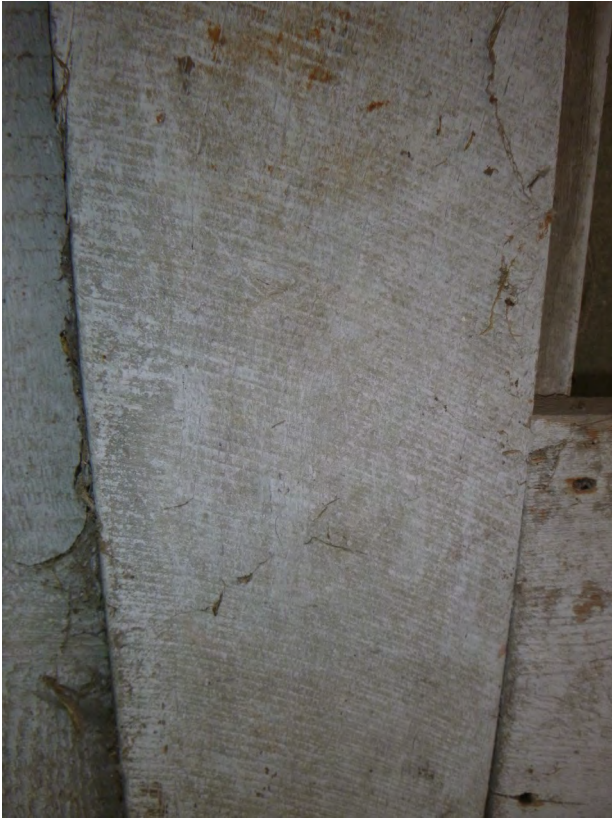
Fig 19:

Ground floor; showing circular saw markings on face of upright timber stud at south end, indicating early C19th or later conversion

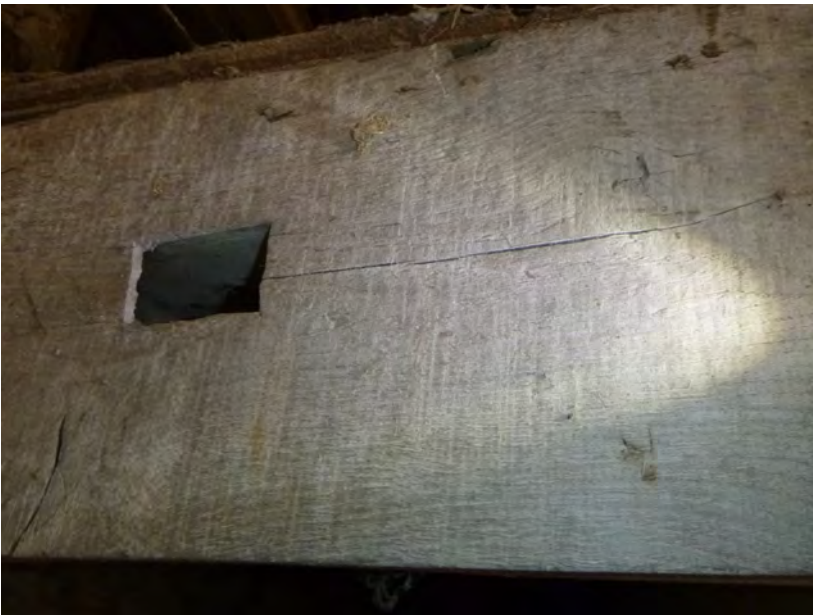
Fig 20:

Ground floor; showing typical pitsaw timber conversion markings on face of primary floor beam

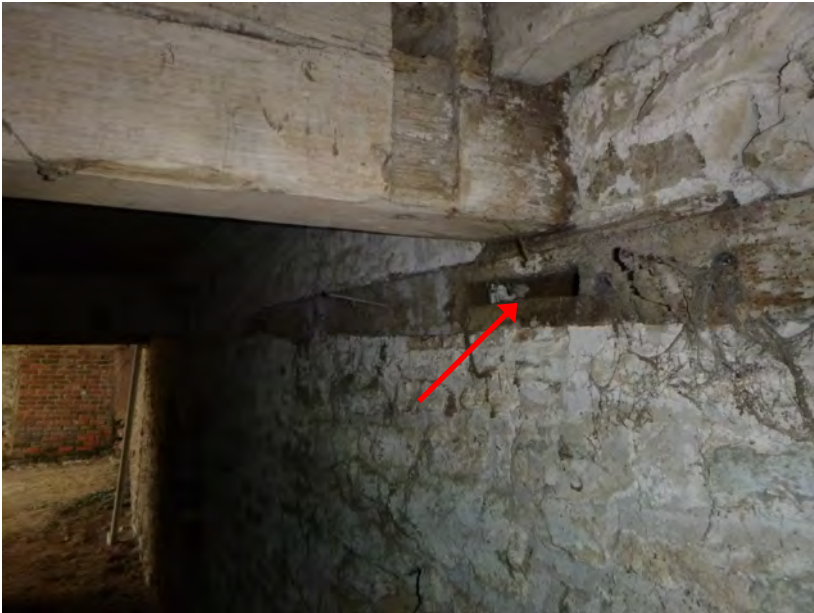
Fig 21:

Ground floor; showing primary floor beam positioned directly over large mortice in timber pad embedded within masonry wall to west side of building. This may be structurally significant

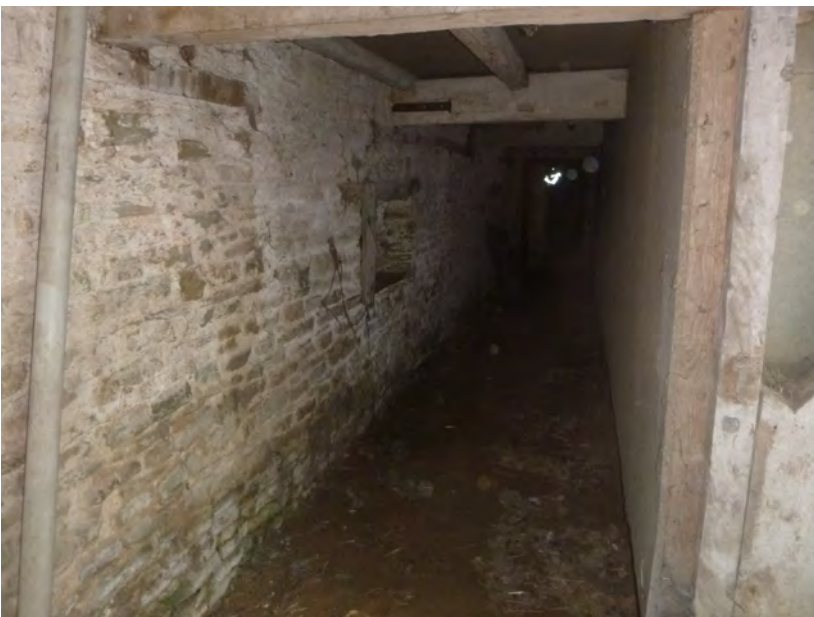
Fig 22:

Ground floor; showing general view of the west side corridor

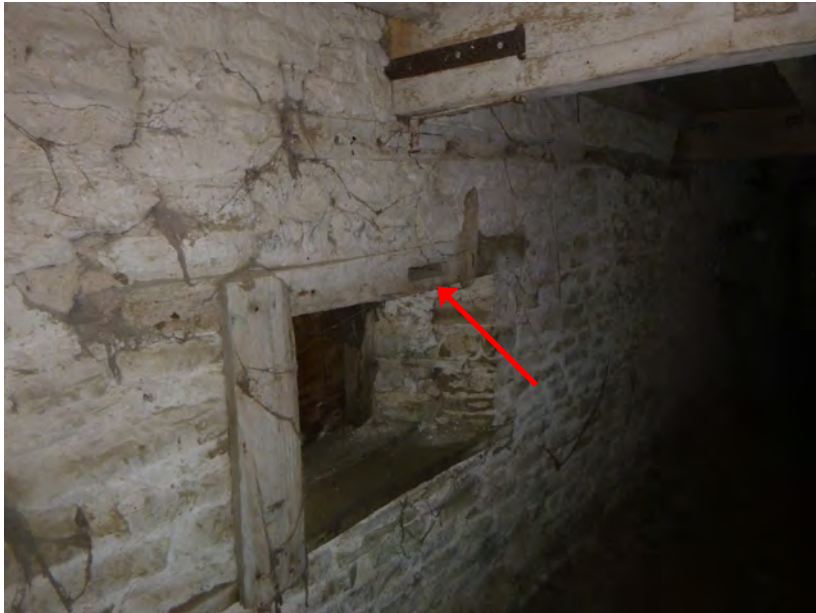
Fig 23:

Ground floor; showing large mortise in lintel over window opening on west side of the building which may be structurally significant. Typical example of reuse of materials for lintels and bonding timbers

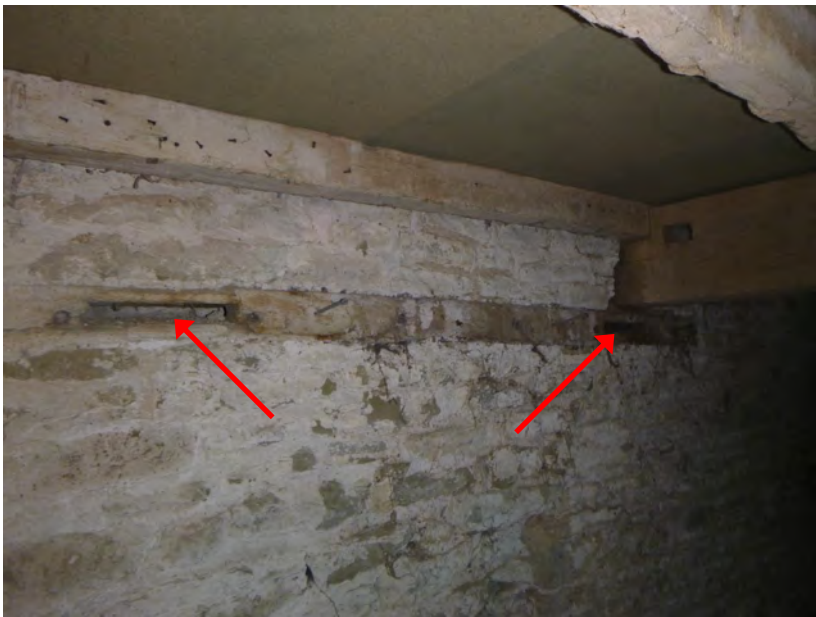
Fig 24:

Ground floor; showing reuse of materials such as large door stiles for bonding timbers or embedded timber pads during construction or remedial works

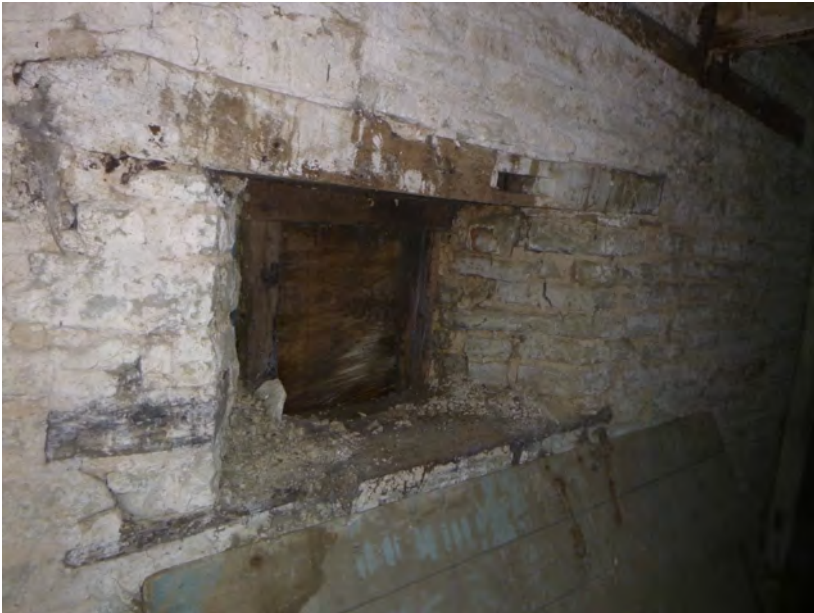
Fig 25:

Ground floor; showing one of the decayed lintels over window openings on the west side of the building. Note again the mortice within the lintel which may be structurally significant. Also note the deflection occurring over the length

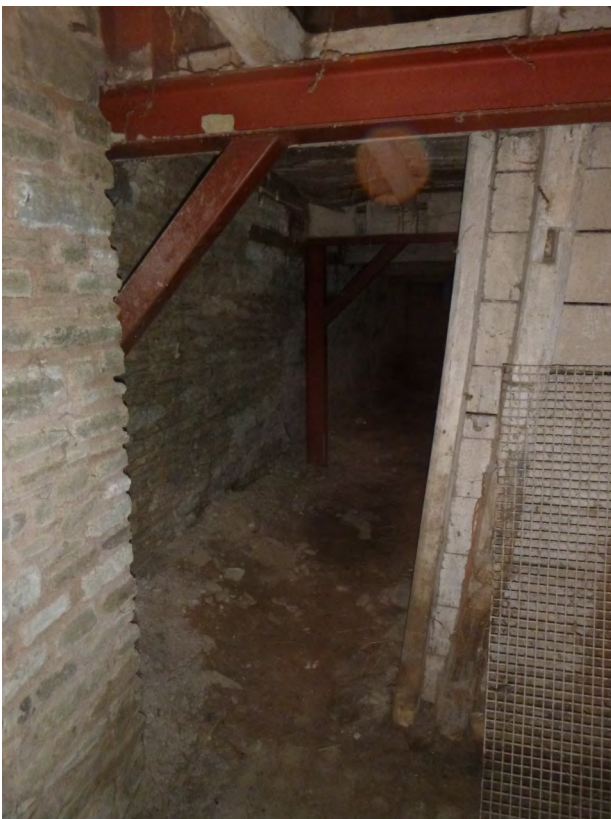
Fig 26:

Ground floor; showing the steel structure installed to counter the outward movement at the top of the east masonry wall

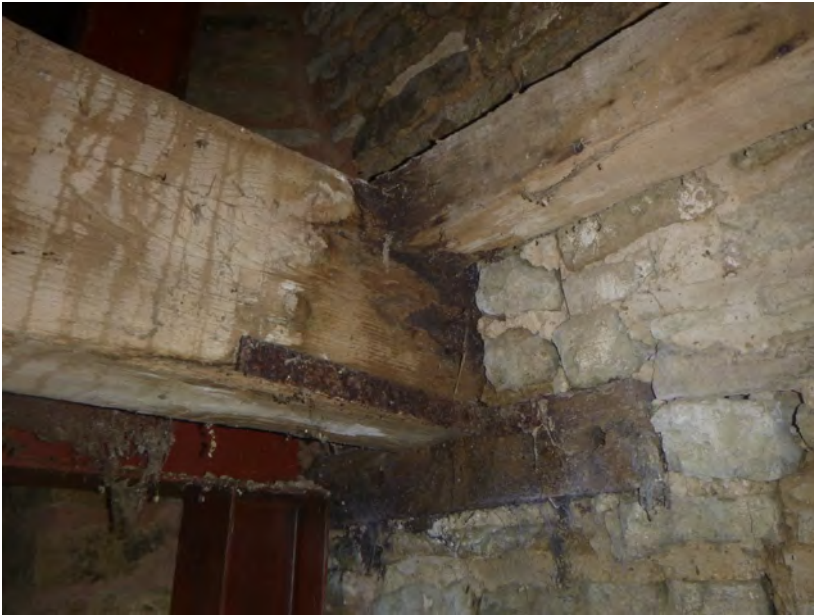
Fig 27:

Ground floor; showing the bearing end of one of the primary beams. Note the water-staining and darkening of the timber suggesting ongoing issues with damp and decay. Moisture content readings taken from timbers on the west side were generally above the decay threshold

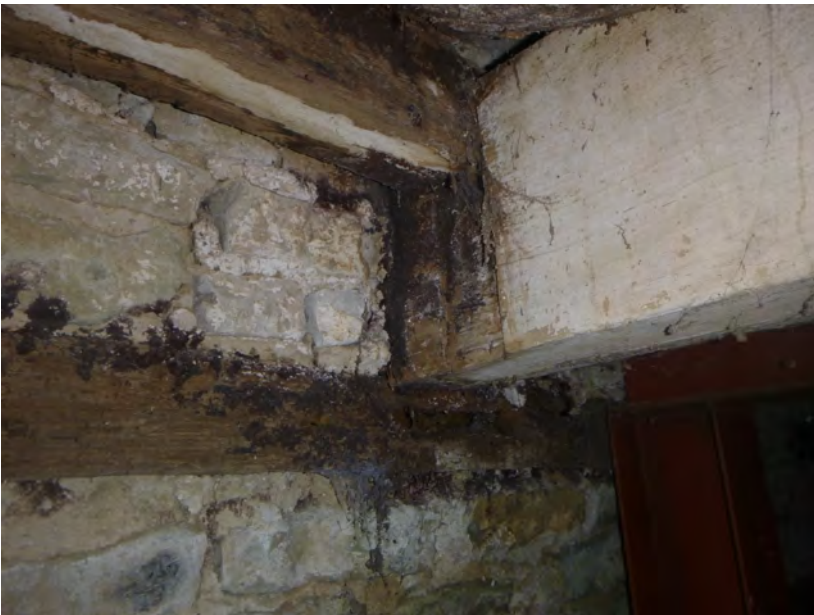
Fig 28:

Ground floor; showing the bearing end of one of the primary beams. Note the water-staining and darkening of the timber suggesting ongoing issues with damp and decay. Moisture content readings taken from timbers on the west side were generally above the decay threshold

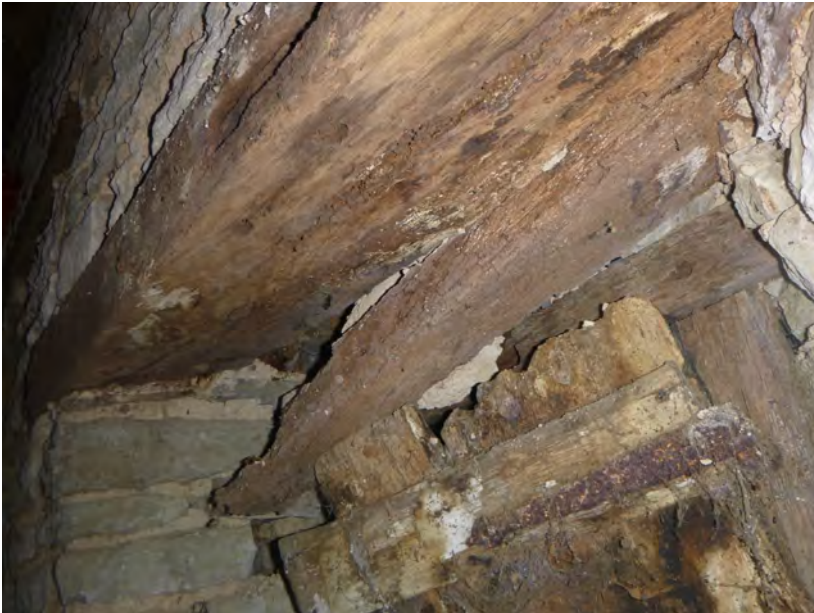
Fig 29:

Ground floor; showing one of the decayed lintels on the west side. Note the two-part build-up and decay of the outermost element by wet rot and subsequent wood-boring beetle infestation

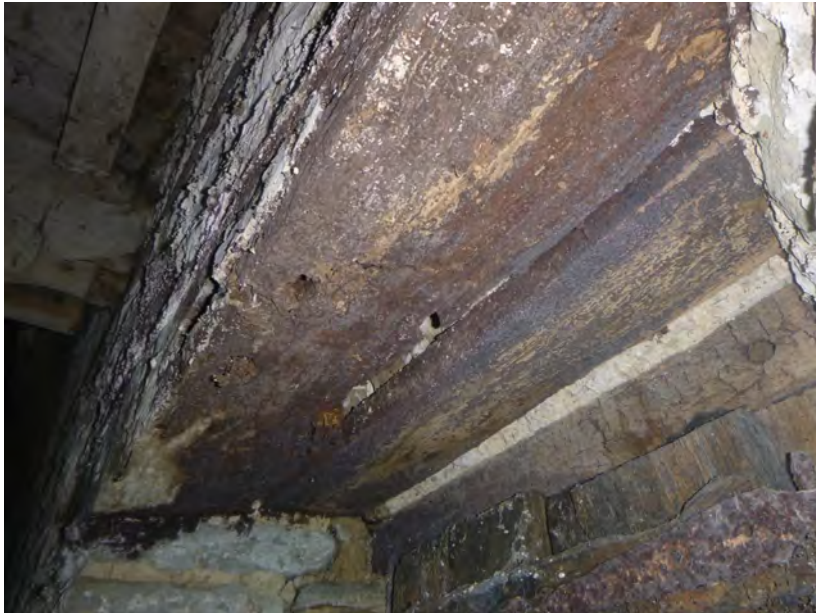
Fig 31:

Ground floor; showing another of the decayed lintels on the west side. The innermost section was decayed by active wet rot and wood-boring beetle infestation

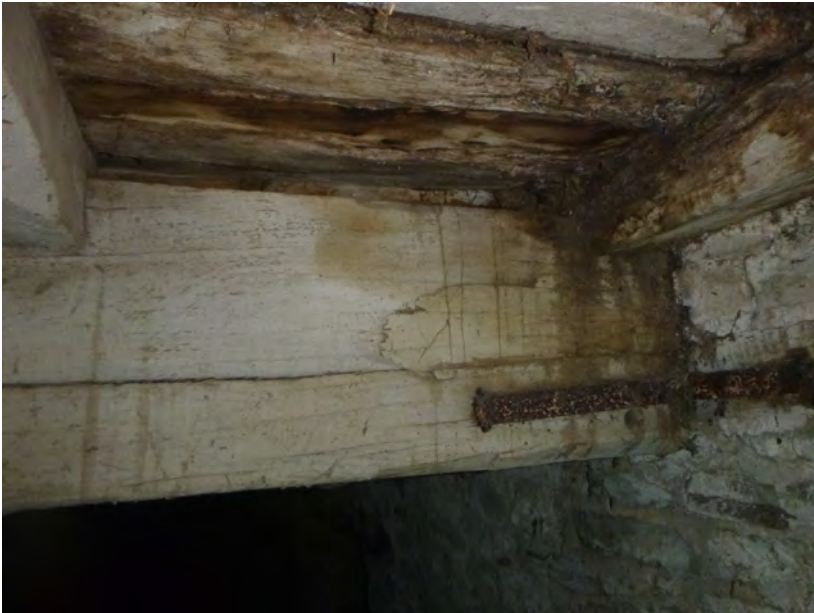
Fig 33:

Ground floor; showing opposite side of beam in previous image, with crack clearly evident on both north and south sides

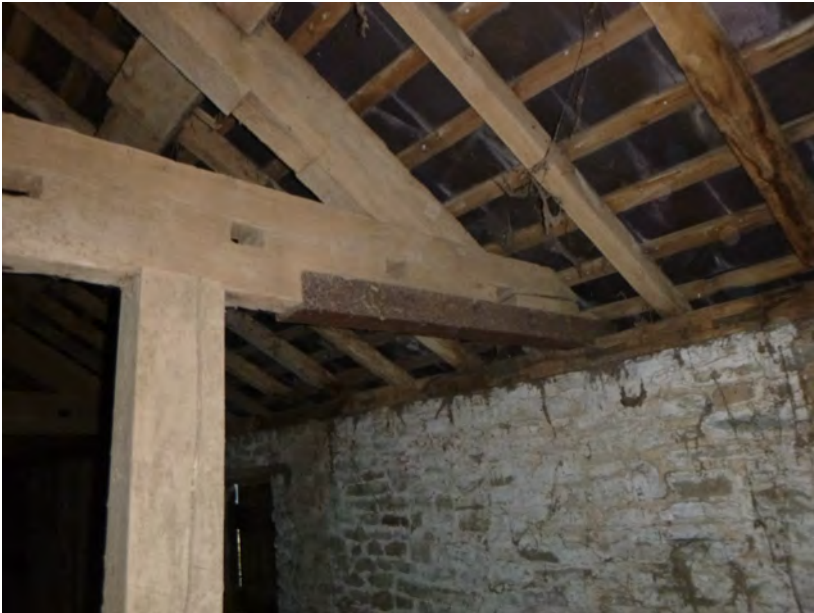
Fig 35:

Truss 10 (T10) at the north end of the barn was noted to have decayed in the past, and had been repaired using steel L-brackets and re-supported on a post, itself supported on the floor structure. The post being supported by the floor structure was considered unlikely to be adequate to support the re-direction of the loading, and additionally was suspected to be affected by active wood-boring beetle infestation and subsequently weakened further. Active water penetration was occurring at this location on the west side of the building, resulting in decay of adjacent elements such as wall plate sections and rafters

First floor; showing previous repairs to west bearing end of tie-beam at north end of the barn, re-supported on oak timber post. Post supported on floor structure below which may not be structurally adequate

No chemical treatment required. Structural Engineer to comment on suitability of previous repairs to tie-beam of truss 10 at north end. Consideration should be given to repairing the bearing end of truss 10 using a traditional beam repair eliminating the necessity to support the post on the floor structure. Every effort should be made to re-direct water away from the building to prevent further structural decay affecting vulnerable timber elements

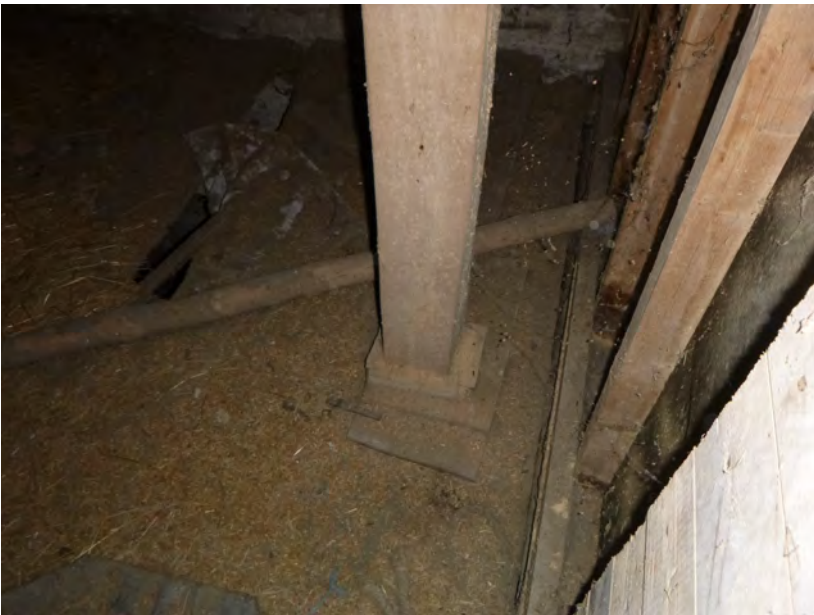
Fig 36:

First floor; showing support post of truss shown in image above supported by floor structure below which may not be structurally adequate. Also post noted to be significantly infested with wood-boring beetle

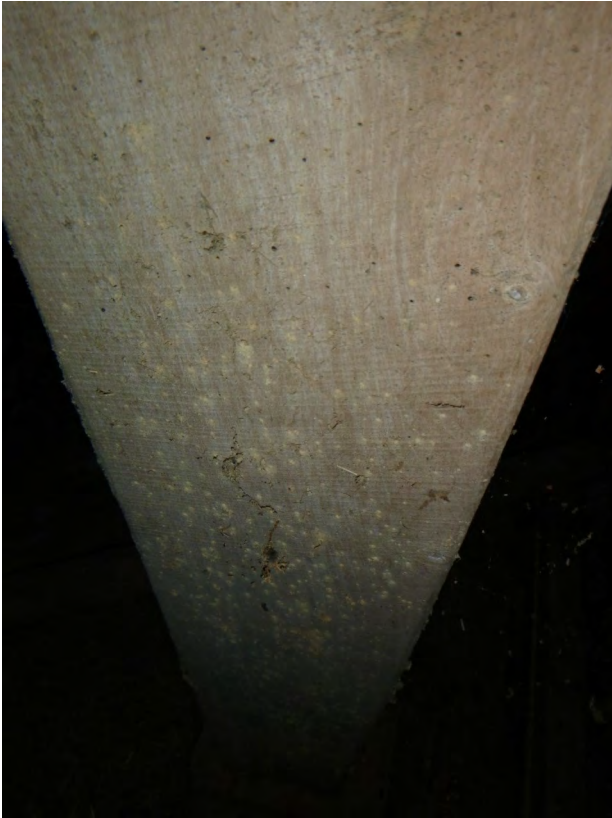
Fig 37:

First floor; showing timber support post described in previous 2no. images above. Note flight holes filled with frass, and moisture content readings were high enough to sustain further infestation

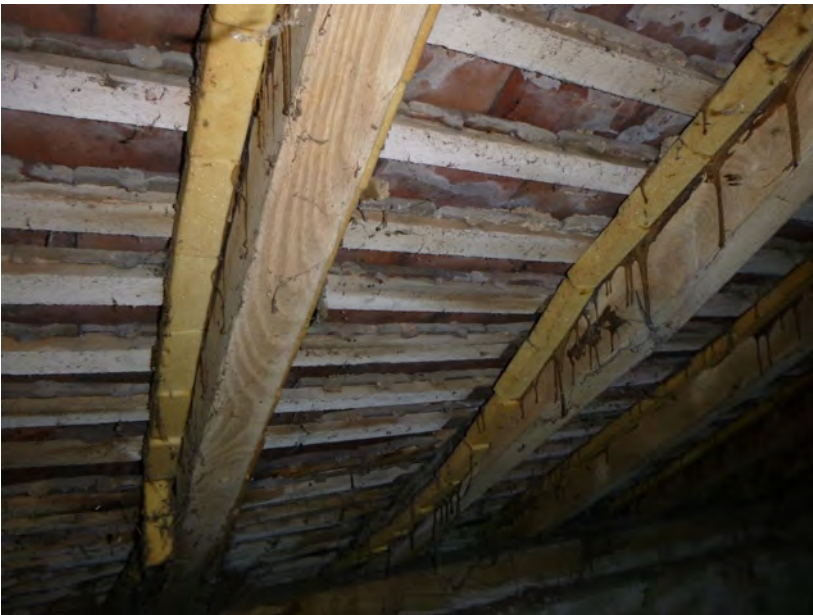
Fig 38:

Roof structure; showing further foam padding to sides of rafters at north end of barn roof. This was possibly to aid in fitting of insulation in the past

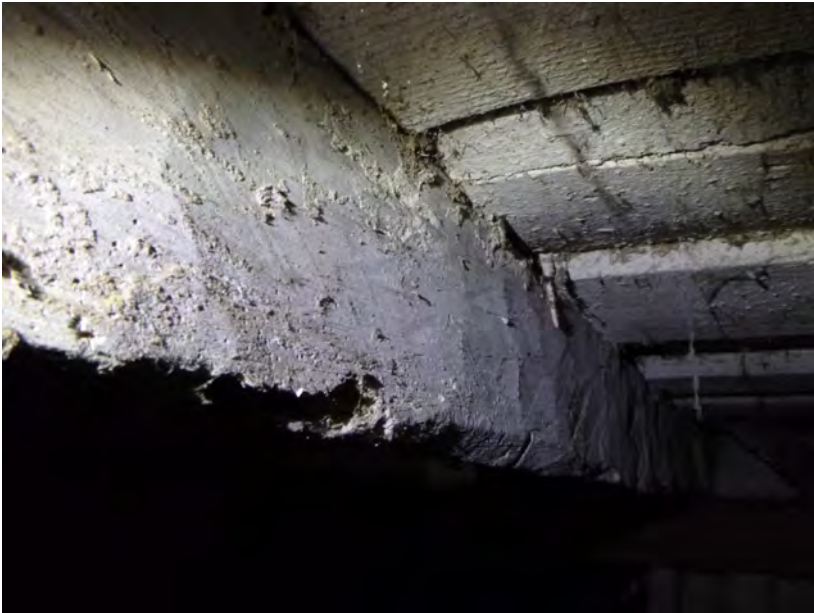
Fig 39:

Ground floor; showing typical hewn timber conversion markings on face of primary floor beam

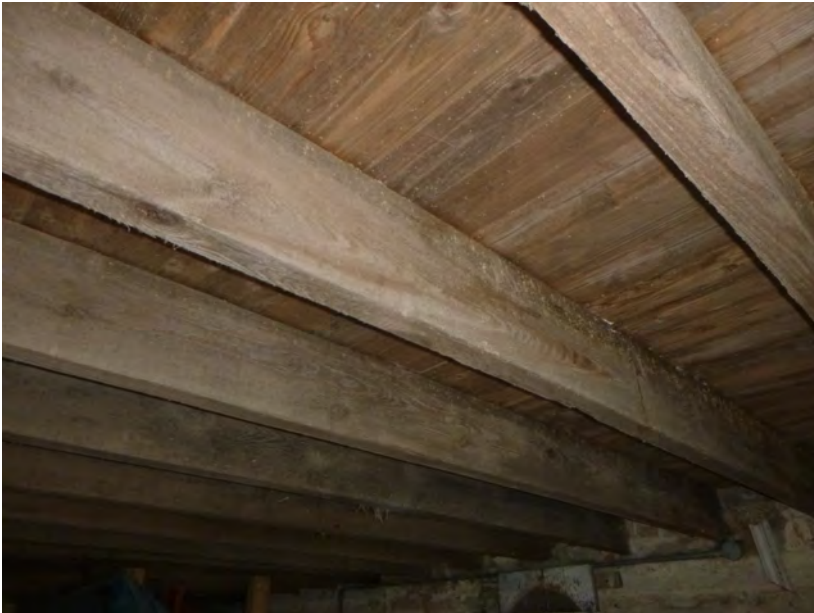
Fig 40:

Ground floor; showing widespread water-staining marks to underside of floor boards of first floor above, indicating issues with water penetration in the past and the likely cause of the elevated moisture content readings supporting widespread wood-boring beetle infestation

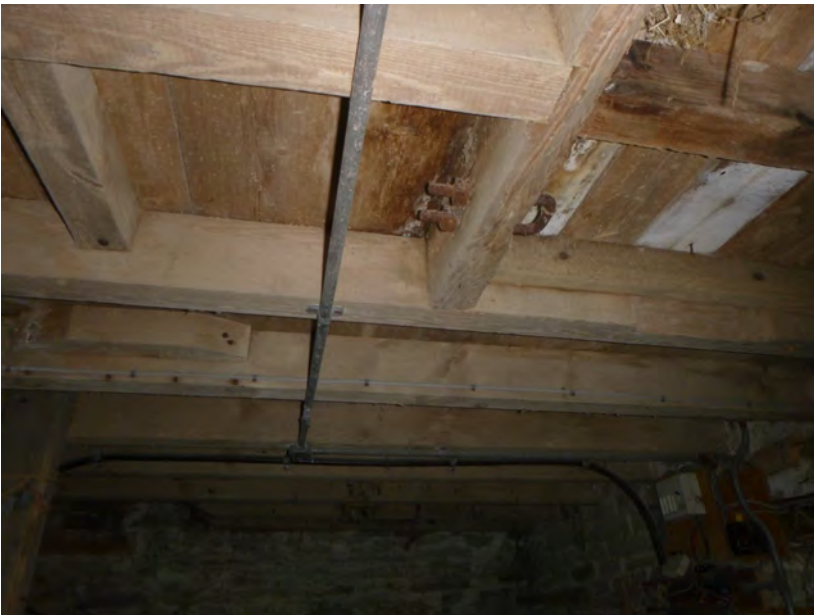
Fig 41:

Ground floor; showing area of newer floor structure at north end of building. Joists and boards were of softwood timber and no structural decay was detected in this location

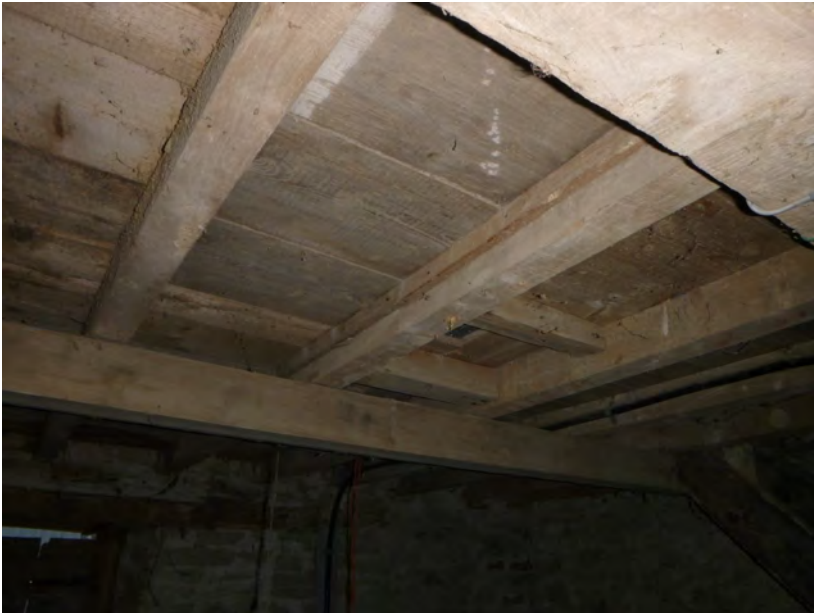
Fig 42:

Ground floor; showing area of newer floor structure at north end of the building. There were areas of localised wood-boring beetle infestation of softwood floorboards above, although joists were mostly free of decay

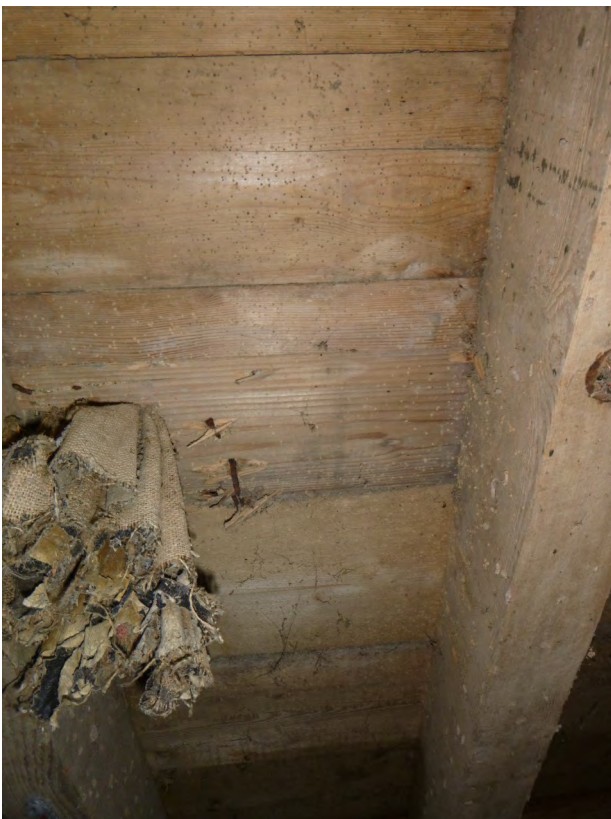
Fig 43:

Ground floor; showing area in north-west corner of building, where historic oak timbers had been replaced with alternative hardwood material. Joists embedded within the west masonry wall were found to be decayed, and the lintel over the doorway to the west was also found to be decayed

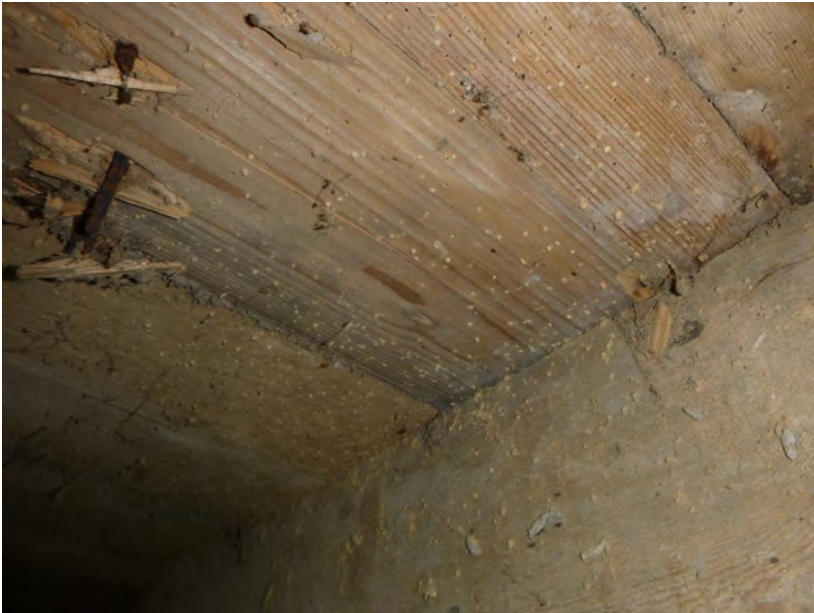
Fig 44:

Ground floor; showing one of the areas of softwood floorboarding affected by wood-boring beetle infestation, at the north end of the barn, as shown on attached plans

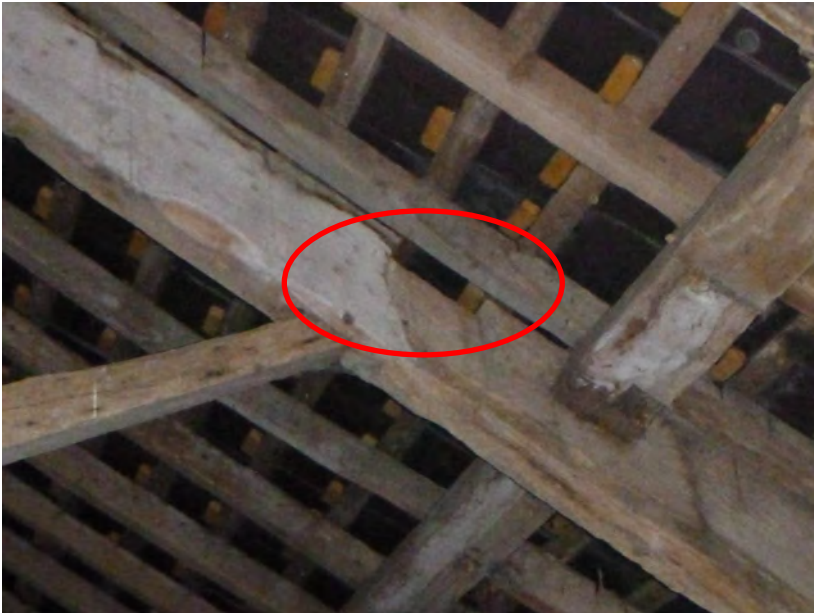
Fig 46:

Roof structure; showing previous patching of historic notching with timber

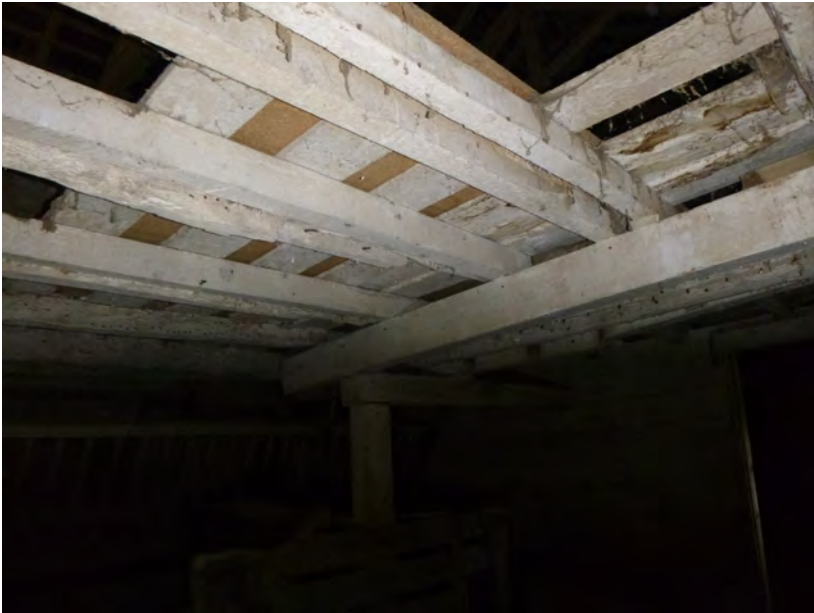
Fig 48:

Floor structure; showing area of historic replacement floor structure at the south-east end of building. Joists and beams were of oak timber and no structural decay was detected in this location

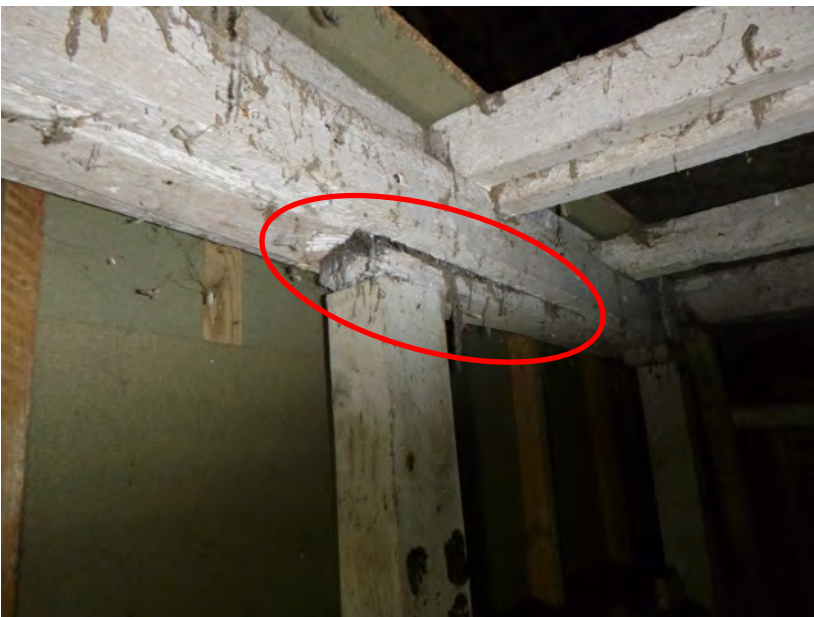
Fig 49:

Floor structure; showing partner repairs to most floor joists in this area, with the supporting partner timbers distinguishable by their clean and square edges

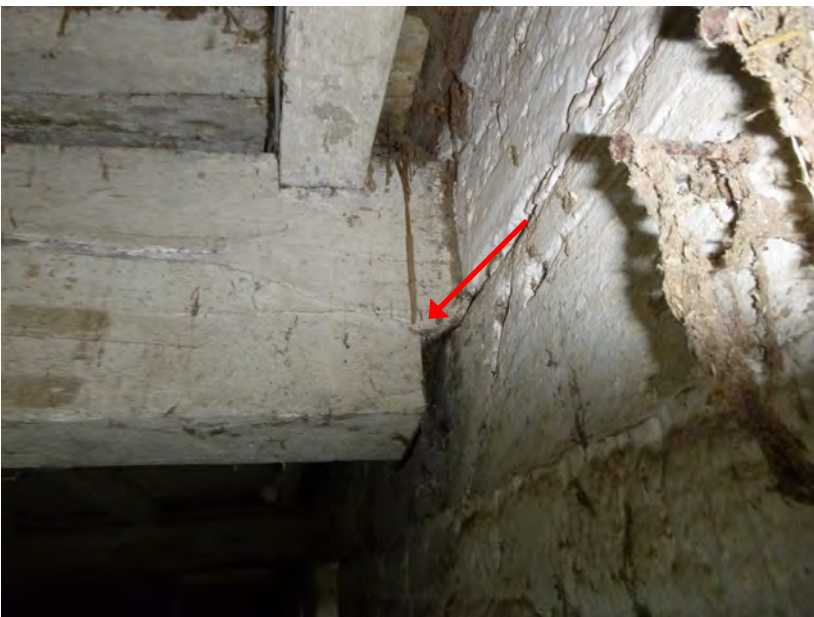
Fig 55:

Floor structure; showing primary floor beam positioned directly over large mortise in timber pad embedded within masonry wall to east side of building. This may be structurally significant

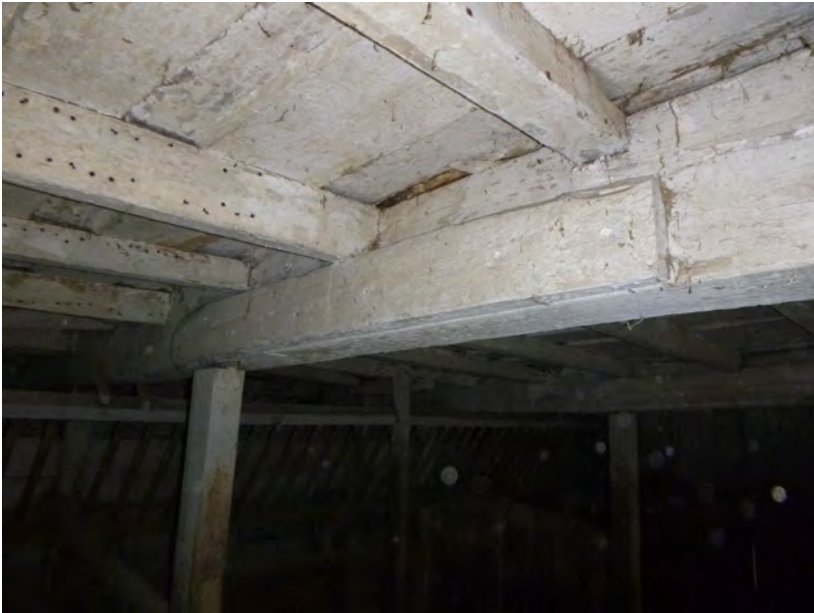
Fig 56:

Floor structure; showing the opening up of gaps between the bearing ends of the beams and the east masonry wall, in this instance ~30mm

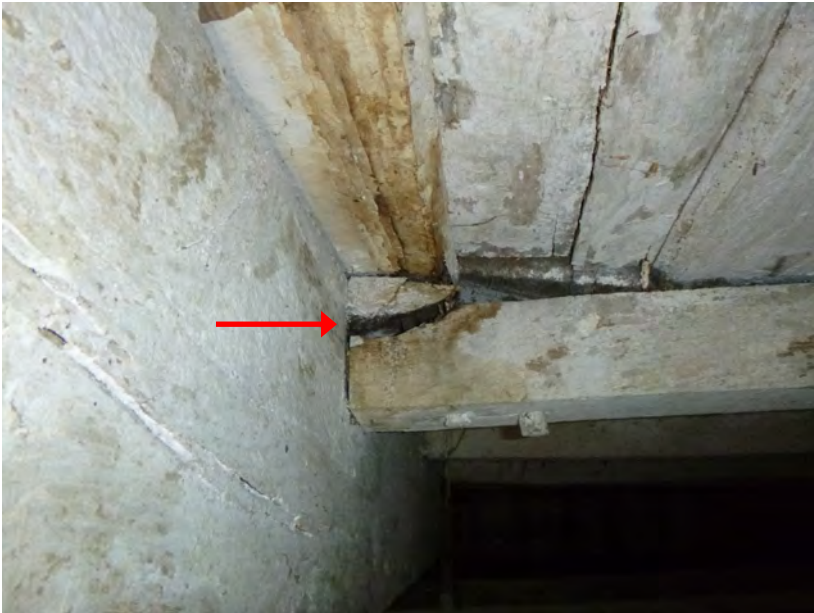
Fig 58:

Floor structure; showing structurally significant outward movement of the east masonry wall

Note the floor beam has held itself and the masonry below it in its original position, whilst the majority of this section of wall has moved outwards, forming the crack observed

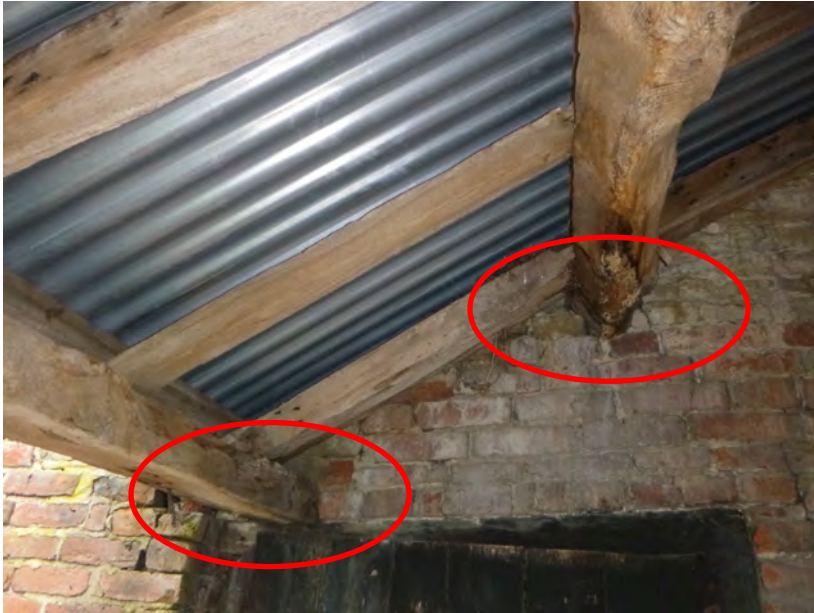
Fig 3:

North stable block; showing structurally significant timber decay affecting bearing end of purlin on south pitch at west end. Also localised decay around wall plate embedded in west masonry wall
