Aston Hall: Investigation of structural timber elements – South range barns

Site note 1 for March 2021, job no. 153.32

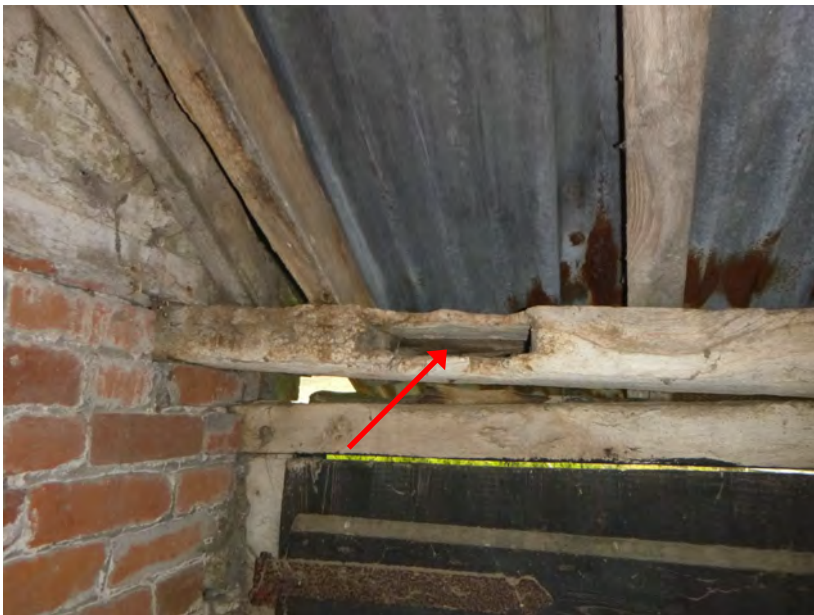
Fig 4:

North stable block; showing large historic mortise in wall plate, directly above north-west corner doorway, may be structurally significant

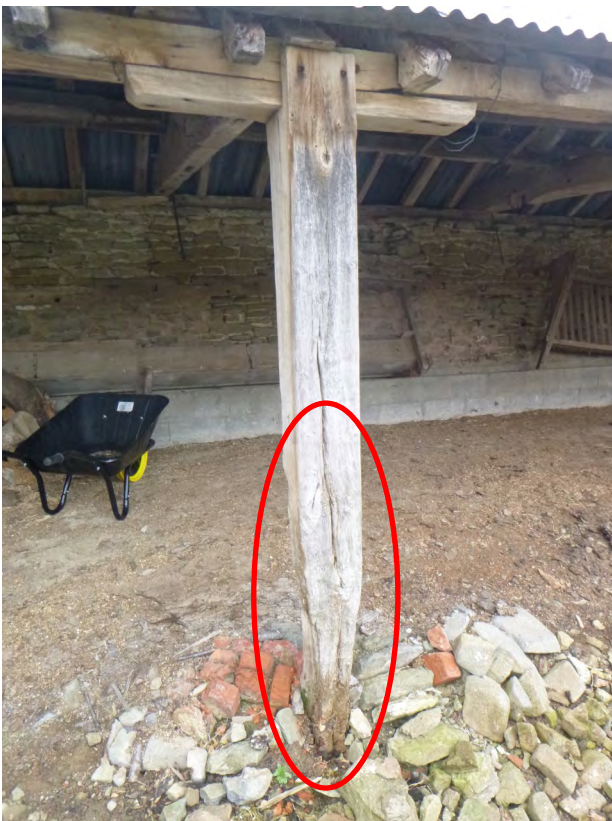
Fig 6:

North stable block; showing oak timber post supporting south eaves between bays 2 and 3. Note almost over 50 per cent loss of cross section at base of post embedded in earth below and vulnerable to issues with decay and wood-boring beetle

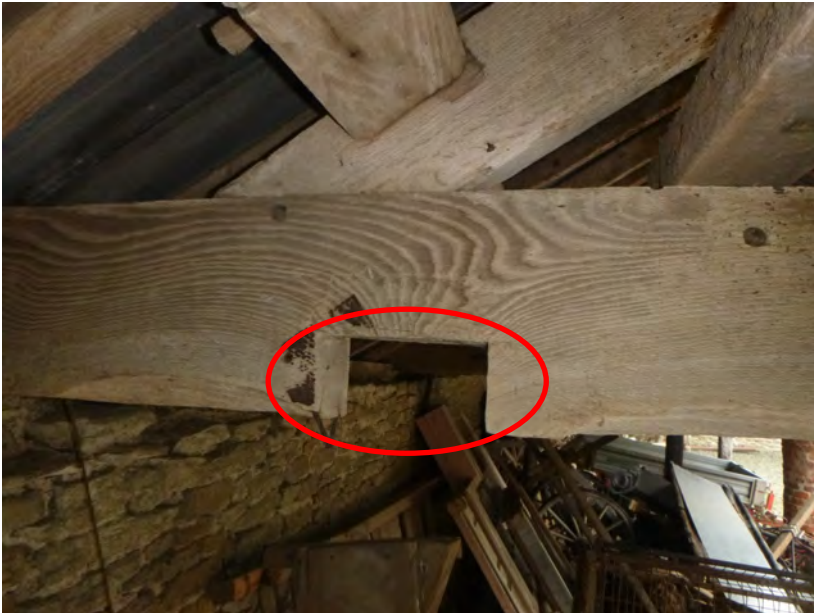
Fig 7:

North stable block; showing large notch in north end of truss 3. May be structurally significant

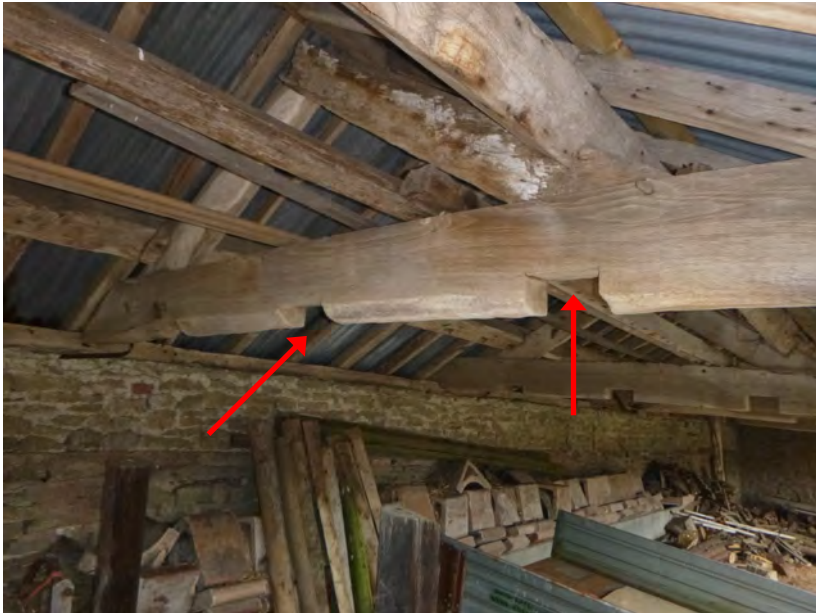
Fig 9:

North stable block; showing relatively large notches on underside of tie beam of truss 5 which may be structurally significant

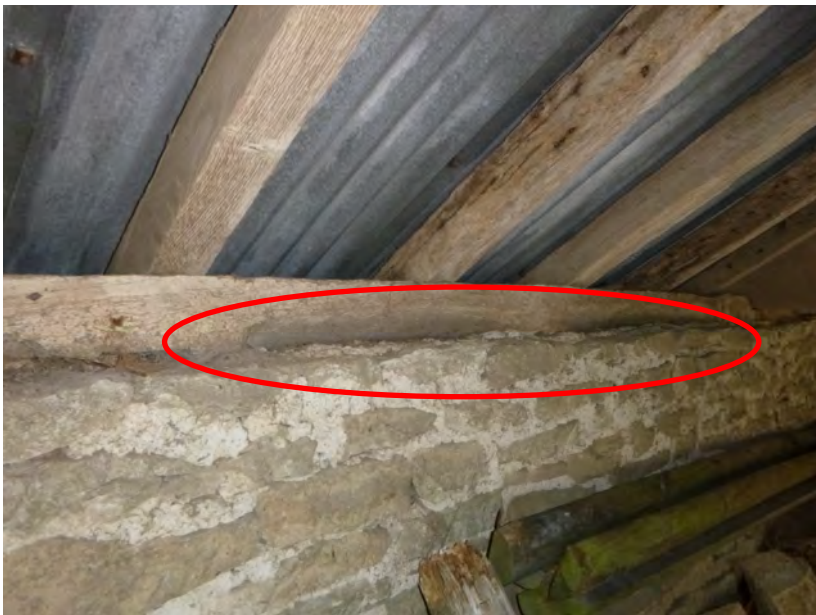
Fig 10:

North stable block; showing localised loss of cross section of timber plate due to wood-boring beetle infestation of sapwood content. However, not likely to be structurally significant as wall plate is relatively substantial along north eaves

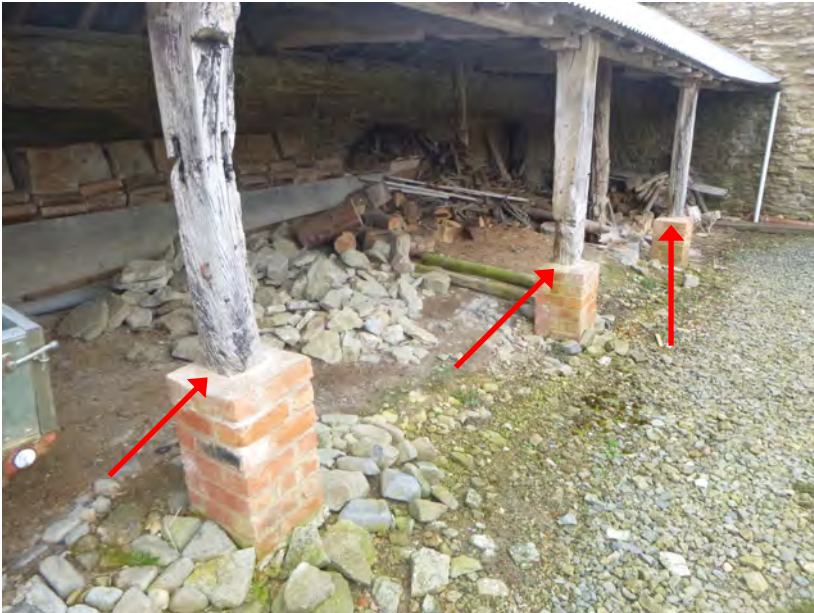
Fig 11:

North stable block; showing support timber posts on brickwork plinths along south eaves at east end, likely to be a result of decay affecting bases of posts in the past. Now flanchued with cement at bases and resulting in localised timber decay from both wet rot and wood-boring beetle

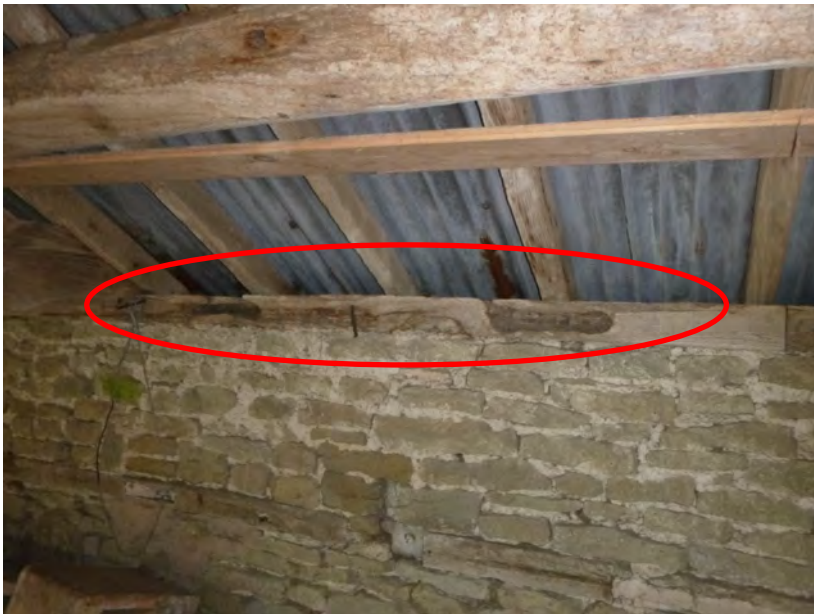
Fig 13:

North stable block; showing large notches in wall plate. However, wall plate relatively substantial in this location, therefore, unlikely to be structurally significant

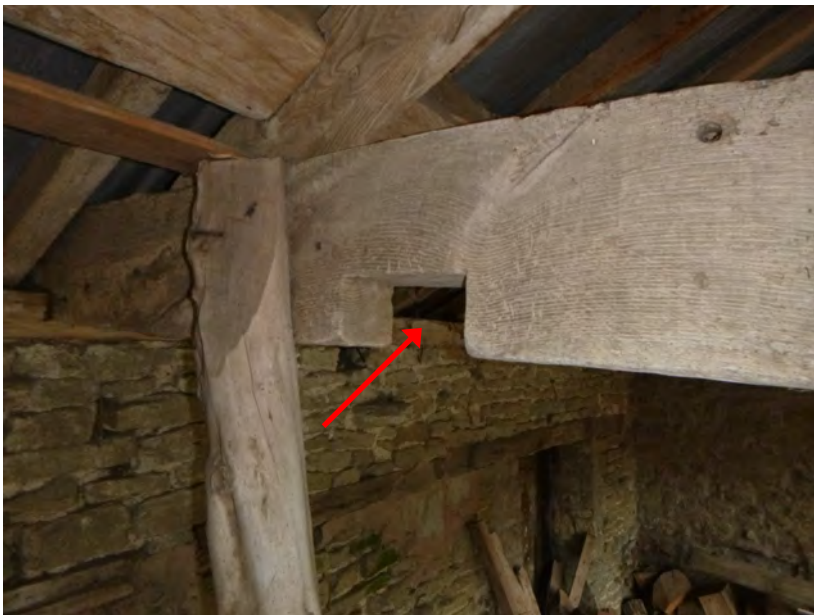
Fig 14:

North stable block; showing large notch in tie beam of truss 8 at north end and notch also noted at south end, reducing overall cross section by 40 per cent, may be structurally significant

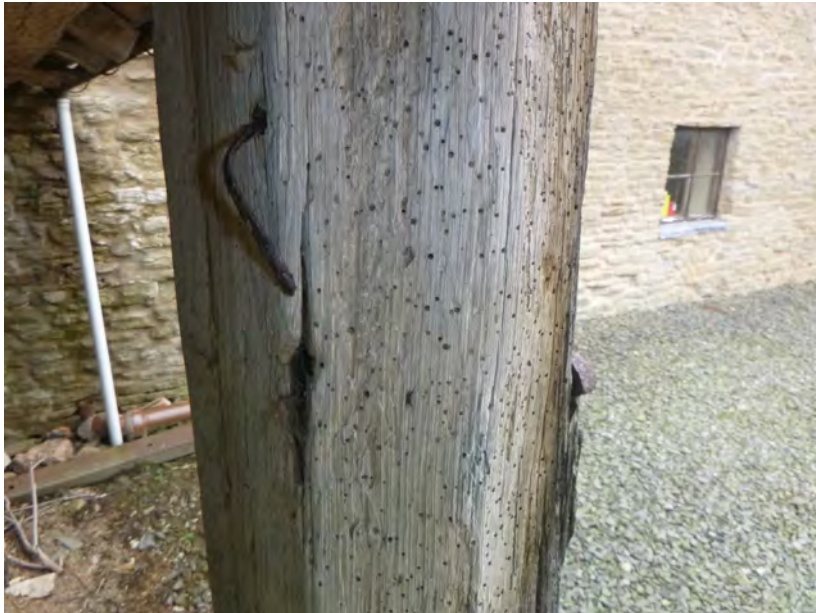
Fig 15:

North stable block; showing widespread wood-boring beetle flight holes on post at south eaves of truss 8. No structurally significant timber decay detected on drilling

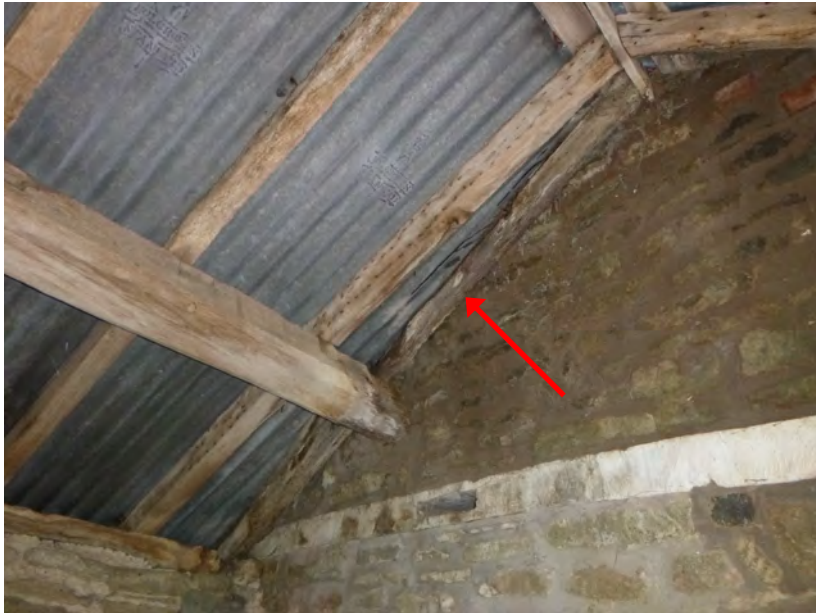
Fig 17:

North stable block; showing structurally decayed common rafter on north pitch at east end

Rafters were deemed suitable for retention for refurbishment at the discretion of the Structural Engineer. The decayed rafter at the east end should be partner repaired or replaced with new to match existing, with provision for isolation from potentially damp masonry. The loss of cross-section affecting the rafter identified on the south pitch should be reinstated using partnering with new timber

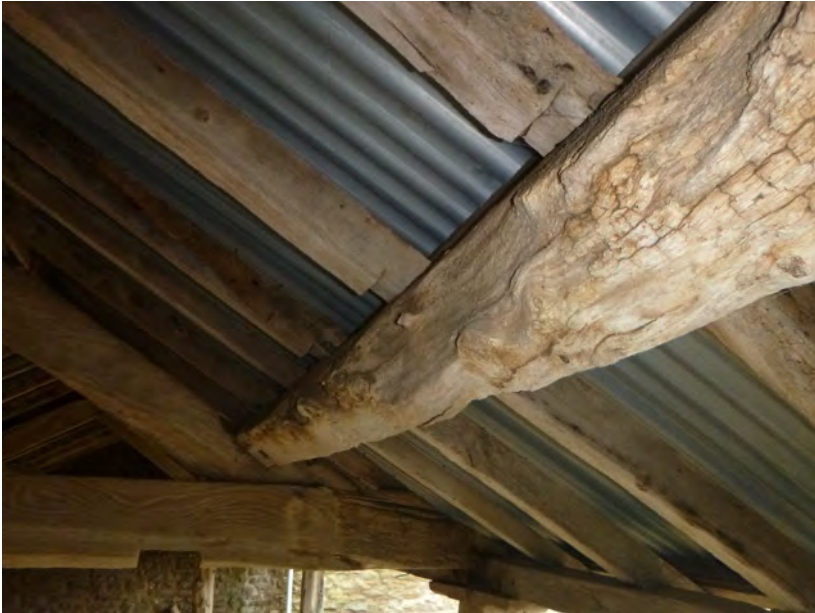
Fig 19:

North stable block; showing localised loss of cross section from historic wood-boring beetle to north side of purlin in bay 7

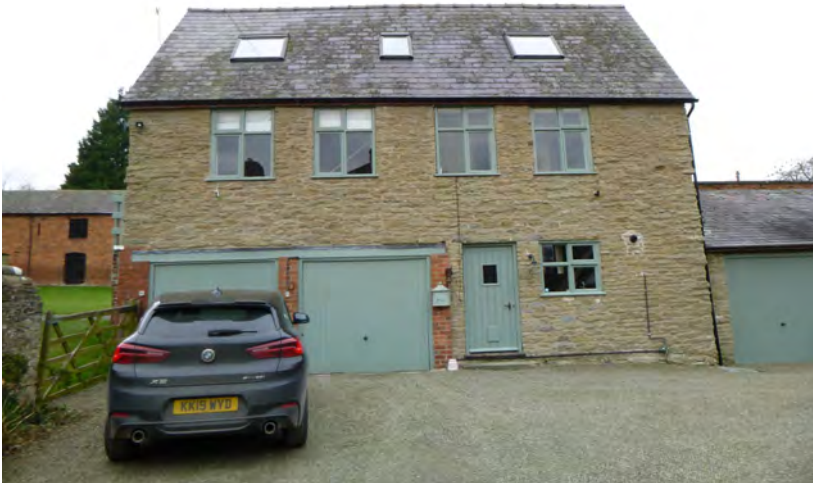
Fig 1:

Exterior, east elevation; showing a general view of the property and of the joinery, which was in good, serviceable order

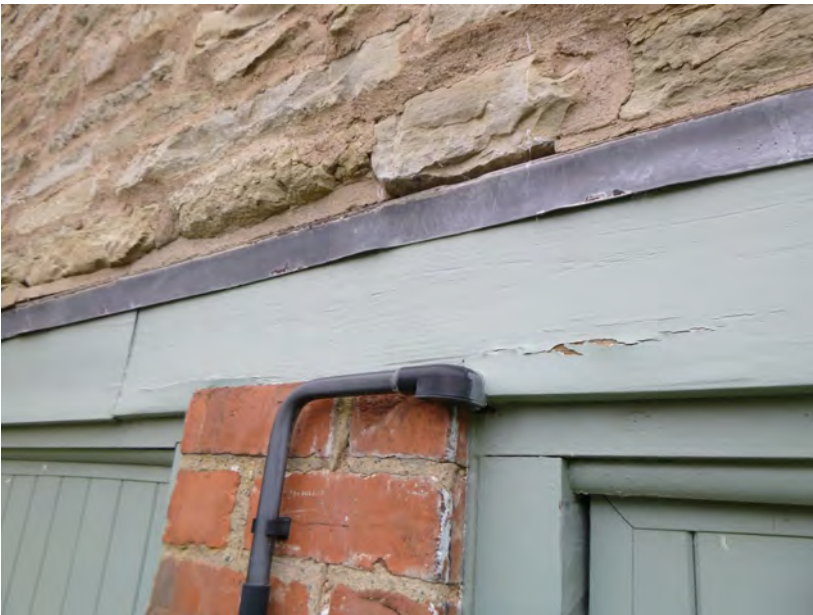
Fig 2:

Exterior, east elevation; showing a localised area of cracking to the finish of the garage lintel fascia board

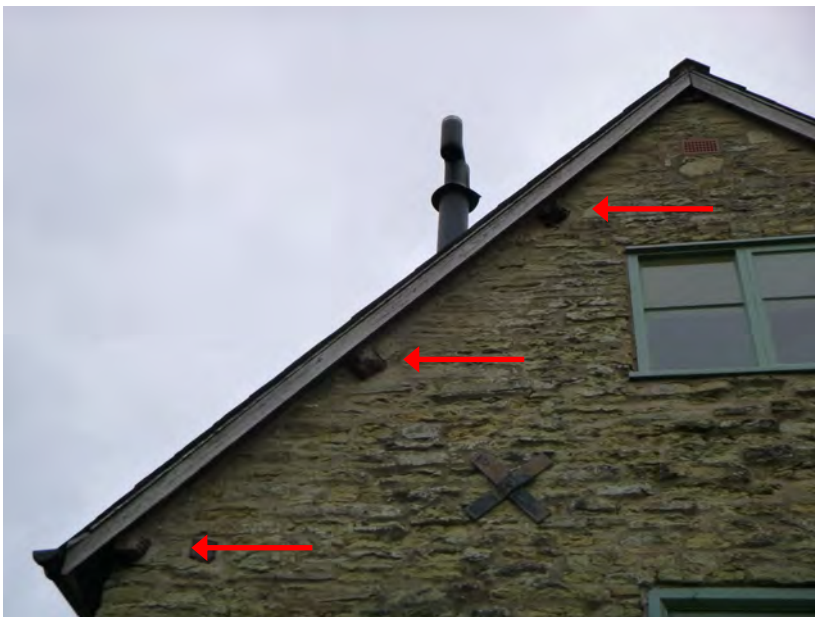
Fig 4:

- 4 Wall plates: The wall plates were concealed in the masonry walls with no accessible voids at the eaves for inspection. As with the purlins, the ends of the wall plates were weathered as they were exposed to the elements. Plates were probed at these areas with no decay observed

Exterior, south elevation; showing the exposed bearing ends of purlins and wall plates, found to be weathered but free of decay

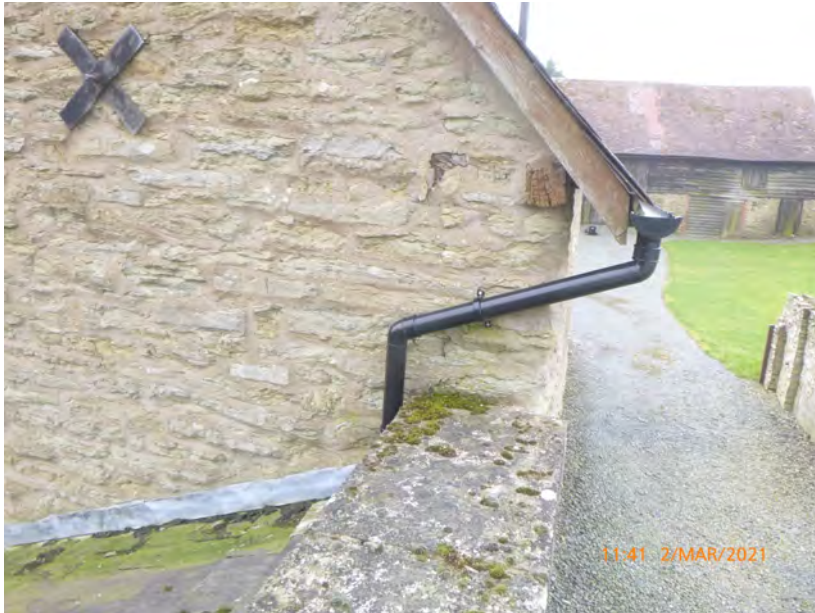
Fig 7:

Exterior, north-west corner of coach house; showing a dog legged downpipe and configuration of wall head plates along west elevation with external rafter plate and tie beam plate on internal face of head of wall

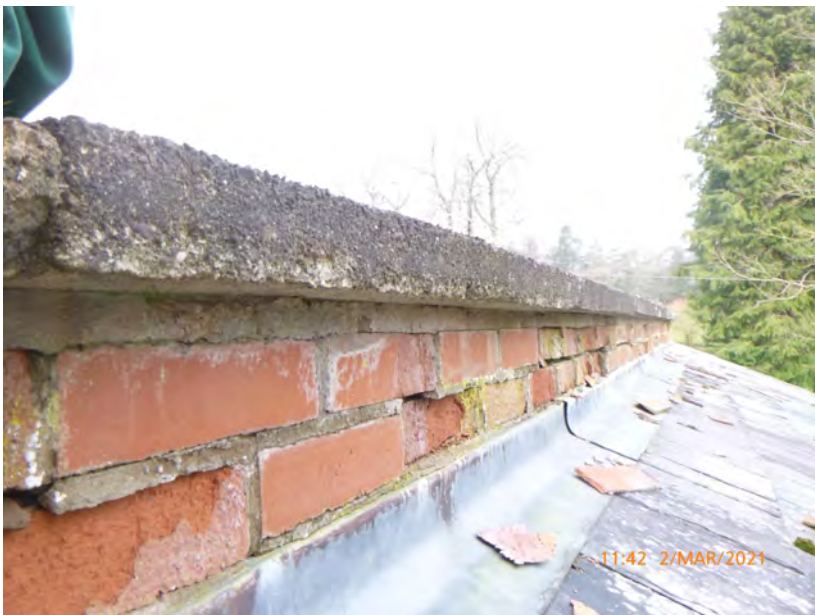
Fig 8:

Exterior, east face of brick parapet wall at east facing pitch of coach house stable roof; showing significant loss of face of bricks due to excessively vapour impermeable hard cementitious pointing and water ingress through coping stones above. Note spalling is particularly acute at coping stone joints

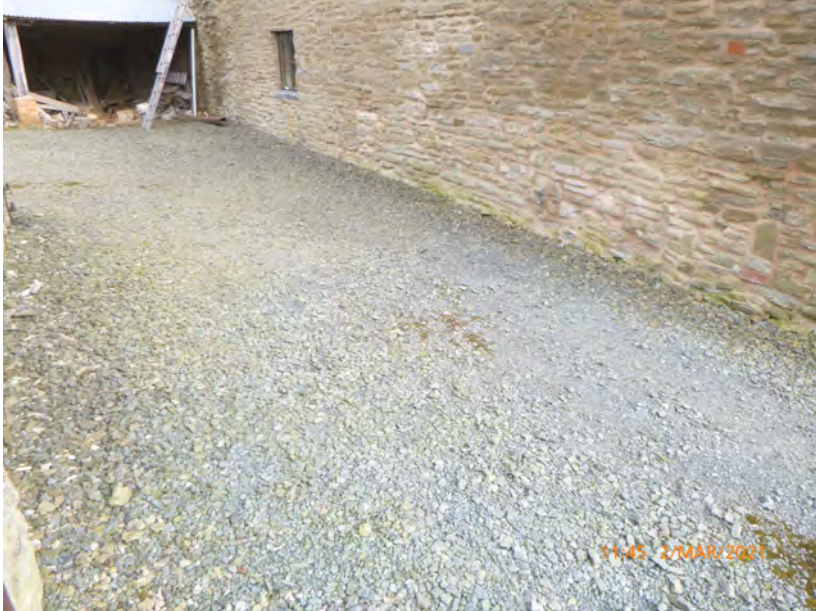
Fig 9:

Exterior, stable yard driveway, west of cottage; showing depression in hardcore suggestive of ponding and perched water at base of cottage at south-west corner

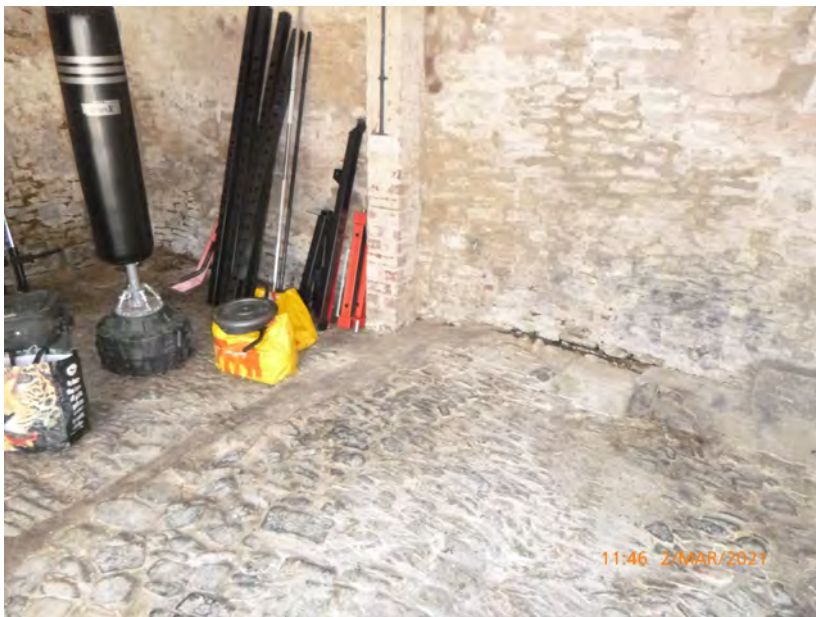
Fig 10:

Interior, west wall base in coach house garages; showing signs of natural water penetration through wall/floor junction

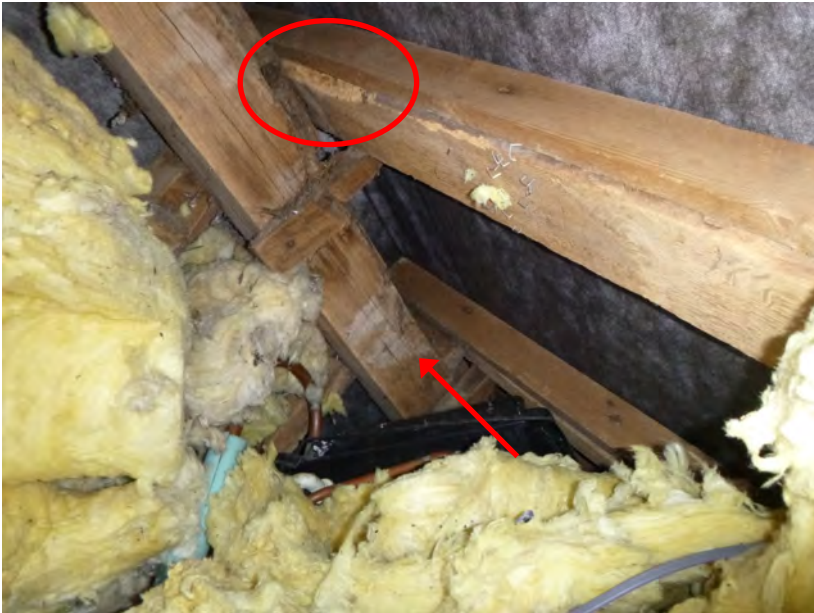
Fig 11:

Interior, attic space; showing a limited view of the roof structure

Also showing superficial sapwood loss from beetle attack and historic water staining to the ridge beam

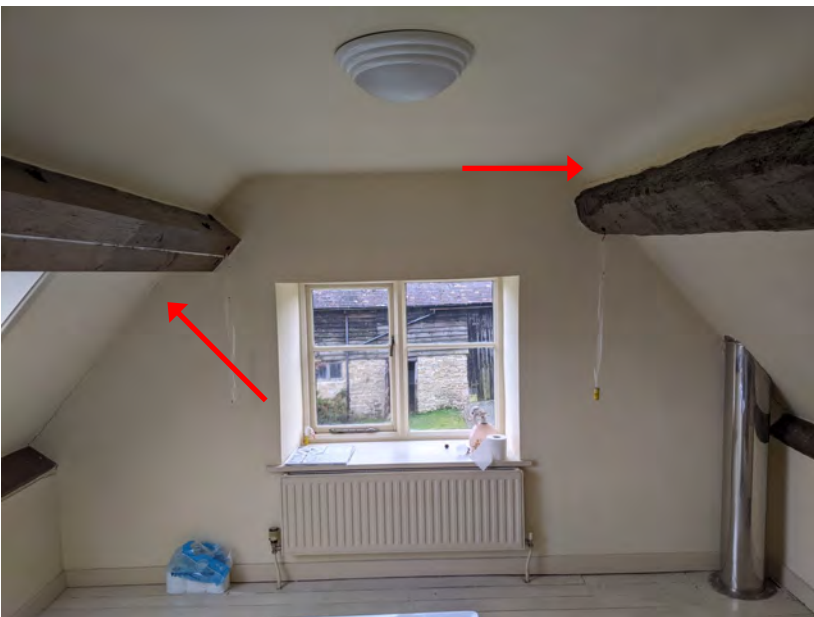
Fig 12:

Interior, second floor; showing a general view of the bathroom

Note the hairline cracking to plaster near to the purlins, not deemed structurally significant

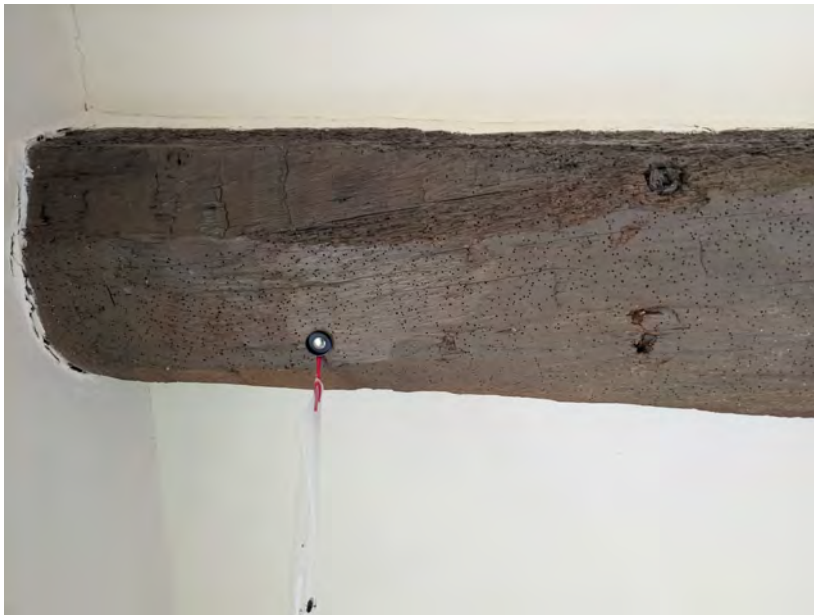
Fig 14:

Interior, second floor; showing historic beetle attack at the south end of the west upper purlin, with flight holes consistent with Common furniture beetle

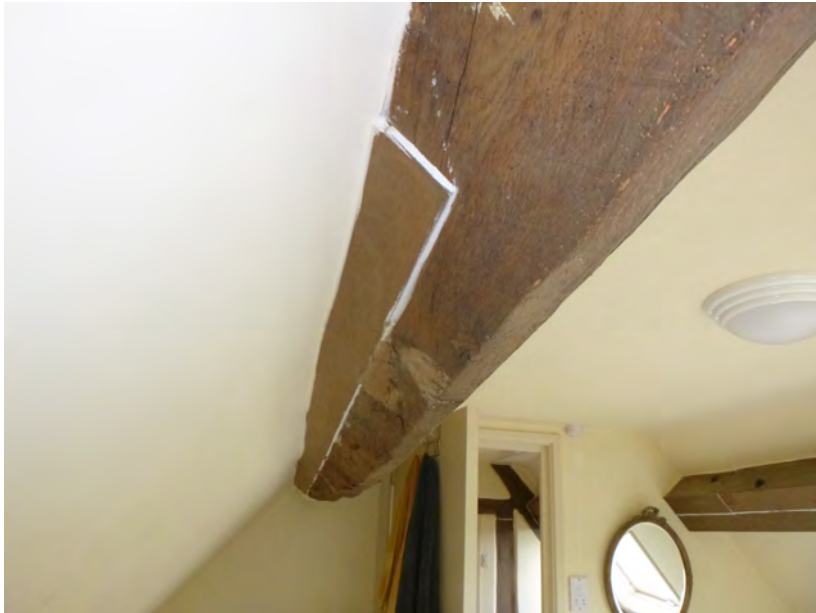
Fig 15:

Interior, second floor; showing a face half-lap joint repair to the west upper purlin

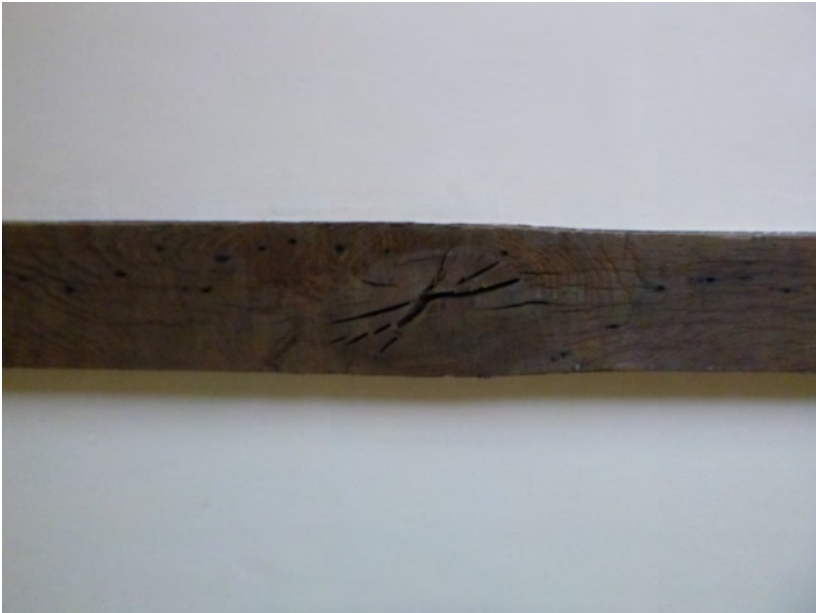
Fig 21:

- 2 Floor joists: Floor joists throughout were in good condition, with no evidence of decay observed. A very large knot was noted to 1 no. joist in the living room and 1 no. joist with knots within 100mm of each other was noted in the first-floor bedroom. Neither of these were decayed however and there was no evidence of

Interior, first floor; showing a large knot covering ~90 per cent of the face of 1no. second floor joist, as seen in the living room. No action required

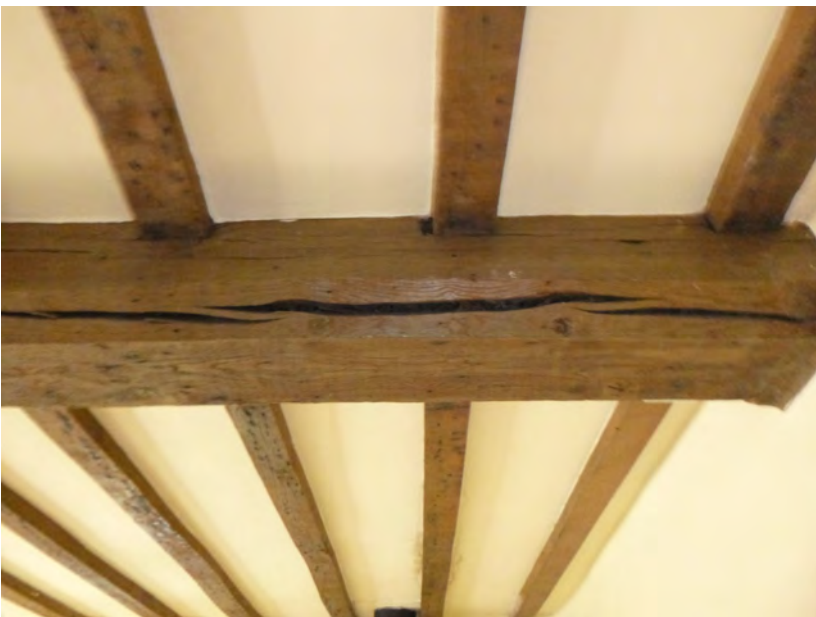
Fig 22:

Interior, first floor; showing a particularly wide drying-out fissure on a second-floor beam, which is a natural defect and not considered to be an issue

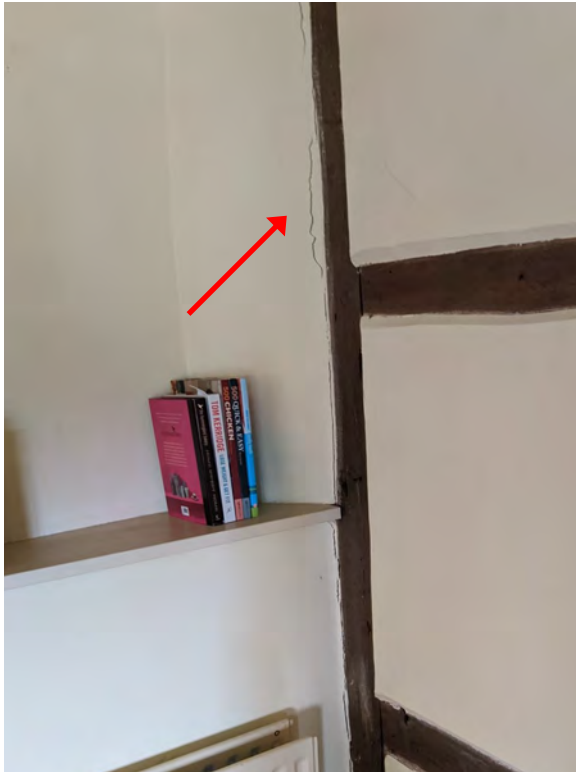
Fig 23:

Interior, first floor; showing hairline cracking to plaster near to the timber stud wall. Subtle movement of timbers and the plaster skim finished without a movement gap was thought to be the cause

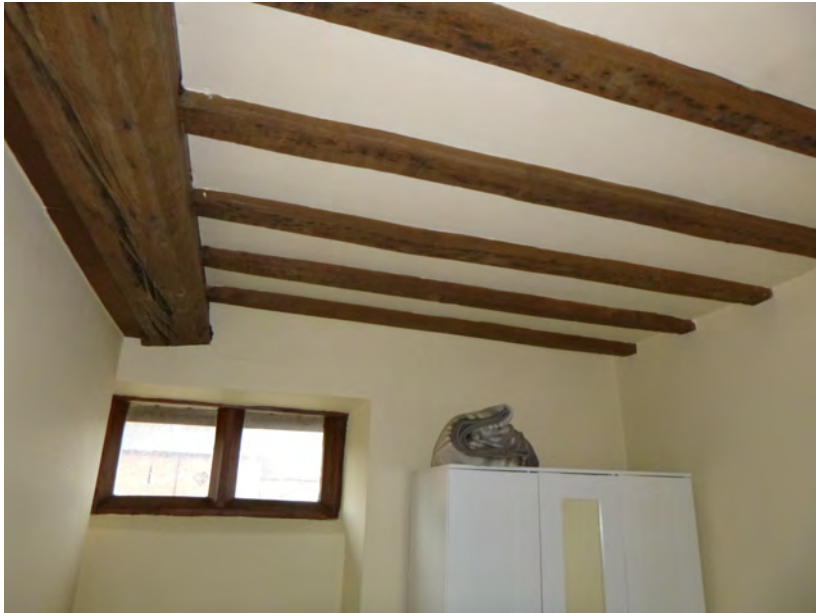
Fig 27:

Interior, first floor; showing another general view of the second floor structure

Also note the drying-out fissure to the floor beam

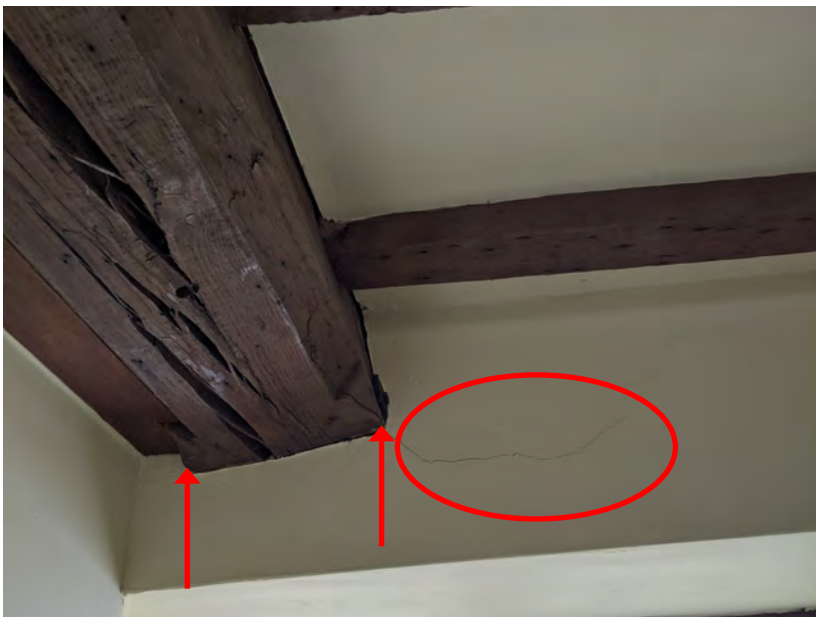
Fig 28:

- 1 Floor beams: No structurally significant decay was detected on drilling floor beams; however, it could not be confirmed whether the floor beams were sat on a suitable DPM or timber pads embedded in the masonry. On the first floor in the living room, drying-out fissures of a considerable size were noted on 1 no. second-floor beam, but this natural defect was not considered structurally significant. The second-floor beam visible within the first-floor bedroom was found to have twisted, the bearing ends had rotated in opposite directions and hairline cracking was noted near the beam ends. Given the minimal size of the cracking and no further evidence of movement to the structure (including no outward lean of masonry walls), it was determined that this was not significant as the beam had now settled in its current position

Interior, first floor; showing a view of the twisted floor beam and associated cracking to plaster. The movement was believed to have settled and was not deemed structurally significant

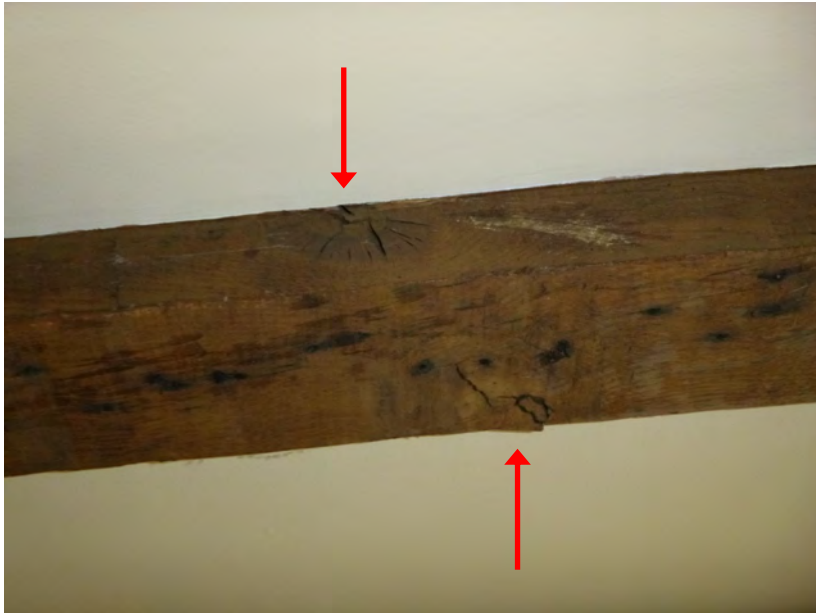
Fig 29:

Interior, first floor bedroom; showing 2 no. knots within 100mm of each other. No evidence of stress to the floor joist and so no action required

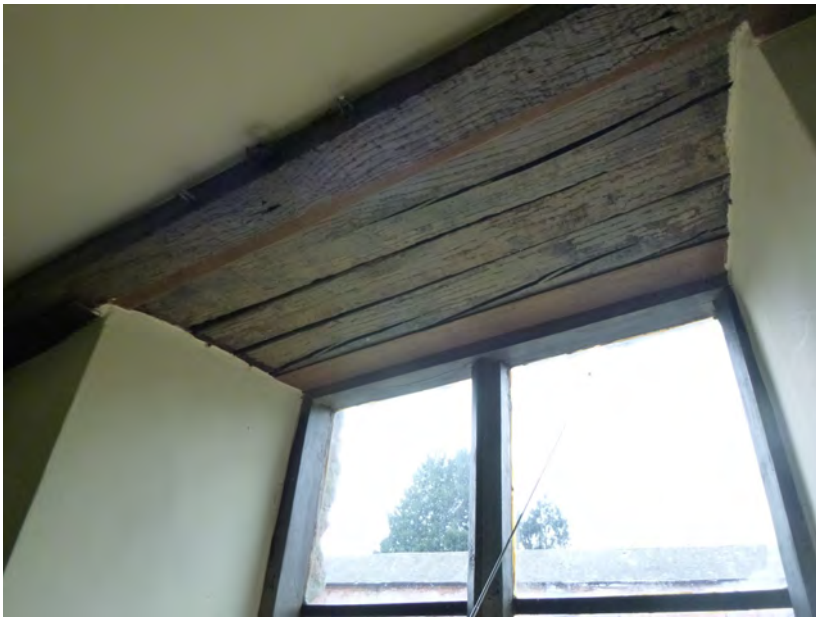
Fig 32:

Interior, ground floor; showing the lintel arrangement made up of several smaller section timbers, no decay detected on drilling

No chemical treatment required in relation to wood-boring beetle infestation or fungal decay organisms. The timber lintels were deemed suitable for retention at the discretion of the Structural Engineer

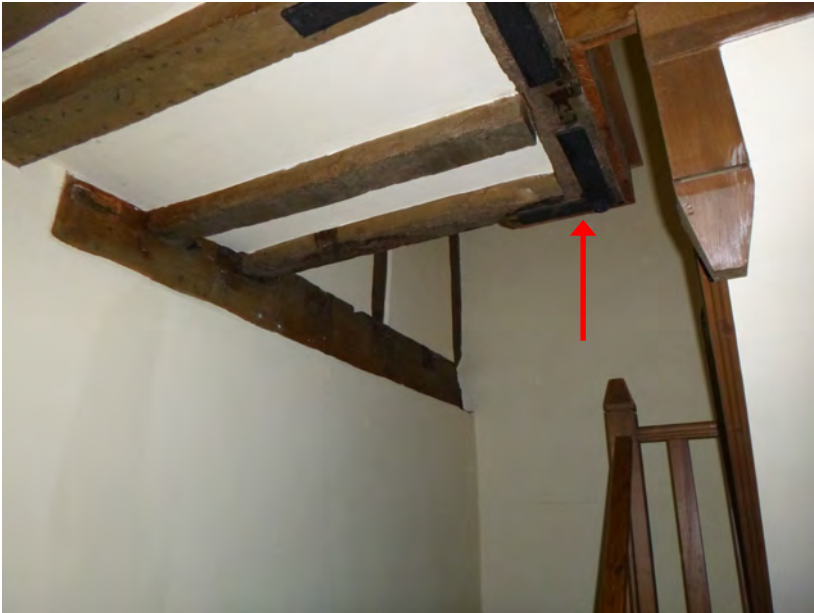
Fig 33:

Interior, ground floor; showing metal reinforcement to the trimmer joist at the stair opening

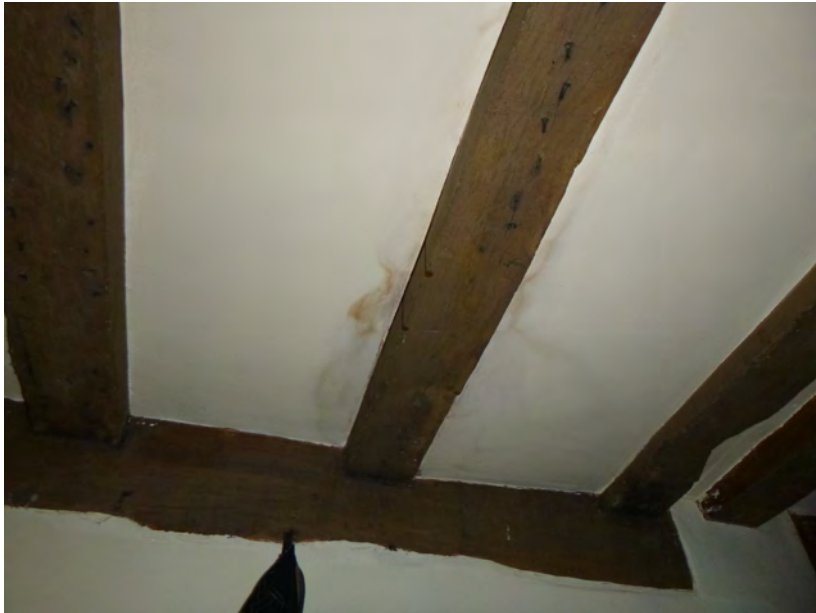
Fig 35:

Interior, ground floor; showing localised water staining to plaster and finishes between first floor joists, thought to be caused by a water leak from the bathroom directly above

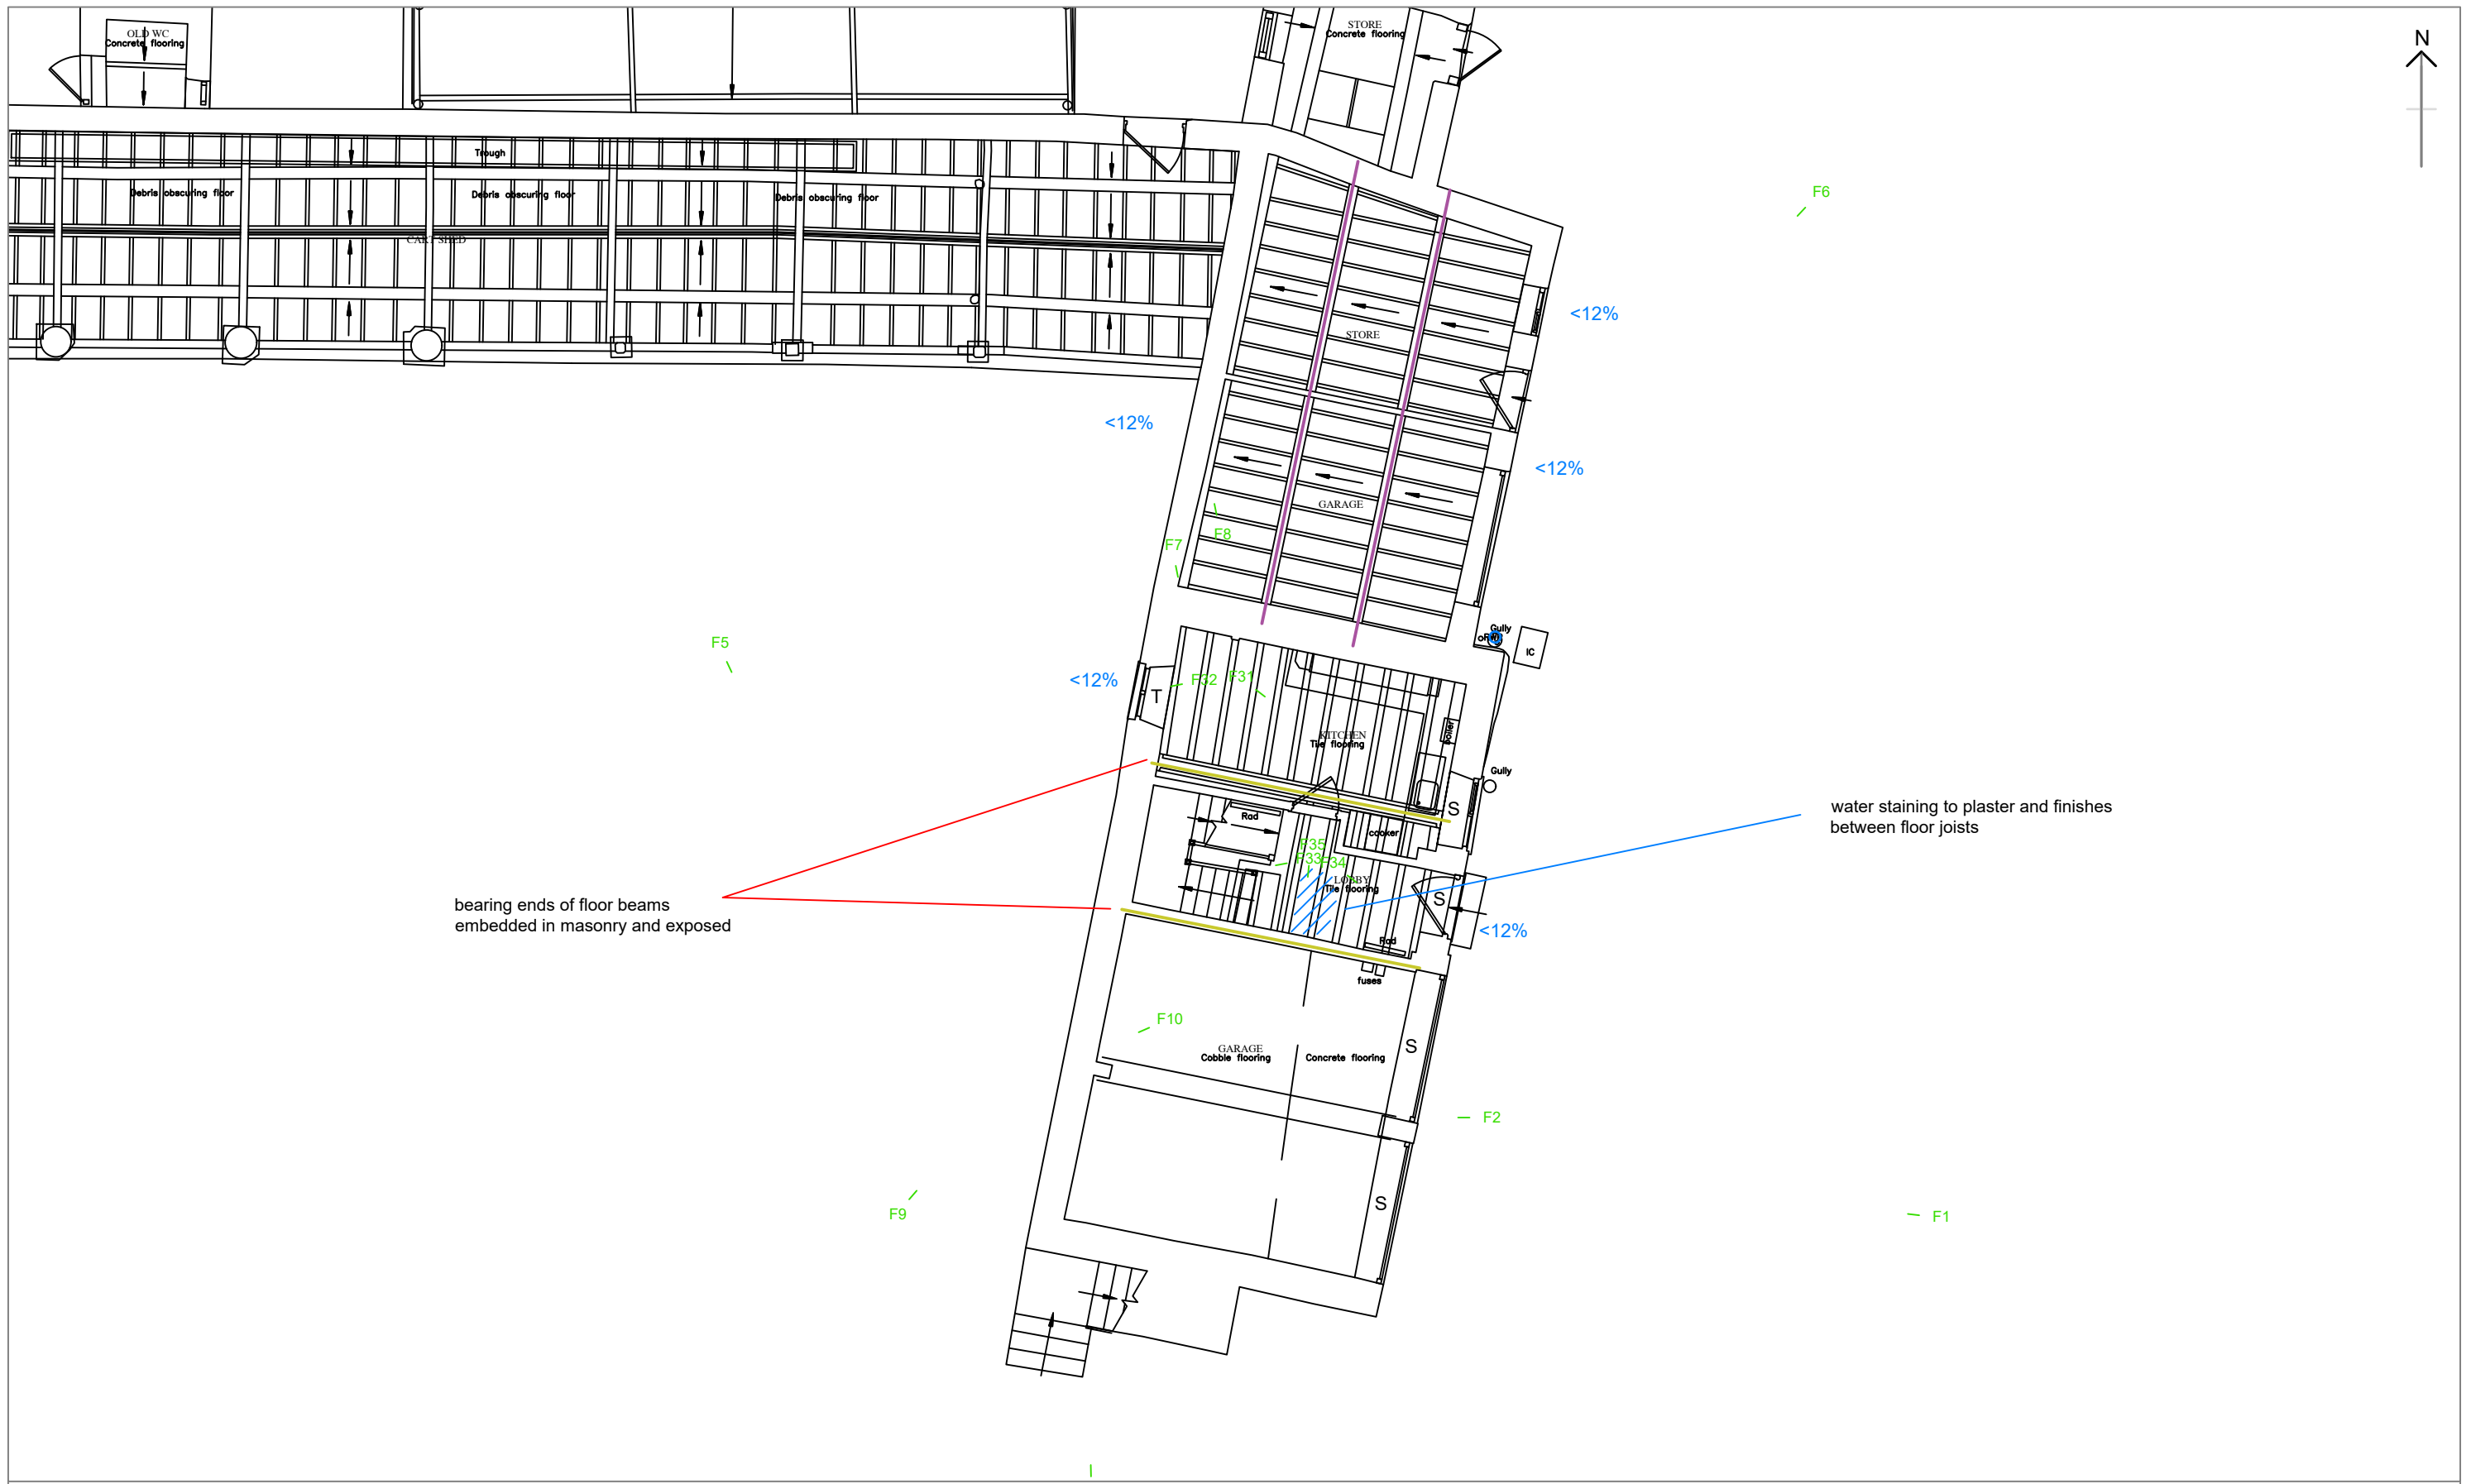
Aston Hall, Coach house - second floor structure
 Preliminary timber condition investigation
 March 2021

bearing ends of floor beams
embedded in masonry and exposed

water staining to plaster and finishes
between floor joists
