ASTON HALL - SHROPSHIRE
Aston Munslow - Craven Arms

DESIGN AND ACCESS AND
HERITAGE STATEMENT

Submission to Local Authority

September 2021 - REV 0

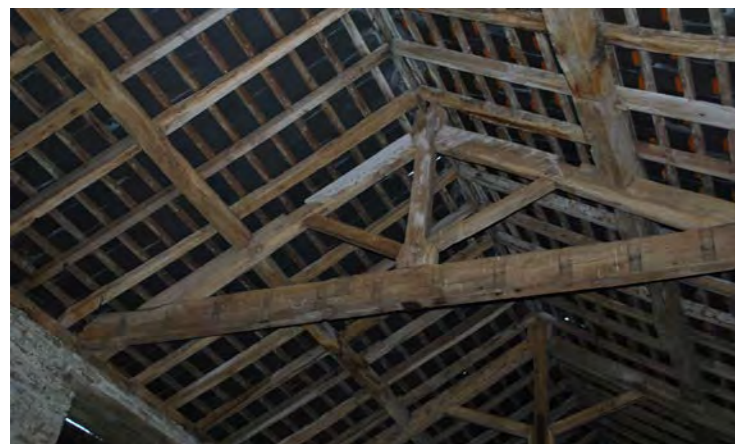
2. KING POST TRUSS MADE FROM RECYCLED TIMBERS

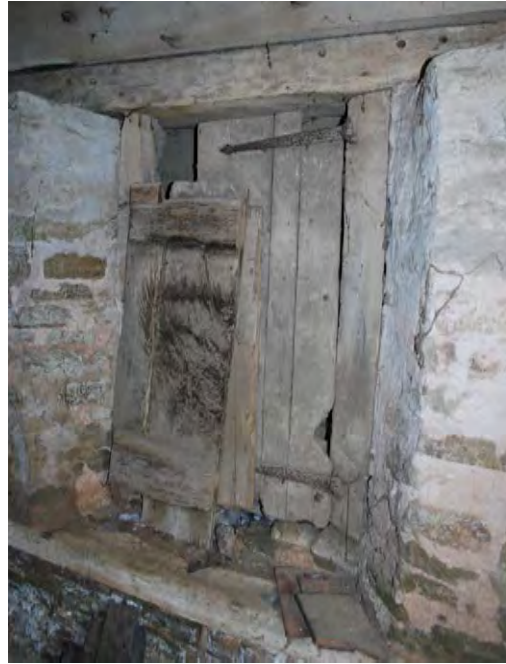
1. FRAGMENTARY REMAINS OF HISTORIC DOORS

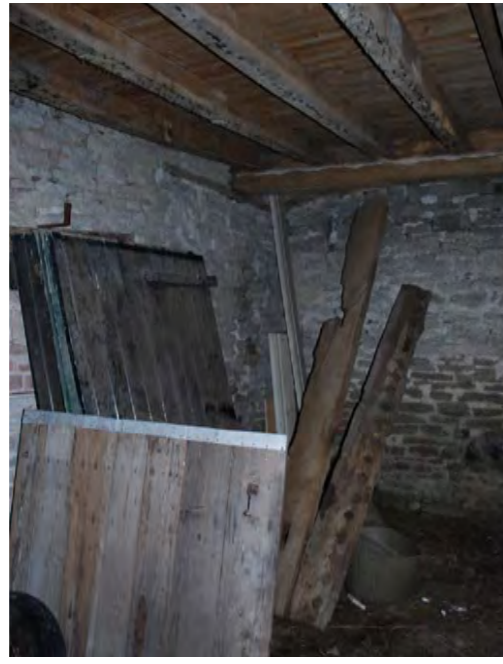
3. REDUNDANT HISTORIC DOORS

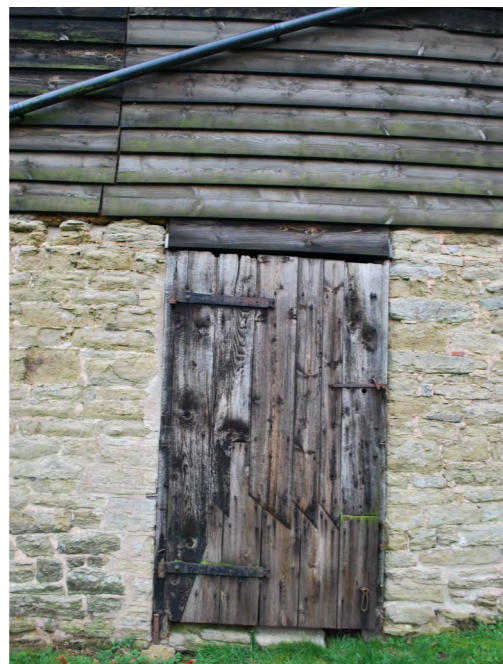
3. HISTORIC DOOR WITH SPAB REPAIRS

4. Door partially repaired at foot where there is wet rot.

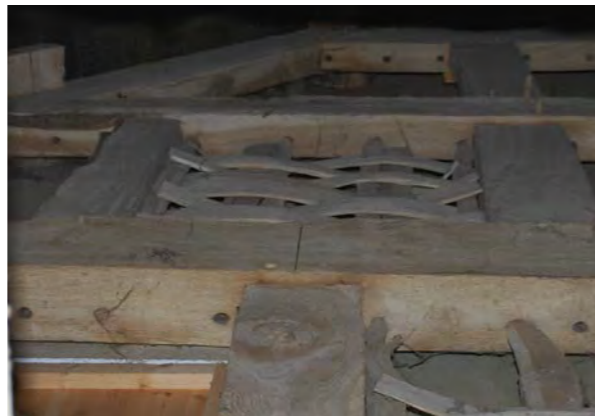
6. A SURVIVING EXAMPLE OF WOVEN STUD WORK

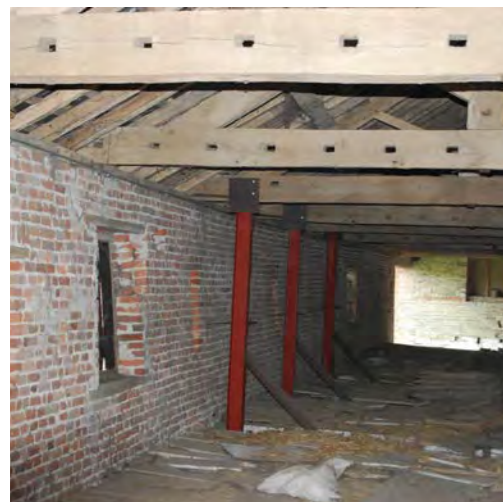
2. Internal steel stanchions (South Wall): the bottom member of the roof truss is now supported in certain places with steel stanchions linked to the ground floor steel beams and stanchions, see photo 4. The structural efficacy of these repairs and strengthening will need to be checked and replaced with something more sensitive.

2. INTERNAL STEEL STANCHIONS (EAST WALL)

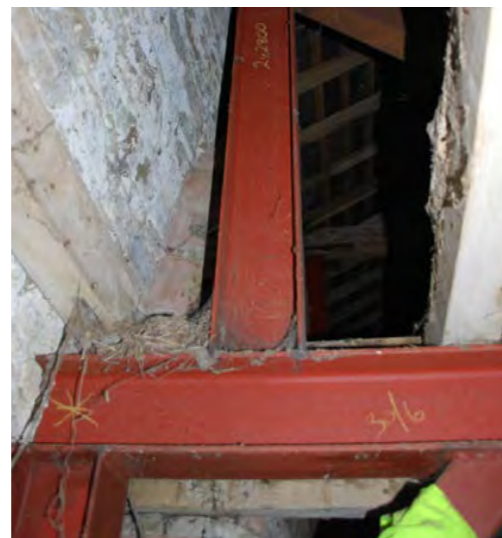
4. Internal Steel Stanchion, (North Wall): The North wall is leaning significantly and is similar; in its effect as the South Wall. This suggests that the South Wall's failure has 'pulled' the North Wall one out of vertical alignment, see Photo 2 above. The shed supports will be replaced with a more sympathetic structural repair.

4. INTERNAL STEEL STANCHIONS (WEST WALL)
