# **Arboriculture Impact Assessment**

Project:
Summerville,
Hargate Drive,
Hale WA15 ONL

Date: June 2021

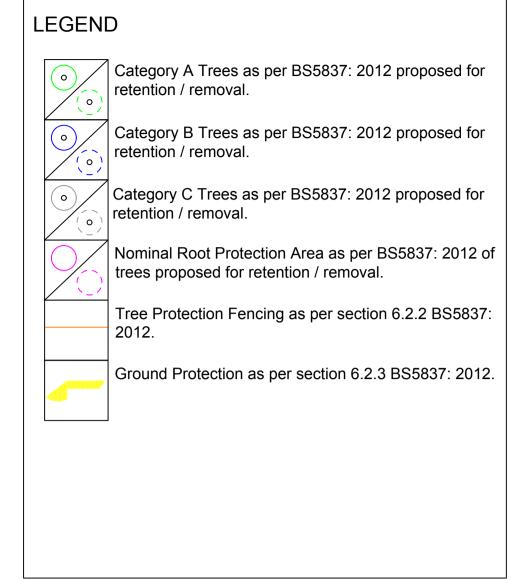
- T3, T5 and T19 positions approximate, plotted
- Plan to be read in conjunction with MPTrees BS5837:2012 Trees Survey Data Tables, Somerville, June 2021
