**STRUCTURAL AND BUILDING METHODOLOGY STATEMENT
FOR THE RESIDENTIAL CONVERSION OF GRANARY BARN
AT**

**Trelash Farm
Warbstow
Launceston
PL15 8RL**

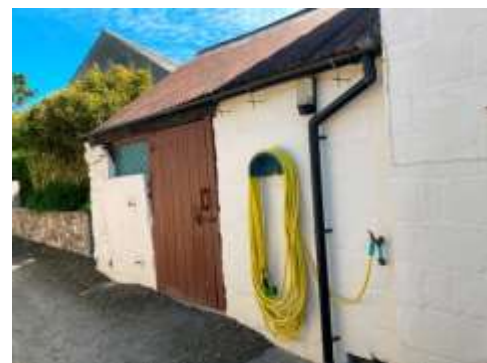
- sawn timber rafter at positions shown on first floor plan TM765a.E2 - adequate condition, but sufficient in number only for a lightweight roof covering - Fig 5

- sawn timber tie beam - these have been positioned high to maximise headroom. A conversion should seek to replace or add a tie-beam lower on the A frames to reduce lateral pressure on the top of the existing walls - Fig 5
