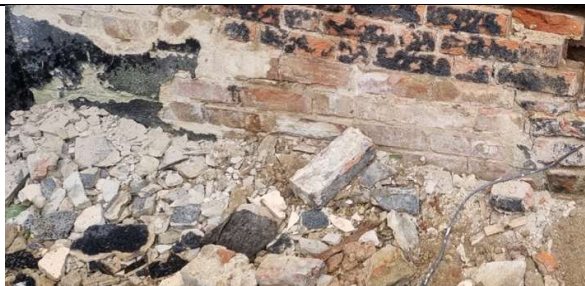
Photos showing areas of concrete render to be removed and photos of render removed. Location on Floorplan G, H and I. Most existing Riven Chestnut laths in good condition, brickwork plinth in good condition.
