BS5837:2012 Tree Survey Report

Proposed Relocation of Wendover Cricket Club to Tring Road, Wendover Site

Tring Road, Wendover, Aylesbury HP22 5PN

Revision B 7th September 2021

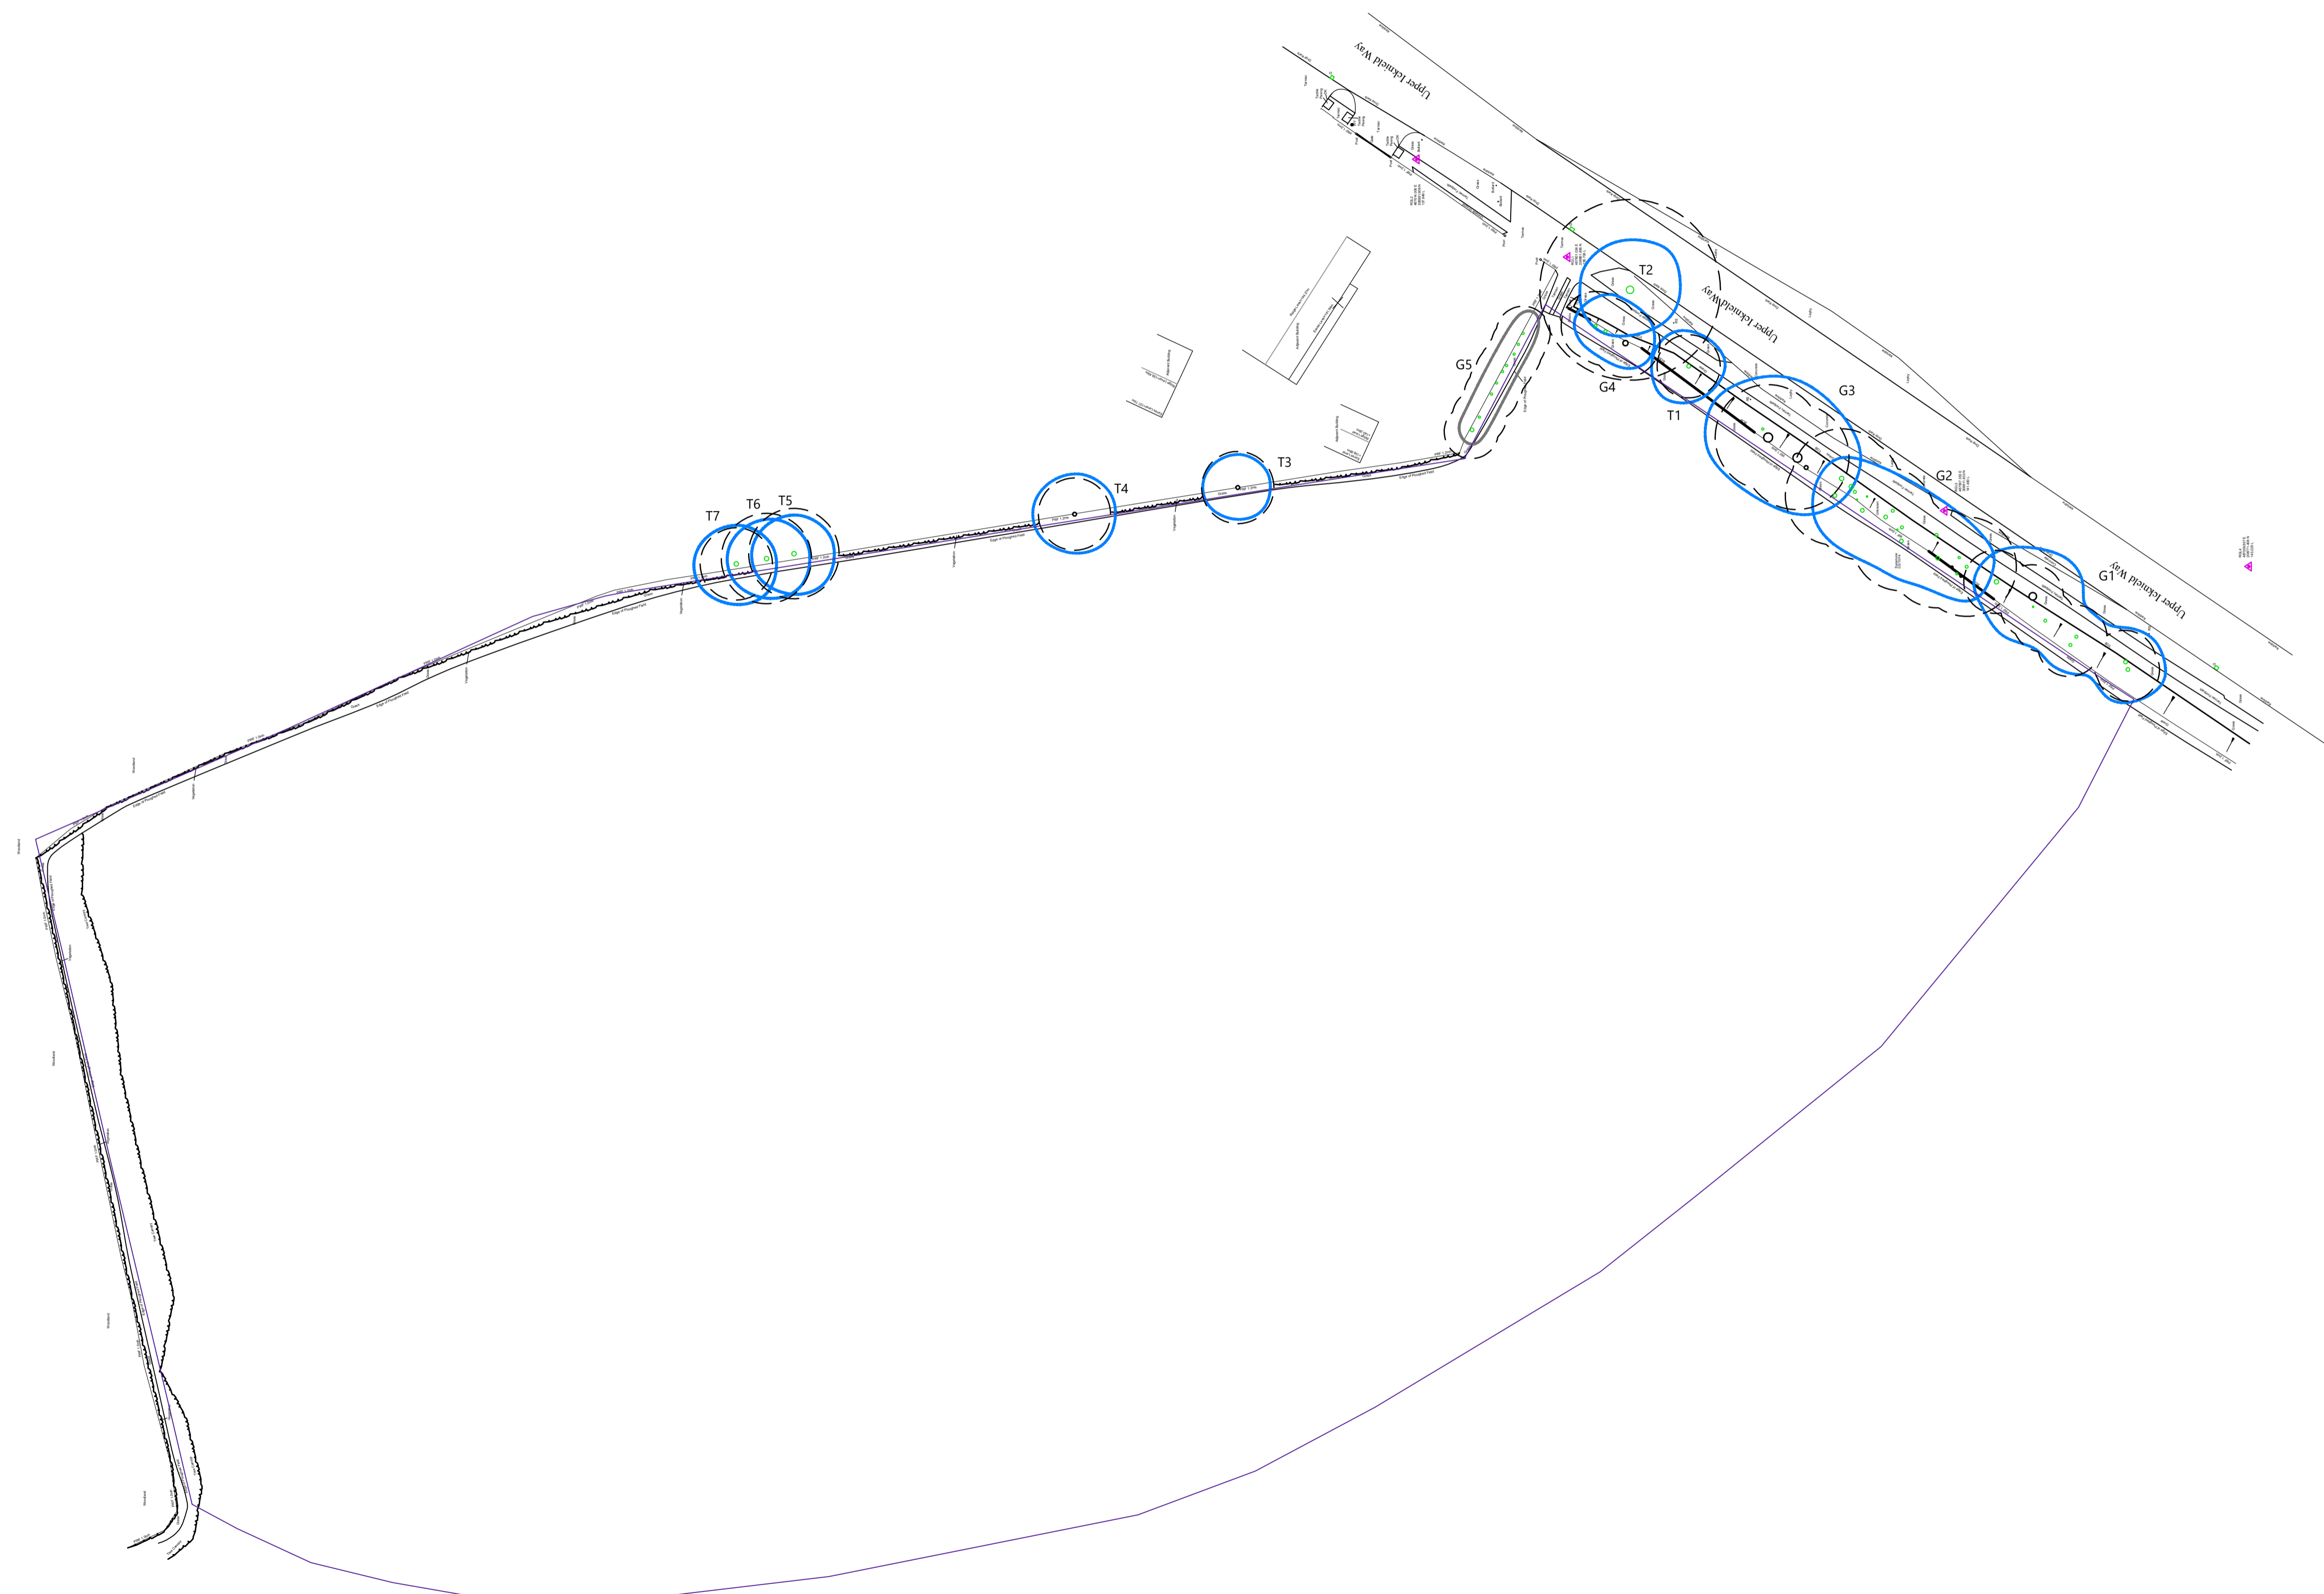
Appendix B - Tree Survey & Constraints Plan

The layout of the car park on the whole does not encroach into the RPA of any of the trees to be retained, with the exception of T3 which has 2 car parking spaces encroaching approximately 2m into the root protection area which is detrimental to the survival of the tree. It is recommended that the layout is amended to move the spaces outside of the RPA. If not, then a “no-dig” cellular confinement system should be used to protect the tree roots when constructing the car parking spaces.

5.3 The layout of the car park on the whole does not encroach into the RPA of any of the trees to be retained, with the exception of T3 which has 2 car parking spaces encroaching approximately 2m into the root protection area which is detrimental to the survival of the tree. It is recommended that the layout is amended to move the spaces outside of the RPA. If not, then a “no-dig”
