## **TREE CONDITION SURVEY & REPORT**

**HOSPITAL OF ST JOHN & ST ELIZABETH,  
60 GROVE END ROAD, LONDON**

**20.10.21 EAS-018**

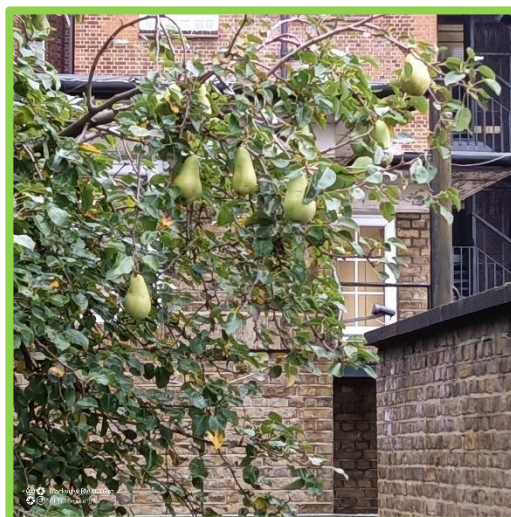
- 5.3 Thirty-one trees were categorised as requiring works to be undertaken within 3 months, See details at Appendix 4. These include to remove the large Pear fruits from T1 (see below), as required each year to eliminate identified H&S hazards from falling fruit.

31 trees were categorised as requiring works to be undertaken within 3 months, See details at Appendix 4. These include to remove the large Pear fruits from T1, as required each year to eliminate identified H&S hazards from falling fruit.
