Forester and Arborist Services Ltd

Inspection of trees on Benefice Land

Record of Remedial Work Proposed and Completed

The Vicarage Tong Shropshire TF11 8PW

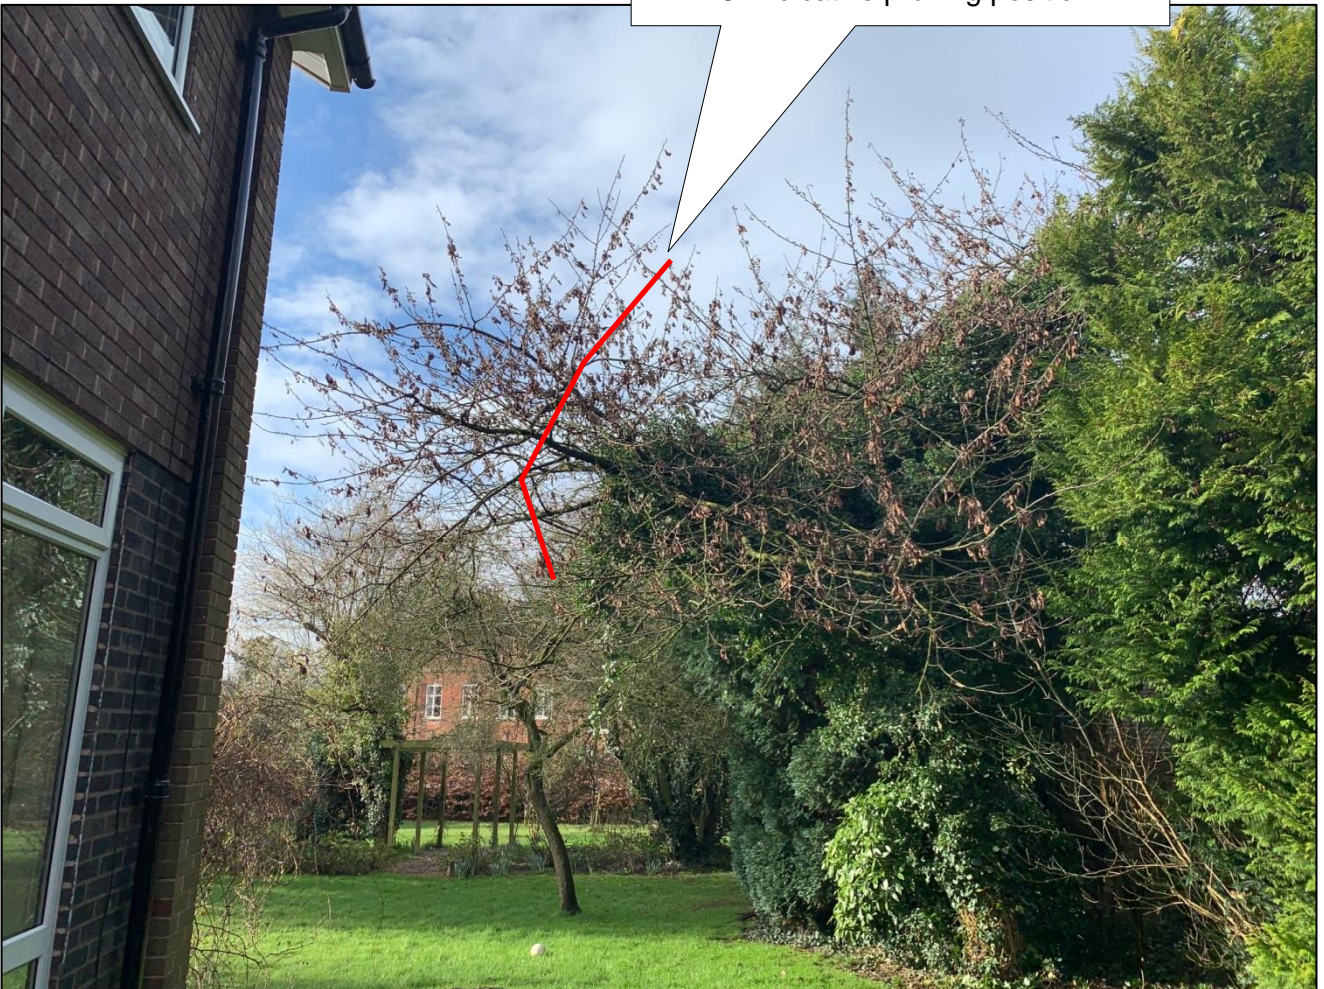
T5	Lawson cypress Gold cv	Mature	Root: No evidence of soil movement. Stem: foliage to ground level Crown: No recent breakouts or dieback. BT cable in contact with upper crown. Risk Assessment: No significant defects visible from ground level.	TFM 23.7.12	Inspect in 5years or following storms Refer to photo detail.	4	
			Root: No evidence of soil movement. Stem: foliage to ground level. Crown: No recent breakouts or dieback. BT cable in contact with upper crown and is deflecting the line. Risk Assessment: the crown is deflecting the telephone line and could cause damage to the line in times of high wind.	ZA 12.02.2020	Reduce the height of the Lawson's cypress by 2m to give clearance to overhead telephone cables. Inspect within 5 years or following storms. Refer to photo detail.	3	
T5a	Dead stem	Dead	Stem is dead and completely obscured by dense ivy.	ZA 12.02.2020	Fell stem to ground level.	3
