Our Ref: 210607/PAH/PMR

**BARN AT WEAVERS FARM, WEAVERS LANE, CABUS, PR3 1AJ.**

**INTRODUCTION**

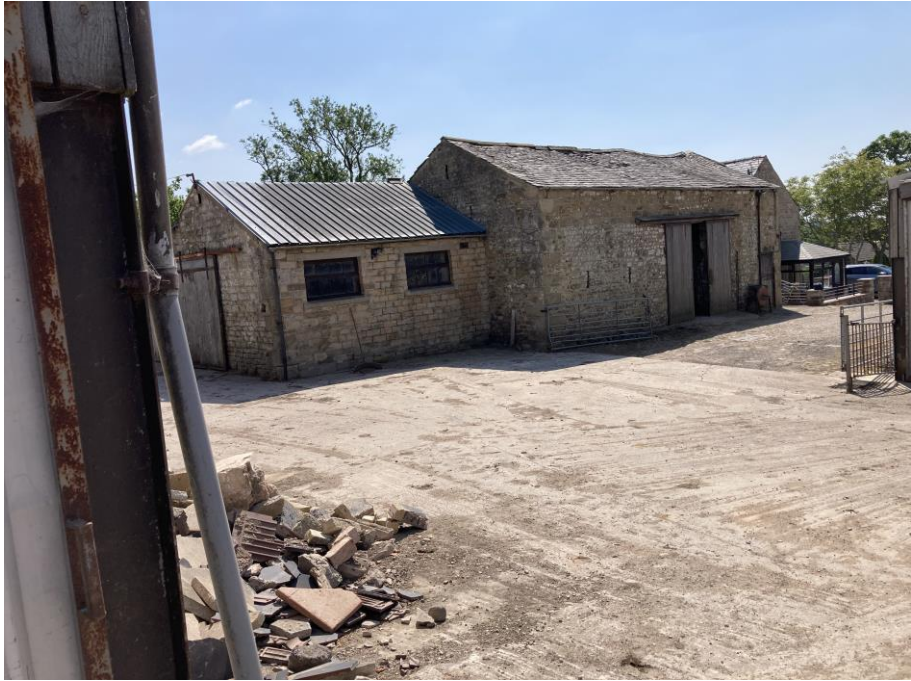
Externally we could see no evidence of structural cracking on any of the elevations and, despite some undulations, most of these appear relatively plumb and level. It is apparent however that the roof has sagged between the internal supporting trusses, see photo at rear of this report.
